DEPARTMENT OF THE INTERIOR  
UNITED STATES GEOLOGICAL SURVEY  
GEORGE OTIS SMITH, DIRECTOR

THE  
SAN FRANCISCO EARTHQUAKE AND FIRE  
OF  
APRIL 18, 1906  
AND THEIR EFFECTS ON STRUCTURES AND  
STRUCTURAL MATERIALS

REPORTS BY  
GROVE KARL GILBERT, RICHARD LEWIS HUMPHREY,  
JOHN STEPHEN SEWELL, AND FRANK SOULÉ

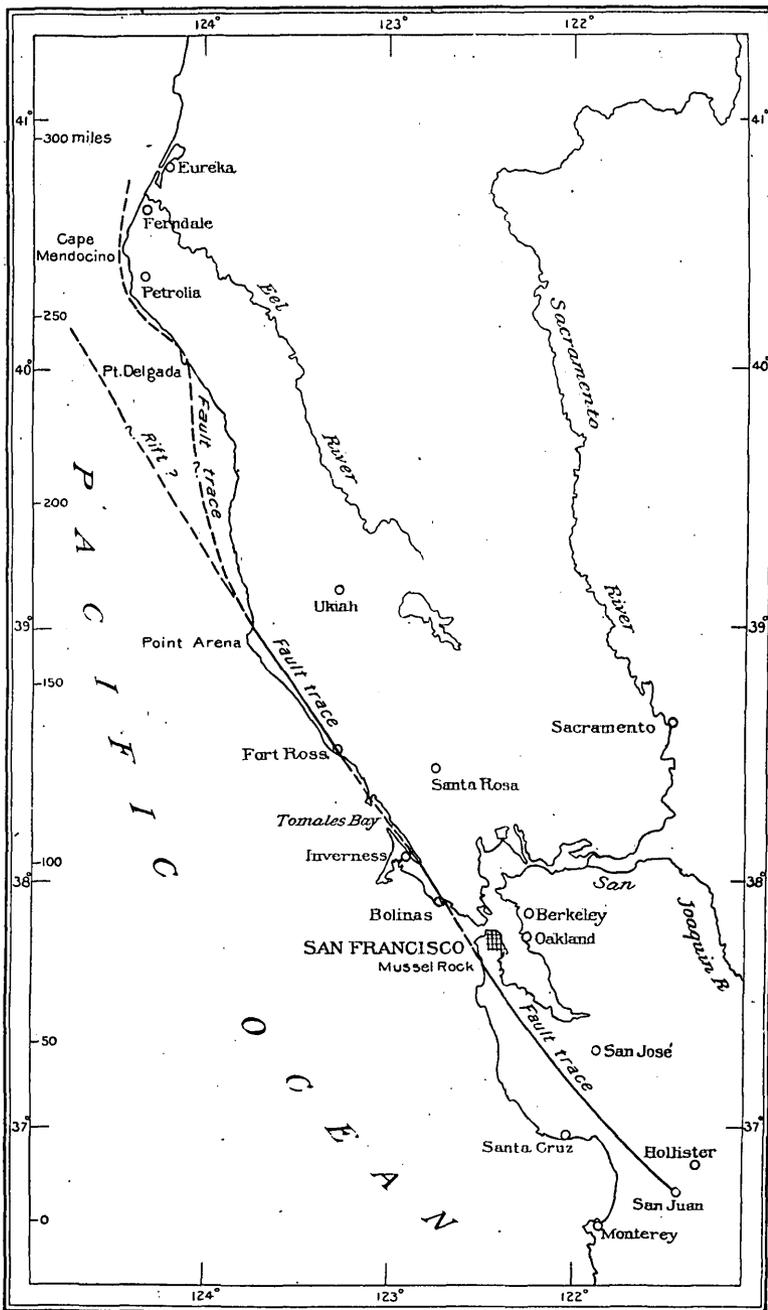
FIG. 1.—Map of the fault trace. Broken lines indicate alternative hypotheses as to its extension north of Point Arena.

The region of high intensity, to which most of the destruction was limited, is a belt 20 to 40 miles wide, extending from the mouth of Eel River at the northwest to Priest Valley at the southeast (fig. 1). This belt includes the surface expression of the principal fault—a feature distinctively known as the fault trace—a large number of cracks, and many local and superficial dislocations of soil and rock variously characterized as landslides and slumps.

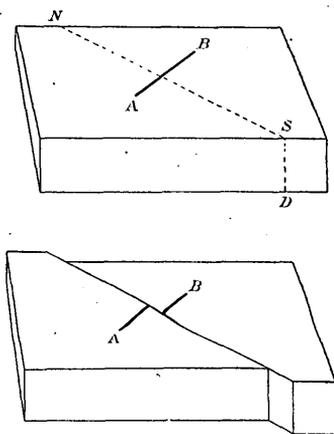
FIG. 2.—Diagrams illustrating the nature of the earthquake-making fault.

As the statement of these relations is sometimes found confusing, they are here illustrated diagrammatically. The upper diagram in fig. 2 represents a rectangular block as if cut from the land, the thickness being 25 feet, the length east and west (right to left) 150 feet, and the width 100 feet. The dotted line NS indicates the surface outcrop of the old fault plane, trending northwest and southeast, this plane cutting the face of the block in the vertical line SD. AB stands for any straight line on the surface of the land—such as would be defined by a road, a fence, or a row of trees—crossing the fault outcrop at right angles. The lower diagram represents the same

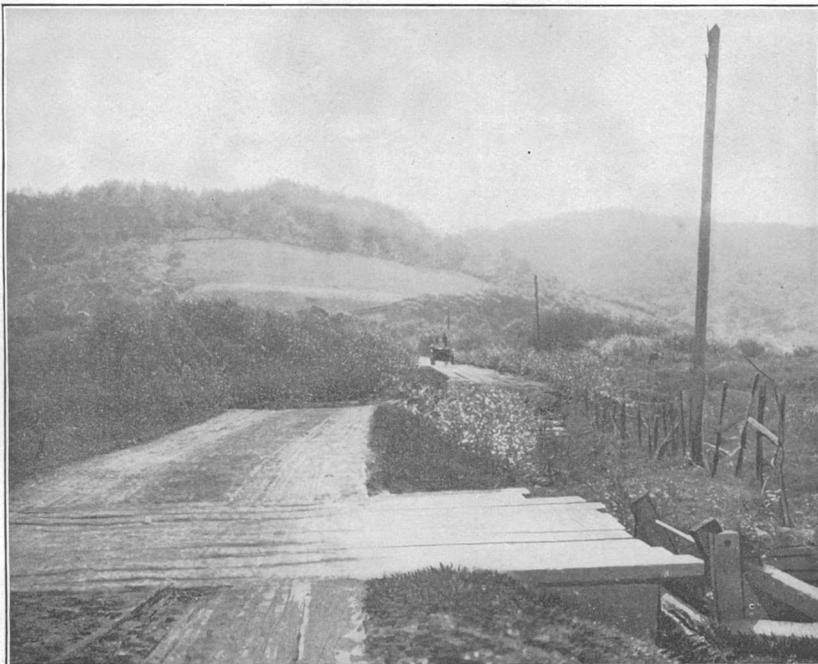
A. ROAD CROSSING FAULT TRACE NEAR POINT REYES STATION.  
Looking southwest. Offset, 20 feet. Photograph by G. K. Gilbert.

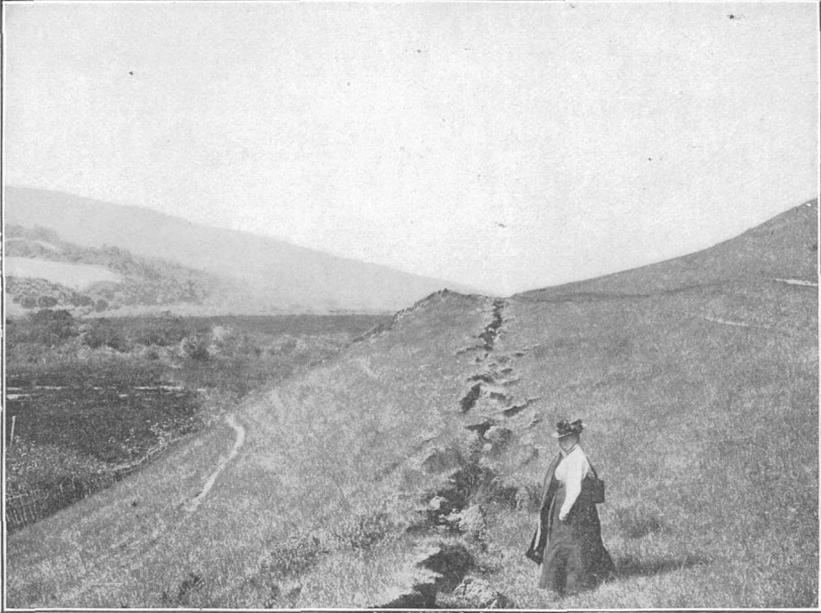
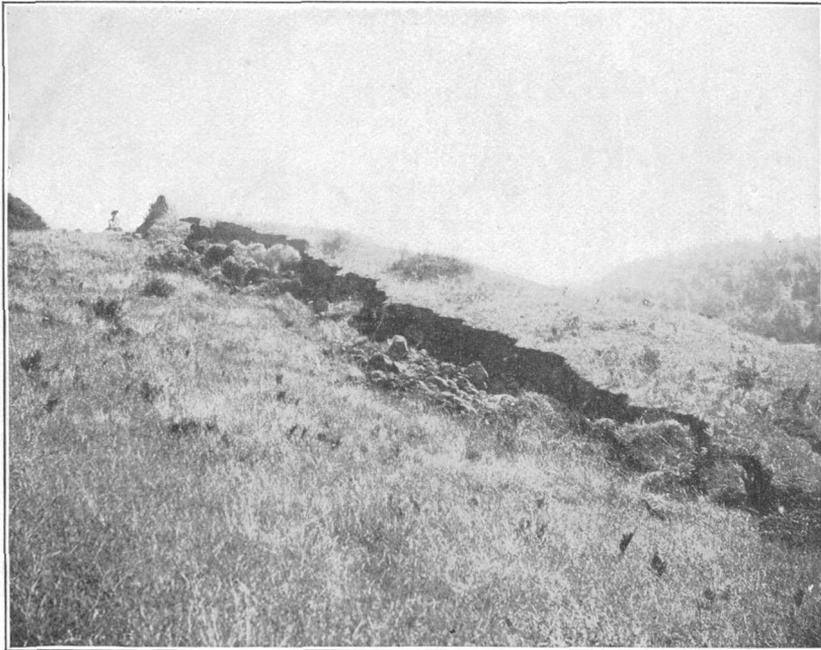
THE FAULT TRACE NEAR POINT REYES STATION.

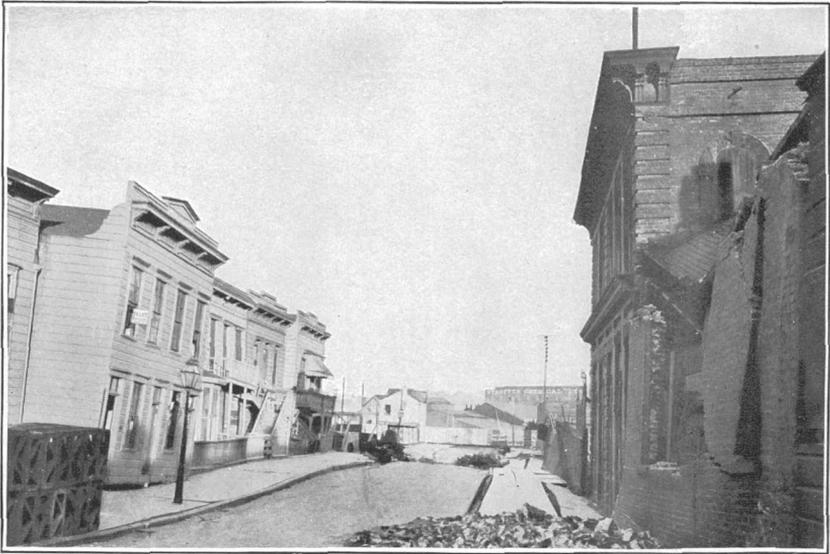
A. SETTLING (5 FEET) ON DORE STREET, BETWEEN BRYANT AND BRANNAN STREETS, SAN FRANCISCO.

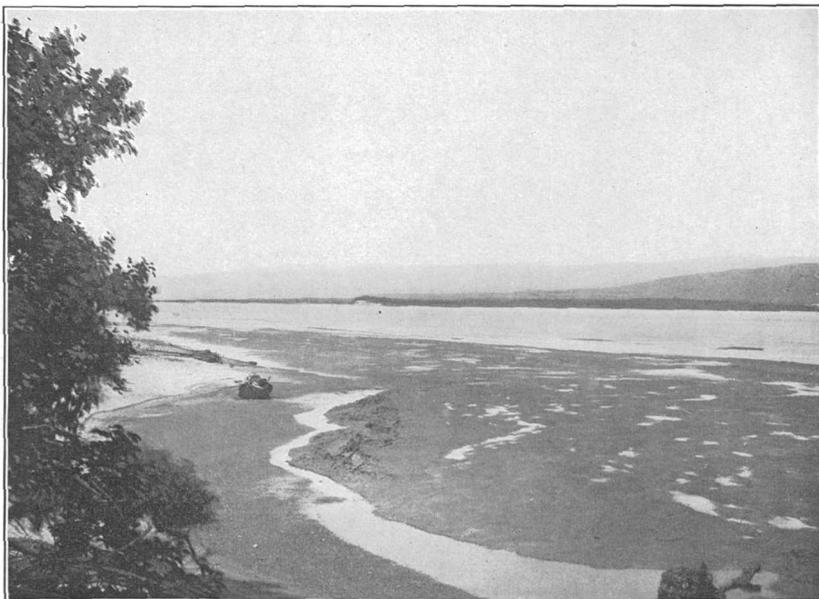
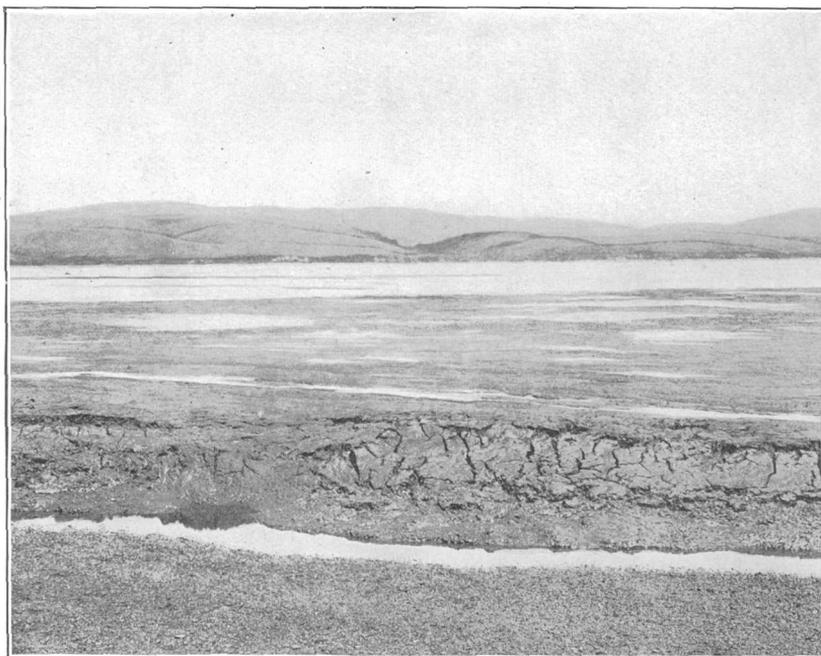
SHIFTED BOTTOM OF TOMALES BAY.

A, General view; B, Edge of new shoal. Photographs by G. K. Gilbert.

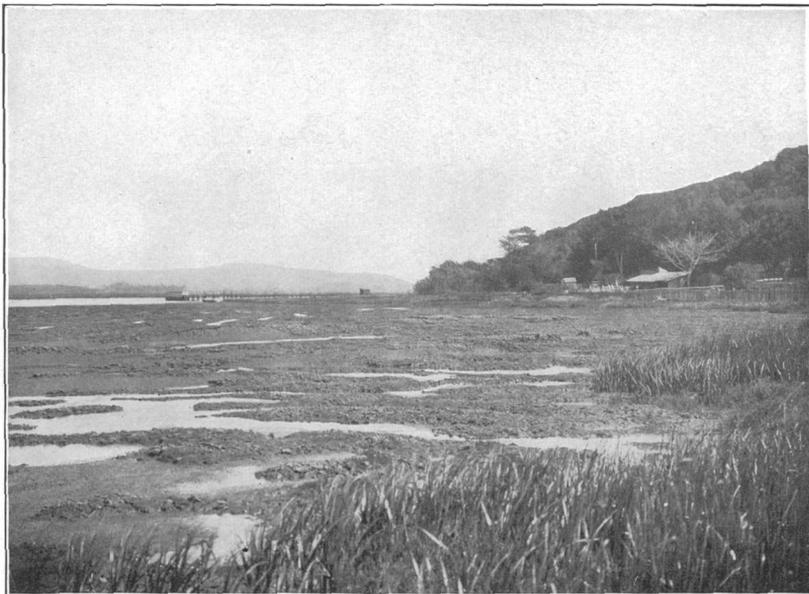
A. EARTHQUAKE RIDGES ON TIDAL FLAT, TOMALES BAY.

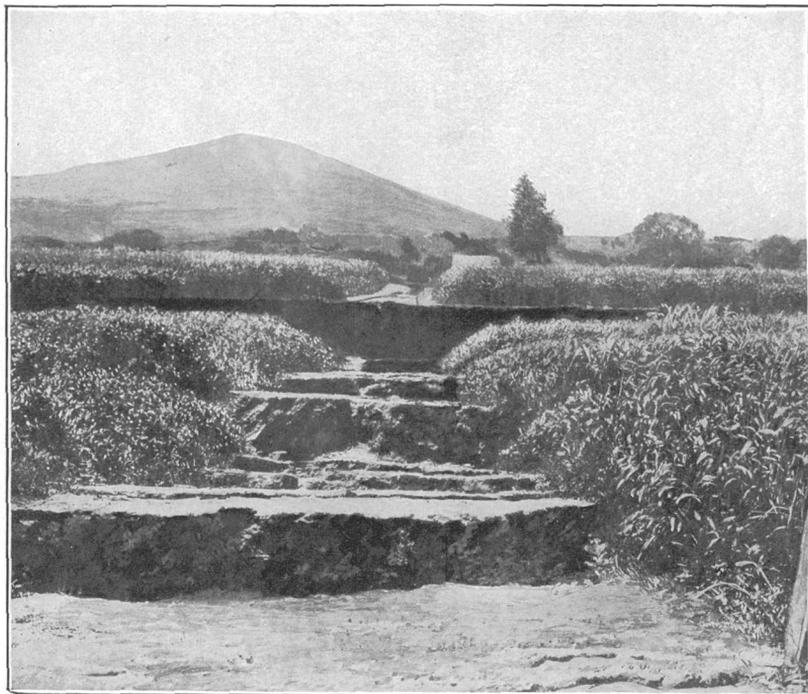
B. SLIPPING OF ALLUVIAL SOIL TOWARD SALINAS RIVER.

Grain field adjoining road along river between Spreckels's sugar mill and Salinas. Photograph by A. C. Lawson.

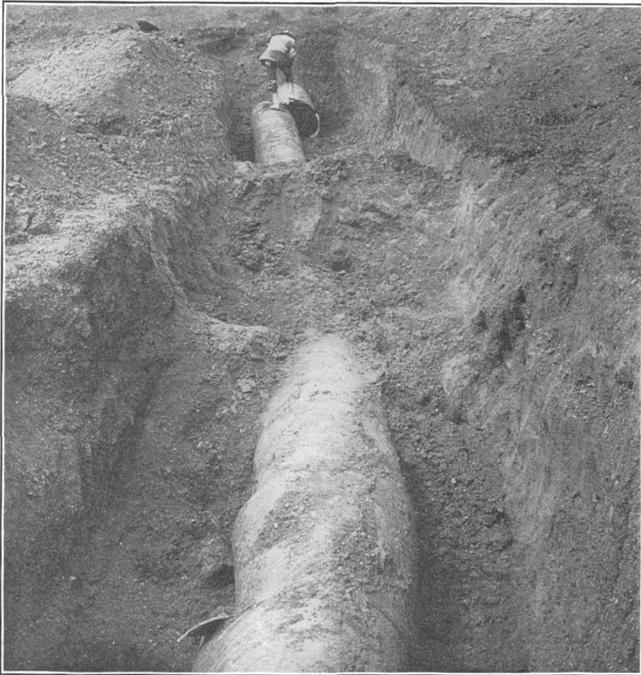
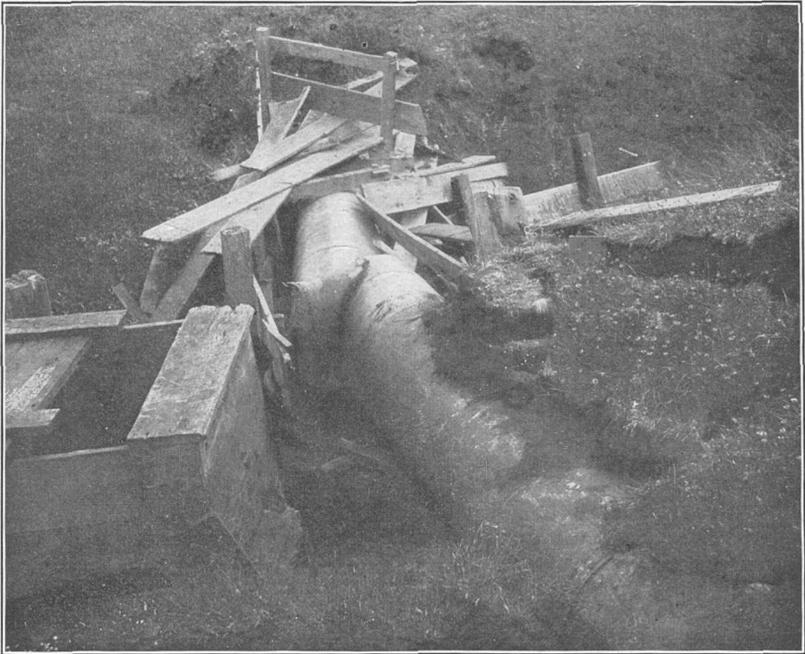
DAMAGE TO PILARCITOS 30-INCH PIPE LINE BY EARTHQUAKE.

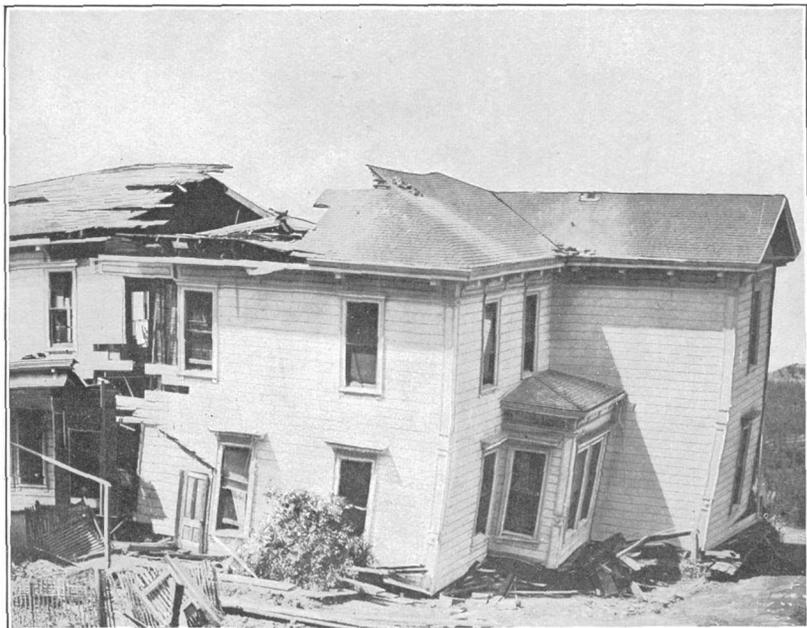
B. HOUSE ON LINE OF FAULT, TORN ASUNDER BY EARTHQUAKE.

Near Wrights Station, on Southern Pacific Railroad. Photograph by Richard L. Humphrey.

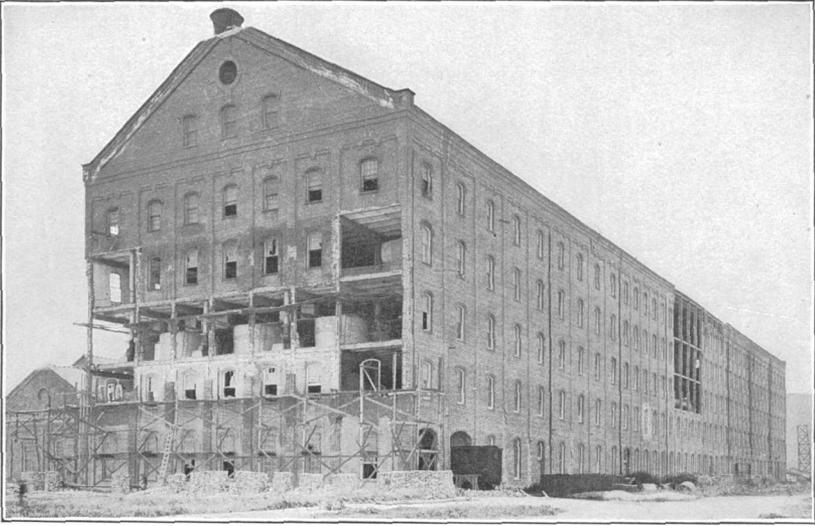
A. EFFECT OF EARTHQUAKE ON THE END AND THE INSUFFICIENTLY BRACED CENTRAL PORTION OF A BRICK BUILDING, SPRECKELS'S SUGAR MILL, ABOUT 4 MILES SOUTH OF SALINAS.

Note the stripping of brick pilasters from steel columns. Photograph by Richard L. Humphrey.

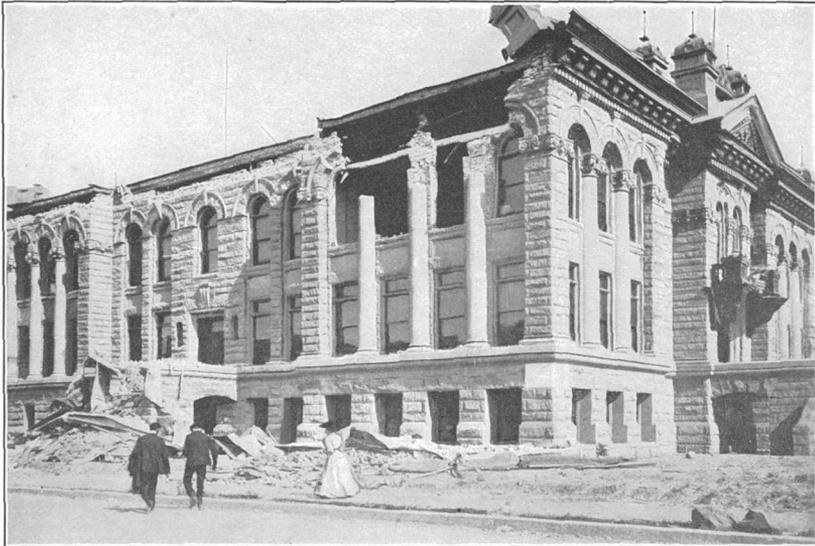
B. EARTHQUAKE WRECK OF NEW HALL OF JUSTICE, SAN JOSE, BUILT ON ALLUVIAL SOIL.

Wreck due to poor quality of stonework and unnecessarily massive construction. Photograph by Frank Soulié.

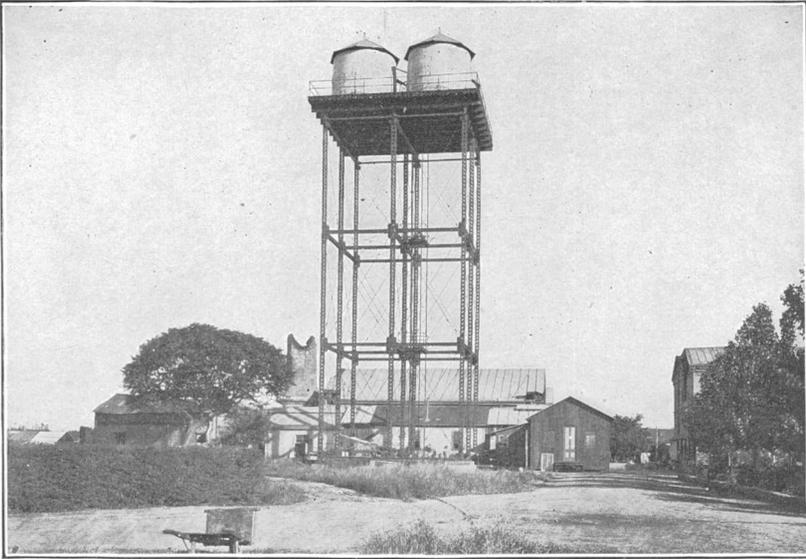
A. COMPARATIVE EARTHQUAKE ENDURANCE OF DISSIMILAR STRUCTURES, AGNEW INSANE ASYLUM, NEAR SAN JOSE.

Tanks on steel trestle, undamaged, and circular brick stack, collapsed. Photograph by Richard L. Humphrey.

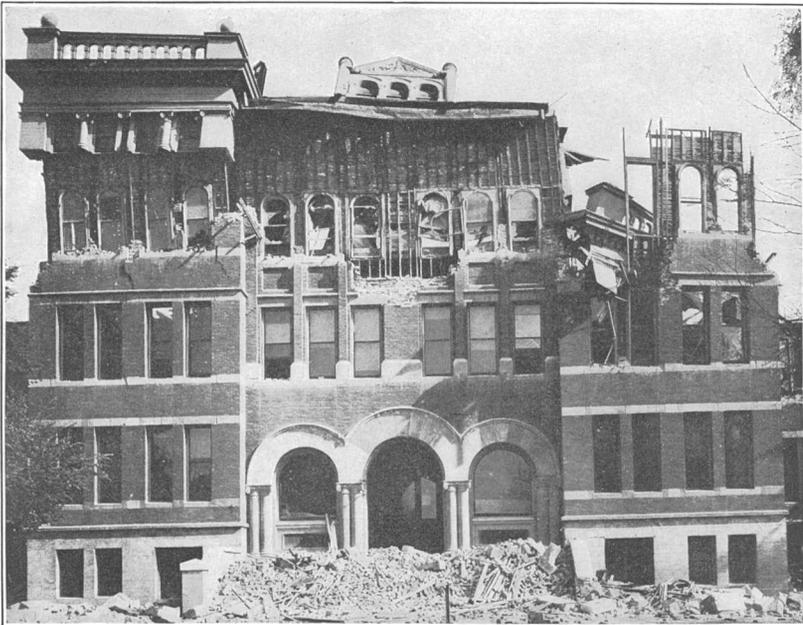
B. EARTHQUAKE EFFECT, HIGH SCHOOL BUILDING, SAN JOSE.

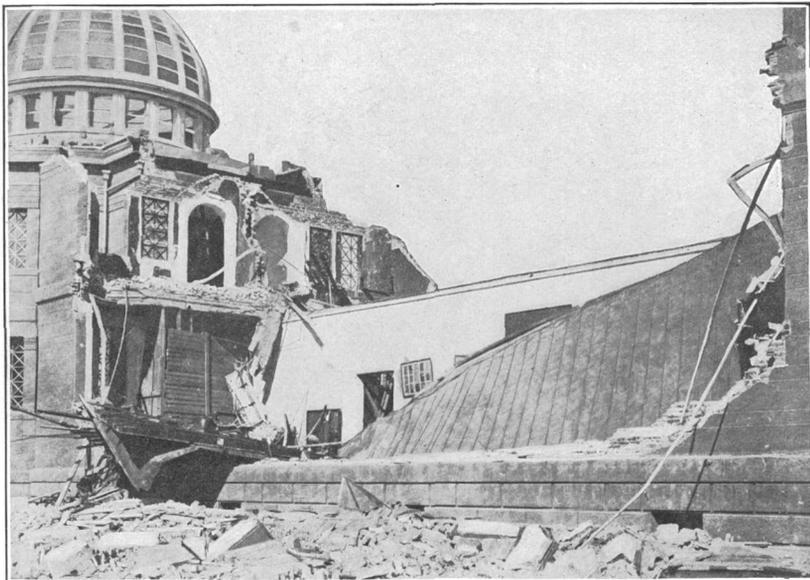
A. COMPARATIVE BEHAVIOR OF REINFORCED CONCRETE AND BRICKWORK UNDER EARTHQUAKE VIBRATION, MUSEUM, LELAND STANFORD JUNIOR UNIVERSITY.

The central portion, of reinforced concrete, was undamaged, but the brick wings collapsed. Photograph by Richard L. Humphrey.

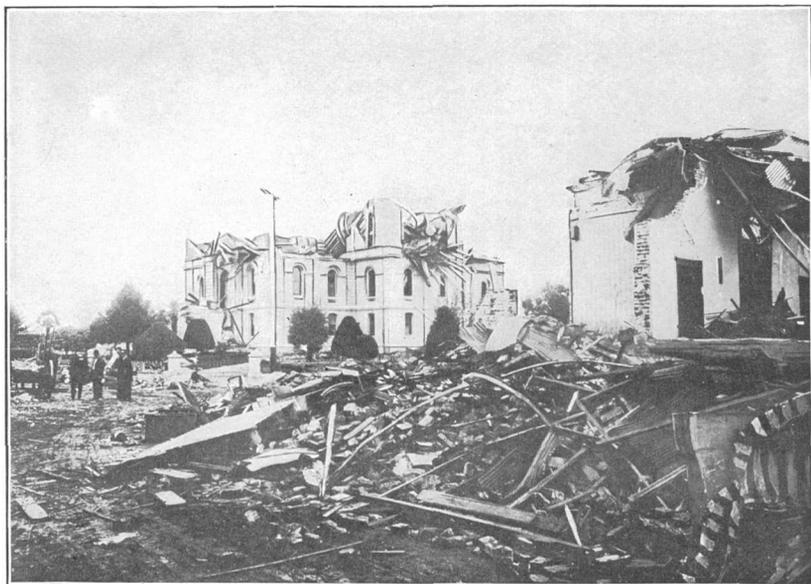
B. COMPLETE WRECK BY EARTHQUAKE, COURT-HOUSE AND HALL OF RECORDS, SANTA ROSA.

Wreck due to light wooden framing, insufficient bracing, and poor mortar. Photograph submitted by Richard L. Humphrey.

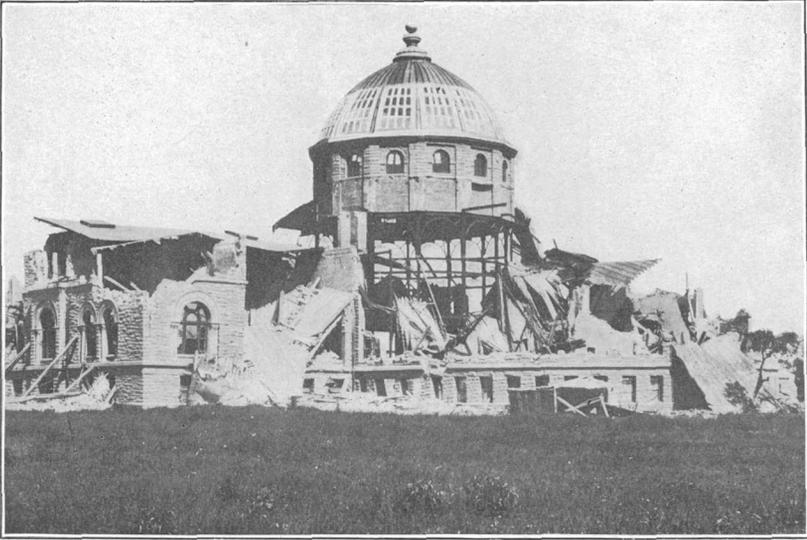
A. UNDAMAGED STEEL FRAMEWORK SUPPORTING DOME OF LIBRARY.

ENDURANCE OF STEEL FRAMEWORK AS AFFECTED BY METHOD OF SUPPORT, LELAND STANFORD JUNIOR UNIVERSITY.

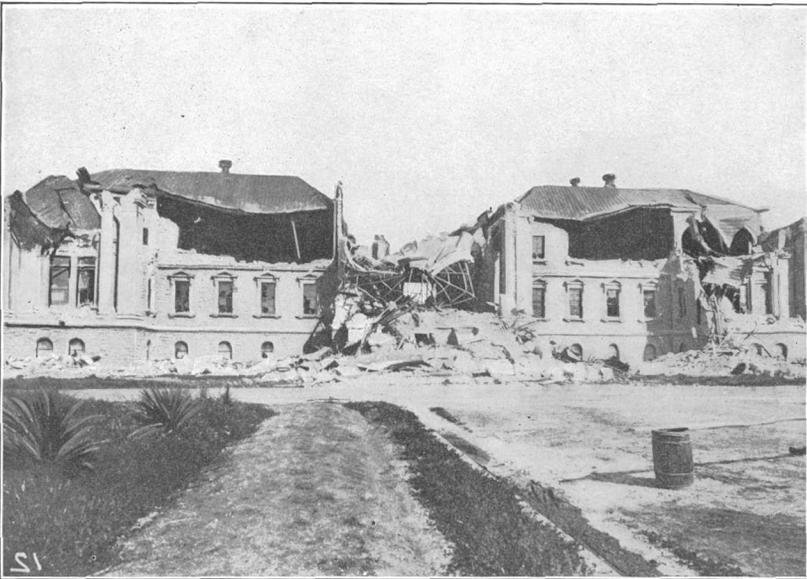
B. COLLAPSE OF BRICK WALLS, CAUSING DESTRUCTION OF STEEL SKELETON DOME OF GYMNASIUM.

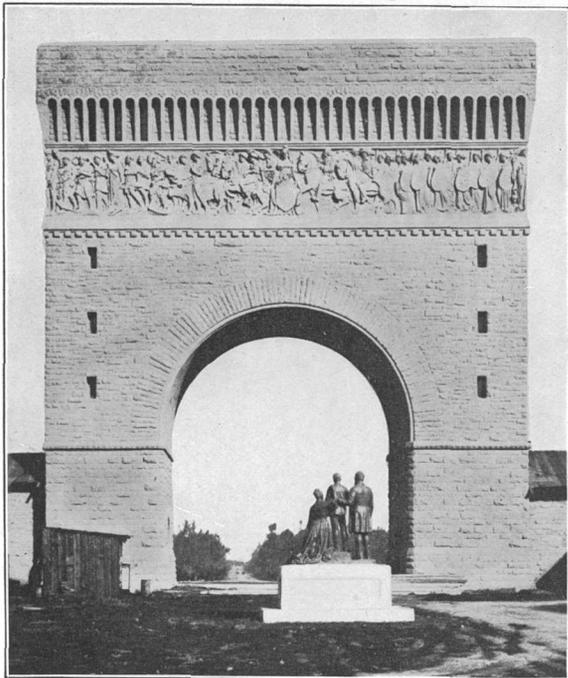
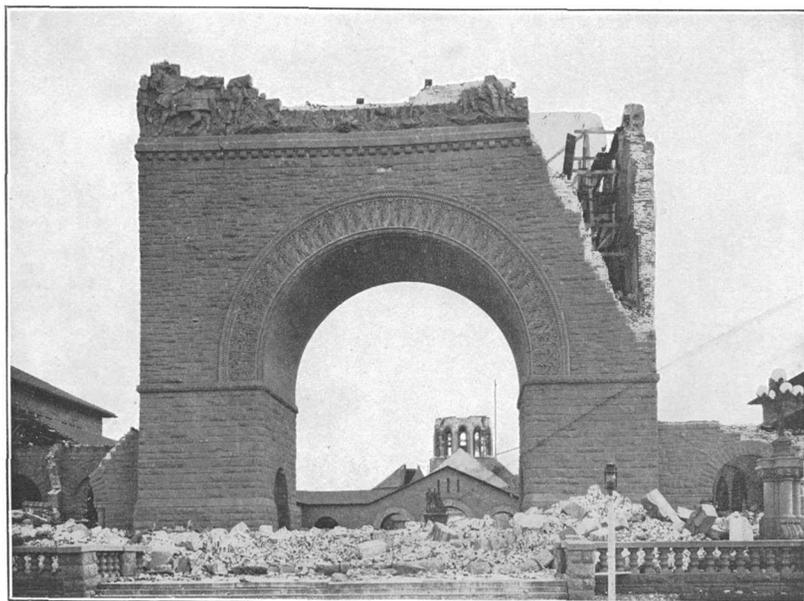
## MEMORIAL ARCH, LELAND STANFORD JUNIOR UNIVERSITY.

A, Before the earthquake (photograph submitted by Richard L. Humphrey); B, Earthquake effect (photograph by Richard L. Humphrey). The beams designed to stiffen the walls were not tied to them and helped to batter them down when the shock came.

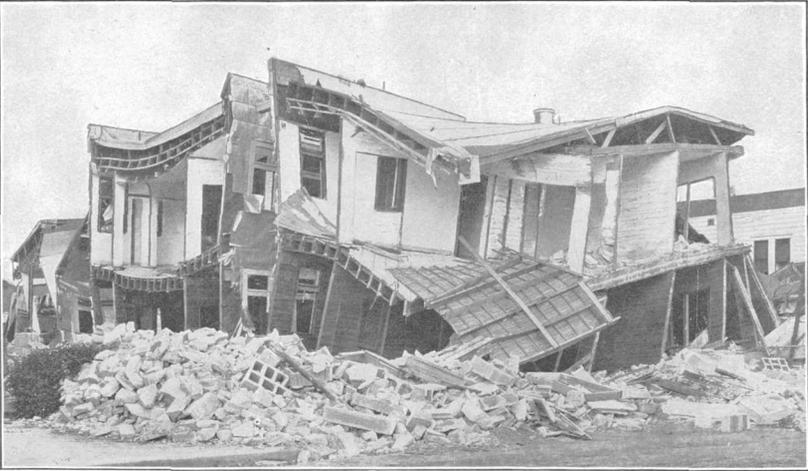
A. COLLAPSE DUE TO LACK OF TIE BETWEEN WALLS AND FRAME, THIELE BUILDING (CEMENT BLOCK), PALO ALTO.

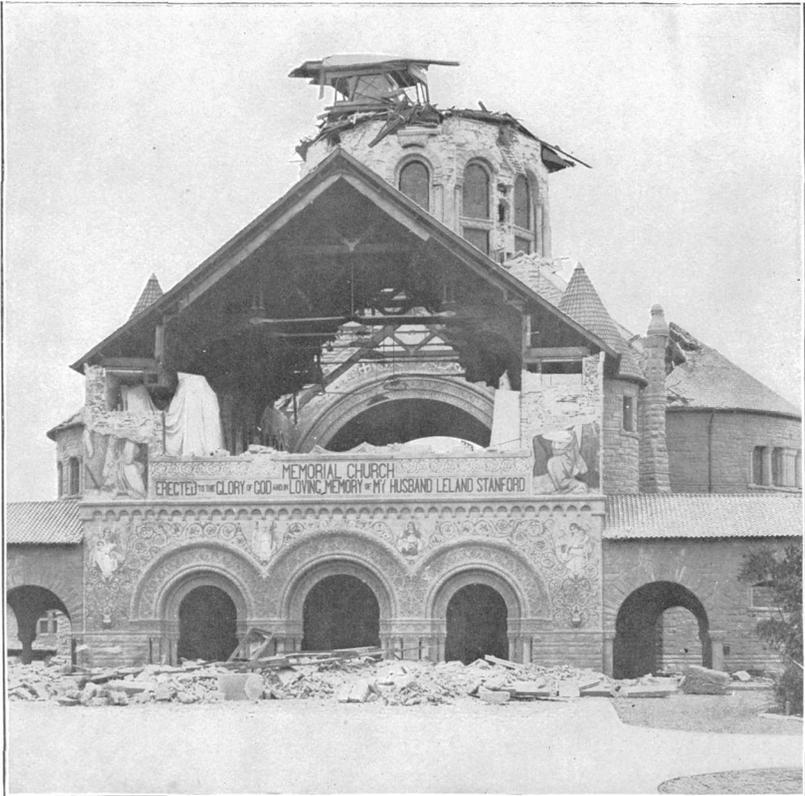
B. COLLAPSED TOWER AND GENERAL EARTHQUAKE WRECKAGE, MEMORIAL CHURCH, LELAND STANFORD JUNIOR UNIVERSITY.

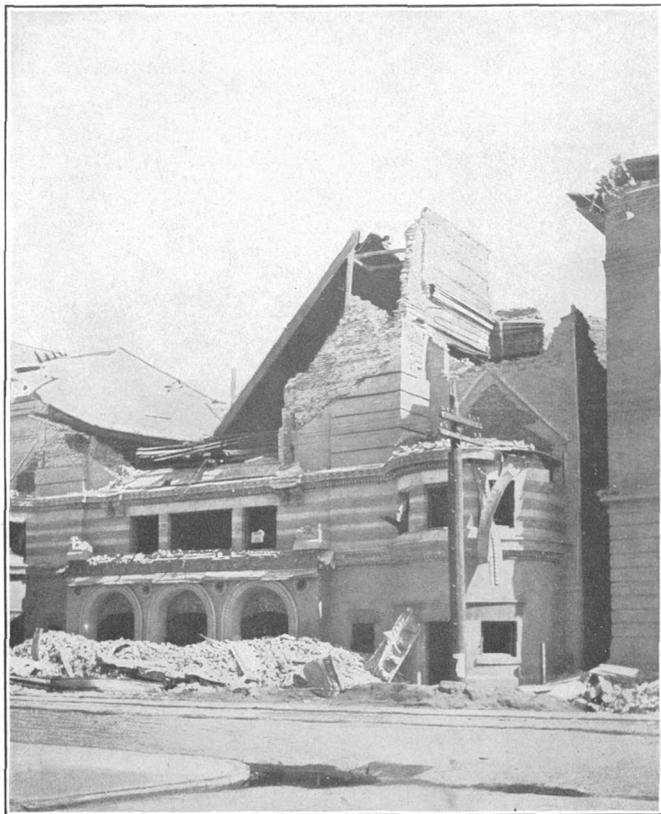
A. RACKING OF NEWLY CONSTRUCTED BUILDING, SYNAGOGUE, GEARY AND FILLMORE STREETS, SAN FRANCISCO.

Note the separation of the brick veneer from the backing; also the racking of the wall at the corner. Photograph by John Stephen Sewell.

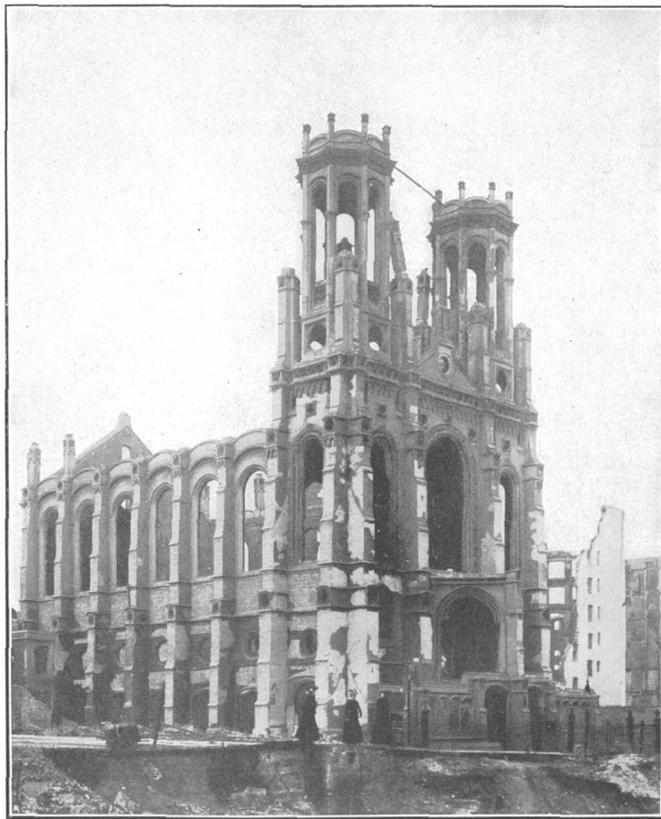
B. GOOD EARTHQUAKE ENDURANCE OF BUTTRESSED WALLS, SYNAGOGUE EMANUEL, SAN FRANCISCO.

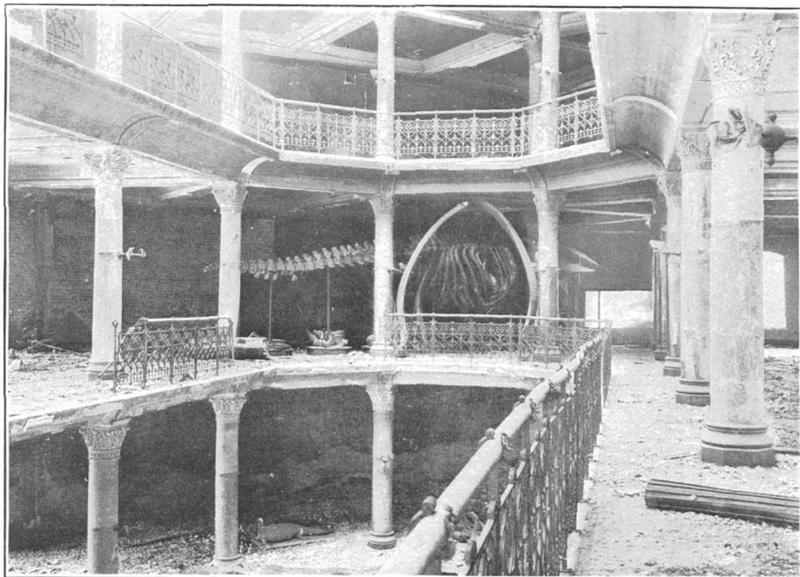
.2. FIRE ENDURANCE OF CONCRETE, ANNEX OF ACADEMY OF SCIENCES BUILDING, SAN FRANCISCO.

Reinforced-concrete floors and concrete-filled cast-iron columns with plaster covering. Photograph by Richard L. Humphrey.

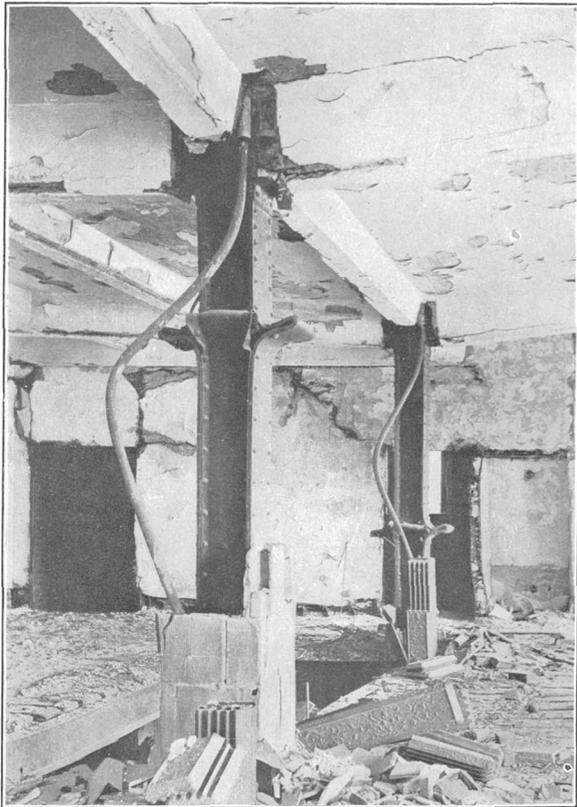
A. BUCKLED COLUMNS AND COLLAPSED FLOOR PANEL,  
BULLOCK & JONES BUILDING, SAN FRANCISCO.

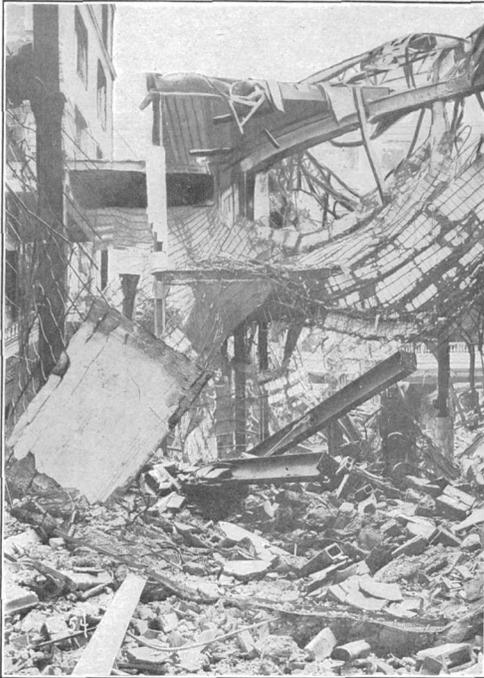
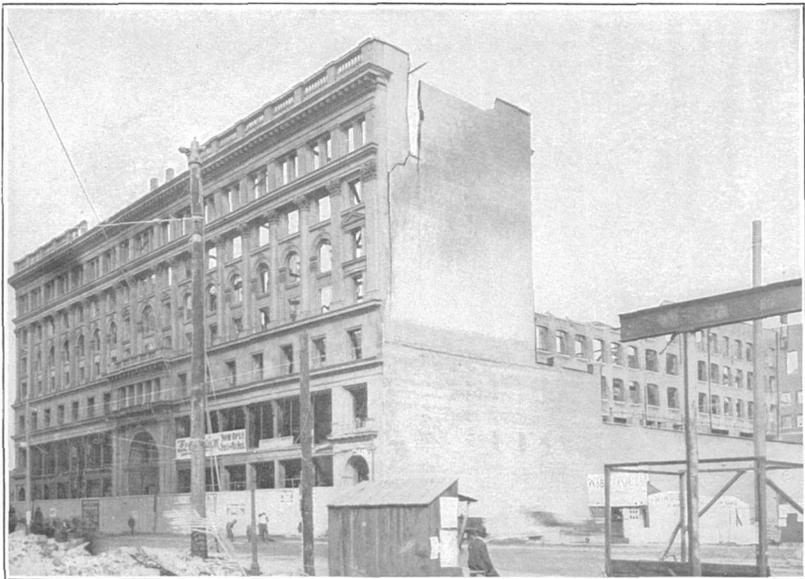
COMPLETE FAILURE OF SLOW-BURNING WOOD CONSTRUCTION,  
THE EMPORIUM, SAN FRANCISCO.

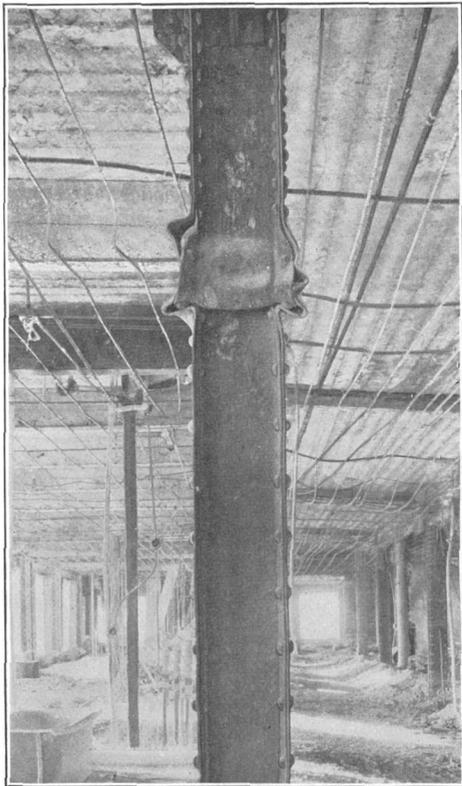
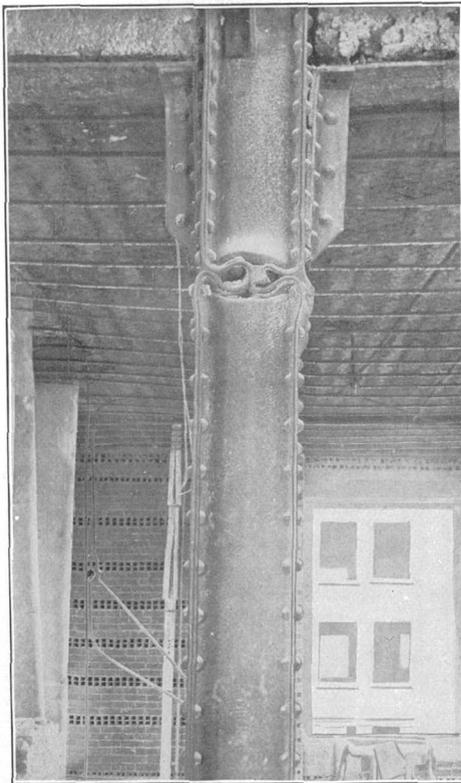
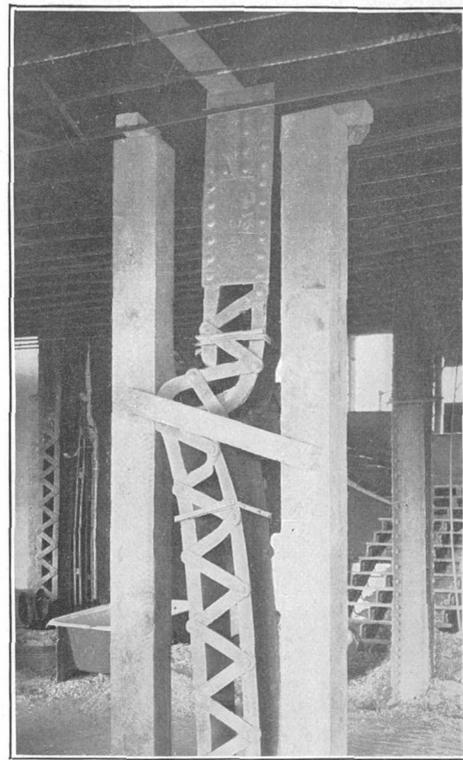
BUCKLING OF COLUMNS DUE TO FAILURE OF PLASTERED METAL-LATH FIREPROOFING, FAIRMOUNT HOTEL, SAN FRANCISCO.

The method of fireproofing was to inclose the column between the metal lath forming the partitions. Photographs by Richard L. Humphrey.

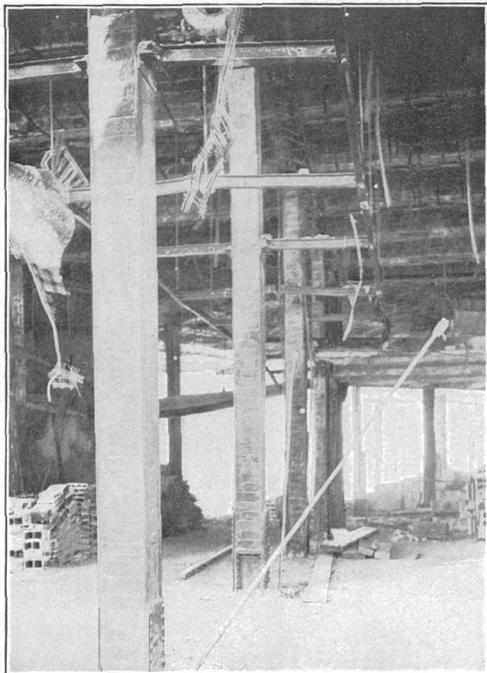
A. INCIPIENT BUCKLING OF COLUMNS FROM HEAT, FIRST STORY, JAMES FLOOD BUILDING, SAN FRANCISCO.

The brick filling probably saved the columns from fatal buckling or collapse. Photograph by John Stephen Sewell.

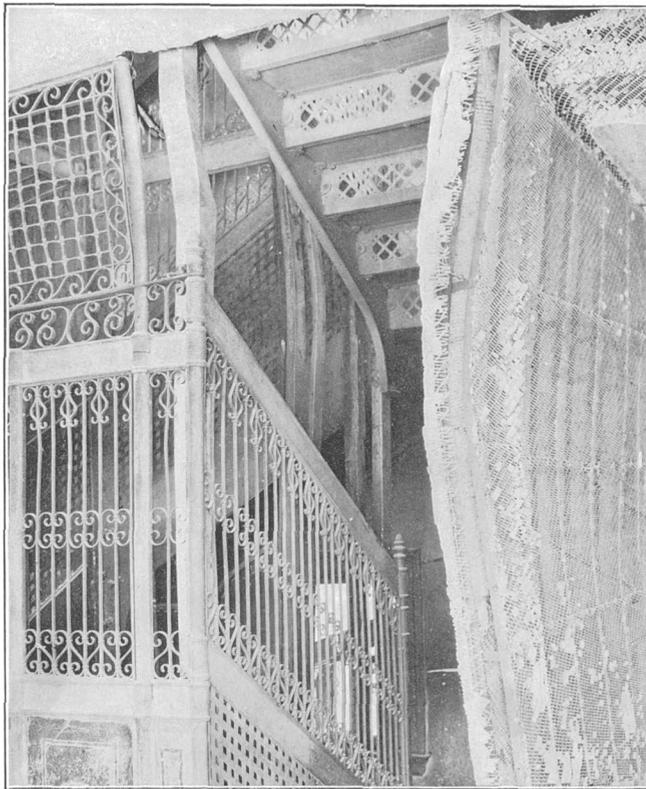
B. WARPING OF PLASTERED METAL-LATH COVERING BY FIRE, MURPHY BUILDING, SAN FRANCISCO.

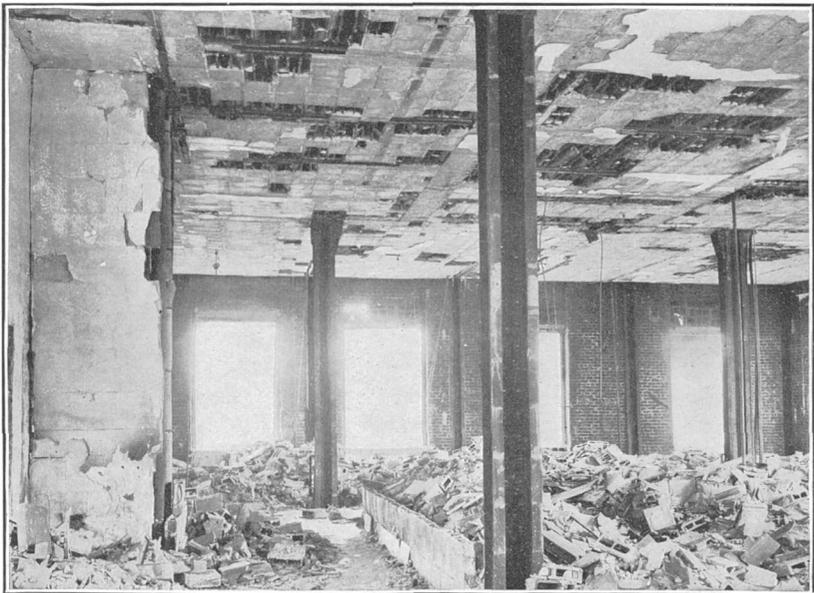
A

#### FAILURE OF HOLLOW TERRA-COTTA TILE FIREPROOFING.

A, First story of Spring Valley Water Company's Building, San Francisco (photograph by John Stephen Sewell);  
B, Mills Building, San Francisco (photograph by Richard L. Humphrey). The lower webs of the floor tiles were spalled or taken entirely off by the fire.

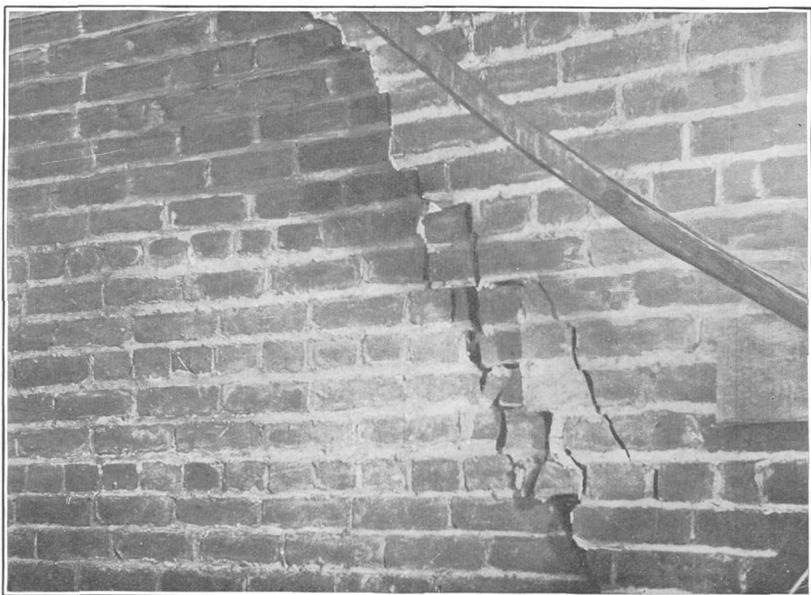
*B.* EFFECT OF SEVERE SHAKING ON WELL-BONDED BRICKWORK FILLED WITH GOOD  
MORTAR, TOWER OF UNION FERRY BUILDING.

Note sagged tie-rod, stretched by the racking of the structure. Photograph by John Stephen Sewell.

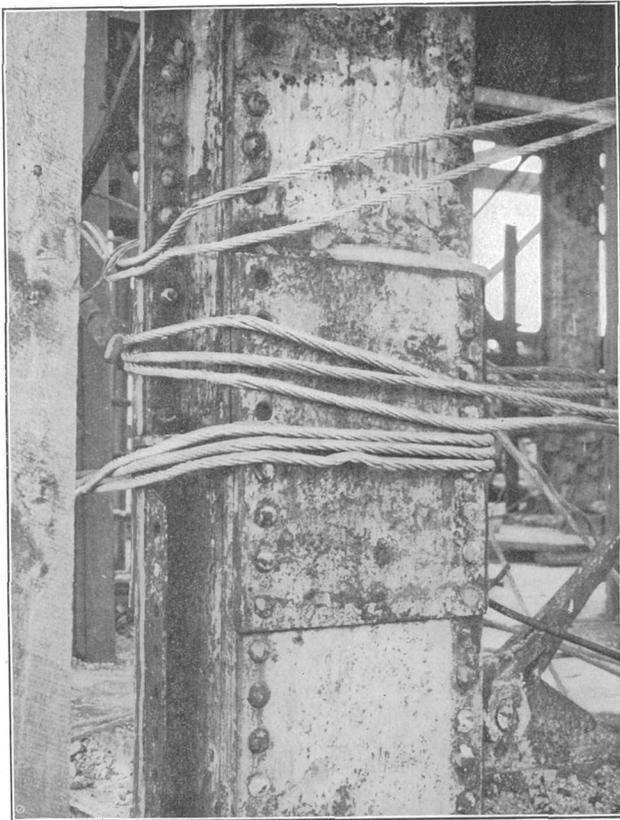
*A*

SHEARED RIVETS, TOWER OF UNION FERRY BUILDING, SAN FRANCISCO.

*A*, In column cover plate; *B*, In diagonal connection. Photographs by Richard L. Humphrey.

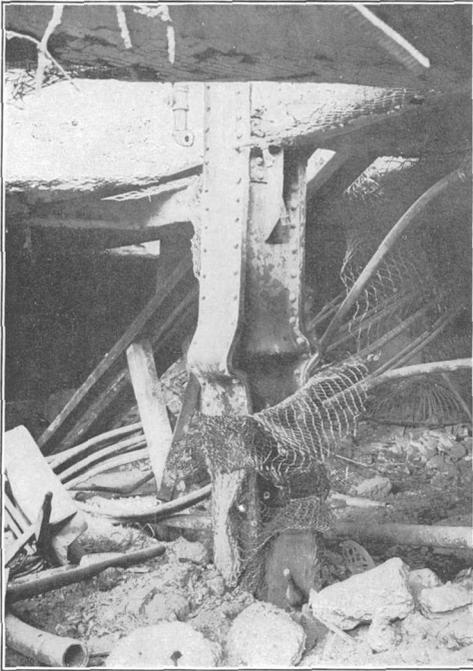
A. BUCKLING OF BASEMENT COLUMN DUE TO FAILURE OF PLASTERED METAL-LATH FIREPROOFING, RIALTO BUILDING, SAN FRANCISCO.

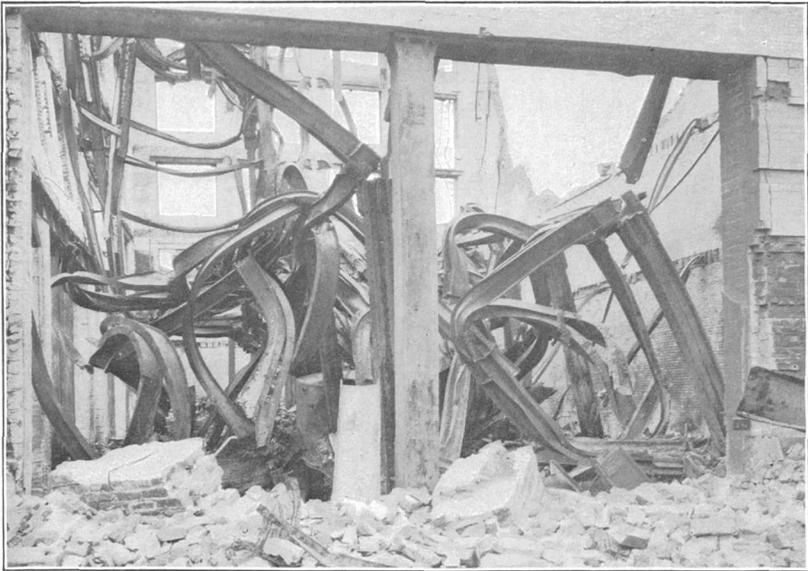
.B. UNPROTECTED STEEL FRAME AND GENERAL FLIMSY CONSTRUCTION, COWELL BUILDING.

EFFECTS OF HEAT ON STEEL WORK, SAN FRANCISCO.

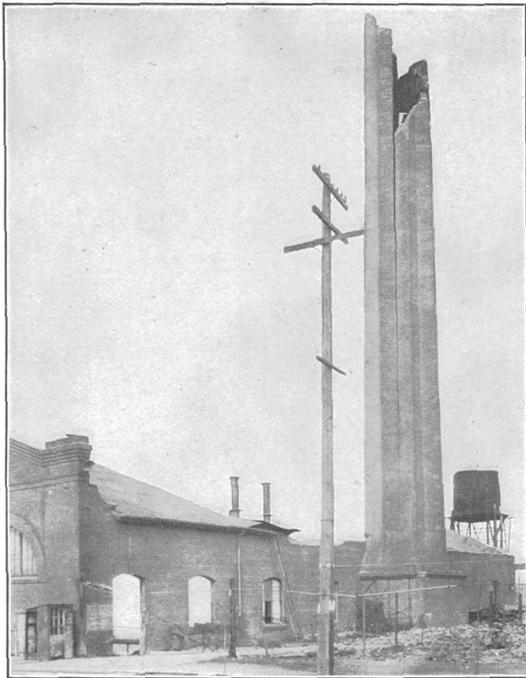
A. EARTHQUAKE DAMAGE TO BRICK STACK OF STAR SECTION, VALENCIA STREET POWER STATION, SAN FRANCISCO.

Showing peculiar crack in reentrant angle. Photograph by Richard L. Humphrey.

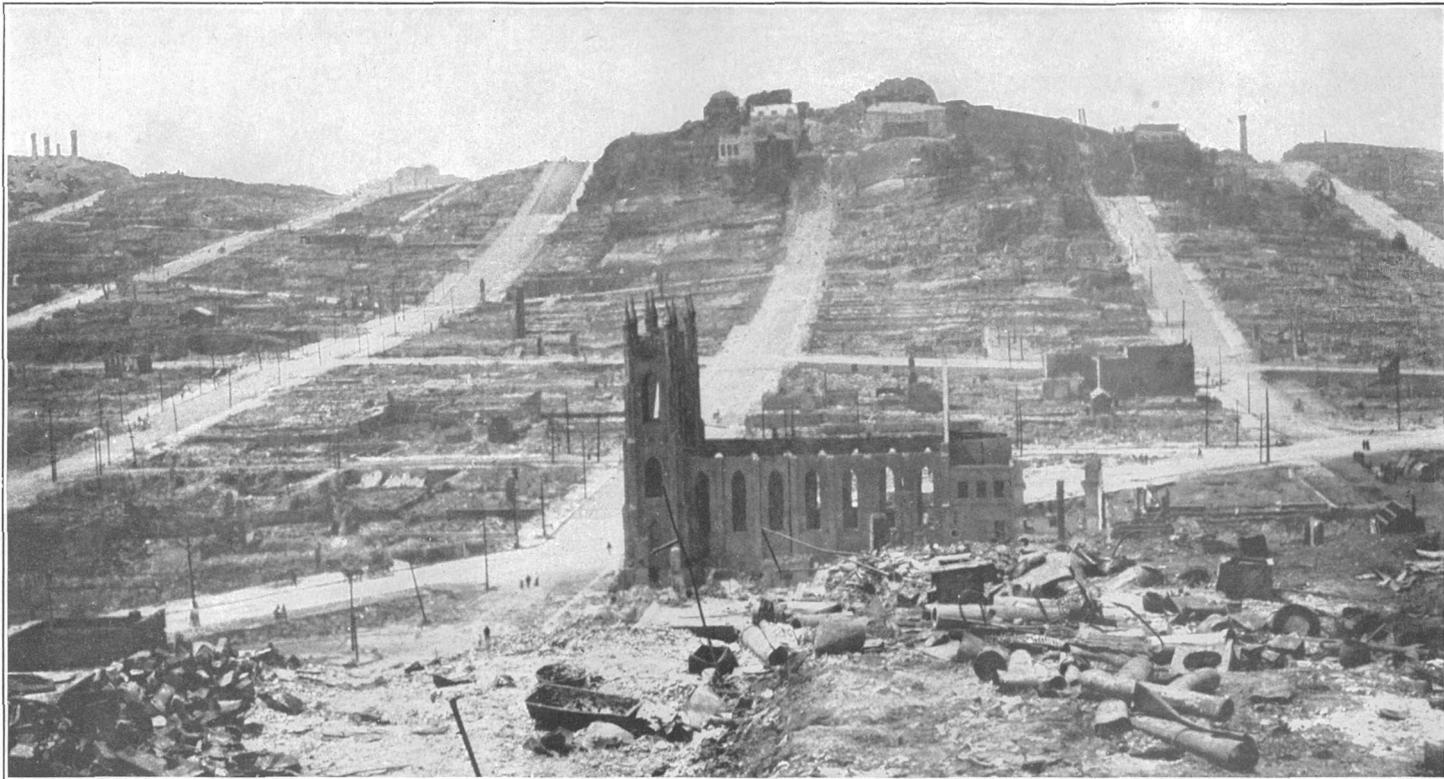
DESTRUCTION BY FIRE, SAN FRANCISCO.

View looking west from Telegraph Hill, showing unburned houses on summit of Russian Hill. St. Francis Roman Catholic Church, with its excellent brick walls, in the foreground. Photograph submitted by Frank Soule.
