DEPARTMENT OF THE INTERIOR  
UNITED STATES GEOLOGICAL SURVEY  
GEORGE OTIS SMITH, DIRECTOR

THE  
SAN FRANCISCO EARTHQUAKE AND FIRE  
OF  
APRIL 18, 1906  
AND THEIR EFFECTS ON STRUCTURES AND  
STRUCTURAL MATERIALS

REPORTS BY  
GROVE KARL GILBERT, RICHARD LEWIS HUMPHREY,  
JOHN STEPHEN SEWELL, AND FRANK SOULÉ

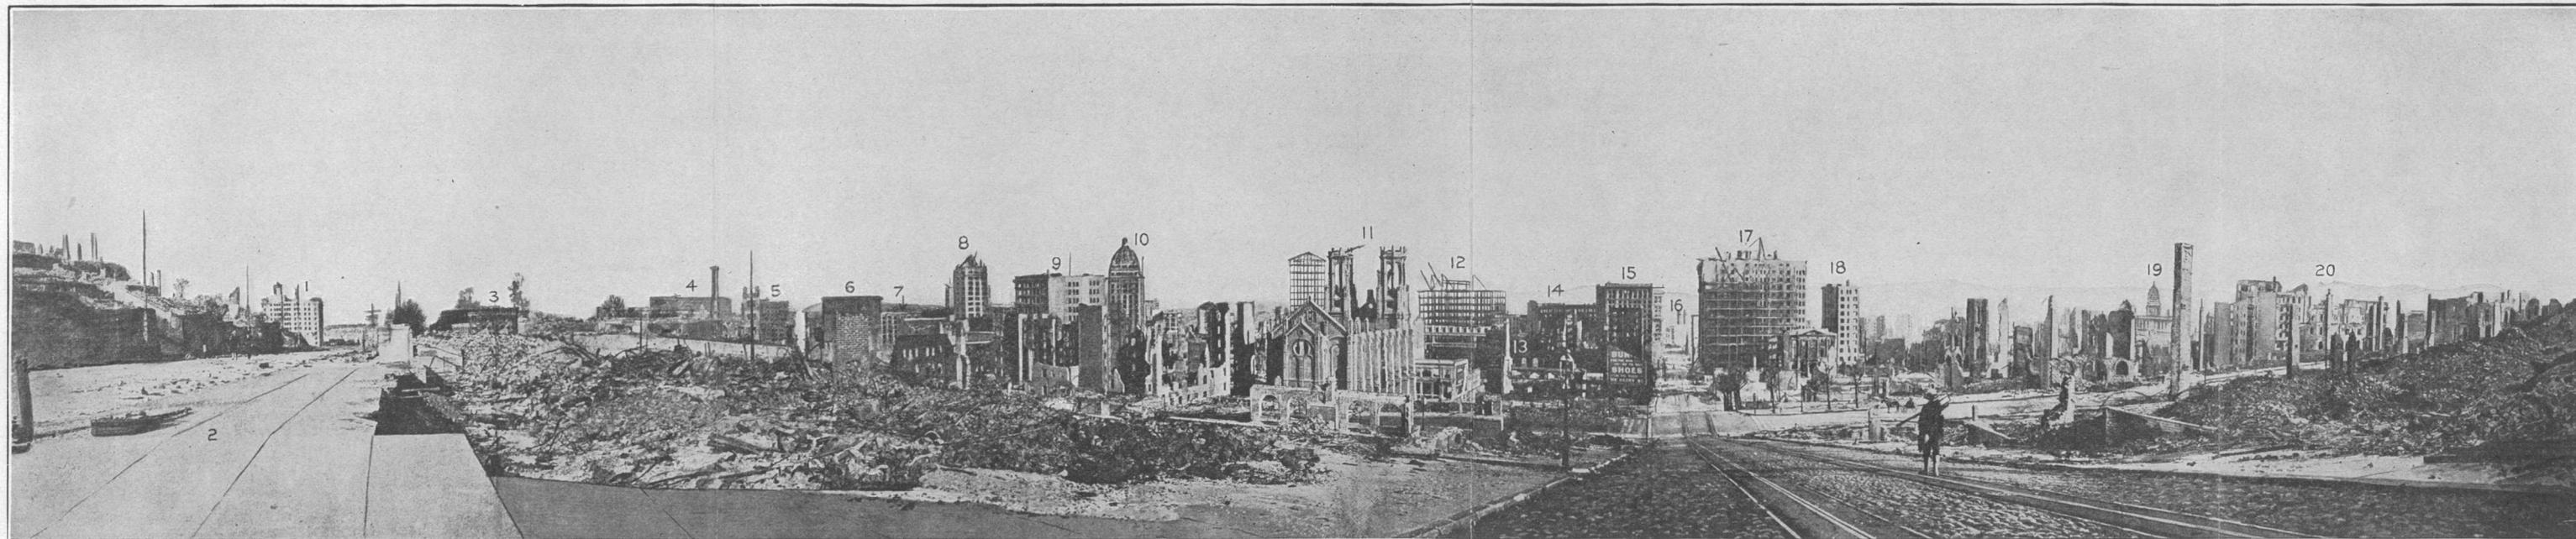
DESTRUCTION BY FIRE, SAN FRANCISCO.

Panorama taken at corner of Pine and Powell streets, showing location of principal buildings in the area south of Pine street. Photograph by John Stephen Sewell.
