Geology of Waterpower Sites on Crater Lake, Long Lake and Speel River near Juneau Alaska

GEOLOGICAL SURVEY BULLETIN 1031-D

*A preliminary examination of the
geologic feasibility of proposed
damsites*

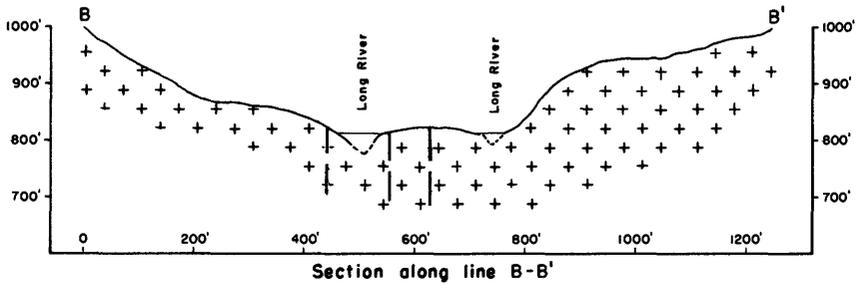
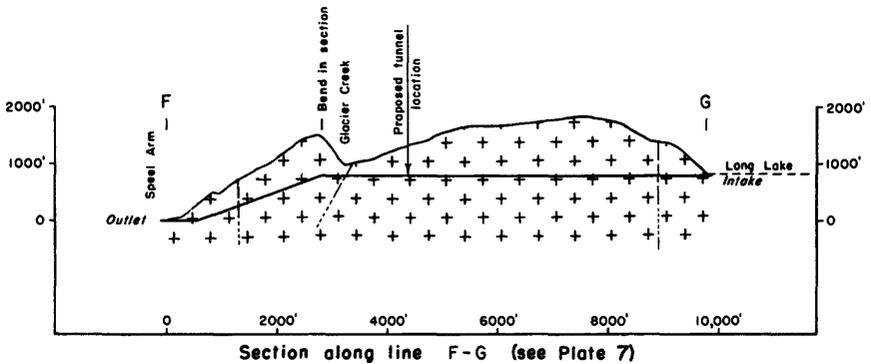
FIGURE 18.—Geologic sections of Long Lake powersite.

and at the damsite, excessive leakage may be induced by the north-westward-trending fractures at the outlet unless extensive scaling or removal of perhaps 20 to 50 feet of bedrock is done in addition to grouting. An extensive drilling program will be necessary to determine how deep these fractures extend and whether excessive leakage may be expected. If exploratory drilling verifies the lack of an impervious foundation it may be possible to select another site about 150

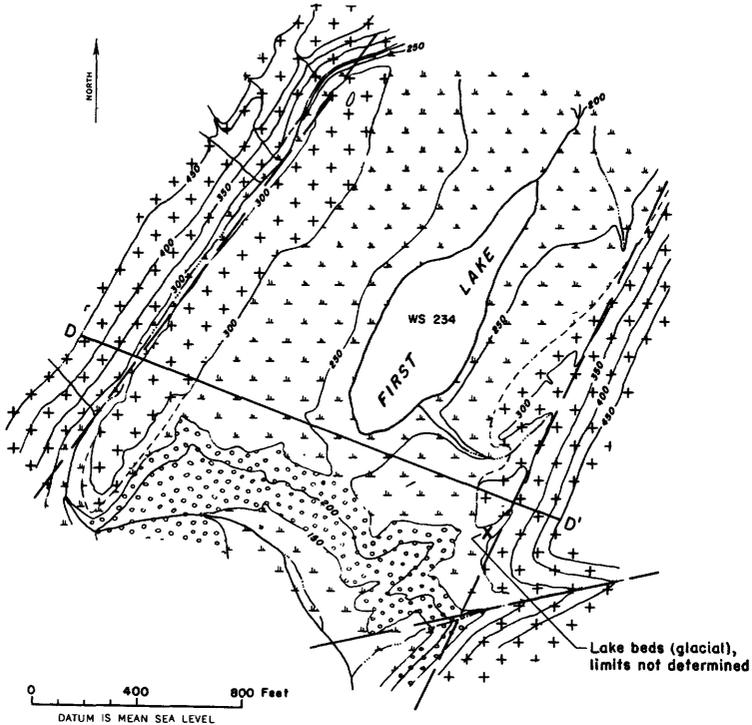
FIGURE 21.—Geologic map of Saddle dams site and Speel River powersite.

The Saddle damsite at the head of First Lake (pl. 7) is suitable for either a flexible fill type or a masonry dam of sufficient height to raise the water to an altitude of 400 feet, the maximum that would likely be considered for this site. A small auxiliary dam would be necessary in the low divide between Glacier Creek and the Second Lake drainage. The depth of alluvium or glacial fill in this divide may be as much as 50 feet or even more. The steep descent of about 100 feet on the south side of the damsite may, however, represent the depth of valley fill. Core drilling would be necessary to establish the depths to bedrock. The geology of the Saddle damsite, map and section, is shown on figures 21 and 22.

The main or longer part of the Saddle dam would probably be a nonoverflow type owing to the character of the alluvial cover in the valley. If a dam of this design should be constructed a spillway at the west side of the valley (figs. 21, 22) would require a minimum of preparation. A spillway at this point would utilize the small valley west of the main dam and would require little excavation. Both abutments of the smaller dam would be in the quartz diorite and the depth to bedrock in the ravine probably does not exceed 10 feet. A spillway of an overflow type could be constructed at the location indicated.
