Stability of the
West Slope of Government Hill
Port Area of Anchorage,
Alaska

GEOLOGICAL SURVEY BULLETIN 1258-D

By DAVID J. VARNES

*An evaluation of the stability of
gravel-capped bluffs of Bootlegger
Cove Clay under static and
seismic conditions*

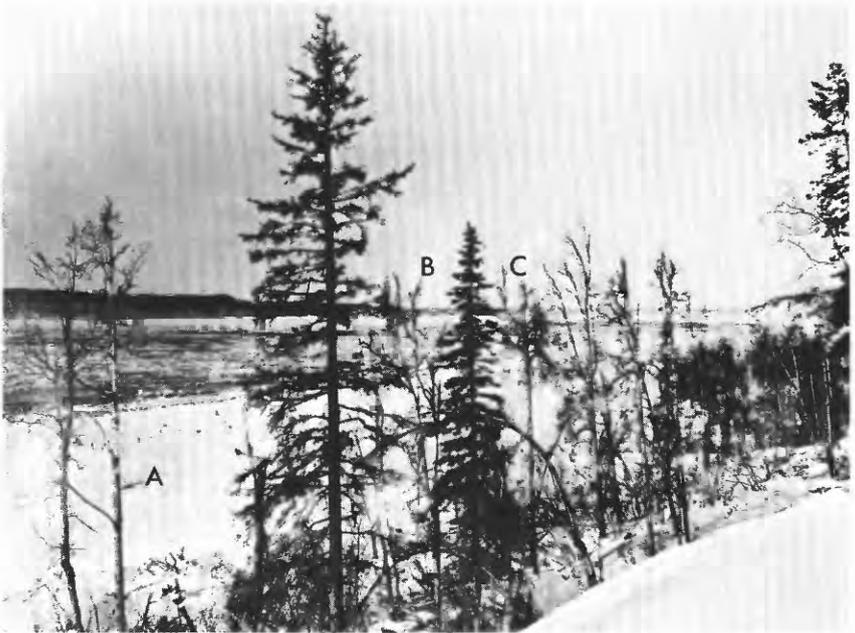
FIGURE 6.—View northward from Government Hill, probably in early 1918. Future site of Independent Lumber Co. warehouse is about at the foot of the landslide deposits beyond tree marked A. Toe of flow slide is in middle distance at right. Letters identify the same trees shown in figure 8. Photograph by Alaskan Engineering Commission.

The presence of old slides in the lower part of the slope crossed by boring line 1, indicated by the early topographic map and photographs (pl. 1, figs. 5, 6, 8), is confirmed also by the logs of borings ARR-1A, ARR-1B, and ARR-1C, which were made late in 1966. Summary logs and results of tests on samples from the borings accompany the vertical section (pl. 3). The difference in elevation of the top of the Bootlegger Cove Clay in borings ARR-1A and ARR-1B indicates offset by sliding, and positions of the same contact in boring ARR-1B and in a nearby earlier boring, DM 64-13, suggest a slight backward tilting of the slide block or blocks. No doubt the distribution of the silt and clay beneath the slumped surface of granular materials is more complicated than can be shown on the basis of available information. Regrading has obscured the topographic form of the slides and much material has been removed from the present location of the lumber warehouse. The ground surface as of about 1916 shown on the section is based on an unpublished map prepared by the Alaskan Engineering Commission about 1916, similar to but more detailed than that shown on plate 1. The old slides may have moved along such surfaces as *ABCFDE* or *ABCFG* on plate 3 and *ABOP* in figure 21.

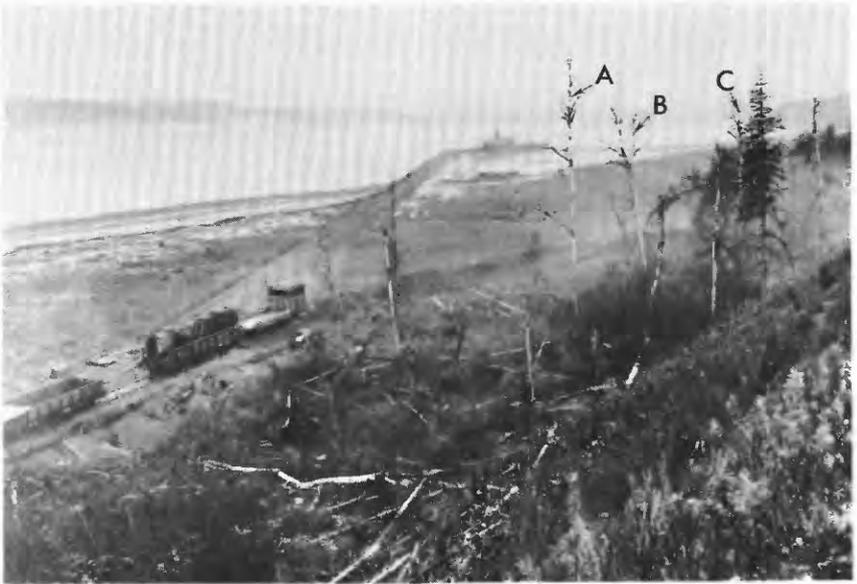
FIGURE 8.—Anchorage harbor as seen from Government Hill, November 7, 1921. Note that the coal-storage bunker has largely been removed. Letters identify the same trees shown in figure 6. Photograph by Alaskan Engineering Commission.

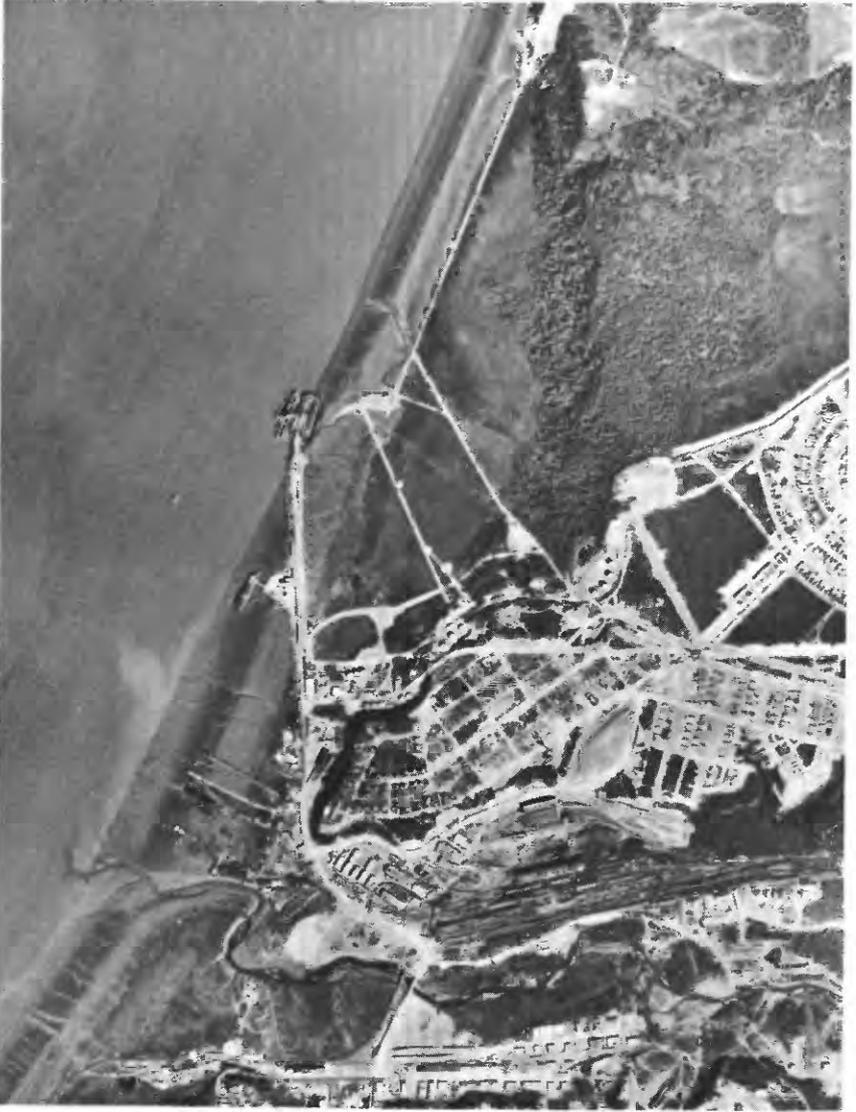
FIGURE 11.—Vertical aerial view of the port area, Anchorage, Alaska, from photograph by U.S. Geological Survey, 102VV, M373, August 8, 1950.

As embankments were built onto the flat, particularly north of the Standard Oil of California development on the flow slide, drainage to the sea was increasingly impeded, and ponds formed between the embankments or between the embankments and the slope (figs. 11, 12, 13). Also, greatly increased runoff from the expanded development at Elmendorf Air Force Base during 1950-62 cut a sharp-walled ravine (shown in the right-central part of fig. 12) and no doubt contributed to the formation of ponds in the flat area.

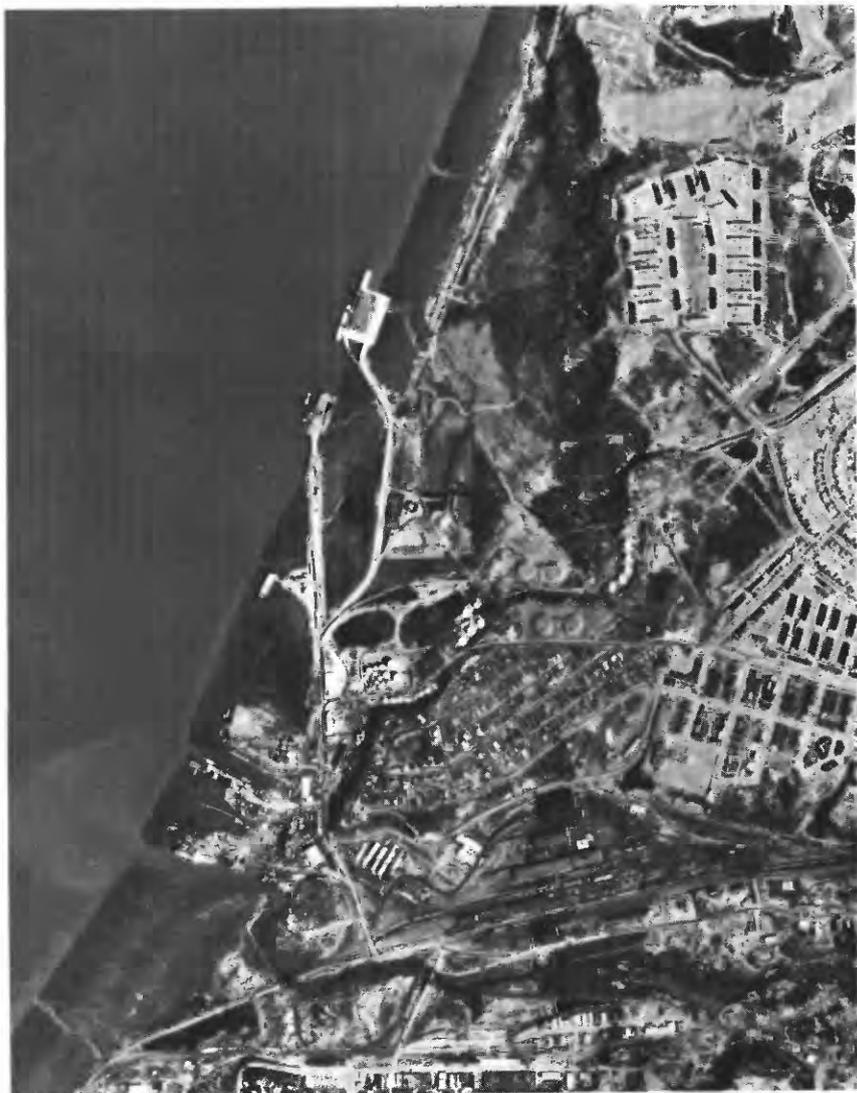
FIGURE 12.—Vertical aerial view of the port area, Anchorage, Alaska, from photograph by U.S. Geological Survey, 1-97, GS-VAFC, May 17, 1962.

Hydraulically placed fill derived from dredging for the new City Dock, built in 1961, occupies much of the light-colored area southeast of City Dock shown in figure 12. This fill also apparently helped create an impervious barrier to waters that formerly flowed from the slopes to the sea. A drainage ditch was constructed in 1962 or 1963 to divert runoff to the north around the growing fills east of City Dock. Nevertheless, in the summer of 1966 much of the area

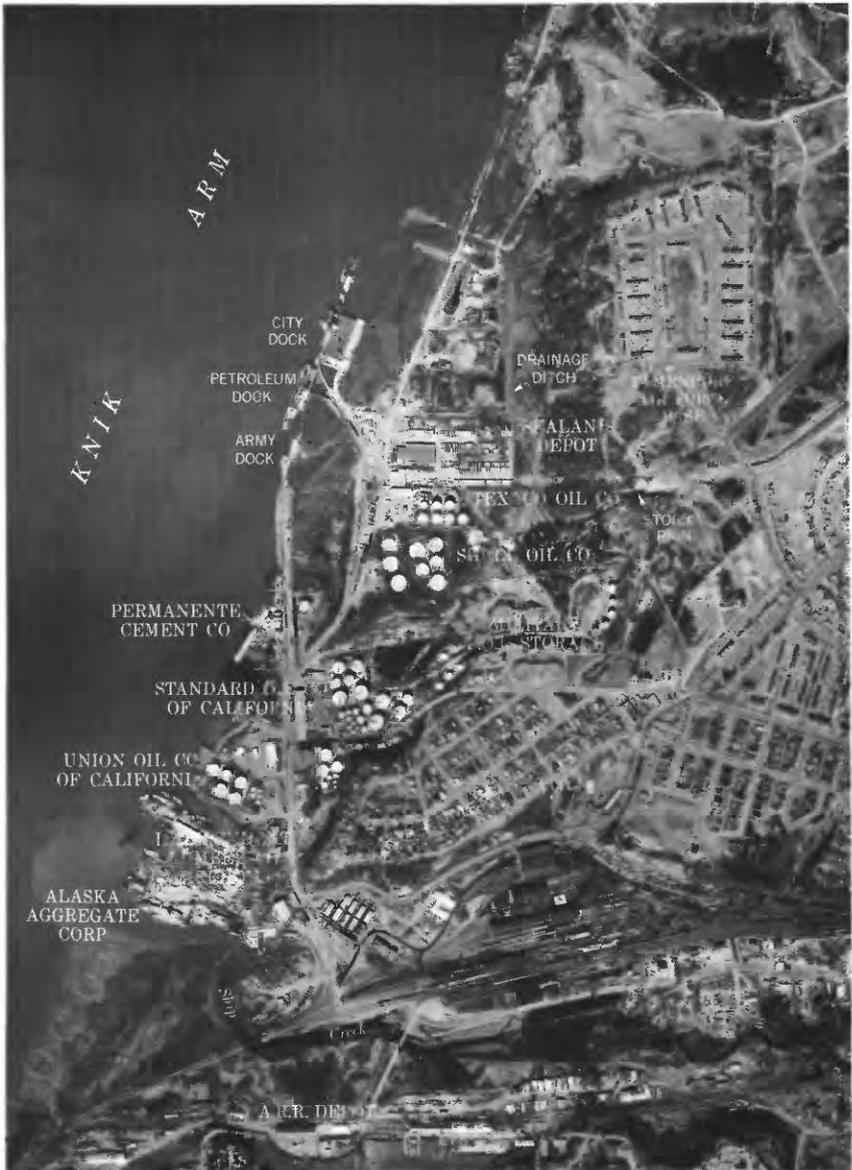
FIGURE 14.—Vertical aerial view of the port area, Anchorage, Alaska. Note large new tanks in the Union Oil Co. of California area, both near the bluff of Government Hill and on fill next to Knik Arm; a new group of large tanks in the Standard Oil of California area, some in a site formerly occupied by a pond; repairs and additions to the Shell Oil Co. tanks; and a new group of seven large and four small tanks erected by Texaco Oil Co. From photograph by Air Photo Tech, Anchorage, ANC 1-2, May 2, 1967.

Rapid development of the port area during the period June 1964–May 1967 (fig. 14) resulted largely from the increased use of the port following the 1964 earthquake. New petroleum dock, handling, and storage facilities were constructed in part to replace those destroyed by the earthquake at other coastal cities.

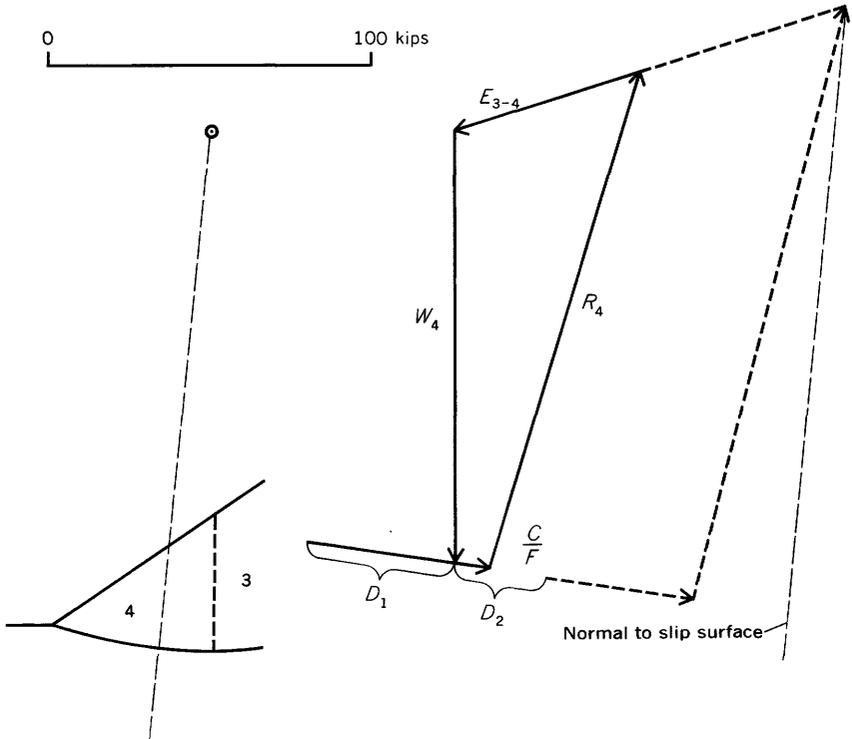
polygon. The final polygon—that for slice 4—is shown in figure 19. This polygon does not close; the assumption that $F'=0.9$ has led to an excess of resistance represented by length D_1 ; and the assumption that $F''=1.1$ to a deficiency given by distance D_2 . A close estimate of the true value of the safety factor, F_t , can be obtained from the expression:

FIGURE 19.—Force polygon for slice 4 of the potential slide shown in figure 17, assuming factor of safety equals 0.9 (solid lines) or 1.1 (dashed lines). Assumption $F'=0.9$ leads to an excess of resistance represented by distance D_1 ; whereas assumption $F''=1.1$ leads to a deficiency given by distance D_2 . True factor of safety has an intermediate value of 1.03.
