Slope Stability in the Marietta Area,
Washington County,
Southeastern Ohio

U.S. GEOLOGICAL SURVEY BULLETIN 1695

By JOHN S. POMEROY

An investigation of the distribution of slope movements
in a part of southeastern Ohio—a discussion of
geologic and other factors involved in their genesis

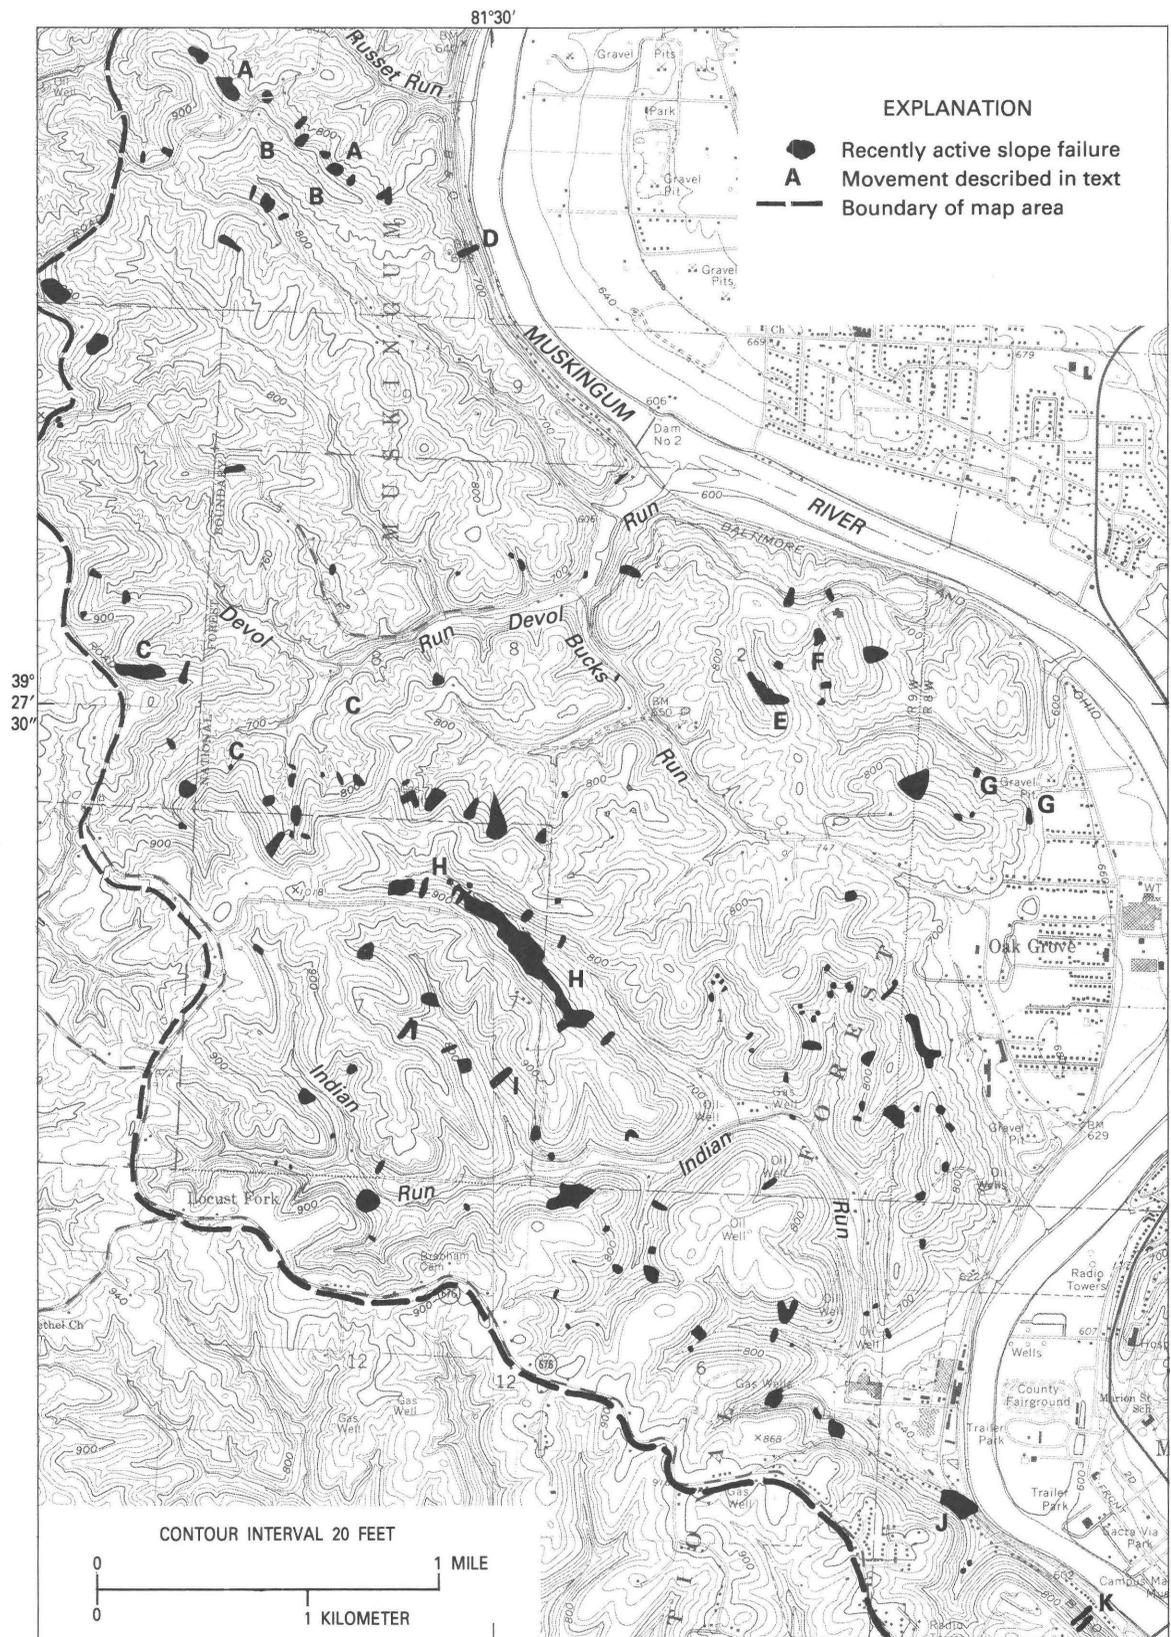
Figure 4. Area north of Ohio 676.

A major failure above Leland and Gilman Streets (locality J; fig. 5) damaged three houses, which were later razed. Most of the colluvial material has been removed from an area where movement had accelerated in March 1976. Costs arising from repurchase of the condemned properties and remedial work exceeded \$350,000. The movement apparently developed after Gilman Street was widened (fig. 5). Slow movement (mostly creep) is continuing in the lower part of the area and still is affecting sections of Leland and Gilman Streets, as well as the railroad track ballast. The lower slope has a subtle hummocky surface of low relief. The problem is compounded by a movement of water-saturated fill from under the road into the Muskingham River, resulting in some subsidence of Gilman Street (Robert Badger, *Marietta Times*, September 20, 1980). Efforts to intercept the drainage continued in 1984.

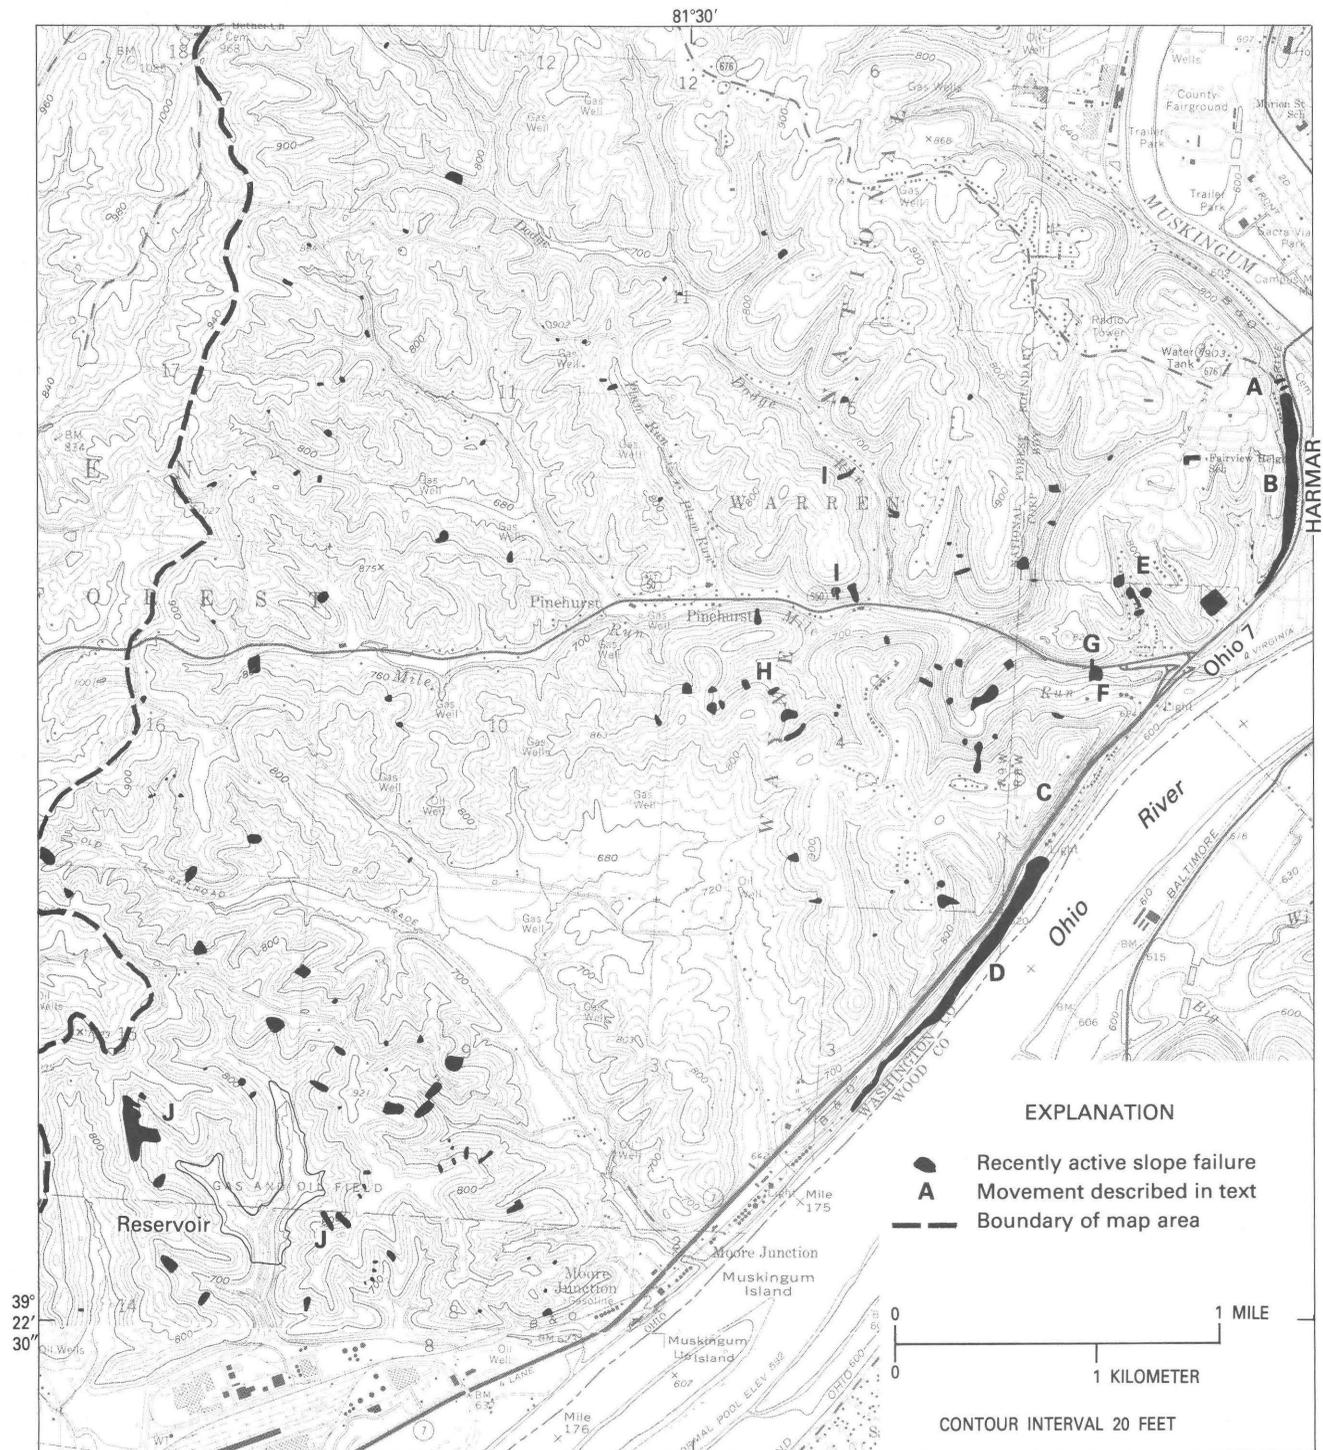
Figure 6. Area south of Ohio 676.

A rapid debris slide (locality G; fig. 8) took place along the steep slope opposite the slump-earth flow (locality F) in early May 1983 during an extremely wet period.

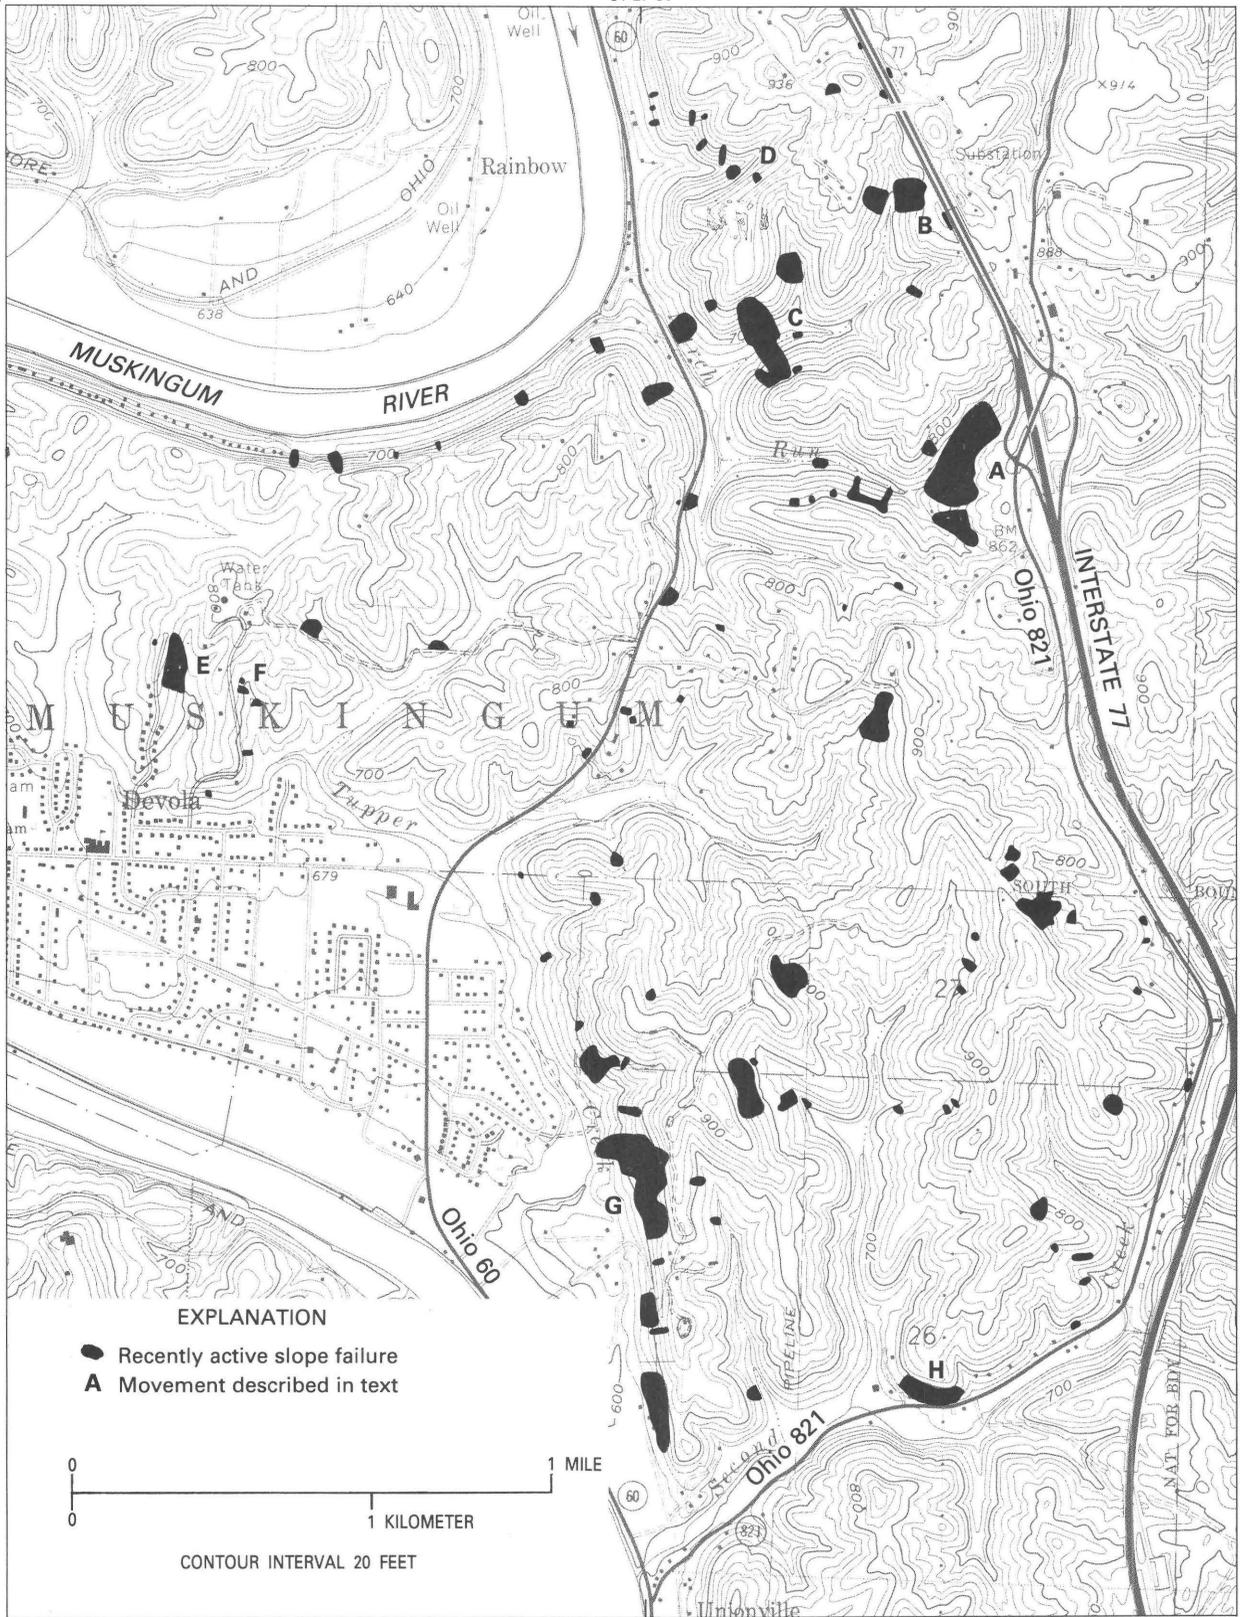
Figure 10. Area north and west of Ohio 821.

of a large house built in 1968 (fig. 13). Slope modification in the immediate vicinity of the house probably triggered movement locally but is not believed to have had any influence on the larger part of the movement to the south. The movement probably is classified best as an earth slump, but a deeper seated rock slump cannot be ruled out. Tilted sections with small ponds in the head area plus an obvious backward dip of the basement and first floor of the house (fig. 13) suggest a slide deeper than the usual shallow planar earth flow of the area.

According to information given Marilyn Ortt (Marietta botanist, written commun., 1984), the house was built in 1968. Slippage first occurred during spring 1975. The contractor did extensive renovation, including reinforcement of the rear concrete block wall, in December 1975. Trees and soil were removed from behind the house after recommendations by "authorities." A local real estate salesman took a 1-yr option to buy and moved in at the beginning of 1979 or 1980. No apparent movement had occurred during the interval that had elapsed since the "repair work." During an especially wet spring in 1979 or 1980, the occupant noticed that a drainpipe parallel to the basement wall jutted into a room within the period of 1 d. The house was abandoned after the occupant confirmed his

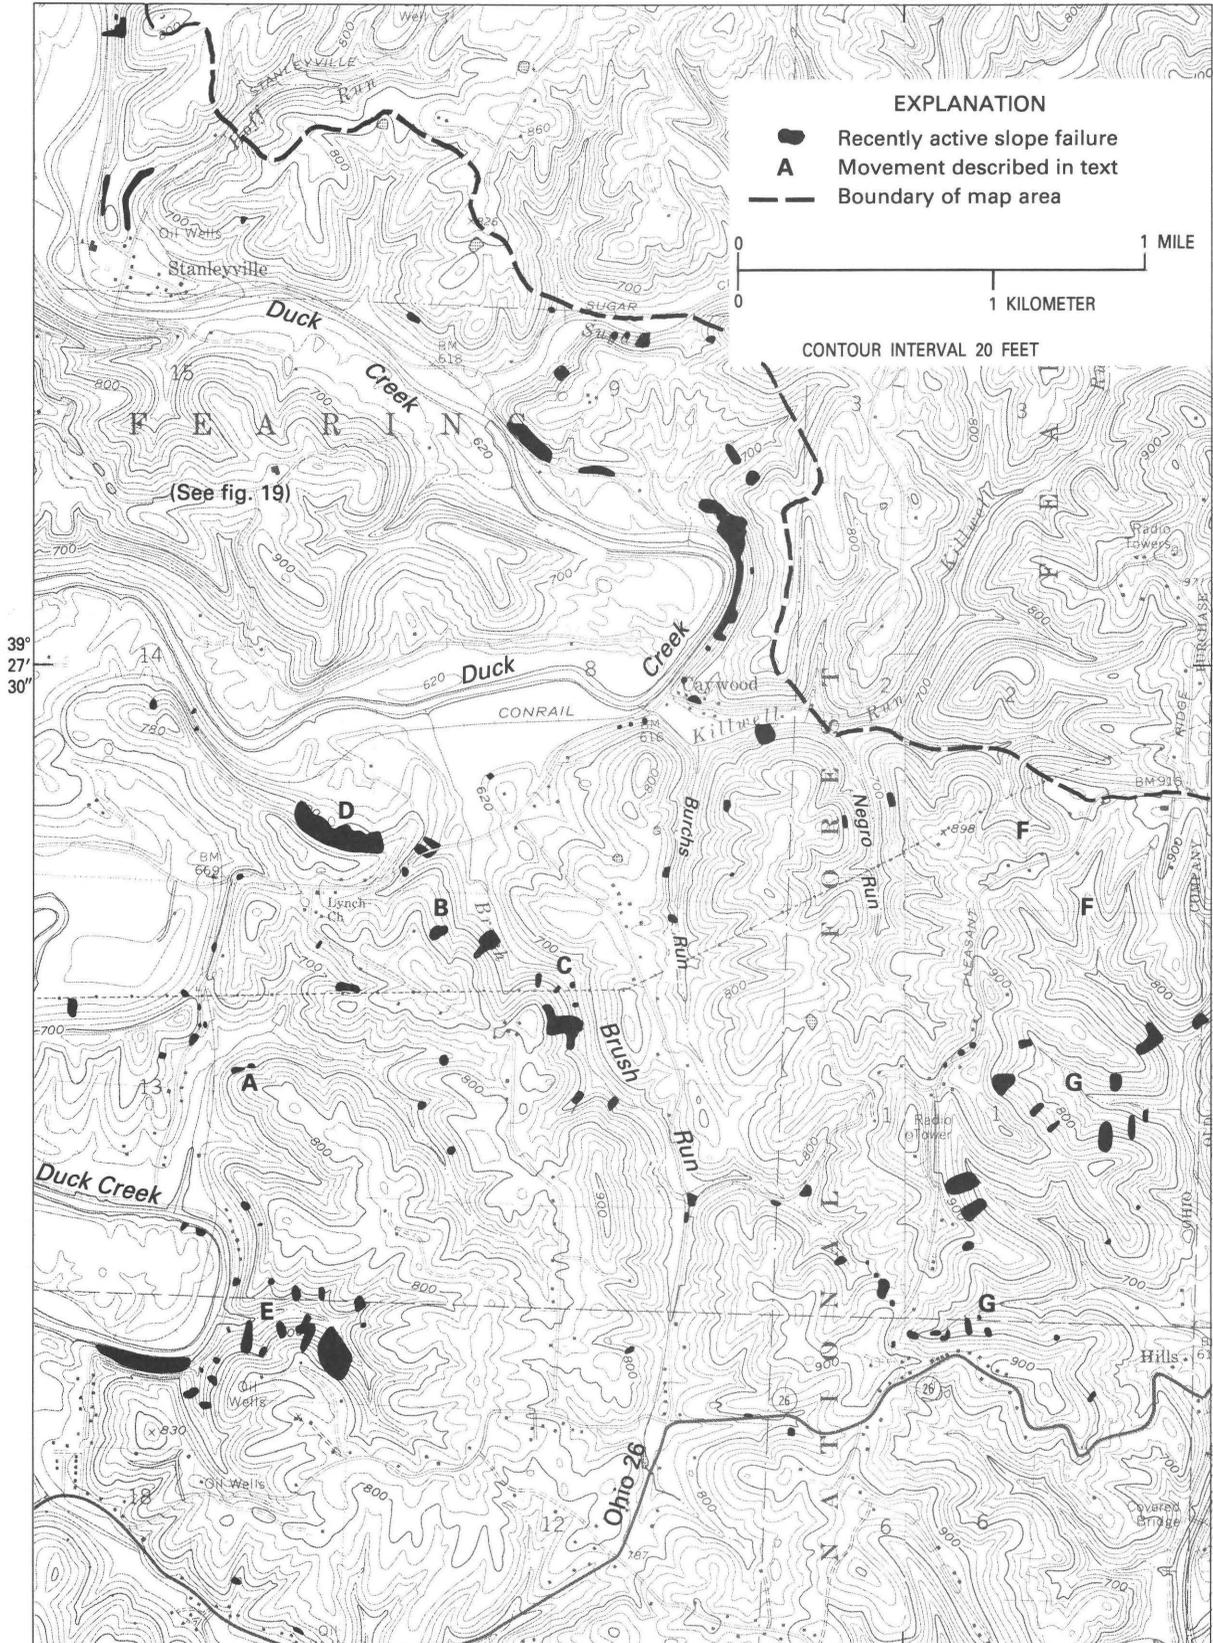
Figure 23. Area north of Ohio 26.

The slope failures are controlled lithologically; a large number have heads at the 800- and 900-ft contours. A discontinuous sandstone ledge of varying thickness commonly lies above each head area, and seeps are common at the contact. Poorly exposed red mudstone and shale underlie the sandstone. No one direction is preferred in the siting of landslides.

No houses are along the hillsides and ridge crests. Although indications of former and current oil and gas exploration are apparent in the form of sometimes poorly defined access roads, their influence on slope failures in this area is believed to be minor. Most of the movements are largely “natural” in cause and are believed to have been

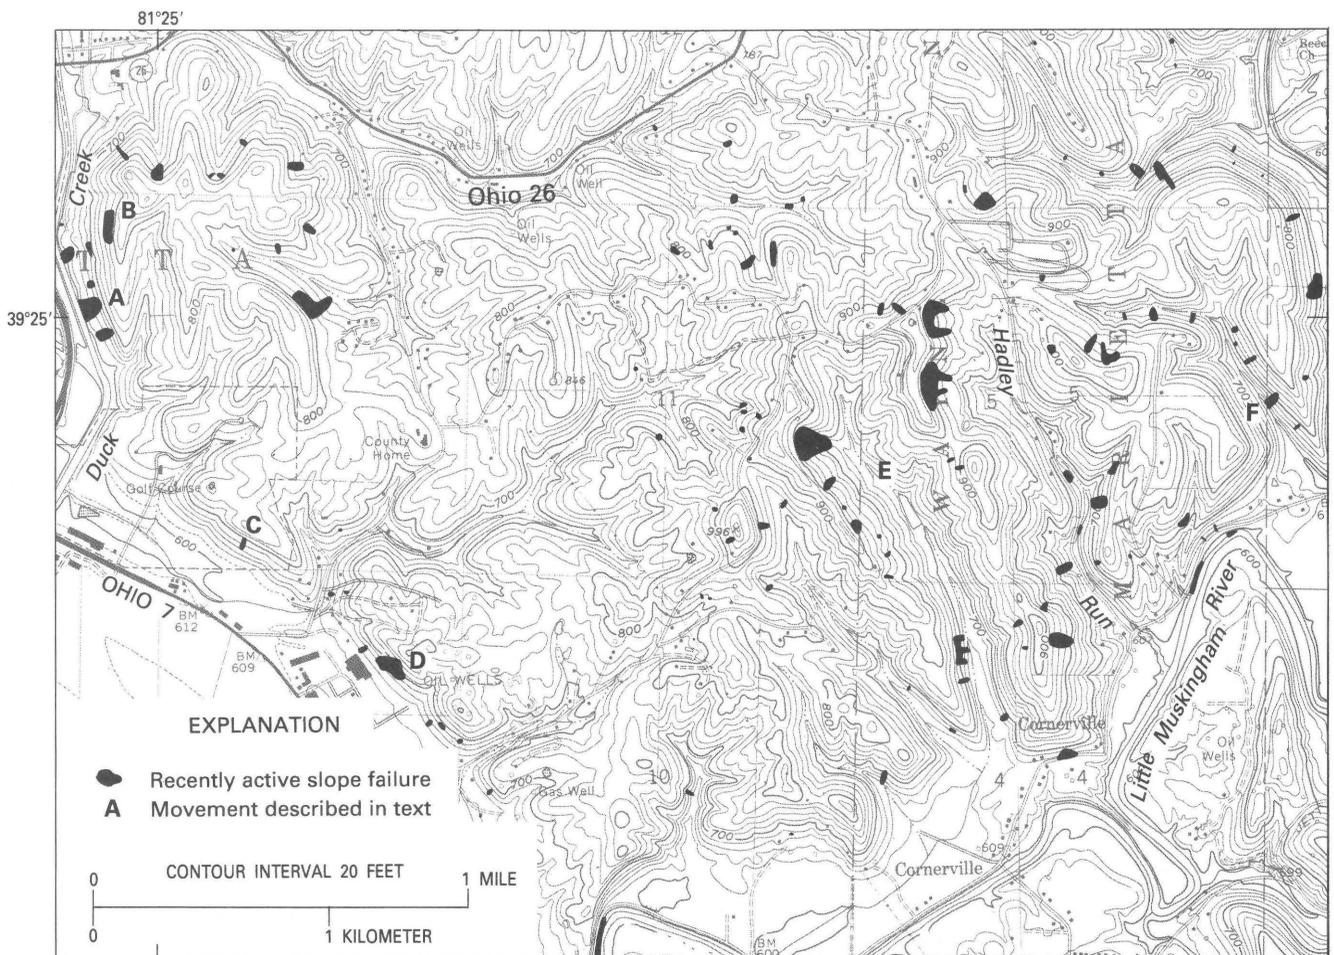
Figure 27. Area south of Ohio 26.

to the threatening movement showed several episodes of probable contemporaneous or slightly older slope failures with successive fronts. Heads of major failures are at the 800- and 900-ft contours along a 27° (52-percent) slope. Shallow planar earth-flow-type movement is suggested for the 1975 failure, during which soil and colluvium as much as 1.8 m thick was removed from the head area. Deep-seated (rock) slumping cannot be discounted for older movements, however.

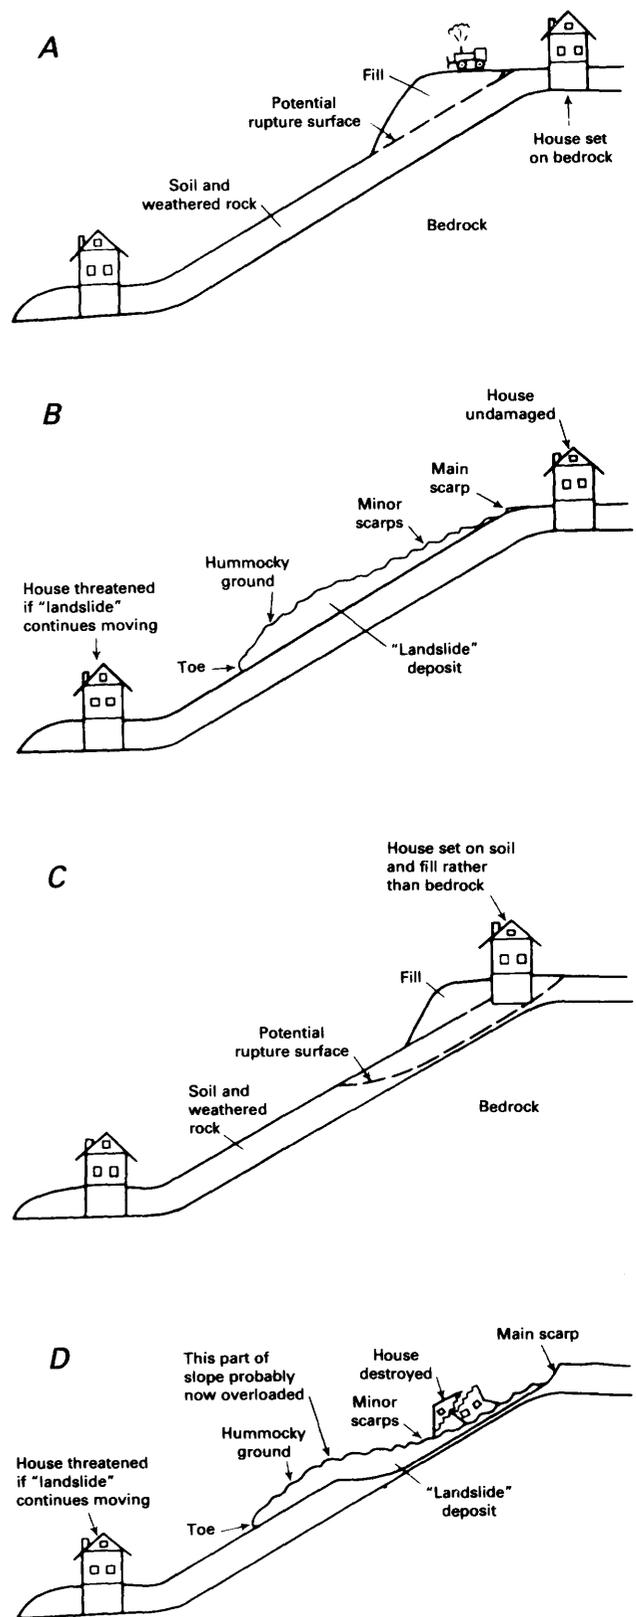
Figure 30. Possible effects of backyard fill placement. A, Backyard fill placed on the slope improperly. B, Potential consequences thereof. C, Sensitive slope overloaded by backyard fill and house set on soil and fill. D, Potential consequences thereof. Slope and soil thickness exaggerated.

a house on a slope or on a ridgetop. A surface of separation might result within the fill, between the fill and soil surface, within the soil and weathered rock, or at the contact of the weathered and unweathered bedrock. Most fill failures probably occur between the fill and soil surface. The Strecker Lane (Devola) fill failure (fig. 10, locality E) is an example. The extensive slope movement along the western side of Interstate 77 (fig. 10, locality A) about 3 km east-northeast of Devola is probably another example.

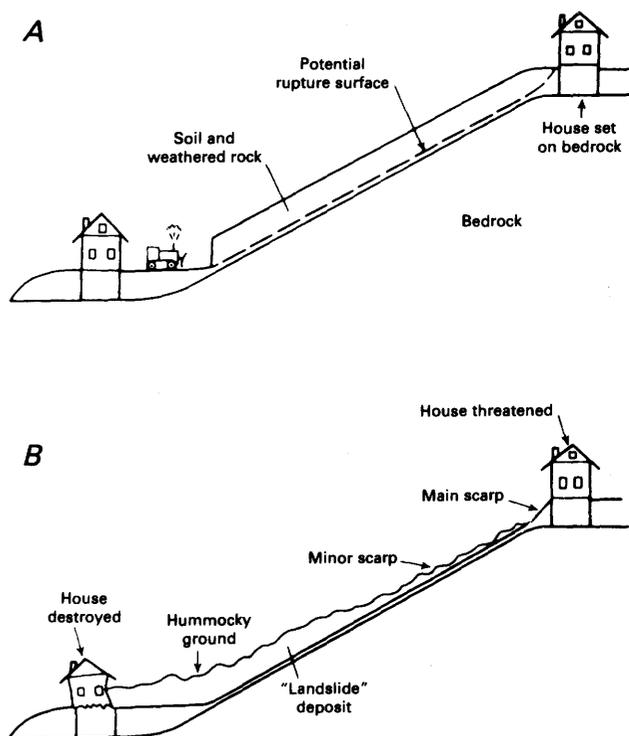
Figure 31. Possible effects of lower slope excavation. *A*, Sensitive slope excavated at bottom. *B*, Potential consequences thereof.

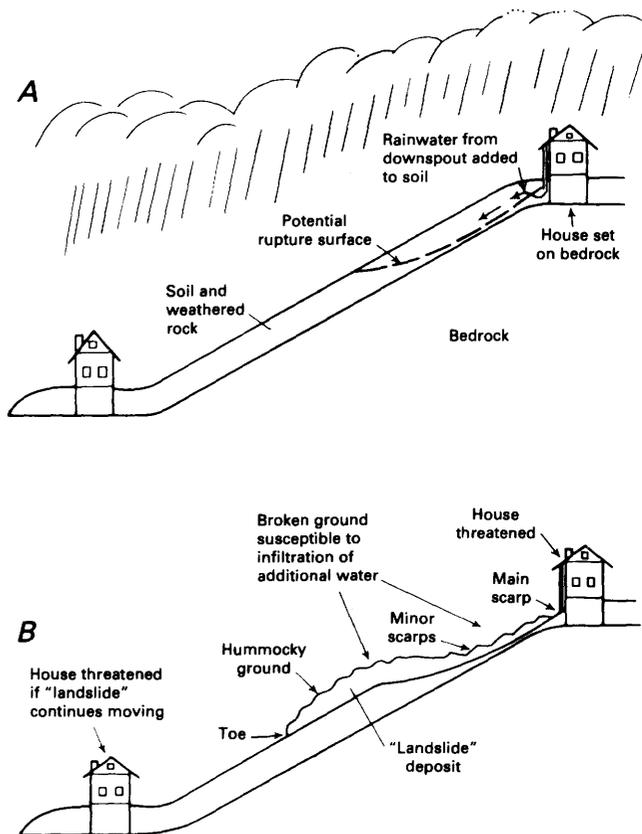
Figure 32. Possible effects of downspout water on slope. *A*, Water added to soil on sensitive slope by poor drainage system; here, a downspout. *B*, Potential consequences thereof.
