Some Slope-Movement Problems in Windsor County, Vermont, 1984

U.S. GEOLOGICAL SURVEY BULLETIN 1828

Prepared in cooperation with the
Vermont Geological Survey

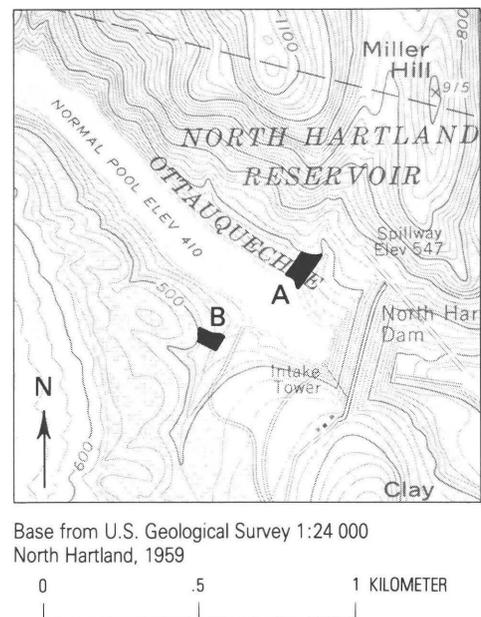
A slide located on the northeastern valley wall of the reservoir (fig. 7) near the North Hartland Dam emergency spillway was an example of the slump-earth flows encountered. This slope movement occurred in spring 1984 along the face of a terrace that formed the northeastern valley wall. An unnamed stream flows southwestward into the reservoir from the west flank of Miller Hill (fig. 1, locality 11; A in fig. 6) along the base of the terrace. The toe of the failure temporarily blocked the stream, but, by eroding the toe, the stream has reoccupied its original channel.

The slope failure had a differential elevation of 110 ft (33.5 m) from the head scarp to the toe at the unnamed stream level. The toe of the failure was stopped by the stream channel just before reaching the lake. The failure length was about 580 ft (176.8 m) from the head scarp to the toe along the axis of sliding and was 475 ft (144.78 m) wide normal to the axis. The upper boundary of this

The eastern side of the failure mass (just out of view on the right side of fig. 7) had numerous en echelon transverse tension gashes and small vertical displacements. The western side of the mass was bounded by an irregular, curving scarp and one or more lateral shear planes. Except for some tension cracks, the central portion of the slope movement had a relatively smooth upper surface.

The lateral tension cracks seen in the left foreground of figure 7 resulted from an increase in friction on the basal shear surface of the failure as the fluidized substrate pinched out, placing the basal shear surface in direct contact with the sole of the slide mass. This caused drag on the sole of the slide mass pulling it apart (extension) as shown in figure 9. Drag on the basal shear surface in the head scarp area generated tension crack openings (tensile

Figure 7. Slope movement on the northeastern wall of the North Hartland Flood-Control Reservoir west of the spillway. The head scarp is in the center. Tension cracks on the midsection of the flow can be seen on the lower left. The shrubs on the lower left were mud coated due to the high water during reservoir flooding. The smooth area in the foreground is the edge of a grass-covered hill on the southeastern side of the unnamed stream valley from which the photograph was taken.

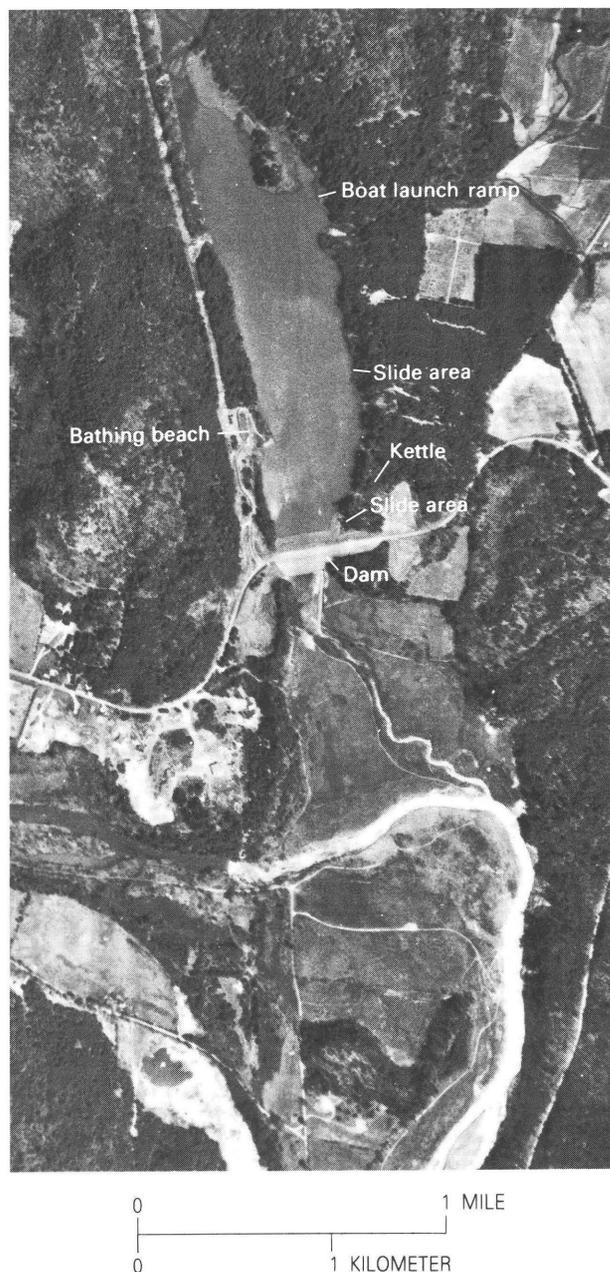
A number of slope failures occurred in ice-marginal deposits at Stoughton Pond (fig. 1; fig. 18) on the North Branch Black River (fig. 1). Stoughton Pond is part of the Army Corps of Engineers North Springfield Flood-Control Project. Slope angles measured on the eastern shore of Stoughton Pond averaged 37° (75 percent).

The Stoughton Pond slope to the north of the kettle rim showed evidence of long-term creep. Here were found small slope movements of approximately 3 to 26 ft (0.9-7.9 m) across; head scarps were 10 to 25 ft (3-7.6 m) upslope from pool level.

Figure 18. The Stoughton Pond area showing the location of the north and south limits of slide sites on the eastern shore. (Photograph courtesy of AeroGraphics Corp., Bohemia, N.Y.)

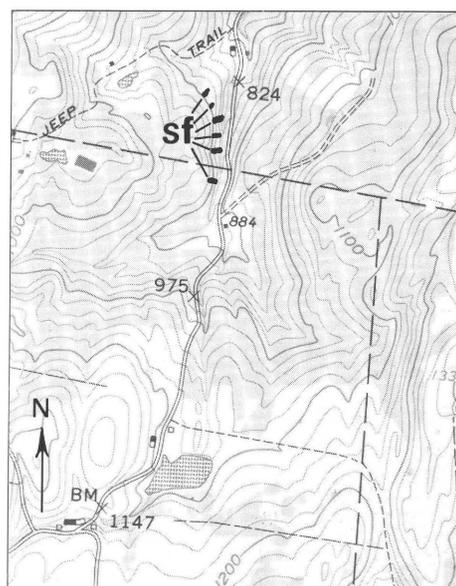
The materials involved in the Holbrook Hill Road slides (fig. 21) were very compact lodgement tills overlain by relatively loose and permeable ablation till with a variable thickness of approximately 60 to over 100 ft (18-over 30.5 m). Numerous landslides have occurred previously in this valley, as indicated by hummocky profiles on the slopes. We noted that several slides in this hummocky terrain were reactivated in spring 1984; one

Figure 21. The Holbrook Hill Road slide area. The letters "sf" point out the slope failures.
