LANDSLIDES OF THE CINCINNATI, OHIO, AREA

U.S. GEOLOGICAL SURVEY BULLETIN 2059-B

# Landslides in Colluvium

*The behavior of colluvial  
landslides is strongly affected  
by differences in thickness*

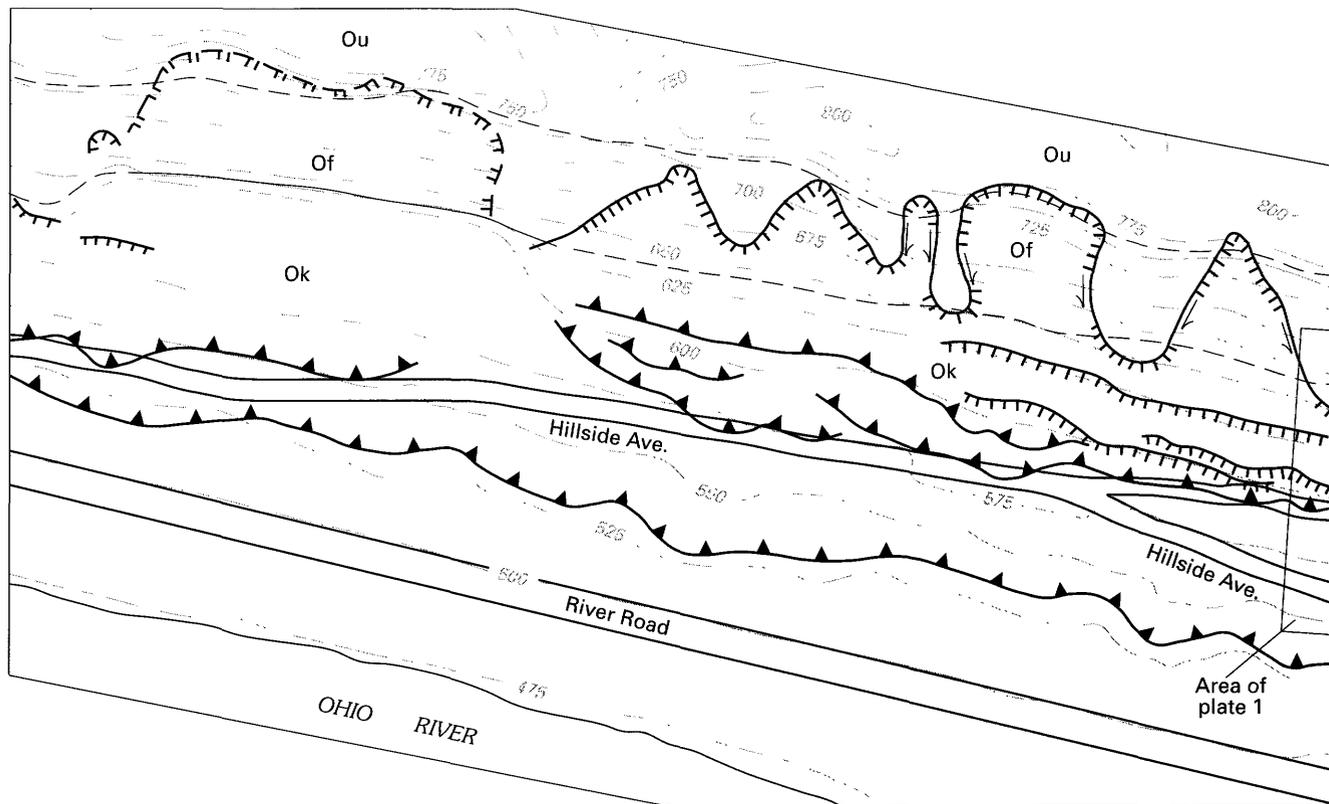
Within the Delhi Pike study area, the slopes have failed extensively (fig. 2). Hillside Avenue is deformed along much of its length, and numerous empty lots containing

**Figure 2 (above and facing page).** Geologic map of the Delhi Pike study area. See figure 1 for location. Contact between the Kope (Ok) and Fairview (Of) Formations is exposed in cut slope in western part of the map area. Contact was projected through map area using apparent dip angle from published geologic maps of areas directly across the Ohio River in Kentucky (Gibbons, 1972). The Fairview Formation was assumed to be 30 m thick.

house foundations and overgrown remnants of driveways and walls attest to a long history of slope movements. Still farther upslope are scarps, scars, and lobes produced by failure of a thinner mantle of colluvium.

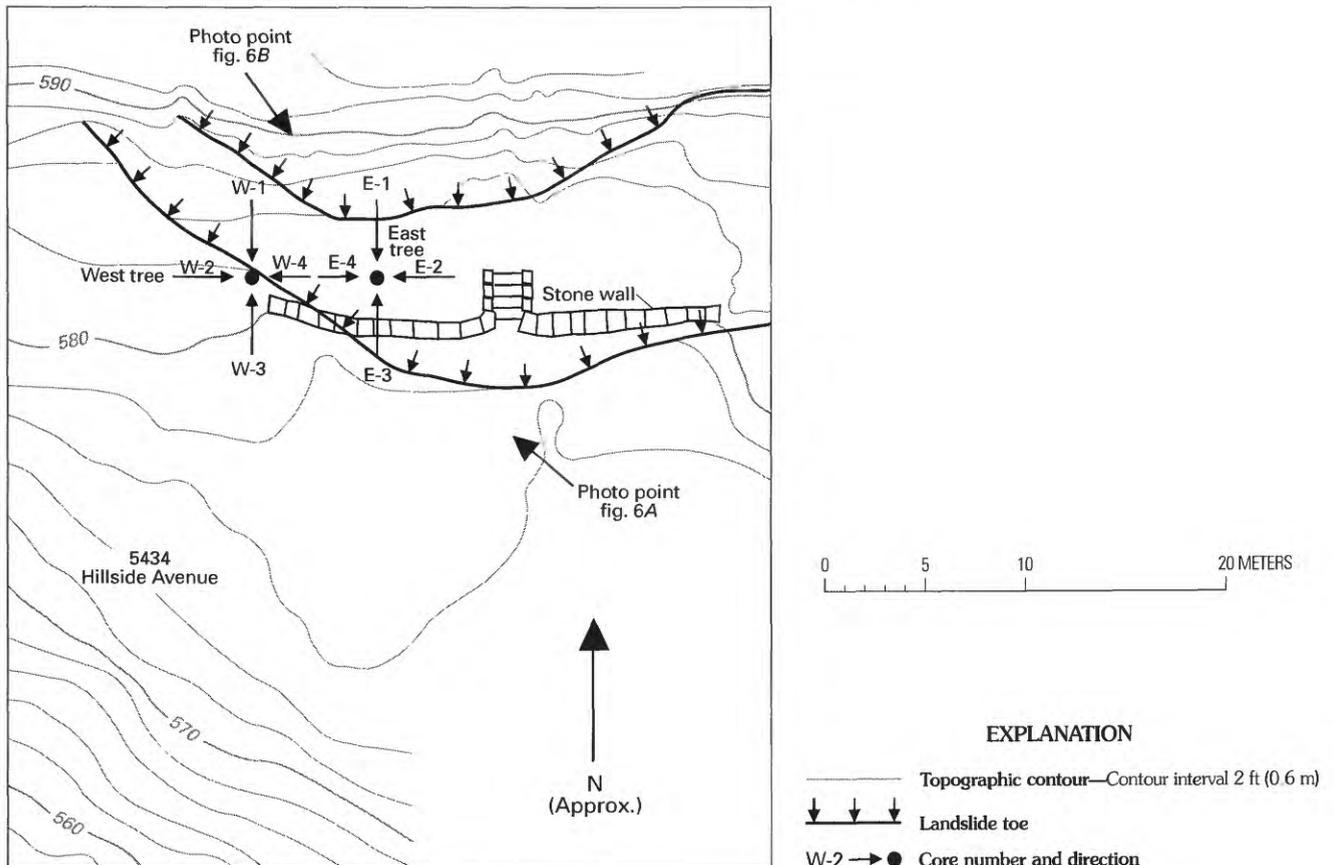
Tree cores were used to examine the growth behavior of two pine trees on the thick landslide at Delhi Pike. The pine trees were planted in the early 1940's in an open area along the driveway to the house at 5434 Hillside Avenue. Both trees have been tilted and deformed in response to landslide movements. The positions of the trees relative to nearby landslide features are shown in figure 5.

**Figure 5.** Sketch map of positions of tilted pine trees, walls, and landslide toes on the property at 5434 Hillside Avenue.

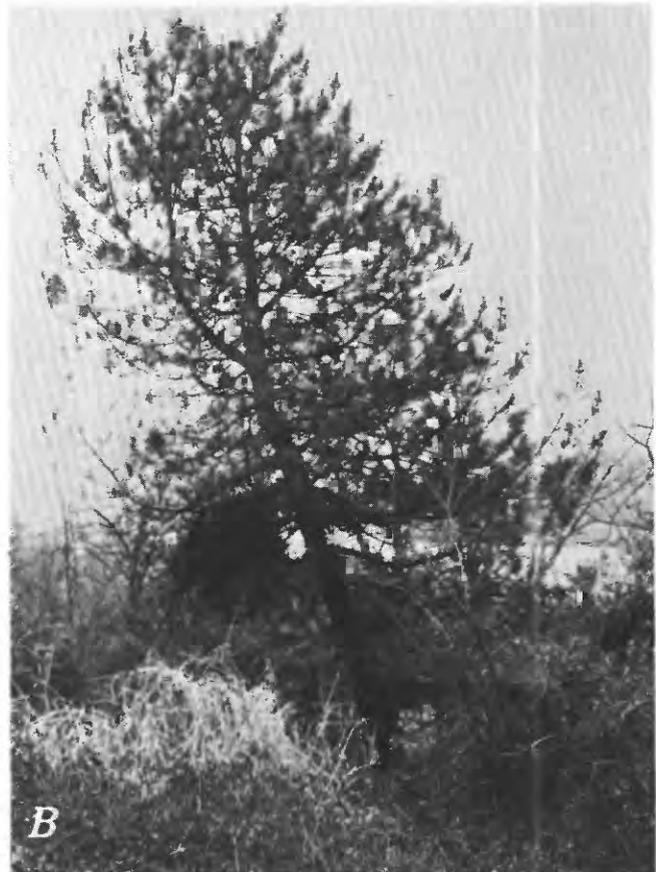
Figure 6A is a photograph of the two pine trees viewed northwest from near the site of the house at 5434 Hillside Avenue. The tree on the left is termed the "west tree" and the tree on the right the "east tree." The bulge in the foreground is a toe bulge that, from right to left, trends through dry grass and crosses the ivy-covered stone wall about in line with the west tree. The bulge passes just to the right of the

west tree, and landslide movement has pushed the tree toward the left or downslope. In response, the tree has grown straight for about 5 m and then is continuously curved except for one small, more abrupt bend about halfway to the top. The continuously curved portion of the tree appears to be a response to small annual increments of landslide movement, and the single, abrupt bend could be a response to one event of more than normal movement of the landslide.

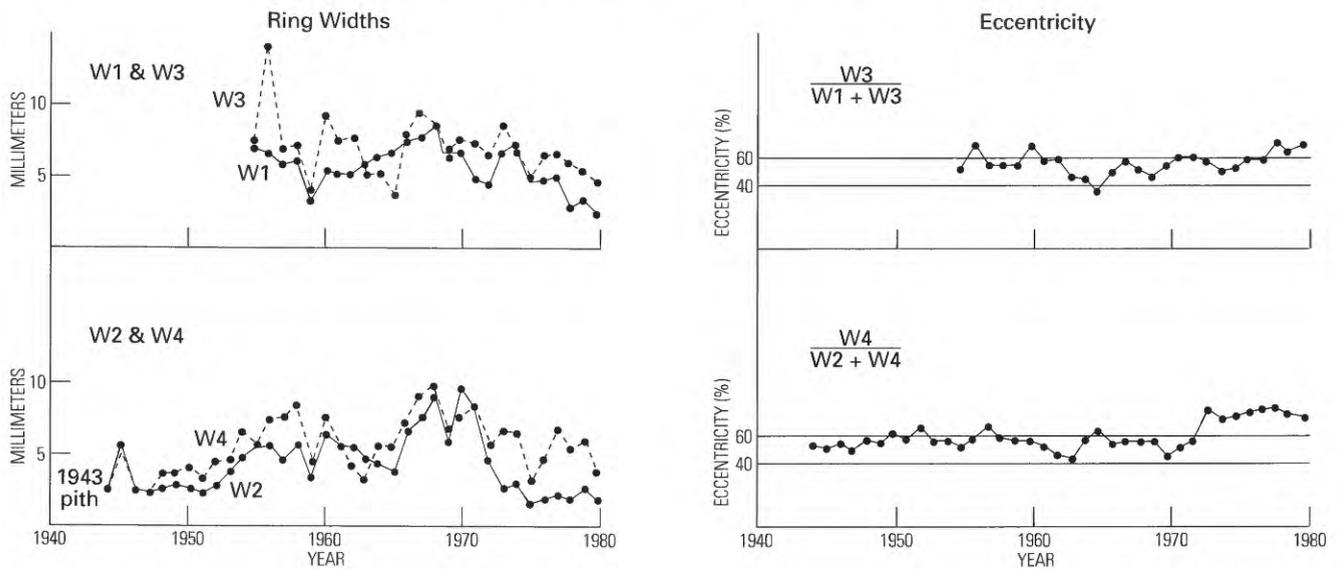
For both the east and west trees, the year 1959 is a year of markedly suppressed growth. The east tree also experienced suppressed growth in 1958. Growth was somewhat suppressed in both trees in 1965, but we have found no other evidence of landslide movements that year.

The combined observations of external changes to the trees (curved trunks and abrupt bends) and the tree-ring data lead to the following conclusions. There were active slope movements at the site as early as the mid-1940’s, but the tree-ring data cannot be extended back in time beyond those years. The most dramatic movement apparently occurred in 1958, following near-record precipitation in calendar year 1957. Abrupt tilting and suppressed growth affected both trees during the 1959 growing season.

**Figure 7.** Thickness of growth rings in the “west tree” of figure 6, plotted as a function of time. Cores are from the uphill (W1), downhill (W3), and lateral (W2 and W4) sides of the tree. Also plotted is the percent eccentricity of rings on opposite sides of the tree.

Although our measurements clearly showed movement during 1979 and 1980, the tree rings formed in those years had no irregularities in growth-ring thicknesses (figs. 7 and 8). We suspect that a small amount of movement occurs during most years, but large, abrupt movements of the thick slides at Delhi Pike apparently occurred only during 1958–59 and 1973.

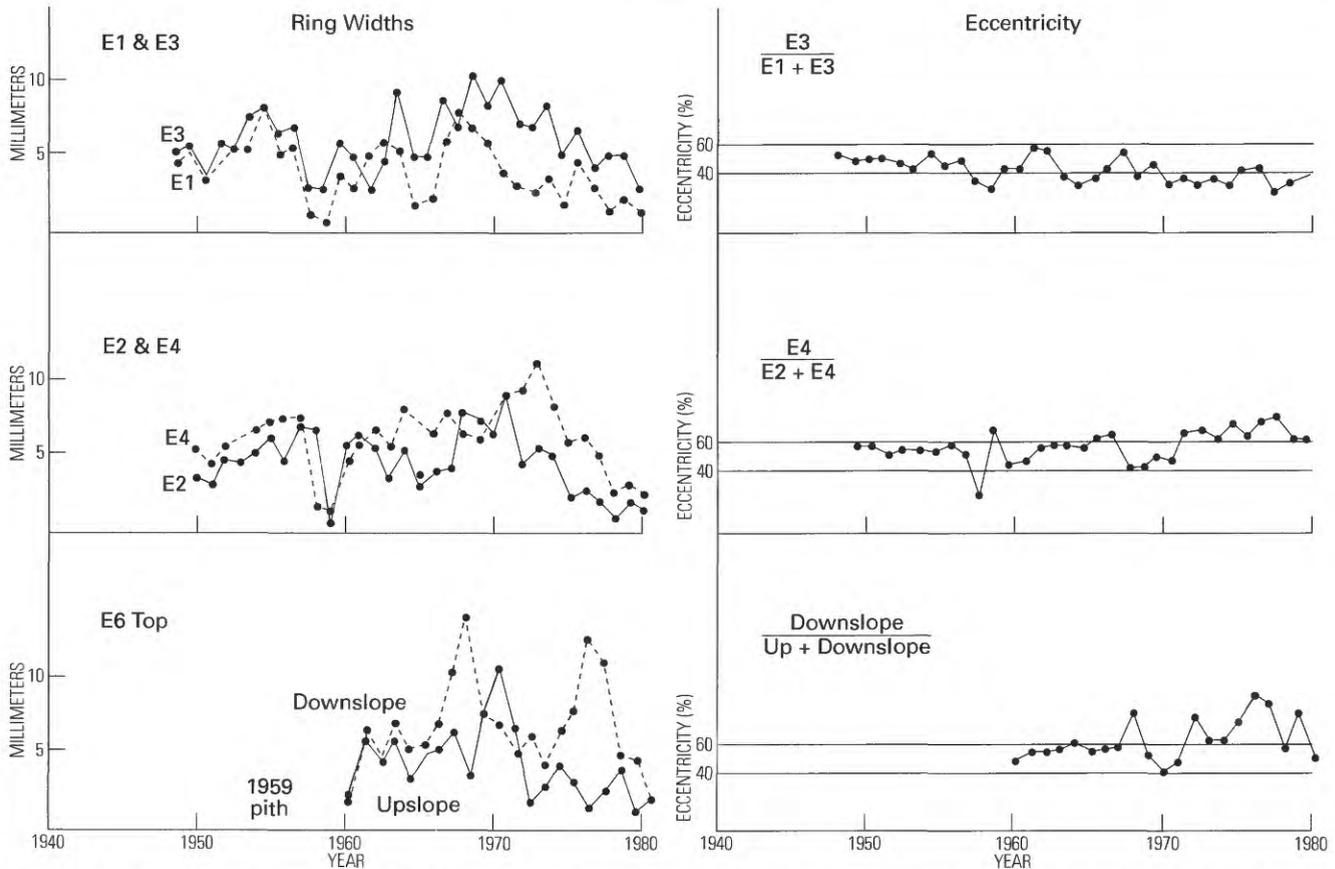
**Figure 8.** Thickness of growth rings in the “east tree” of figure 6, plotted as a function of time. Cores are from the uphill (E1), downhill (E3), and lateral (E2 and E4) sides of the tree. E6 is the tree core from just above the sharp bend shown in figure 6B. The bend probably formed in 1958. Also plotted is the percent eccentricity of rings on opposite sides of the tree.

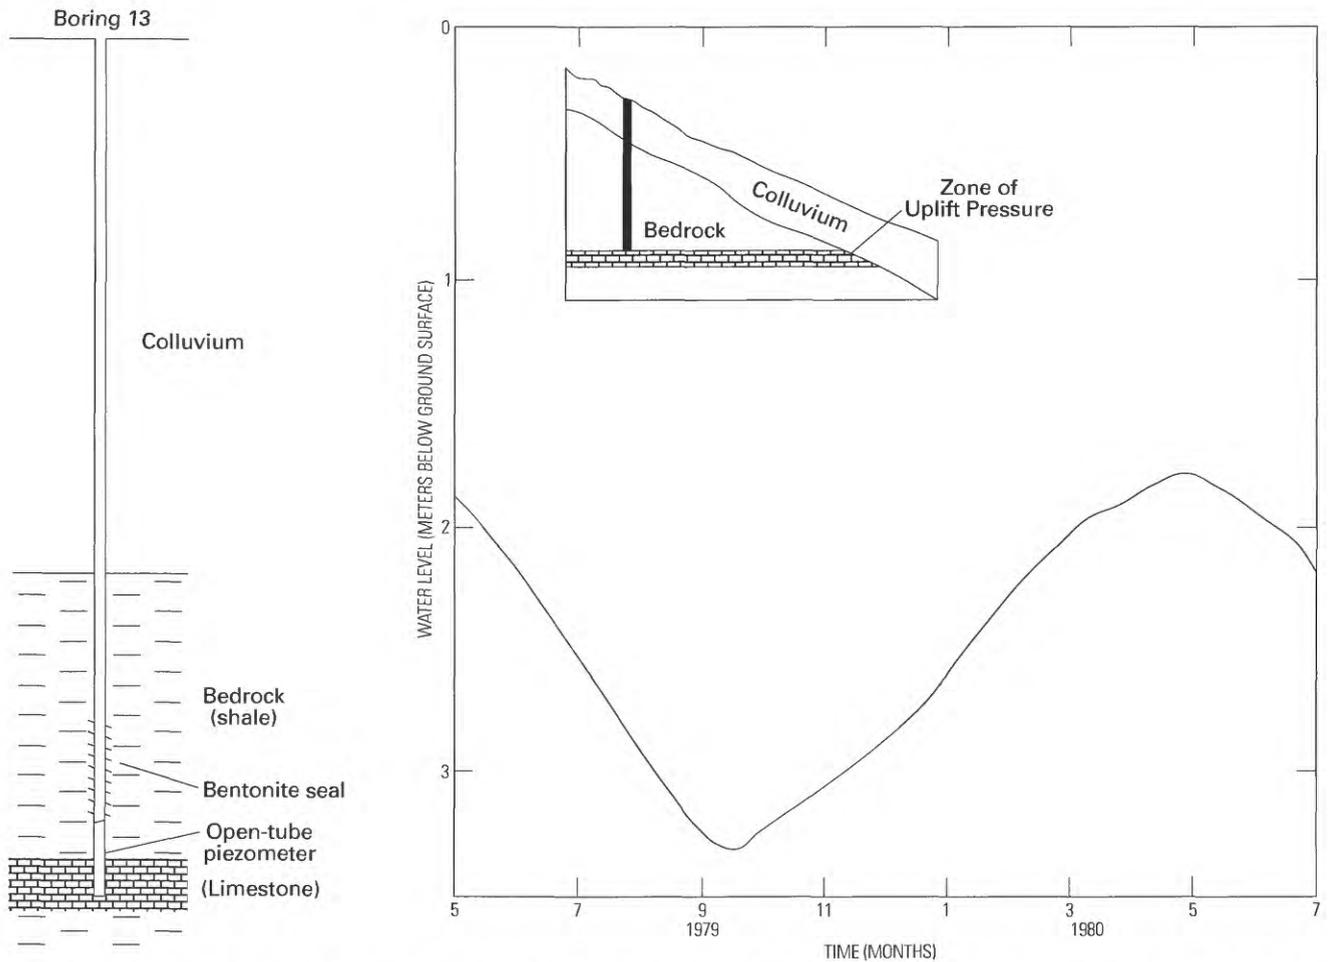
The typical subsurface water condition was illustrated by measurements in boring 13. There, the colluvium was not saturated. Free water was first encountered in the first limestone bed under the colluvium that was penetrated by drilling. This water was under artesian pressure and responded to an annual cycle of maximum pressure in the late spring and minimum pressure in the early fall (fig. 12). In those parts of the landslide that extend nearly to the contact between bedrock and colluvium (that is, the head region), the artesian pressures could significantly reduce stability. Most of the toes of the thick landslides are entirely within the colluvium and significantly removed from the bedrock containing artesian water. The effect of the artesian pressure is

**Figure 12.** Water-level record of one year for an open-tube piezometer (No. 13, pl. 1) sealed in a limestone layer in bedrock. Depth to layer was 3.4 m, and water level varied from 3.3 m during September 1979 to 1.8 m about May 1, 1980. The line of intersection of the limestone layer with the base of the colluvium is a zone of artesian pressure that develops a head as great as 1.5 m during the spring. (See inset figure.) (From Fleming and others, 1981.)

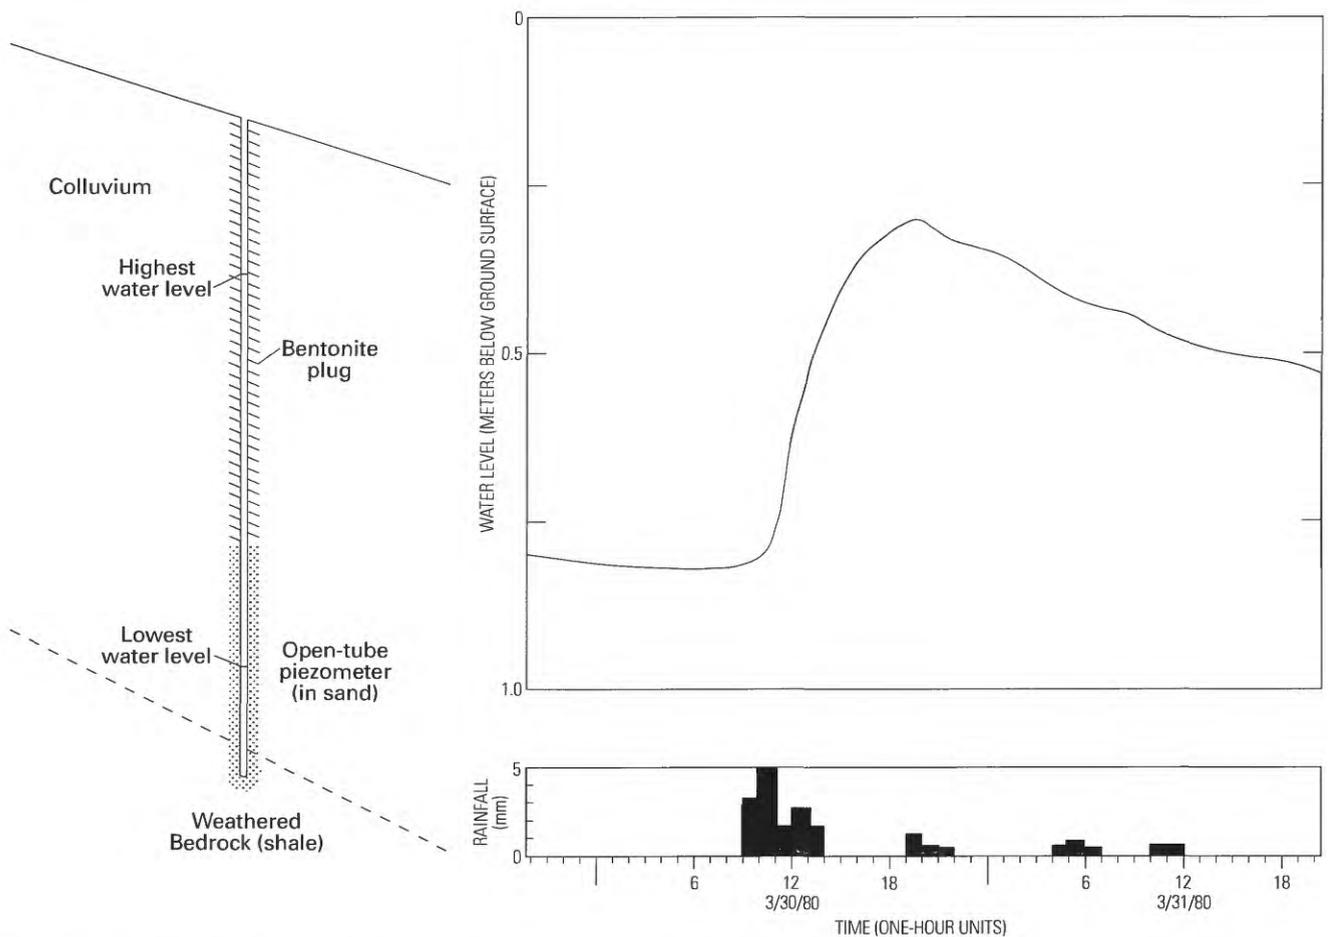
The time of activity of thin landslides throughout the metropolitan area is restricted to the interval between the spring thaw and the leafing of vegetation. Episodes of movement of thin landslides usually occur during major storms in the period of mid-March to early May. During the remainder of the year, either the vegetation is serving as an effective agent for dewatering the thin colluvium or the ground is frozen. Open-tube piezometers were dry except during the spring, when water levels responded almost immediately to rainfall (fig. 15). The behavior of subsurface water in the thin colluvium has been described by Gökce (1989) and by Haneberg and Gökce (in press).

**Figure 15.** Water-level and precipitation record for an open-tube piezometer (P-5, pl. 1) placed at contact between colluvium and bedrock. This piezometer was dry for most of the year but, during the spring, water levels changed dramatically in response to rainfall. This particular record shows water-level response to a 1.7-cm rainfall on March 30–31, 1980. Sketch to the left of the water record shows location of piezometer relative to colluvium and weathered bedrock. (From Fleming and others, 1981.)

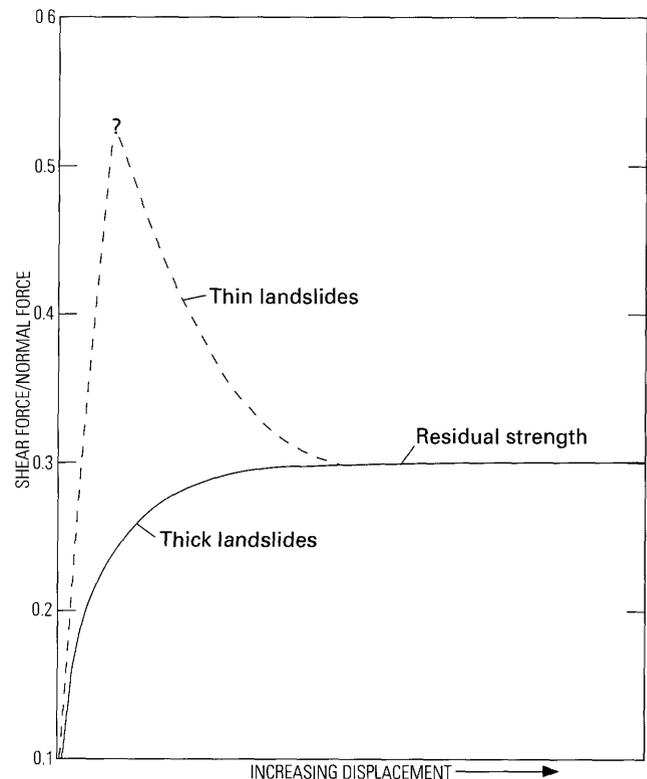
**Figure 18.** Hypothetical force-ratio-displacement models for thin and thick landslides. Back-calculation of stability of thin colluvium reveals that the residual strength is insufficient to support the slope. Field behavior indicates that some form of stick-slip behavior produces large initial strength that is lost after a small amount of displacement. The back-calculation of stability of thick colluvium reveals that failure is consistent with the measured value of residual strength.

about thin landslides, then, is not why some slopes have failed, but rather why failure is not more extensive. Observations of episodes of movement of typical thin landslides (fig. 18) suggest that a type of stick-slip phenomenon may contribute to larger-than-measured initial strength. We observed that a small displacement causes a large loss of resistance, and a thin landslide commonly accelerates out of the slide scar. The situation, shown schematically in figure 18, may be equivalent to the abrupt loss of strength in first-time failures of slopes compared to reactivation of previously failed slopes. For thin colluvium, however, the slope has previously failed and yet retains greater resistance to sliding than predicted by laboratory measurements.
