GEOLOGICAL SURVEY CIRCULAR 31

LANDSLIDE PROBLEMS OF SOUTHWESTERN
COLORADO

By
Helen D. Varnes

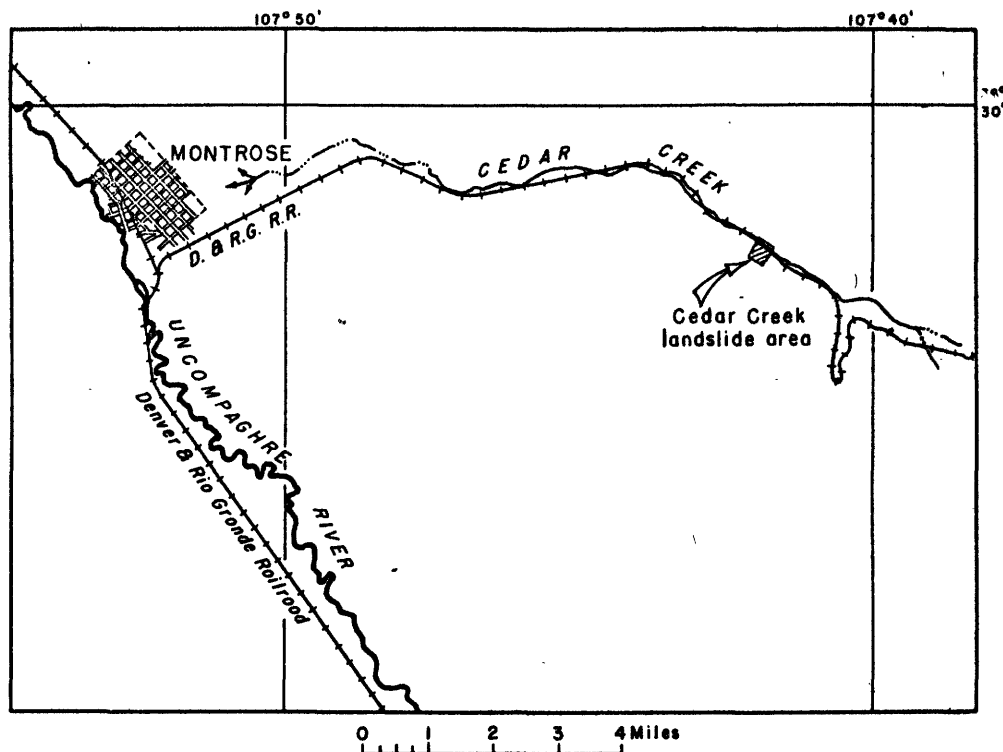
The Cedar Creek landslide crosses the Denver & Rio Grande Western Railroad about 9 miles east of Montrose. (See fig. 2.) Recently active landslides extend for almost a mile along the north-facing side of the valley. Detailed studies were confined to the area where one of the most recent slides has disrupted the railroad. This landslide (see fig. 3) occupies an area about 1,000 feet square with a maximum height of about 300 feet measured from the railroad grade to the top of the cliff.

Figure 2.—Index map of the Cedar Creek landslide area.

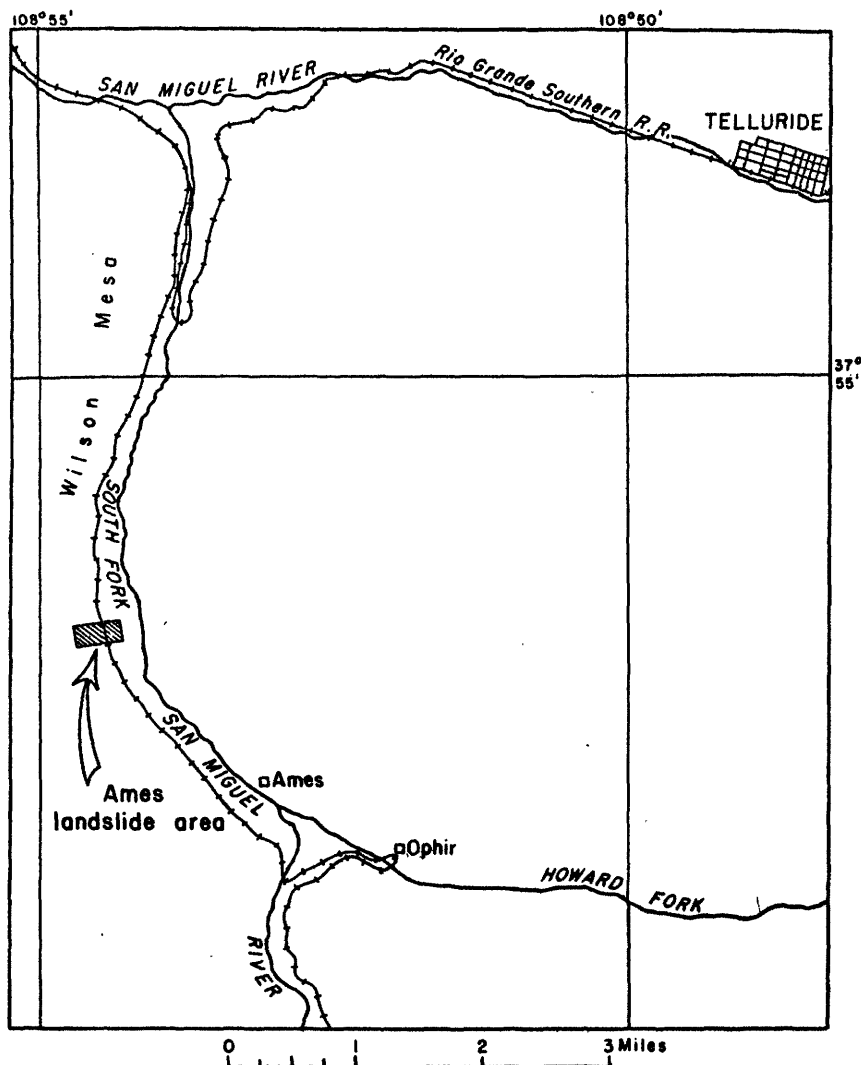
Figure 5.—Index map of the Ames landslide area.
