Effects of the Truckee California, Earthquake of September 12, 1966

By Reuben Kachadoorian, R. F. Yerkes, and A. O. Waananen

GEOLOGICAL SURVEY CIRCULAR 537

A contribution to west-coast earthquake investigations

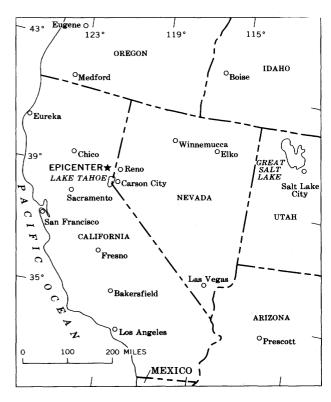
The earthquake was felt over an area which extended from San Francisco on the west to Salt Lake City on the east and from Bakersfield on the south to Chico on the north (fig. 1). Russel Valley, about 8 miles north-northeast of Truckee, was the

FIGURE 1.—Location of the epicenter of the Truckee earthquake and area over which it was felt. Open circles indicate cities where the earthquake was felt.

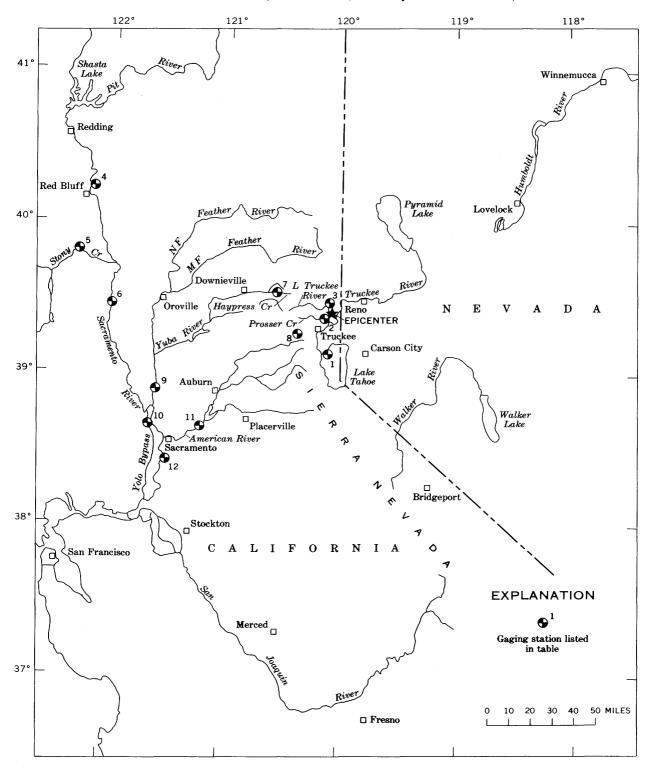
Fluctuations recorded at selected gaging stations are listed in table 1; the location of these stations is shown in figure 14. Lesser effects were indicated by the charts from many other stations in the valley and lower foothill areas. Stations in the Sierra Nevada and upper foothill areas on the west slope generally showed little or no effect. For example, the record for Haypress Creek, a headwater tributary of the North Yuba River about 15 miles east

FIGURE 14.—Selected gaging stations whose records showed effects of the Truckee earthquake, September 12, 1966. Gaging stations listed in table 1.

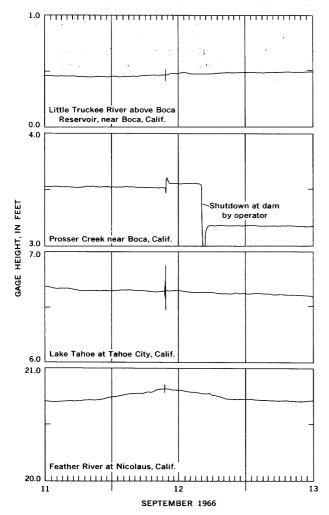
Parts of recorder charts showing fluctuations in response to the principal seismic shock on September 12, 1966, at four selected gaging stations are reproduced in figure 15. The record for Feather River at Nicolaus, Calif., shows a direct response to the seismic shock and is representative of the records at most gaging stations.

FIGURE 15.—Fluctuations recorded at gaging stations in response to the Truckee earthquake.

The record for Lake Tahoe at Tahoe City (fig. 15), obtained at a pier 1,000 ft east of the dam at the outlet near the north end of the lake, indicates
