# **EARTHQUAKES AND RELATED CATASTROPHIC EVENTS, ISLAND OF HAWAII, NOVEMBER 29, 1975**

**A Preliminary Report**

**GEOLOGICAL SURVEY CIRCULAR 740**

By Robert I. Tilling, Robert Y. Koyanagi,  
Peter W. Lipman, John P. Lockwood, James G.  
Moore, and Donald A. Swanson

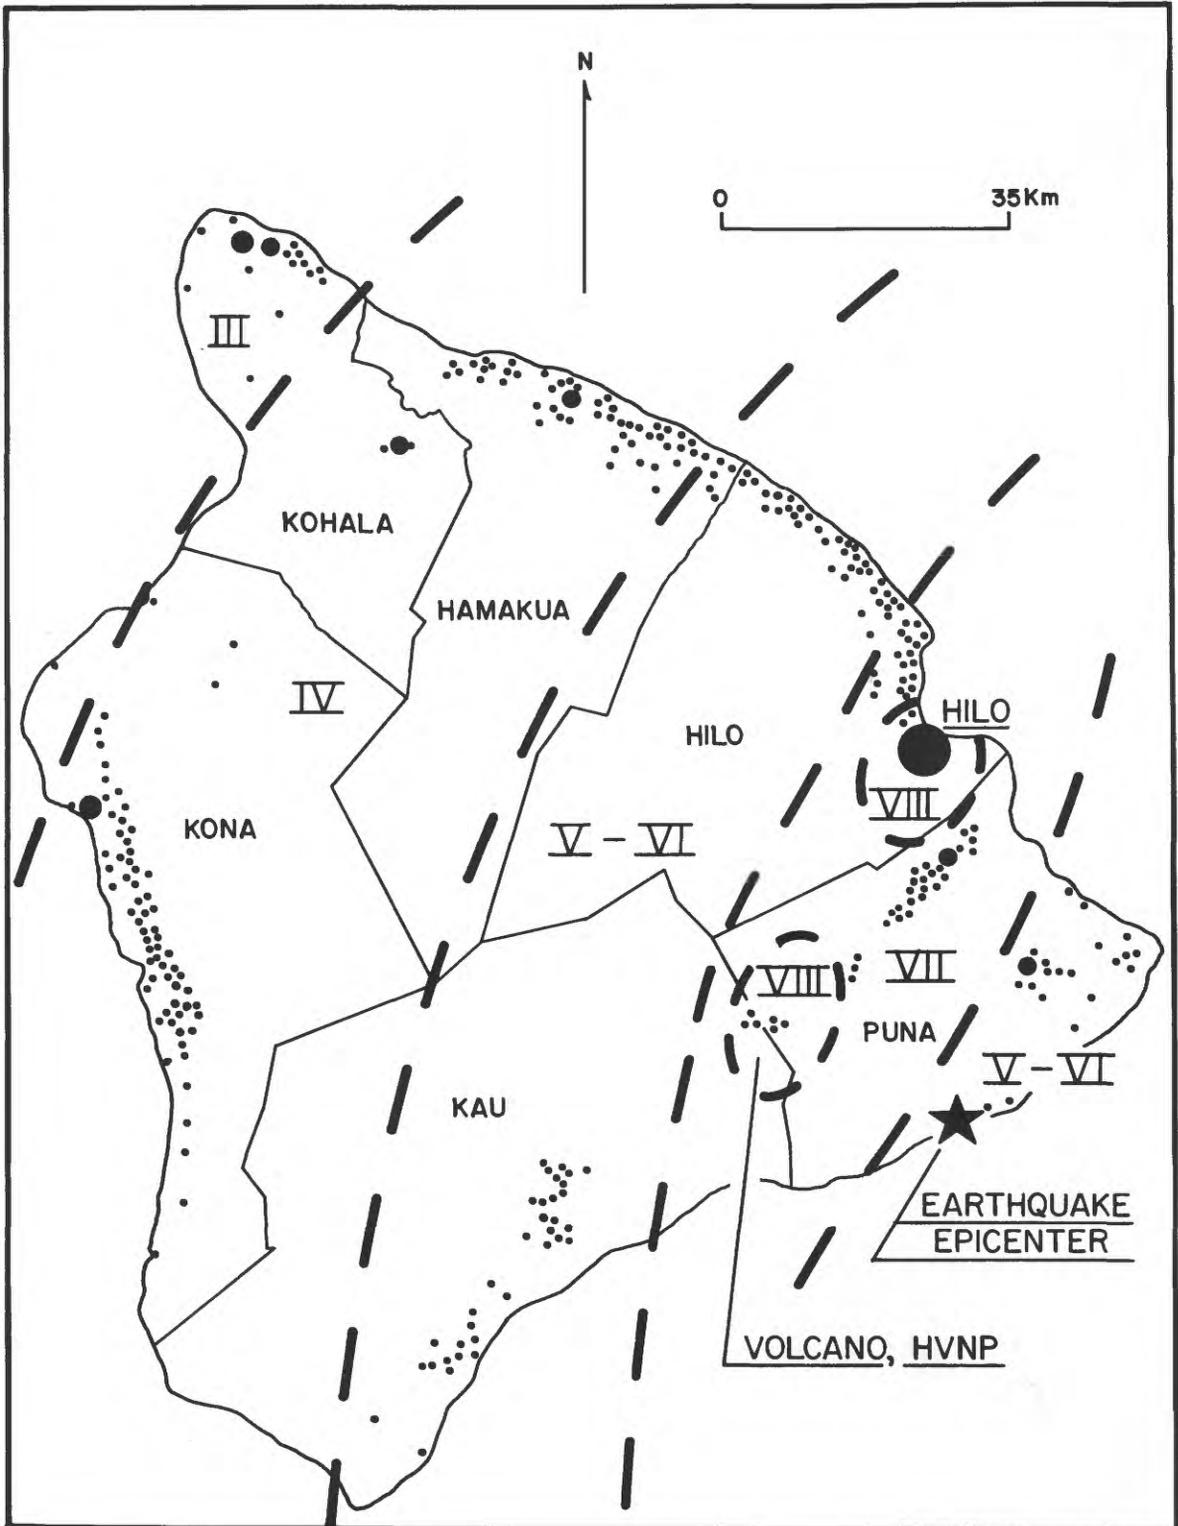
As much of Hawaii is unpopulated, direct observations of ground shaking and its effects are not known for large areas; for this reason, the intensity map for the main earthquake (fig. 4) is based on irregularly distributed, statistically inadequate, data. Nonetheless, observations do show most buildings within 20 km of the earthquake epicenter sustained no significant structural damage from the ground shaking, whereas buildings in Hilo and at the summit region of Kilauea Volcano, far from the epicenter, showed

extensive damage. The building at the Wahaula Visitor Center of Hawaii Volcanoes National Park, located almost directly at the earthquake epicenter, was virtually undamaged. The apparent offset of the zone of maximum damage (intensity VII-VIII; fig. 4) from the epicentral region poses an enigma for which there are no ready solutions at present.

FIGURE 4.—A preliminary isoseismal map of the island of Hawaii for the 7.2-magnitude earthquake, November 29, 1975 (compiled from damage reports summarized in table 3 and other sources). Intensities (III–VIII) are based on the Modified Mercalli Scale, 1956 version (table 2). Areas in Hilo, Volcano, and Hawaii Volcanoes National Park (HVNP) generally were most damaged (intensity VIII). Approximate population density of the island shown by dots; each small dot represents 100 people; larger dots represent principal towns containing from a few hundred to several thousands of people.

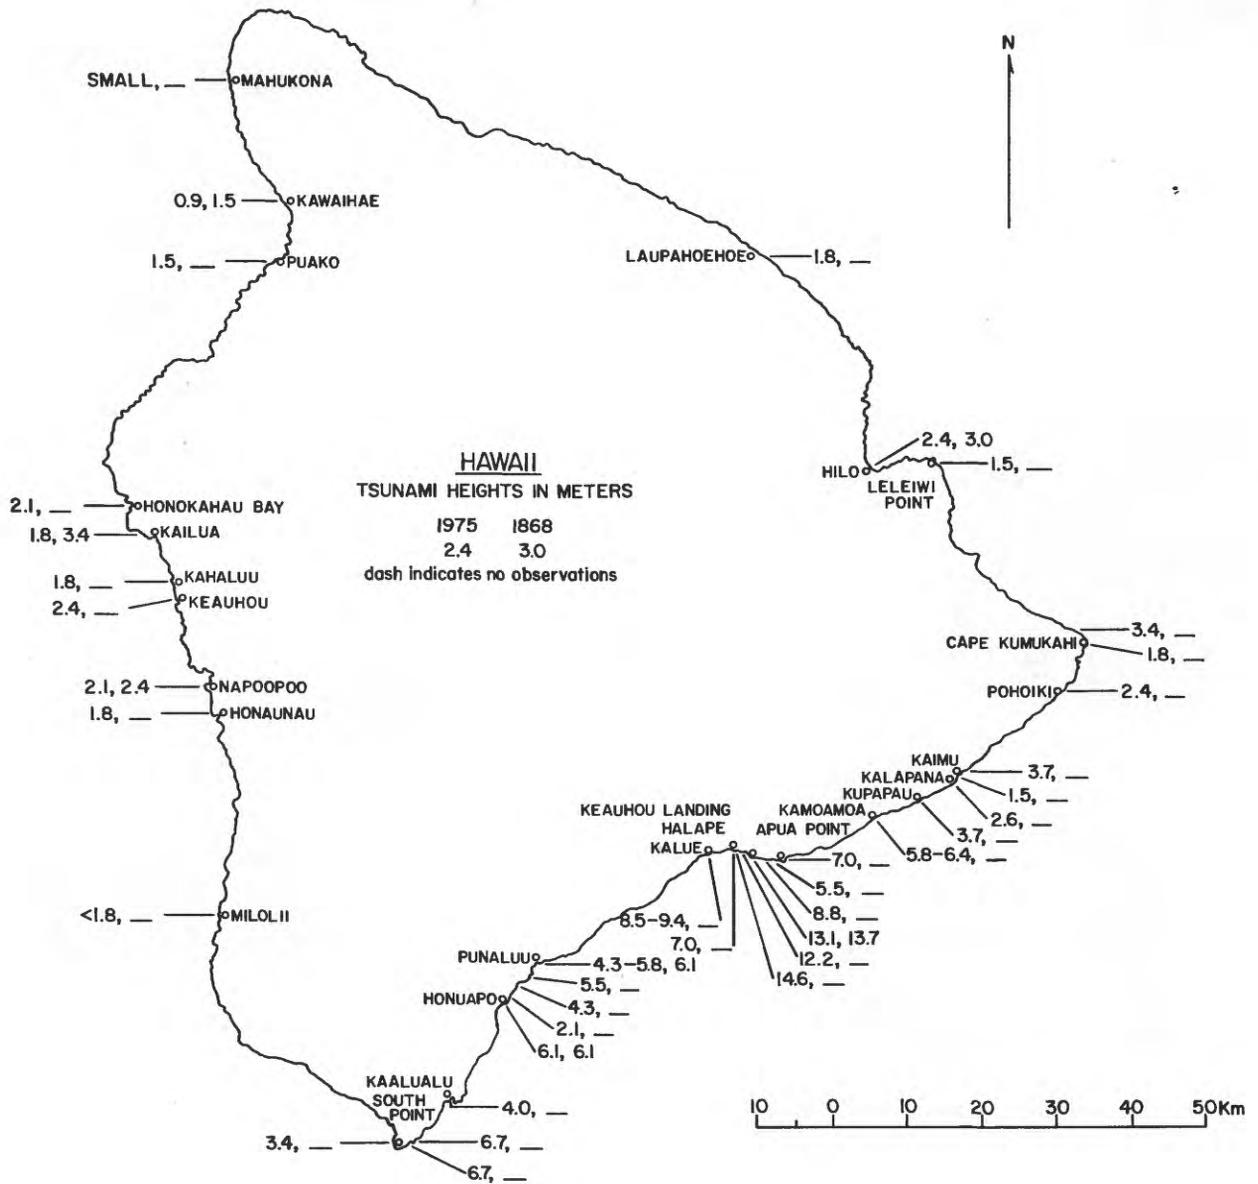
FIGURE 7.—Maximum heights of the two locally generated tsunamis (April 1868 and November 1975) on the shore of the island of Hawaii in historic time. All wave heights are given in meters relative to present, that is, postsubsidence, mean lower low water.

The tsunami reached its maximum height of 14.6 m above mean lower low water about 1.5 km east of Halape (fig. 7), where it was channeled against a low cliff trending about normal to the coast. Generally the tsunami rose highest on the low ground within the Halape-Keauhou Landing area, where it averaged about 9 m above low water. This part of the coast subsided 3–3.5 m during and immediately after the earthquake; it is not known whether the wave swept the coast before or after the subsidence was complete.

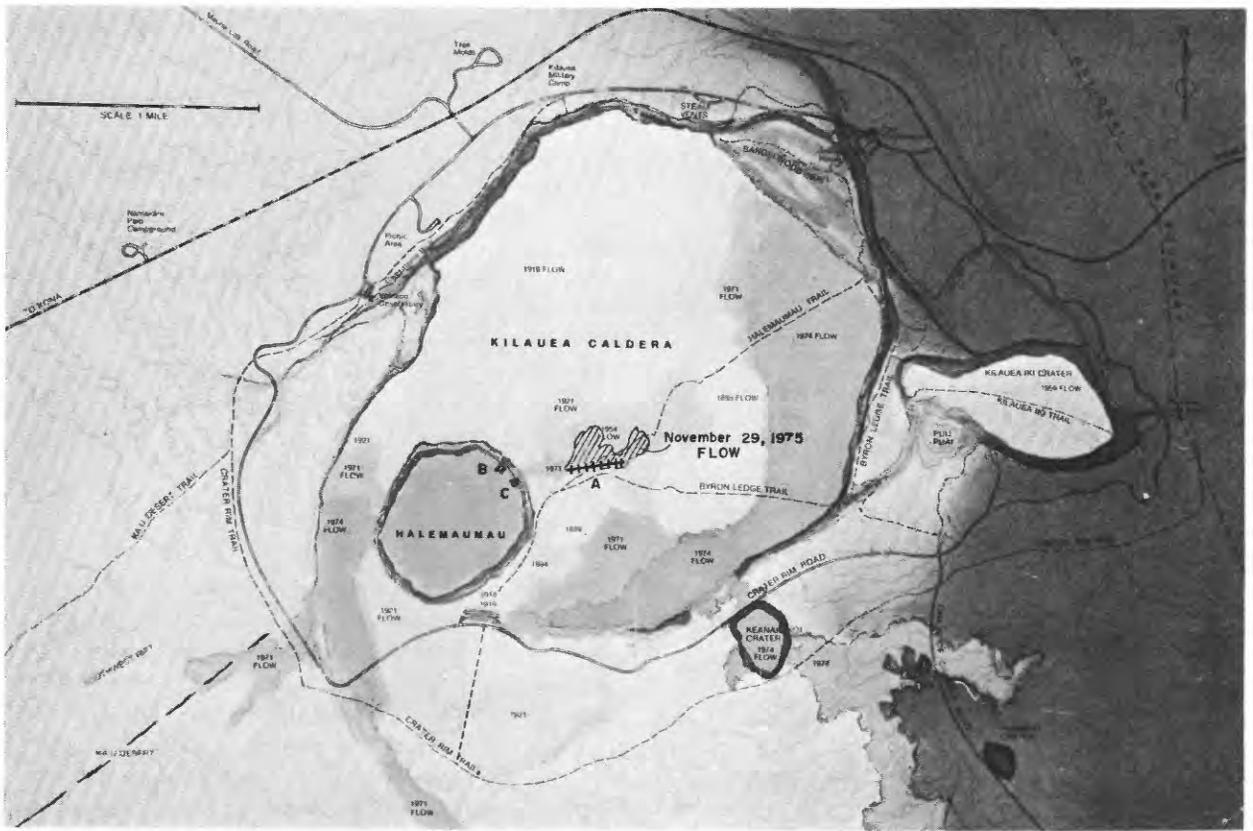
The lava from vents B and C in Halemaumau, judged by its high viscosity, probably was erupted at a relatively low temperature, perhaps from a body of magma trapped in a pocket high within the volcano. The total volume of lava produced during this short-lived eruption was small, approximately 250,000 m<sup>3</sup> from vent A, 3,200 m<sup>3</sup> from vent B, and 300 m<sup>3</sup> from vent C (fig. 12).

FIGURE 12.—Sketch map of recent vents and lava flows, Kilauea Caldera and vicinity. Approximate area covered by the November 29, 1975, flow shown by hachures; principal fissure (A) by heavy black line. The two minor vents (B and C) are at the base of the northeast wall of Halemaumau Crater. (Base map from *Halemaumau Trail*, 1975, Hawaii Natural History Association.)

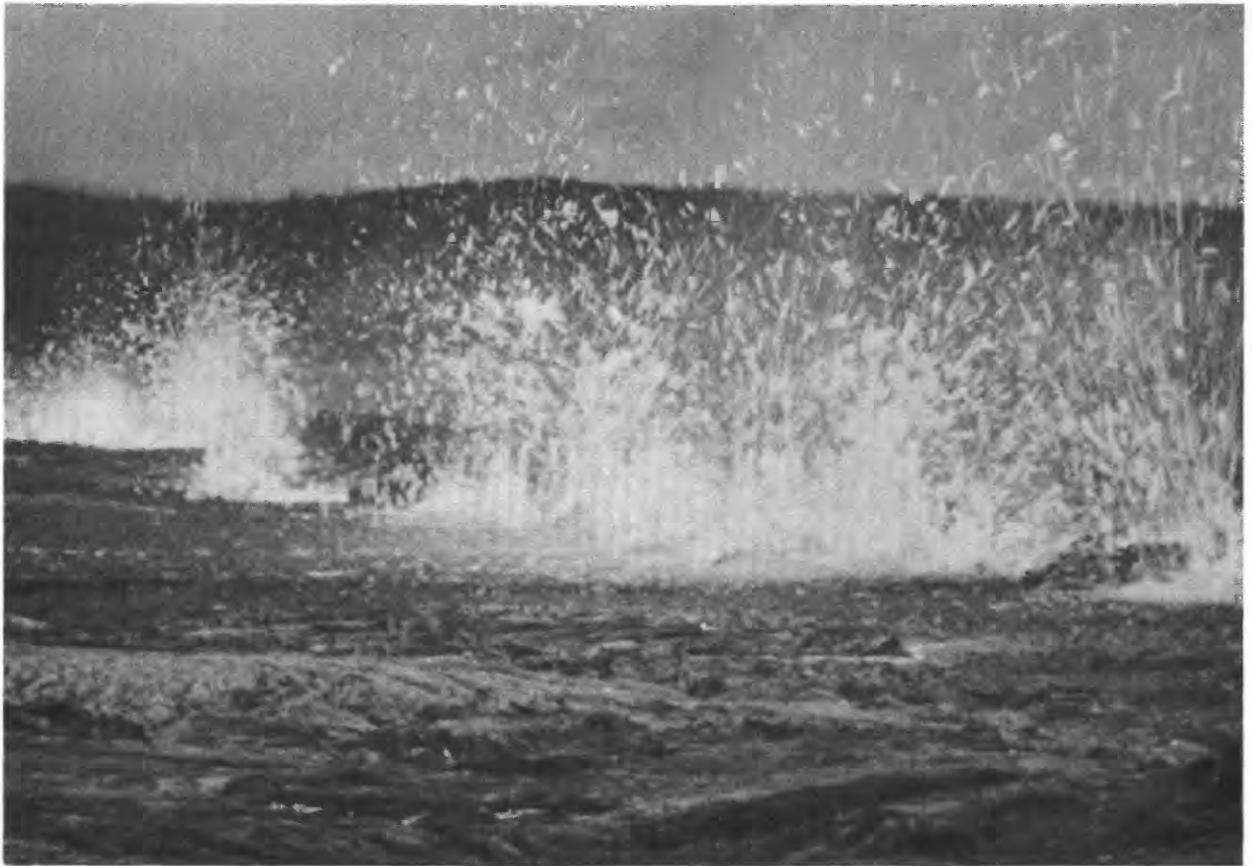
northeast of Halemaumau (A, fig. 12). The new lava issued from a continuous line of fountains as much as 50 m high. Within 15 minutes, the fountains decreased to 5–10 m high (fig. 13), eventually dying out about 0700. The fountains fed a small basaltic pahoehoe flow that spread mainly north from the eruptive fissure, eventually covering an area of about 0.25 km<sup>2</sup> on the caldera floor (fig. 14). As fountaining abated, emission of gases became increasingly vigorous. After eruption of lava had ceased, jetlike, noisy degassing continued from the vents.

FIGURE 13.—Lava fountains on floor of Kilauea Caldera at about 0600, November 29, 1975. View from near west end of eruptive fissure; fountains are about 10 mm high.

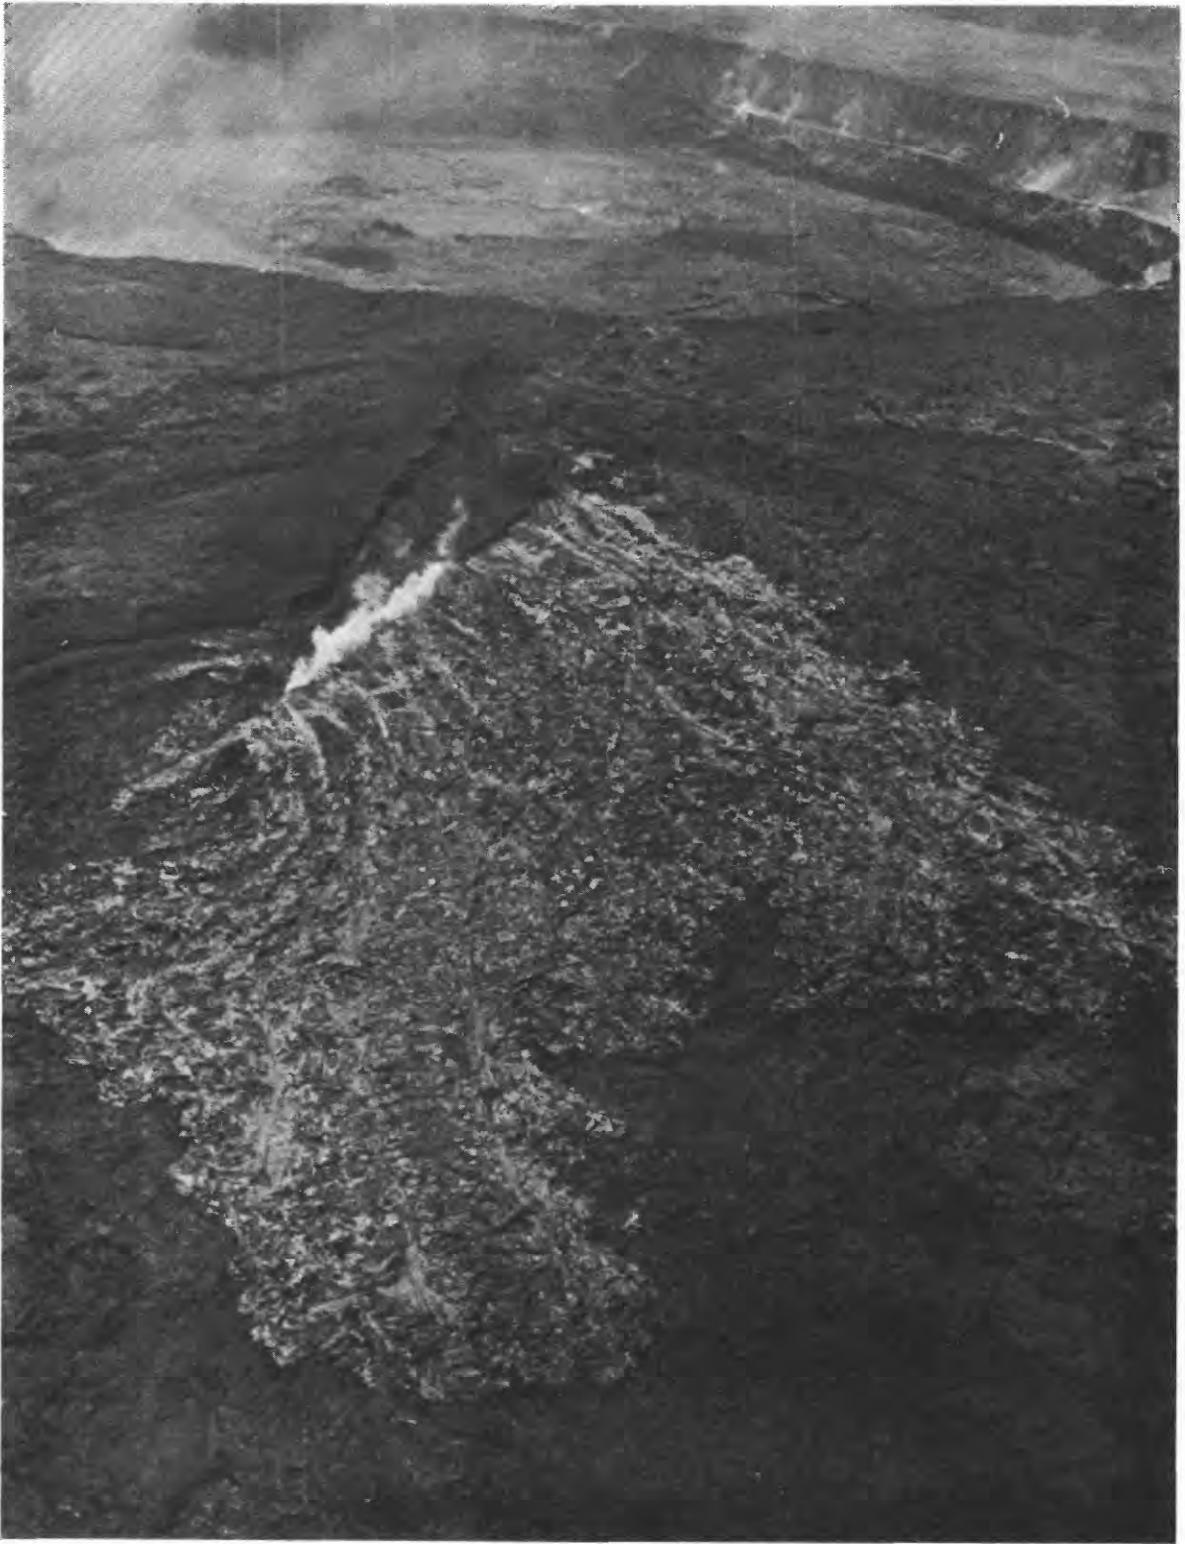
FIGURE 14.—Oblique aerial view to southwest showing floor of Kilauea Caldera, and distribution of lava flow of November 29, 1975. Fume rises from the main vent fissure, which cuts across fissure of 1954 eruption. Halemau-mau in background.

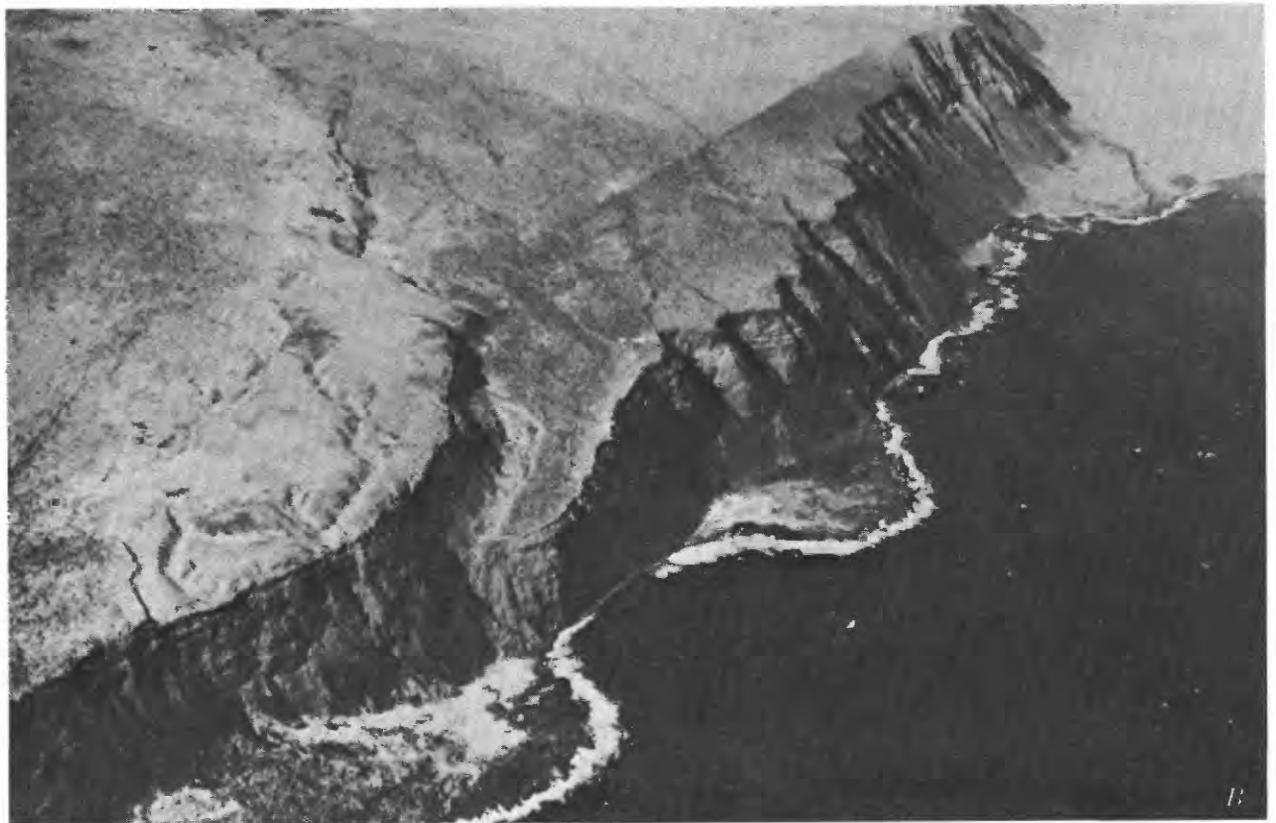
In the past lava flows have cascaded over most of the "palis" (Hawaiian for cliffs or scarps) of the Hilina fault system (fig. 18A), gradually building them southward toward the sea. The new ground rupture took place near the top of the palis, presumably along the buried faults that originally created the cliffs. Some palis, such as the seaward flank of Puu Kaone (figs. 18B), have not been built seaward by draping of younger flows, but rather have retreated northward through erosion; hence, ground rupture took place near the base of these scarps (fig. 19).

FIGURE 19.—Vertical offset of about 1.5 m along new fault, south face of Puu Kaone (see fig. 18B).

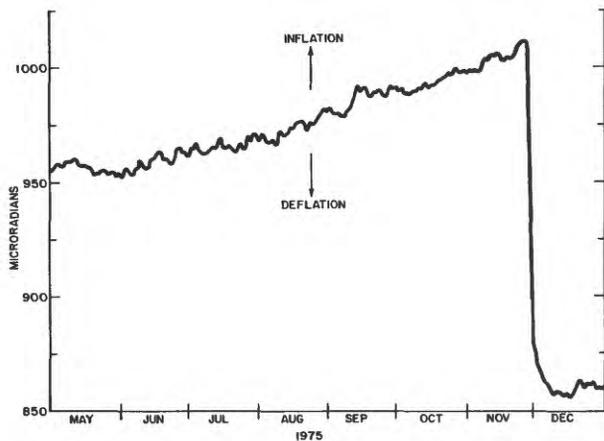
Kilauea's summit area began to deflate as soon as the eruption began. The rate of deflation, measured by a tiltmeter in a vault near the Hawaiian Volcano Observatory, was 2–3 microradians<sup>4</sup> per hour during the early part of the eruption, gradually increased to 4–5 microradians per hour later in the morning, continued at this high rate for about 30 hours, then at lower rates for more than a week (fig. 24). Total deflation recorded was about 241 microradians, the largest deflation in the summit area since the 1960 Kapoho eruption.

FIGURE 24.—Changes in tilt May–December 1975, as recorded on E–W component of water-tube tiltmeter located in vault near Hawaiian Volcano Observatory. Plot shows E–W component of deflation associated with November 29 events to be about 145 microradians. N–S component of deflation (not shown), approximately 193 microradians, resulted in total deflation of about 241 microradians.

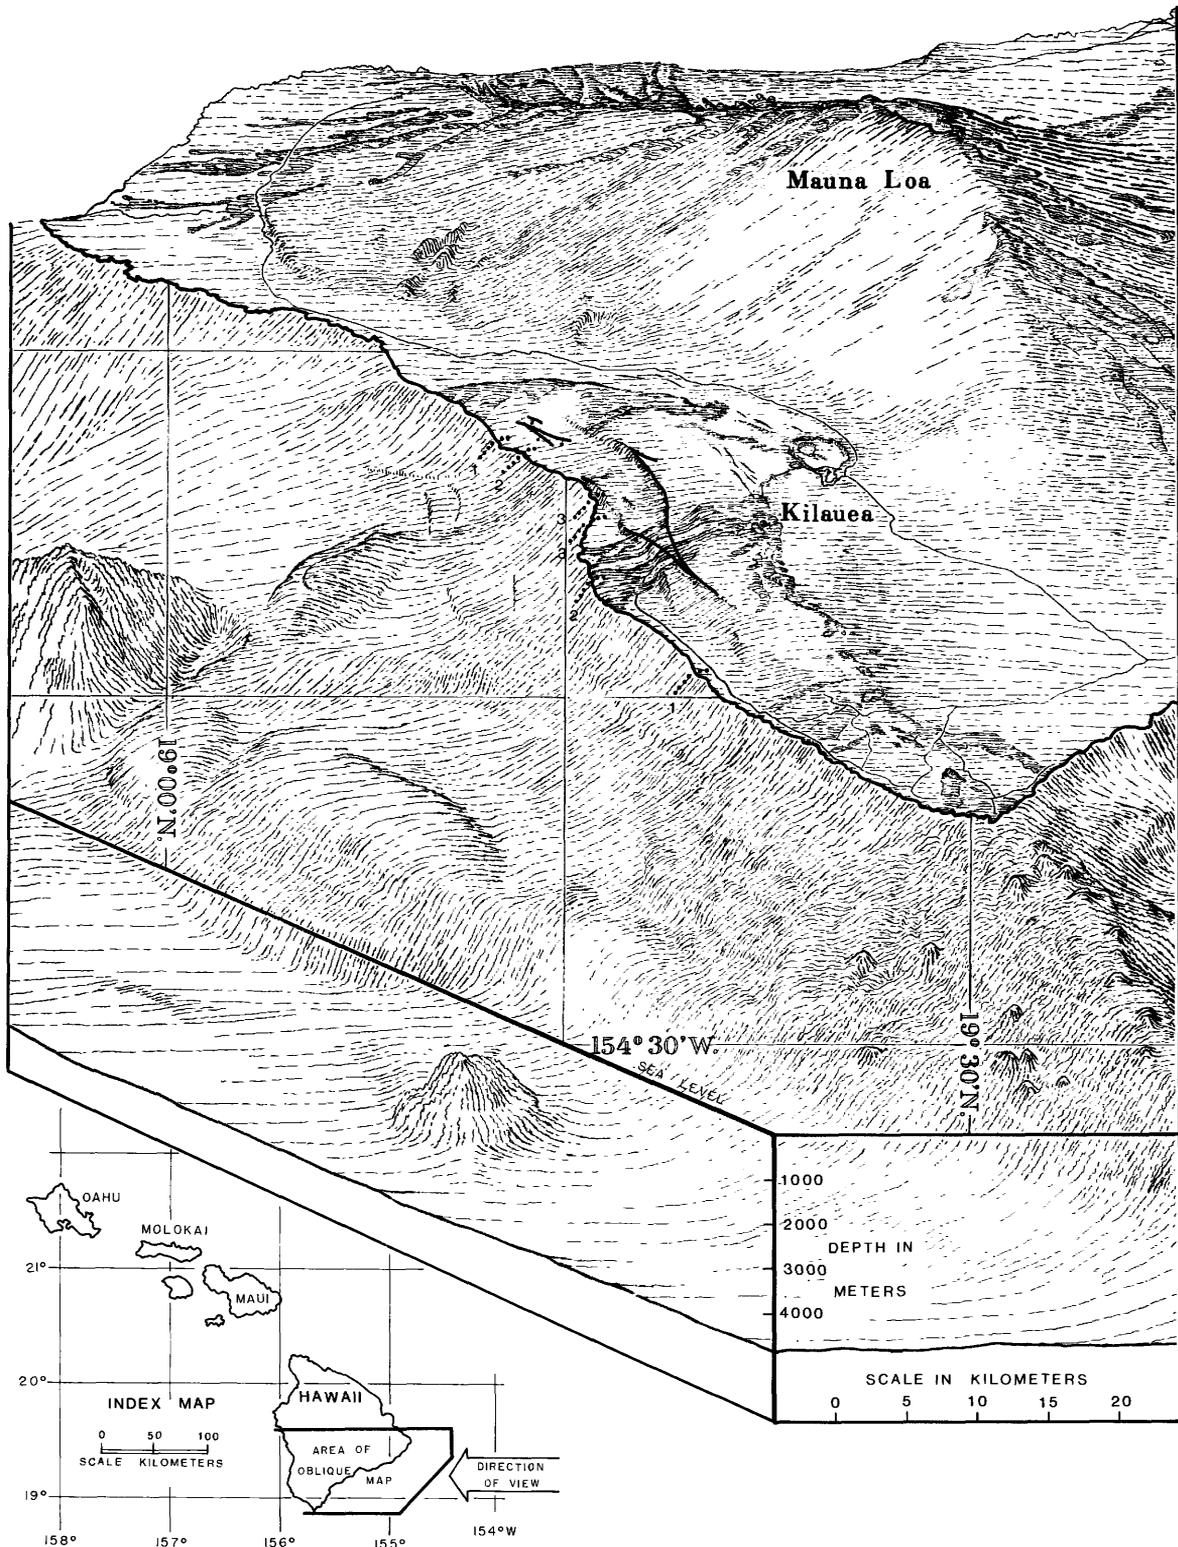
slopes about  $8^\circ$  to a depth of about 4.5 km below sea level. The flank is unstable because (1) it is almost completely detached from the rest of the volcano along fractures of the two rift zones and the Koa'e fault system (fig. 1); (2) it consists in part of loose, poorly coherent debris formed earlier in Kilauea's growth; and (3) it is subject to seaward shoving by magma injected into the rift zones. Piling up of lava flows on the surface of the south flank further increases the gravitational instability. Eventually, when some critical threshold is exceeded, part of the flank tears loose along the Hilina fault zone, and a mammoth block of ground lurches downslope (seaward). In a sense, the Hilina fault system marks the heads of giant landslides (fig. 25).

FIGURE 25.—Oblique map of the south half of the island of Hawaii as viewed from the east showing submarine topography. Heavy lines define new faulting, and dotted lines indicate amount of coastal subsidence in meters during the 1975 earthquake. Physiographic drawing by Tau Rho Alpha.
