# Implications for Earthquake Risk Reduction in the United States from the Kocaeli, Turkey, Earthquake of August 17, 1999

U.S. Geological Survey Circular 1193

Field investigations were coordinated with the U.S. Army Corps of Engineers and National Institute of Standards and Technology

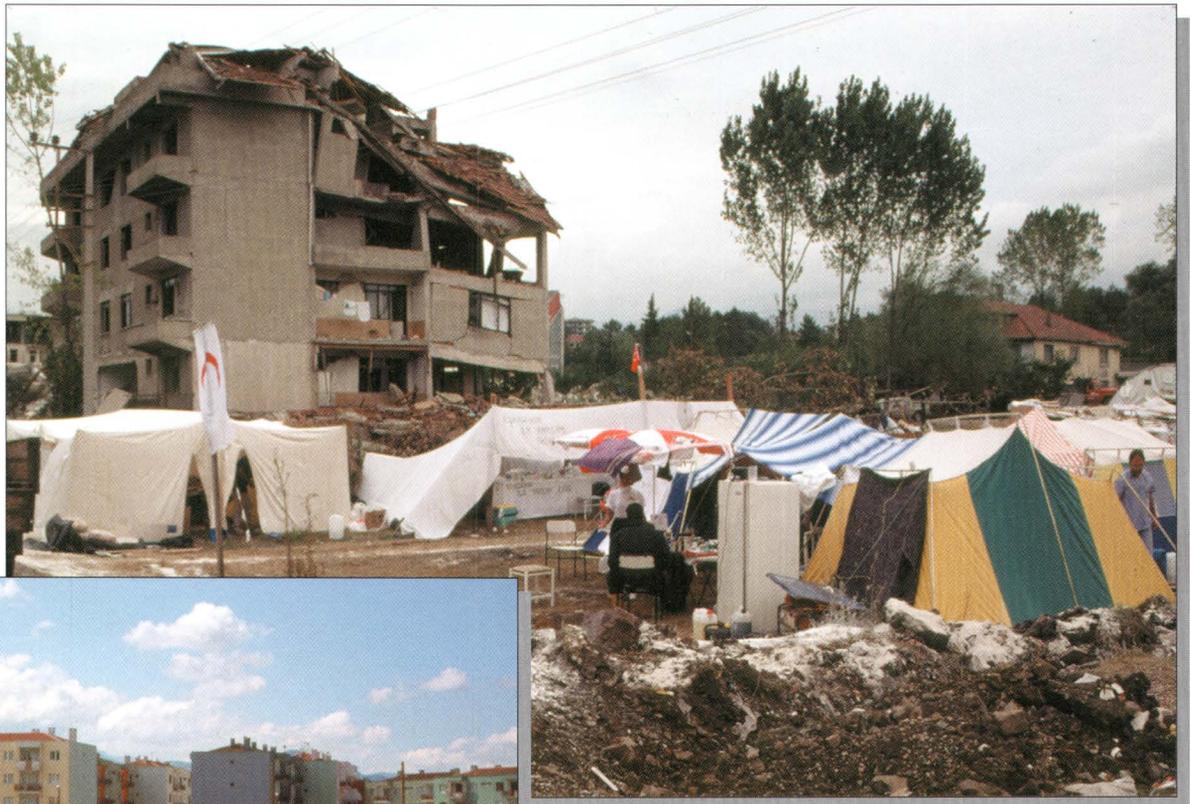
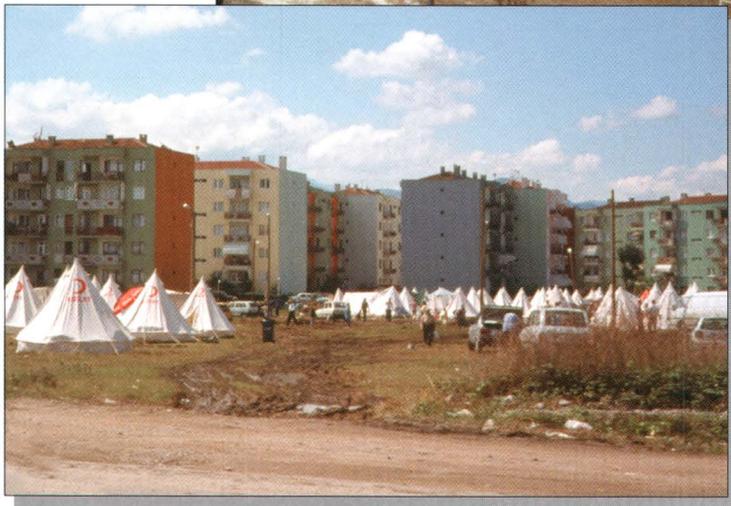
**Figure 1.** The heavy damage to residences required the use of 113,869 tents in 121 tent cities for temporary shelter. *Photographs by Thomas L. Holzer.*

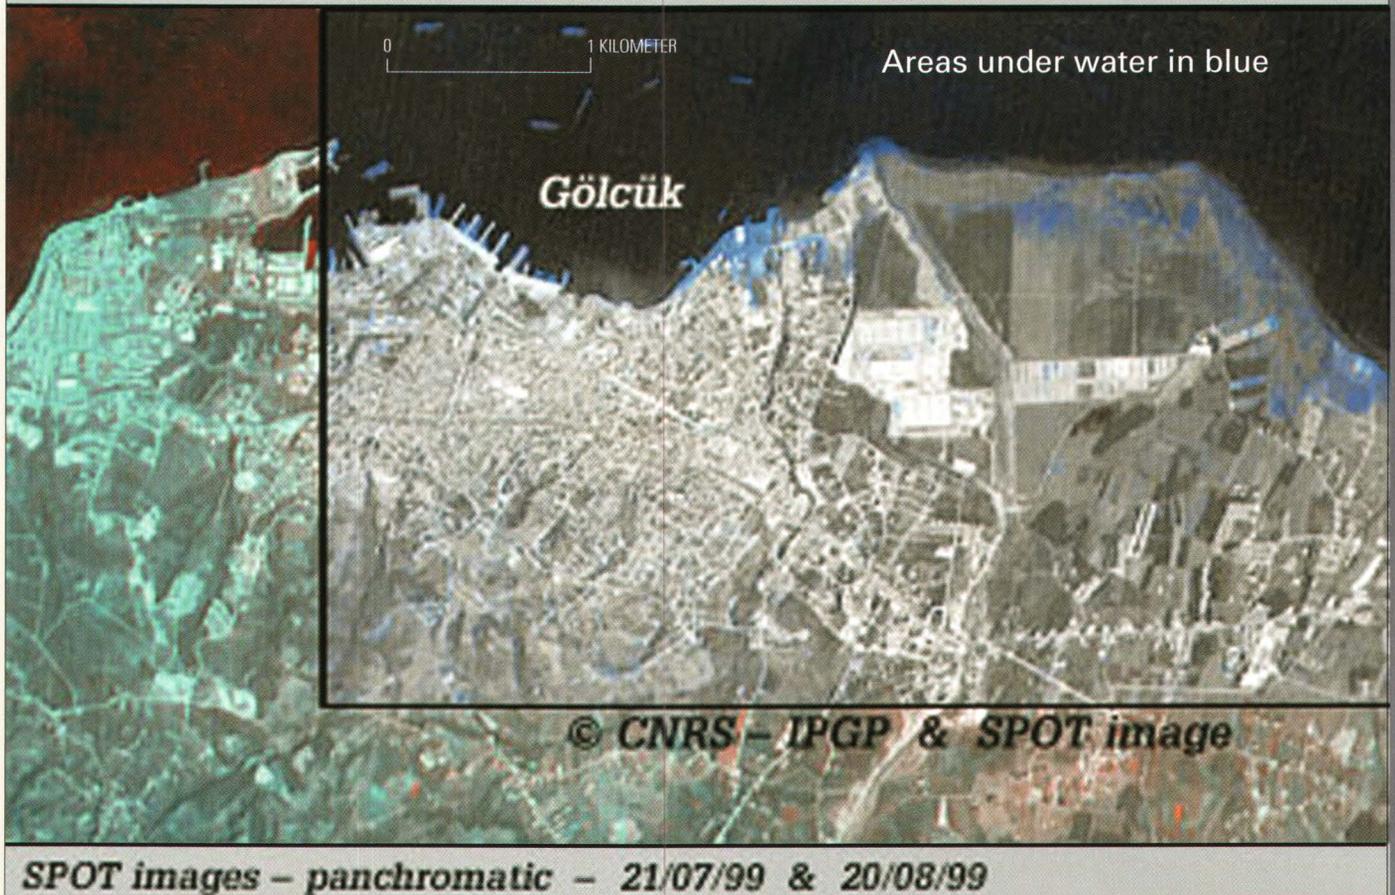
**Figure 11.** Satellite image of Gölcük area showing zones of coastal submergence (blue). Strike-slip faulting occurred through the port area (upper left) and oblique faulting occurred on the Gölcük (normal) fault. Copyrighted image by CNRS-IPGP and SPOT image; used with permission.

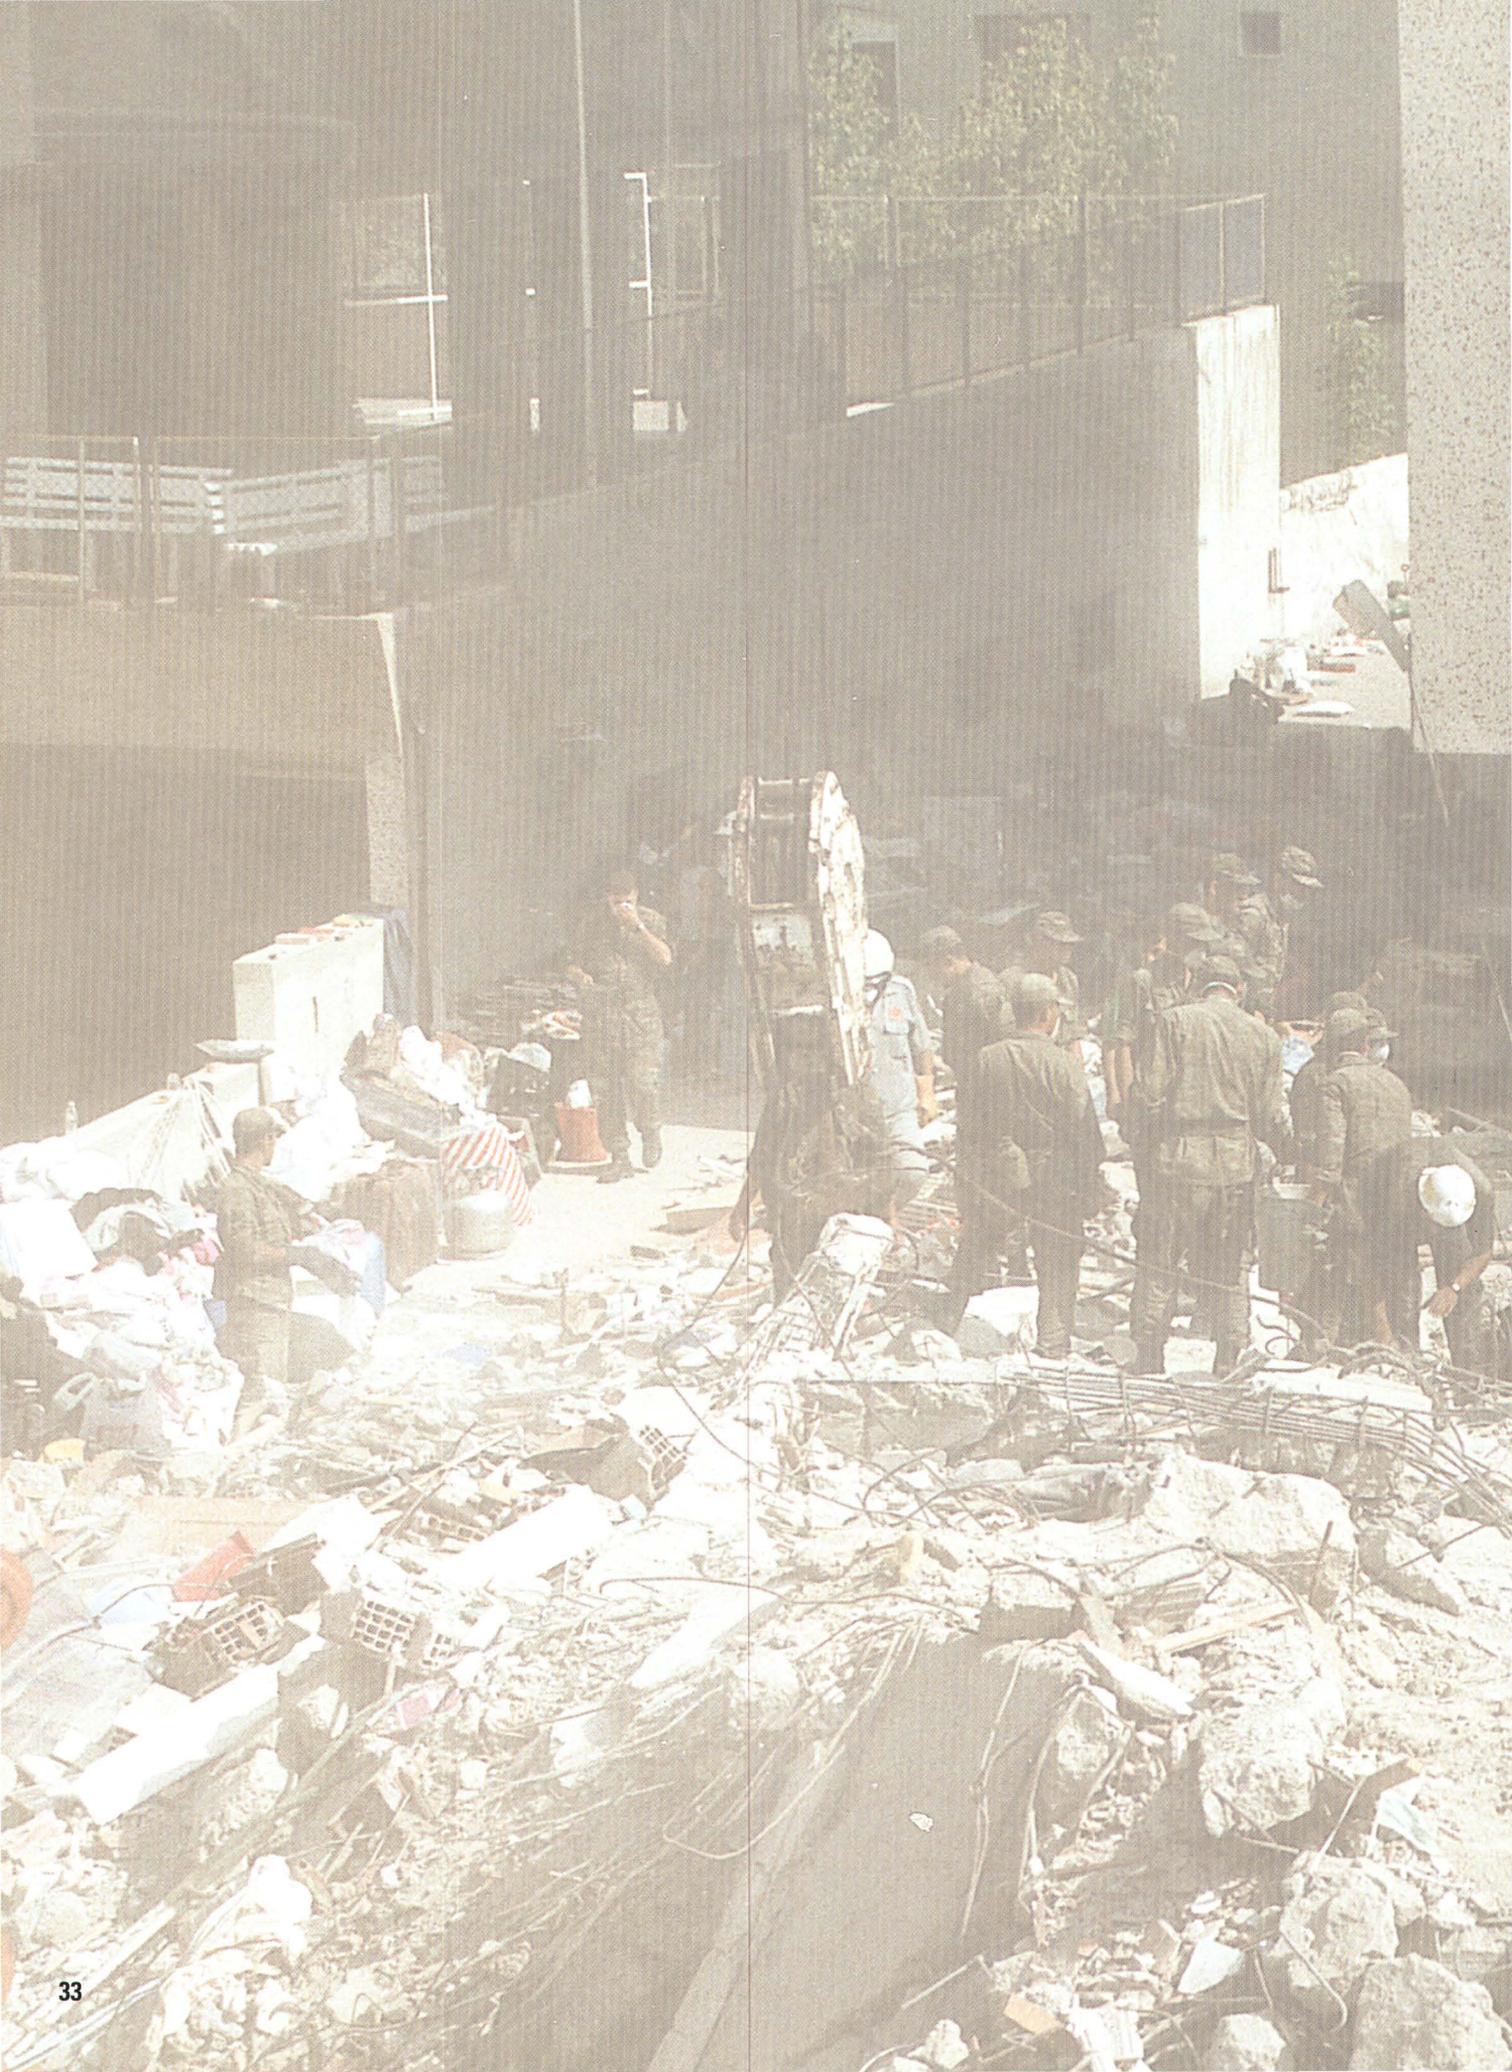
**Figure 31.** Rescue effort 4 days after the main shock at a collapsed building in area of concentrated damage in Avcilar. *Photograph by Thomas L. Holzer.*

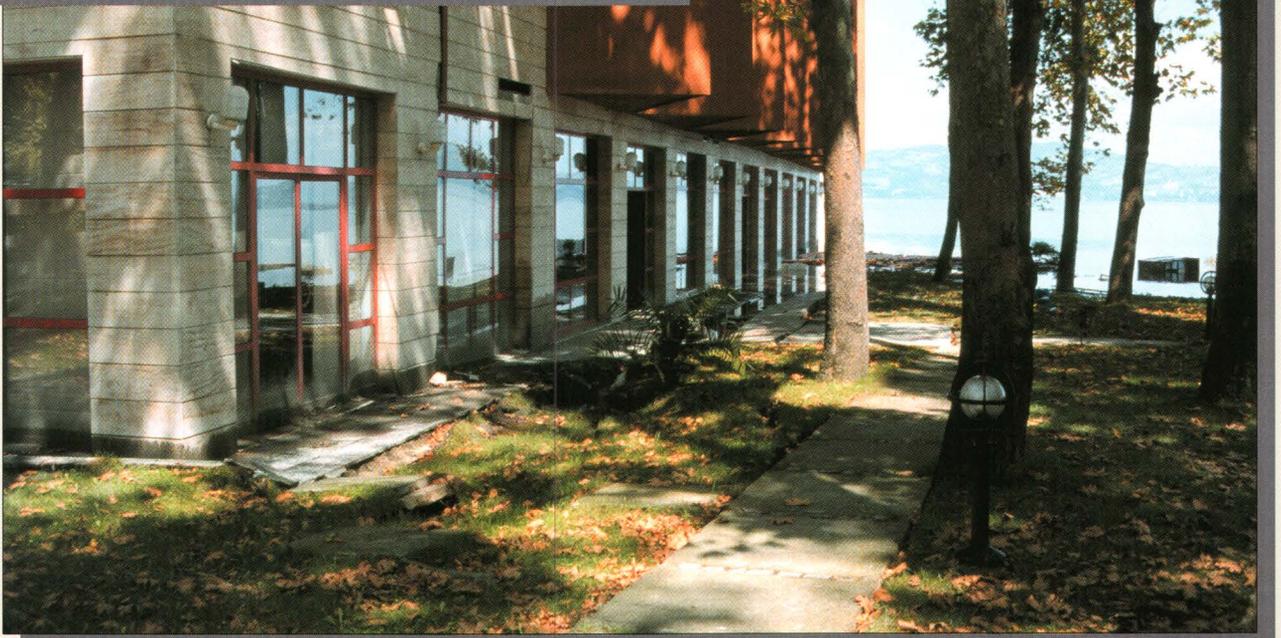
Along the southeast shore of Lake Sapanca, soils also liquefied and the Lake Sapanca Hotel was dramatically affected. The hotel, which was built on an old stream delta that had prograded into Lake Sapanca, sank about 0.3 m into the ground. The regional land surface around the hotel also lowered causing the shoreline to submerge (figs. 37, 38). In addition, the hotel was displaced about 0.5 m toward the lake by a lateral spread along the shoreline of the lake. Large quantities of subsurface sand vented to the surface and covered much of the driveway and the landscaping around the hotel.

**Figure 37.** Submergence of shoreline at Lake Sapanca and settlement of Sapanca Hotel. "Moat" adjacent to wall indicates the hotel has sunk into the ground because of liquefaction of underlying sandy soil. *Photographs by Thomas L. Holzer.*

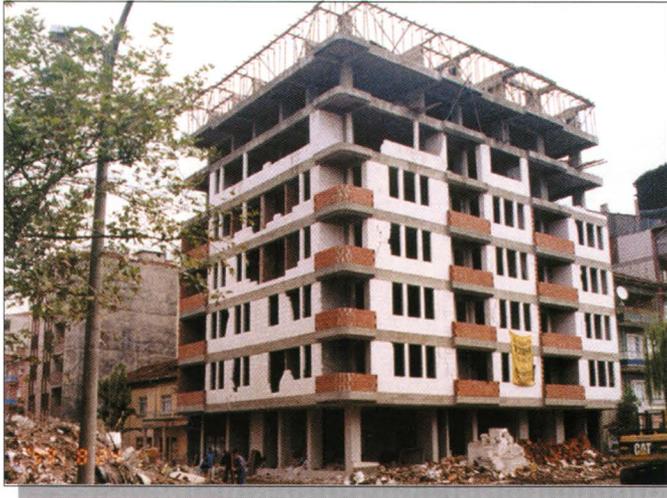
Figure 40 shows a building under construction illustrating common construction practice. In most cases of building collapse, there was no evidence of shear walls. Consequently, lateral resistance to the strong ground shaking was provided solely by frame action. Concrete compressive strength was not measured, but honeycombing was observed in similar new construction that did not collapse suggesting somewhat poorer concrete placement practices than typically found in U.S. construction. Furthermore, undeformed reinforcing bars were widely used for both flexural and shear reinforcement, a practice not permitted under U.S. building codes. Most of the reinforced concrete buildings can be characterized as having little or no ductility.

**Figure 40.** Building in Izmit under construction using reinforced concrete frame construction. Note absence of shear walls. *Photograph by National Institute of Standards and Technology.*

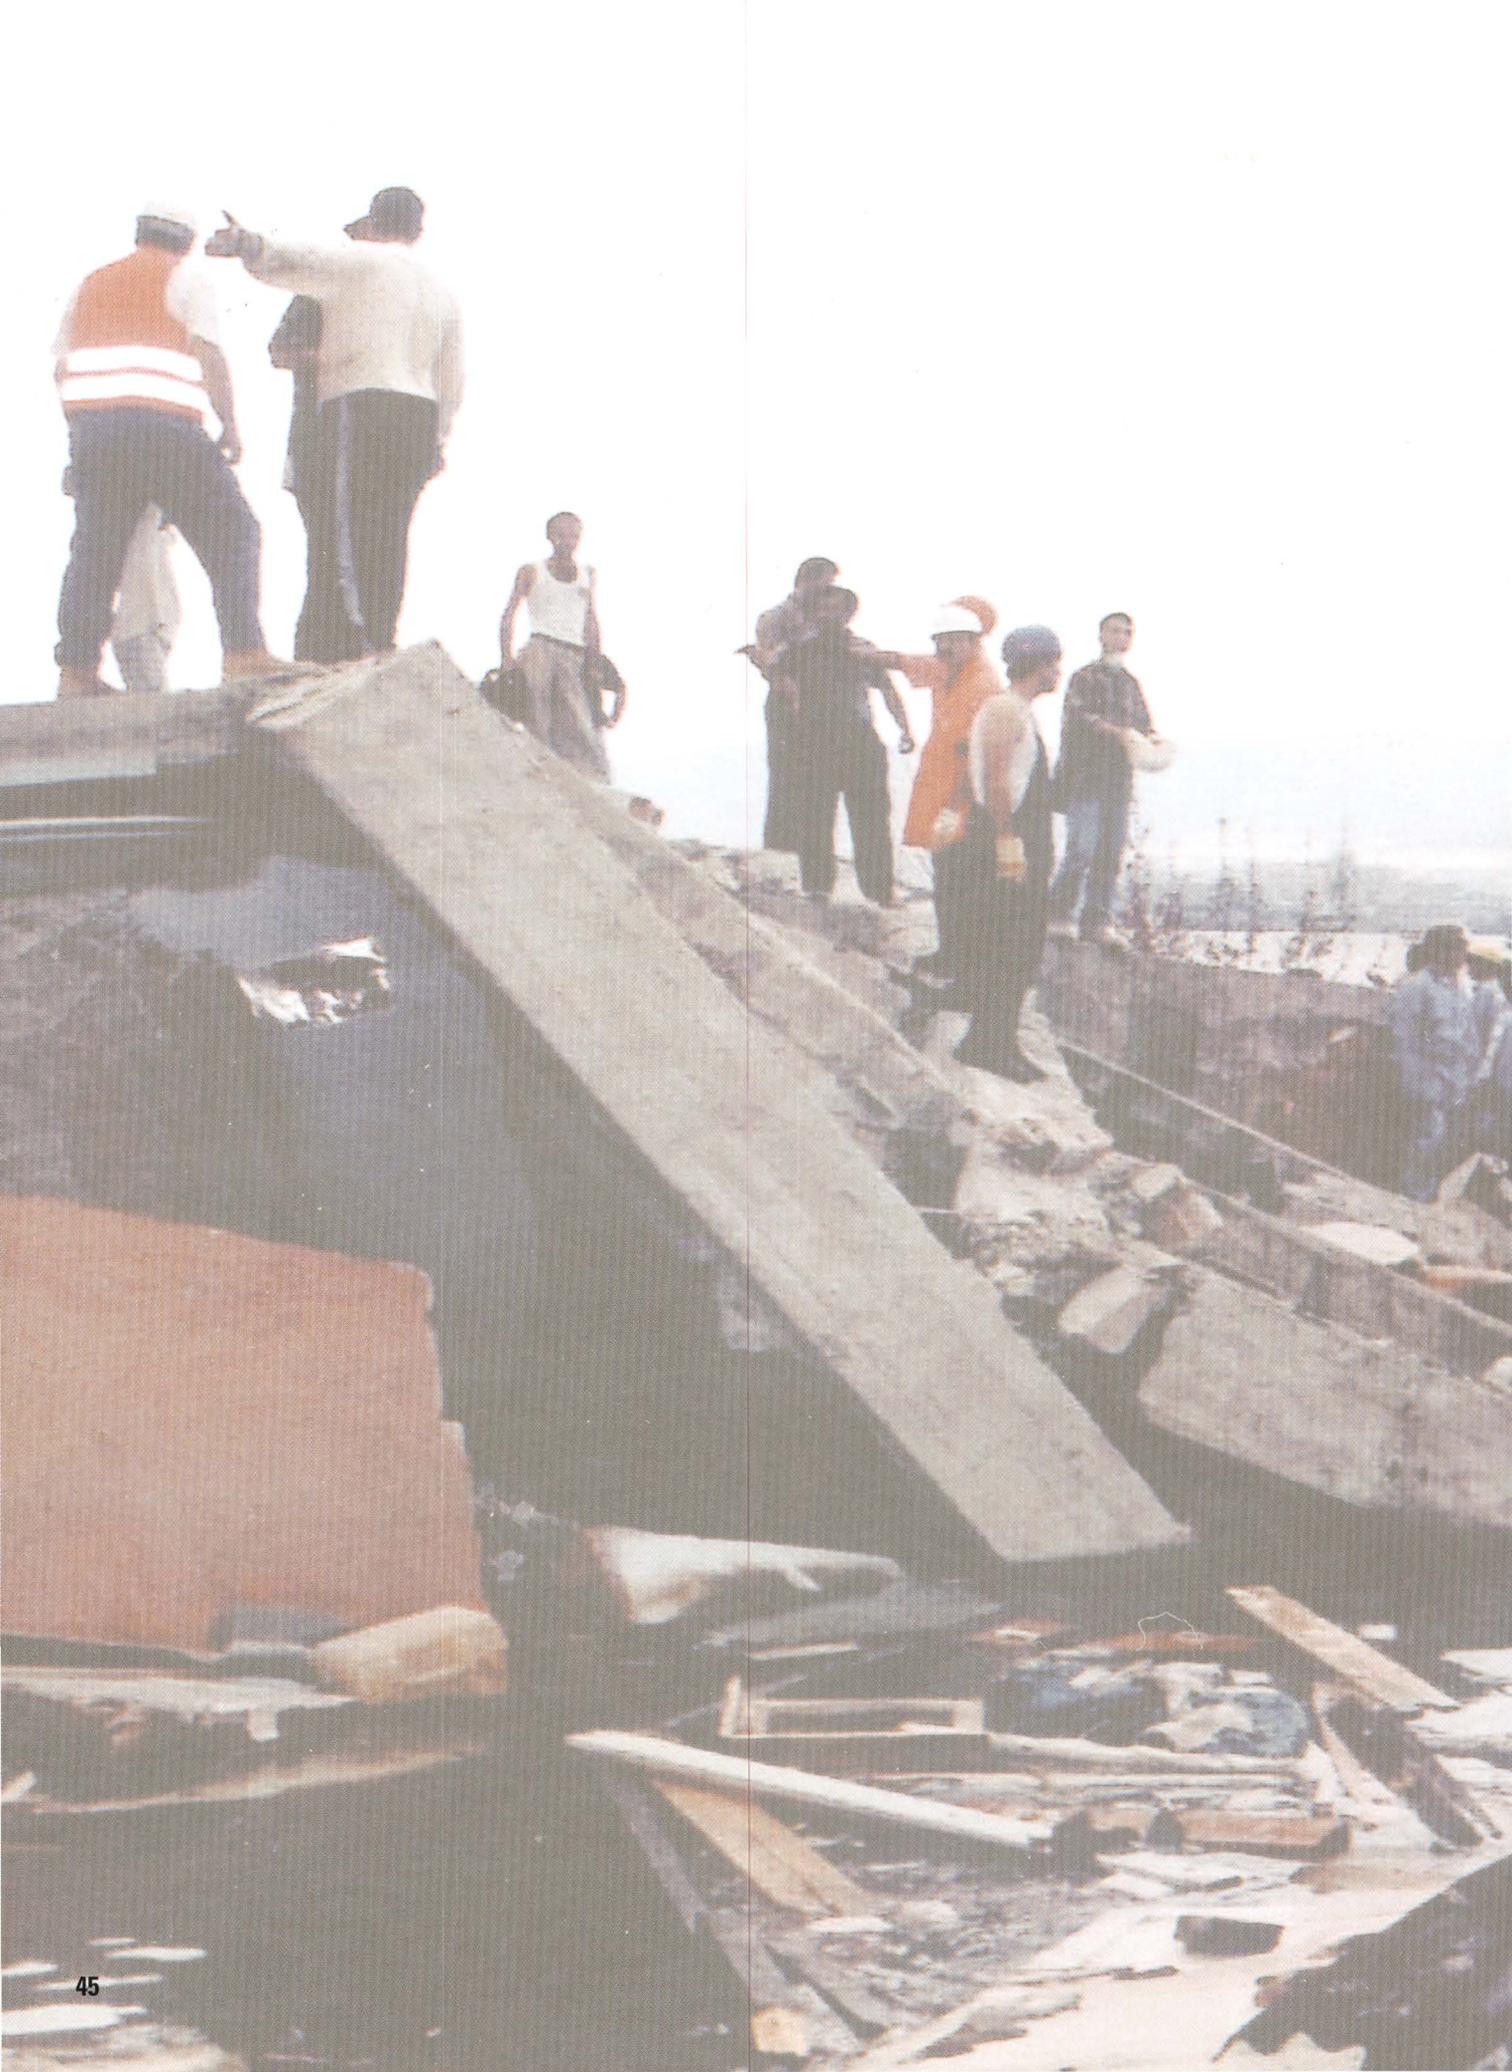
The Kocaeli earthquake also demonstrated the hazard posed by aftershocks to buildings following a large earthquake. Figure 47 shows a building in Gölcük before and after it collapsed during a  $M_W$  5.9 aftershock on September 13. This aftershock, which was the largest magnitude aftershock at that time to follow the August 17 earthquake, killed 7 people, injured at least 239 people, and caused dozens of buildings to collapse in three cities near the epicenter.

**Figure 47 (pages 45–46).** Multistory residential building in Gölcük. Tectonic subsidence associated with faulting in the main shock caused the inundation of the first floor of the building. Upper photograph shows building standing after the August 17 main shock and before it collapsed in an aftershock; photograph by Thomas L. Holzer. Lower photograph shows building collapsed by  $M_W$  5.9 aftershock four weeks after the main shock; copyrighted photograph by AP/Wide World Photos, used with permission.

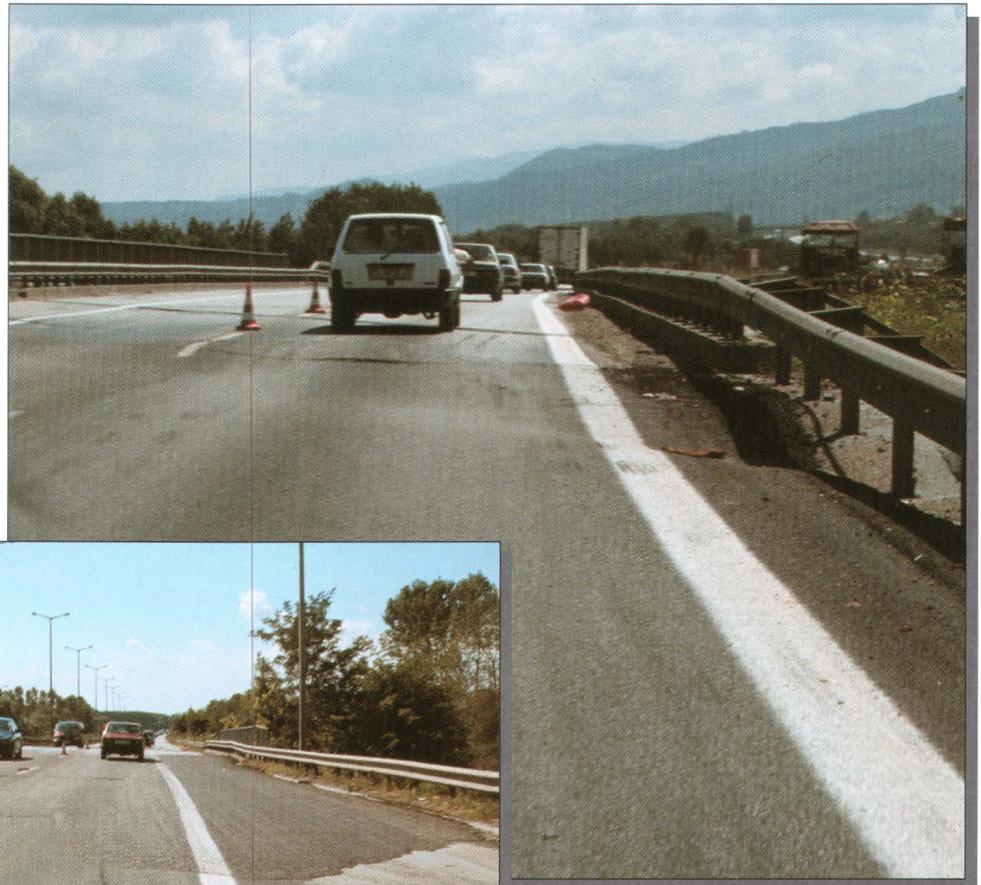
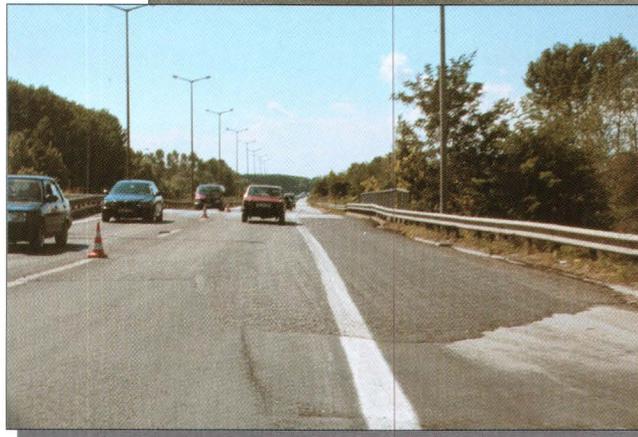
**Figure 52.** Densification of dry approach fill adjacent to bridges of the Trans European Motorway was widespread and caused disruption of the roadway. Immediately following the earthquake, Turkish highway engineers placed asphalt ramps on the roadway to reduce the hazard. *Photographs by Thomas L. Holzer.*

Permanent ground displacements, such as extensive cracks and settlement, caused significant damage to the roadway surface. Approximately 50 km of the TEM required resurfacing. Densification of dry fill commonly caused settlements in areas where the motorway approached bridges, viaducts, and culverts; some areas settled as much as 0.3 m. Figure 52 shows one example of settlement.

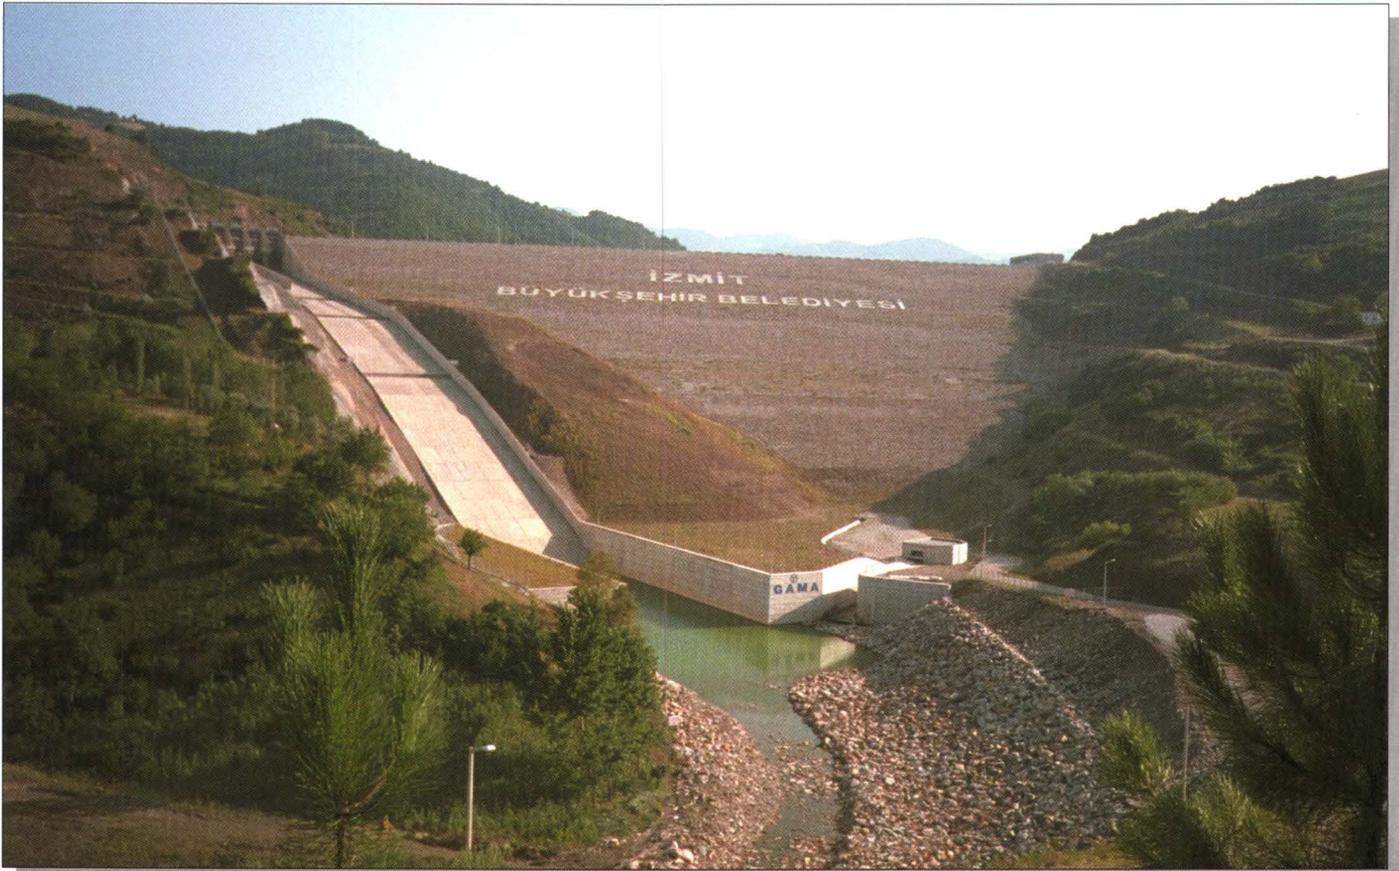
**Figure 55.** View of Kirazdere (Yuvacik) Dam after the Kocaeli earthquake. The dam was only about 4 km from the surface rupture and did not suffer damage. Photograph by Richard S. Olsen.

Kirazdere Dam, also known as Yuvacık Dam, is an earth-fill dam with a clay core, sand and gravel filters, and a rock shell (fig. 55). Kirazdere Dam is of particular interest because it is only 4 km from the surface rupture associated with the Kocaeli earthquake. The dam is inferred to have experienced 0.3 to 0.4 g of peak horizontal acceleration, a shaking duration of 30 s with accelerations greater than 0.05 g, and a spectral range of excitations from 0.2 to 6.0 Hz. However, the dam appears to have suffered no damage from the earthquake. The dam manager stated that a few short 2-mm-wide cracks resulted from the earthquake on the gravel road along the crest near the left abutment looking upstream, parallel to the axis of the dam. The lengths of these cracks were not measured. The road on the crest is heavily used and the cracks quickly disappeared. A few hairline cracks were seen in a one-story concrete structure at the dam. No cracks were seen in the concrete of the spillway.

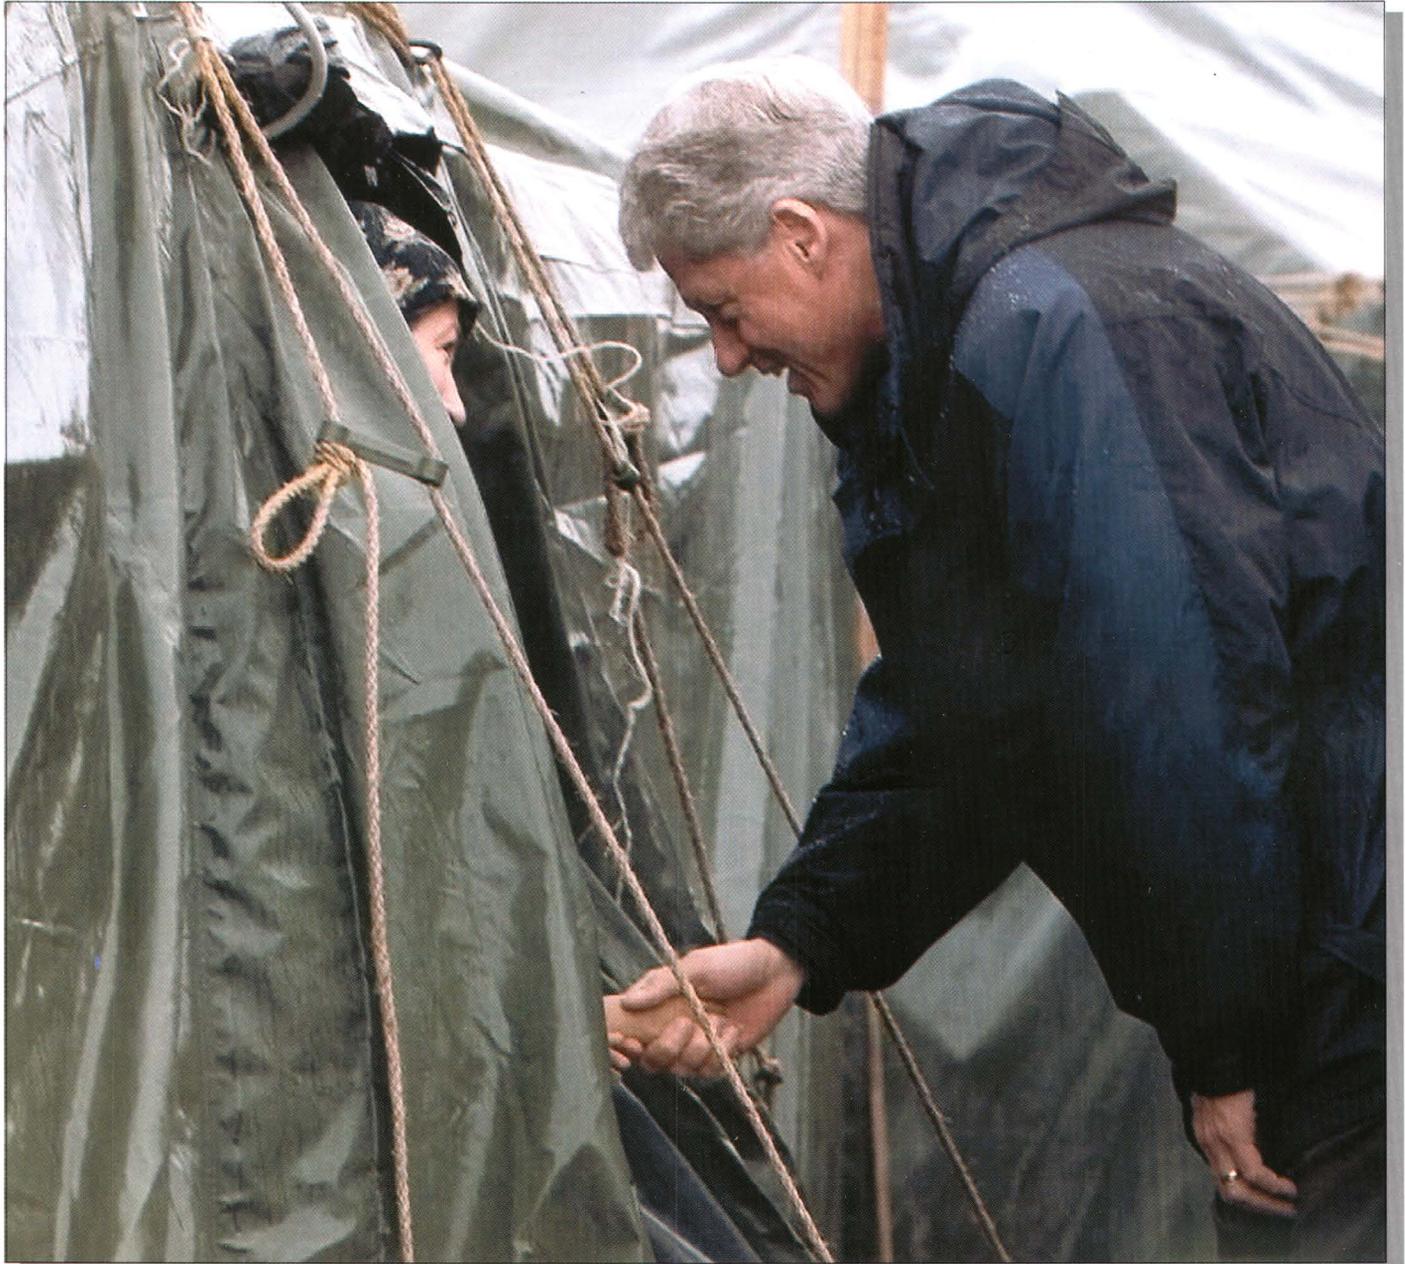
**Figure 56.** On November 16, 1999, President Clinton greets a displaced Turkish family living in a temporary tent city near Izmit since the August 17 Kocaeli earthquake. *Copyrighted photograph by J. Scott Applewhite, AP/Wide World Photos, used with permission.*

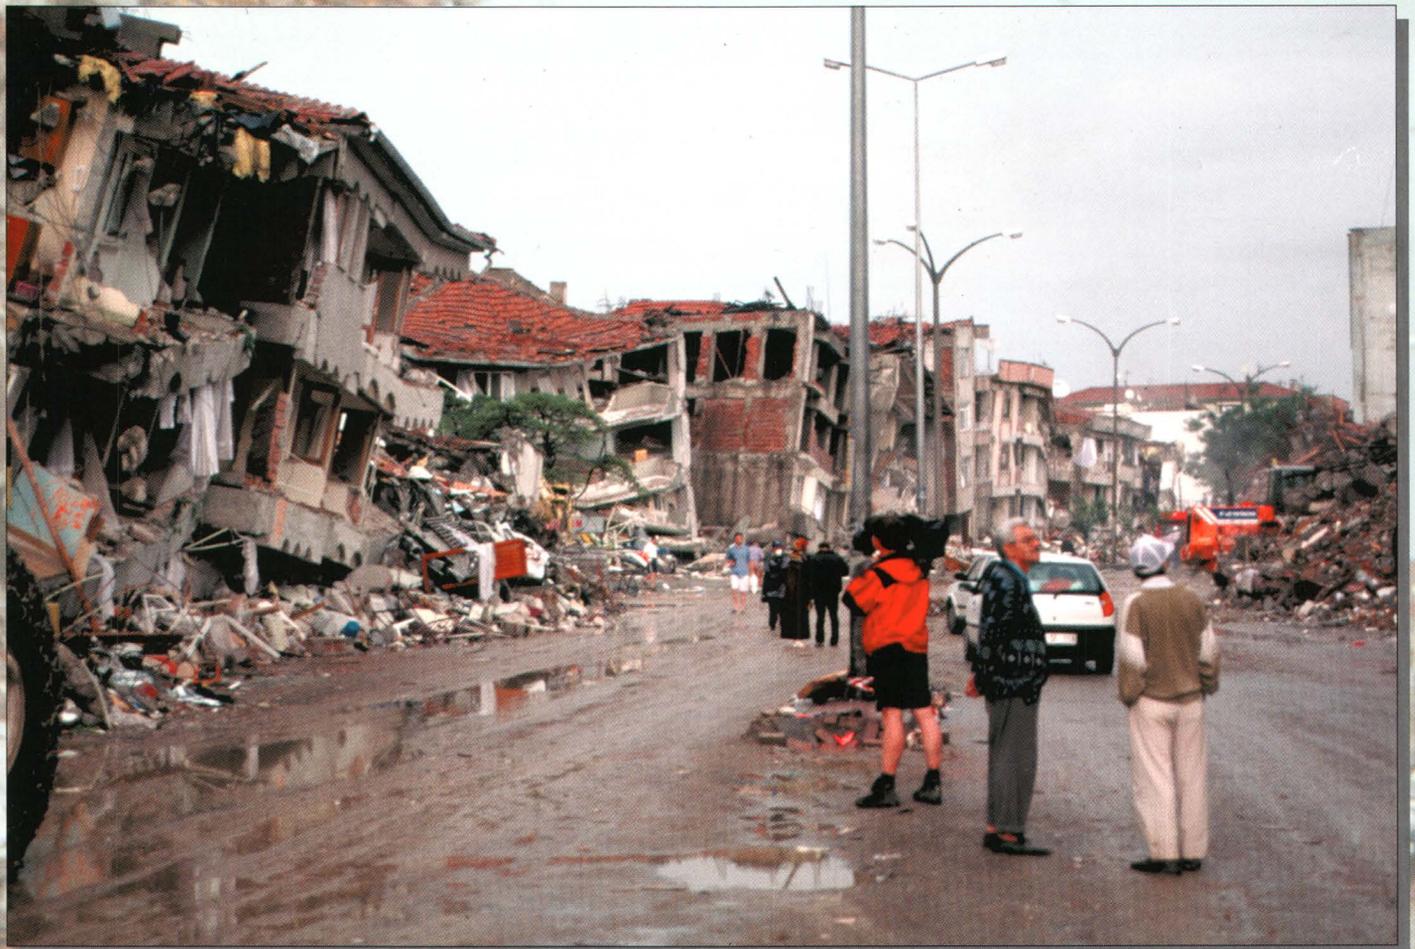
**Figure 57.** Street scene in Adapazari following the Kocaeli, Turkey, earthquake. Extensive damage to concrete structures with little or no ductility displaced more than a quarter of a million people from their homes in the epicentral region. *Photograph by Thomas L. Holzer.*
