Implications for Earthquake Risk Reduction in the United States from the Kocaeli, Turkey, Earthquake of August 17, 1999

U.S. Geological Survey Circular 1193

U.S. Department of the Interior
U.S. Geological Survey

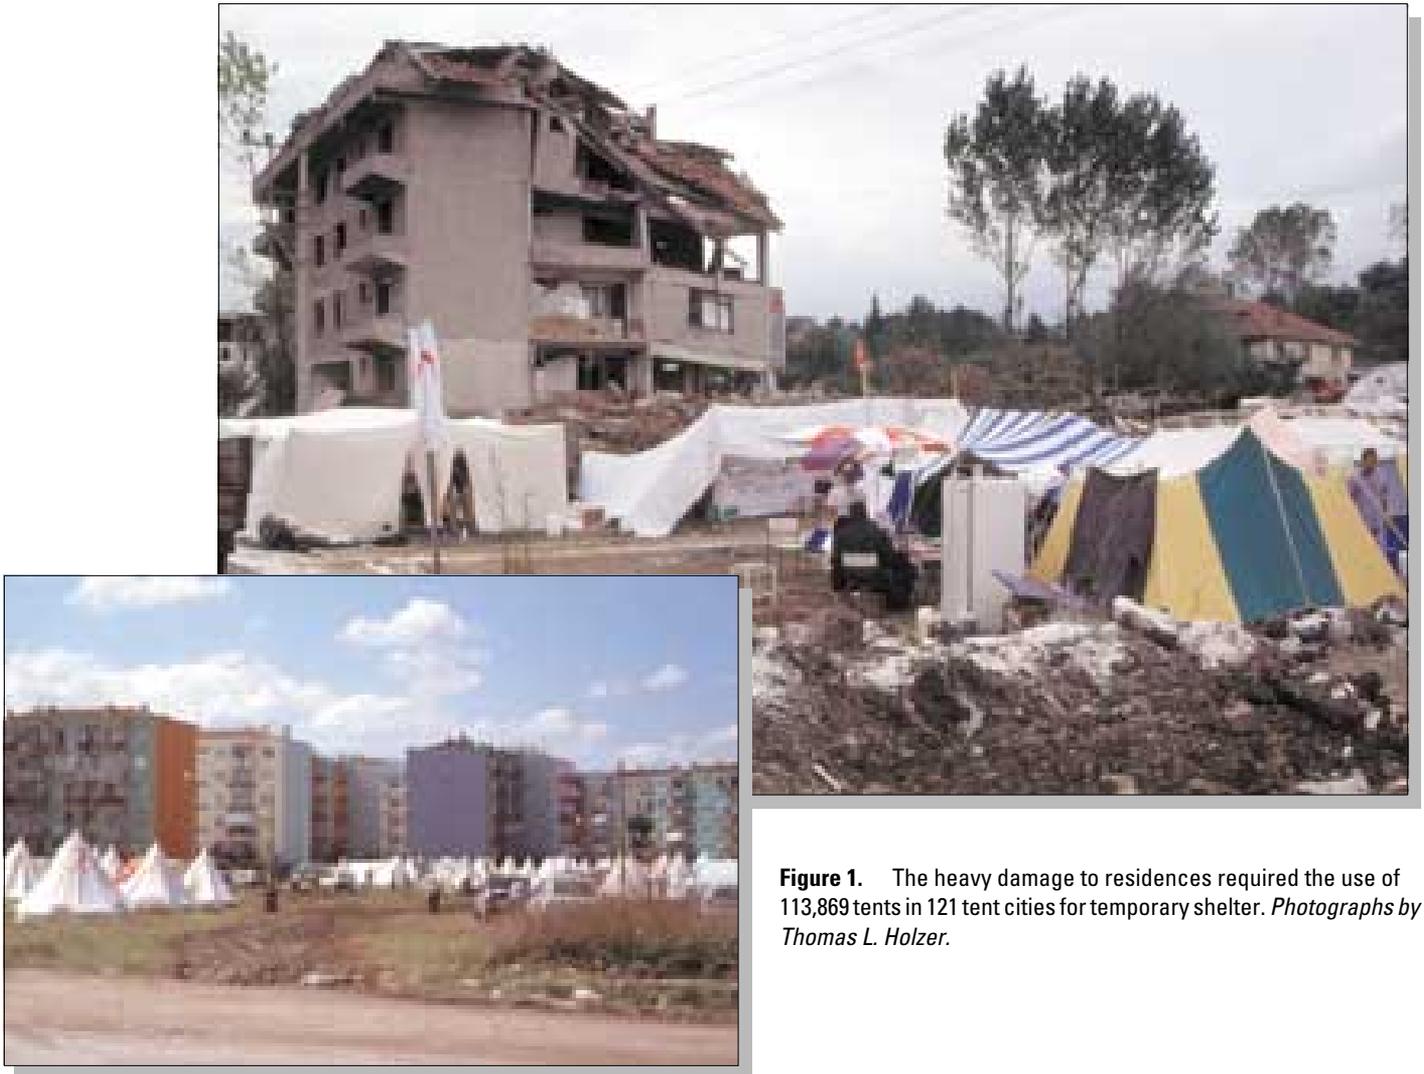
Figure 1. The heavy damage to residences required the use of 113,869 tents in 121 tent cities for temporary shelter. *Photographs by Thomas L. Holzer.*

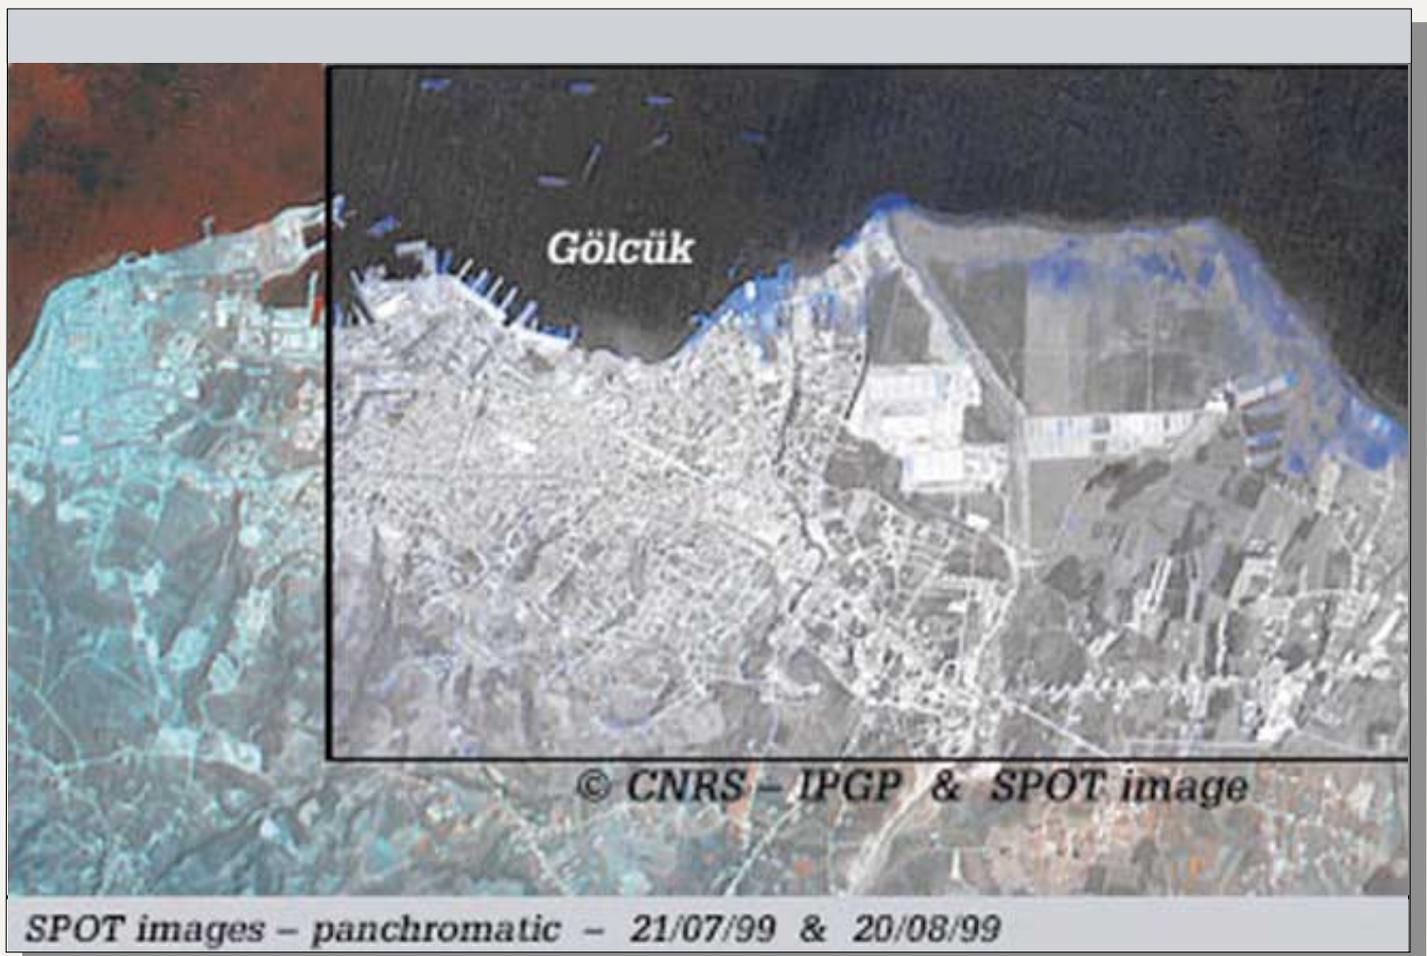
Figure 11. Satellite image of Gölcük area showing zones of coastal submergence (blue). Strike-slip faulting occurred through the port area (upper left) and oblique faulting occurred on the Gölcük (normal) fault. Copyrighted image by CNRS-IPGP and SPOT image; used with permission.

normal fault in Gölcük. Additional strike-slip faulting was not observed on the south side of Izmit Bay (B. Meyer, oral commun., 1999). The normal faulting in the Gölcük area caused regional subsidence that submerged part of the coast (fig. 11). Approximately 4 km of coastline on the south shore of Izmit Bay subsided about 2 to 3 m. Many structures built near the shore were inundated by the sea (fig. 12).

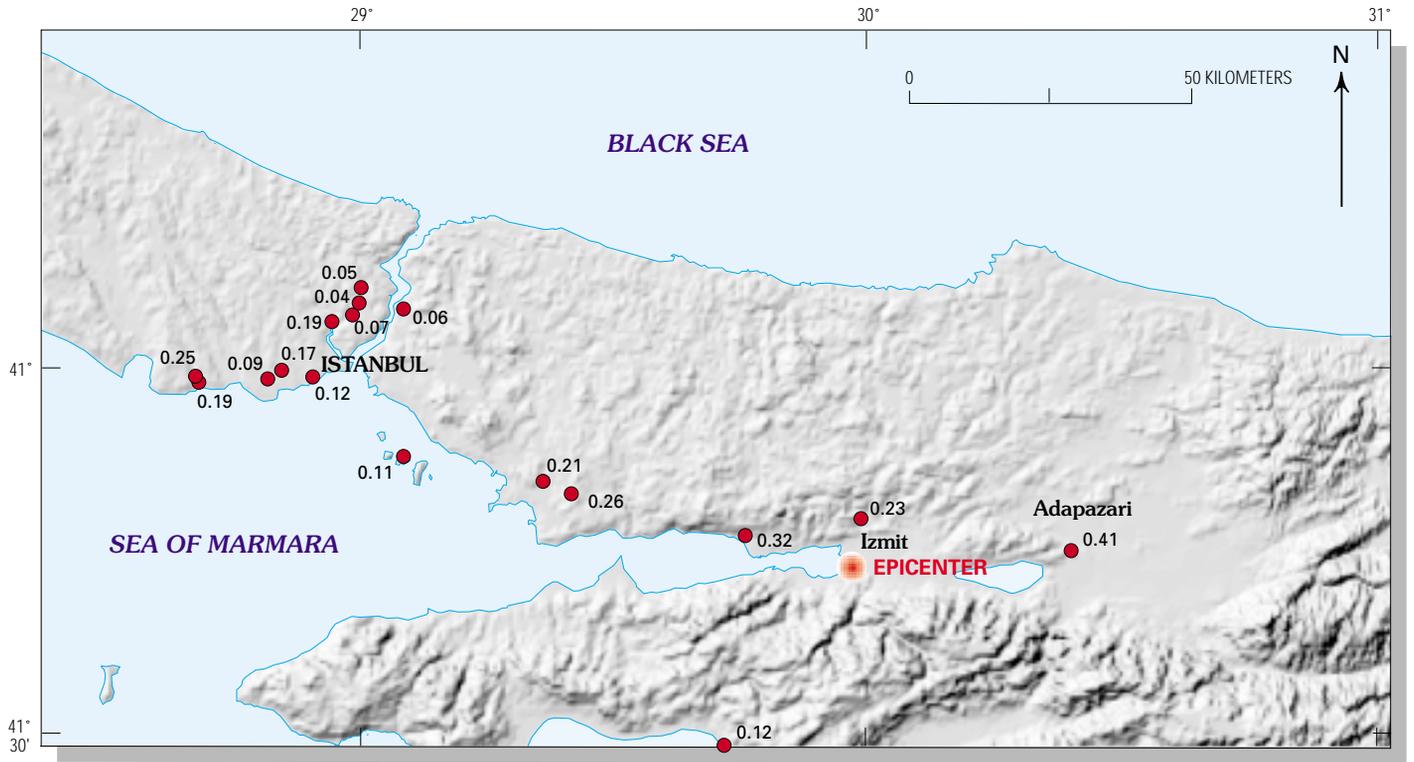
Figure 22. Map showing locations of peak horizontal accelerations recorded at strong motion stations in and near the epicentral area. The network stations included are from ERD, ITÜ, and KOERI. Base map courtesy of BKS Surveys Ltd., N. Ireland.

Table 1 compiles peak accelerations for each of the three components of accelerometers at 19 strong motion stations located in or near the epicentral region. Figure 22 is a map of the peak horizontal acceleration recorded at these stations. Most of the stations are housed in buildings, some of which are more than two stories high. Standard practice in the United States when compiling free field recordings is to ignore recordings from buildings that are more than two stories high because it is believed that the structural response of these buildings may modify the recording from free field conditions. Soil conditions beneath the stations in Turkey also have not been systematically documented.

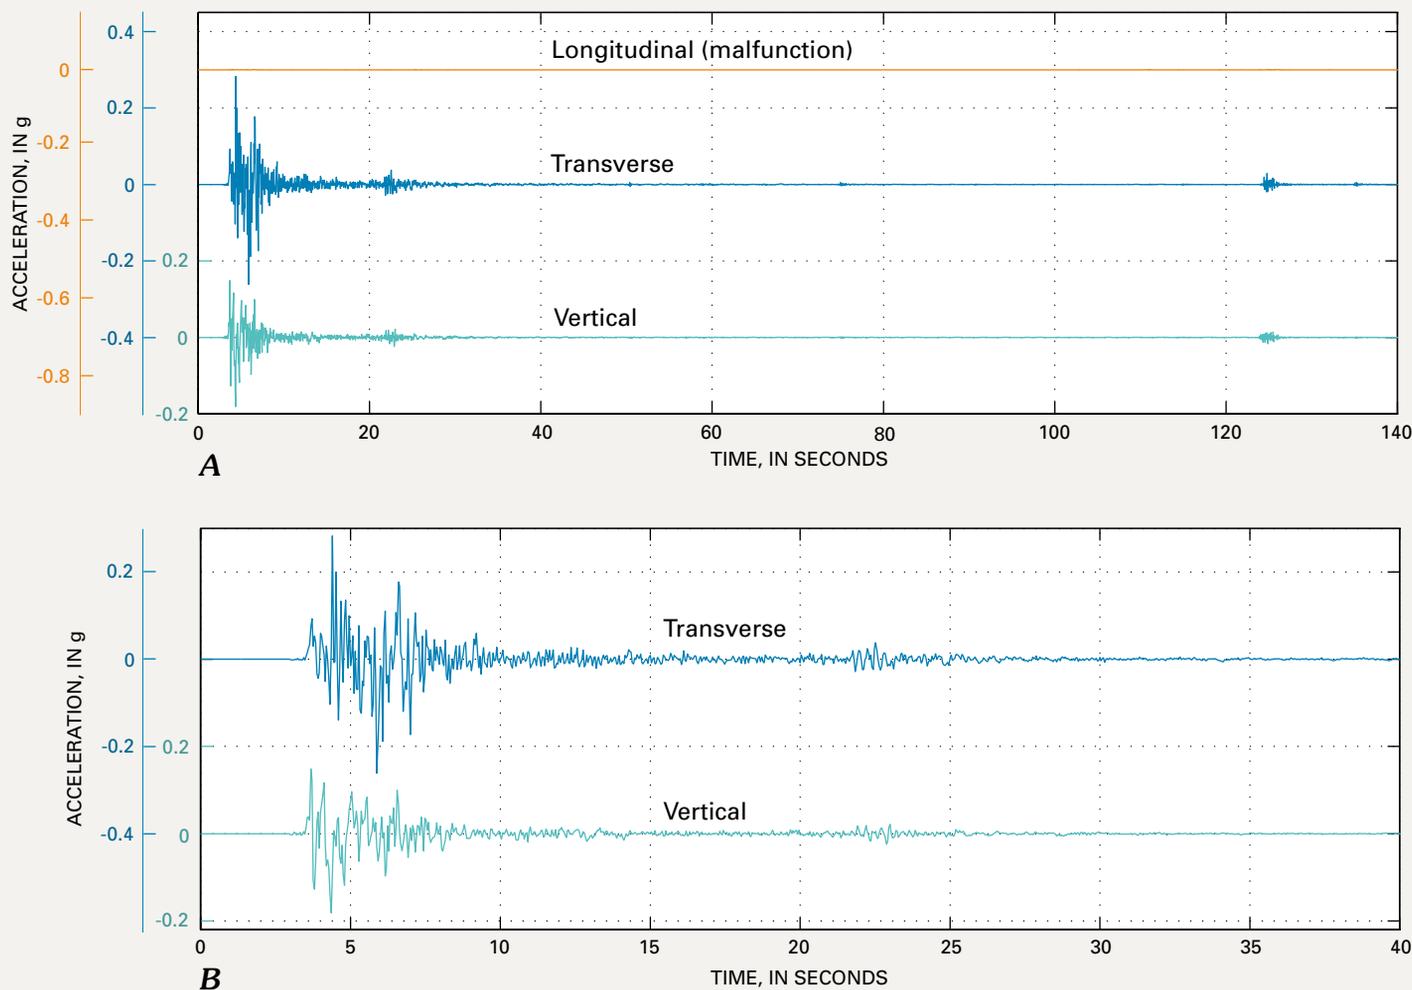
Figure 23. A, Time histories of acceleration for 140 s at SKR; note that longitudinal component malfunctioned. The plot shows several events: B, time history with first 40 s of the acceleration record; C, the cumulative sum of the squared acceleration values; and D, effective duration of significant strong motion during the main shock, based on time between 5 and 95 percentiles of the cumulative sum, is 4.5 s. *Illustration by Mehmet Çelebi.*

The time history of acceleration recorded at SKR (Adapazari in Sakarya Province), a ERD station, is shown in figure 23A. The station is on soft rock and about 3.5 km from the surface trace of the fault. The record reveals at least two aftershocks immediately followed the main shock. Figures 23B, C show only 40 s of the record and figure 23D shows the cumulative sum of the square of the acceleration superimposed on the acceleration time history. This sum has been used by Trifunac and Brady (1975) to define an effective earthquake duration. The effective duration is the time between the 5 and 95 percentile values of the cumulative sum. This yields an effective duration of the main shock at SKR of approximately 4.5 s. This duration is different than the duration felt and reported by humans. People typically can sense ground shaking at levels of less than 0.01 g. The main shock contributes approximately 97 percent of the significant ground shaking of the two shocks within the 40 s of the record as inferred from the cumulative sum of the square of the acceleration.

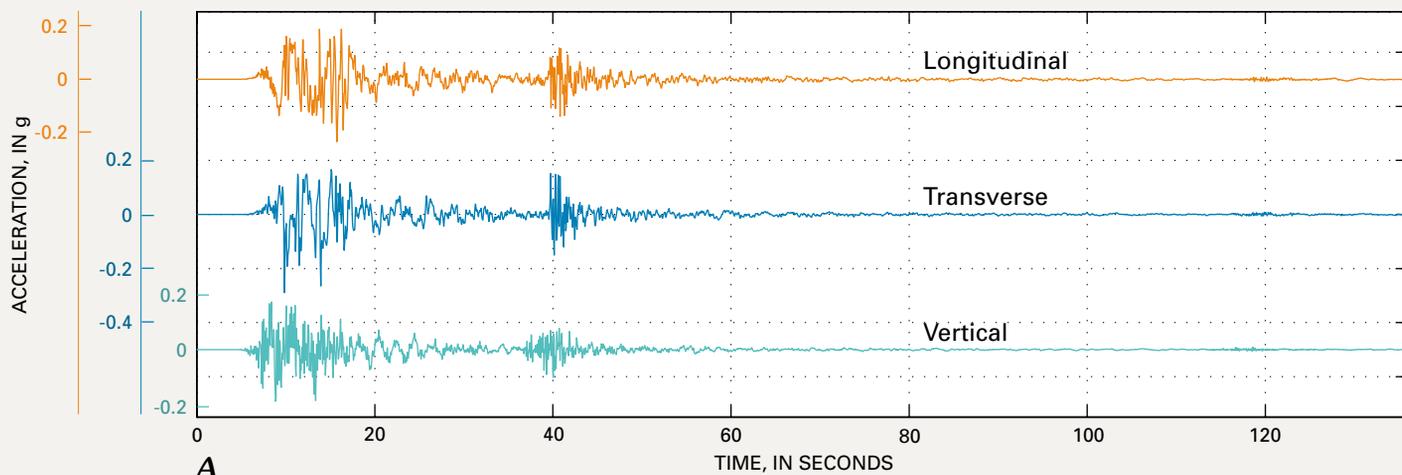
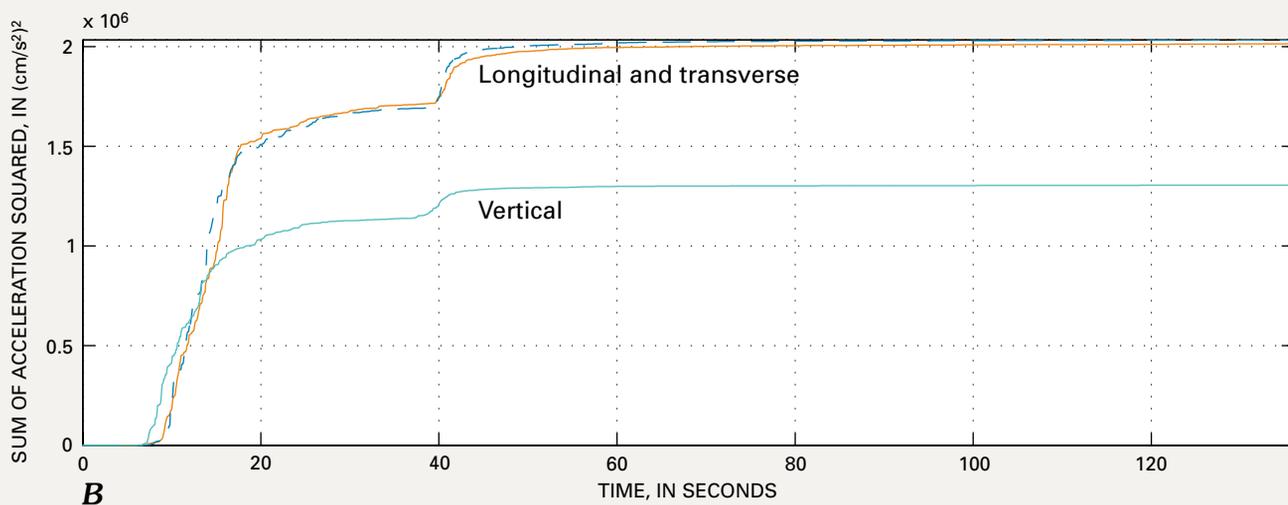
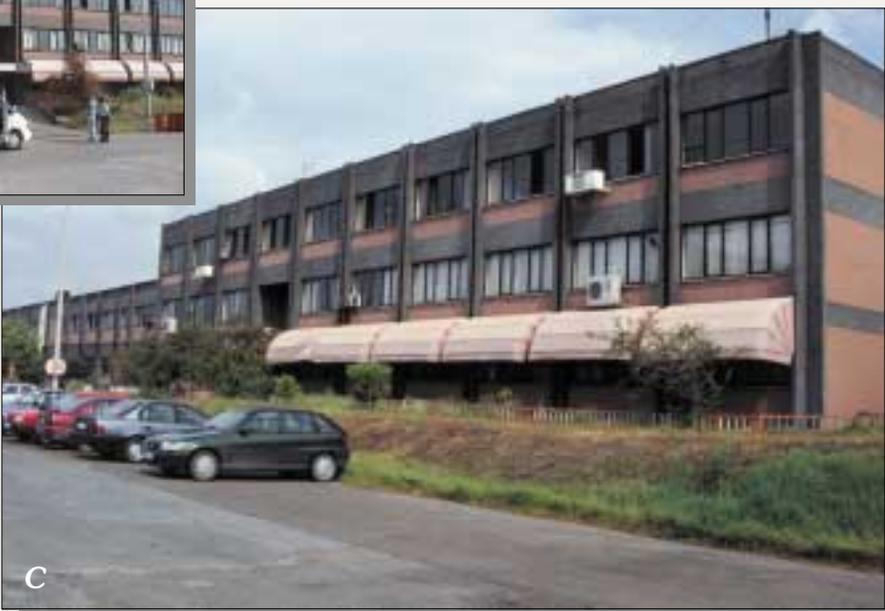
The time history of acceleration recorded at YPT (Petro-Chemical Plant in Korfez), a KOERI station, is shown in figure 24A. The station is located on alluvium. The time history reveals two distinct earthquake pulses. Figure 24B shows the cumulative sum of the square of acceleration, indicating an effective duration of approximately 15 s for the main shock. The main shock contributes approximately 85 percent of the significant ground shaking caused by the two events. The YPT instrument is housed on the first floor of a three-story building (fig. 23C).

Figure 24. *A*, Time histories of acceleration at YPT showing a second event approximately 33 s after the main shock. *B*, The main shock contributes approximately 85 percent of the total significant strong motion and its effective duration was about 15 s. Illustration by Mehmet Çelebi. *C*, Three-story building that houses the YPT accelerograph. Instrument is inside on first floor next to entrance. *Upper photograph* by Mehmet Çelebi, *lower photograph* by Thomas L. Holzer.

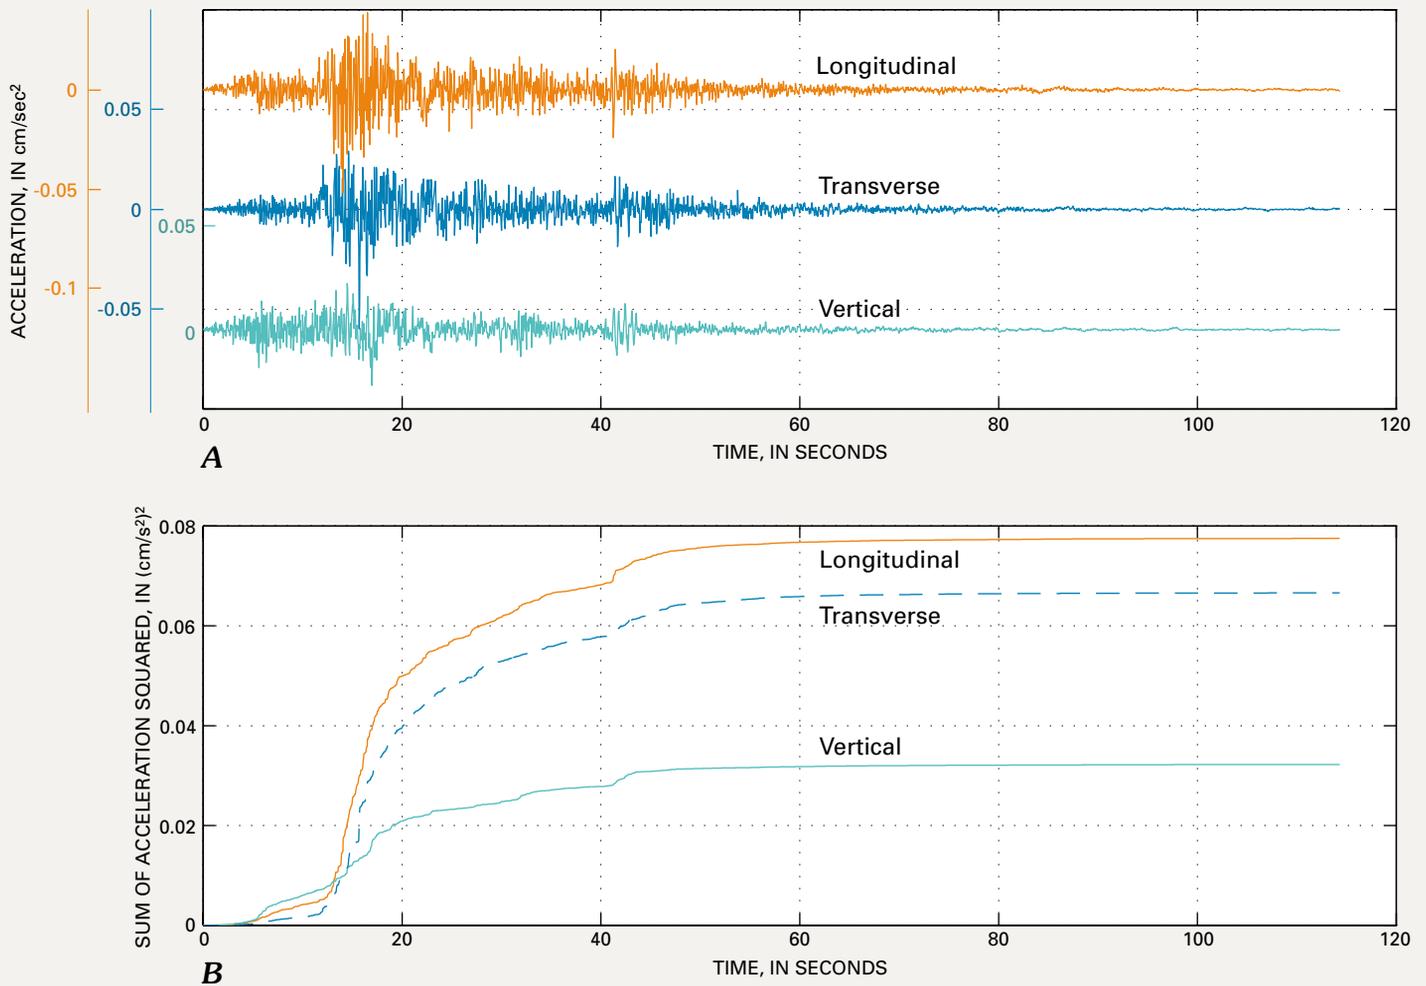
Figure 25. *A*, Time histories of acceleration at MCK in Istanbul. The plot shows several events. *B*, the cumulative sum of the squared acceleration values indicates the main shock contributed at least 90 percent of the total significant strong motion and the effective duration of strong motion was 36 s. *Illustration by Mehmet Çelebi.*

Figures 25A, B show the acceleration time history and the cumulative sum of the squared accelerations of the Mecidiyeköy (Istanbul) record (MCK), an ITÜ station. This station is located on rock.

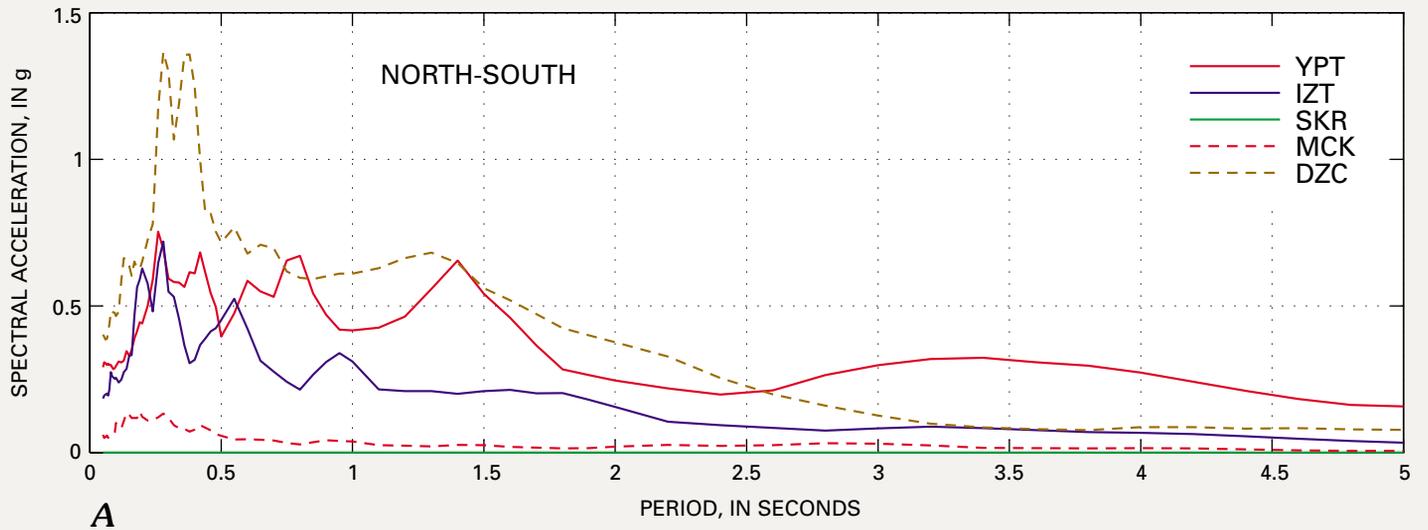
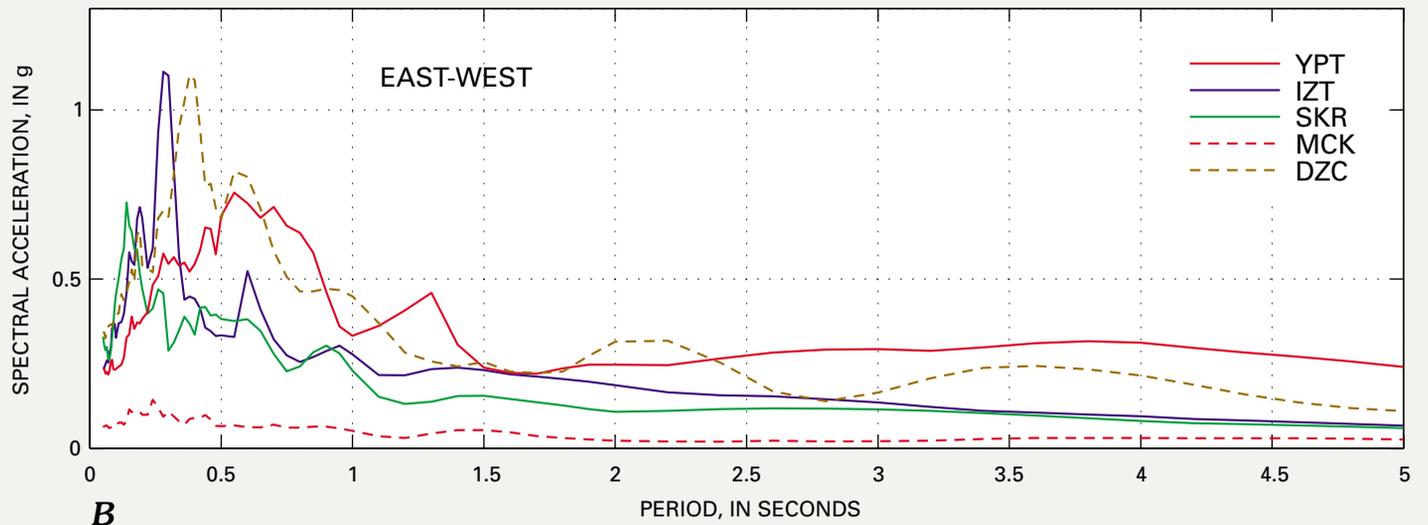
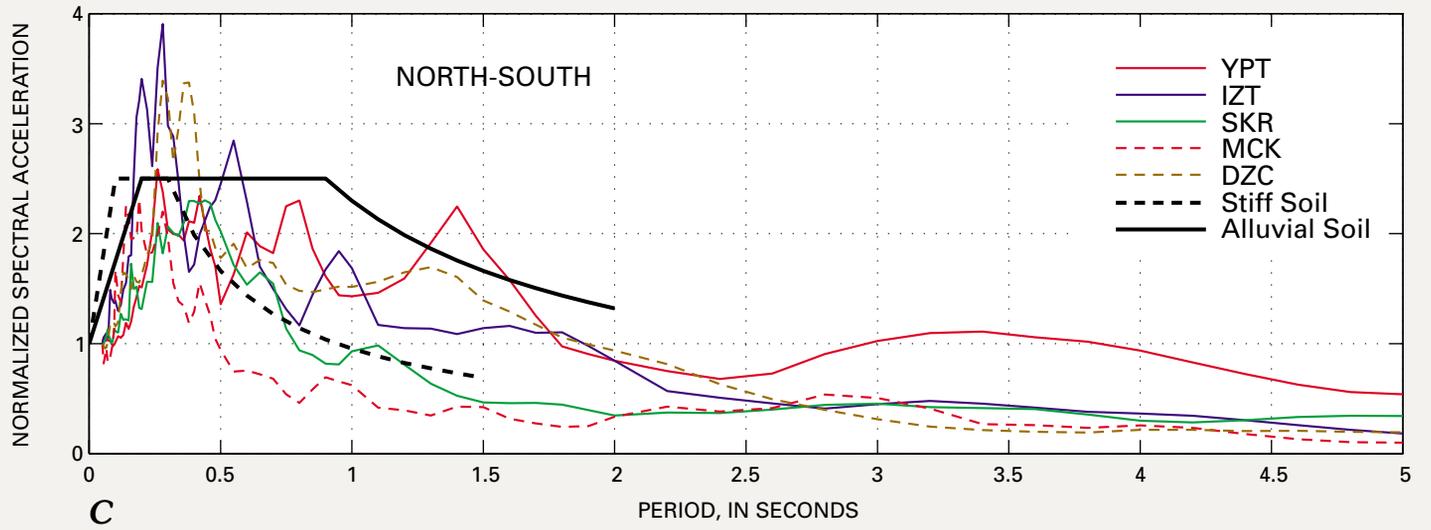
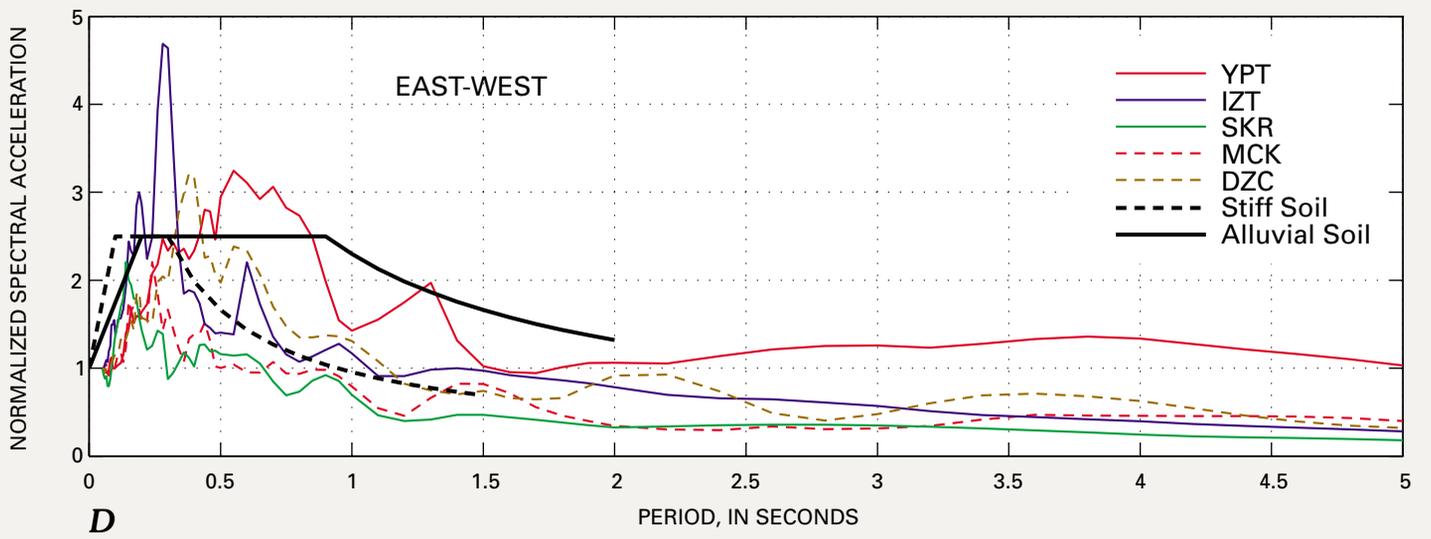
Figure 26 shows actual and normalized (with respect to zero-period accelerations) pseudo-acceleration response spectra, for north-south and east-west directions, respectively, for 5 stations, DZC, IZT, MCK, SKR, and YPT. Four of the stations (DZC, IZT, SKR, YPT) are in the epicentral area, two of which, (DZC, SKR) are near areas with heavy damage in the eastern part of the epicentral area. The fifth station (MCK) is in Istanbul. Three stations (DZC, IZT, YPT) are on alluvium whereas two stations (SKR, MCK) are on either stiff soil or soft rock. The response spectra reveal different resonant periods at each station. The normalized response spectra indicate that both YPT

and DZC have long resonant periods or low-frequency responses. For comparison, the design spectra for the current Turkish Building Code for soil and alluvial site conditions are also shown in figures 26C, D (Aydinoglu, 1998). For periods between 0.1 and 1 s, the design spectra, which are similar to those used in the United States, were either nearly or actually exceeded during the Kocaeli earthquake. The majority of the structures in the epicentral area were built to a lower design spectra before the 1998 code was implemented. Thus, the strength of many structures would have been insufficient to resist the forces generated by the Kocaeli earthquake even if the structures had been constructed according to existing codes.

Figure 26. Actual pseudo-acceleration response spectra (**A**, **B**) and normalized (with respect to zero-period acceleration) response spectra (**C**, **D**) for 5 stations. The normalized response spectra also show the response spectra of the 1998 Turkish Building Code for stiff and alluvial soil site conditions. *Illustration by Mehmet Çelebi.*

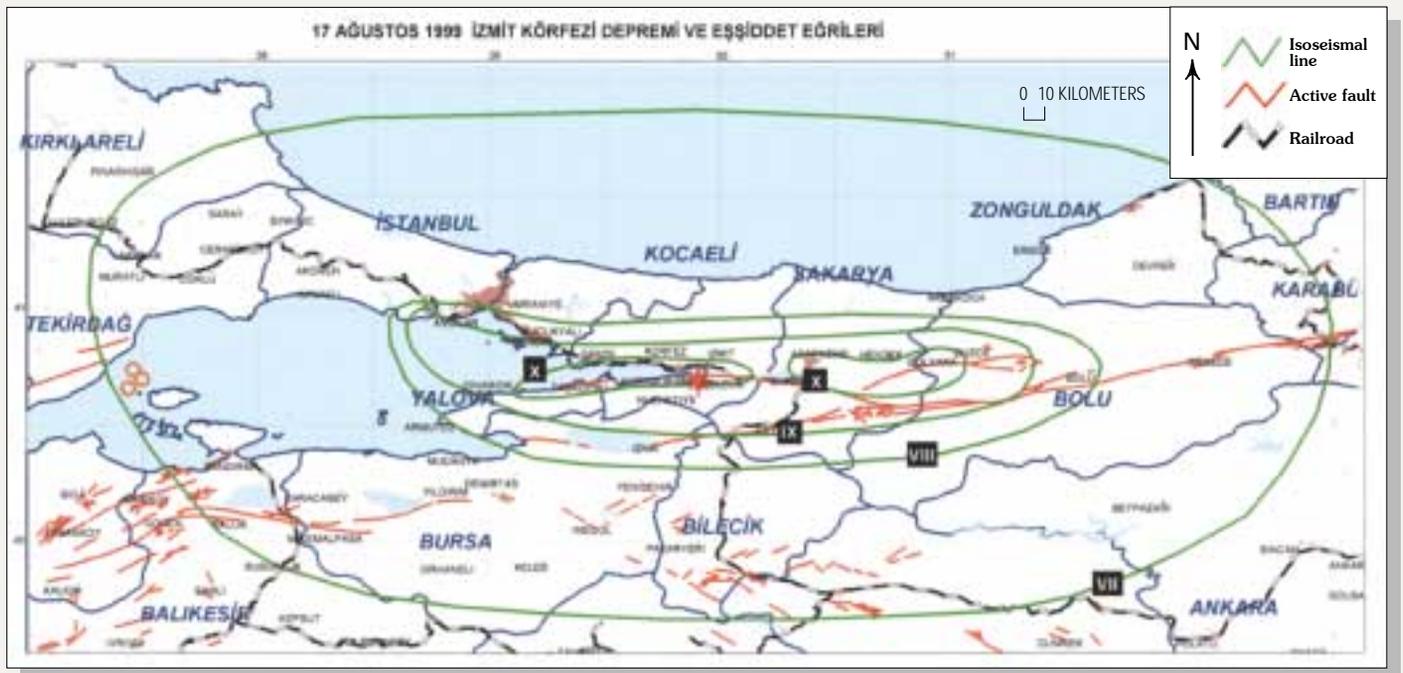
Figure 27. Preliminary isoseismal map of Modified Mercalli intensities (Roman numerals) of the August 17, 1999, Kocaeli earthquake. *Modified from Earthquake Research Department, Directorate for Disaster affairs, Ministry of Public Works and Settlement.*

The small number of strong-motion stations in the epicentral region that recorded the main shock precludes a detailed mapping of ground motions. However, the areal extent of strong shaking can be inferred from mapping damage and reports of felt shaking. The ERD of the Ministry of Public Works and Settlement issued a preliminary Modified Mercalli intensity map in late September 1999, a month after the main event (fig. 27). The Modified Mercalli scale uses observations of damage to infer the intensity of shaking (Wood and Neumann, 1931). About 150,000 km² was shaken at Modified Mercalli intensity VII or greater, intensities that prompt people to run outdoors.

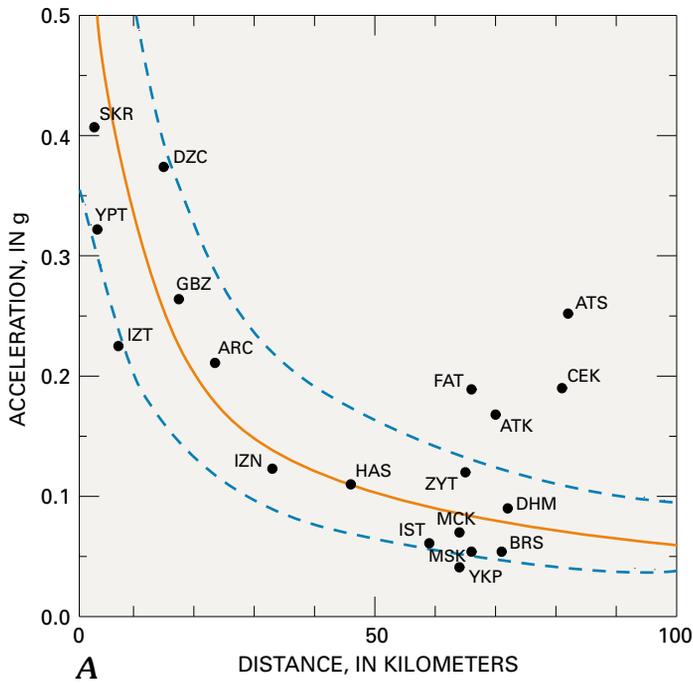
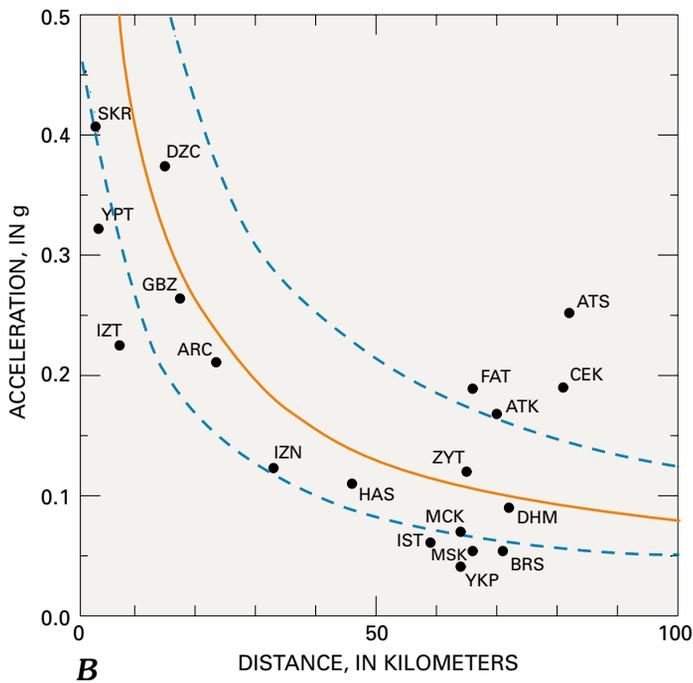
Figure 28. Values of peak horizontal acceleration recorded during the Kocaeli earthquake as a function of distance from the fault compared to values predicted by Boore and others (1994) for a M_W 7.4 earthquake in Western North America. **A**, Values predicted for sites with average shear wave velocities of 760 m/s. **B**, Values predicted for sites with average shear wave velocities of 360 m/s. Uncertainty is shown by the one standard deviation curves (dashed lines). *Illustration by Selcuk Toprak.*

Peak horizontal accelerations from the Kocaeli earthquake for the 19 stations compiled in table 1 are compared to values predicted by the empirical attenuation relation proposed by Boore and others (1994) in figure 28. Their attenuation relation, which predicts how peak accelerations decrease with distance from the surface rupture, is based on regression analyses of peak accelerations recorded in western North America. The comparison suggests that observed peak horizontal accelerations were below average within at least 7.5 km of the fault rupture for an M_W 7.4 earthquake. At greater distances from the fault, the values were more typical of those to be expected for an M_W 7.4 earthquake although values from recorded at distances from 10 to 50 km from surface rupture also are slightly on the low side. One of the factors in the regression is the soil condition at each recording site. Peak ground motions are generally higher at soil sites than rock sites. Because site conditions are poorly documented at most of the strong motion stations in Turkey, values are compared to attenuation curves for two different site conditions. Figure 28A compares the observed values to an attenuation curve for sites underlain by materials with an average shear wave velocity of 760 m/s in the upper 30 m. Figure 28B compares observed values to an attenuation curve for site conditions with an average shear wave velocity of 360 m/s in the upper 30 m beneath the station. The 760 m/s velocity is the boundary between rock and very dense soil/soft rock; the 360 m/s velocity is the boundary between very dense soil/soft rock and stiff soil (Federal Emergency Management Agency, 1998). Based on field inspection of the three stations that are closest to the surface rupture, one (SKR) is estimated to be near the 760 m/s boundary and two (IZT and YPT) are estimated to be near the 360 m/s boundary.

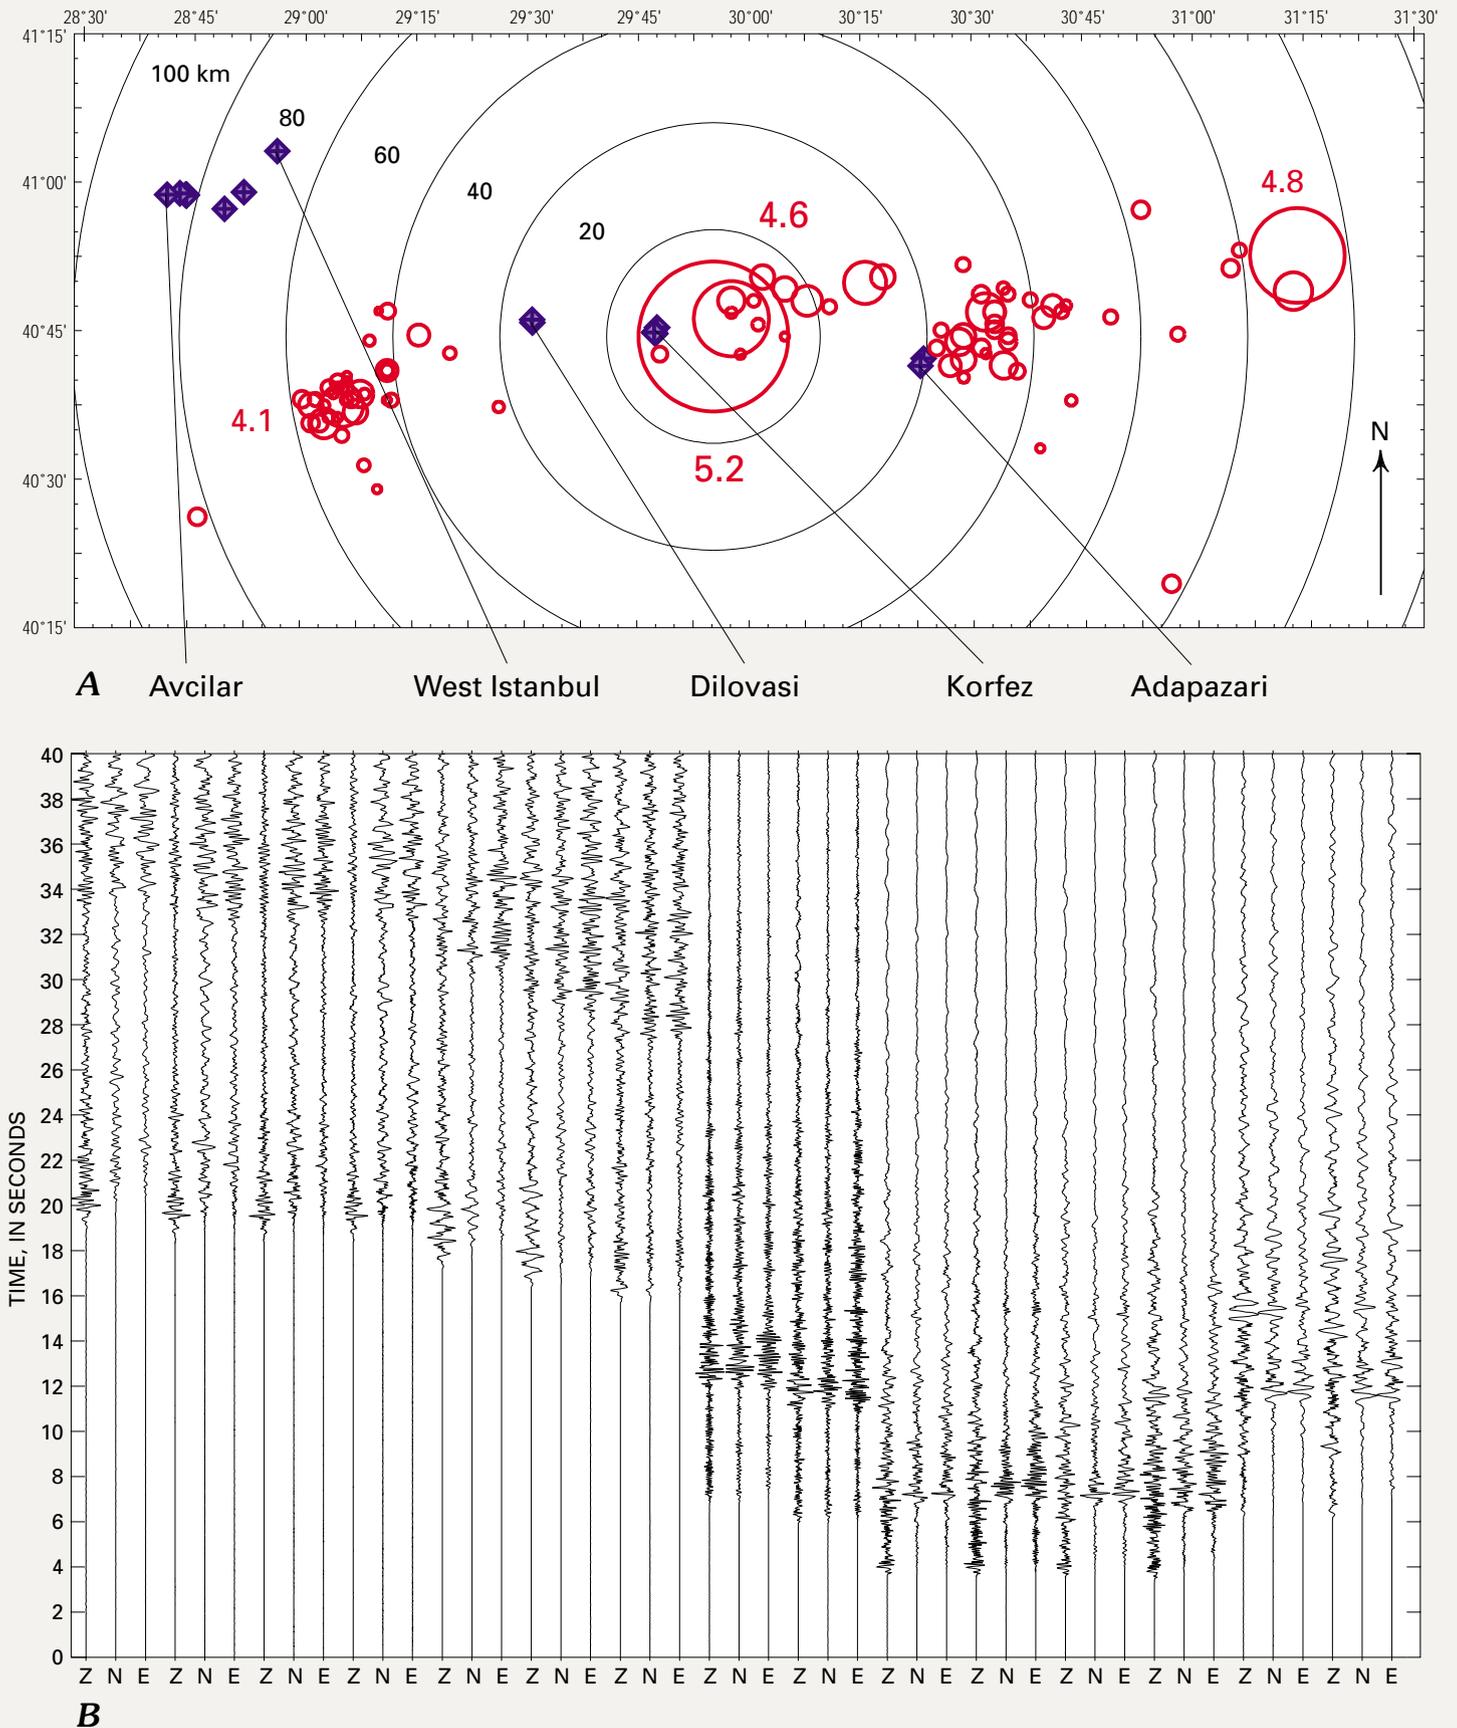
Figure 30. **A**, Map of Kocaeli earthquake aftershock zone and sites of USGS portable, digital seismographs (blue diamonds). Black concentric circles centered on the M 5.2 aftershock epicenter are in 20-km increments. Red circles are aftershock locations and their radii are proportional to their size; the magnitudes of the four largest events are annotated. **B**, The corresponding three components of ground motion for the M 5.2 aftershock recorded at the USGS sites are shown as a pseudo-record section of 40-s duration; Z, vertical, N, north-south, E, east-west. The amplitudes of each trace are normalized to the peak value of that trace. *Illustration by Edward Cranswick.*

Figure 30A shows the locations of USGS instruments and epicenters of aftershocks recorded by at least one station during the initial visit. The Avcilar district, an area of severe damage, is located west of the Istanbul airport and about 80 km from the end of the main-shock seismic source zone. The damage in Avcilar (fig. 31) was surprising, given its distance from the main shock and the fact that it is surrounded by areas that sustained little damage. Three instruments were located inside the zone of severe damage and four instruments were located in the surrounding area west of Istanbul. Dilovasi, 35 km west of the main-shock epicenter, is the site of planned port facilities and the northern abutment of a planned suspension bridge across the Gulf of Izmit. Two instruments were located in Dilovasi, one on rock and one on artificial fill. Korfez, 10 km west of the main-shock epicenter, suffered severe damage and four instruments were set up, three in a triangle-shaped array on young deposits near the city center (at the TUPRAS campus), and one on older deposits several kilometers away. Adapazari, 40 km east of the main-shock epicenter, was also heavily damaged and three instruments were located in a triangular array in an alluvial valley south of the city center (at the Toyota assembly plant).

Figure 30B illustrates the breadth and quality of the USGS ground-motion data. The plot shows three-component seismograms recorded at selected sites during a magnitude 5.2 aftershock (fig. 30A) on August 31. Figure 32A shows three-component seismograms (low-pass filtered at 4 Hz) recorded at the Dilovasi and Toyota sites recorded during a magnitude 4.1 aftershock (fig. 30A) on August 31. Plotted on a common amplitude scale, these seismograms illustrate two site effects. First, horizontal shaking at Dilovasi is clearly amplified at the seismograph located on fill when compared to the shaking at the seismograph located nearby on rock. Second, shaking is much stronger at the two Toyota plant sites in the alluvial valley south of Adapazari than at Dilovasi, even though the Toyota plant sites are located farther from the epicenter of the aftershock. Figure 32B shows the coherence of low-frequency ground motion (from the magnitude-5.2 aftershock, low-pass filtered at 0.25 Hz) recorded at each station in the triangular array in Korfez. Figure 33A is a map of the Avcilar area showing units of surface geology categorized according to geotechnical properties. Low-frequency ground motion (from the magnitude-5.2 aftershock, low-pass filtered at 0.25 Hz) is strongly amplified at sites in the damage area at Avcilar compared to nearby sites outside the damage area (fig. 33B).
