Implications for Earthquake Risk Reduction in the United States from the Kocaeli, Turkey, Earthquake of August 17, 1999

U.S. Geological Survey Circular 1193

U.S. Department of the Interior
U.S. Geological Survey

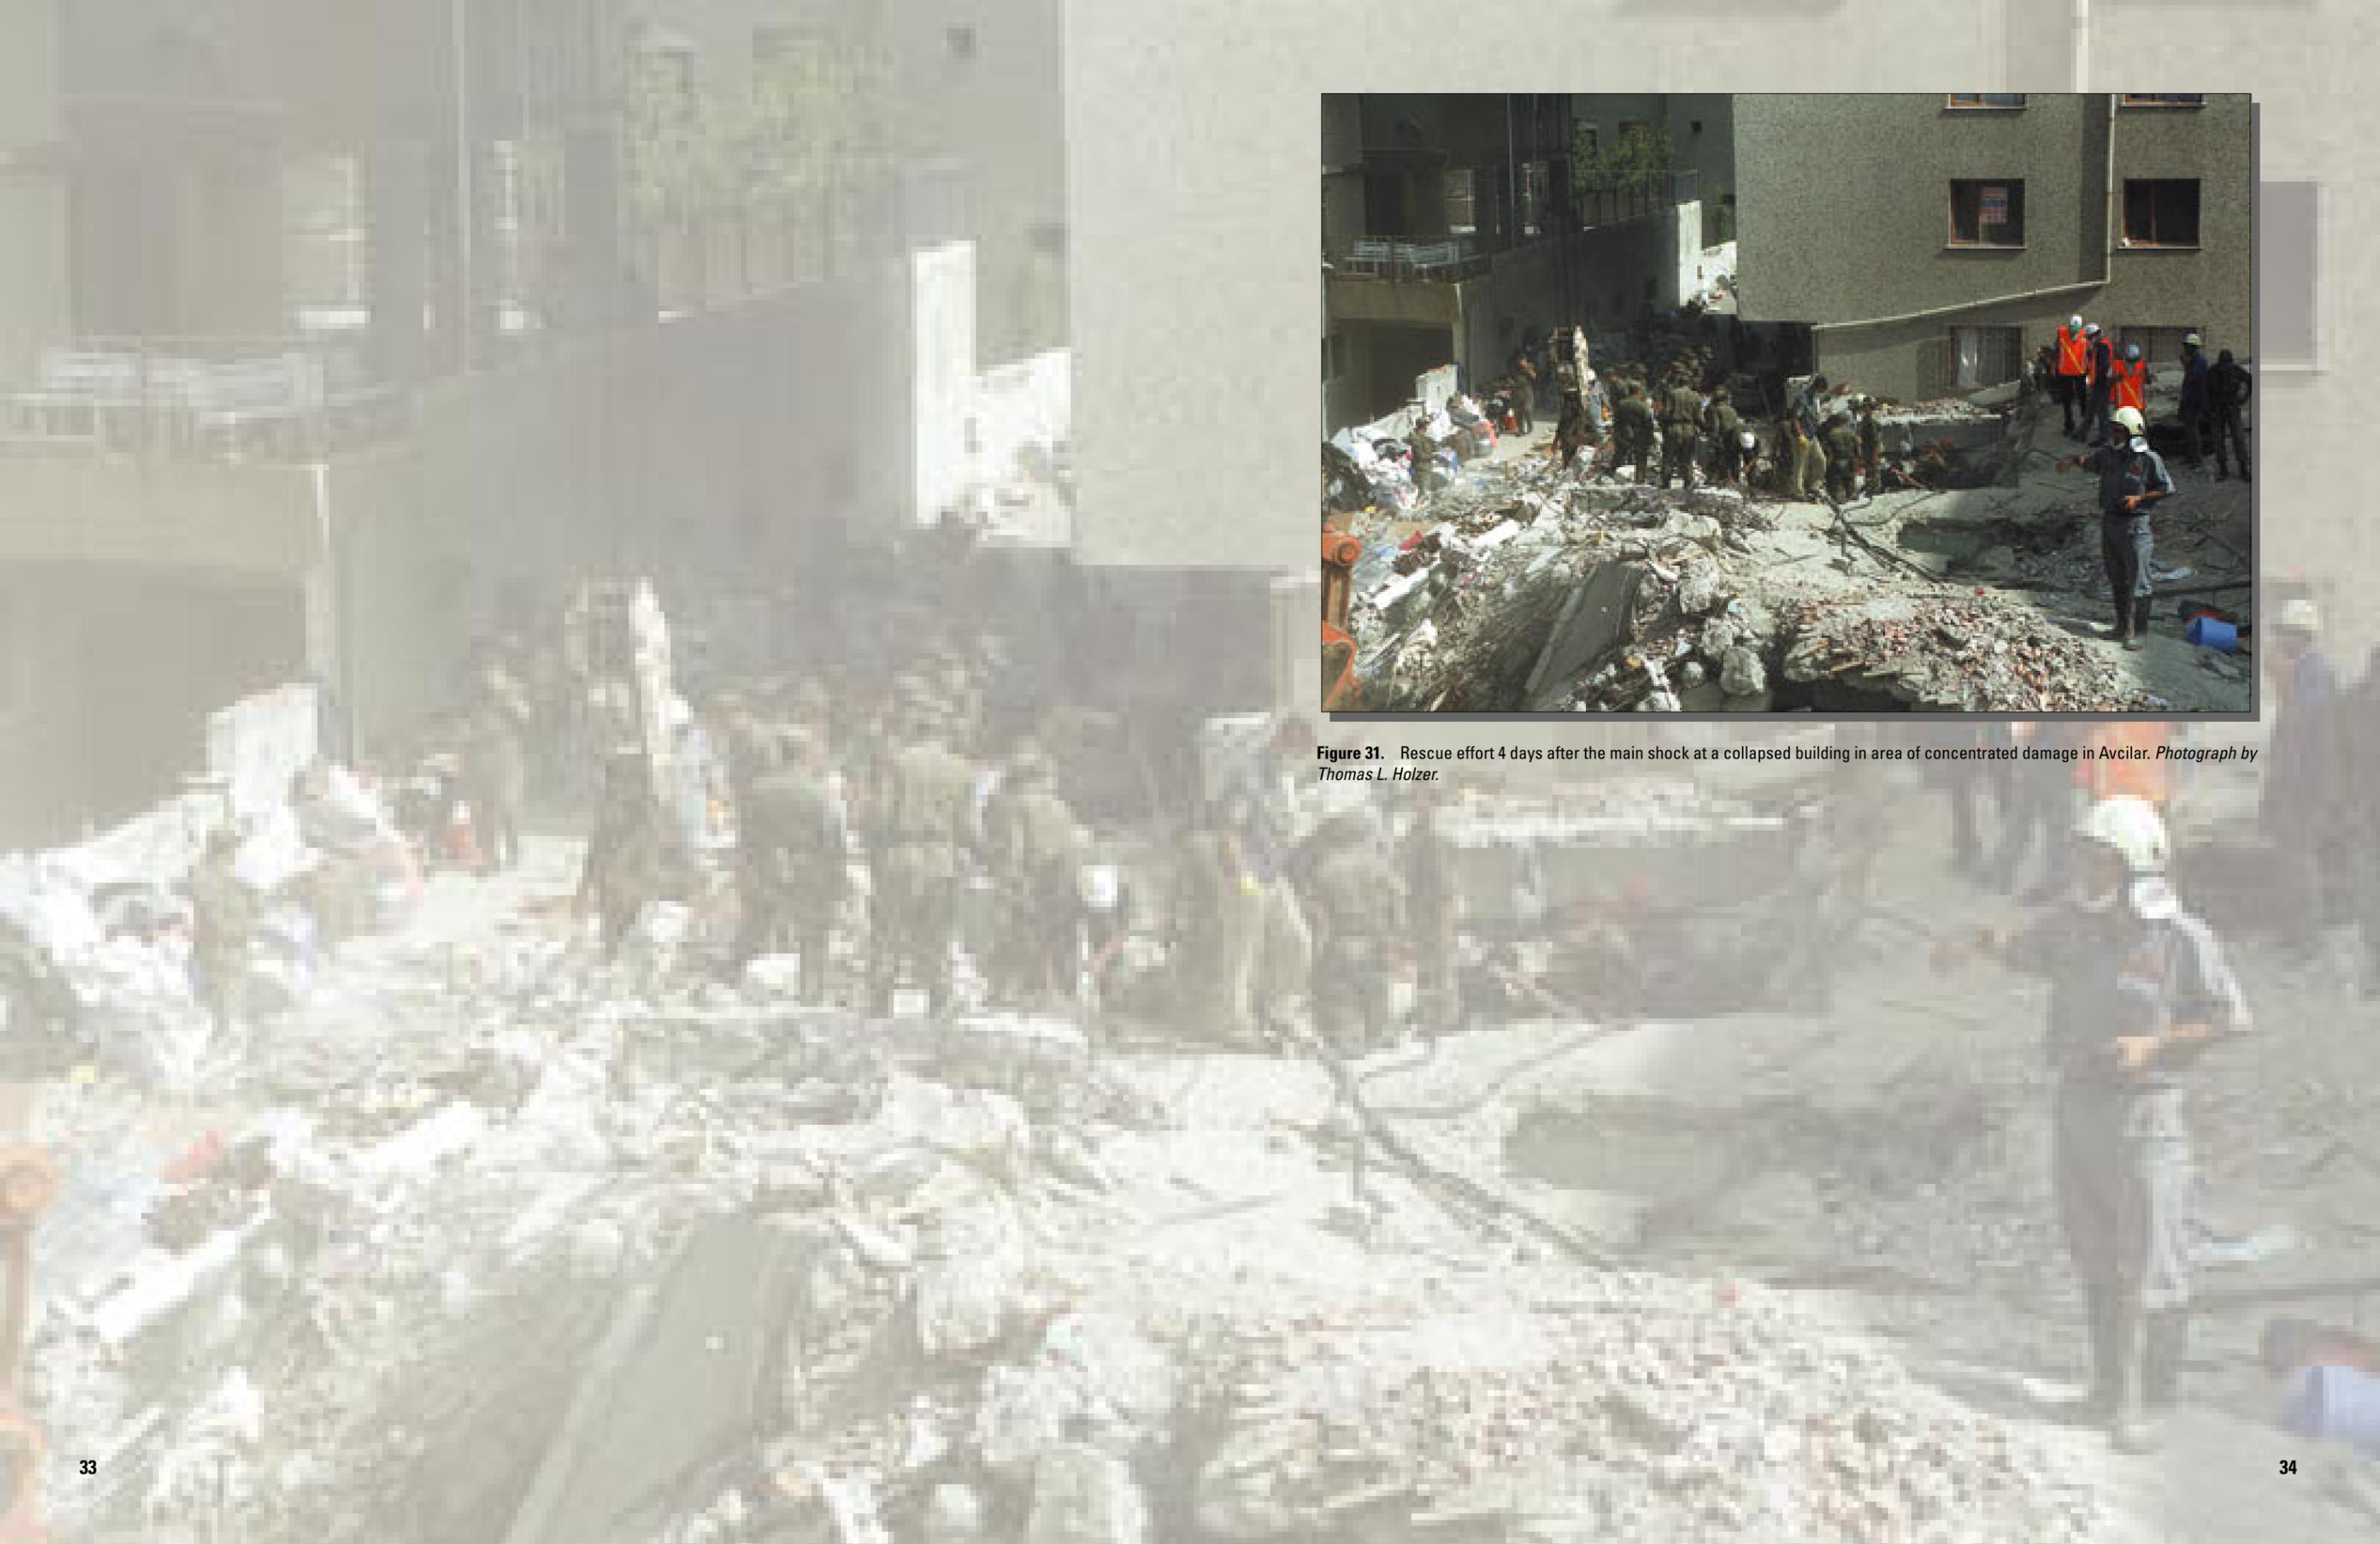
Figure 31. Rescue effort 4 days after the main shock at a collapsed building in area of concentrated damage in Avcilar. *Photograph by Thomas L. Holzer.*

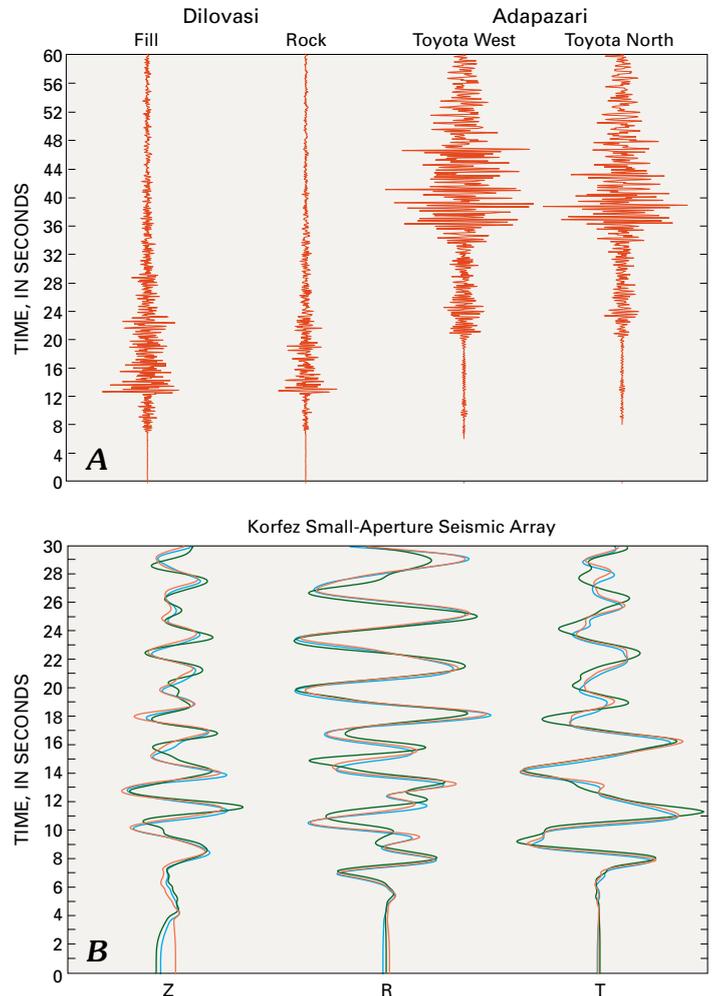
Figure 32. A, Pseudo-record section of ground motions from two pairs of stations at Dilovasi and Adapazari plotted on the same amplitude and time scales. Note the S-minus-P time of the first pair is approximately 5 s and that of the second is approximately 16 s. B, Overlay of Z, R, T components of closely spaced North, South, West stations at Korfez, all traces plotted on the same amplitude and time scales. *Illustration by Edward Cranswick.*

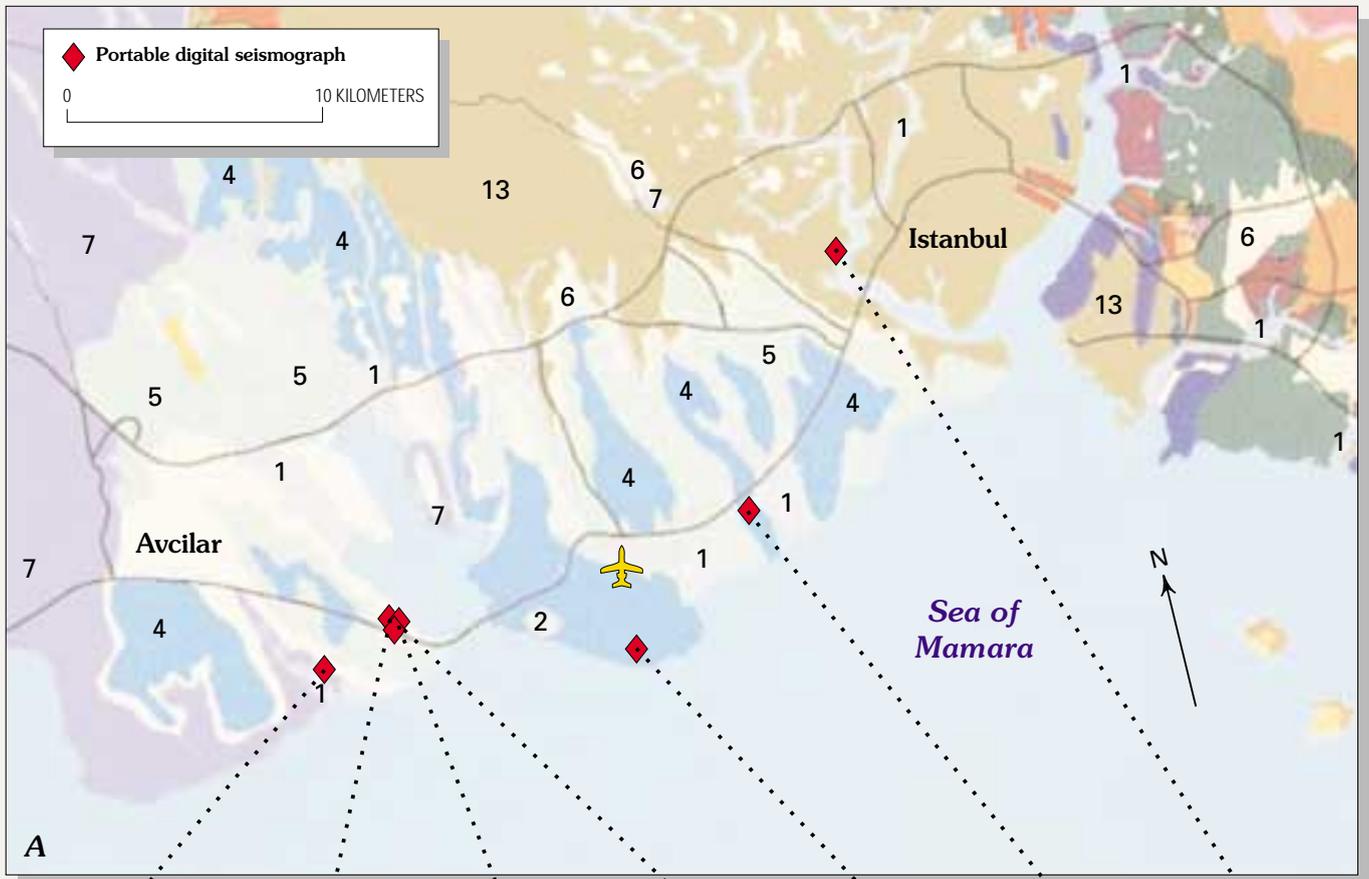
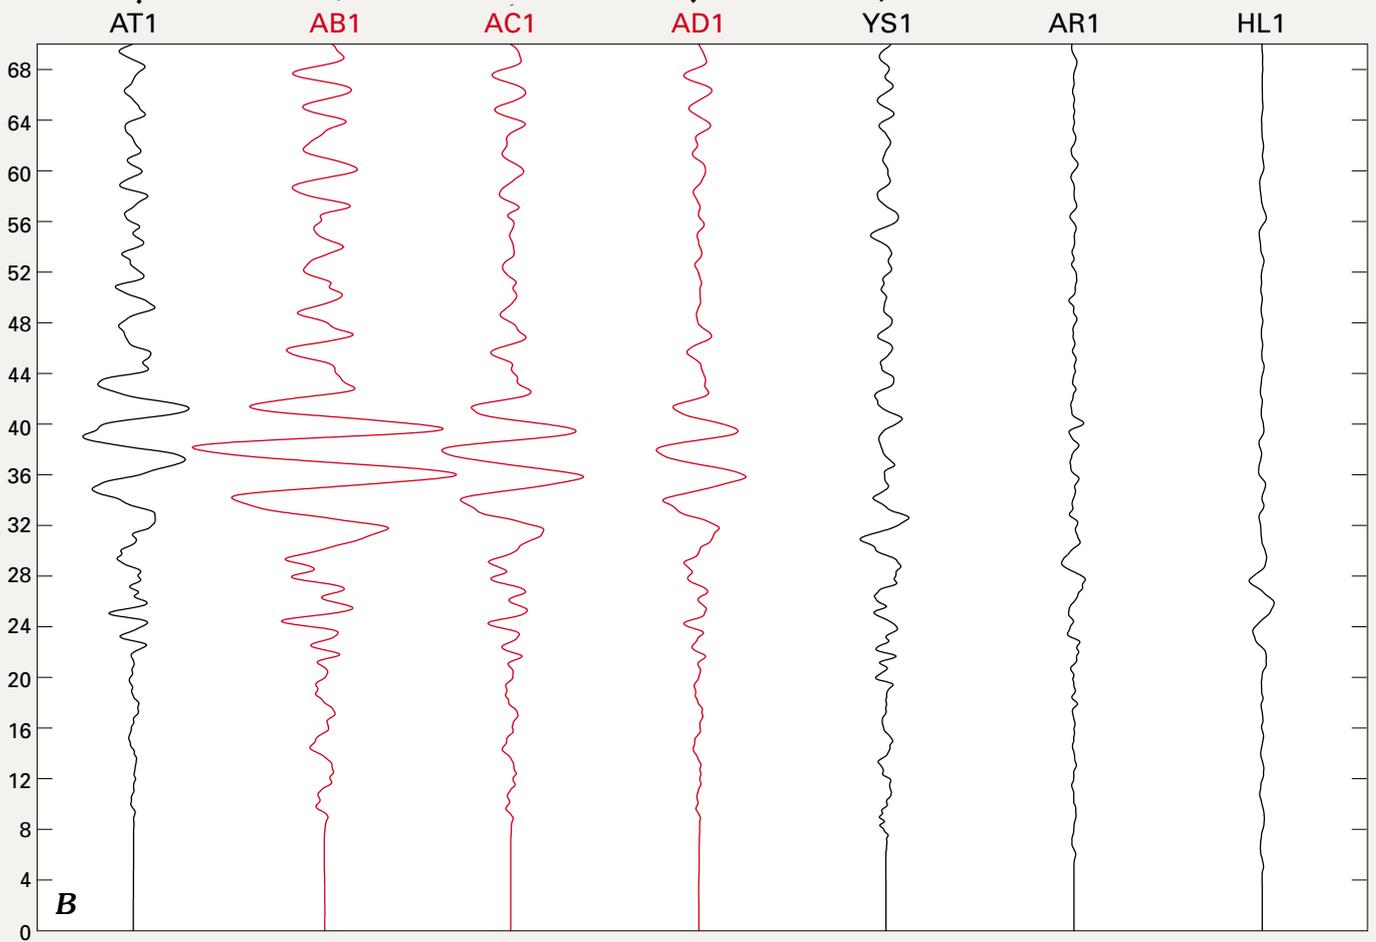
The USGS portable instruments were placed to confirm the importance of local geologic conditions as a mechanism for concentrating damage from shaking. The instruments at Avcilar, Dilovasi, and Adapazari all revealed local amplification of ground motion. The geologic control in Avcilar is of particular concern because, as discussed previously, the earthquake potential south of Istanbul may have been increased by the Kocaeli earthquake. In addition, understanding the specific geologic controls that contributed to damage in Avcilar during the Kocaeli earthquake may provide insight about what can be expected elsewhere in the world. For example, there is a striking resemblance between ground-motion and damage patterns in the Avcilar district in Istanbul in 1999 and the Marina district in San Francisco in 1989 (O'Rourke, 1992). Worldwide, many cities are situated in similar geologic and geotechnical settings.

Figure 33 (facing page). A, Geotechnical surface map of Avcilar district and West Istanbul. 1-3, alluvium with low-loading capacities where load capacity increases from 1 to 3 (3 not mapped in this area); 4, alluvium with good loading capacity with weak zones locally; 5, alluvium with low-loading capacity with increase probability of landslides on slopes reaching 14-15°; 6, alluvium with high-loading capacity but landslides may occur where ground water accumulates at bottom of slopes; 7, alluvium with low-loading capacities with known damage to structures; 13, rock with high-loading capacities except on slopes. B, Low-frequency ground motion is amplified at sites in the damage area of the Avcilar district, stations AB1, AC1, and AD1 (in red). Only radial components are displayed. *Illustration by Mark Meremonte.*

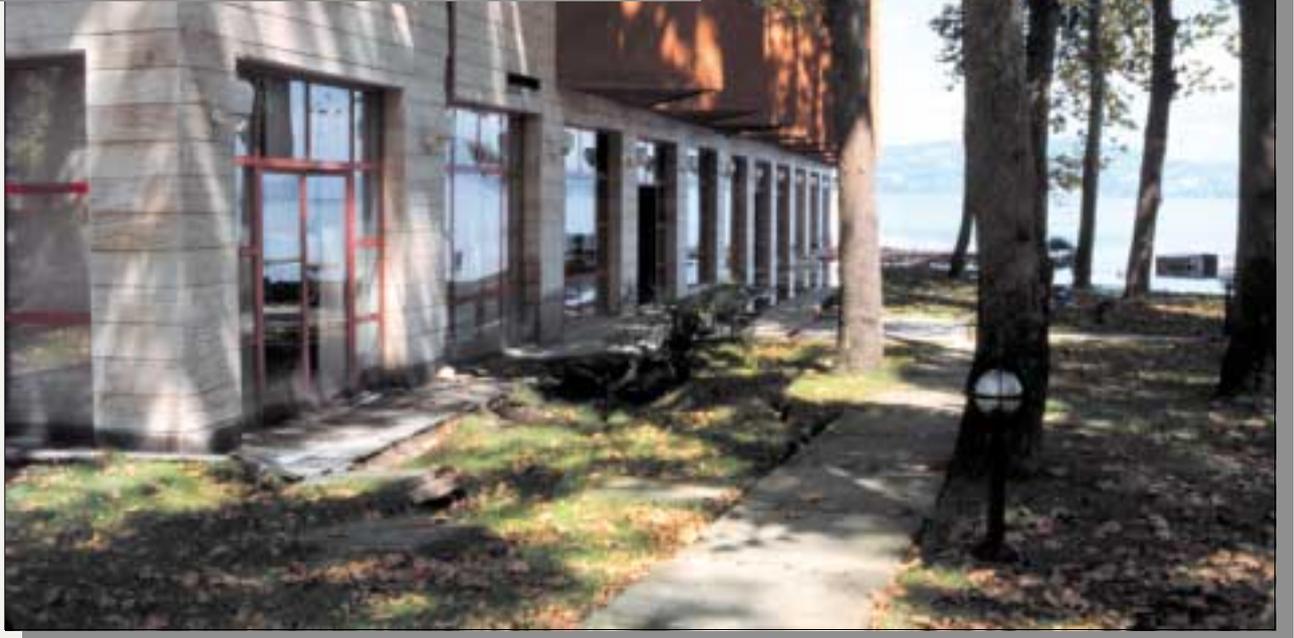
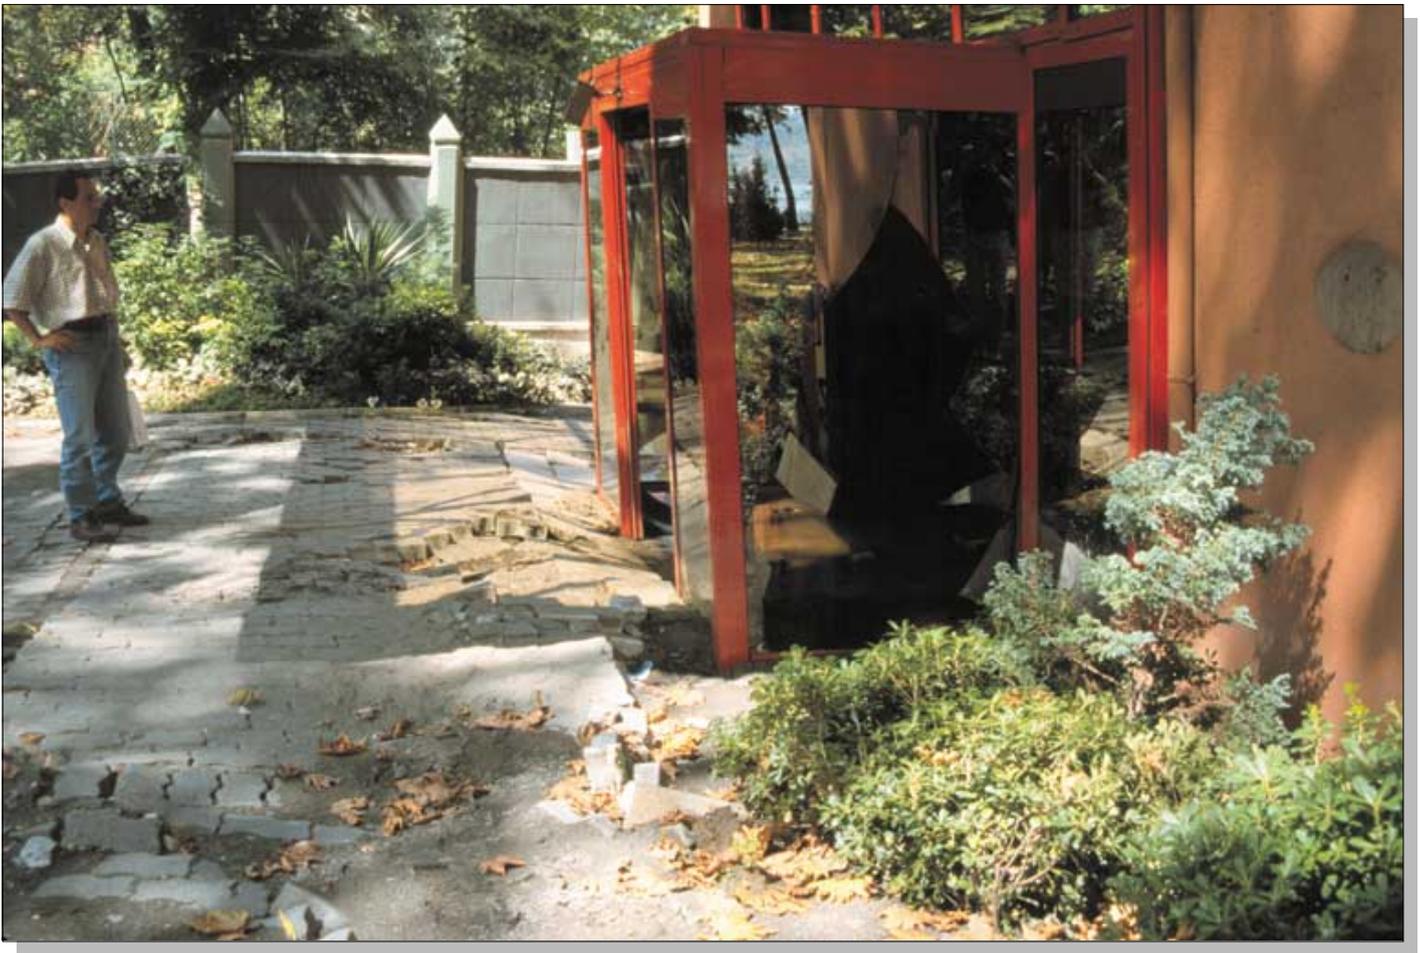
Along the southeast shore of Lake Sapanca, soils also liquefied and the Lake Sapanca Hotel was dramatically affected. The hotel, which was built on an old stream delta that had prograded into Lake Sapanca, sank about 0.3 m into the ground. The regional land surface around the hotel also lowered causing the shoreline to submerge (figs. 37, 38). In addition, the hotel was displaced about 0.5 m toward the lake by a lateral spread along the shoreline of the lake. Large quantities of subsurface sand vented to the surface and covered much of the driveway and the landscaping around the hotel.

Figure 38. Sunken entryway into Sapanca Hotel created when building sank into liquefied soil. *Photograph by Thomas L. Holzer.*

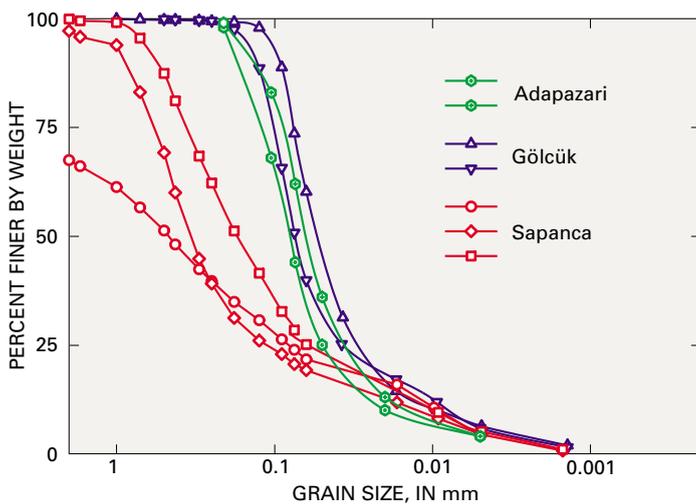
Figure 39. Grain-sized distributions of sand boils sampled near sites of sunken buildings in Adapazari, Gölcük, and Sapanca. Vertical axis is percent of sample by weight finer than the grain size shown on the horizontal axis. *Illustration prepared by Michael J. Bennett. Data from USGS and ERDC.*

Sand boils were sampled at Adapazari, Gölcük, and Sapanca. Liquefied material was predominantly fine grained; grain-size distributions of the material typically ranged from silts to silty sands (fig. 39). The two coarser sand boils sampled at the Sapanca site contained cobbles and other coarse-grained material. These sand boils may have been contaminated with cobbles contained in the base of a driveway. The other sand boil at Sapanca was in an open area and not susceptible to contamination.

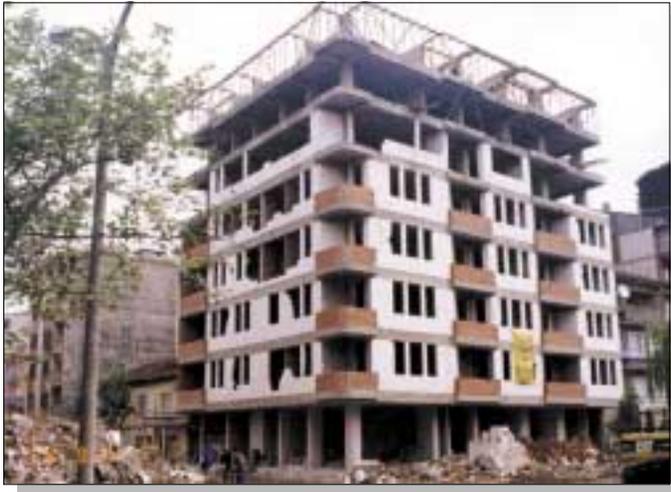
Figure 40 shows a building under construction illustrating common construction practice. In most cases of building collapse, there was no evidence of shear walls. Consequently, lateral resistance to the strong ground shaking was provided solely by frame action. Concrete compressive strength was not measured, but honeycombing was observed in similar new construction that did not collapse suggesting somewhat poorer concrete placement practices than typically found in U.S. construction. Furthermore, undeformed reinforcing bars were widely used for both flexural and shear reinforcement, a practice not permitted under U.S. building codes. Most of the reinforced concrete buildings can be characterized as having little or no ductility.

Figure 40. Building in Izmit under construction using reinforced concrete frame construction. Note absence of shear walls. *Photograph by National Institute of Standards and Technology.*

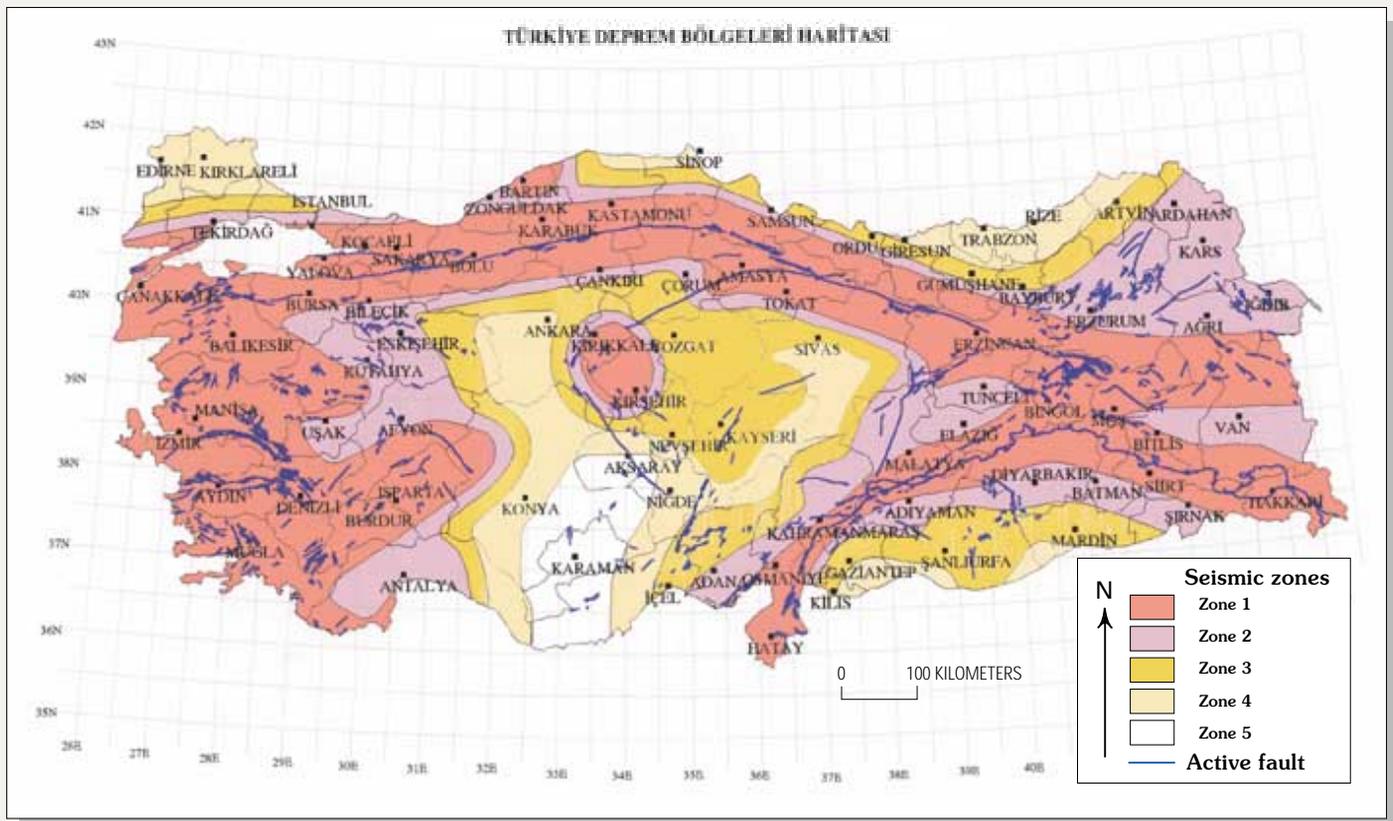
Figure 46. Modified earthquake zoning map of Turkey. Modified from Earthquake Research Department, Directorate for Disaster Affairs, Ministry of Public Works and Settlement.

Turkey has adopted modern building codes with up-to-date seismic design provisions. According to the Turkish seismic zone map, the areas affected by the Kocaeli earthquake are in the zone of highest risk (fig. 46). Although only examples of severe damage and collapse have been reported here, many buildings in the affected areas performed well with little or no apparent damage. Indeed, on figure 42, three buildings, one of which collapsed completely, one of which suffered partial collapse, and one of which appears to be relatively undamaged are visible. The absence of shear walls, deficient detailing around beam-column joints, and use of smooth rather than deformed steel reinforcement may have contributed to the extent of damage and collapse by reducing the ductility of the buildings. However, the heavy

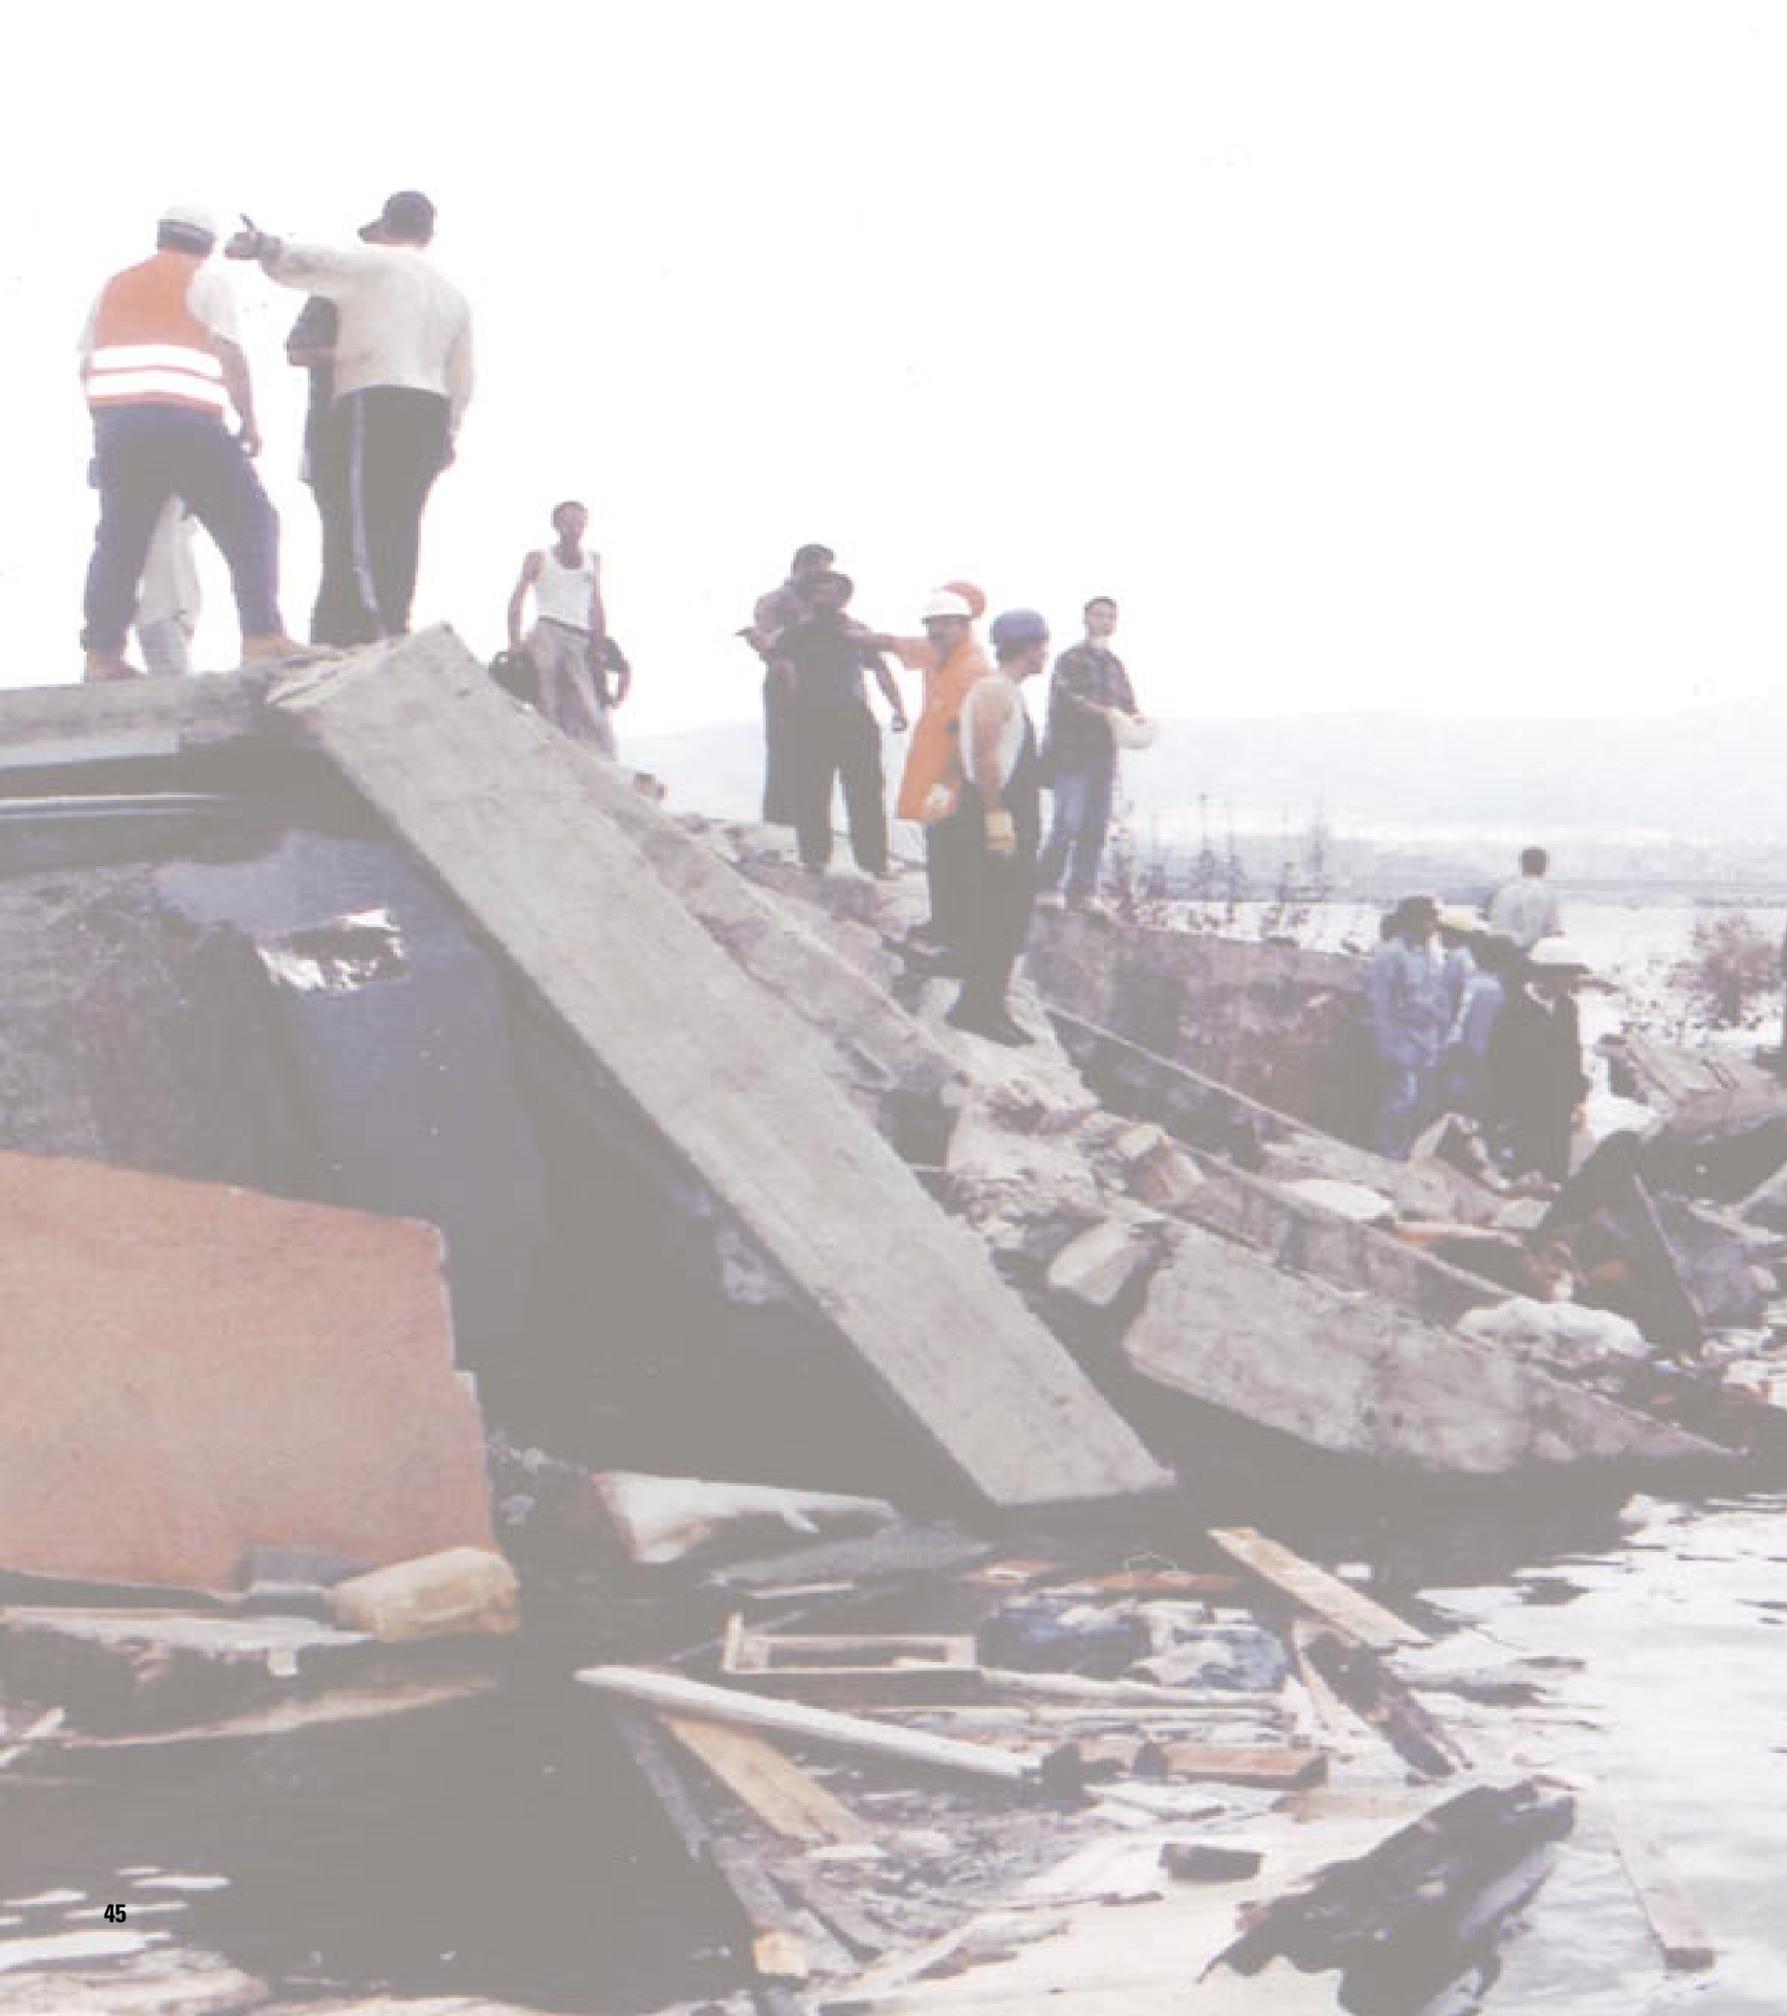
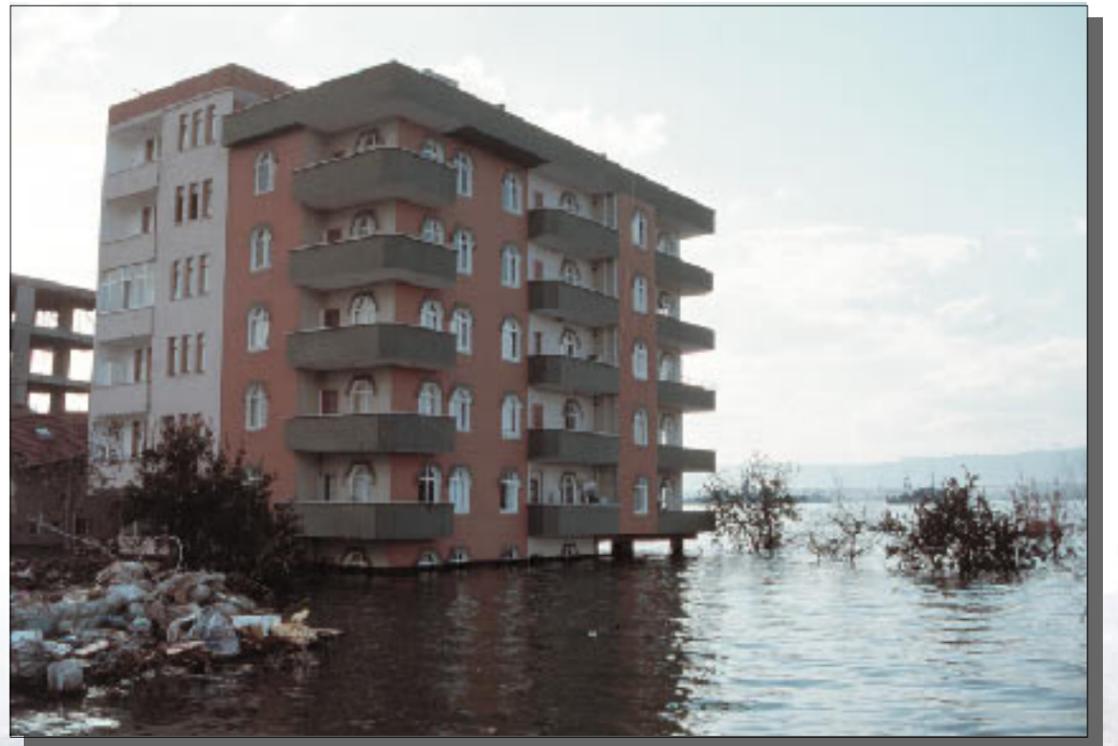
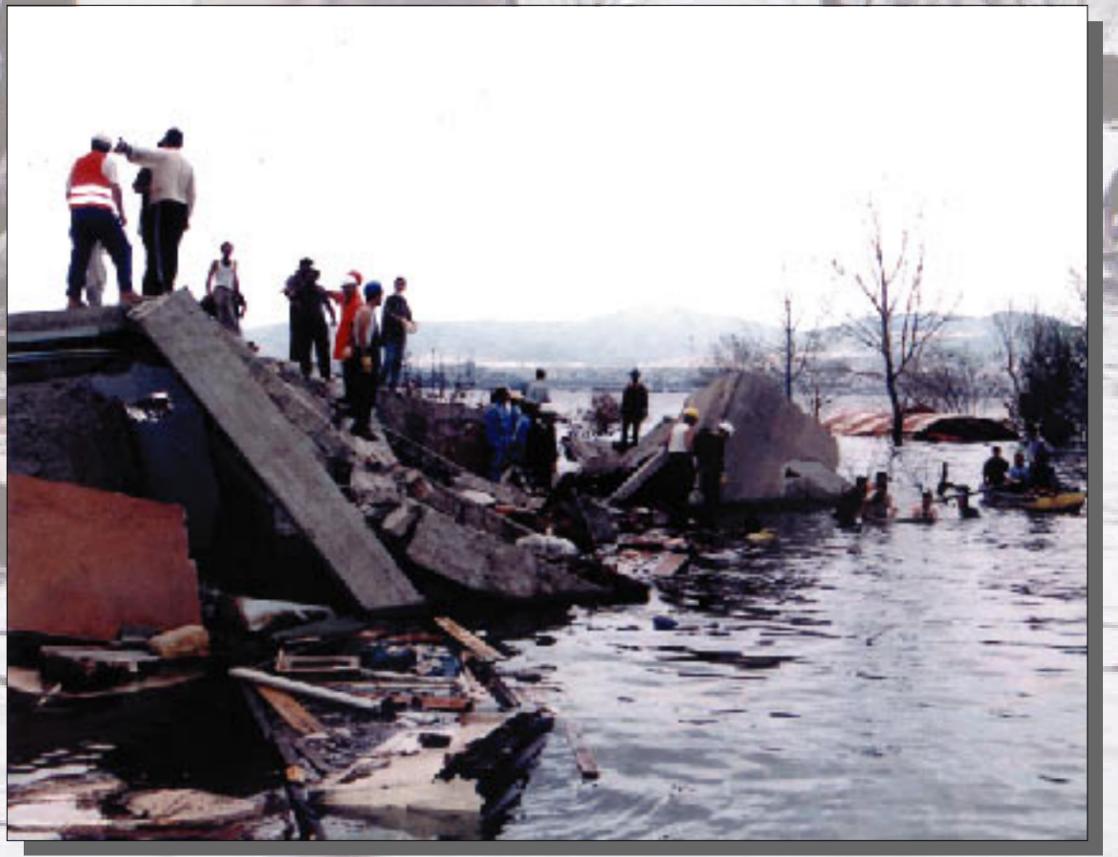
The Kocaeli earthquake also demonstrated the hazard posed by aftershocks to buildings following a large earthquake. Figure 47 shows a building in Gölcük before and after it collapsed during a M_W 5.9 aftershock on September 13. This aftershock, which was the largest magnitude aftershock at that time to follow the August 17 earthquake, killed 7 people, injured at least 239 people, and caused dozens of buildings to collapse in three cities near the epicenter.

Figure 47 (pages 45–46). Multistory residential building in Gölcük. Tectonic subsidence associated with faulting in the main shock caused the inundation of the first floor of the building. Upper photograph shows building standing after the August 17 main shock and before it collapsed in an aftershock; photograph by Thomas L. Holzer. Lower photograph shows building collapsed by M_W 5.9 aftershock four weeks after the main shock; copyrighted photograph by AP/Wide World Photos, used with permission.

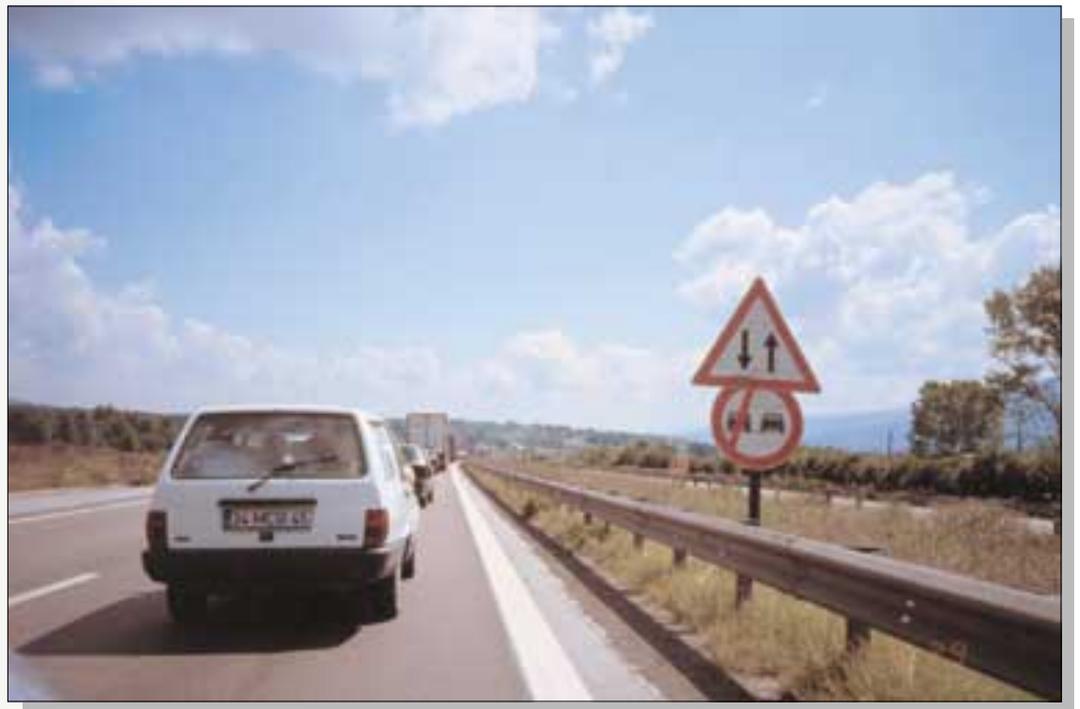
Immediately following the August 17, 1999, earthquake, the section of the TEM east of Izmit was closed because large cracks and areas of settlement on the roadway, one collapsed overpass, and the need to inspect all of the bridges. Temporary repairs were made and the TEM was reopened to the traffic after three days. In some areas, however, traffic was limited to two-way traffic on one side and speed limits were imposed while repairs continued (fig. 48). Most repair work was completed within 18 days following the earthquake and the TEM returned to normal operation.

Figure 48. Following the earthquake, road surface repairs forced alternative use of the eastbound and westbound lanes of the Trans European Motorway as a two-way highway with greatly reduced speeds from Izmit to about 50 km east of Izmit. *Photograph by Thomas L. Holzer.*

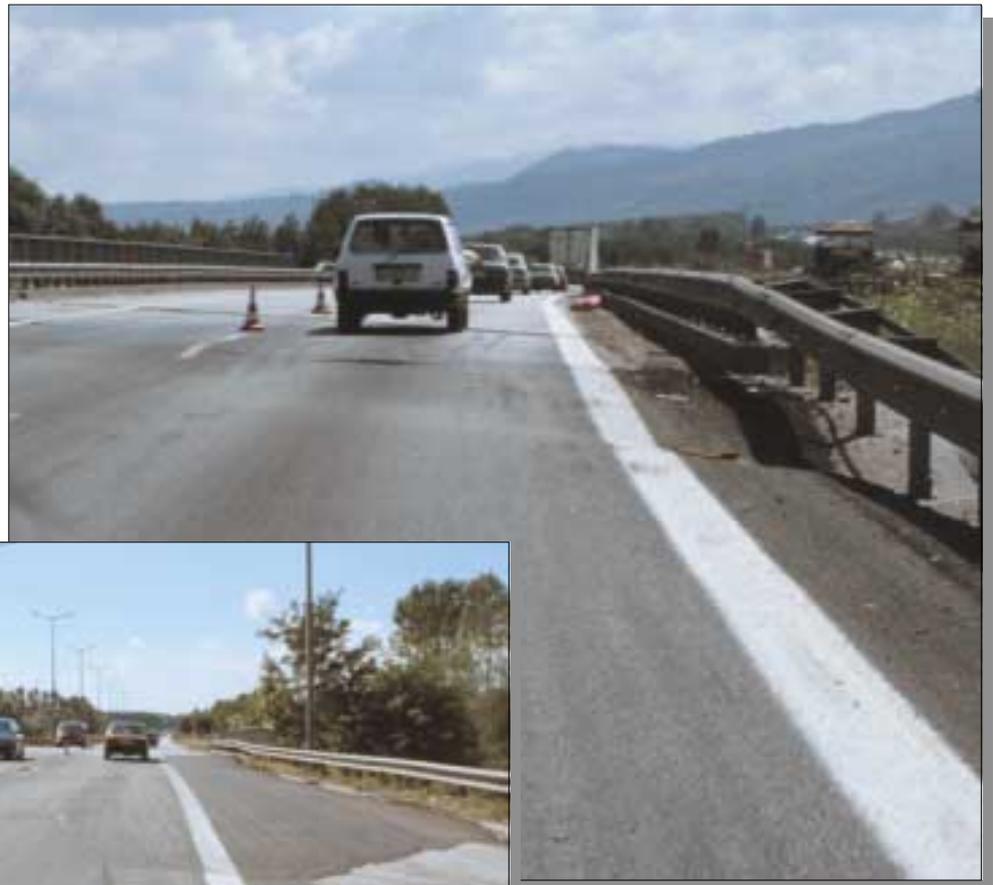
Figure 52. Densification of dry approach fill adjacent to bridges of the Trans European Motorway was widespread and caused disruption of the roadway. Immediately following the earthquake, Turkish highway engineers placed asphalt ramps on the roadway to reduce the hazard. *Photographs by Thomas L. Holzer.*

Permanent ground displacements, such as extensive cracks and settlement, caused significant damage to the roadway surface. Approximately 50 km of the TEM required resurfacing. Densification of dry fill commonly caused settlements in areas where the motorway approached bridges, viaducts, and culverts; some areas settled as much as 0.3 m. Figure 52 shows one example of settlement.
