Implications for Earthquake Risk Reduction in the United States from the Kocaeli, Turkey, Earthquake of August 17, 1999

U.S. Geological Survey Circular 1193

U.S. Department of the Interior
U.S. Geological Survey

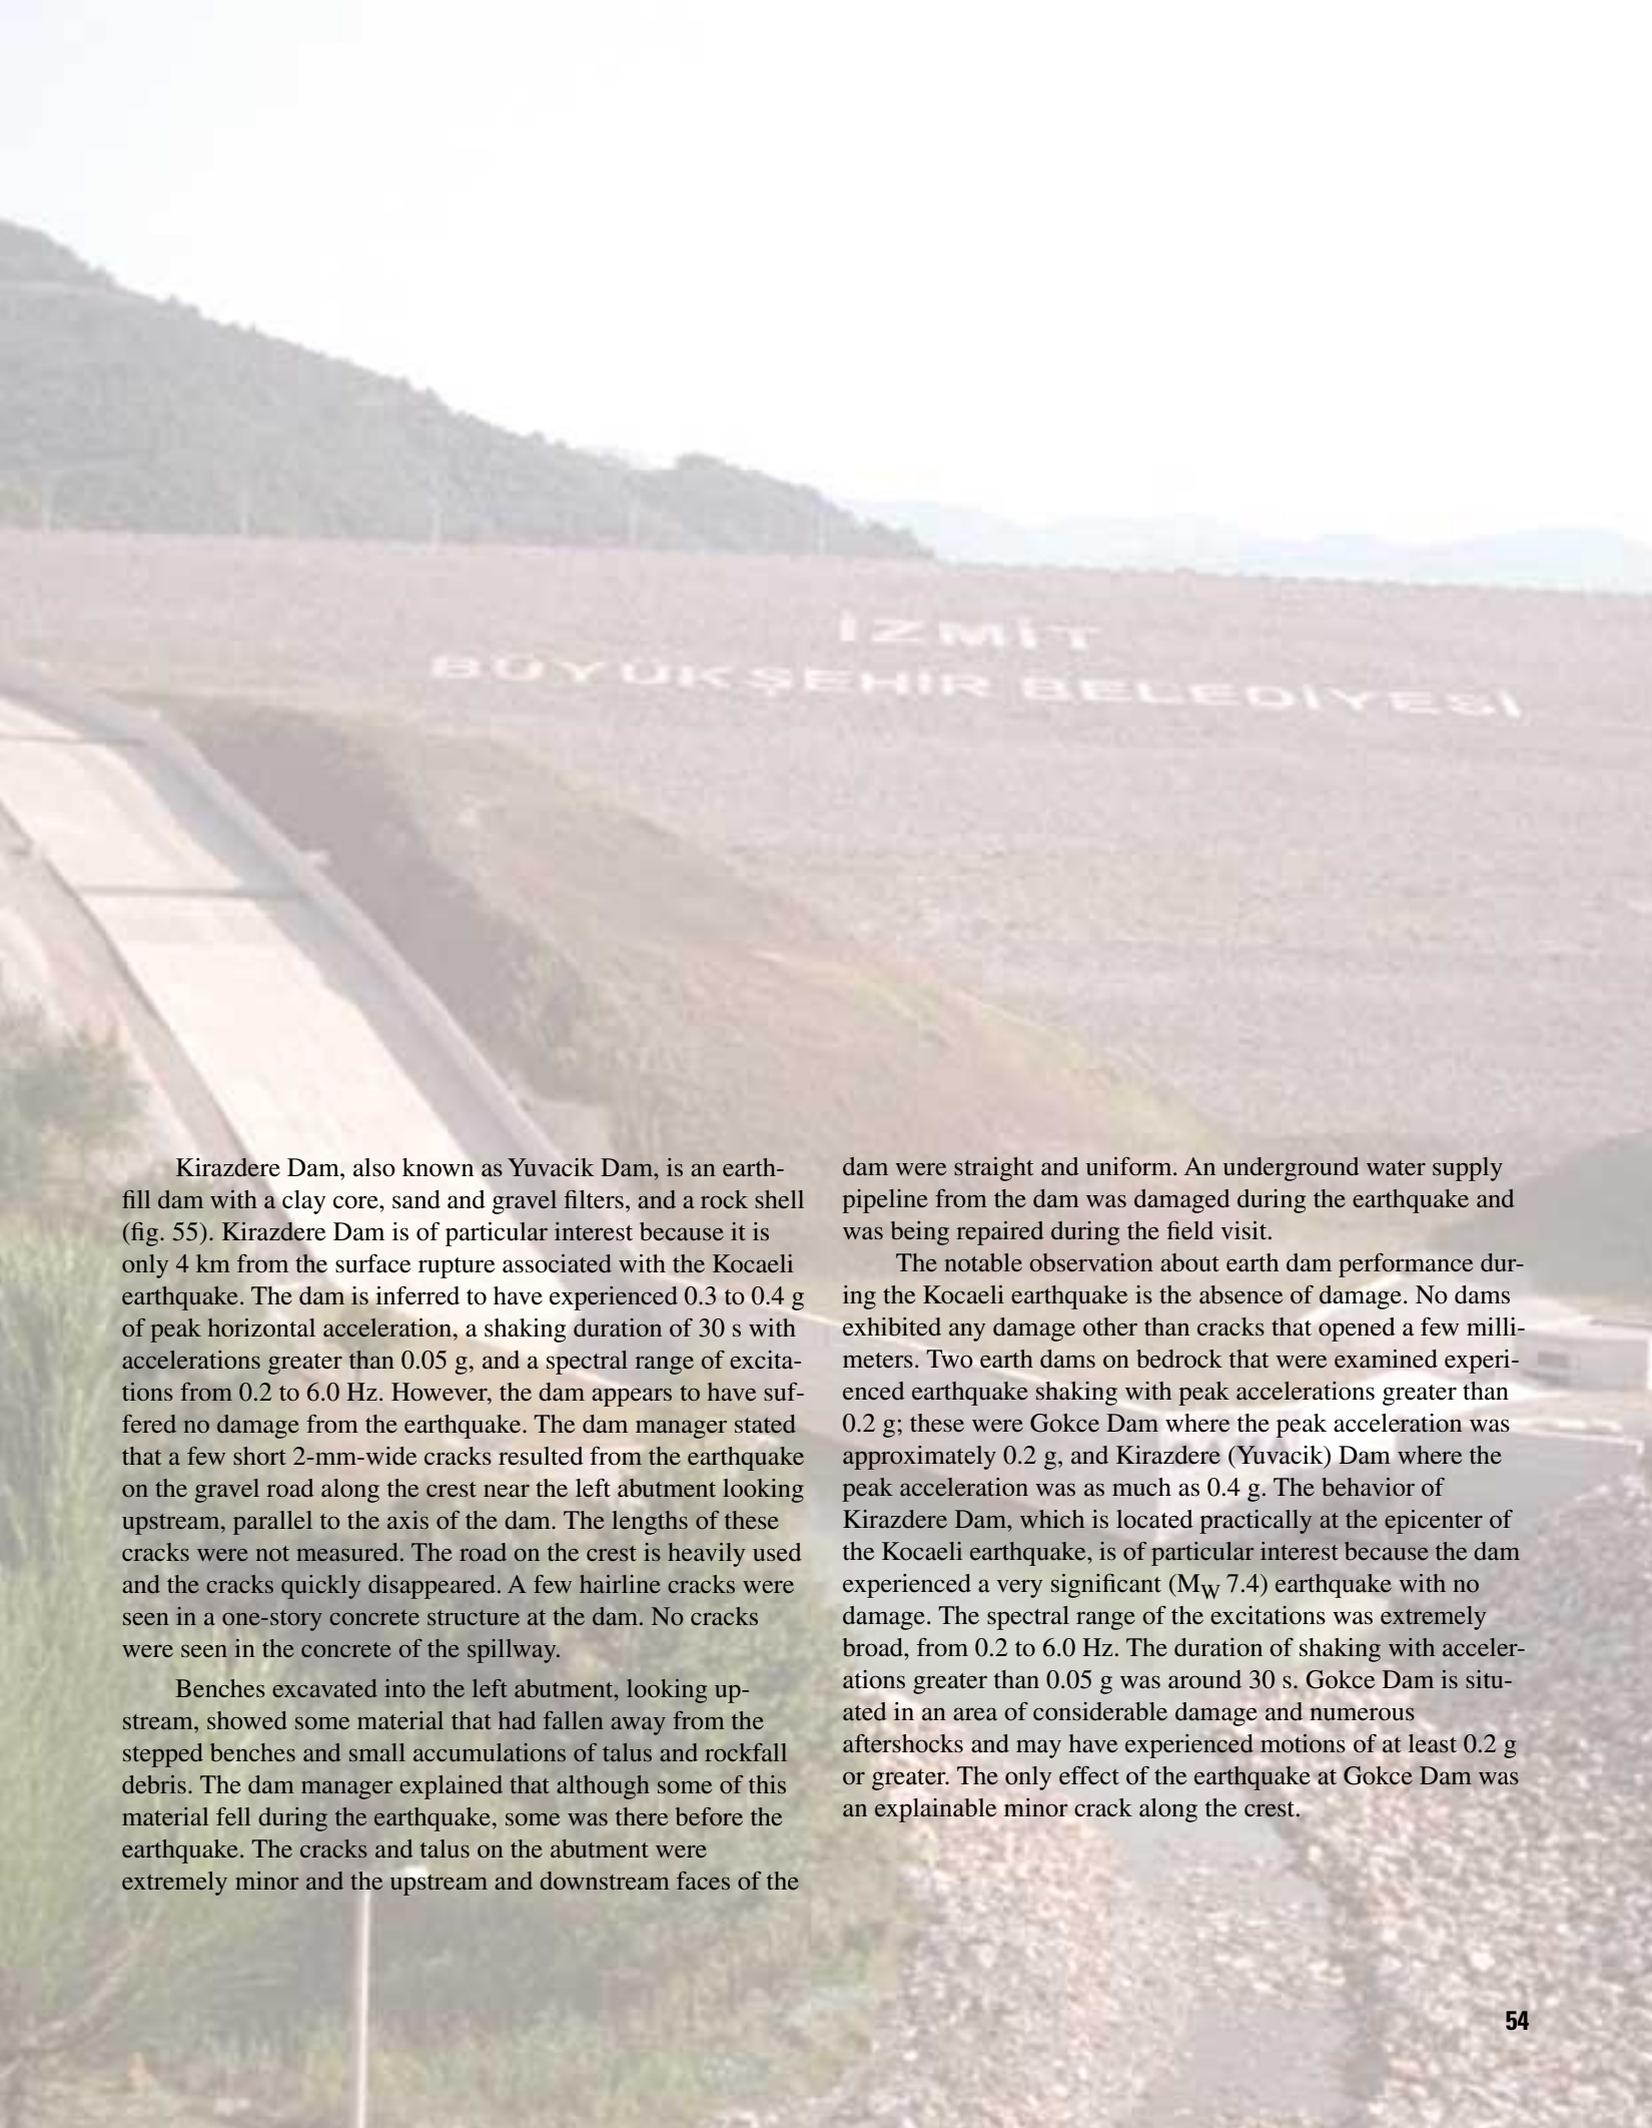
Figure 55. View of Kirazdere (Yuvacik) Dam after the Kocaeli earthquake. The dam was only about 4 km from the surface rupture and did not suffer damage. *Photograph by Richard S. Olsen.*

Kirazdere Dam, also known as Yuvacik Dam, is an earth-fill dam with a clay core, sand and gravel filters, and a rock shell (fig. 55). Kirazdere Dam is of particular interest because it is only 4 km from the surface rupture associated with the Kocaeli earthquake. The dam is inferred to have experienced 0.3 to 0.4 g of peak horizontal acceleration, a shaking duration of 30 s with accelerations greater than 0.05 g, and a spectral range of excitations from 0.2 to 6.0 Hz. However, the dam appears to have suffered no damage from the earthquake. The dam manager stated that a few short 2-mm-wide cracks resulted from the earthquake on the gravel road along the crest near the left abutment looking upstream, parallel to the axis of the dam. The lengths of these cracks were not measured. The road on the crest is heavily used and the cracks quickly disappeared. A few hairline cracks were seen in a one-story concrete structure at the dam. No cracks were seen in the concrete of the spillway.

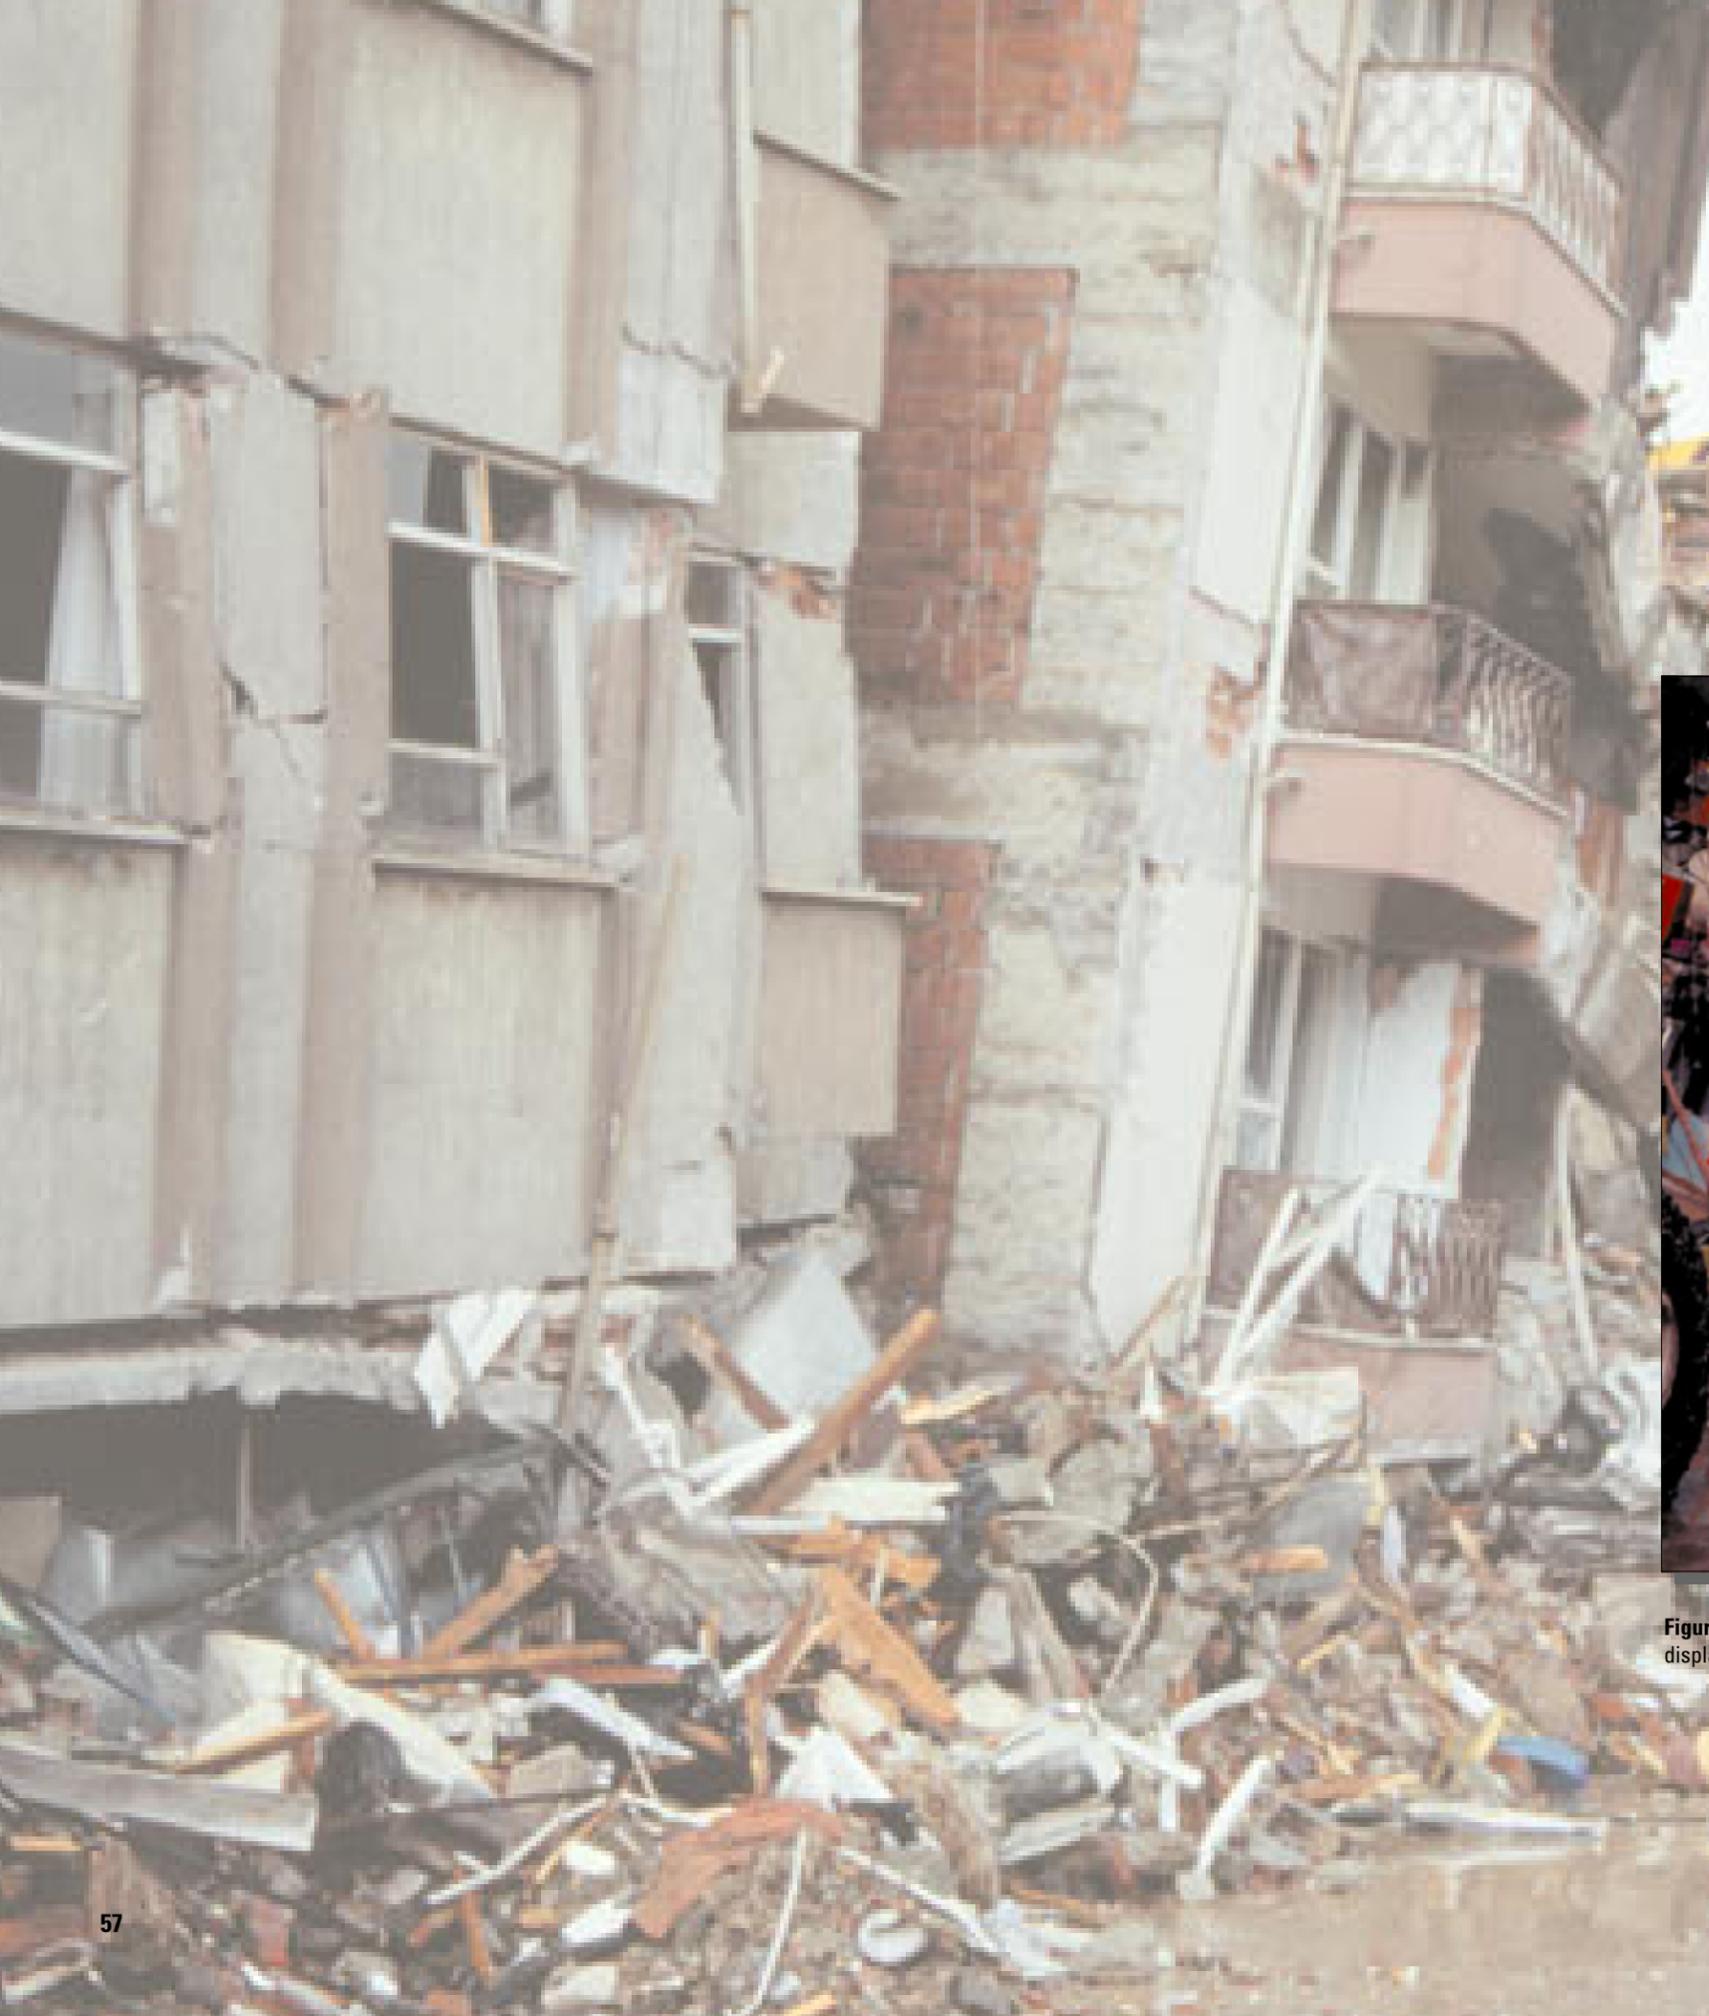
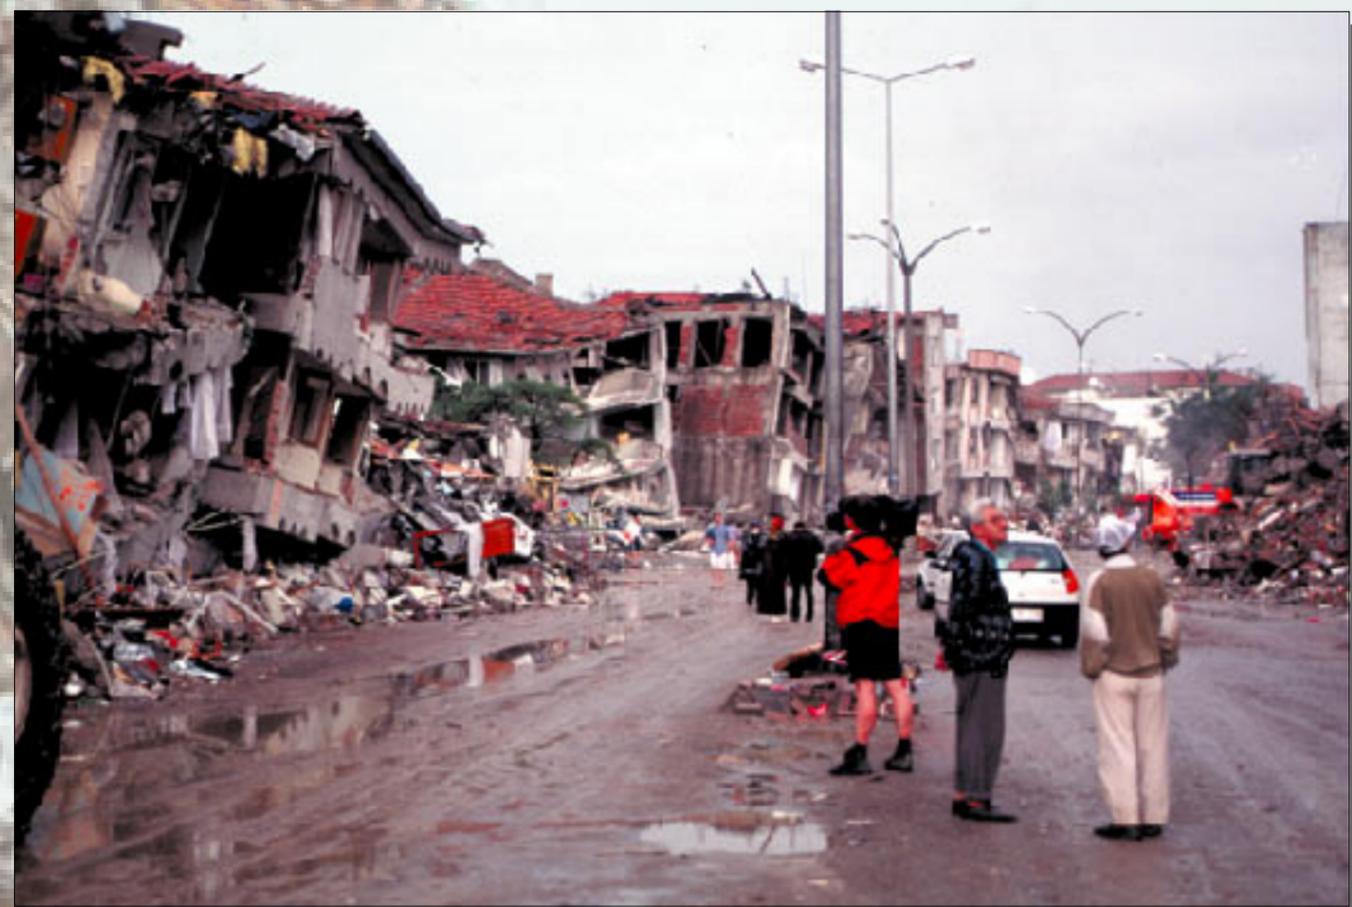
Figure 57. Street scene in Adapazari following the Kocaeli, Turkey, earthquake. Extensive damage to concrete structures with little or no ductility displaced more than a quarter of a million people from their homes in the epicentral region. *Photograph by Thomas L. Holzer.*
