**SURFACE FRACTURES FORMED IN THE POTRERO CANYON, TAPO CANYON, AND McBEAN PARKWAY AREAS IN ASSOCIATION WITH THE 1994 NORTHRIDGE, CALIFORNIA, EARTHQUAKE**

By  
MICHAEL J. RYMER<sup>1</sup>, JEROME A. TREIMAN<sup>2</sup>, THOMAS J. POWERS<sup>1</sup>, THOMAS E. FUMAL<sup>1</sup>,  
DAVID P. SCHWARTZ<sup>1</sup>, JOHN C. HAMILTON<sup>1</sup>, and FRANCESCA R. CINTI<sup>3</sup>

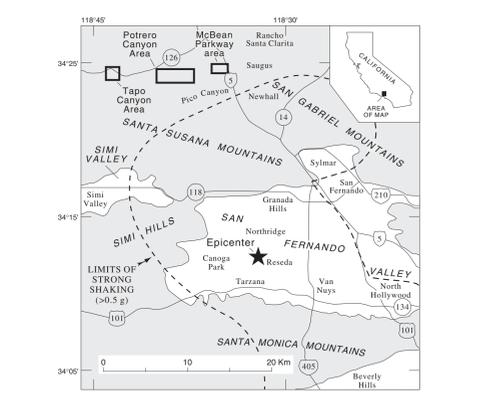
Figure 1. San Fernando Valley, California, area, showing the location of the Potrero Canyon, Tapo Canyon, and McBean Parkway study areas relative to the 17 January 1994 Northridge earthquake epicenter (solid star). Dashed line, boundary of strong ground motion greater than 0.5 g.

This report describes fault- and nonfault-related surface fractures that occurred at three sites, Potrero Canyon, Tapo Canyon, and the McBean Parkway area, 22 to 28 km north-northwest of the main shock (Fig. 1). Investigation of these sites documents far-reaching effects of even moderately large earthquakes. Study of such effects has become increasingly important, with further urbanization and development. Hekker and others (1995a, 1995b) documented the distribution of surface deformation associated with the Northridge earthquake in the Santa Susana Mountains.
