Geologic features of certain dam sites  
in the  
Bear River, Colorado River, and Rio Grande basins,  
1936-37  
by

Arthur M. Piper

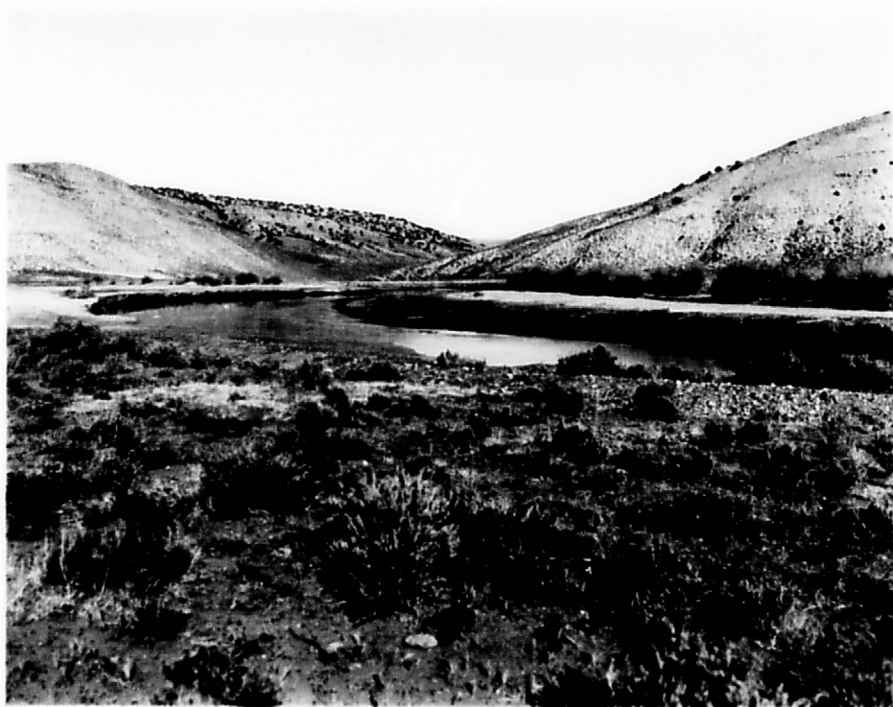
A. Woodruff Narrows upper dam site, viewed downstream.

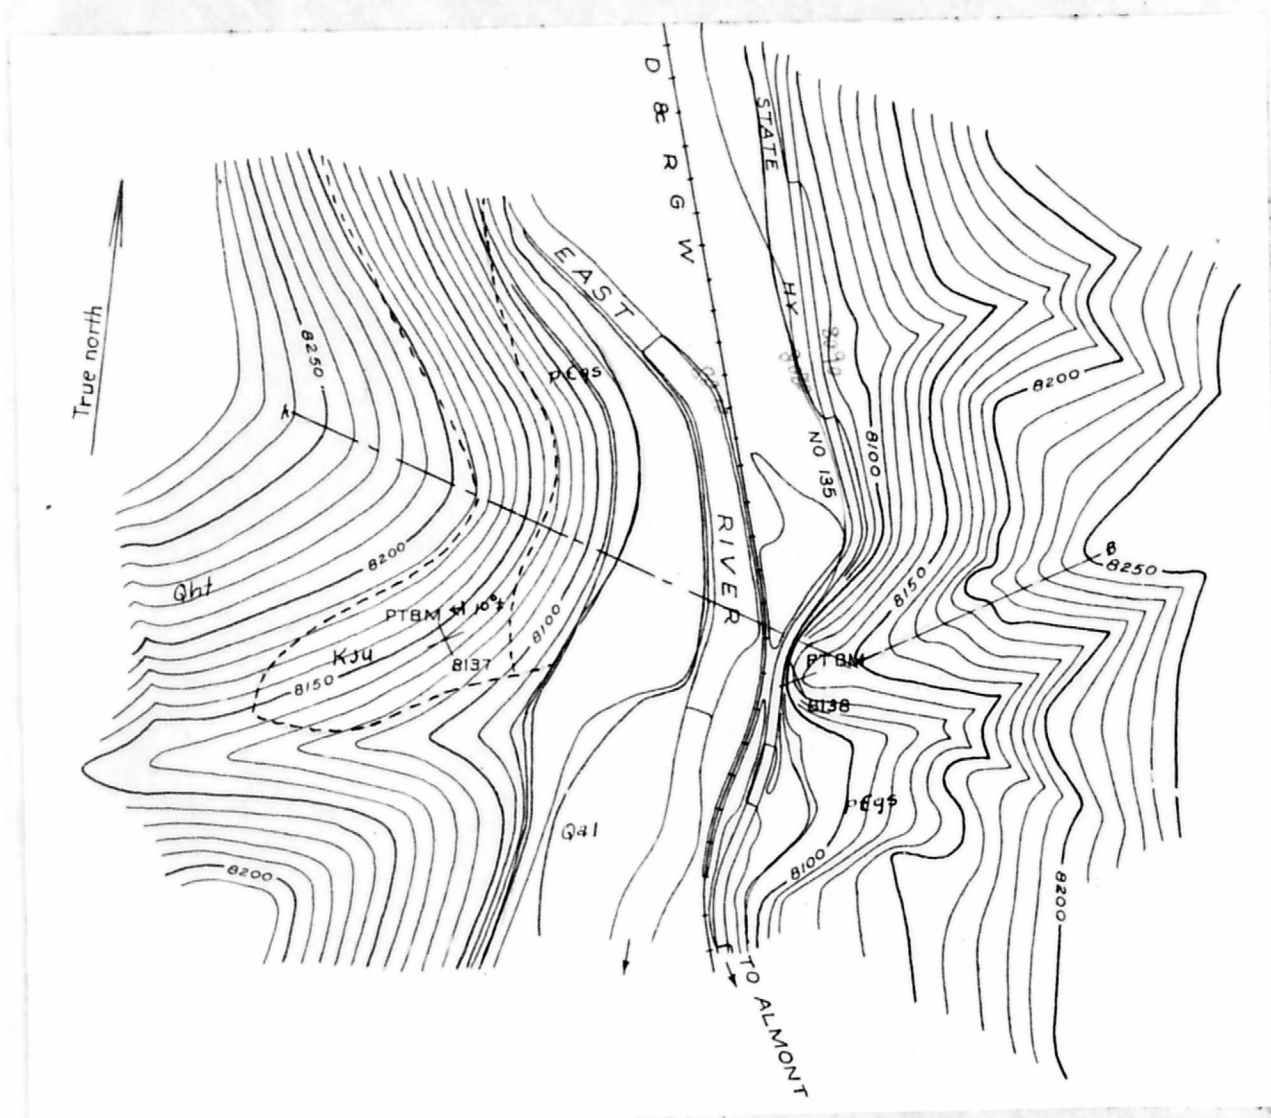
Geologic map of the East River dam site

In contrast to the uniform load-sustaining capacity of the granite that forms all the left abutment, the materials in the right or west abutment are quite diverse. In the lowest part of the abutment - from the edge of the flood plain up to about the 8,140-foot contour or to a height of about 70 feet above the river - granite crops out discontinuously. In all its features this rock is a counterpart of that across the river. However, this mass of rigid rock probably is not extensive because its top is a near-plane erosion surface that dips about  $5^{\circ}$  -  $10^{\circ}$  W. or NW., and so descends to river level about 800 feet upstream from the line that is marked "AB" on plate 7, A and about an equal distance to the west of the flood plain.

Overlying the granite is cross-bedded somewhat friable sandstone which has only moderate capacity to sustain load and doubtless is pervious through interstices and fractures alike. This rock is inferred to have the shape of a wedge with a base resting everywhere on the granite and a top which is nearly horizontal within the area shown on plate 7, A. In the streamward face of the abutment this sandstone wedge is from 40 to 60 feet thick; to the west it thickens at an estimated rate of from 10 to 15 feet in each 100 feet.

Overlying the sandstone in turn - above the 8,190-foot contour - is a mass of the heterogeneous unstable material that has been termed the high-terrace deposit (p. 31). This material extends up to a flattish surface at an altitude of 8,290 feet; this surface is about 900 feet wide and is a remnant of a rude terrace, once more extensive. Over most of this remnant, the high-terrace deposit is estimated to be at least 100 feet thick. Near the southern edge of the area shown on plate 7, A a tongue of the deposit, possibly even thicker, descends to the margin of the flood plain.

For a dam not more than 70 feet high, with pool level at the 8,140-foot contour, the site affords a foundation and two abutments all in rigid granite; to this height, the site appears suitable for a rigid dam of gravity cross-section provided the insecure rock low on the left bank is stripped and all fractures are thoroughly sealed against leakage. The low-angle fractures dipping downstream in the granite would require care in so preparing the foundation to resist the tendency of a dam to slide. Any dam at the site will raise water against the pervious sandstone in the right bank but there is believed to be little chance of excessive leakage if pool level is no more than 70 feet above the river bed.

A dam more than 70 feet but less than 120 feet high would rest on the weaker sandstone in the upper part of its right abutment and so should be moderately broad if rigid. Also, it should embody an impervious membrane extended a moderate distance into the abutment to restrain leakage through the sandstone.

A dam more than about 120 feet/<sup>high</sup>at the East River site would raise the pool above the sandstone and would saturate the unstable high-terrace deposit. To be secure, a dam so high would require a foundation excavated to the sandstone or granite bedrock, also a substantial cut-off structure seated in sound bedrock entirely across the high terrace - that is, to an estimated depth of about 100 feet below the land surface for a distance of some 900 feet.

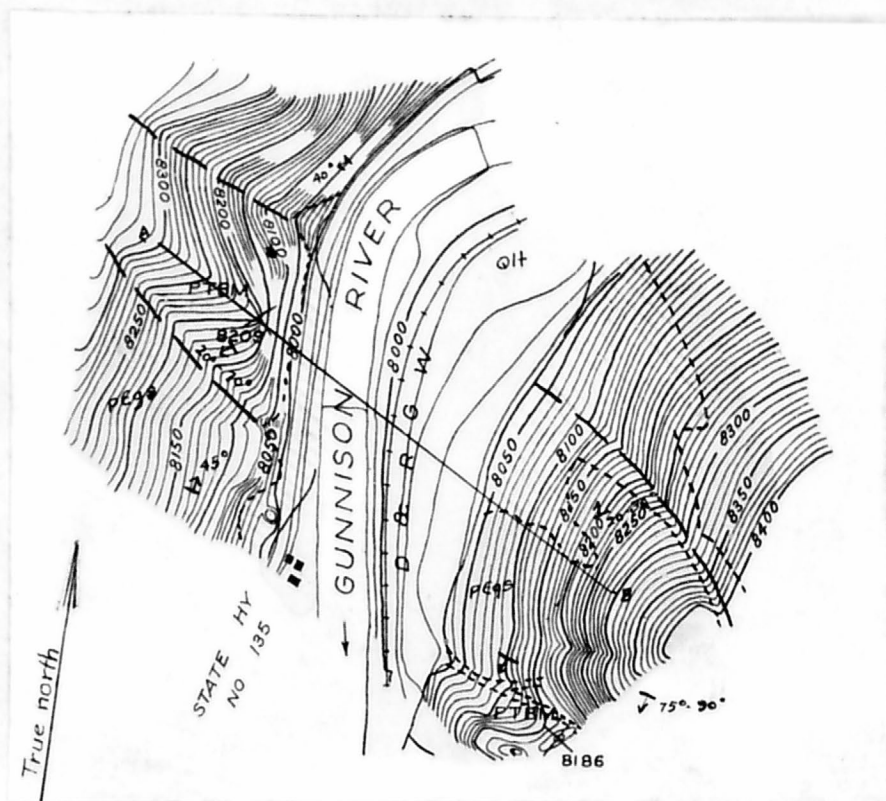
Geologic map of the Almont dam site on the  
Gunnison River

The crystalline rock is biotite granite or quartz monzonite of medium or coarse grain with many inclusions, large and small, of biotite schist. Discrimination of granite and schist on the geologic map is impossible, so closely are the two rocks intergrown over many parts of the site. However, in the central part of the area shown on plate 9 a zone formed largely of granite trends northwestward or diagonally across the river. This zone or plate is subvertical and from 250 to 500 feet thick; its axis is approximately along the line marked "AB". Both upstream and downstream this plate is enclosed <sup>by schist</sup> with many irregular injections of granite. The central thick plate of granite is essentially a structural unit and is the most suitable position for a dam. It appears to be sufficiently rigid and to have adequate mass to support a rigid dam.

The granite at the Almont site is everywhere parted by fractures, of which the most extensive sets are indicated on plate 9 and are about as follows: (1) In the left or east abutment, a parting into plates from half a foot to 6 feet thick by subvertical fractures that strike N. 70°-85°W. or across the stream and parallel to the axis of the central plate of granite. These fractures are most conspicuous in a zone about 300 feet wide and extending the full height of the abutment just south of the line AB; commonly the individual fractures are not extensive and are arranged en echelon. On the opposite bank, fractures in this direction are common in the thin spur along the line AB at an altitude of 8,200 feet. (2) Strike N. 70° E., dip 20°-30° N, or diagonally upstream and downward into the right abutment, a few extensive fractures high on both banks of the river forming several rock plates from 30 to about 75 feet thick. The fractures in this direction and those first described appear most likely to be extensive beneath the surficial zone in which the rock is exposed to frost and to the seasonal variation in temperature. (3) Dip subvertical, strike N. 50° W., or diagonally across the river, forming a zone of platy parting about 50 feet wide along the upstream face of the thin spur in the right abutment. With depth, the fractures tend to die out but the dip flattens to as little as 40° S. at an altitude of 8,060 feet in the streamward face of the spur. (4) In the downstream half of the spur in a zone about 40 feet thick, curved fractures forming spheroidal shells from 3 to 10 feet thick; at the crest of the spur, at an altitude of 8,200 feet, these fractures dip 20° S. 55° -90°W., then steepen downward and dip about 70° SW. or W. at an altitude of 8,050 feet. The two sets of curved fractures just described are peculiar in form. Although they may have been accentuated by the agents of weathering, they are believed to be due primarily to regional stresses, resolved locally about inclusions of schist within the more rigid granite. Thus, it is concluded that they do not indicate any serious weakness in the right abutment.

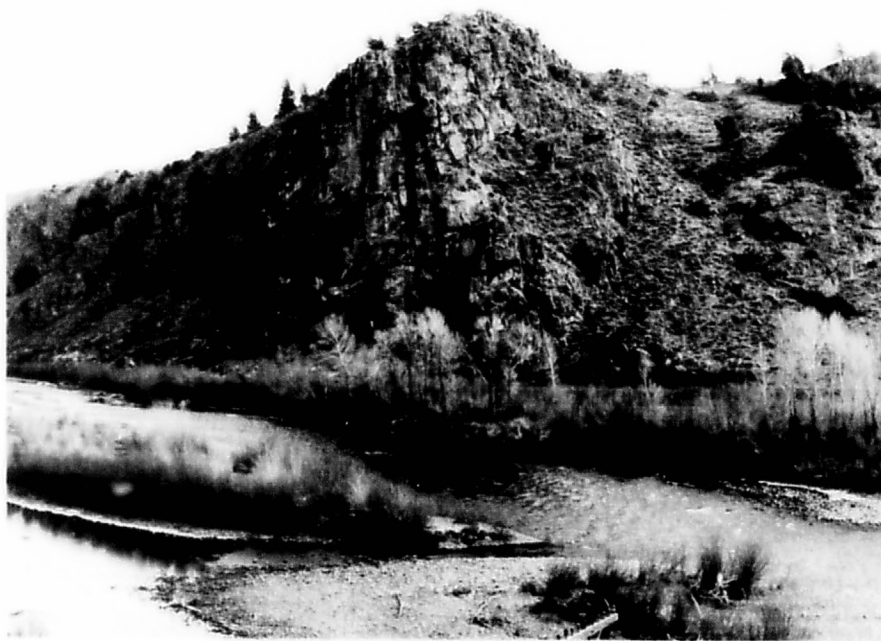
A. Left (east) abutment of the North Beaver upper site,  
viewed along the axis of the proposed dam.

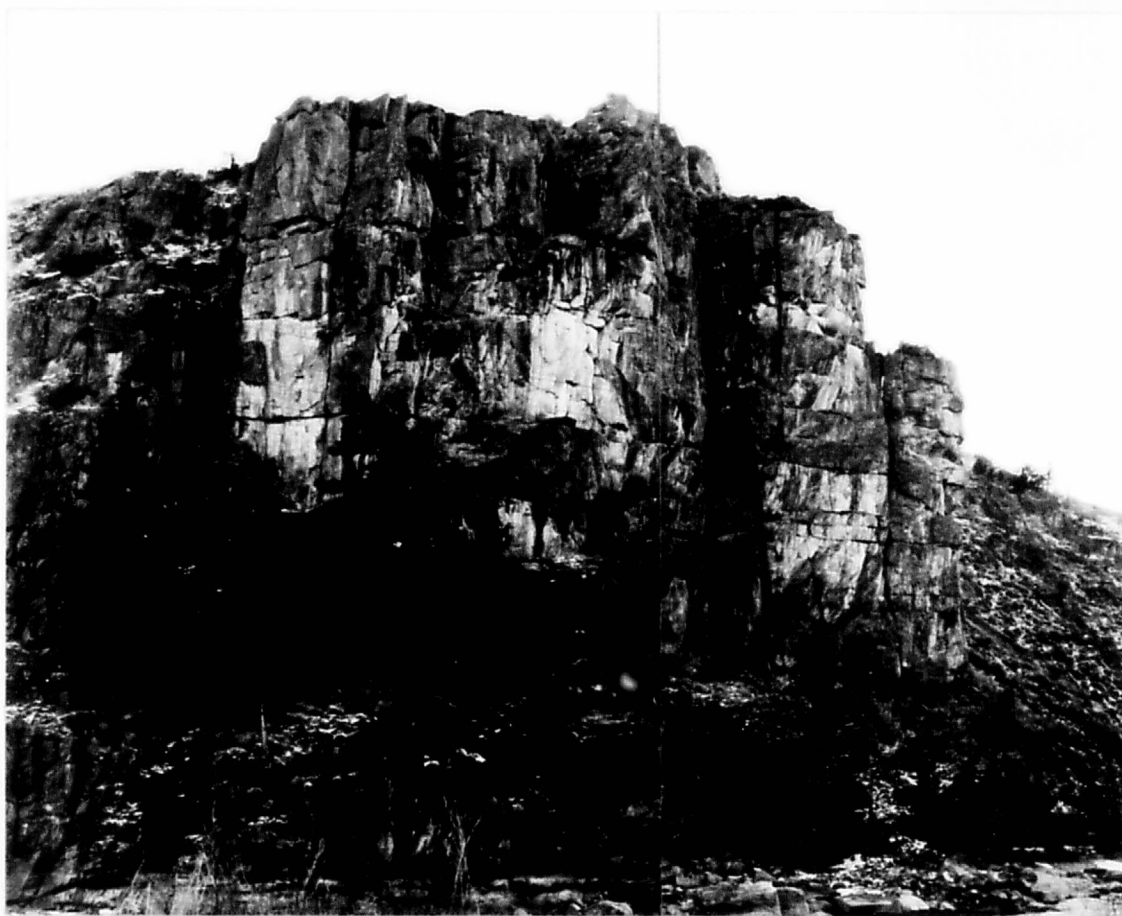
B. Left (south) abutment at the Lake Fork Junction dam site, viewed  
directly across the Gunnison River.

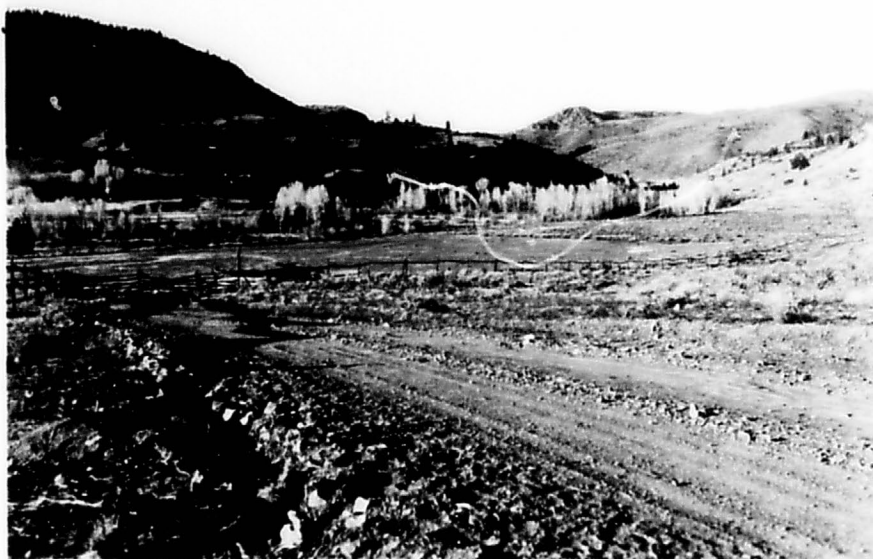
A. Riverside School dam site, viewed downstream. (The site is indicated in outline.)

The right or east abutment at the site has been formed by a slide of slope wash which entered the dam-site area from the east and overrode the stream-laid terrace deposit on the right bank. The material includes angular rock fragments in all sizes up to 6 feet in length embedded in a reddish brown earthy matrix. The slide is relatively young, its surface is moderately steep, and its matrix includes considerable material that probably would be plastic if saturated with water. Thus, although there is no obvious evidence that the slide has been in motion recently, it may not be wholly stable under natural conditions and, if its toe were saturated by raising the water level, it quite likely would be unstable.

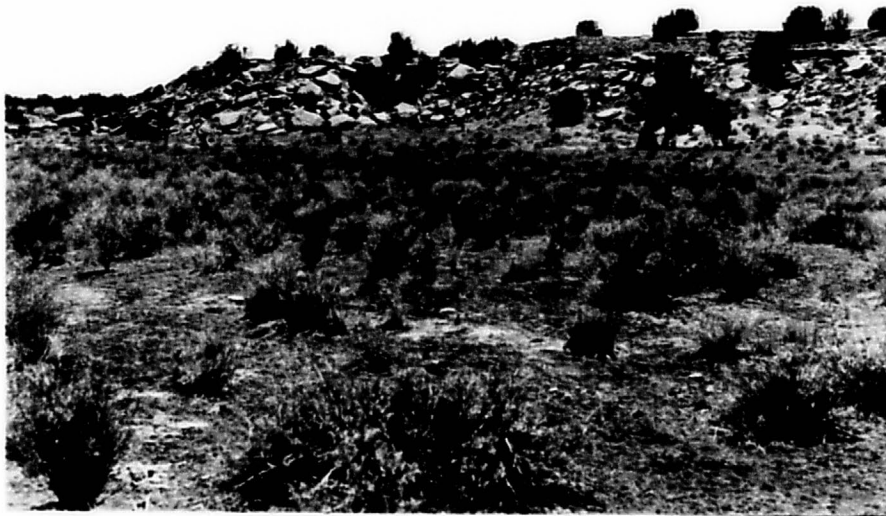
Pavement of sandstone blocks overlying shale of the  
Moenkopi formation on the left abutment of the Greer  
dam site

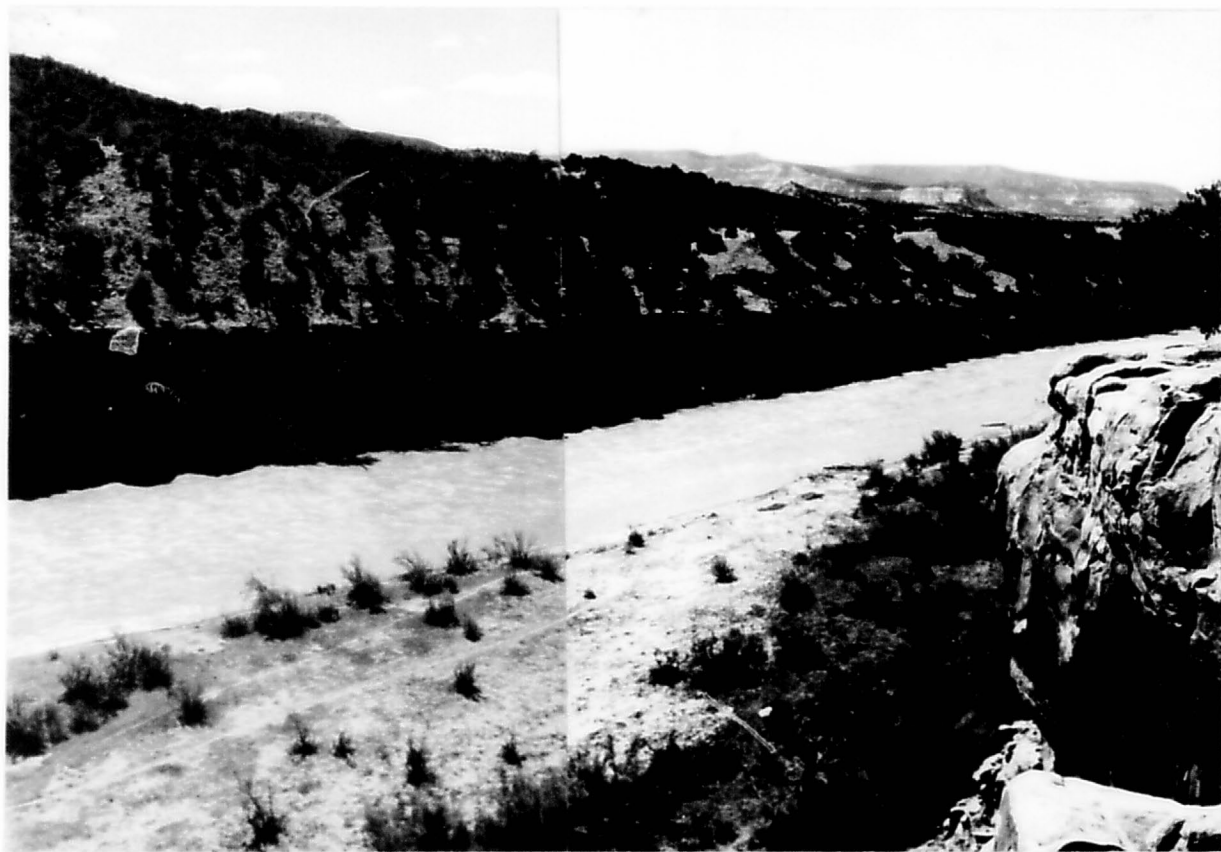
Rio Chama, Cañon de Chama dam site viewed upstream from the left abutment

200 feet high is contemplated. For a dam so high only one economical position exists, as indicated on plate 39, A by the line marked "AB". Also, only a structure of moderate width is permitted by the narrow spur that affords the left (north) abutment, so that a fill of earth or rock seems infeasible. For a lower dam, not more than 120 feet high, there is a more advantageous position about 350 feet downstream, indicated by the line marked "CD".

With reference to the high dam, the most critical features of the site are: (1) the depth of excavation necessary in the several incoherent deposits, which are extensive on either bank; (2) the extent and relative bearing power of the two bedrock formations, Poleo sandstone and Chinle (?) formation; (3) the watertightness of the bedrock in the narrow spur that affords the left (north) abutment and (4) the local earthquake hazard. These four features are treated in order by following paragraphs.

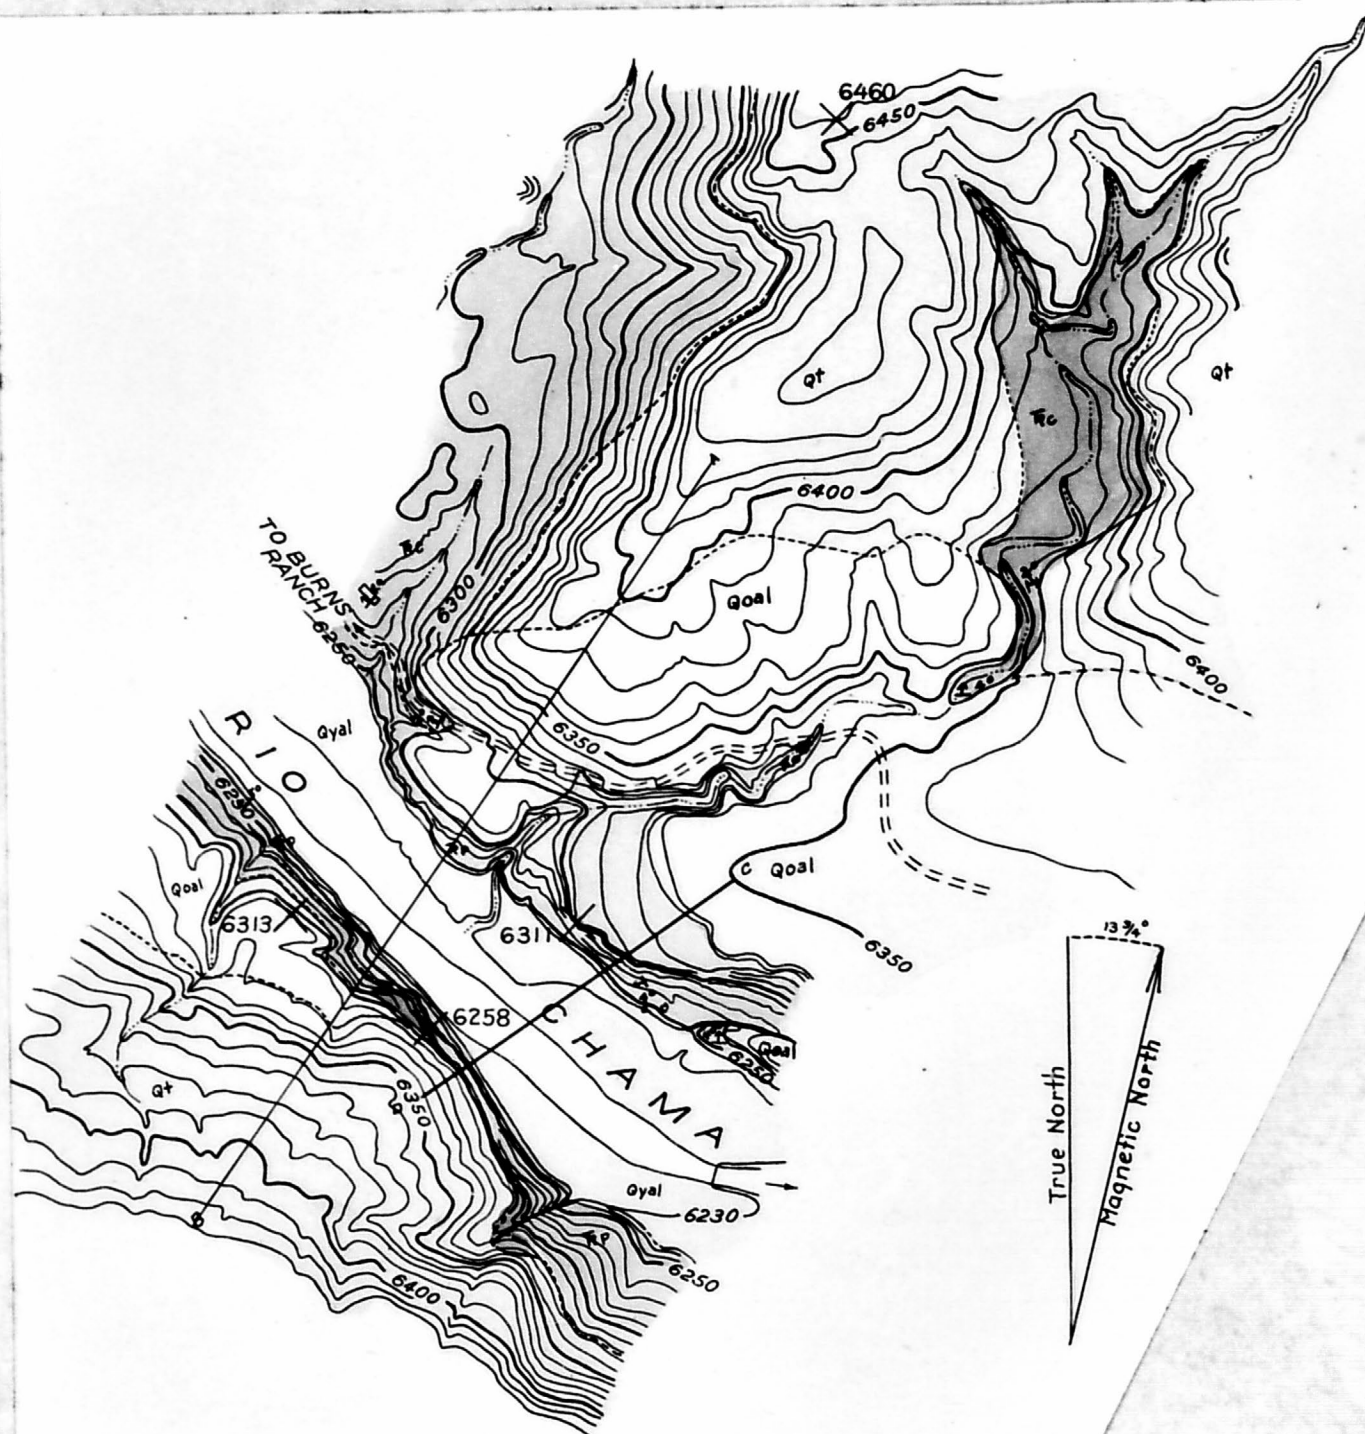
GEOLOGIC MAP OF  
CANYON DE CHAMA DAM SITE  
(MILE 45.9-SHEET 4)

Neither the several terrace deposits nor the old talus affords a stable foundation for the high dam. These incoherent deposits are continuous above the 6,295-foot contour on the right bank and the 6,280-foot contour on the left bank - that is, beneath all the proposed dam except the lower 50 to 60 feet of either abutment. On the left bank, their average thickness is estimated as 40 feet; on the right bank somewhat more, possibly not less than 50 feet. Thus, a large volume of material must be excavated to prepare a satisfactory foundation; also, a dam more than 170 feet high (above the 6,400-foot contour) would require a long wing or a substantial cut-off structure on the crest of the left abutment.

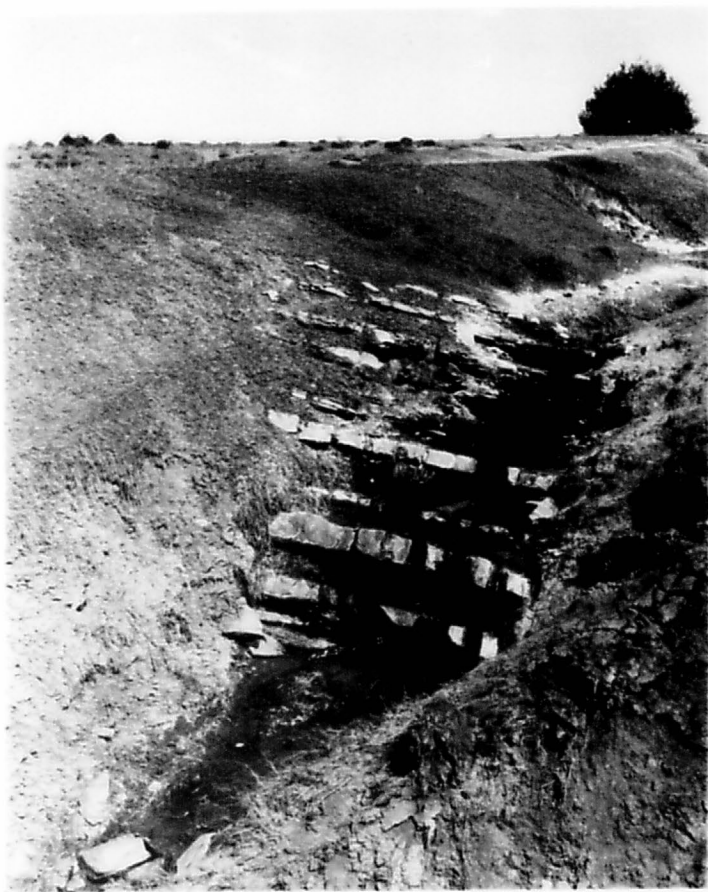
A. Greenhorn (?) limestone member in the Mancos shale, Willow Creek middle dam site.

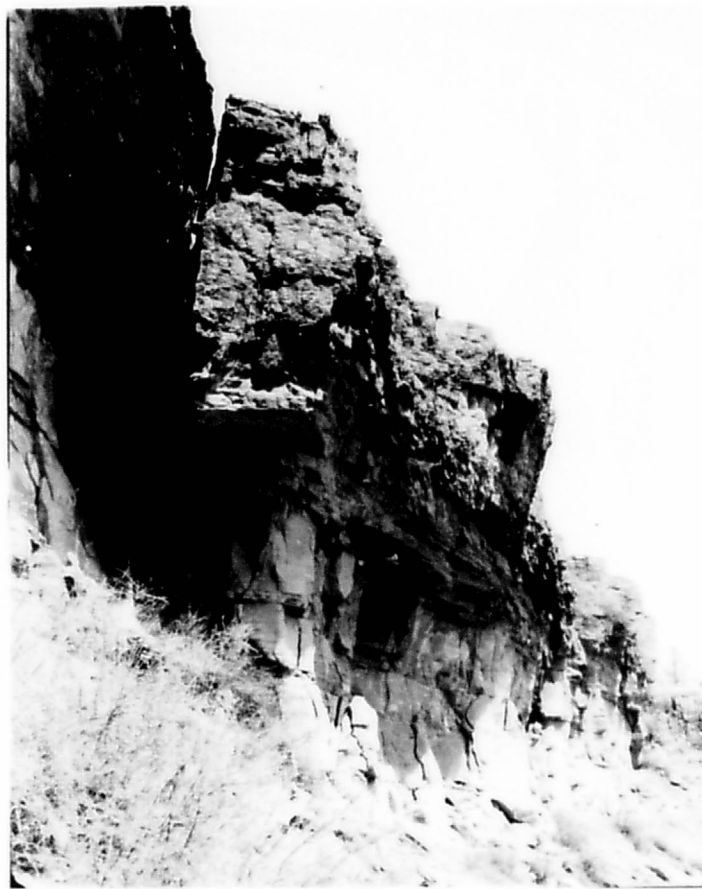
B. Cliff-forming Dakota sandstone, Willow Creek lower dam site.

Dakota sandstone: Thick-bedded massive sandstone, grains about a millimeter in diameter, slightly friable, light buff and light gray in color; a prominent cliff-maker. (See pl. 46, B.) Forms the upper part of either

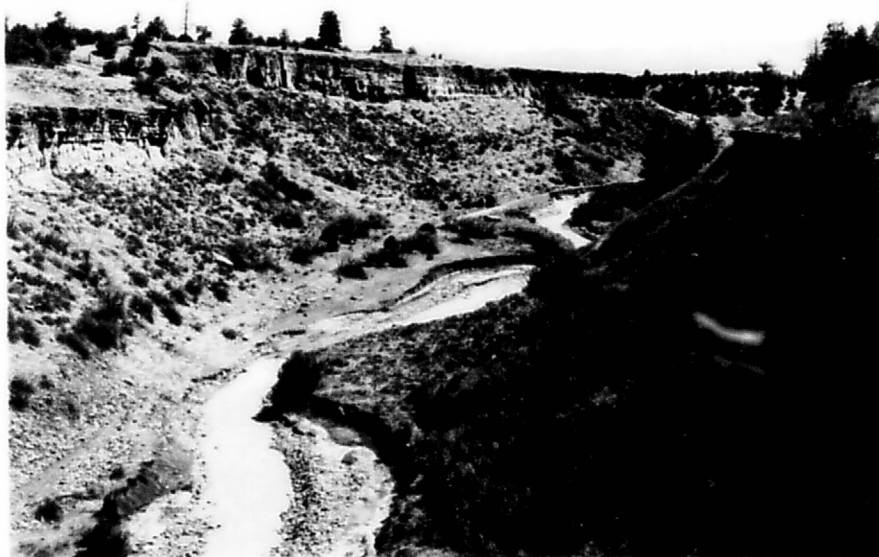
A. Downstream reach of the middle dam site on Willow  
Creek, viewed upstream.  
(The upfaulted block in the mid-distant part of the field  
is the right abutment for the most feasible dam.)

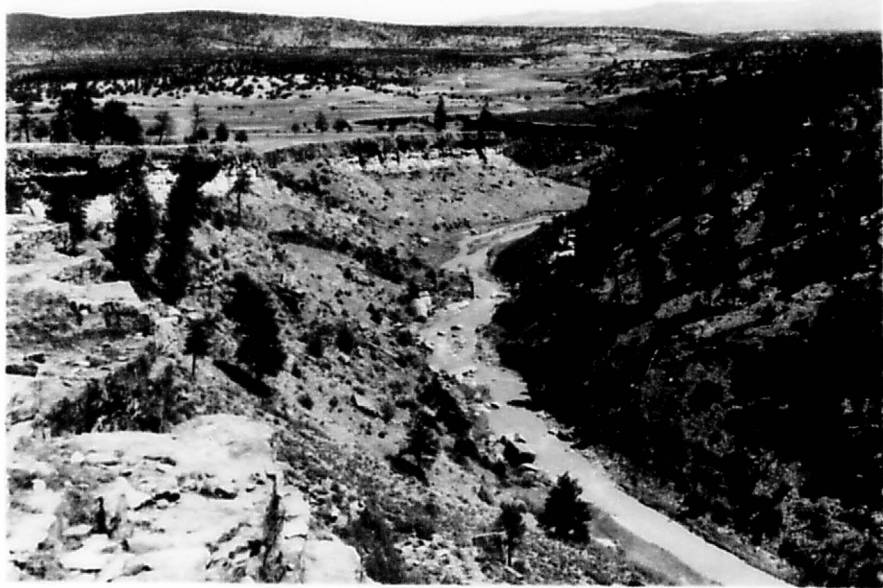
B. Lower dam site on Willow Creek, viewed upstream.  
(The site is on the flank of an asymmetric dome in the  
Dakota sandstone.)
