LANDSLIDES IN THE
SAN FRANCISCO SOUTH QUADRANGLE, CALIFORNIA

M. G. ^oBONILLA

Open-file report

January 1960

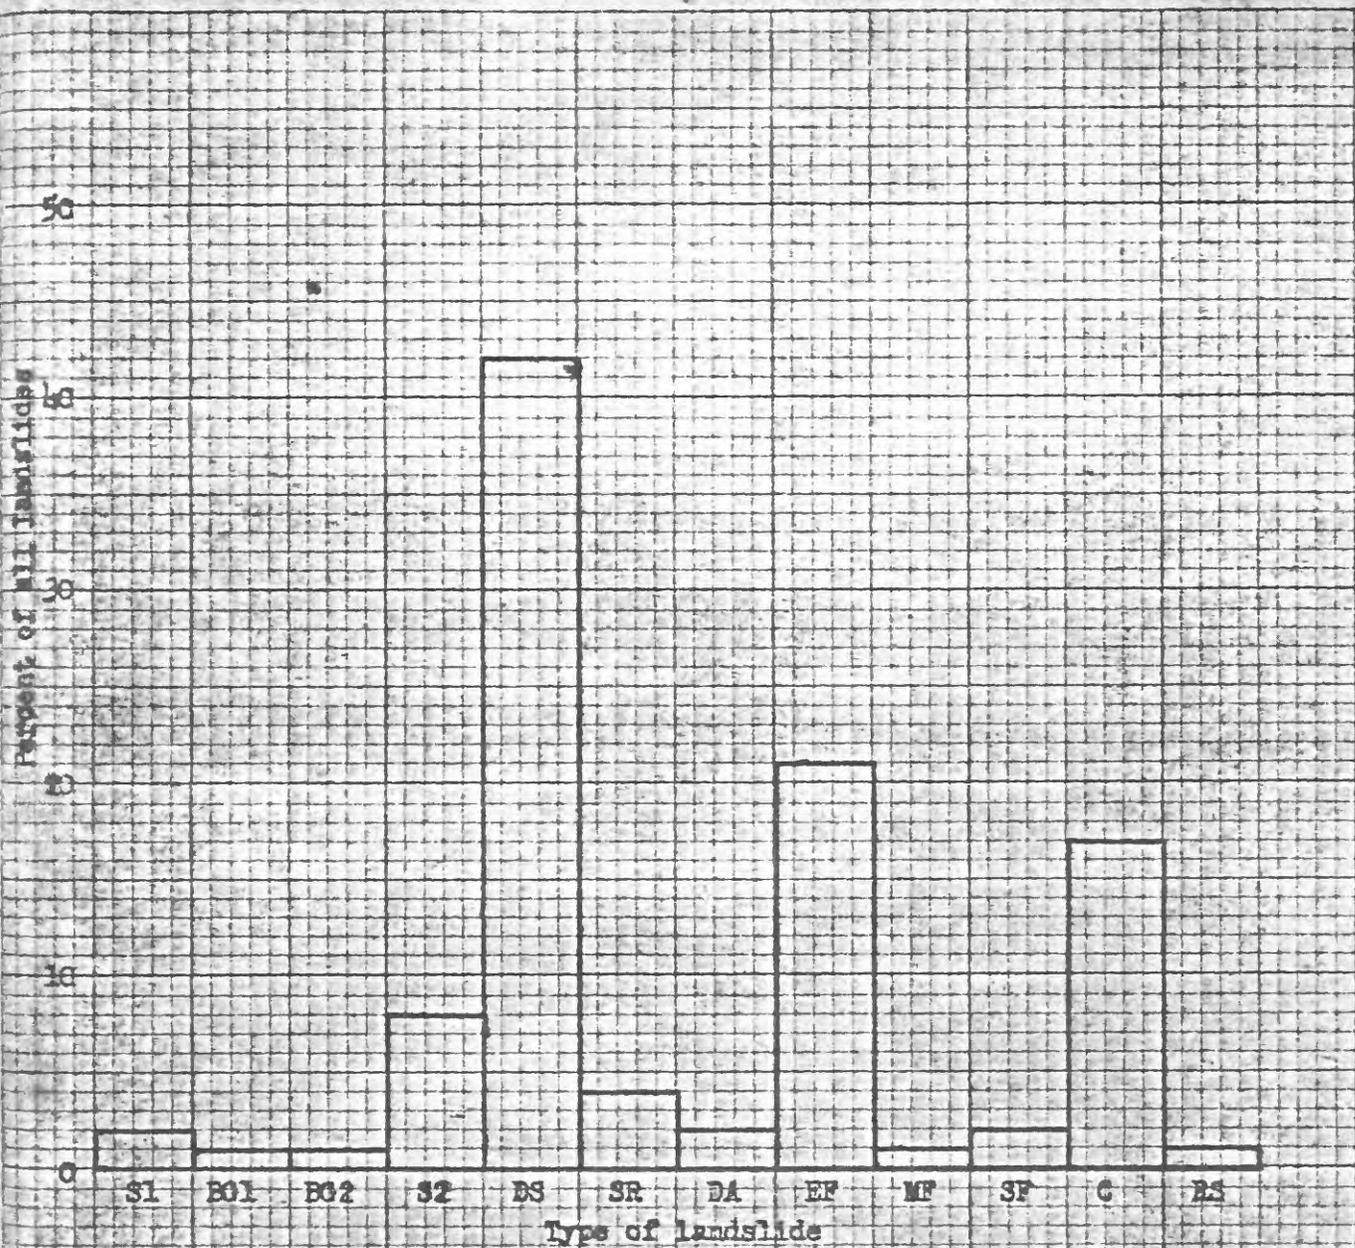
Figure 1. FREQUENCY OF LANDSLIDES BY TYPE

Key to types: S1, slump in rock; BG1, block glide in rock; BG2, block glide in soil; S2, slump in soil; DS, debris slide; SR, sand run; DA, debris avalanche; EF, earthflow; MF, mudflow; SF, sand flow; C, complex; RS, rock slide.

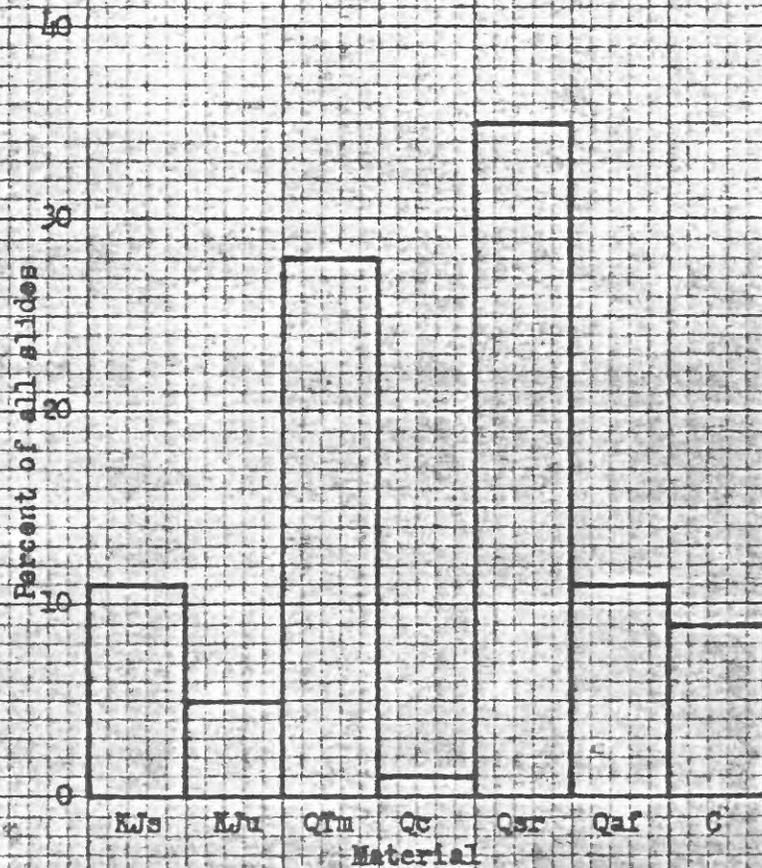
Figure 3. FREQUENCY OF LANDSLIDES BY MATERIAL.

As shown on figure 8, slope debris and ravine fill was involved in the greatest number of landslides. About 35 percent of all the slides were in this material. Landslides in the Merced formation were the next most common, but almost all of these landslides were in the steep sea cliffs cut in the Merced. The decreasing order of frequency of slides in other materials, including combinations of materials, is as follows: sandstone and shale of the Franciscan formation, artificial fill, sheared rocks, serpentine, greenstone and

Key to type of material: KJs, Franciscan sandstone and shale; KJu, sheared rocks; QM, Merced formation; Qc, Colma formation; Qsr, slope debris and ravine fill; Qaf, artificial fill; C, combinations of material. Included under "C" are six slides involving greenstone and chert of the Franciscan formation, and serpentine.

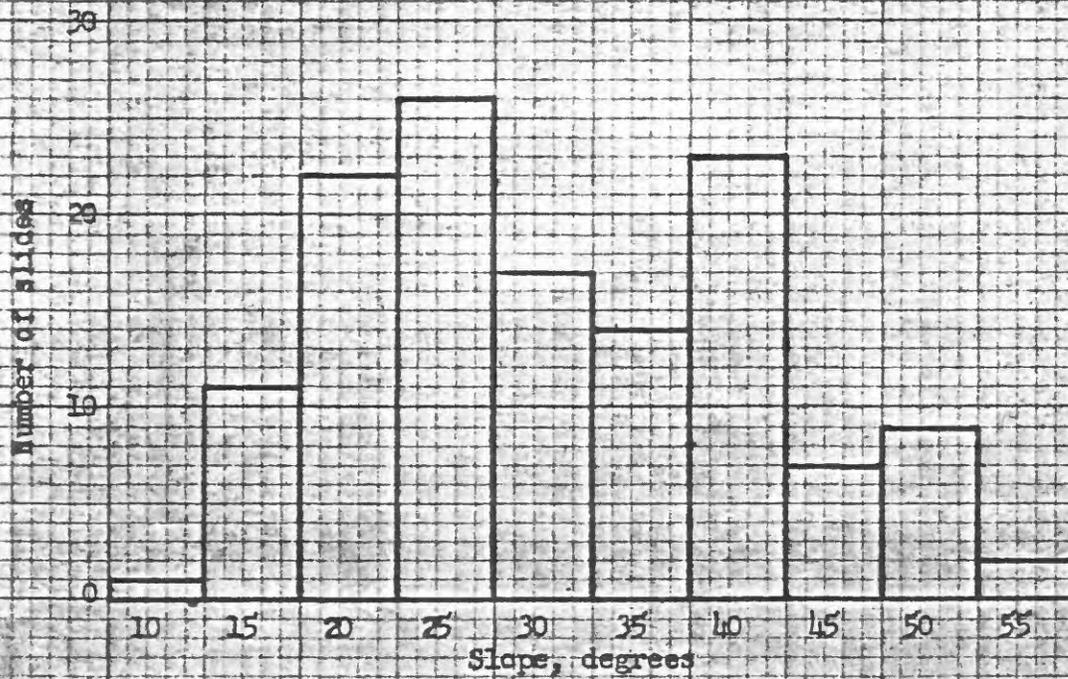
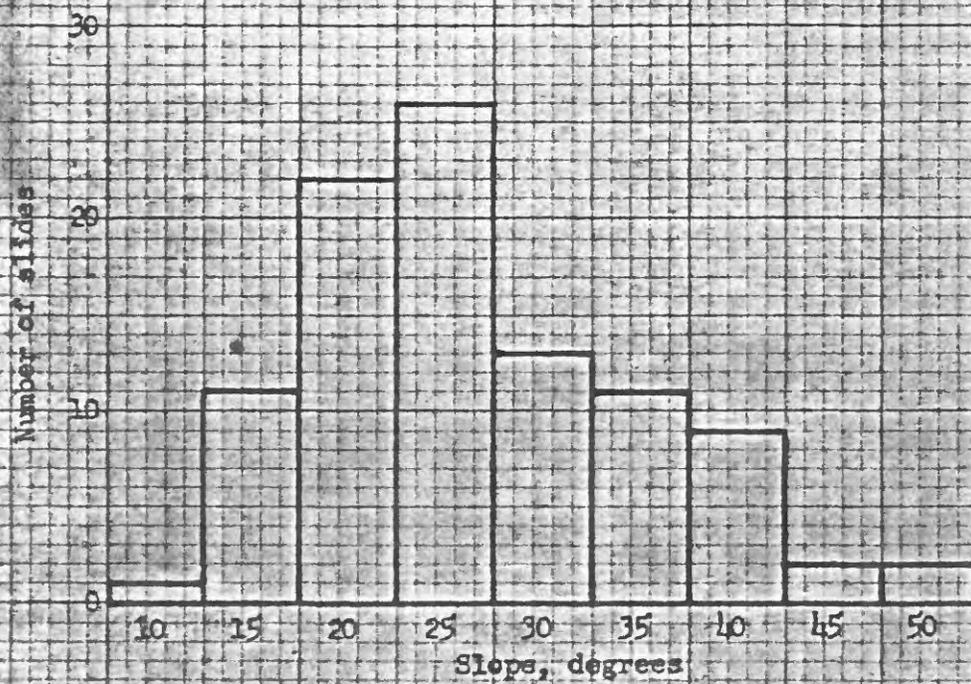
Figure 9. SLOPE INCLINATION BEFORE FAILURE

Inclination of a slope before failure was in most cases assumed to be the same as adjacent slopes that have not failed. Most of the slopes were determined in the field but some were obtained from the topographic map, which has a scale of 1:24,000 and a contour interval of 25 feet. In figure 9 the slope angles have been rounded off to the nearest 5° .

Figure 9A shows that most of the landslides occurred on slopes of 25° , and almost as many occurred on slopes of 40° . The peak in figure 9A at 40° is the result of including data from the long sea cliff which has a slope of about 40° . In figure 9B the slope figures for the sea cliff have been omitted and the histogram gives a more significant picture of the general relationship over most of the area of the quadrangle, between landslides and inclination of slope. The peak at 25° rather than at a higher slope is the result of the interaction of several factors, none of which is easily evaluated. The most important factors are probably (1) the relative abundance of slopes of a given inclination (a rough estimate suggests that most of the surface of the quadrangle has a slope of less than 20°);

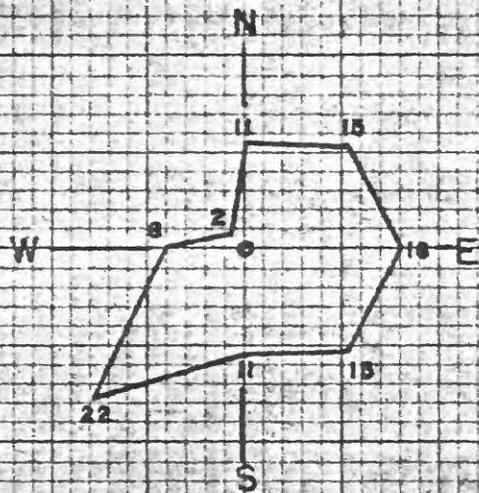
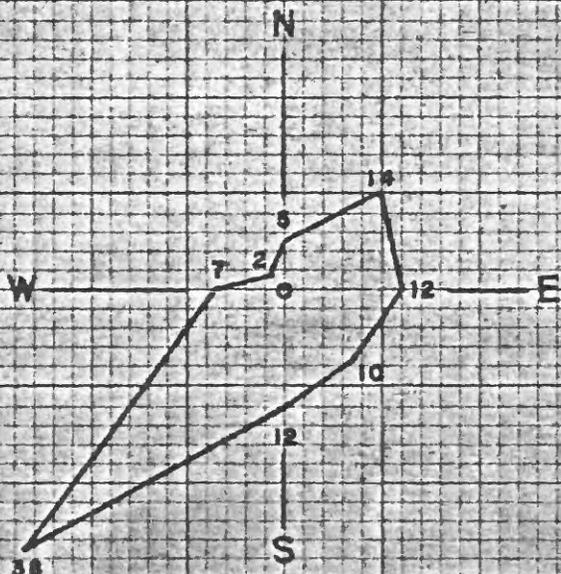
Figure 10. PERCENTAGE OF LANDSLIDES ON SLOPES FACING IN THE INDICATED DIRECTIONS

In a recent study Beaty (1956) found a preponderance of landslides on north-facing slopes in areas east and north of Berkeley. However, most of the landslides in the San Francisco South quadrangle are on west and southwest-facing slopes. Most of the landslides on west-facing slopes are on the long sea cliff. Because the cliff covers a small proportion of the total area of the quadrangle, and in order to permit a better comparison with Beaty's results, landslides along the sea cliff have been omitted from figure 10A. This figure shows a small peak in the southwest direction.

Figure 10B includes all debris slides, debris avalanches, and earthflows except those probably caused by wave erosion or artificial changes in slope or drainage. Although figure 10B includes only 42 landslides, it is probably more meaningful than figure 10A, which includes 96 landslides of varied types and causes.

Assuming that the shape of figure 10B is significant and not merely a result of insufficient data, most shallow, wet landslides occur on southwest-facing slopes and fewest occur on northwest-facing slopes. Because the structural trend is northwest in this area, more

Slopes face northeast and southwest than face northwest and southeast; a plot of landslide frequency should therefore be elongated in a northeast-southwest direction. According to figure 10B, however, more than twice as many landslides of the specified types occurred on southwest slopes as occurred on northeast slopes.
