RECENT SURFACE MOVEMENTS THROUGH JULY 1962

IN THE BALDWIN HILLS, LOS ANGELES COUNTY, CALIFORNIA

Staff, Geological Survey

January 1964

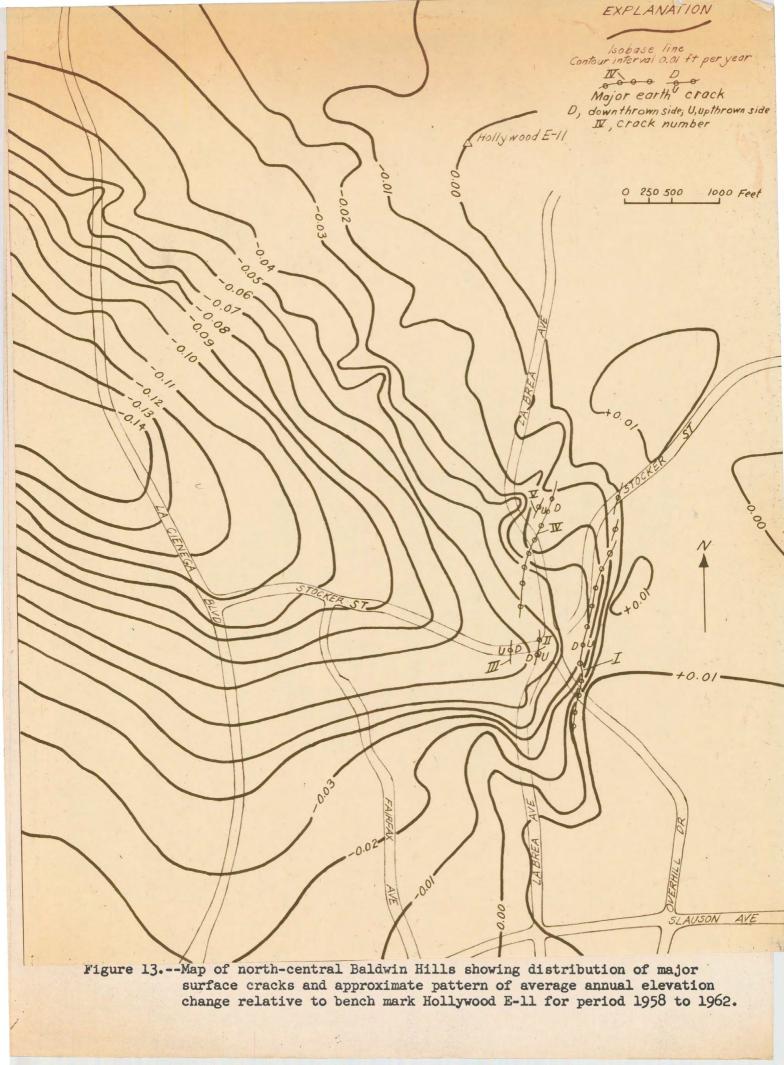
on figure 12 and, to a lesser extent, on figure 11, is that a sharp break in the rate of vertical movement parallels Crack IV, but this break is displaced 150 to 200 feet east rather than being coincident with the crack. This anomaly may be a reflection of abatement of movement along Crack IV and the eastward shift of more pronounced subsidence. The evidence is inconclusive, but broken pavement and sagging curbs noted in the fall of 1961 suggest incipient cracking along a zone approximately 150 feet east of the northern reaches of Crack IV.
