APPRAISAL OF NEAR-SURFACE SUBSIDENCE CRACKS
ON THE PANOCHÉ CREEK FAN, FRESNO COUNTY, CALIFORNIA

By William B. Bull 1930 -

Prepared in cooperation with the
California Department of Water Resources

OPEN-FILE REPORT

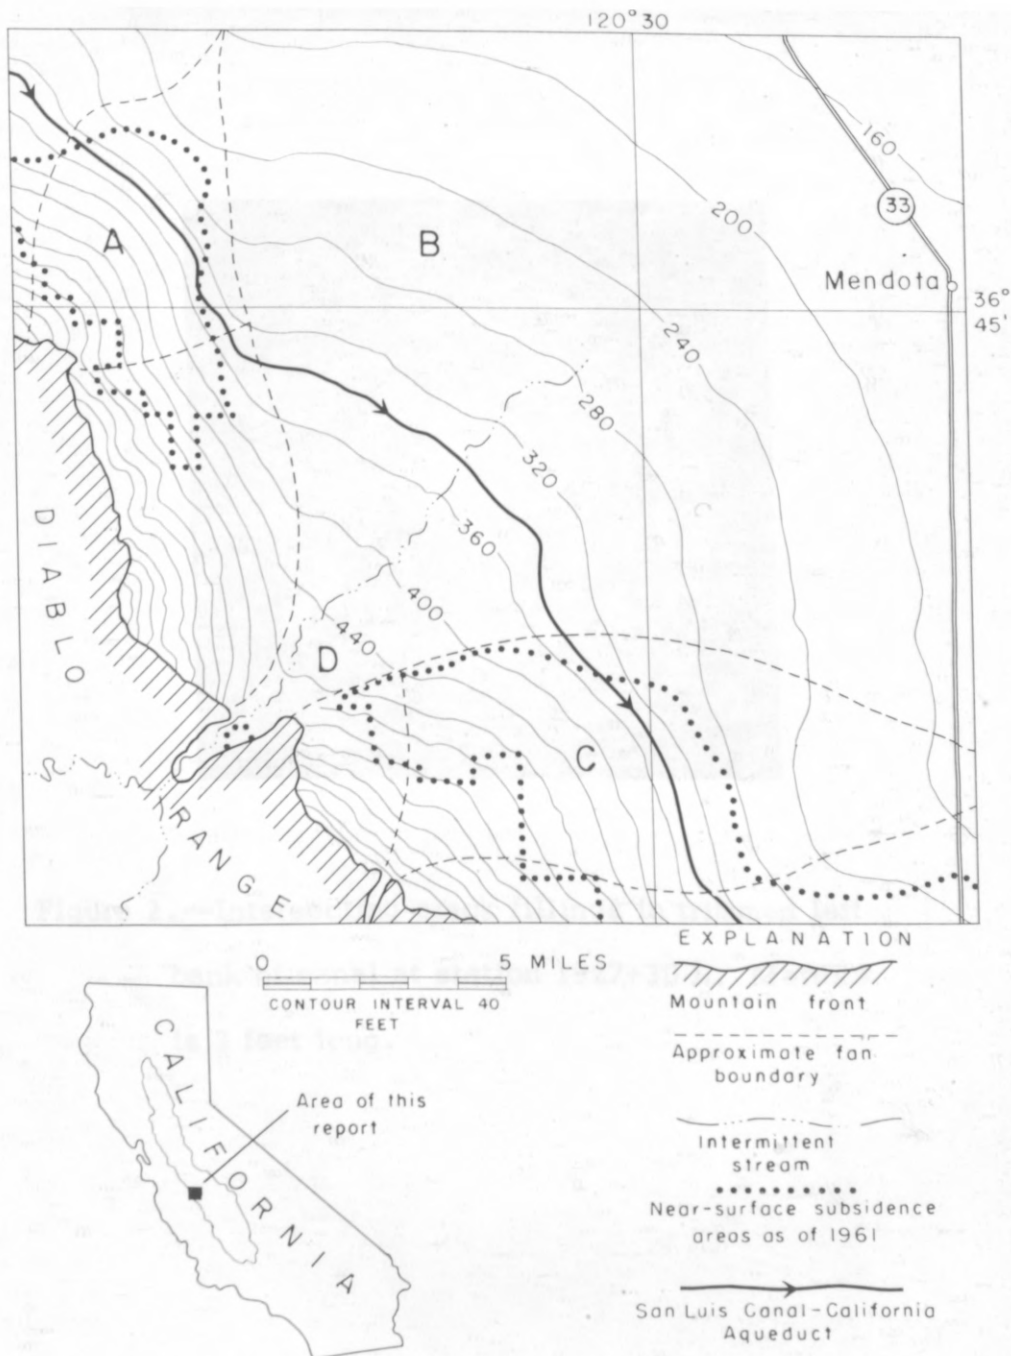
Figure 1.- Map of study area. Moreno Gulch, Panoche Creek, and Tumey Gulch fans are lettered A, B, and C respectively. Dis location of small subsidence area shown on figure 5
