CLARK COUNTY FLOOD CONTROL DIVISION  
DEPARTMENT OF PUBLIC WORKS

A BRIEF HYDROLOGIC APPRAISAL OF THE JULY 3-4, 1975,  
FLASH FLOOD IN LAS VEGAS VALLEY, NEVADA

T. L. <sup>O</sup>Katzer,  
Patrick A. <sup>Glancy</sup>Glancy,  
and  
Lynn Harmsen

Prepared cooperatively by the  
U.S. Geological Survey  
Carson City, Nevada

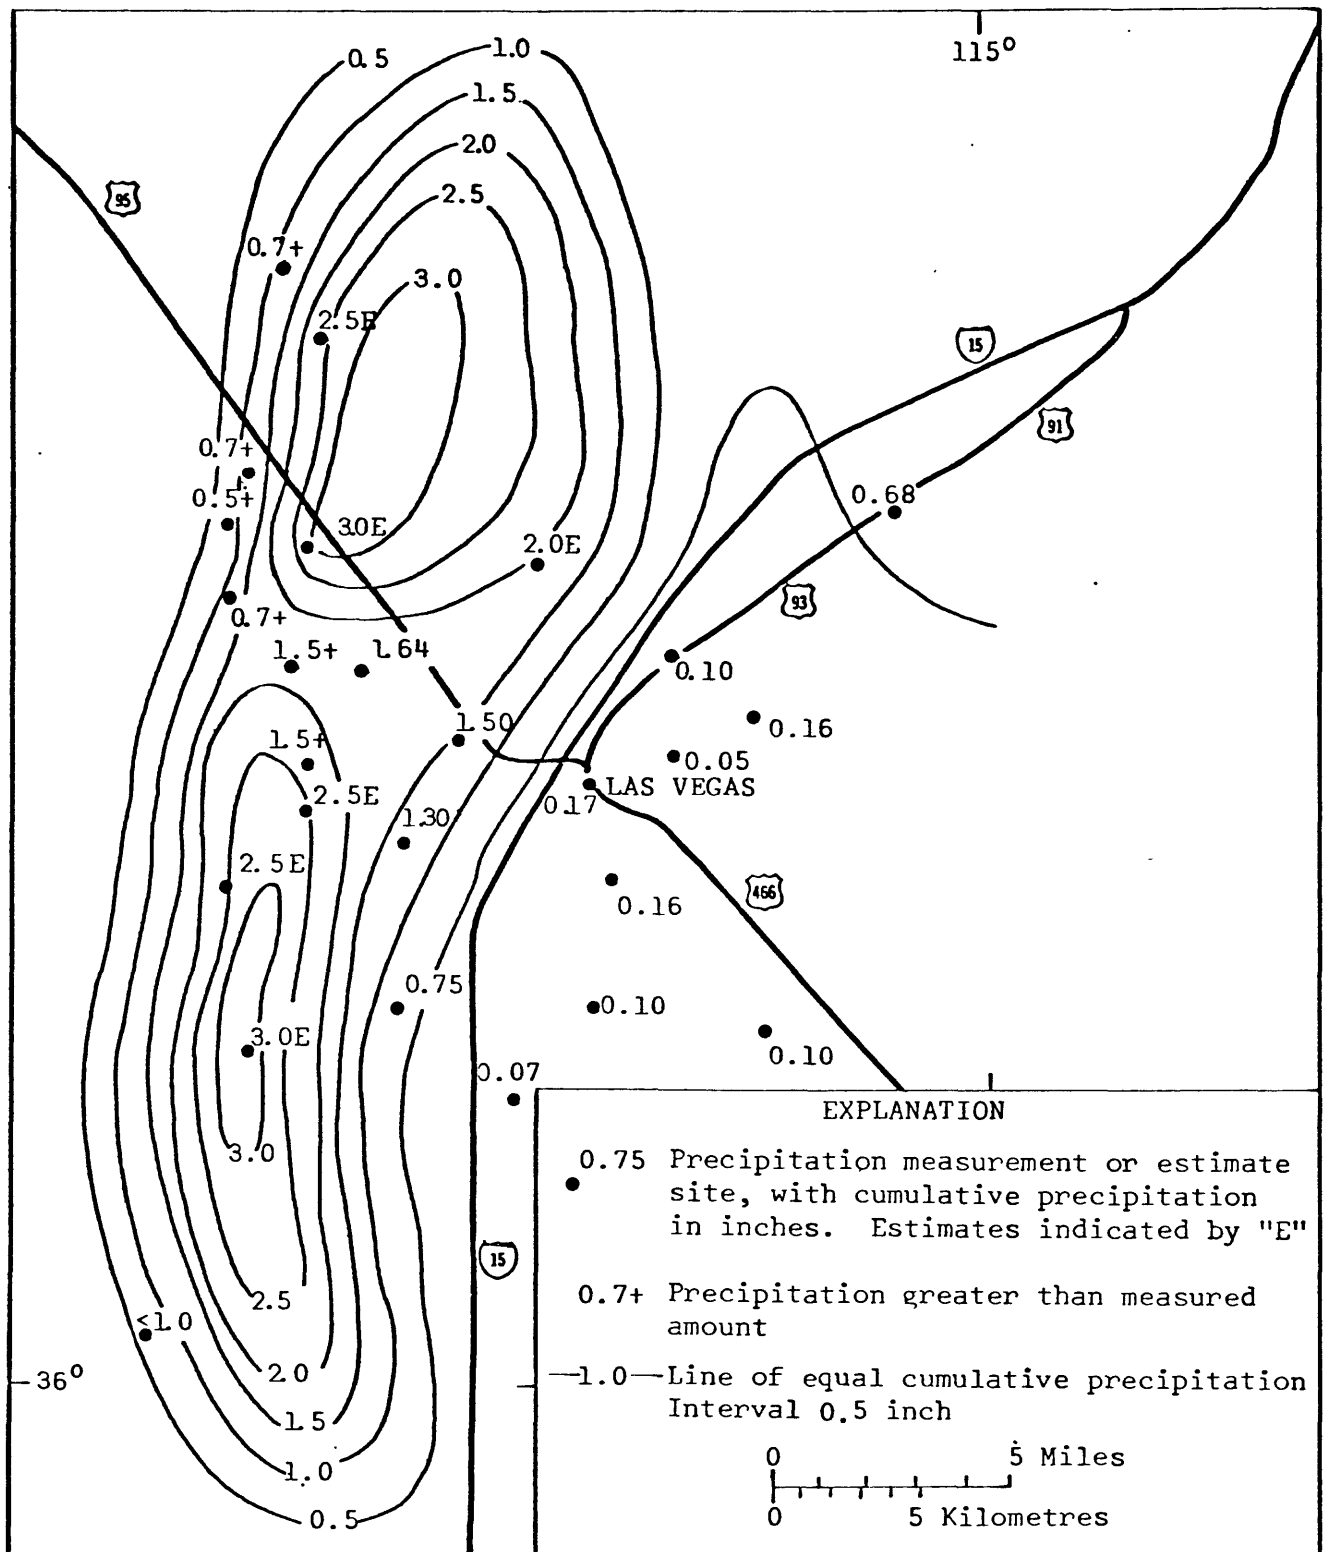
The period of intensive rainfall occurred generally between 1200 and 1800 hours, Pacific Daylight Time, July 3. The heaviest cumulative rainfall was about 1 inch per hour. The rainfall was accompanied by strong surface wind gusts (about 50 knots, or 93 km per hour) and some hail about half an inch (13 mm) in diameter. D. Randerson (written commun., 1975) estimates a total storm-water yield of about 19,000 acre-feet ( $2.4 \times 10^7 \text{ m}^3$ ) on the area that received more than half an inch of precipitation (about  $210 \text{ mi}^2$ , or about  $550 \text{ km}^2$ ). As stated above, the storm area which yielded effective runoff contributing to flooding was estimated by the authors as about 350 square miles ( $910 \text{ km}^2$ ) on the basis of field evidence. Runoff is assumed to have generally occurred from the areas that received more than 0.1 inch of precipitation. Therefore, the storm-water yield was slightly modified in this report to an estimated 20,000-25,000 acre-feet ( $2.5 \times 10^7 \text{ m}^3$ - $3.1 \times 10^7 \text{ m}^3$ ), and includes runoff from a  $350\text{-mi}^2$  ( $910 \text{ km}^2$ ) area. The contributing area is only about 20 percent of the total drainage area tributary to Las Vegas Wash (about  $1,600 \text{ mi}^2$ , or  $4,100 \text{ km}^2$ ). Heaviest known rainfall seemed to occur in two separate areas, one southwest of the central city business district and the other to the north. Figure 2 is a isohyetal map showing the general distribution of cumulative rainfall.

Figure 2.--Cumulative rainfall during storm of July 3, 1975. Map from Darryl Randerson (National Oceanic Atmospheric Administration, written commun., 1975).

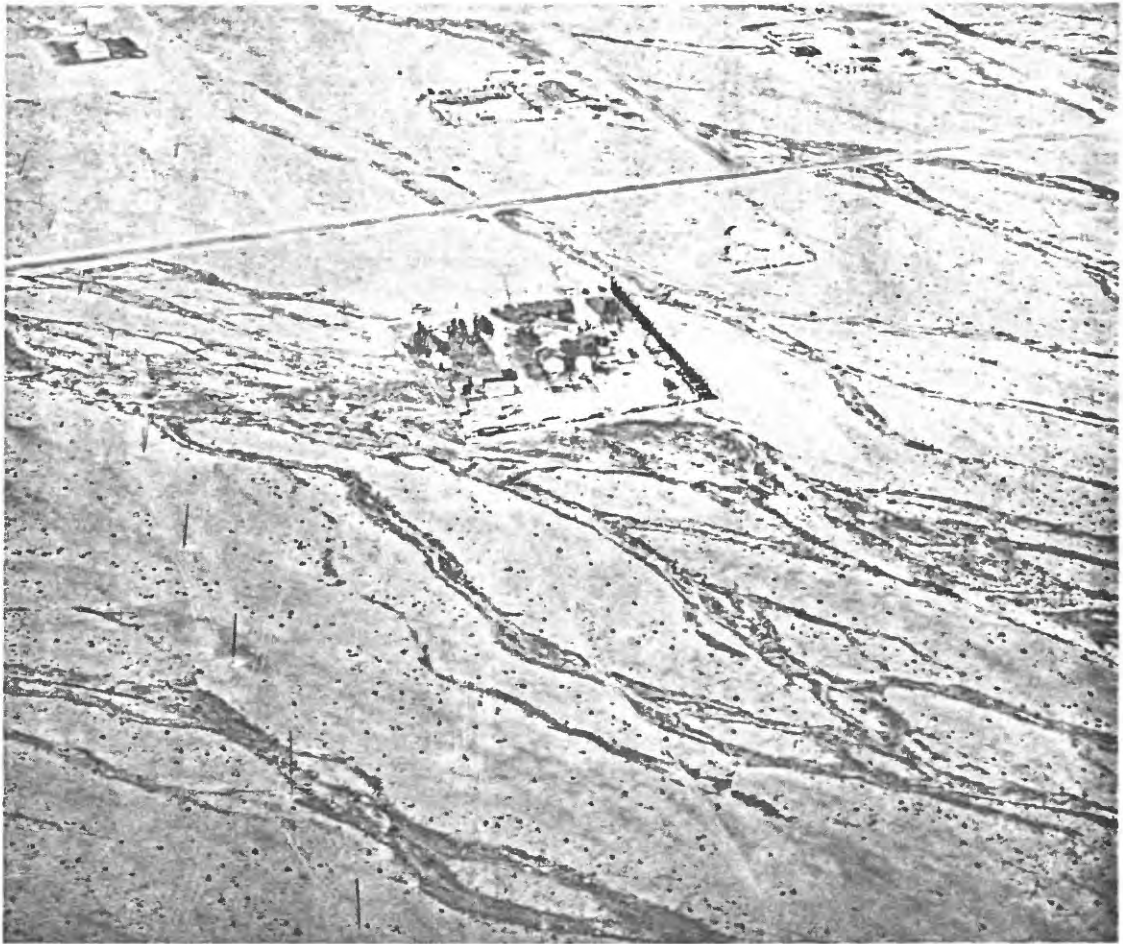
The alluvial fan system southwest, west, and north of metropolitan Las Vegas received the greatest amount of precipitation and therefore contributed most of the runoff. The complex drainage patterns superimposed on the alluvial surfaces, shown in figure 3, indicate that this type of storm runoff has occurred many times in the past. Much of the alluvial surface area was inundated by shallow sheet flow. The vegetation on the alluvium is sparse to moderate, consisting of desert shrubs and grasses, and is not very effective in retarding flows and promoting infiltration. Thus, as sheet flow moves downslope it tends to become channelized. As flow capacities of major channels are sometimes exceeded, areally widespread flooding occurs during particularly large runoff events, as shown in figure 4.

Figure 3. Well-developed fan drainage tributary to Tropicana Wash about 2.6 miles (4.2 km) west of Interstate Highway 15 and 1.1 miles (1.8 km) south of Tropicana Avenue. Photograph taken July 4, 1975. All Photograph sites are shown on Plate 1.

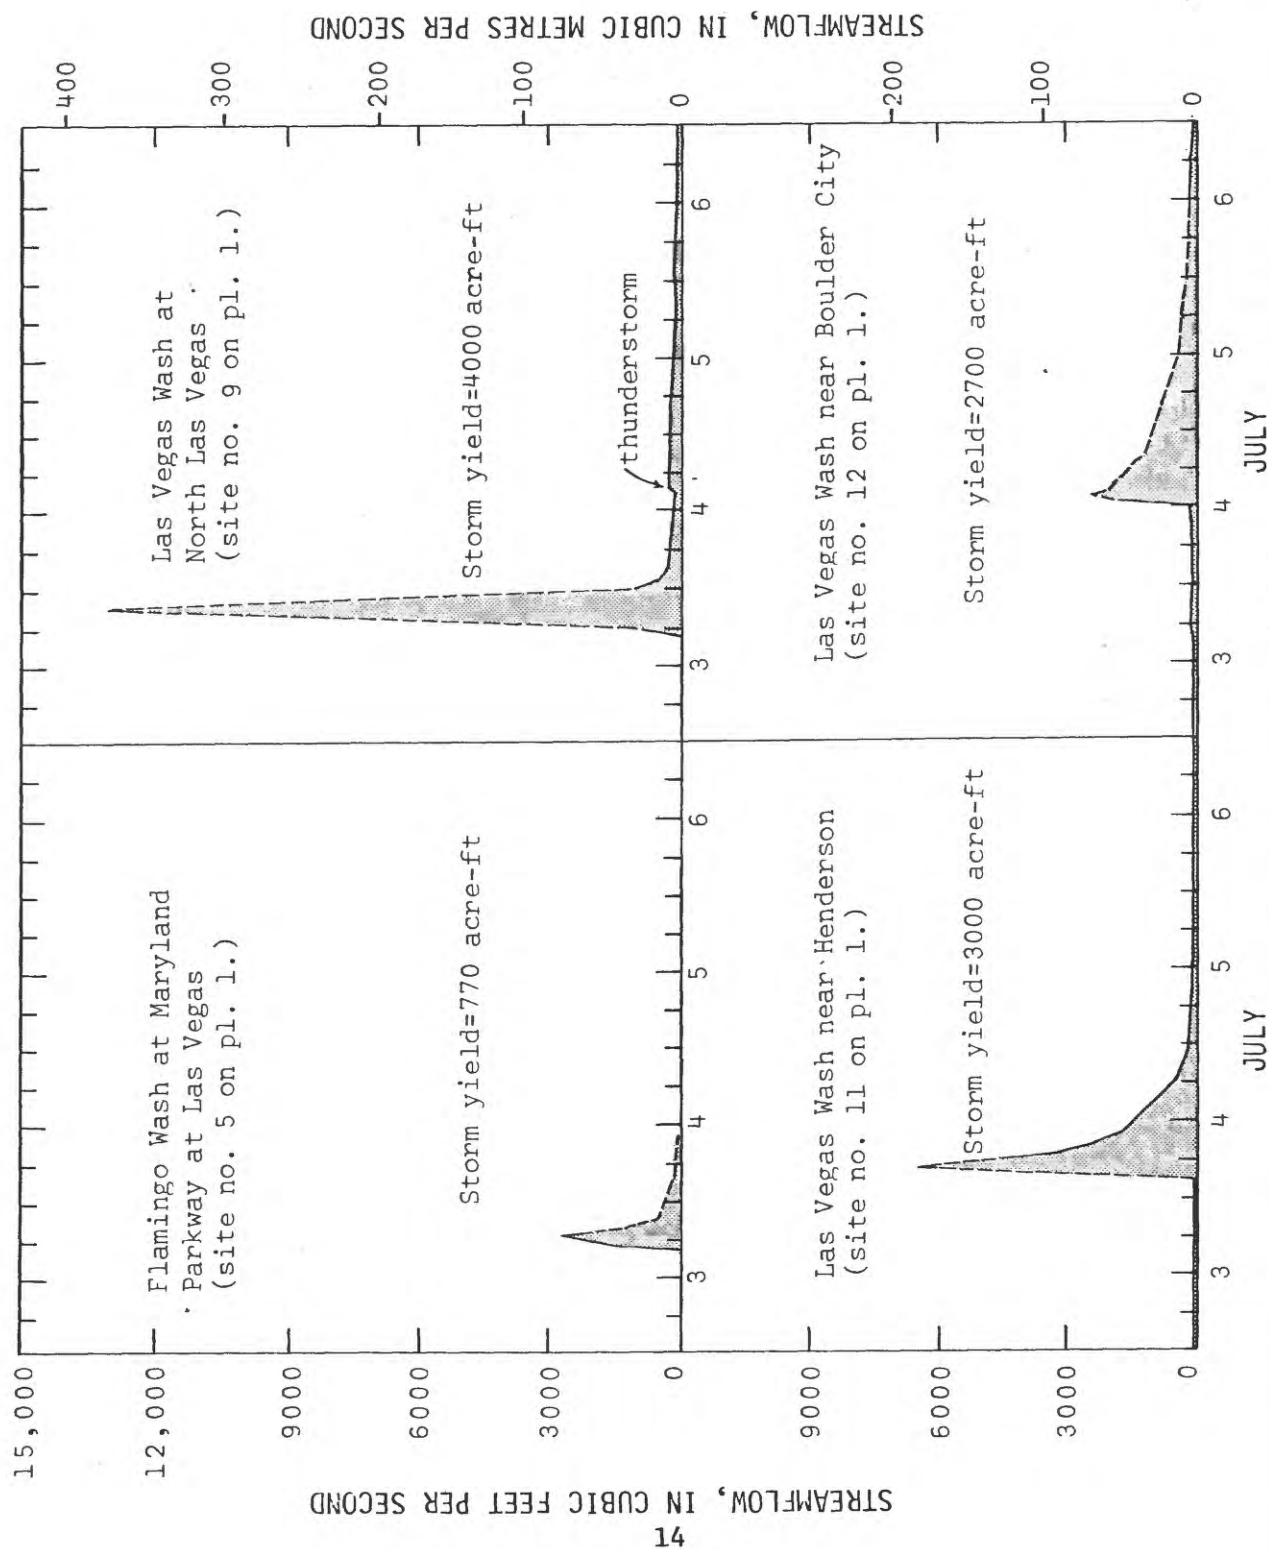
Peak flows for the various measurement sites are shown on plate 1 and listed in table 2. Flood hydrographs of the four recording streamflow stations are shown in figure 5. Parts of these hydrographs have been estimated. Flood peaks generally diminish in a downstream direction in the absence of additional tributary inflow. This reduction in peak flow is at least in part the result of some of the flow being temporarily stored or retarded on the flood plain because of localized flooding. Some of this localized flooding is frequently caused by flood debris clogging bridge and culvert openings, thereby reducing channel capacities and forcing some flow out of the main channels.

Figure 5.--Hydrographs at continuous-record streamflow gaging stations during July 1965.

Parkway at 5:00 p.m., about 5 hours after the storm started, with the peak occurring at 6:30 p.m. and lasting just a few minutes. By 7:30 p.m., the flood crest had dropped about 3 feet (.9 m) and was decreasing rapidly. This was the only gaging station that operated throughout the peak-flow period; however, the gage became inoperative later during the flow recession. No known data fix the time of peak flow on Duck Creek.
