UNITED STATES DEPARTMENT OF THE INTERIOR  
GEOLOGICAL SURVEY

A Preliminary Inventory, Description, and  
Statistical Evaluation of Landslides in a  
Region of Projected Urban Development,  
Sheridan, Wyoming

Open-File Report 76-571

1976

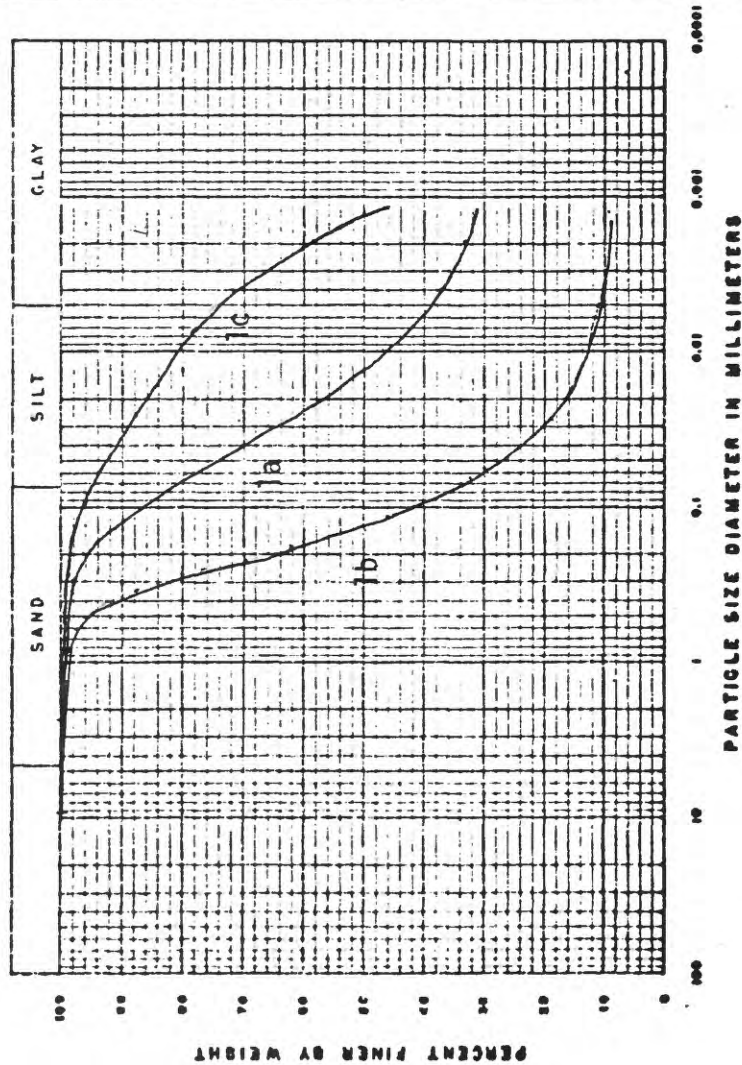
Sample No.	Collection location	LL	PL	PI	Water content, (percent)	Grain density (grams-cm <sup>3</sup> )
1a	Stream bottom	47	23	24	41%	2.67
1b	Base of scarp	NP	NP	NP	17%	2.66
1c	Base of scarp 15 ft below crown	60	46	14	66%	2.57

FIELD OBSERVATIONS: June 5, 1975

The slide mass was very wet--nearly saturated over most of its surface. Springs emanate from a variable lithology at the scarp base, especially from carbonaceous layers. Soldier Creek, below the slide, has been diverted by the toe of the slide.

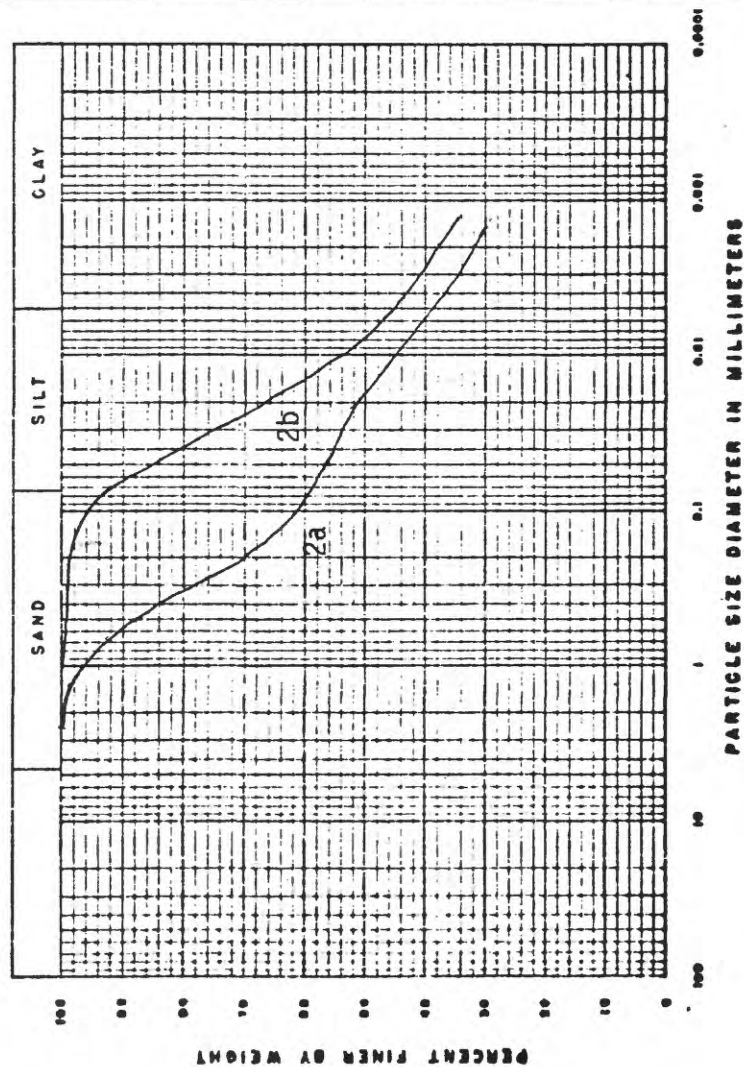
Sample No.	Collection location	LL	PL	PI	Water content (percent)	Grain density (grams-cm <sup>3</sup> )
2a	Top of scarp	NP	NP	NP	45%	2.41
2b	Middle of scarp	41	18	23	26%	2.69

FIELD OBSERVATIONS: June 6, 1975

Much of the surface of the slide mass was dry and crusted; however, the slide material was very wet 1 1/2 feet below the surface. Desiccation cracks in clayey zones are as much as 2 inches wide. Saturated zones and small springs at the scarp base, the middle of the slide, and the toe are associated with thin coal or carbonaceous shale beds. Goose Creek is actively undercutting the toe of the slide and adjacent parts of the hillside. An extensive terrace surface above the slide is irrigated at times.

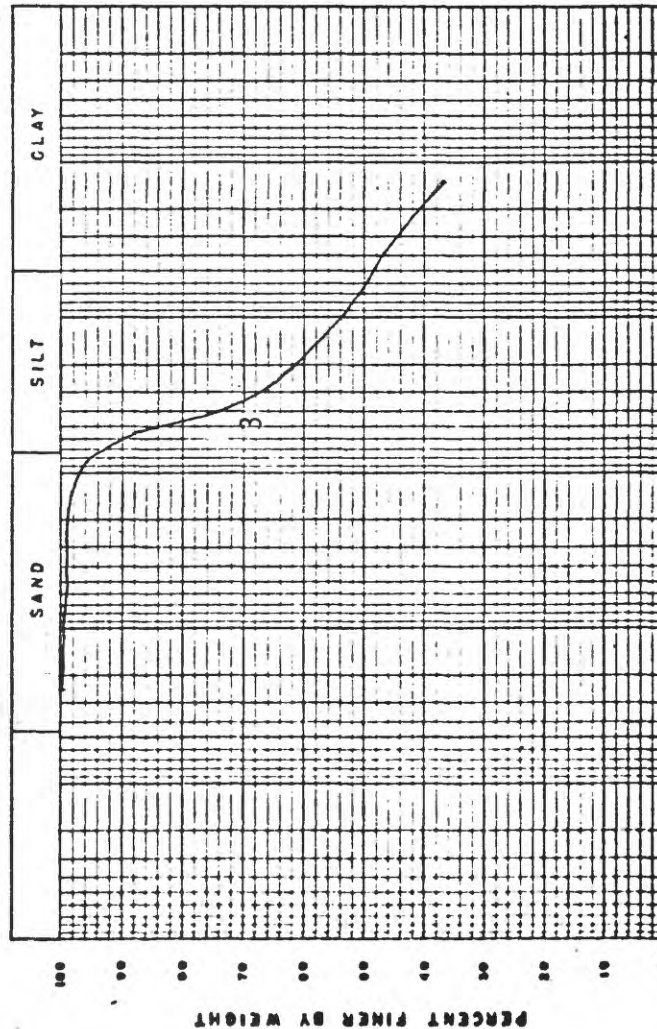
Sample No.	Collection location	LL	PL	PI	Water content (percent)	Grain density (grams-cm <sup>3</sup> )
3	Top of scarp	40	16	24	16%	2.67

FIELD OBSERVATIONS: July 8, 1975

The slide mass was damp to wet over most of the surface; some ponding occurs at the head of the slide where the mass is the wettest.

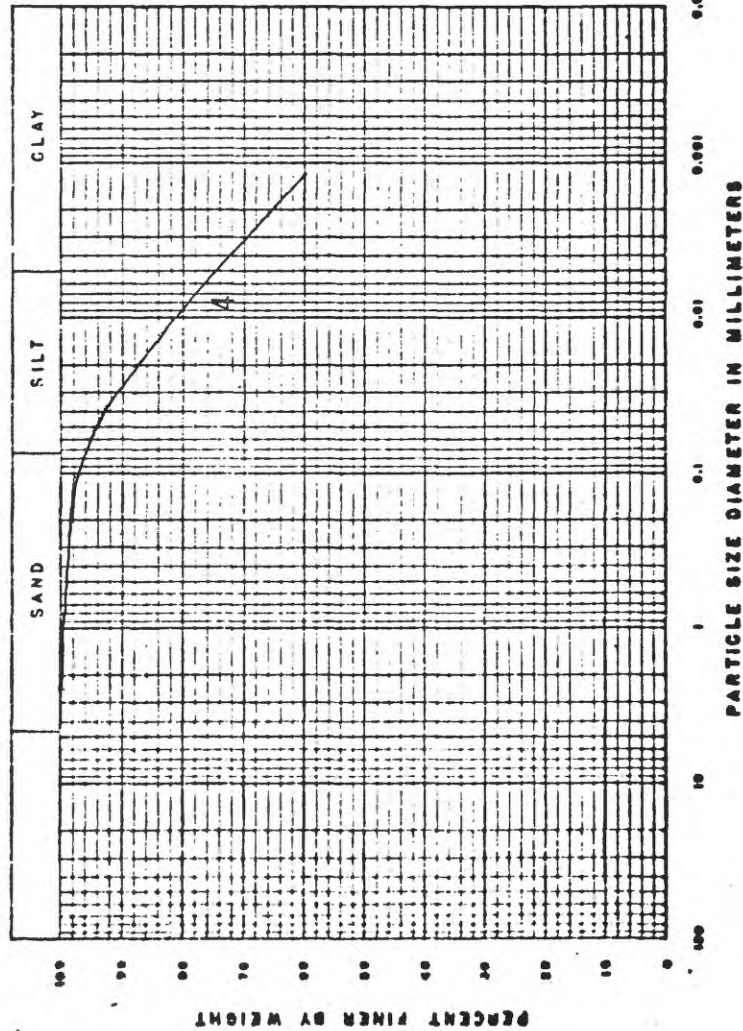
Sample No.	Collection location	LL	PL	PI	Water content (percent)	Grain density (grams-cm <sup>3</sup> )
4	Base of scarp	73	24	49	31%	2.67

FIELD OBSERVATIONS: July 8, 1975

Several areas of the slide mass are very wet. Ponding occurs at the head of the slide. Goose Creek runs near the toe but is not undercutting the present slope. An irrigated terrace surface extends northwest of the slide.

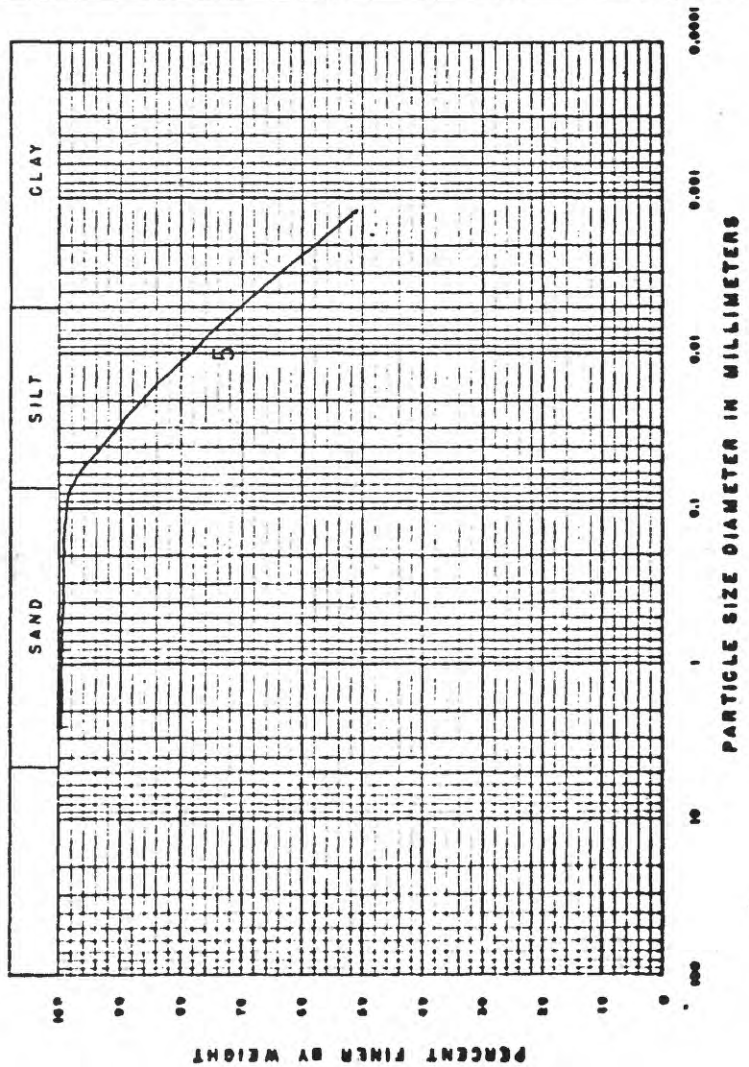
Sample No.	Collection location	LL	PL	PI	Water content (percent)	Grain density (grams-cm <sup>3</sup> )
5	Middle of scarp	61	21	40	23%	2.68

FIELD OBSERVATIONS: July 8, 1975

The slide was very wet at various places below the scarp, and standing water was observed at the head and the toe. An irrigated gravel terrace extends in a northwesterly direction above the slide. The exposed scarp reveals a 2- to 4-foot gravel cap underlain by a blue-gray clay.

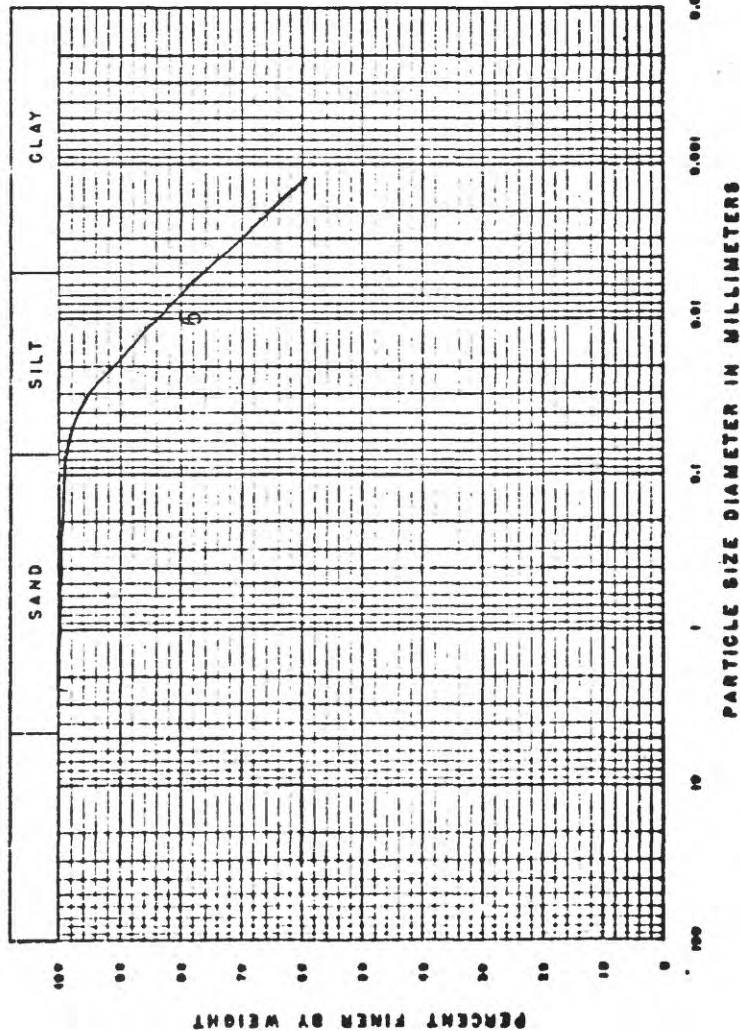
Sample No.	Collection location	LL	PL	PI	Water content (percent)	Grain density (grams-cm <sup>3</sup> )
6	Base of scarp	68	26	42	22%	2.71

FIELD OBSERVATIONS: July 10, 1975

The slide is part of a large slide area composed of several coalescing earthflow/slump-type movements. The failure occurs in a small drainage on a hillside topped by a terrace surface that has been extensively irrigated. The surface of the slide was dry, with the exception of a zone just below the head, where ponding occurs.

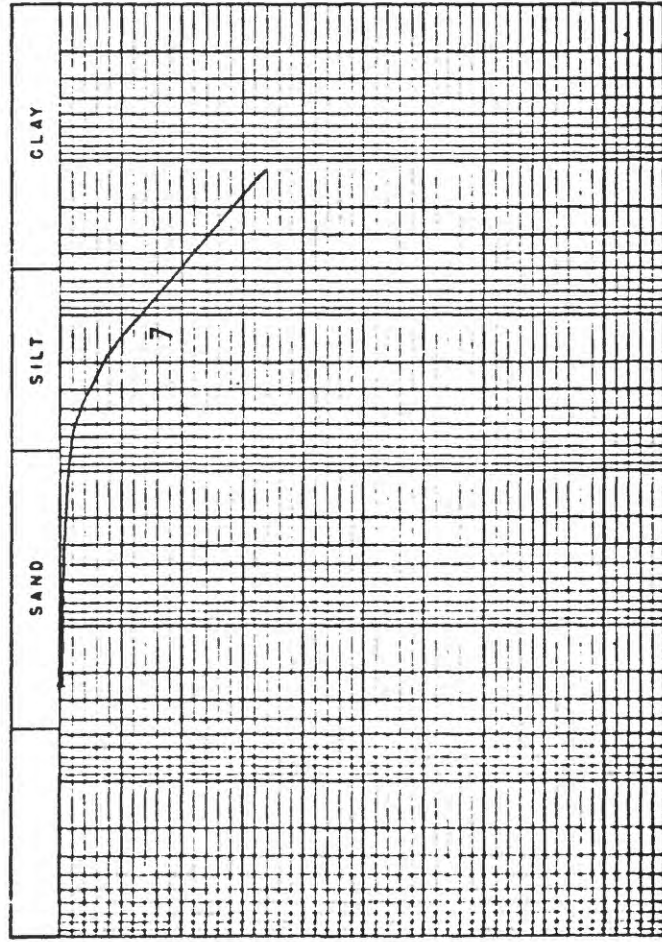
FIELD OBSERVATIONS: July 10, 1975

The landslide is located on the side of a small knoll in an irrigated field. The main ditch of the irrigation system that supplies water to the field is located just above and behind the slide. A smaller ditch leading from the main ditch runs directly onto the failed slope. The irrigation system was not in use at the time of these observations and the surface of the slide mass was dry.

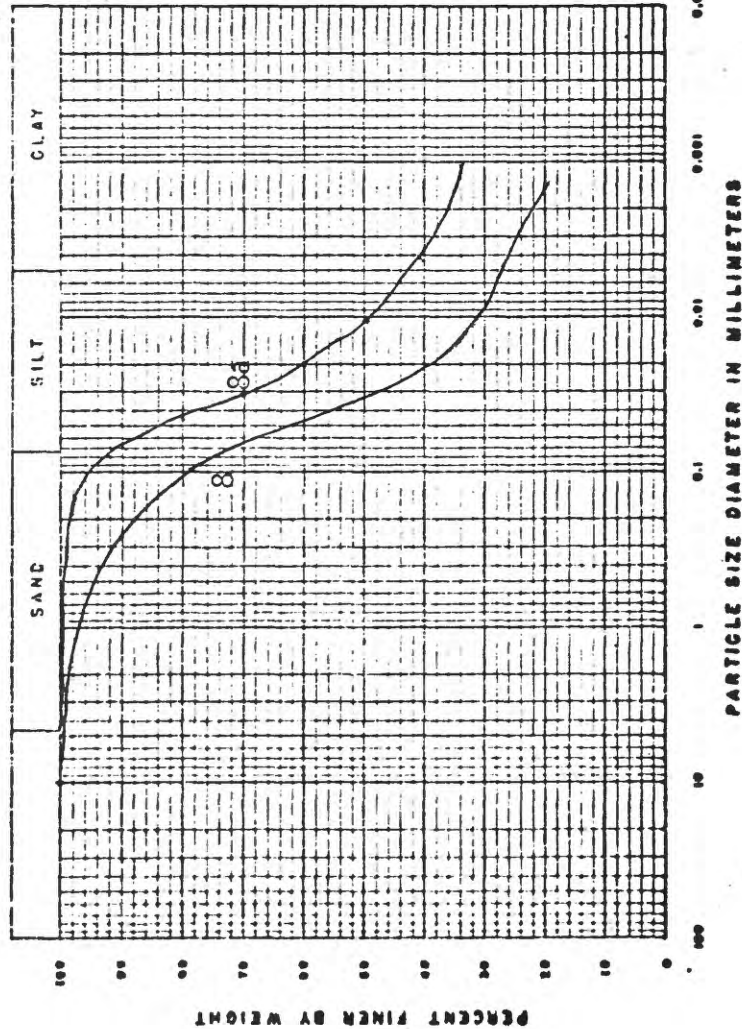
Sample No.	Collection location	LL	PL	PI	Water content (percent)	Grain density (grams-cm <sup>3</sup> )
8	Base of scarp	30	21	9	22%	2.69
8a	Creek bottom	35	19	16	35	2.53

FIELD OBSERVATIONS: July 7, 1975

The scarp was wet near the base and much ponding was observed below the head of the slide. Jackson Creek is located at the bottom of the failed slope adjacent to the toe. An alluvial terrace gravel tops the hill and is exposed in the upper half of the scarp.

The occurrence of the landslide has been reported by Lowry and Cummings (1966), who presented photographs of the site for the years 1954, 1958, and 1961 showing its development. Lowry and Cummings stated that the landsliding "is due in part to the disturbance of the equilibrium caused by the rechanneling of the creek into the toe of the slope, and in part by the irrigation of land above the slope."

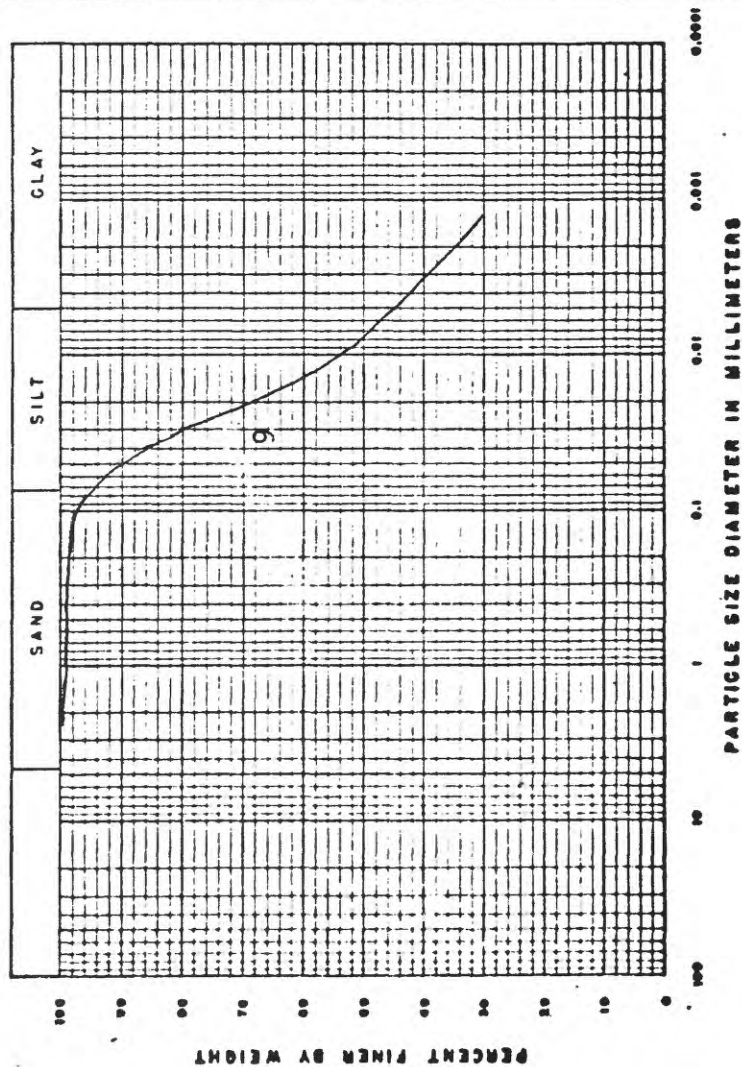
Sample No.	Collection location	LL	PL	PI	Water content (percent)	Grain density (grams-cm <sup>3</sup> )
9	Base of scarp	43	18	25	13%	2.72

**FIELD OBSERVATIONS:** July 10, 1975

The surface of the slide was dry and overgrown with weeds. No evidence of ponding was observed. An alluvial terrace surface extends to the northwest above and behind the slide mass; however, there is no indication of irrigation activity near the slide.

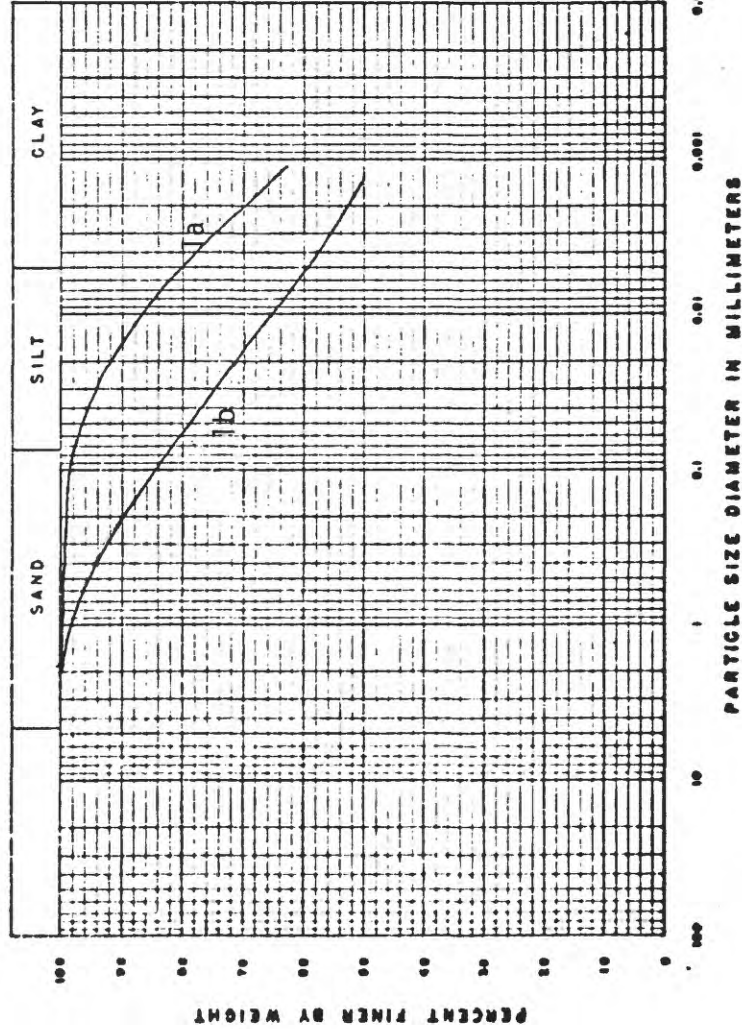
Sample No.	Collection location	LL	PL	PI	Water content (percent)	Grain density (grams-cm <sup>3</sup> )
1a	Base of scarp	74	26	48	26%	2.67
1b	Toe of slide	56	23	33	27%	2.64

FIELD OBSERVATIONS: May 28, 1975

The slide occurs at the head of a small drainage on a convex slope. It is well defined by a fresh scarp, pressure ridges at the flanks, and a hummocky surface; however, little displacement has occurred.

The property owner reports that the slide activity took place after a heavy snowstorm in April of 1974. He also reports that the failed slope has never been irrigated.

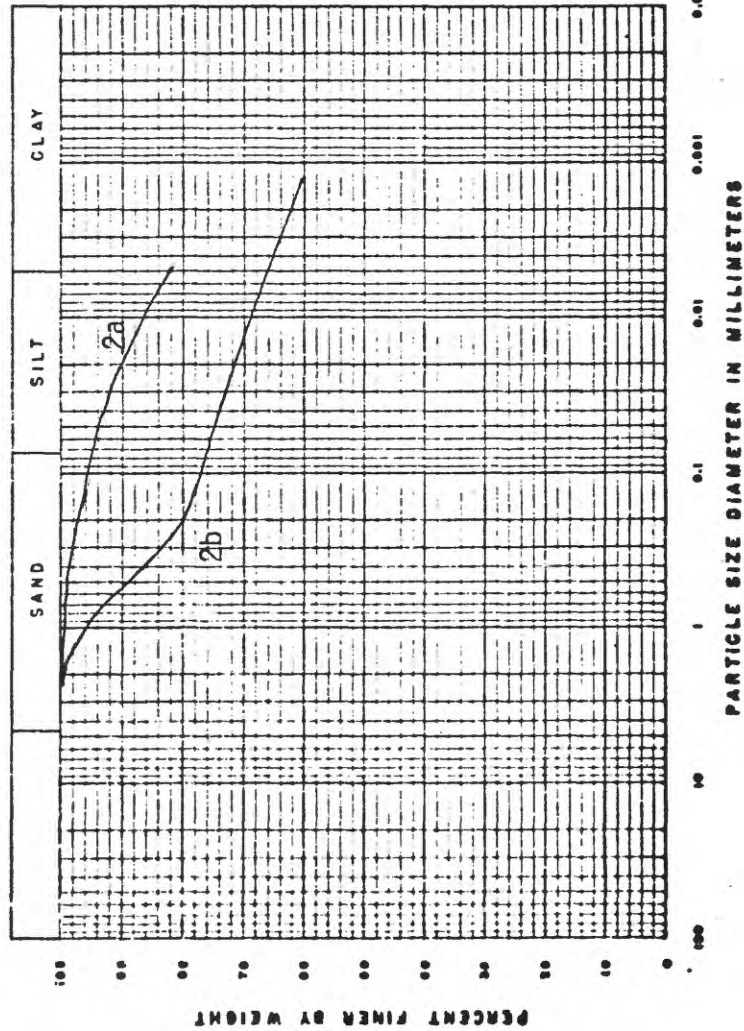
Sample No.	Collection location	LL	PL	PI	Water content (percent)	Grain density (grams-cm <sup>3</sup> )
2a	Top of scarp	80	26	54	30%	2.71
2b	Top of scarp	58	26	32	32%	2.70
2c	Toe of slide	--	--	--	27%	2.66

FIELD OBSERVATIONS: May 28, 1975

Most of the surface of the slide was very wet. Ponding occurs near the middle of the slide.

According to the property owner, the sliding took place after a big snowstorm in April of 1973.

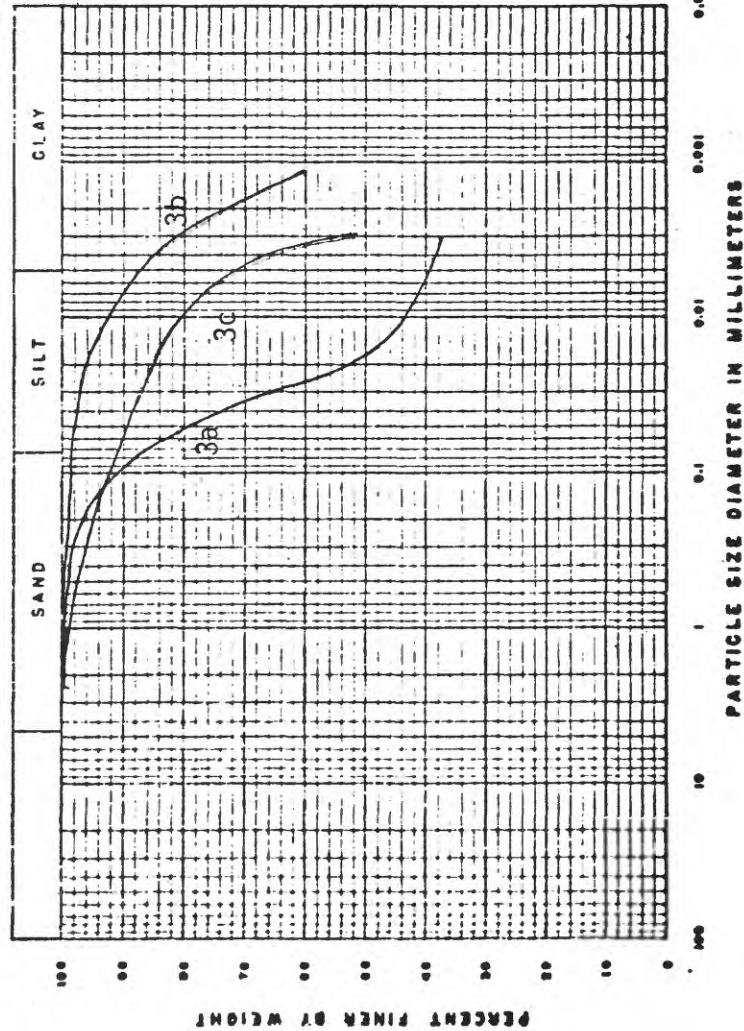
Sample No.	Collection location	LL	PL	PI	Water content (percent)	Grain density (grams-cm <sup>3</sup> )
3a	Top of scarp	61	27	34	27%	2.82
3b	Middle of scarp	61	37	24	45%	2.92
3c	Toe of slide	62	25	37	26%	2.77

## FIELD OBSERVATIONS: May 30, 1975

The slide surface was dry and overgrown with grass and weeds. A line of vegetation on the upper part of the slope marks a break in lithology.

Aerial photographs taken in 1966 indicate that the slope failure had taken place prior to that time.

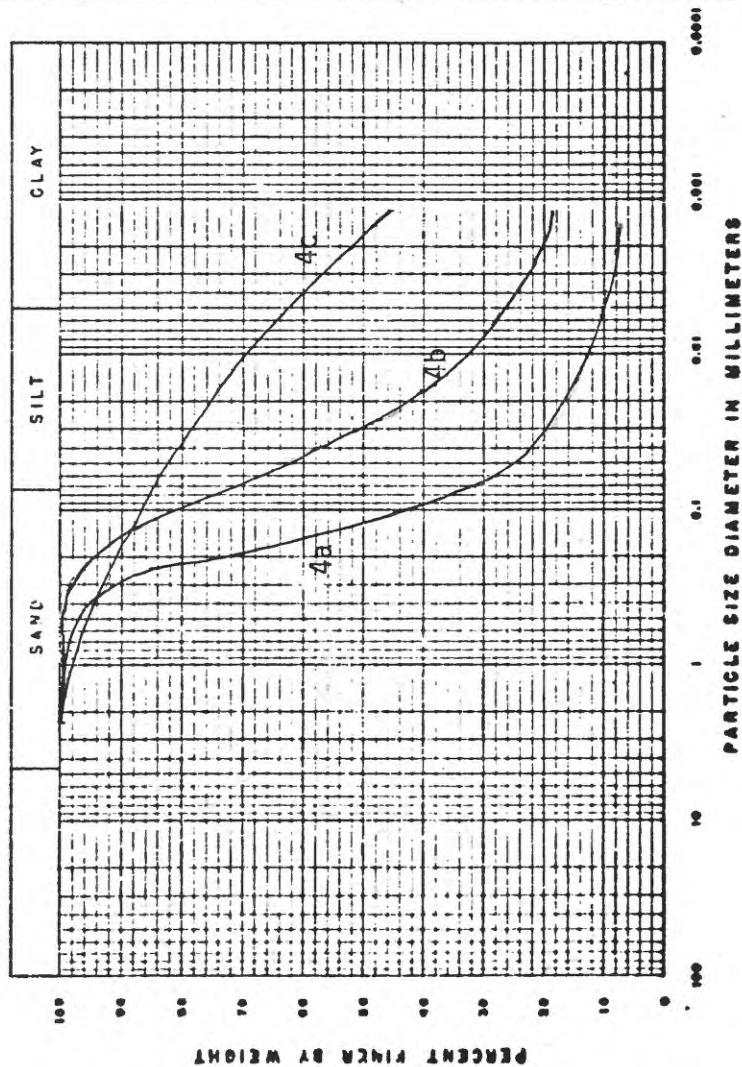
Sample No.	Collection location	LL	PL	PI	Water content (percent)	Grain density (grams-cm <sup>3</sup> )
4a	Top of scarp	NP	NP	NP	15%	2.68
4b	Middle of scarp	31	20	11	13%	2.70
4c	Toe of slide	39	21	18	27%	2.70

**FIELD OBSERVATIONS:** May 30, 1975

The upper part of the slide surface was very wet. Ponding occurs at the toe. A spring line marked by bushes occurs on either side of the slide area at the elevation of the scarp. A small irrigation ditch has been overrun by the toe of the slide, and another irrigation ditch is located on the opposite side of the hill at or above the level of the scarp.

Aerial photographs of the site taken in 1966 show a slightly hummocky surface, indicating that a slope failure had been initiated prior to that time; however, most of the movement has occurred since 1966.

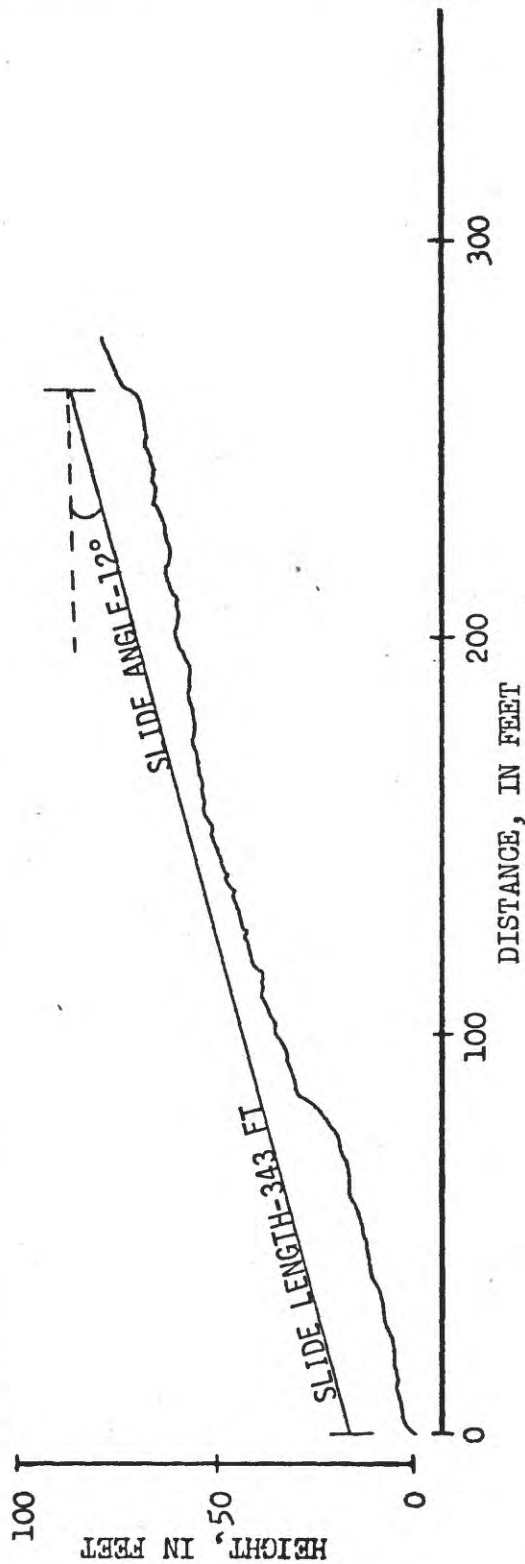
# AREA 2-SITE 6

Scarp slope 70°

Estimated slide depth 15 ft

Ponding was observed in the upper part of the slide. The toe of the slide runs into an irrigation ditch and a small creek (Prairie Dog Creek) at the foot of the slope.

Slumping and flow movement occurred in the upper half of the slide. Shear fractures with 30- to 80-foot spacing are associated with the slumping. A large slump with a slickensided scarp occurs three-quarters of the way down the slide and may represent more recent movement within the larger mass.

A property owner reports that the slide activity took place in the spring of 1973.

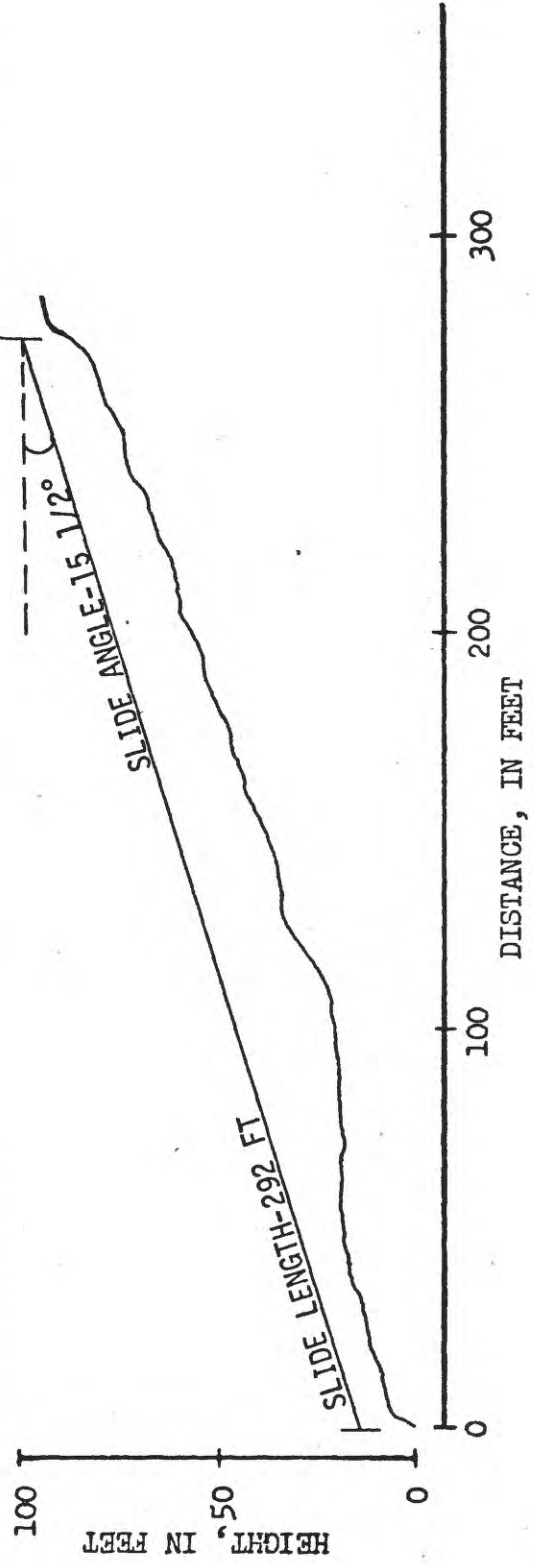
# AREA 2-SITE 7

Greatest flank width 90 ft  
Scarp width 88 ft  
Scarp length 20 ft

Scarp slope 31 1/2°  
Estimated slide depth 20 ft

The slide is overgrown with vegetation. Most of the depressions and fractures are filled in and obscured by grass and weeds. A spring-fed pond is located just above the toe. The rest of the slide surface was wet but did not appear saturated.

The slope failure is evident in aerial photographs taken in 1966.

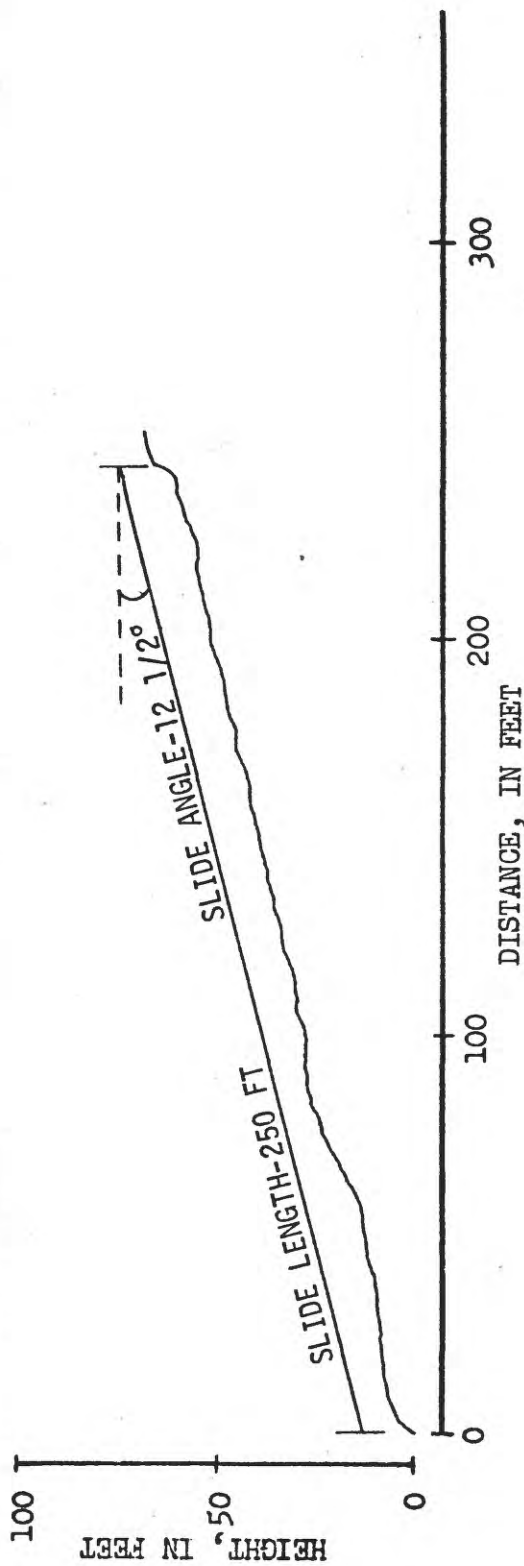
Scarp slope 80°

Estimated slide depth 10 ft

The profiled slide heads in an older slide mass near the top of the slope.

Aerial photographs taken in 1966 show an old slope failure at the site. The profiled slide appears in 1974 photos, indicating that the recent activity took place between 1966 and 1974.

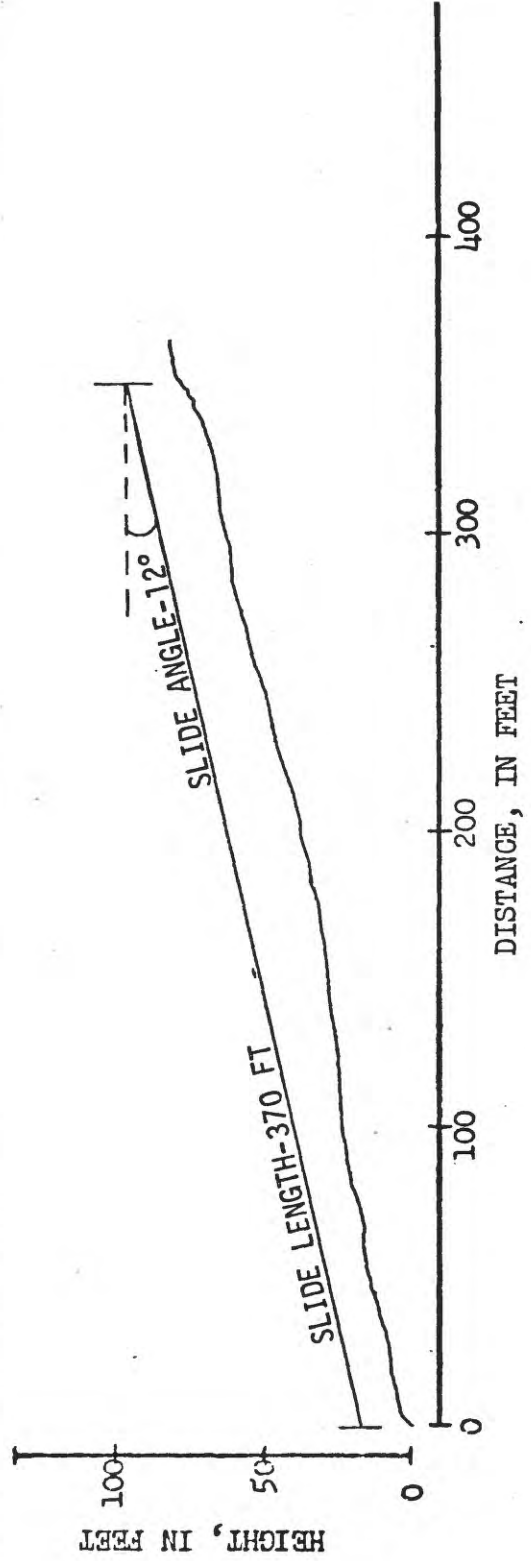
Greatest flank width 182 ft  
Scarp width 179 ft  
Scarp length 17 ft

Scarp slope 23°  
Estimated slide depth 30 ft

The profiled slide is not well defined because of little movement. There is very little broken ground other than a fresh scarp and tear fractures at the flanks. The rest of the movement is expressed at the surface as hummocky topography. Older sliding at the site is indicated by healed transverse fractures on the slide surface.

Aerial photographs taken in 1966 show a spring line marked by vegetation and old landsliding just south of the site. It could not be determined whether the profiled landslide had occurred by that time or not.

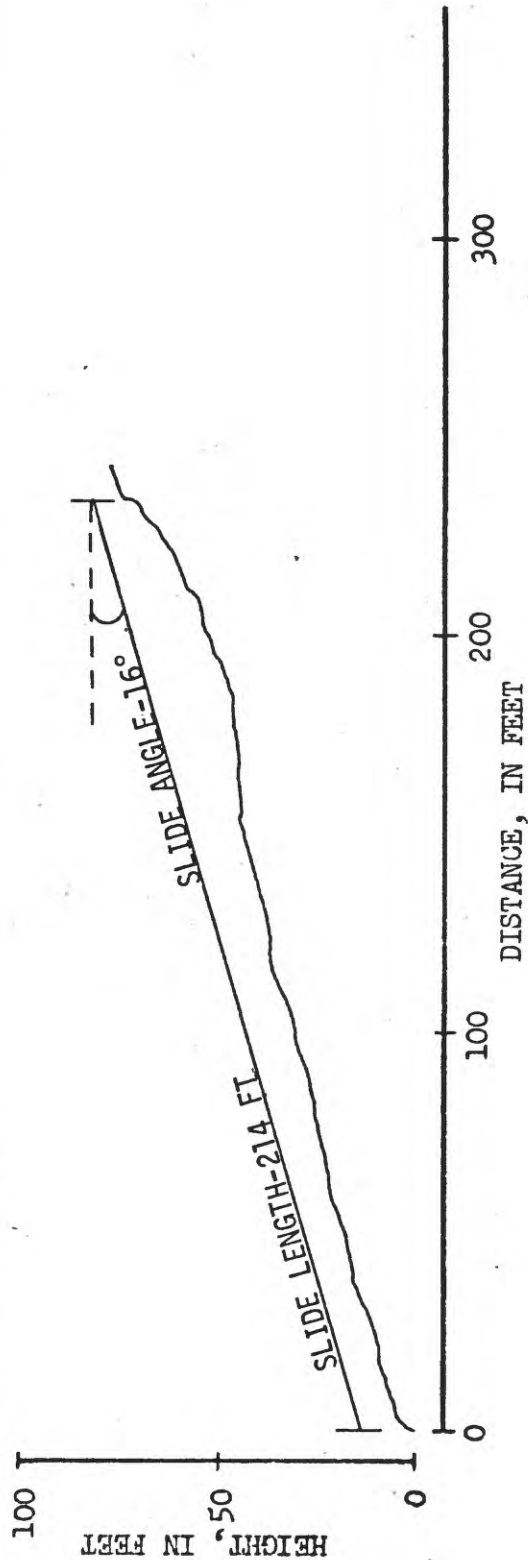
AREA 2-SITE 10

8 Greatest flank width 237 ft  
Scarp width 197 ft  
Scarp length 52 ft

Scarp slope 26°  
Estimated slide depth 20 ft

The profiled slide is part of a large slide area composed of several coalescing earthflow-type movements.

Tensional and shear fractures with 1- to 4-foot spacings were observed on the slide surface near the scarp.

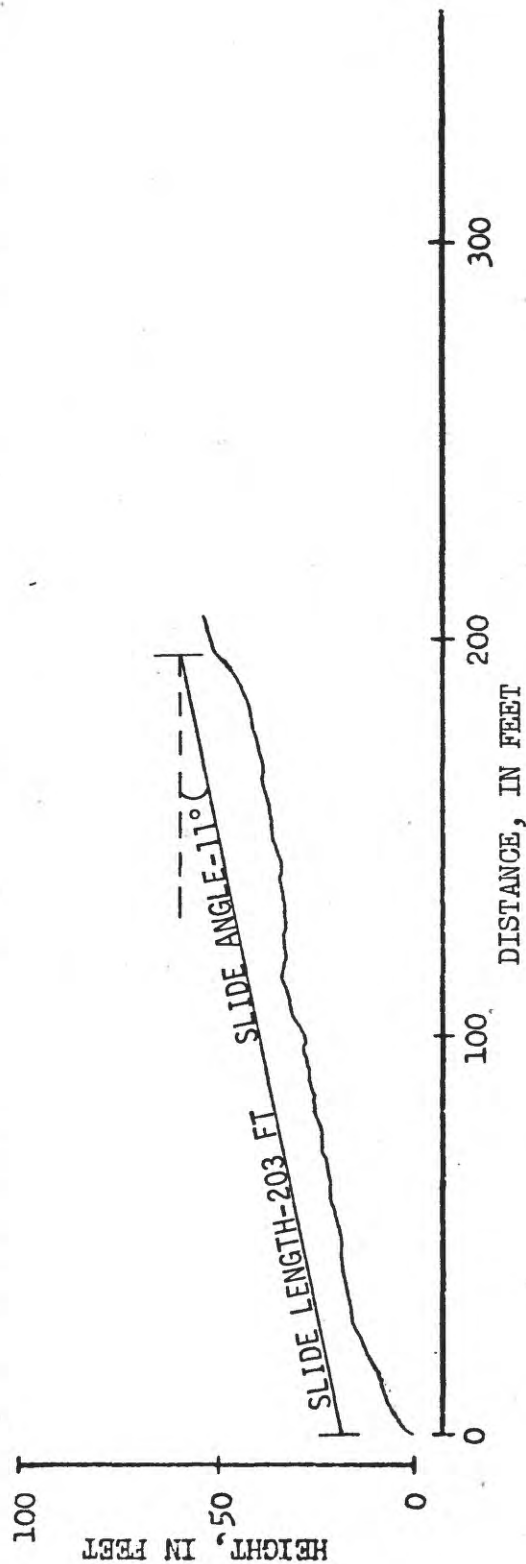
Greatest flank width 100 ft  
Scarp width 59 ft  
Scarp length 24 ft

Scarp slope 22°  
Estimated slide depth 15 ft

The slide surface was dry and covered with weeds and grass. The scarp is vegetated three-quarters of the way up. Fractures and depressions on the surface are mostly filled and not well defined.

Aerial photographs taken in July of 1966 clearly show the profiled slide.

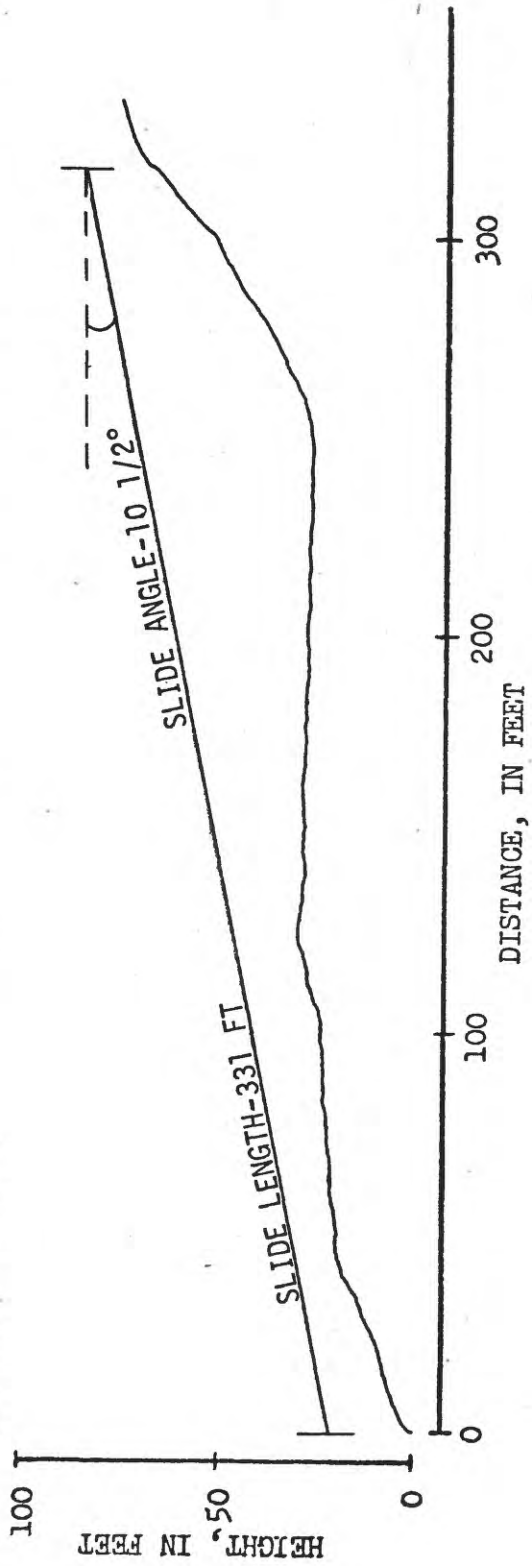
## AREA 3-SITE 2

Greatest flank width 430 ft  
Scarp width 420 ft  
Scarp length 76 ft

Scarp slope 32°  
Estimated slide depth 50 ft

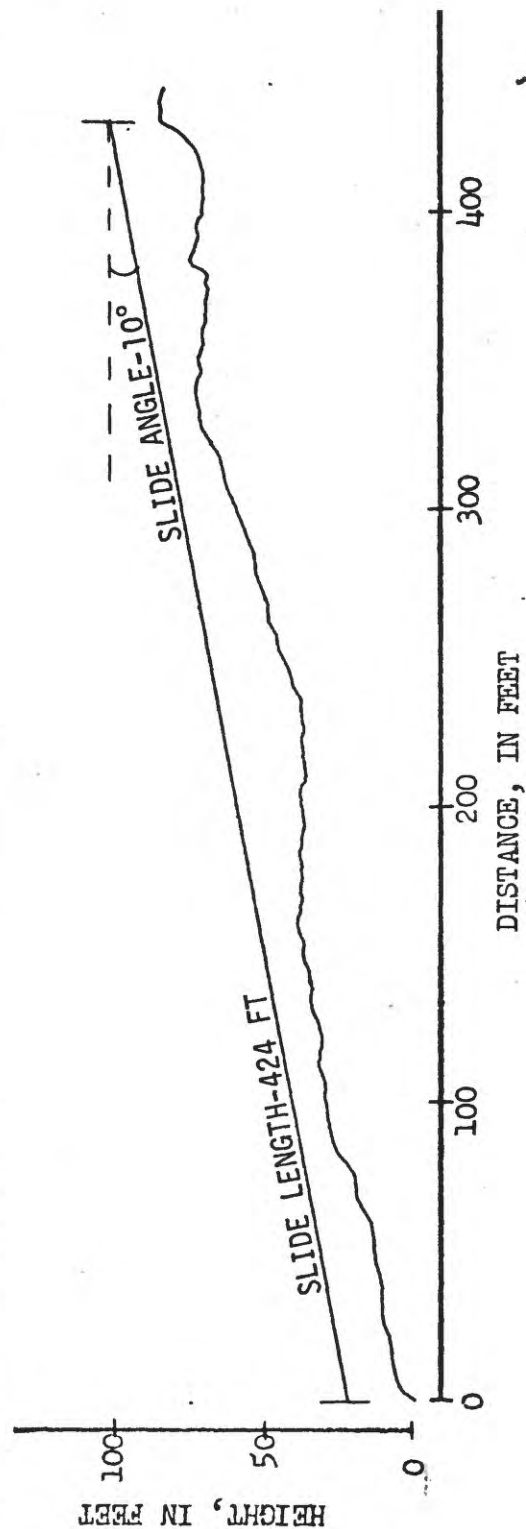
AREA 3-SITE 3

Scarp slope 36°

Estimated slide depth 40 ft

The slide is the result of recent movement on a slope that has a history of landslide activity. The hillside is scarred by numerous older slides. Hummocky landforms and the remains of old slope failures that have spilled out onto the Piney Creek flood plain can be seen to the northwest along 3 miles of slope.

The profiled slide had wet zones throughout, and ponding was noted above the toe. An irrigated alluvial terrace is located northwest of the slide.

Two slump blocks were observed in the upper part of the slide, where the slope is the steepest. Flow movement is dominant in the lower part, where the material has moved out beyond the foot of the hillslope.
