CHANNEL EROSION SURVEYS ALONG TAPS ROUTE, ALASKA, 1976

UNITED STATES DEPARTMENT OF THE INTERIOR
GEOLOGICAL SURVEY

By
Paul F. Doyle
and
Joseph M. Childers

77-170

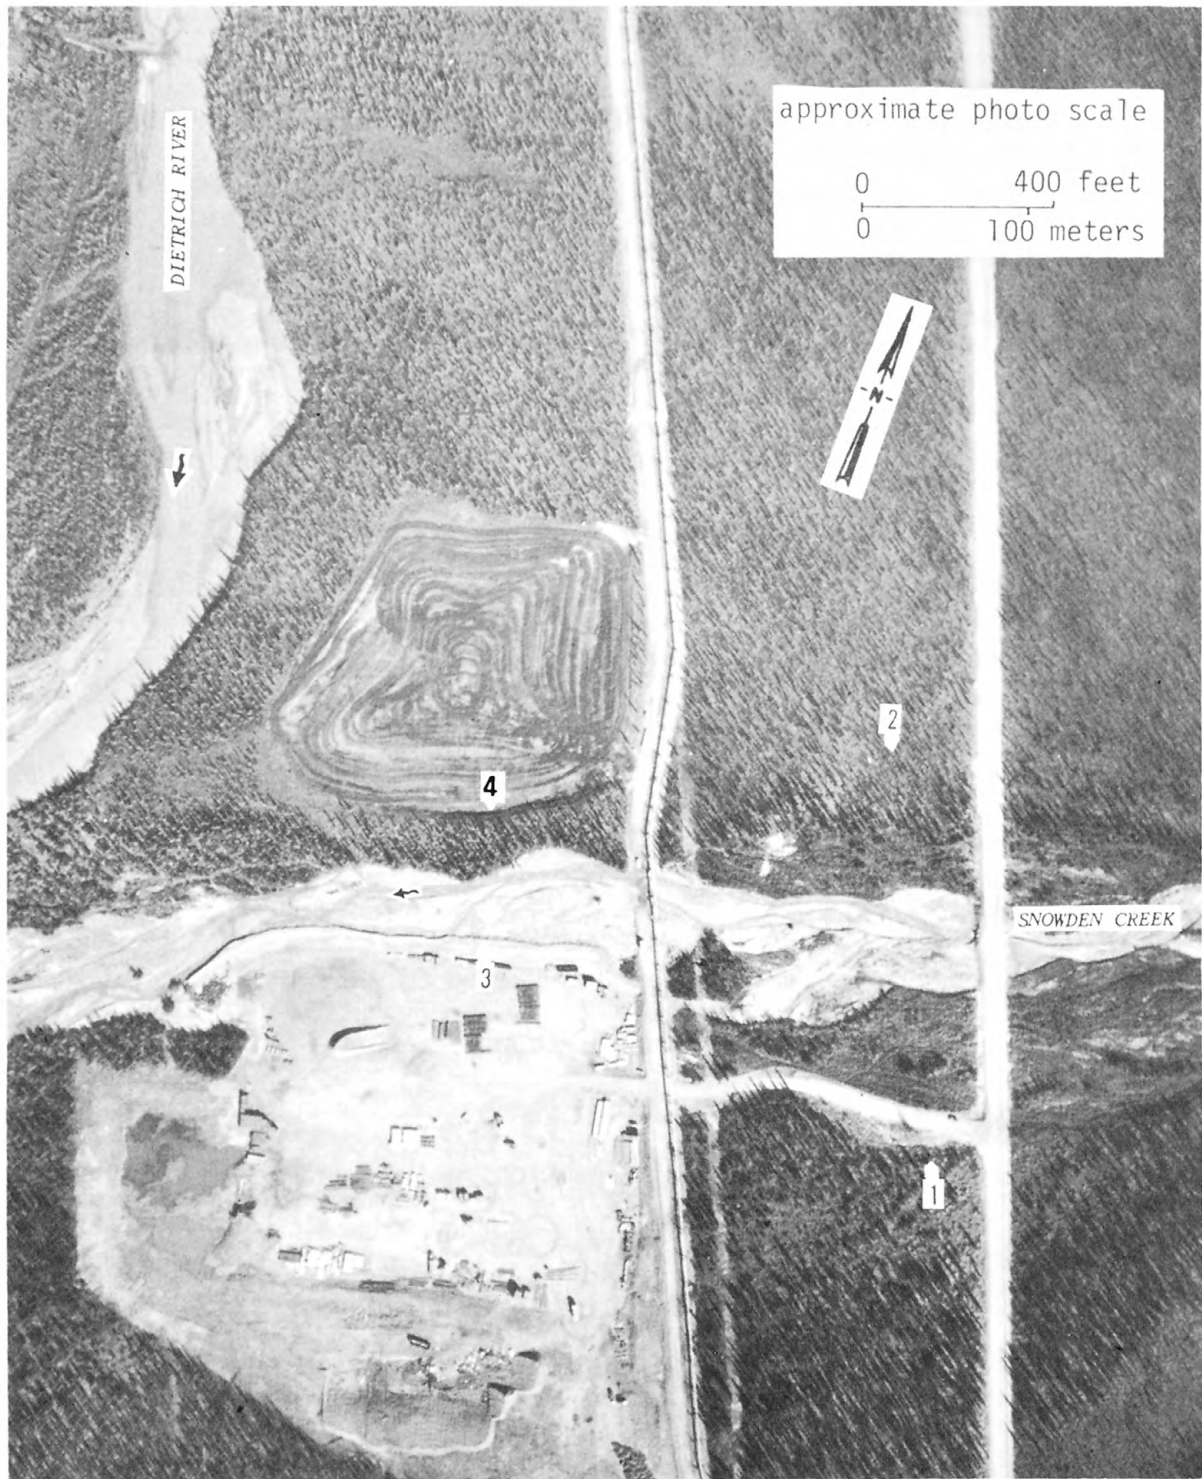
1976 Surveillance.--Figure 2 shows the Snowden Creek crossing site on August 2, 1976. During the past year the overhead pipe crossing has been completed and the material-removal site on the right bank at the downstream cross section has been seeded over and abandoned. Figure 2, which was taken right after the reported high water of July 29 and 30 (Schroeder, written commun., 1976), indicates that the channel had migrated laterally in places since 1975 and had partially eroded sections of the dike protecting the material storage yard on the left bank.

Figure 2.-- Snowden Creek near Dietrich Camp, August 2, 1976. AIR PHOTO TECH

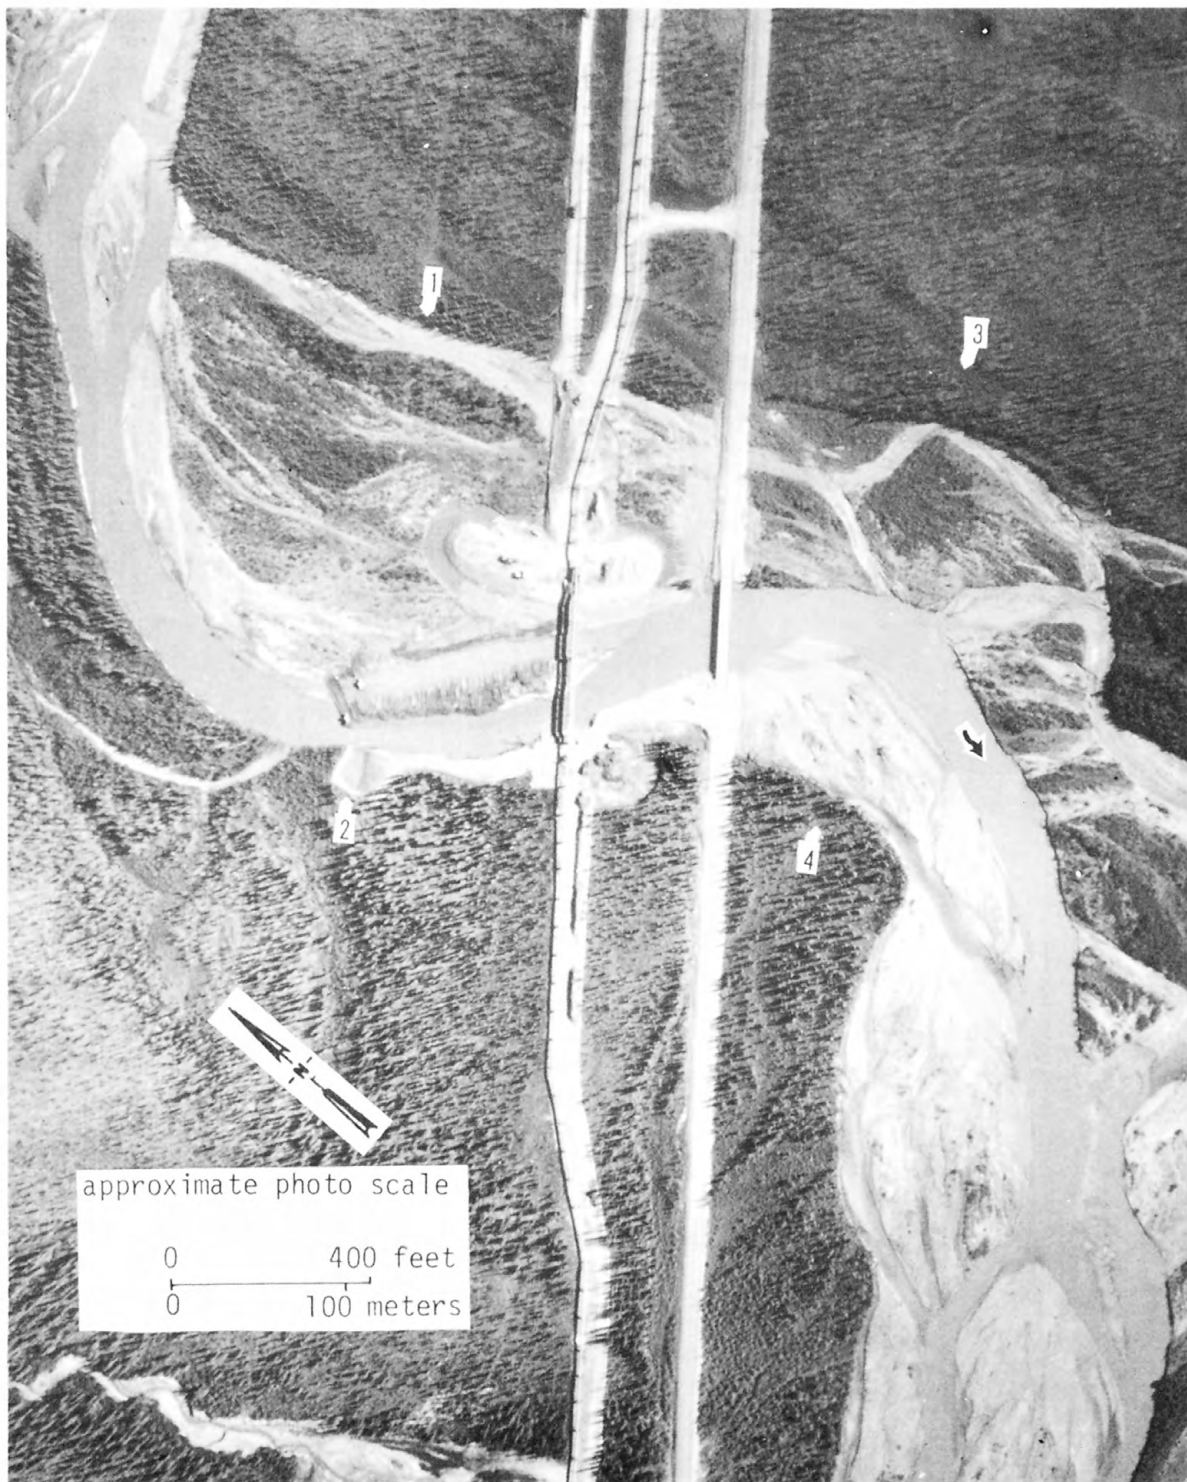
1976 Surveillance.--Figure 4 shows the Dietrich River crossing site on August 2, 1976. The overhead pipe crossing is in place and bank protection along the right bank is in progress. The temporary bridge which was just upstream of the pipe crossing in 1975 has been removed.

Figure 4.-- Dietrich River at Bettles River, August 2, 1976. AIR PHOTO TECH

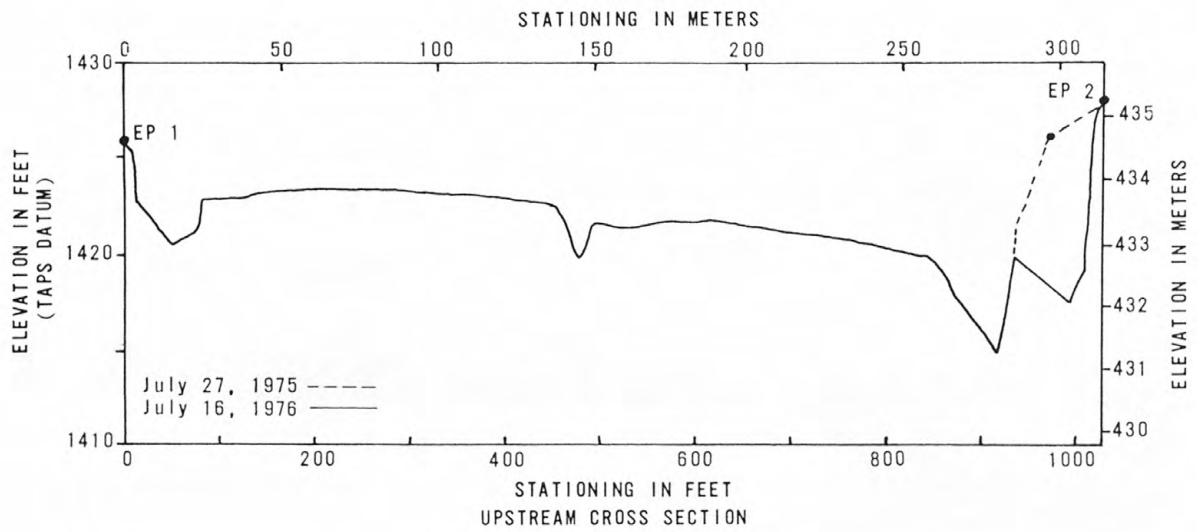
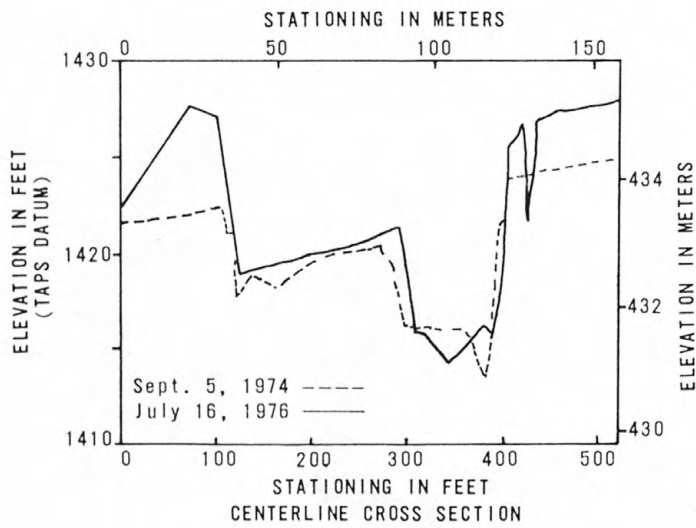
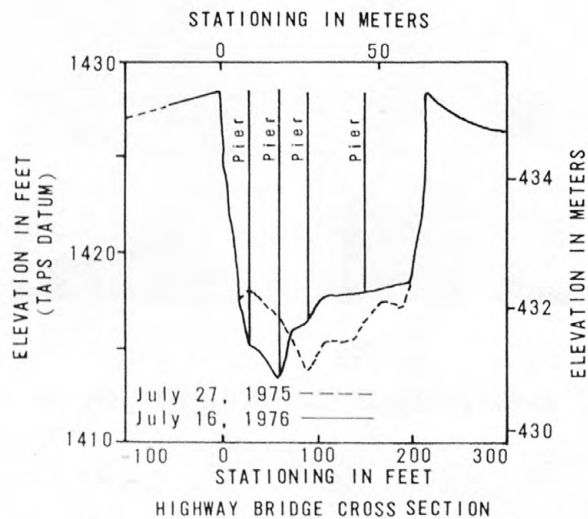
The crossing site was resurveyed in July 1976. There was no significant change in the downstream section. Figure 5 shows construction changes in the upstream and centerline cross sections and also the thalweg shift at the highway bridge cross section.

Figure 5.-- Cross sections of the Dietrich River at Bettles River.

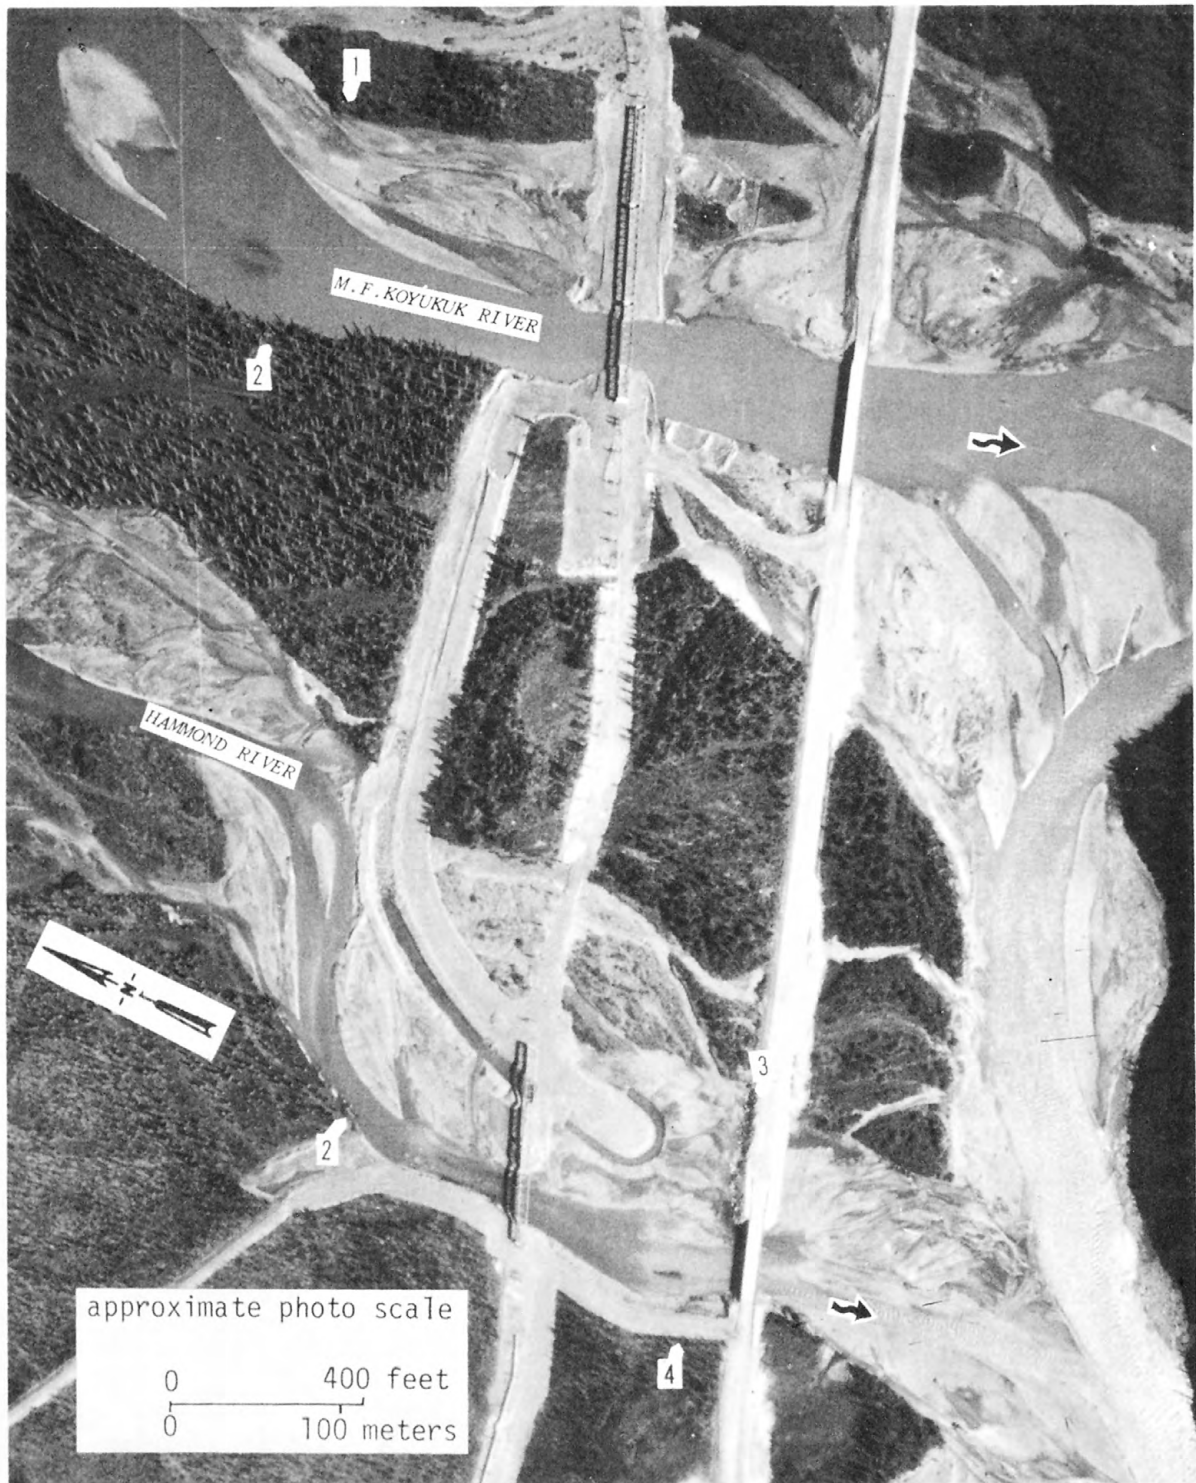
1976 Surveillance.--Figure 6 shows the Middle Fork Koyukuk River at Hammond River crossing site on July 19, 1976. The overhead pipe bridge has been completed and work is progressing on a protective dike which extends from the right bank of the river to the left bank of the Hammond River. On the right bank fill has been extended out from the natural bank about 65 ft (20 m).

Figure 6.-- Middle Fork Koyukuk River at Hammond River and Hammond River near Wiseman, July 19, 1976. AIR PHOTO TECH

1976 Surveillance.--Figure 6 shows the Hammond River crossing site on July 19, 1976. The overhead pipe bridge has been completed and work is in progress on protective dikes on both banks of the river.

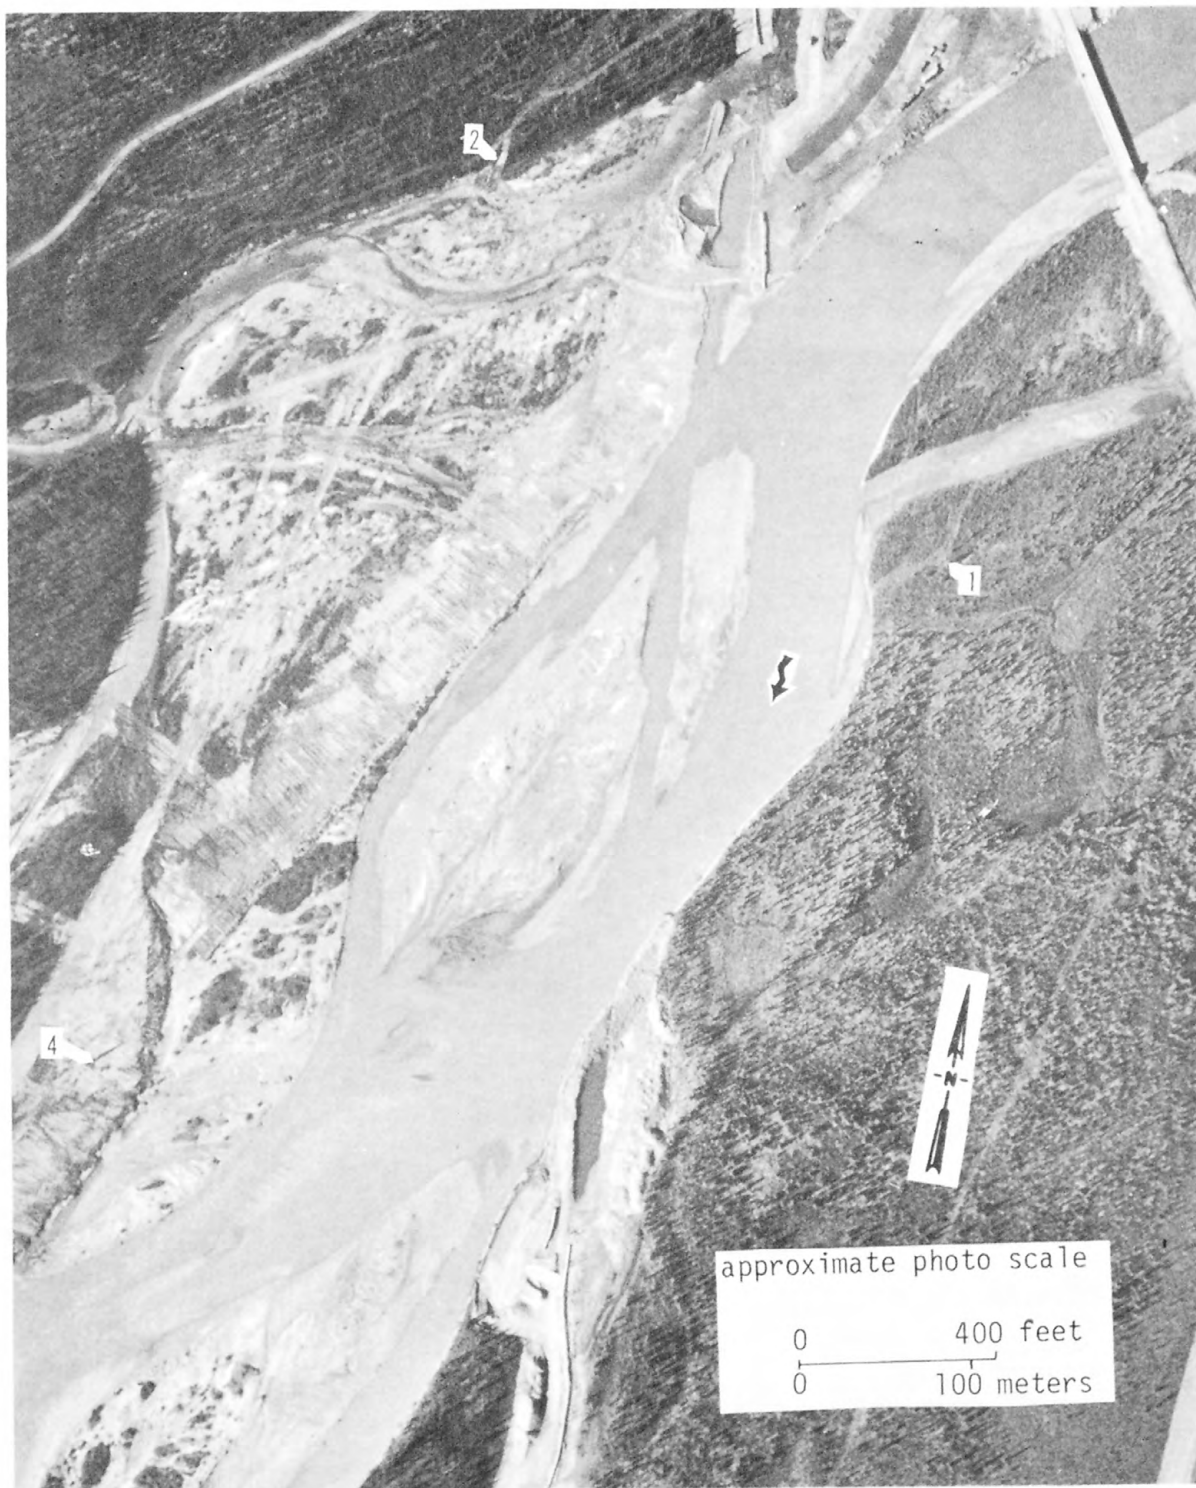
1976 Surveillance.--Figure 9 shows the Middle Fork Koyukuk River near

Figure 9.-- Middle Fork Koyukuk River near Wiseman, August 2, 1976.

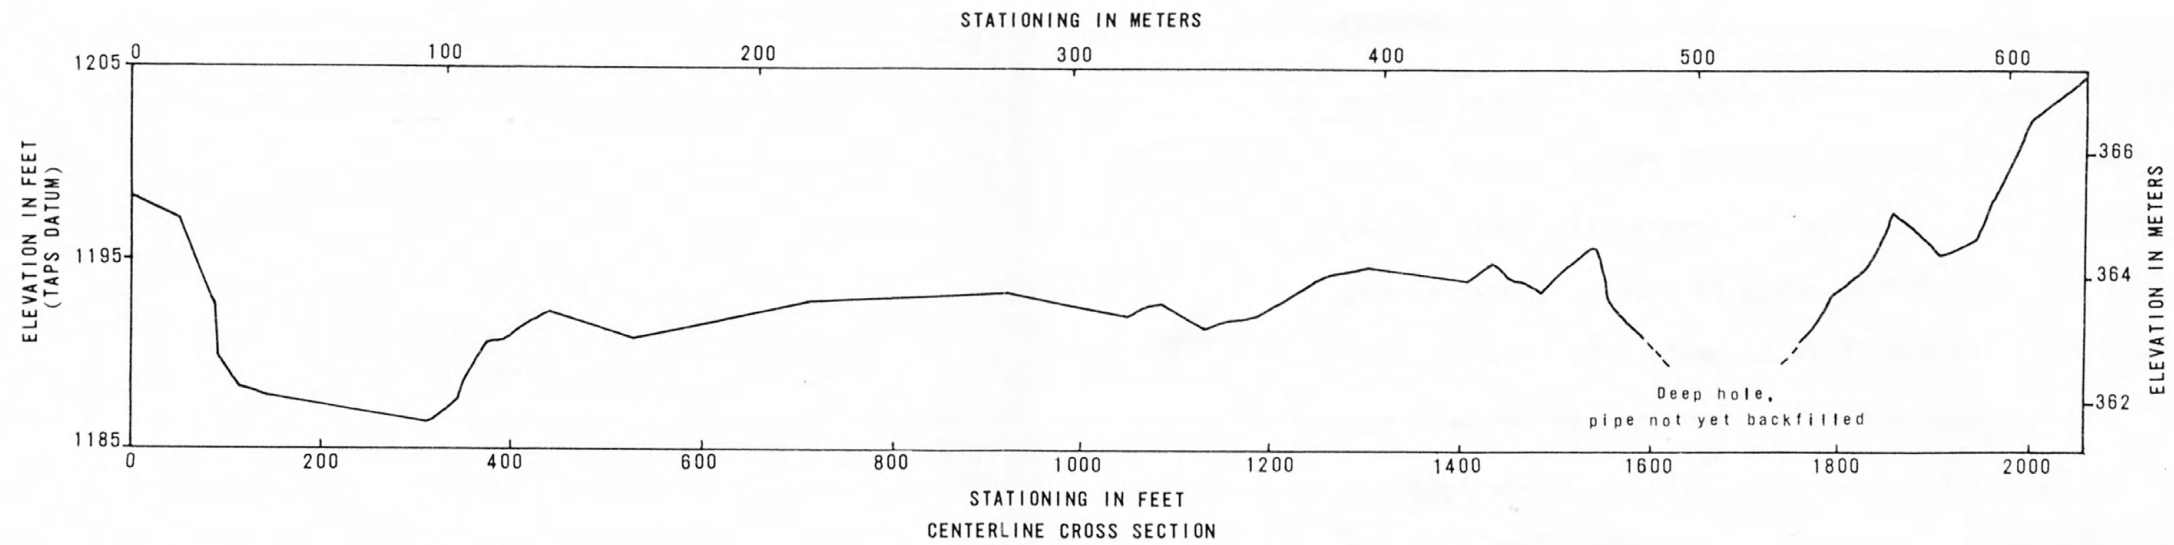
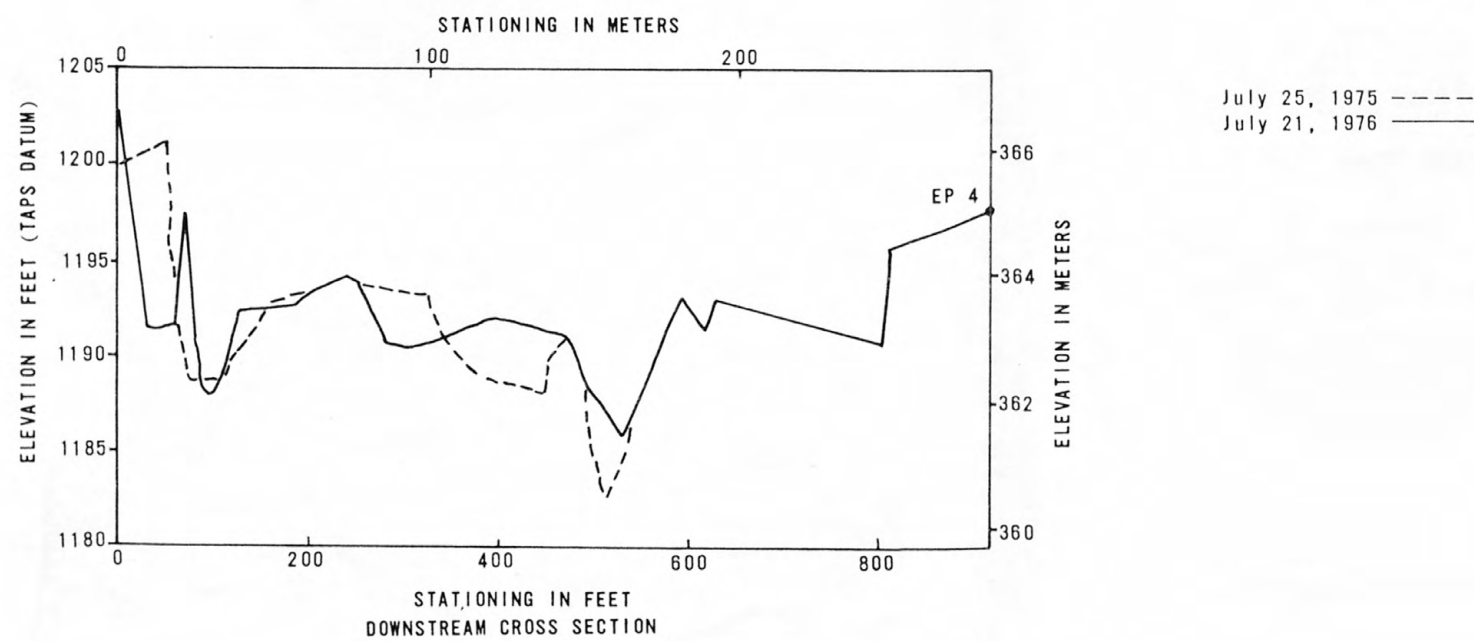
The crossing site was resurveyed in July 1976. Except for elimination of the dike on the right bank and the depression along the centerline where the pipe has been buried, the upstream cross section had not significantly changed since 1975. Figure 10 shows the new centerline cross section and the changes in the downstream cross section where the channel continues to be very active. Ongoing construction has changed the configuration of the left bank on the downstream section and resulted in destruction of EP-3.

Figure 10.-- Cross sections of the Middle Fork Koyukuk River near Wiseman.

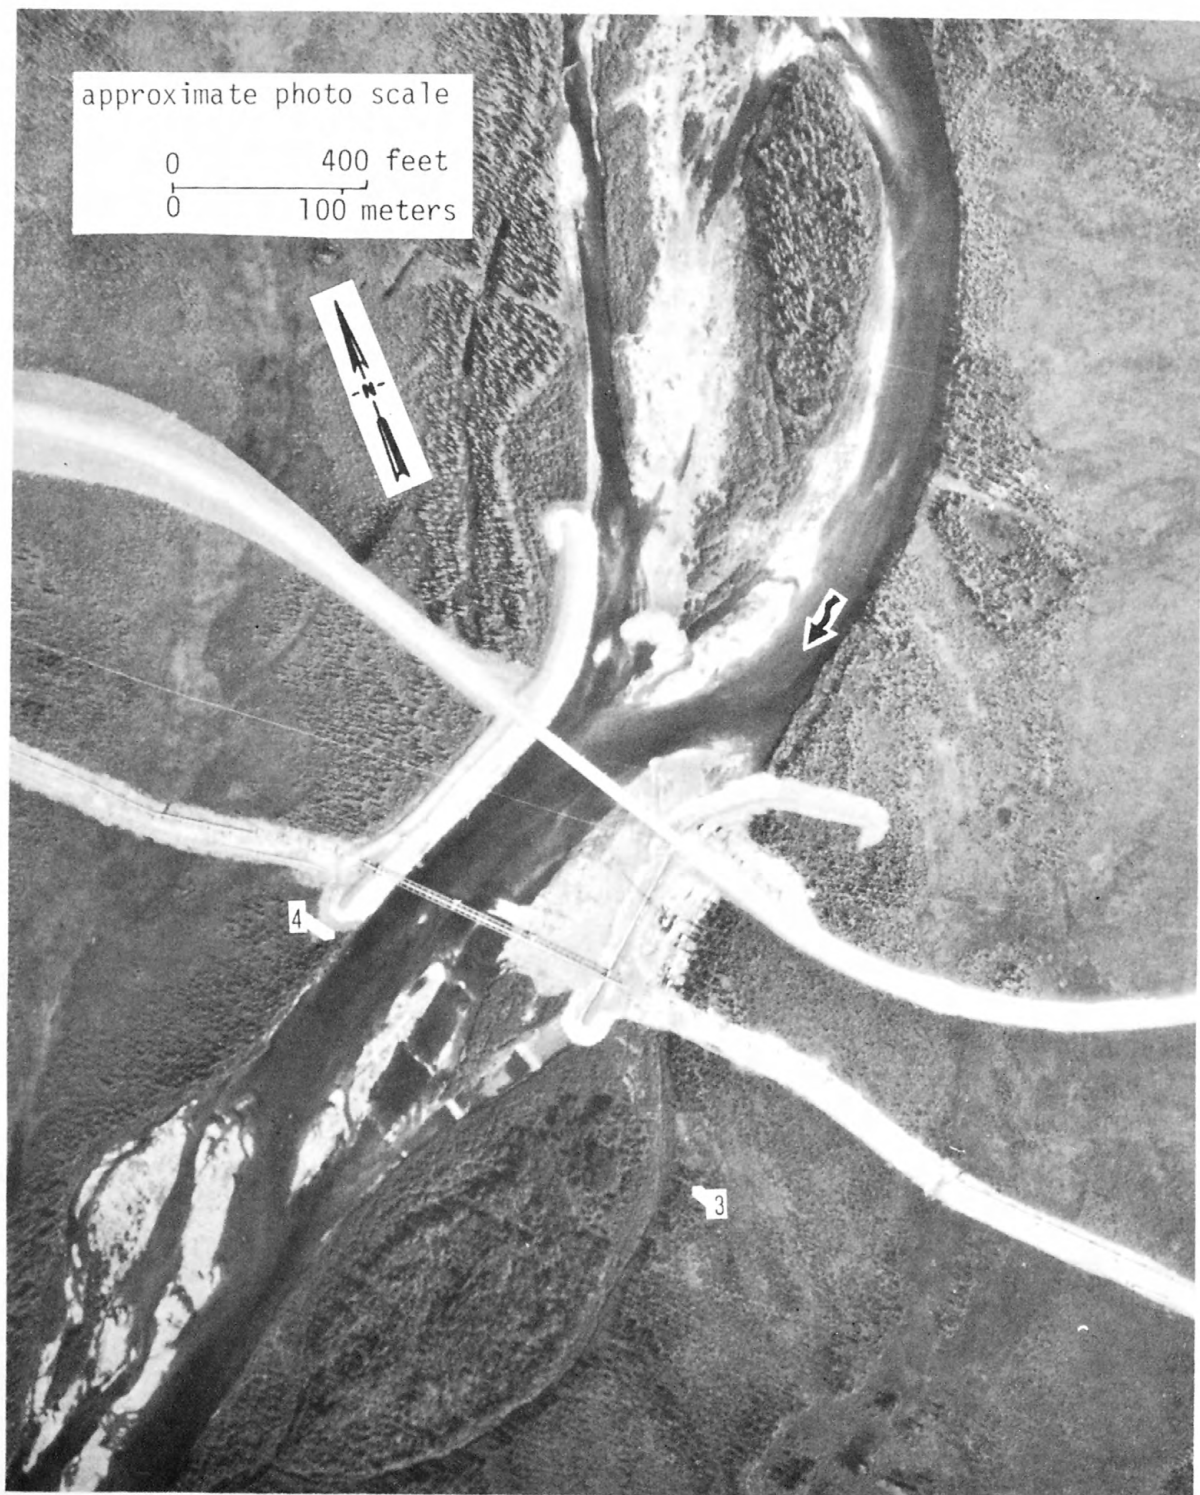
1976 Surveillance.--Figure 12 shows the South Fork Koyukuk crossing site on July 19, 1976. The overhead pipe crossing has been completed, and both banks from above the highway bridge to below the pipeline have been diked and lined with riprap.

Figure 12.-- South Fork Koyukuk River near Wiseman, July 19, 1976.
AIR PHOTO TECH

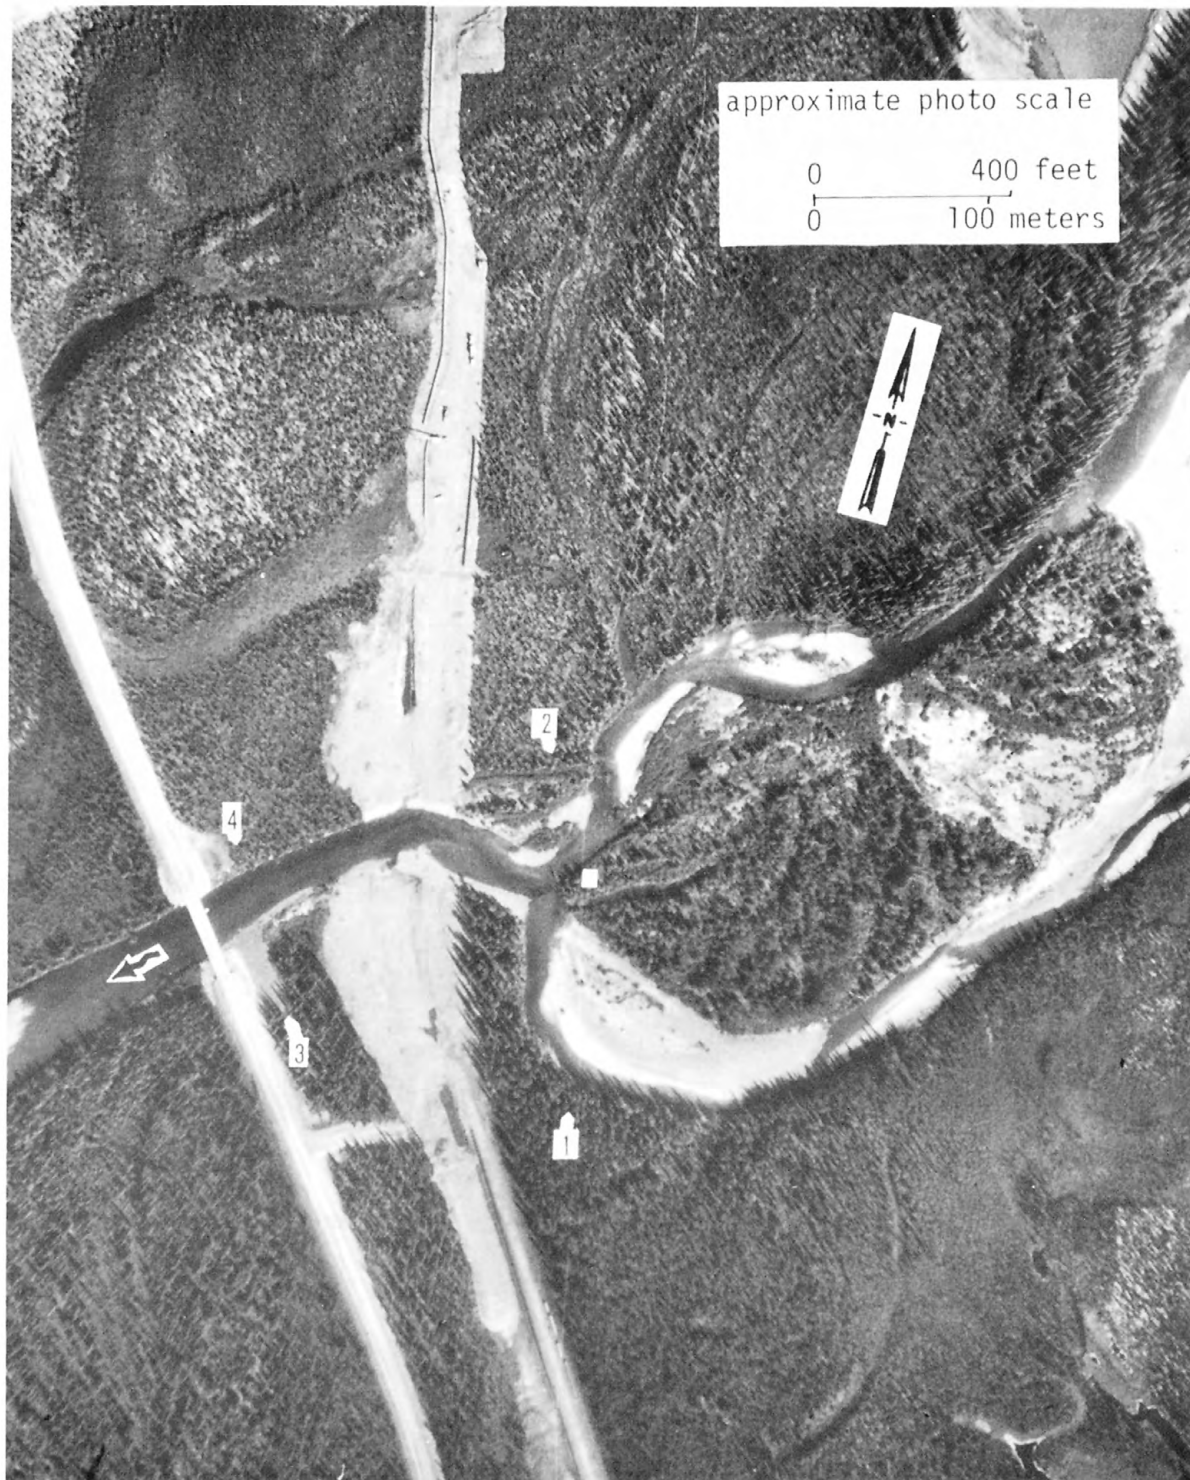
1976 Surveillance.--Figure 14 shows the Jim River crossing site on July 19, 1976. The pipe has been buried at this crossing.

Figure 14.-- Jim River near Prospect Creek Camp, July 19, 1976.

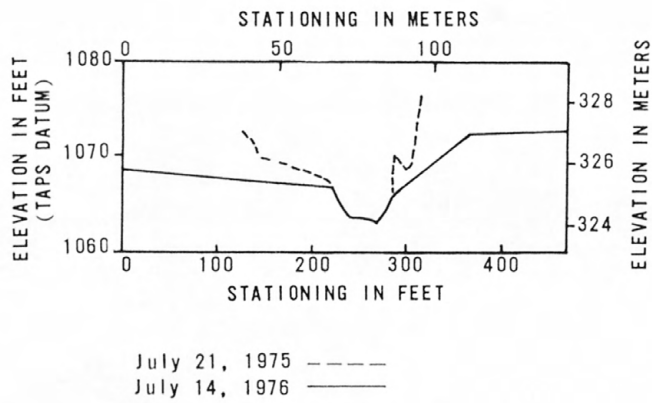
The crossing site was resurveyed in July 1976. Figure 15 shows the construction changes at the centerline cross section. Backfilling had not been completed when the survey was made.

Figure 15.-- Centerline cross section of the Jim River near Prospect Creek Camp.

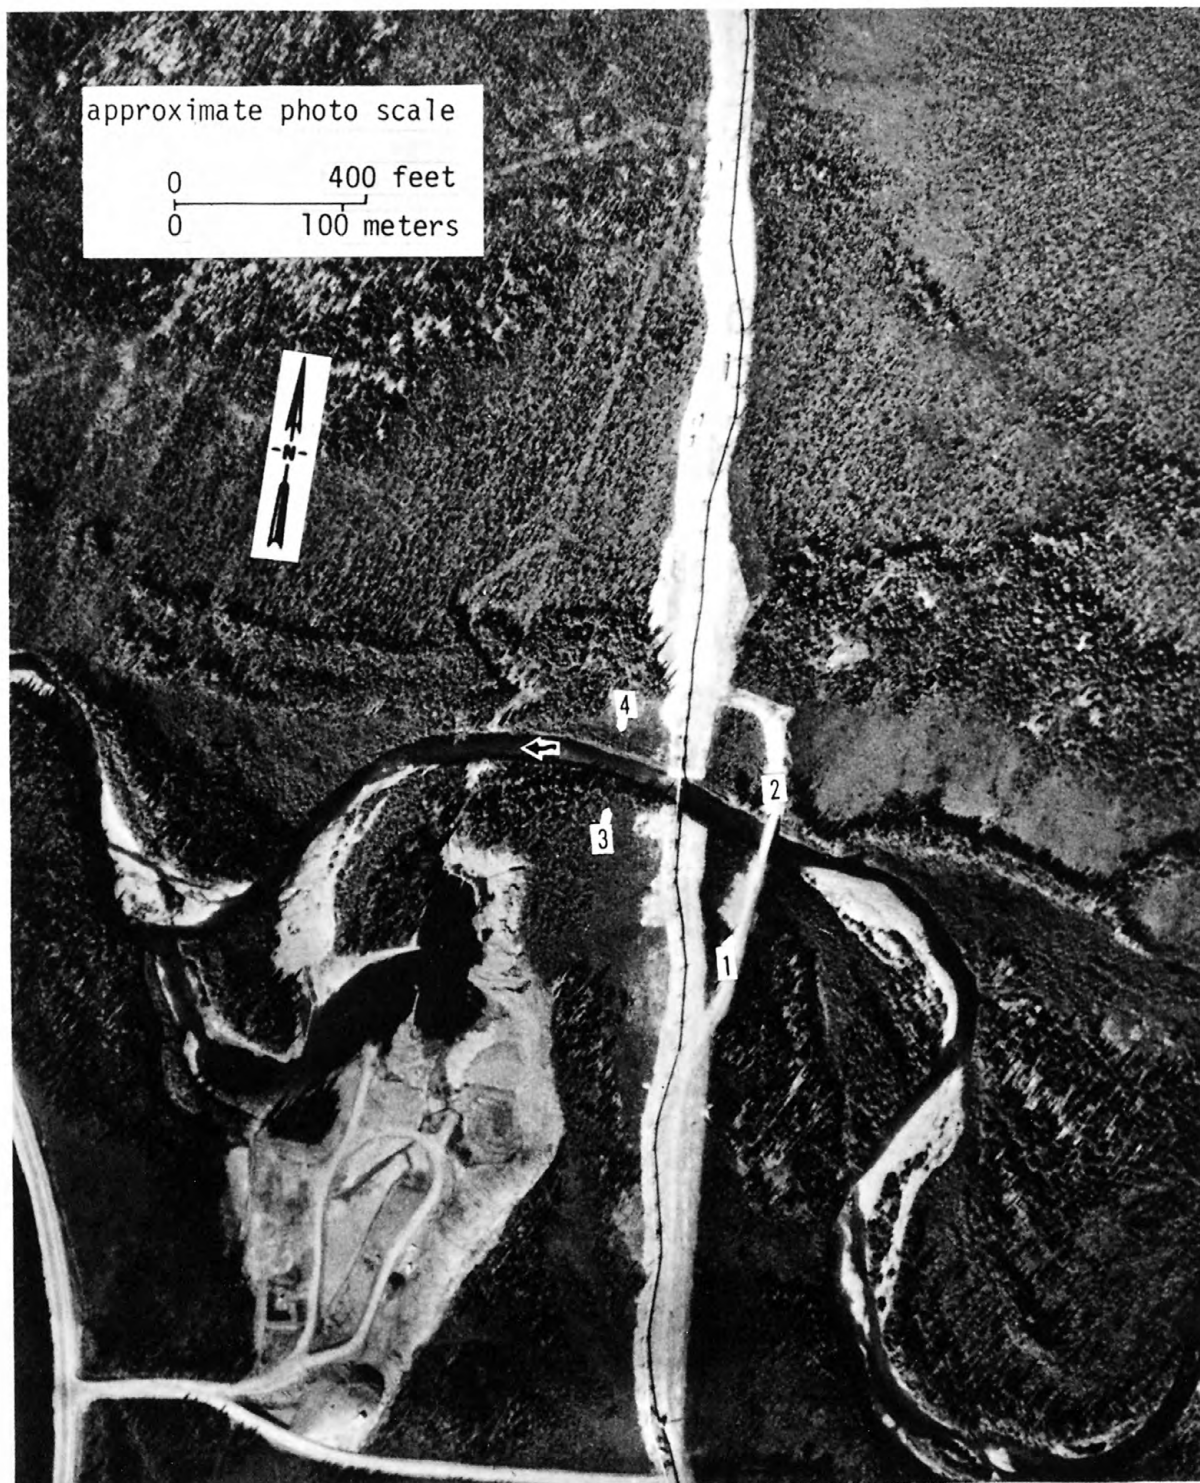
1976 Surveillance.--Figure 16 shows the Prospect Creek crossing site on August 2, 1976. The overhead pipe crossing has been completed.

Figure 16.-- Prospect Creek near Prospect Creek Camp, August 2, 1976.

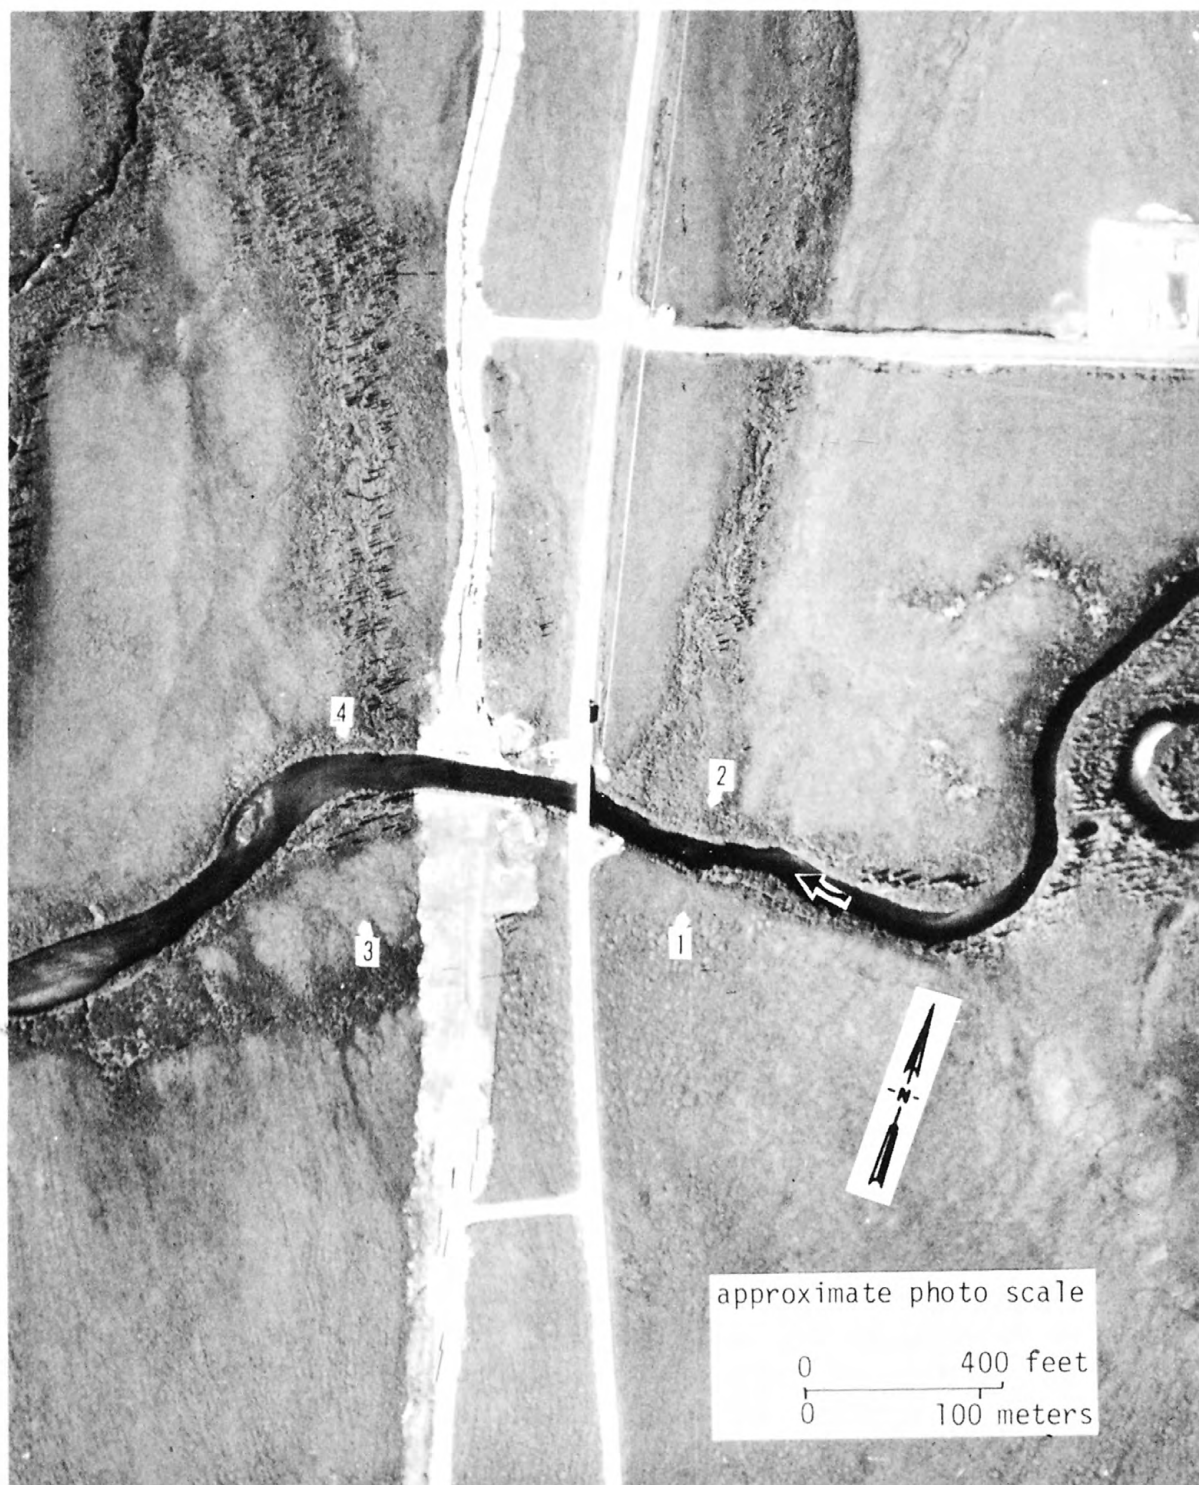
1976 Surveillance.--Figure 19 shows the Kanuti River crossing site on August 2, 1976. The pipe has been buried and the banks lined with riprap at centerline.

Figure 19.-- Kanuti River near Bettles, August 2, 1976. AIR PHOTO TECH

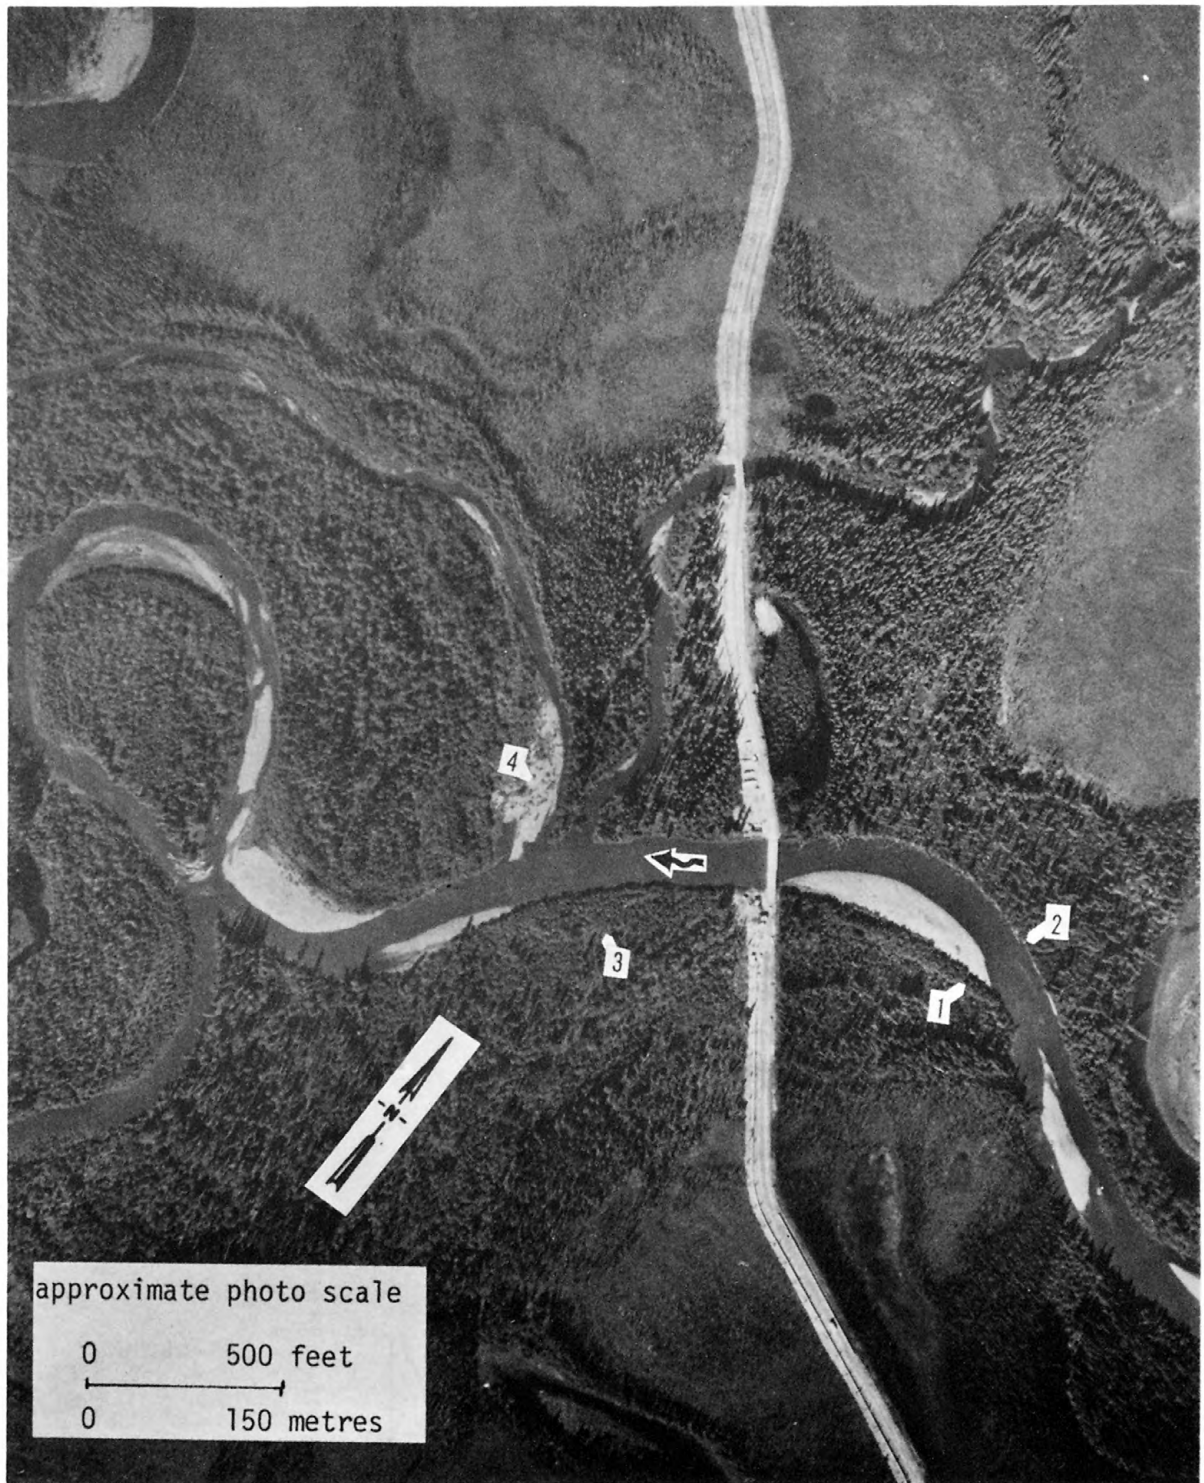
1976 Surveillance.--Figure 21 shows the Hess Creek crossing site on June 26, 1976. A temporary access bridge has been constructed just upstream of centerline. The workpad extends to both banks and work is in progress on the overhead pipe crossing. At the time of the resurvey, this was the only channel erosion site under surveillance where the pipe crossing had not yet been done.

Figure 21.-- Hess Creek near Livengood, June 26, 1976. AIR PHOTO TECH

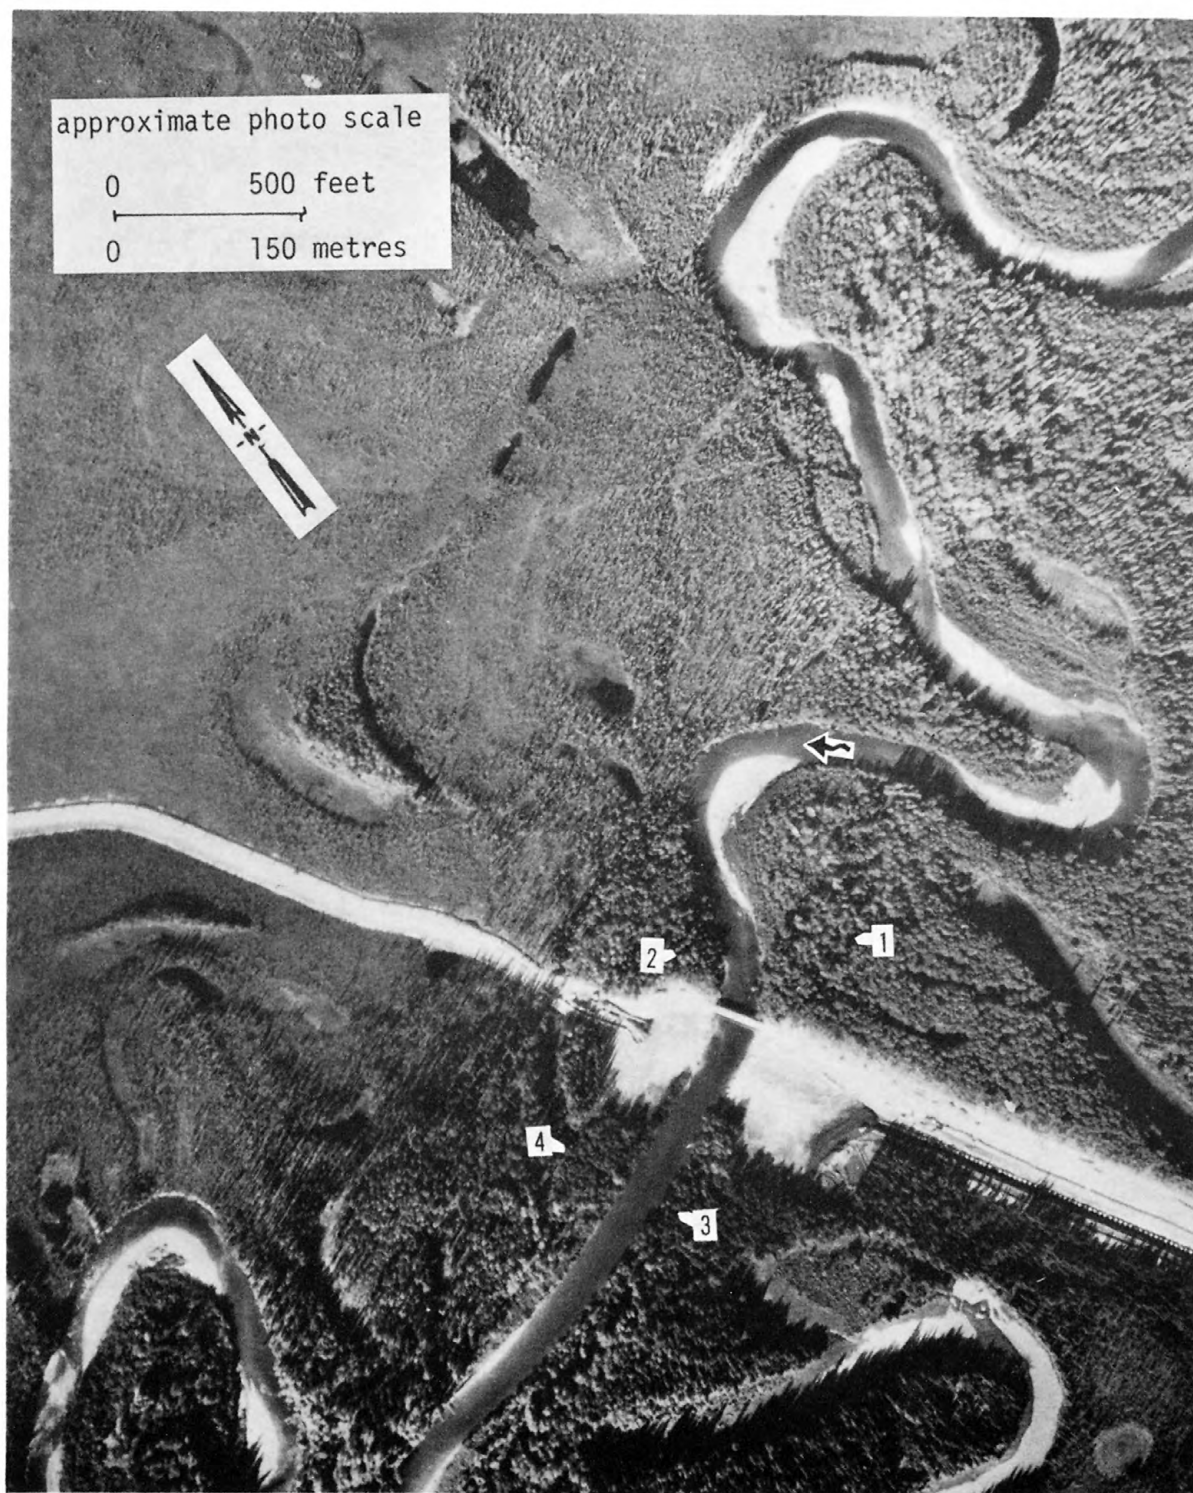
1976 Surveillance.--Figure 23 shows the Chatanika River crossing site on June 26, 1976. A bridge has been installed just upstream of the pipe centerline, and the pipe has been buried across the channel. A log crib has been built at the left bank on the centerline to help stabilize the bank sloughing.

Figure 23.-- Chatanika River near Olmes, June 26, 1976. AIR PHOTO TECH
