CHANNEL EROSION SURVEYS ALONG TAPS ROUTE, ALASKA, 1976

UNITED STATES DEPARTMENT OF THE INTERIOR
GEOLOGICAL SURVEY

By
Paul F. Doyle
and
Joseph M. Childers

77-170

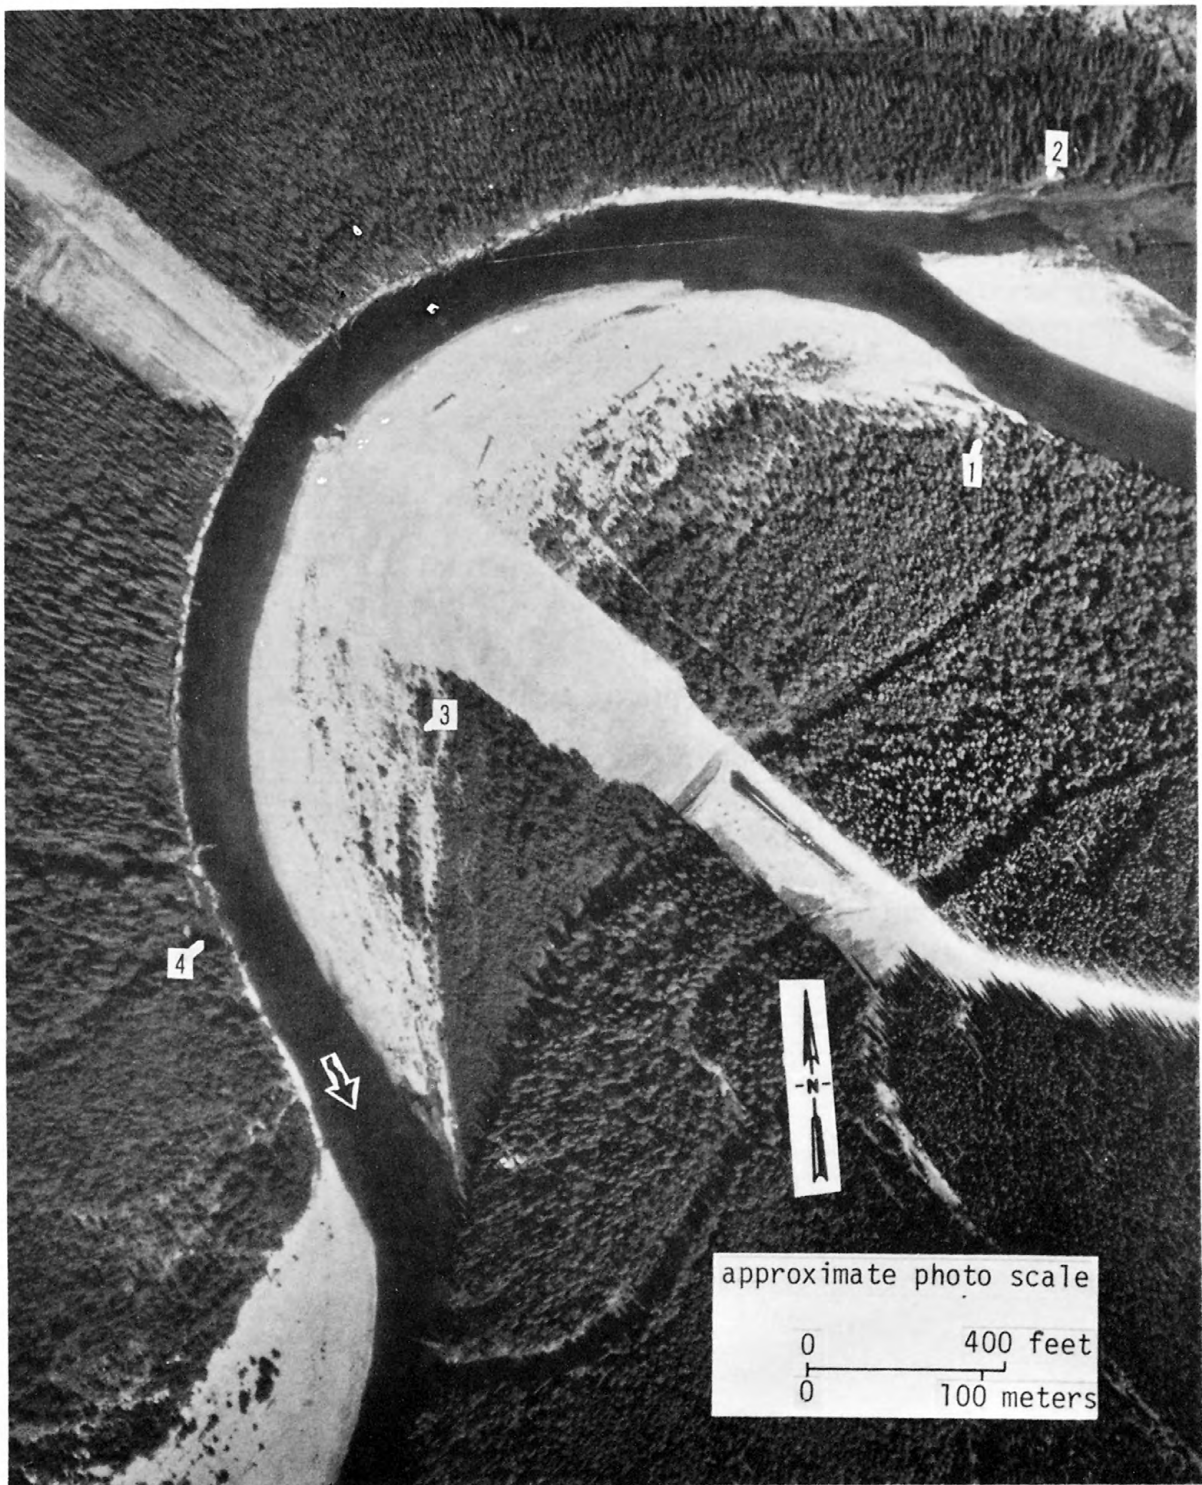
1976 Surveillance.--Figure 25 shows the Salcha River crossing site on August 1, 1976. The pipe has been buried across the flood plain and main channel.

Figure 25.-- Salcha River near Salchaket, August 1, 1976. AIR PHOTO TECH

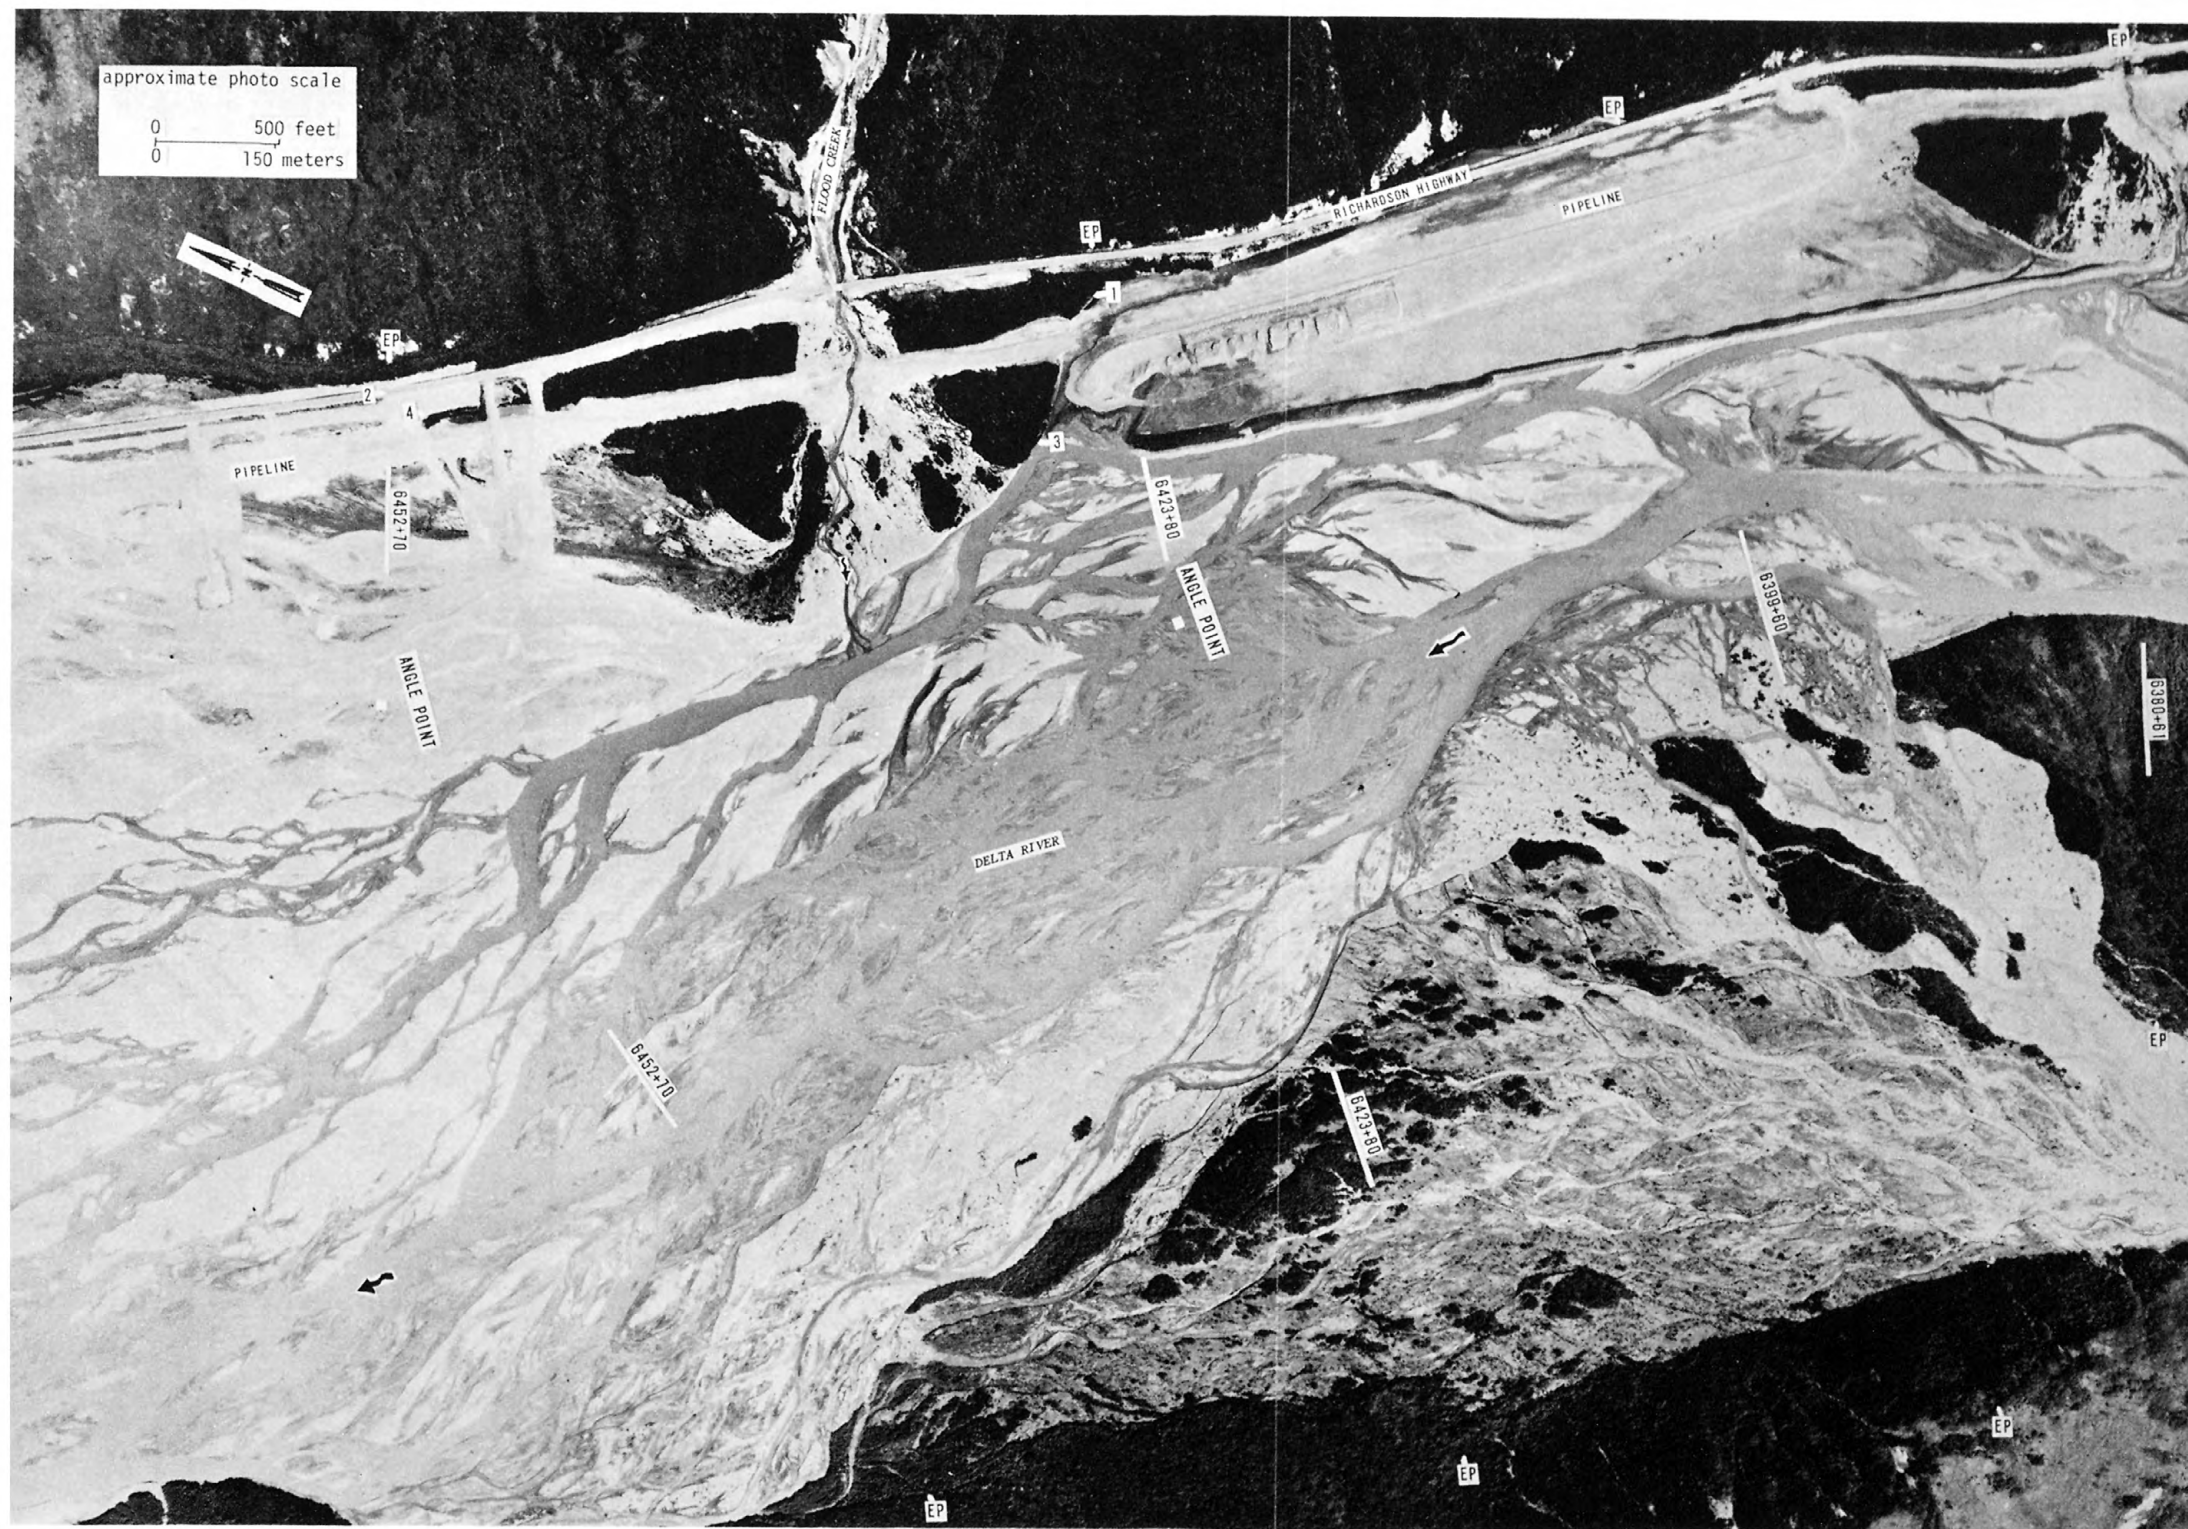
1976 Surveillance.--Figure 27 shows the Flood Creek crossing on July 6, 1976. The pipe has been buried across the Flood Creek fan.

Figure 27.-- Delta River at Flood Creek and Flood Creek near Rapids, July 6, 1976. AIR PHOTO TECH

1976 Surveillance.--Figure 27 shows the Delta River at Flood Creek site on July 6, 1976. Lateral dikes have been built to protect the buried pipe between Michael and Flood Creeks. These dikes have forced the flow to the left side of the channel to some extent.

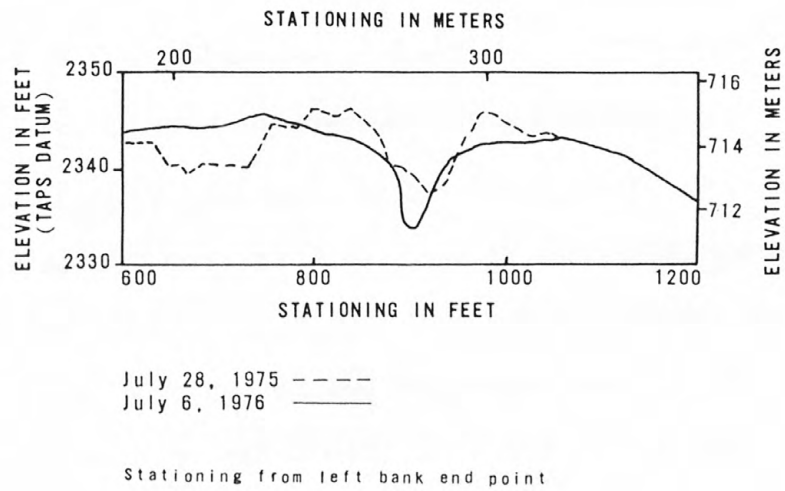
The crossing site was resurveyed photogrammetrically in July 1976, and the downstream section was resurveyed on the ground in September. There were no significant changes in the upstream or downstream cross sections at Flood Creek itself although the channel at the downstream section is straightening. All three cross sections have been changed by construction at the fan edges. Figure 28 shows the construction change at centerline at Flood Creek itself.

Figure 28.-- Centerline cross section of Flood Creek near Rapids.

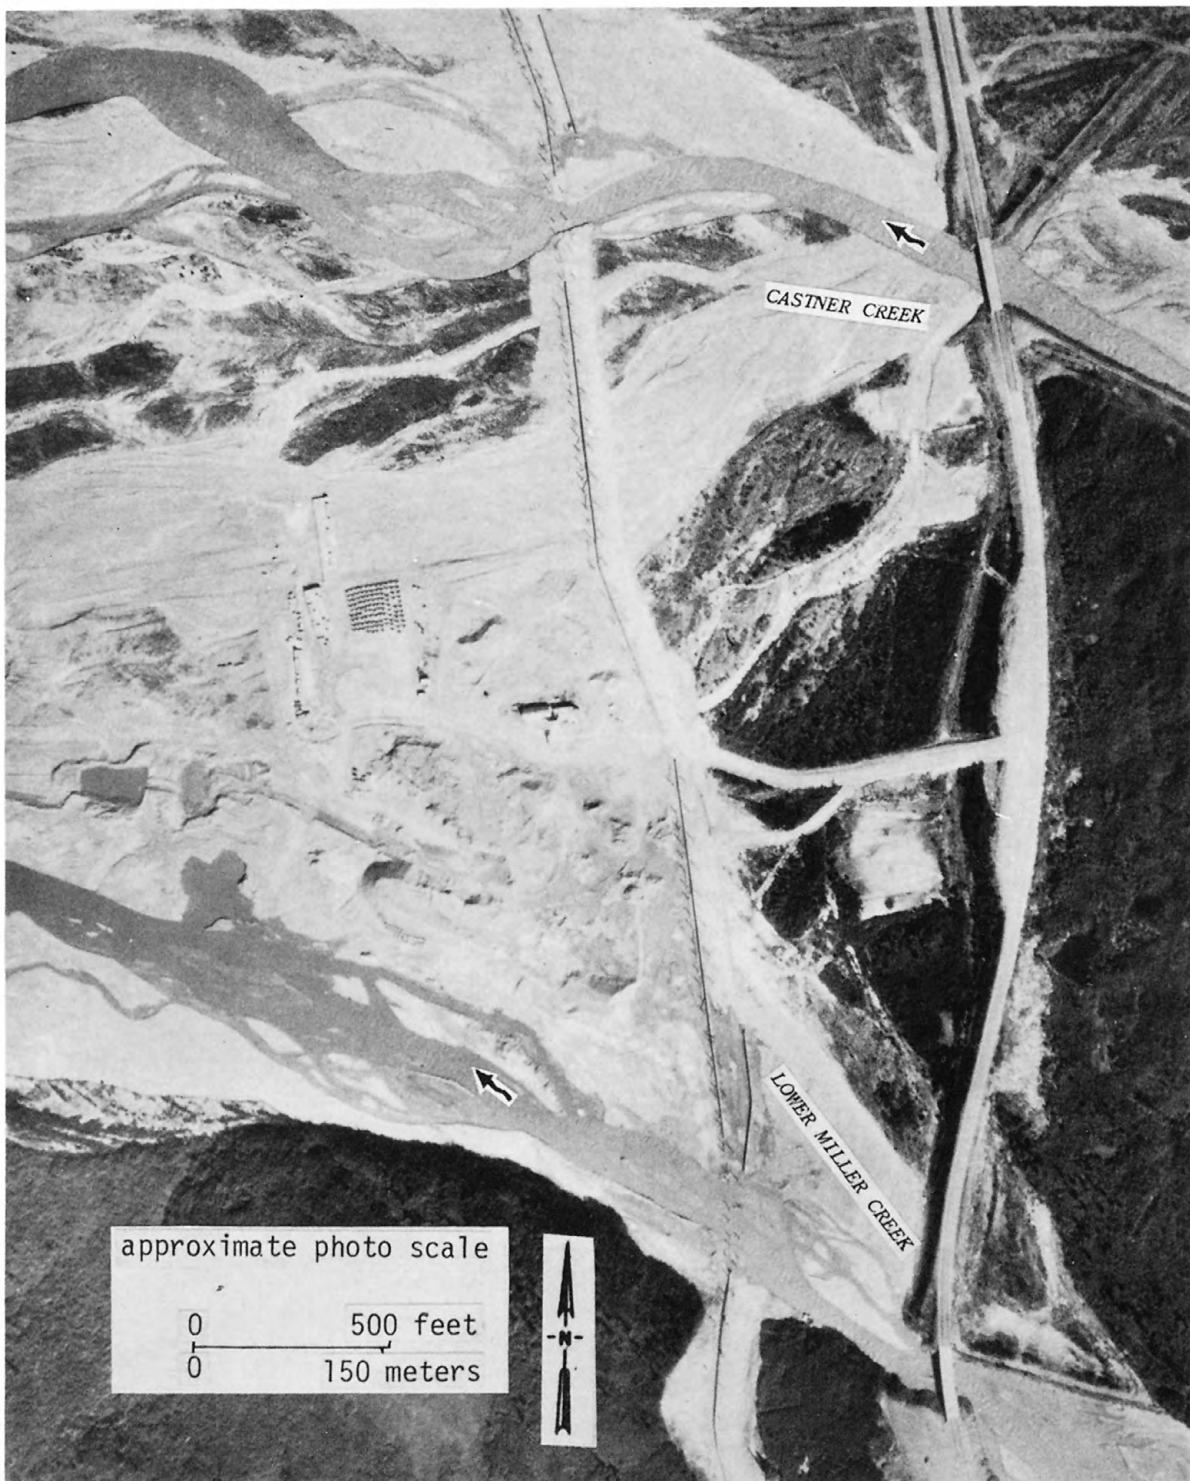
Figure 30 shows the Castner Creek and Lower Miller Creek near Rapids site on August 1, 1976. The VSMs can be seen in place across the entire floodway. Figure 31 shows the completed pipe on a similar crossing on Miller Creek which is just south of these two crossings. The light truck under the pipe in the photo gives an idea of the scale.

Figure 30.-- Castner Creek and Lower Miller Creek near Rapids, August 1, 1976. AIR PHOTO TECH

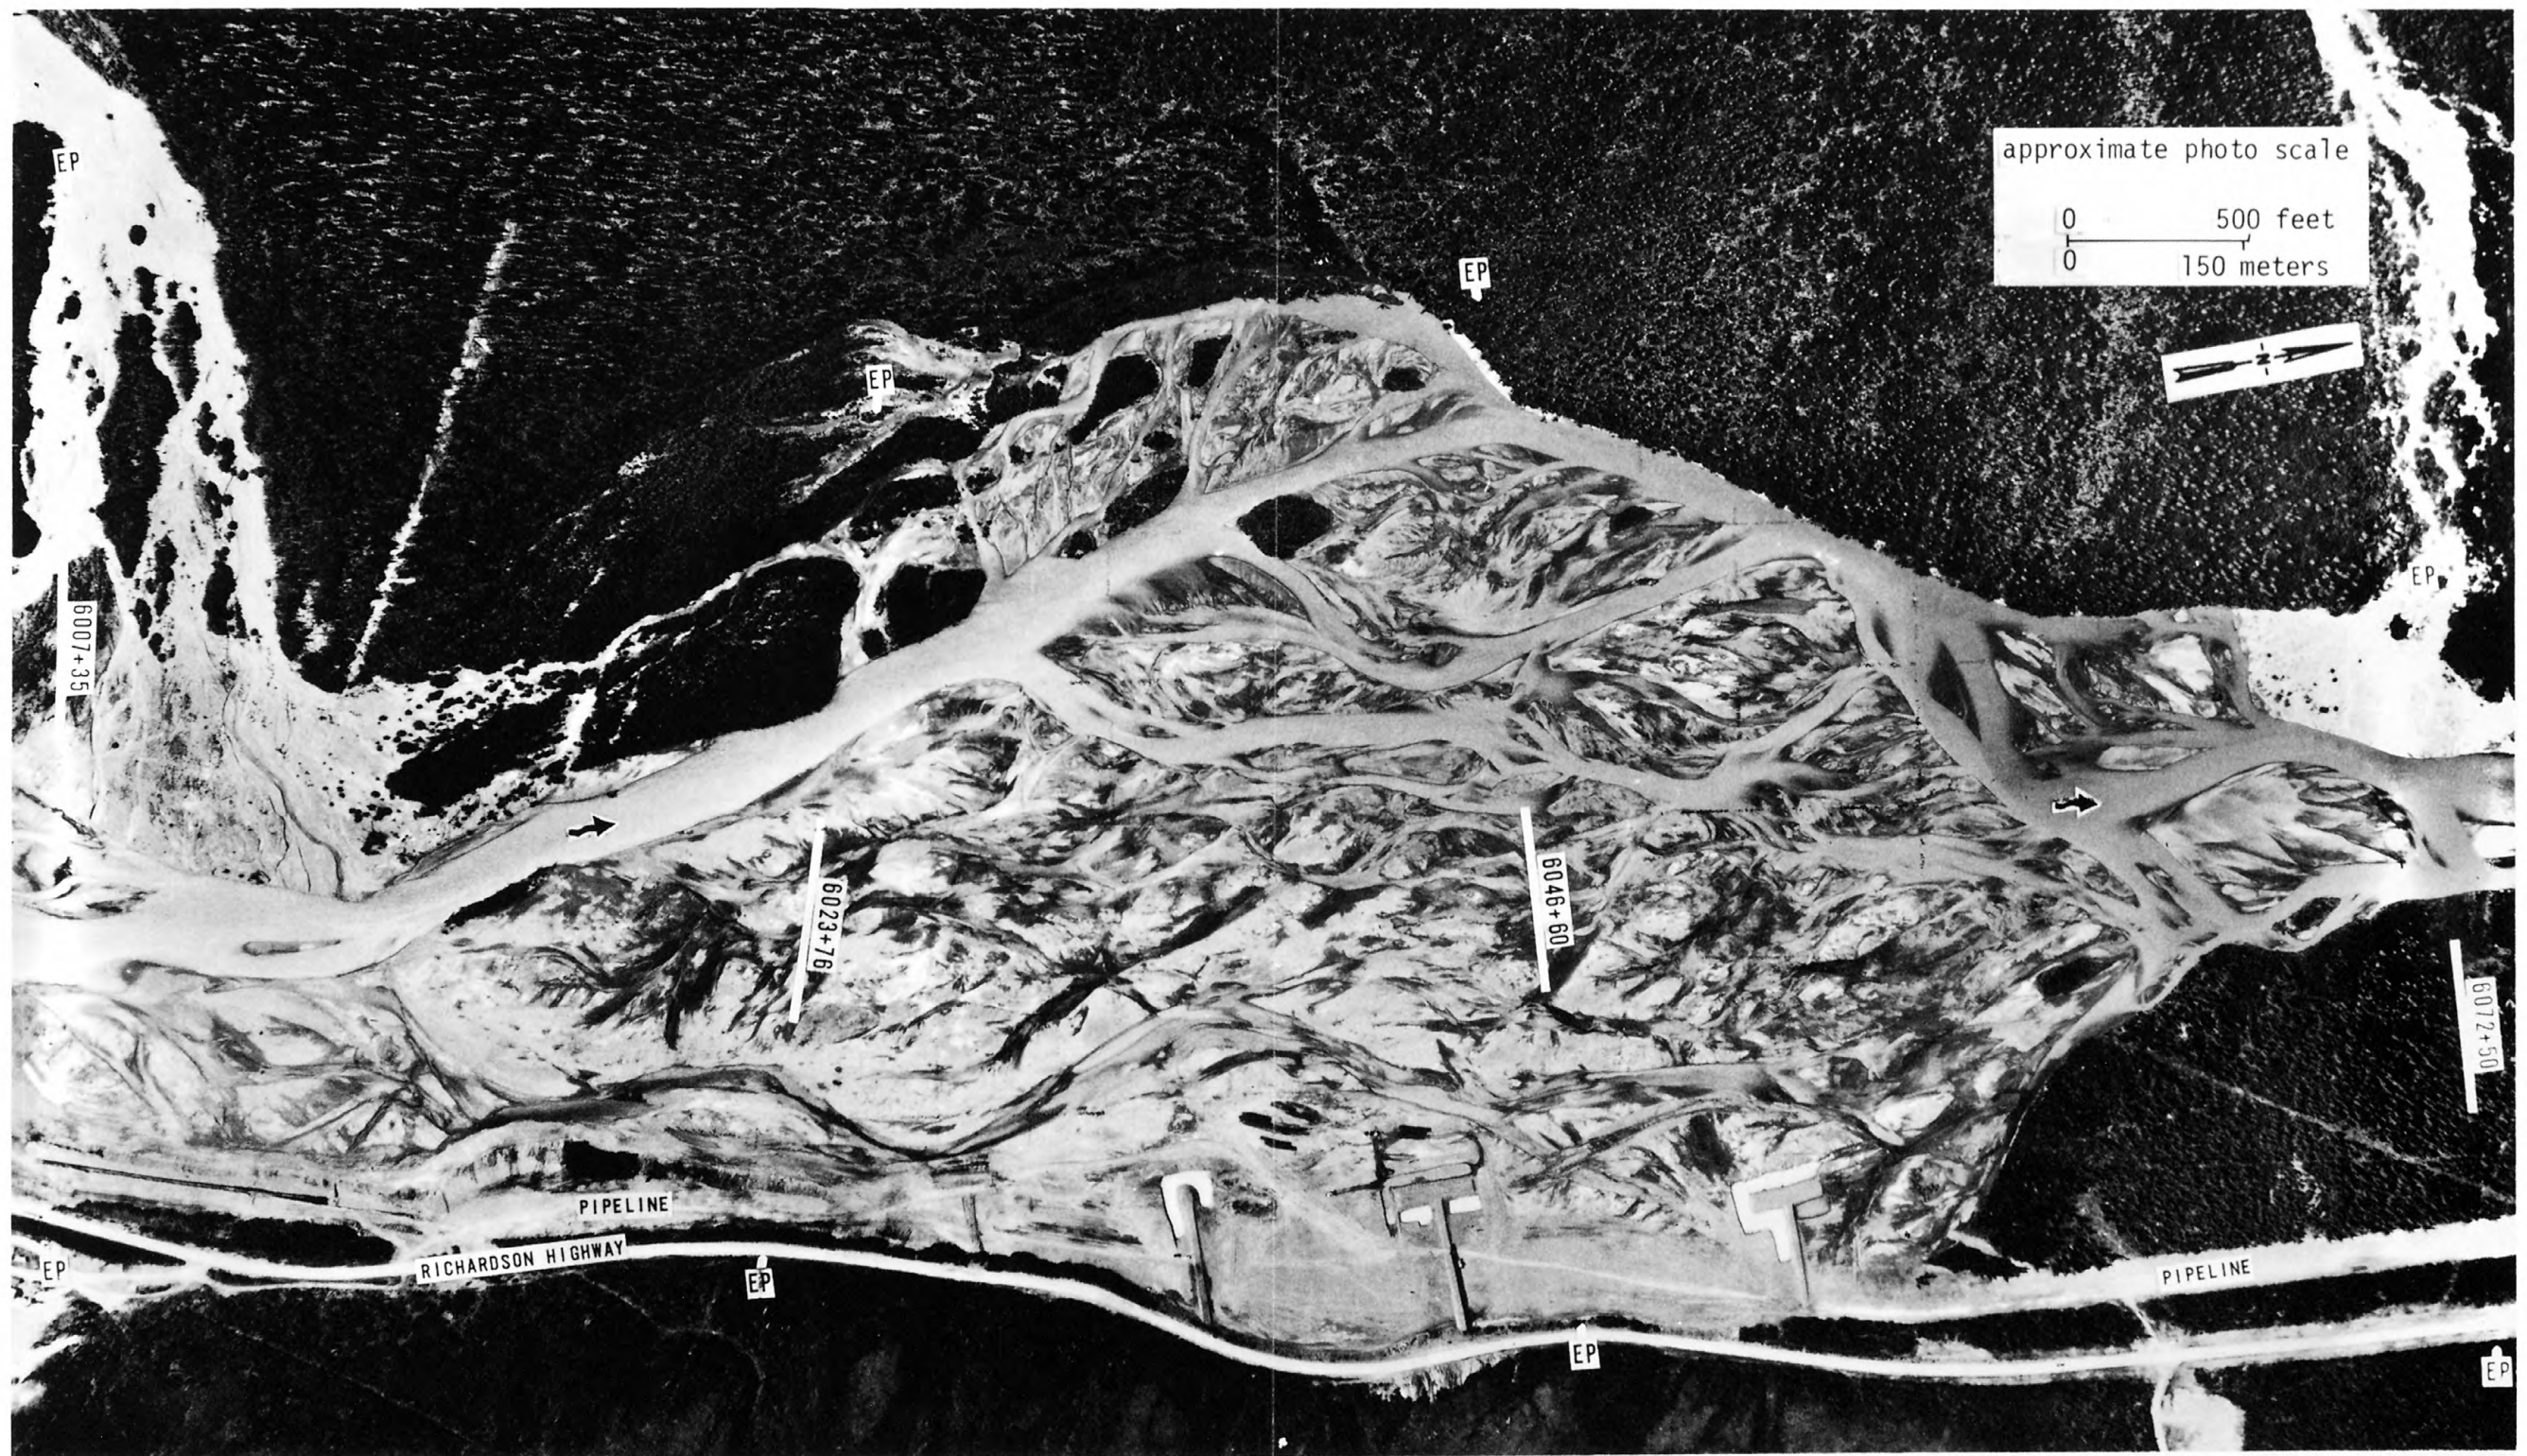
1976 Surveillance.--Figure 32 shows the Delta River at Phelan Creek site on July 6, 1976. The pipe has been buried along the right side of the flood plain and construction of protective spur dikes is in progress.

The site was resurveyed photogrammetrically in July and no significant changes were found in any of the surveyed cross sections. The subchannels have continued to shift back and forth within the flood plain. A field inspection of the site was made in September and a check of the thalweg at section 6007+35 indicated no change since 1975.

Figure 32.-- Delta River at Phelan Creek, July 6, 1976. AIR PHOTO TECH

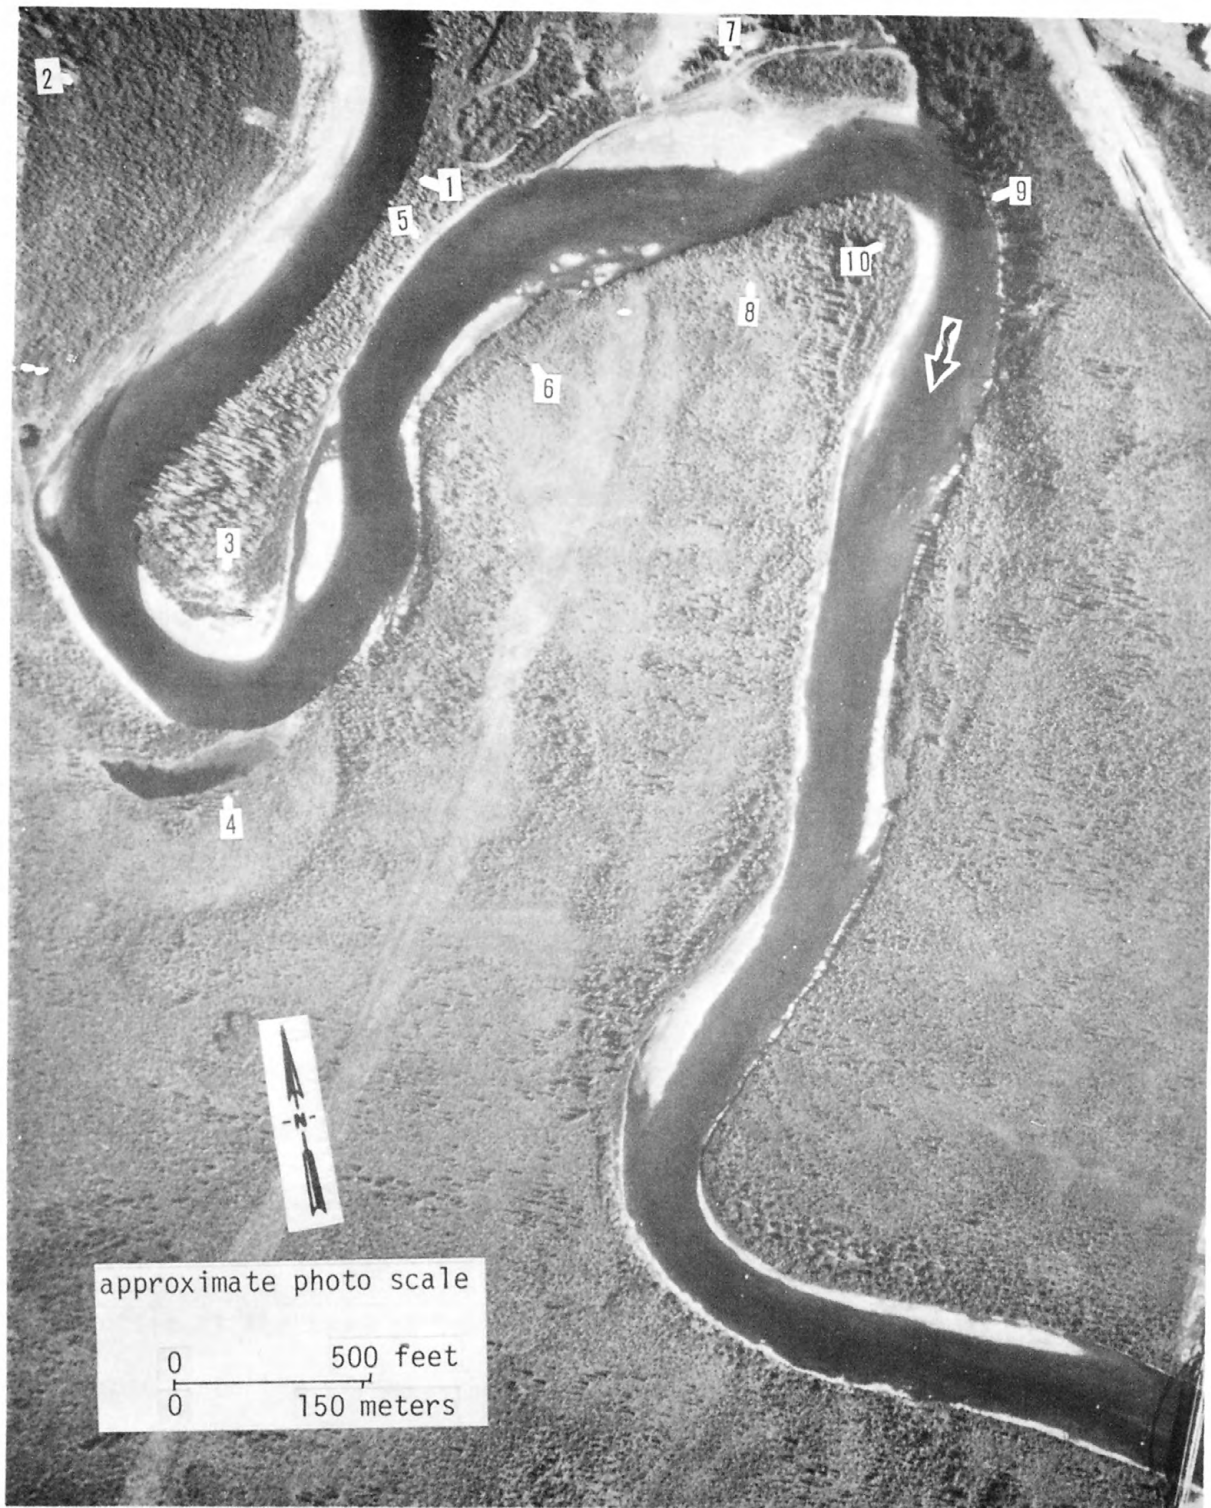
1976 Surveillance.--Figure 33 shows the Gulkana River site on August 1, 1976. The pipe alinement has been changed since the 1975 survey and the new crossing site is shown in the lower right hand corner of Figure 33. It was decided to continue monitoring the cross section at the former pipeline crossing because of the several years of cross section data already obtained and the relative position of the sections on the meander loops which should provide an excellent long-term record of river behavior on a meandering reach.

The site was resurveyed in September 1976. No significant change was found in any section; however, at section 5 the left bank continues to slump. Bank slumping has moved EP-9 15 ft (4.6 m) closer to the stream since the 1975 survey, but the surveyed profile is the same as in 1975. This indicates that as the bank slumps into the stream, the flow carries the material downstream.

Figure 33.-- Gulkana River near Sourdough, August 1, 1976. AIR PHOTO TECH

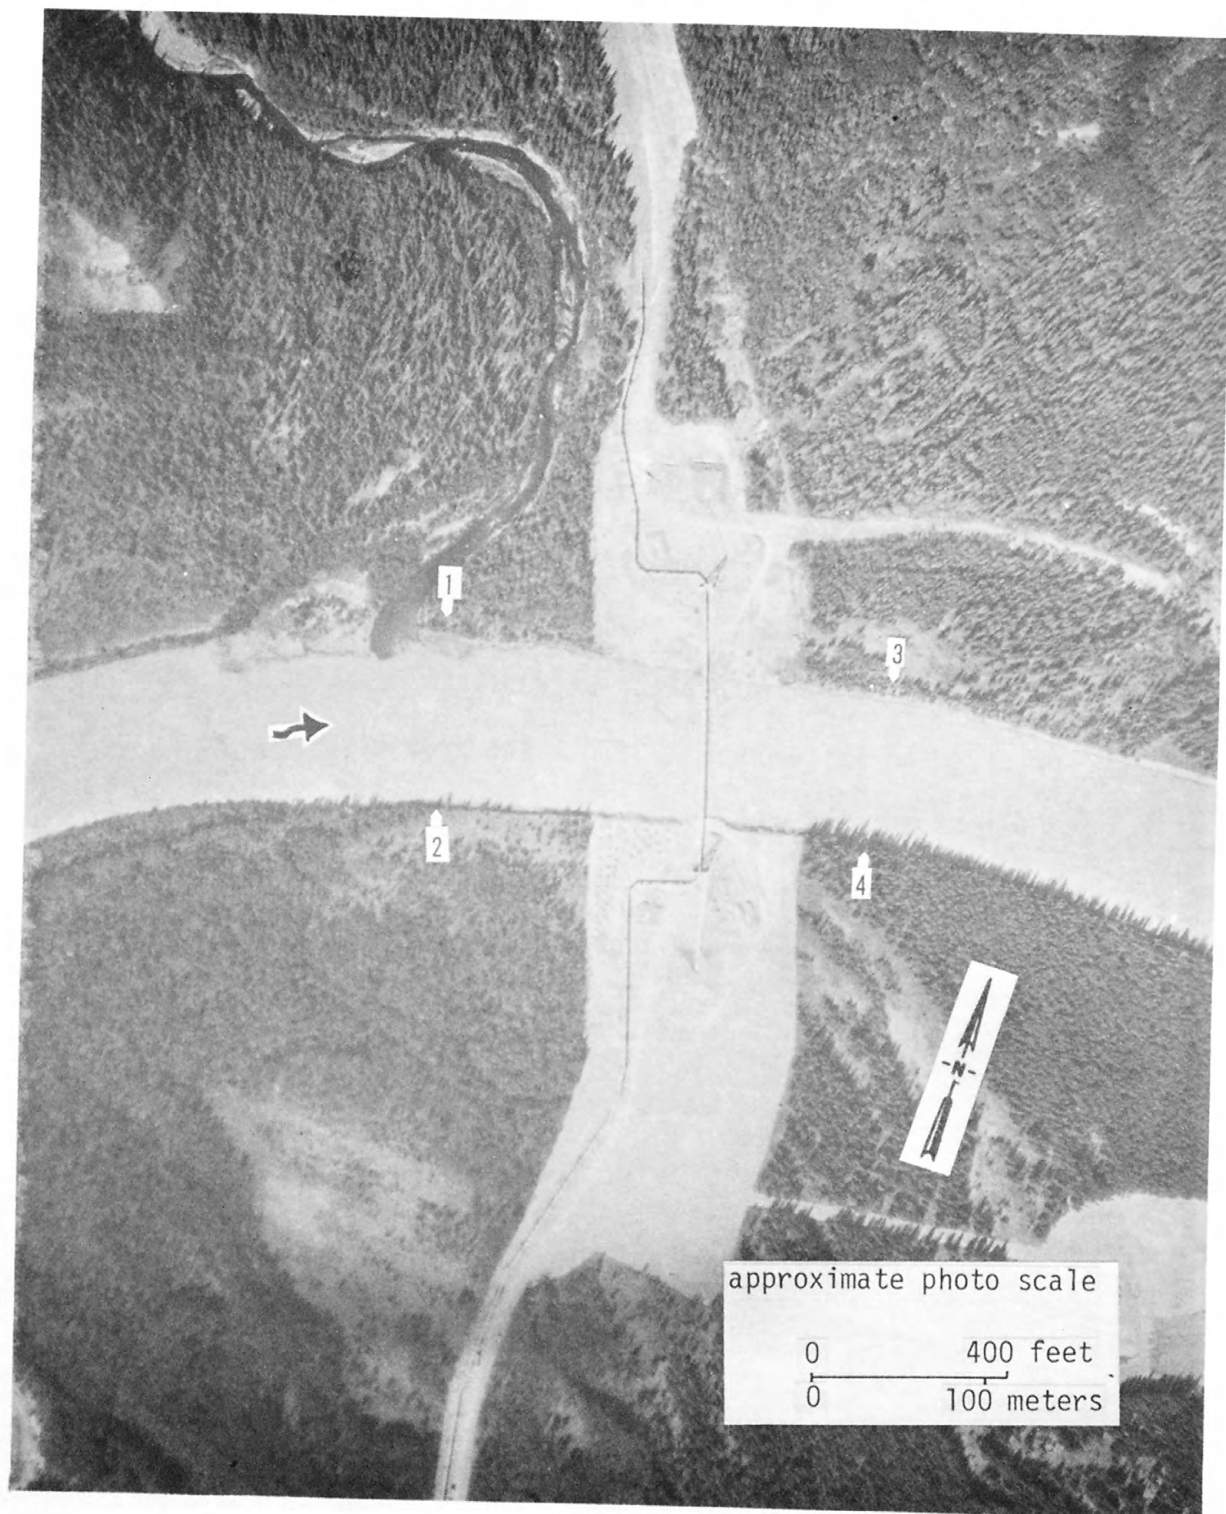
1976 Surveillance.--Figure 34 shows the Tazlina River crossing site on July 31, 1976. The overhead pipe crossing has been completed.

The crossing site was visually inspected in September 1976 during the peak of a glacier-dammed lake break-out flood which occurred on September 22, 1976. The peak discharge computed by indirect methods was $30,000 \text{ ft}^3/\text{s}$ ($850 \text{ m}^3/\text{s}$). Observation of the stream banks during this sudden high flow showed no bank erosion taking place; however, measured cross sections were not obtained.

Figure 34.-- Tazlina River near Glennallen, July 31, 1976. AIR PHOTO TECH

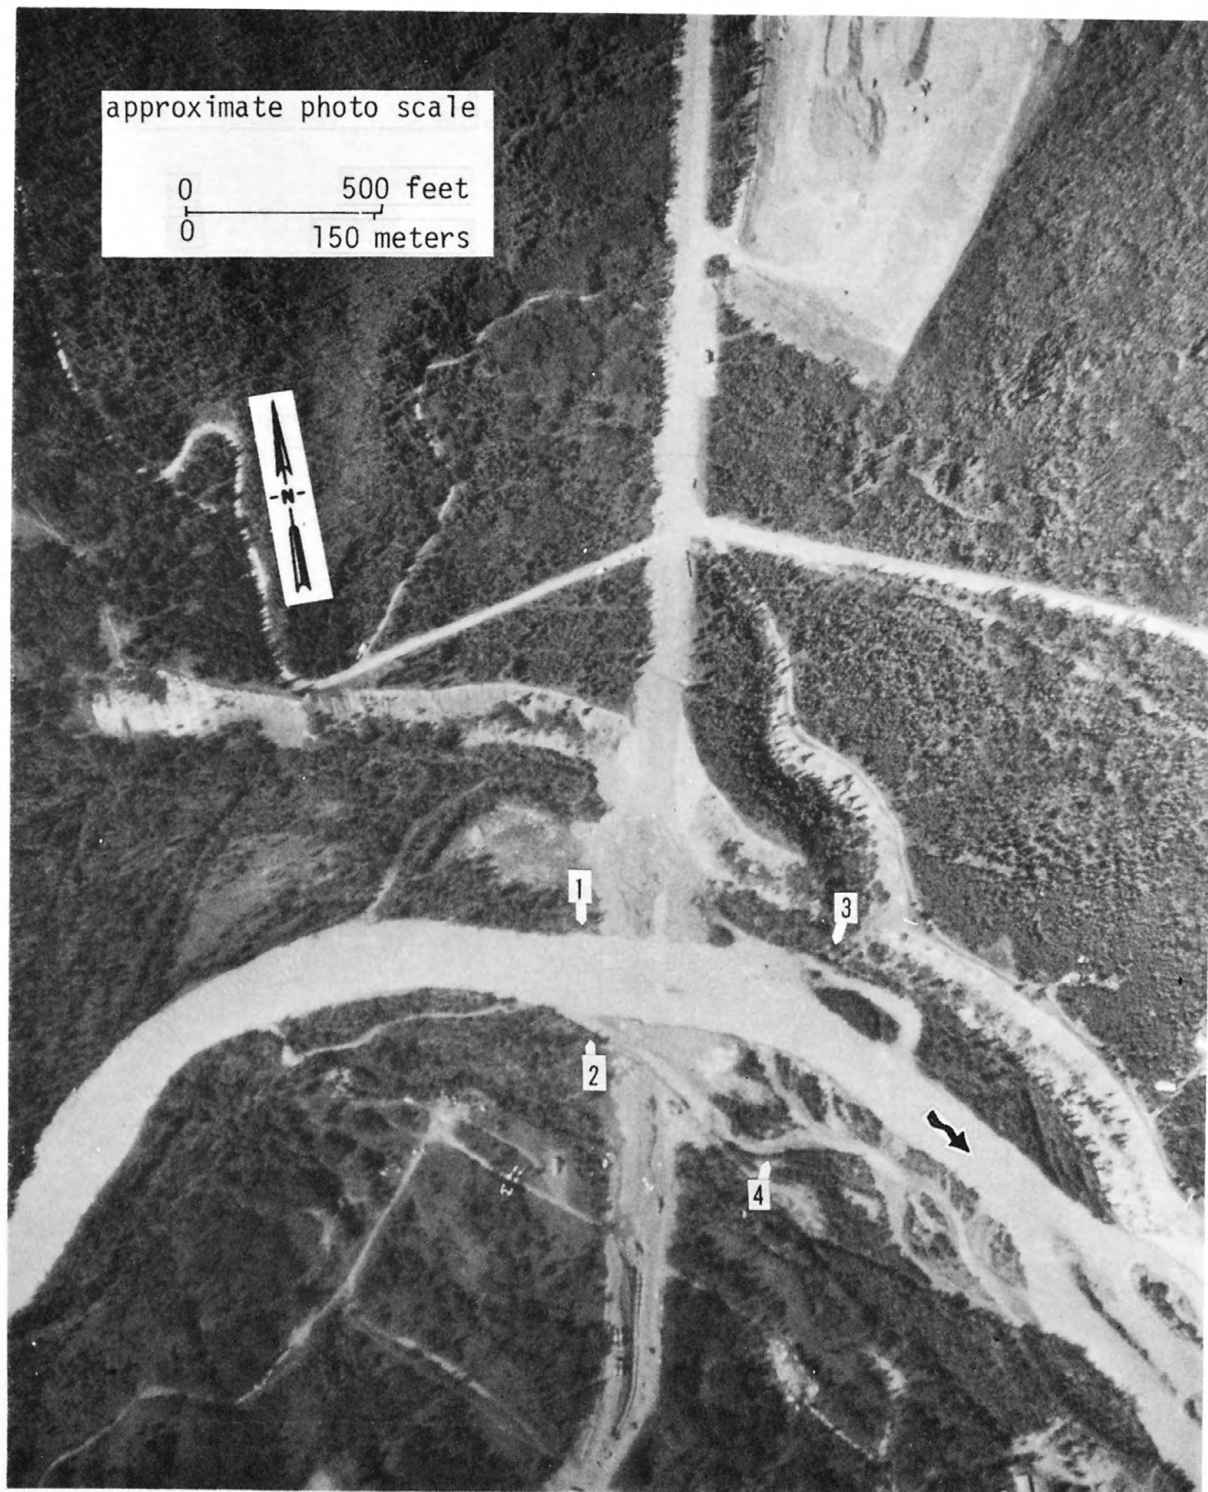
1976 Surveillance.--Figure 35 shows the Klutina River crossing site on July 31, 1976. The pipe has been buried across the channel.

Figure 35.-- Klutina River near Copper Center, July 31, 1976. AIR PHOTO TECH

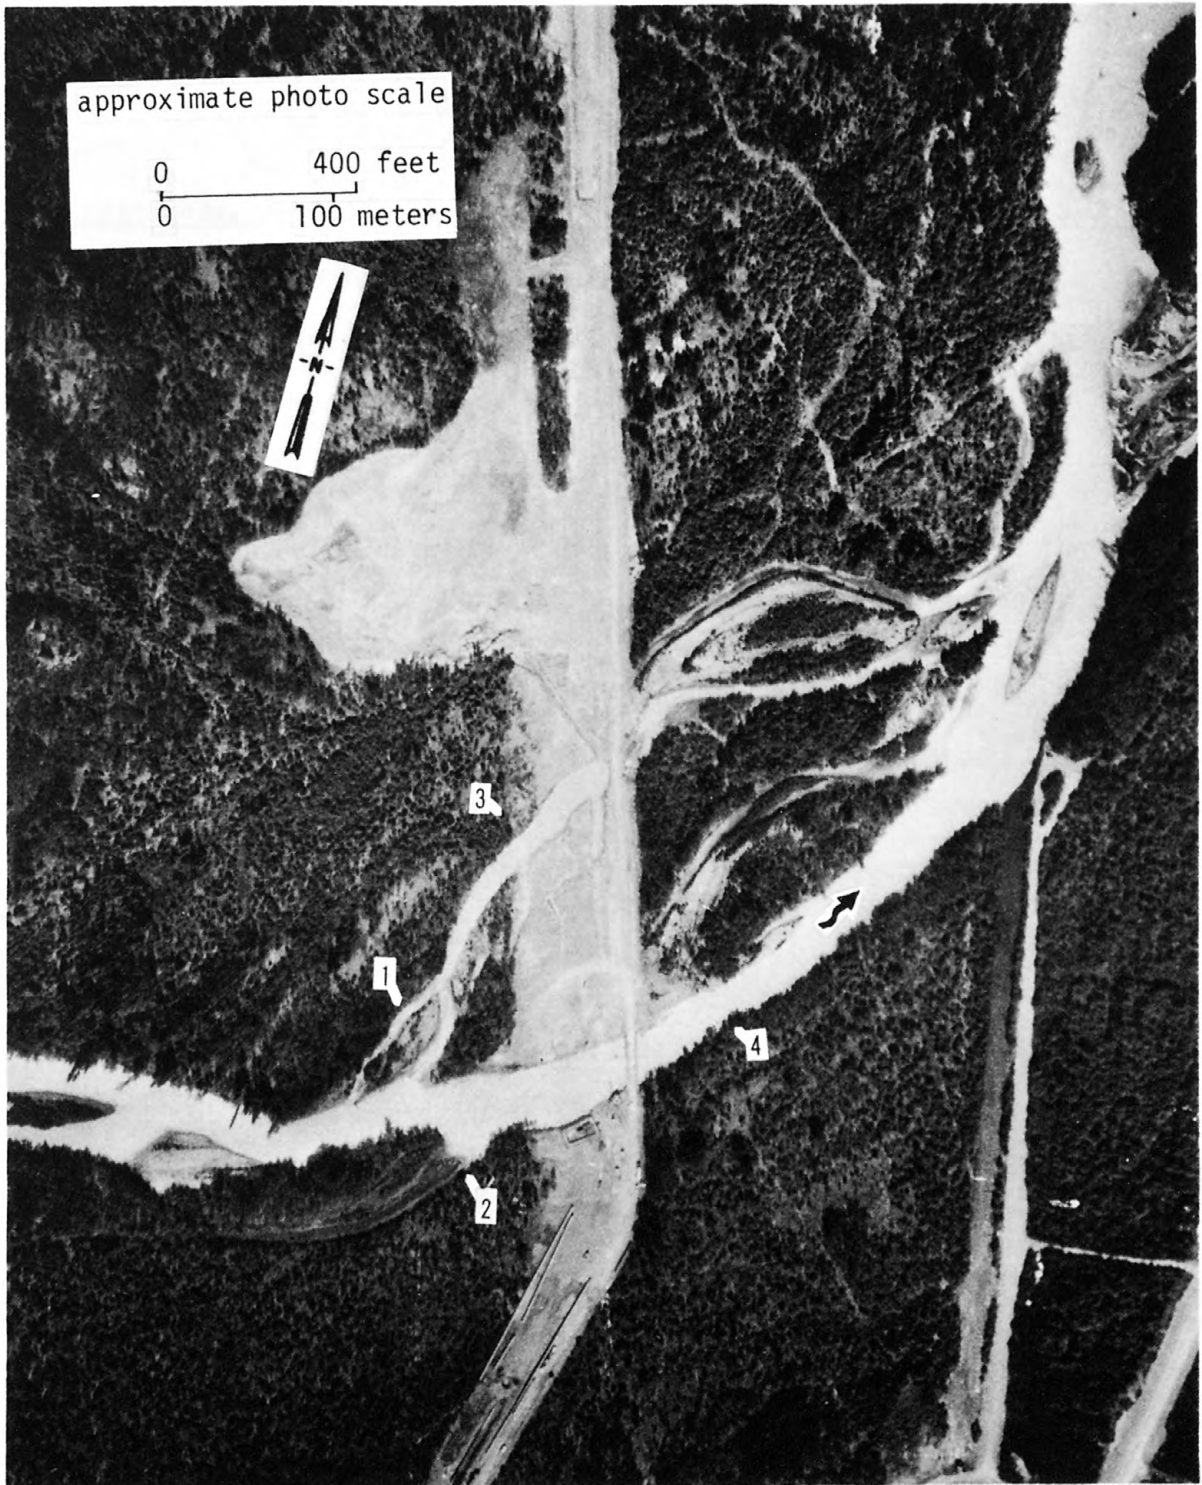
1976 Surveillance.--Figure 37 shows the Tonsina River crossing site on June 24, 1976. There has been additional construction work along the centerline and 3- to 4- ft-(1.0- to 1.2- m-) diameter riprap has been placed along the right bank at centerline since the May 1975 survey.

Figure 37.-- Tonsina River near Tonsina, June 24, 1976. AIR PHOTO TECH

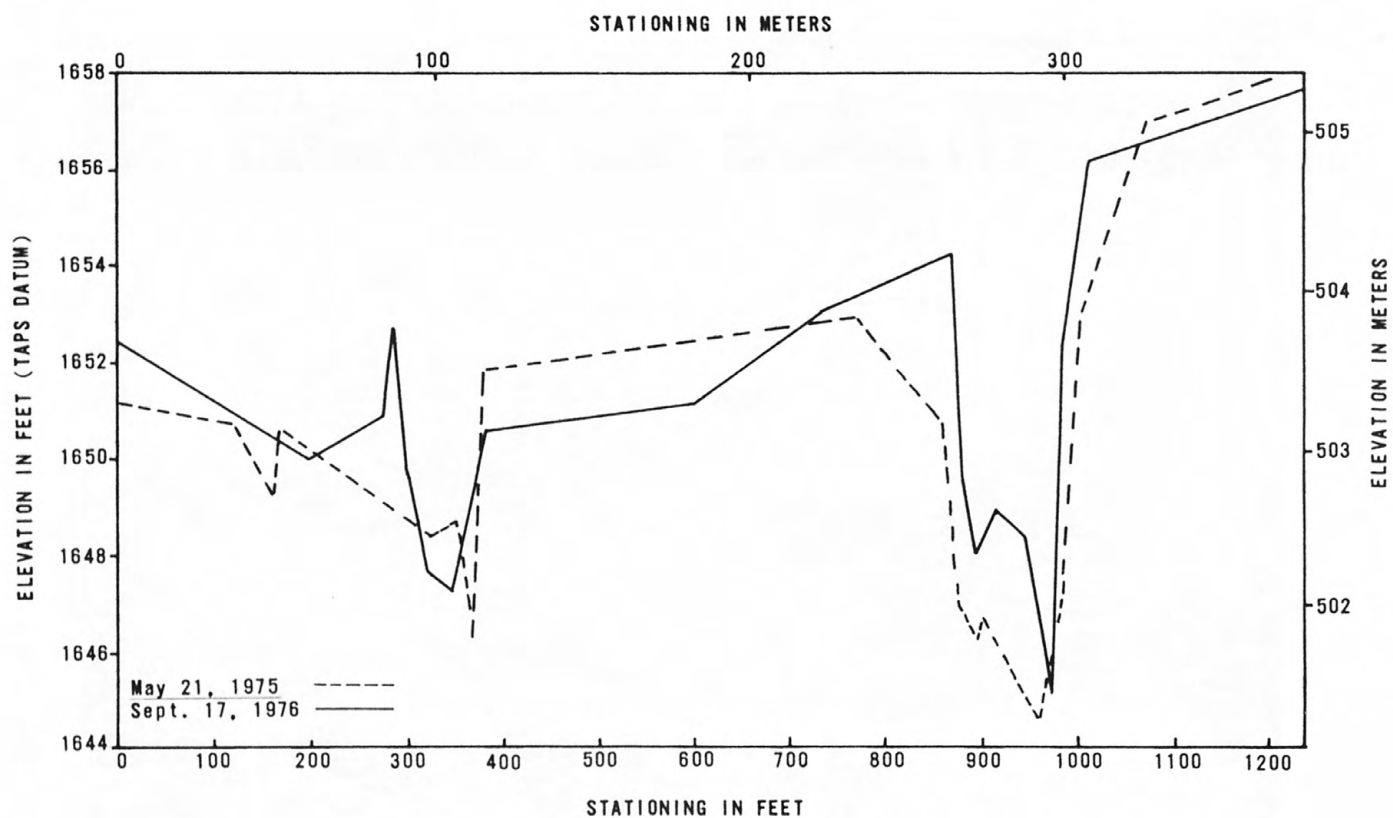
Figure 38.-- Centerline cross section of Tonsina River near Tonsina.

The crossing site was resurveyed in September 1976. Figure 38 shows construction changes at the centerline cross section. There was no significant change in either the upstream or downstream cross section.

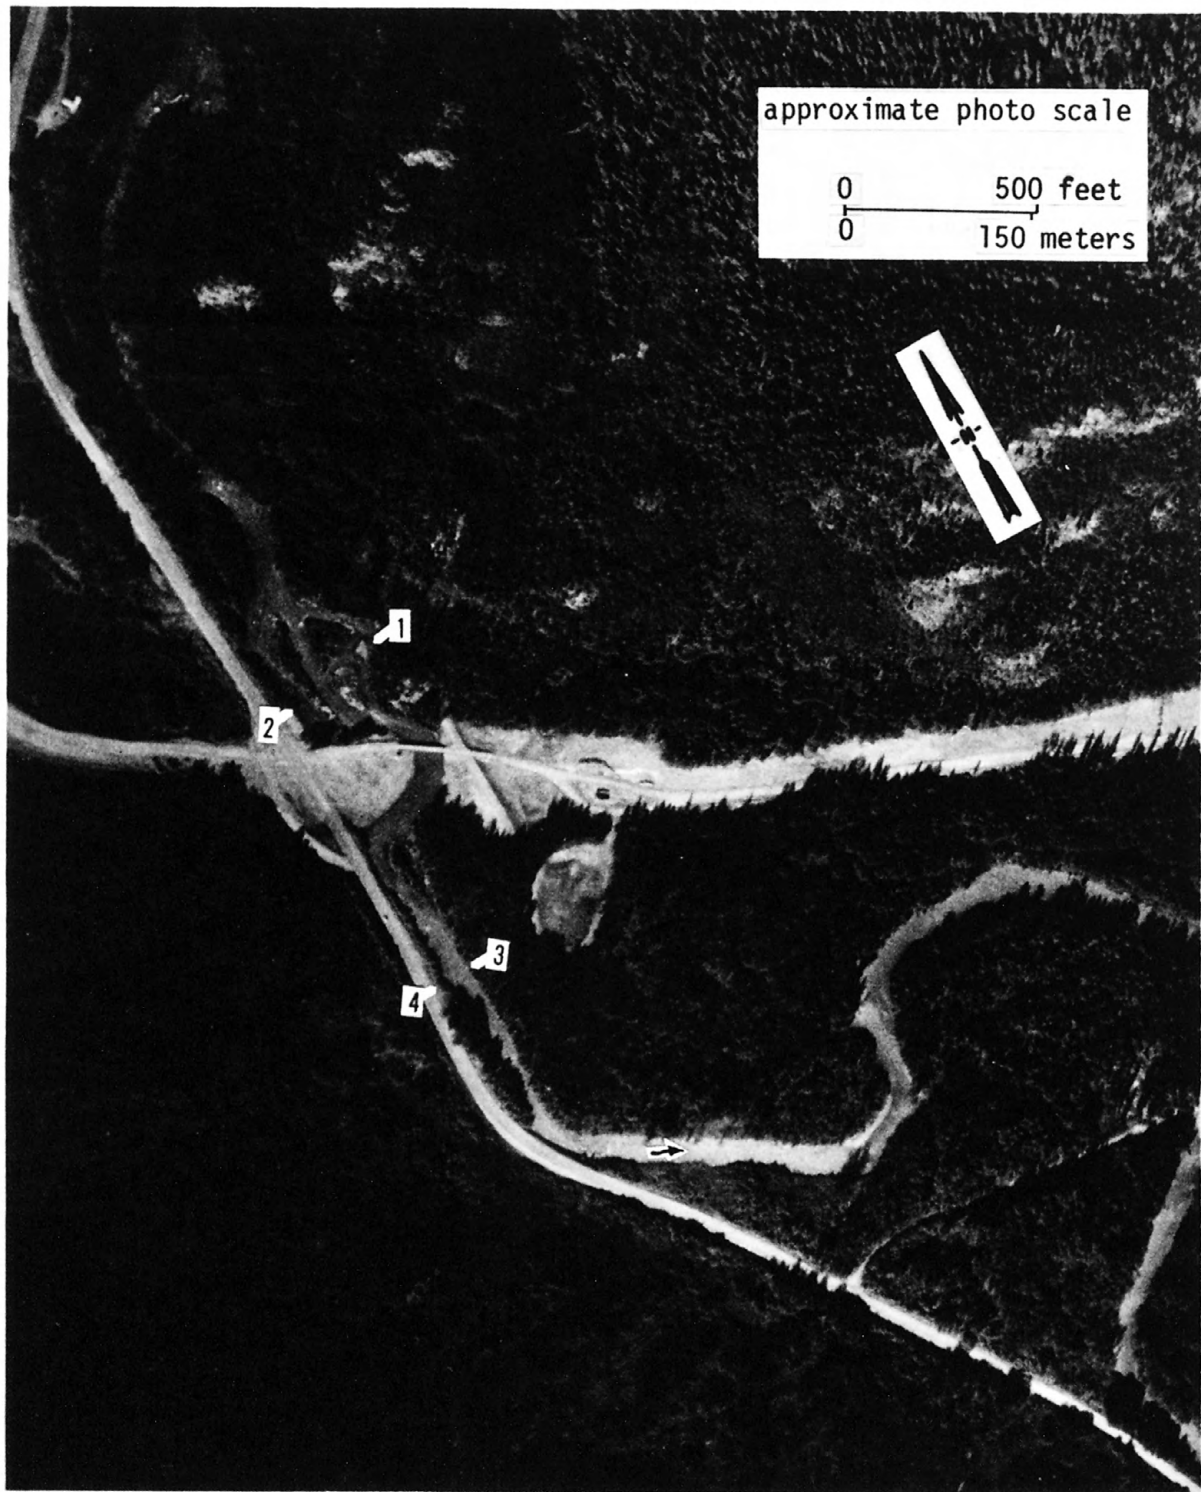
Figure 39.-- Tiekel River at Tiekel, July 31, 1976. AIR PHOTO TECH

1976 Surveillance.--Figure 39 shows the Tiekel River at Tiekel crossing site on July 31, 1976. The pipe has been buried across the channel, and a dike has been constructed on the left bank at centerline to prevent high water from flowing down the pipeline.
