CHANNEL EROSION SURVEYS ALONG TAPS ROUTE, ALASKA, 1976

UNITED STATES DEPARTMENT OF THE INTERIOR
GEOLOGICAL SURVEY

By
Paul F. Doyle
and
Joseph M. Childers

77-170

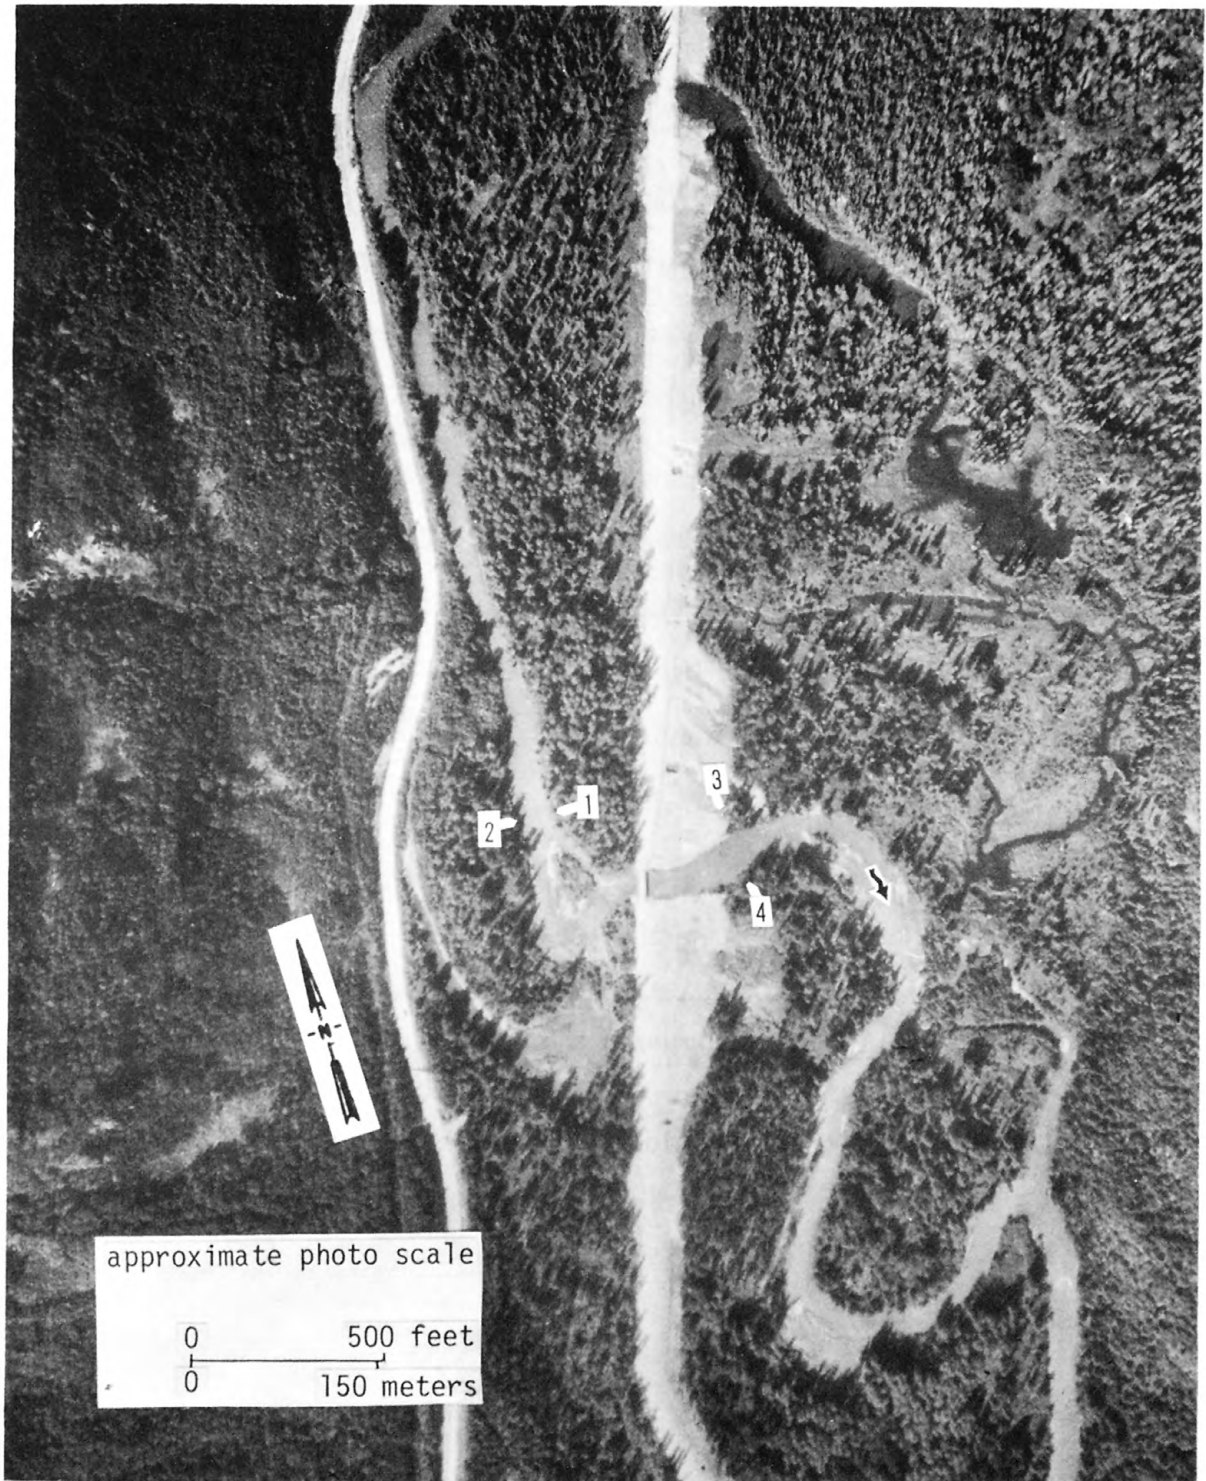
Figure 41.-- Tiekel River near Tiekel, July 31, 1976. AIR PHOTO TECH

1976 Surveillance.--Figure 41 shows the Tiekel River near Tiekel

crossing site on July 31, 1976. The pipe has been placed beneath the channel.

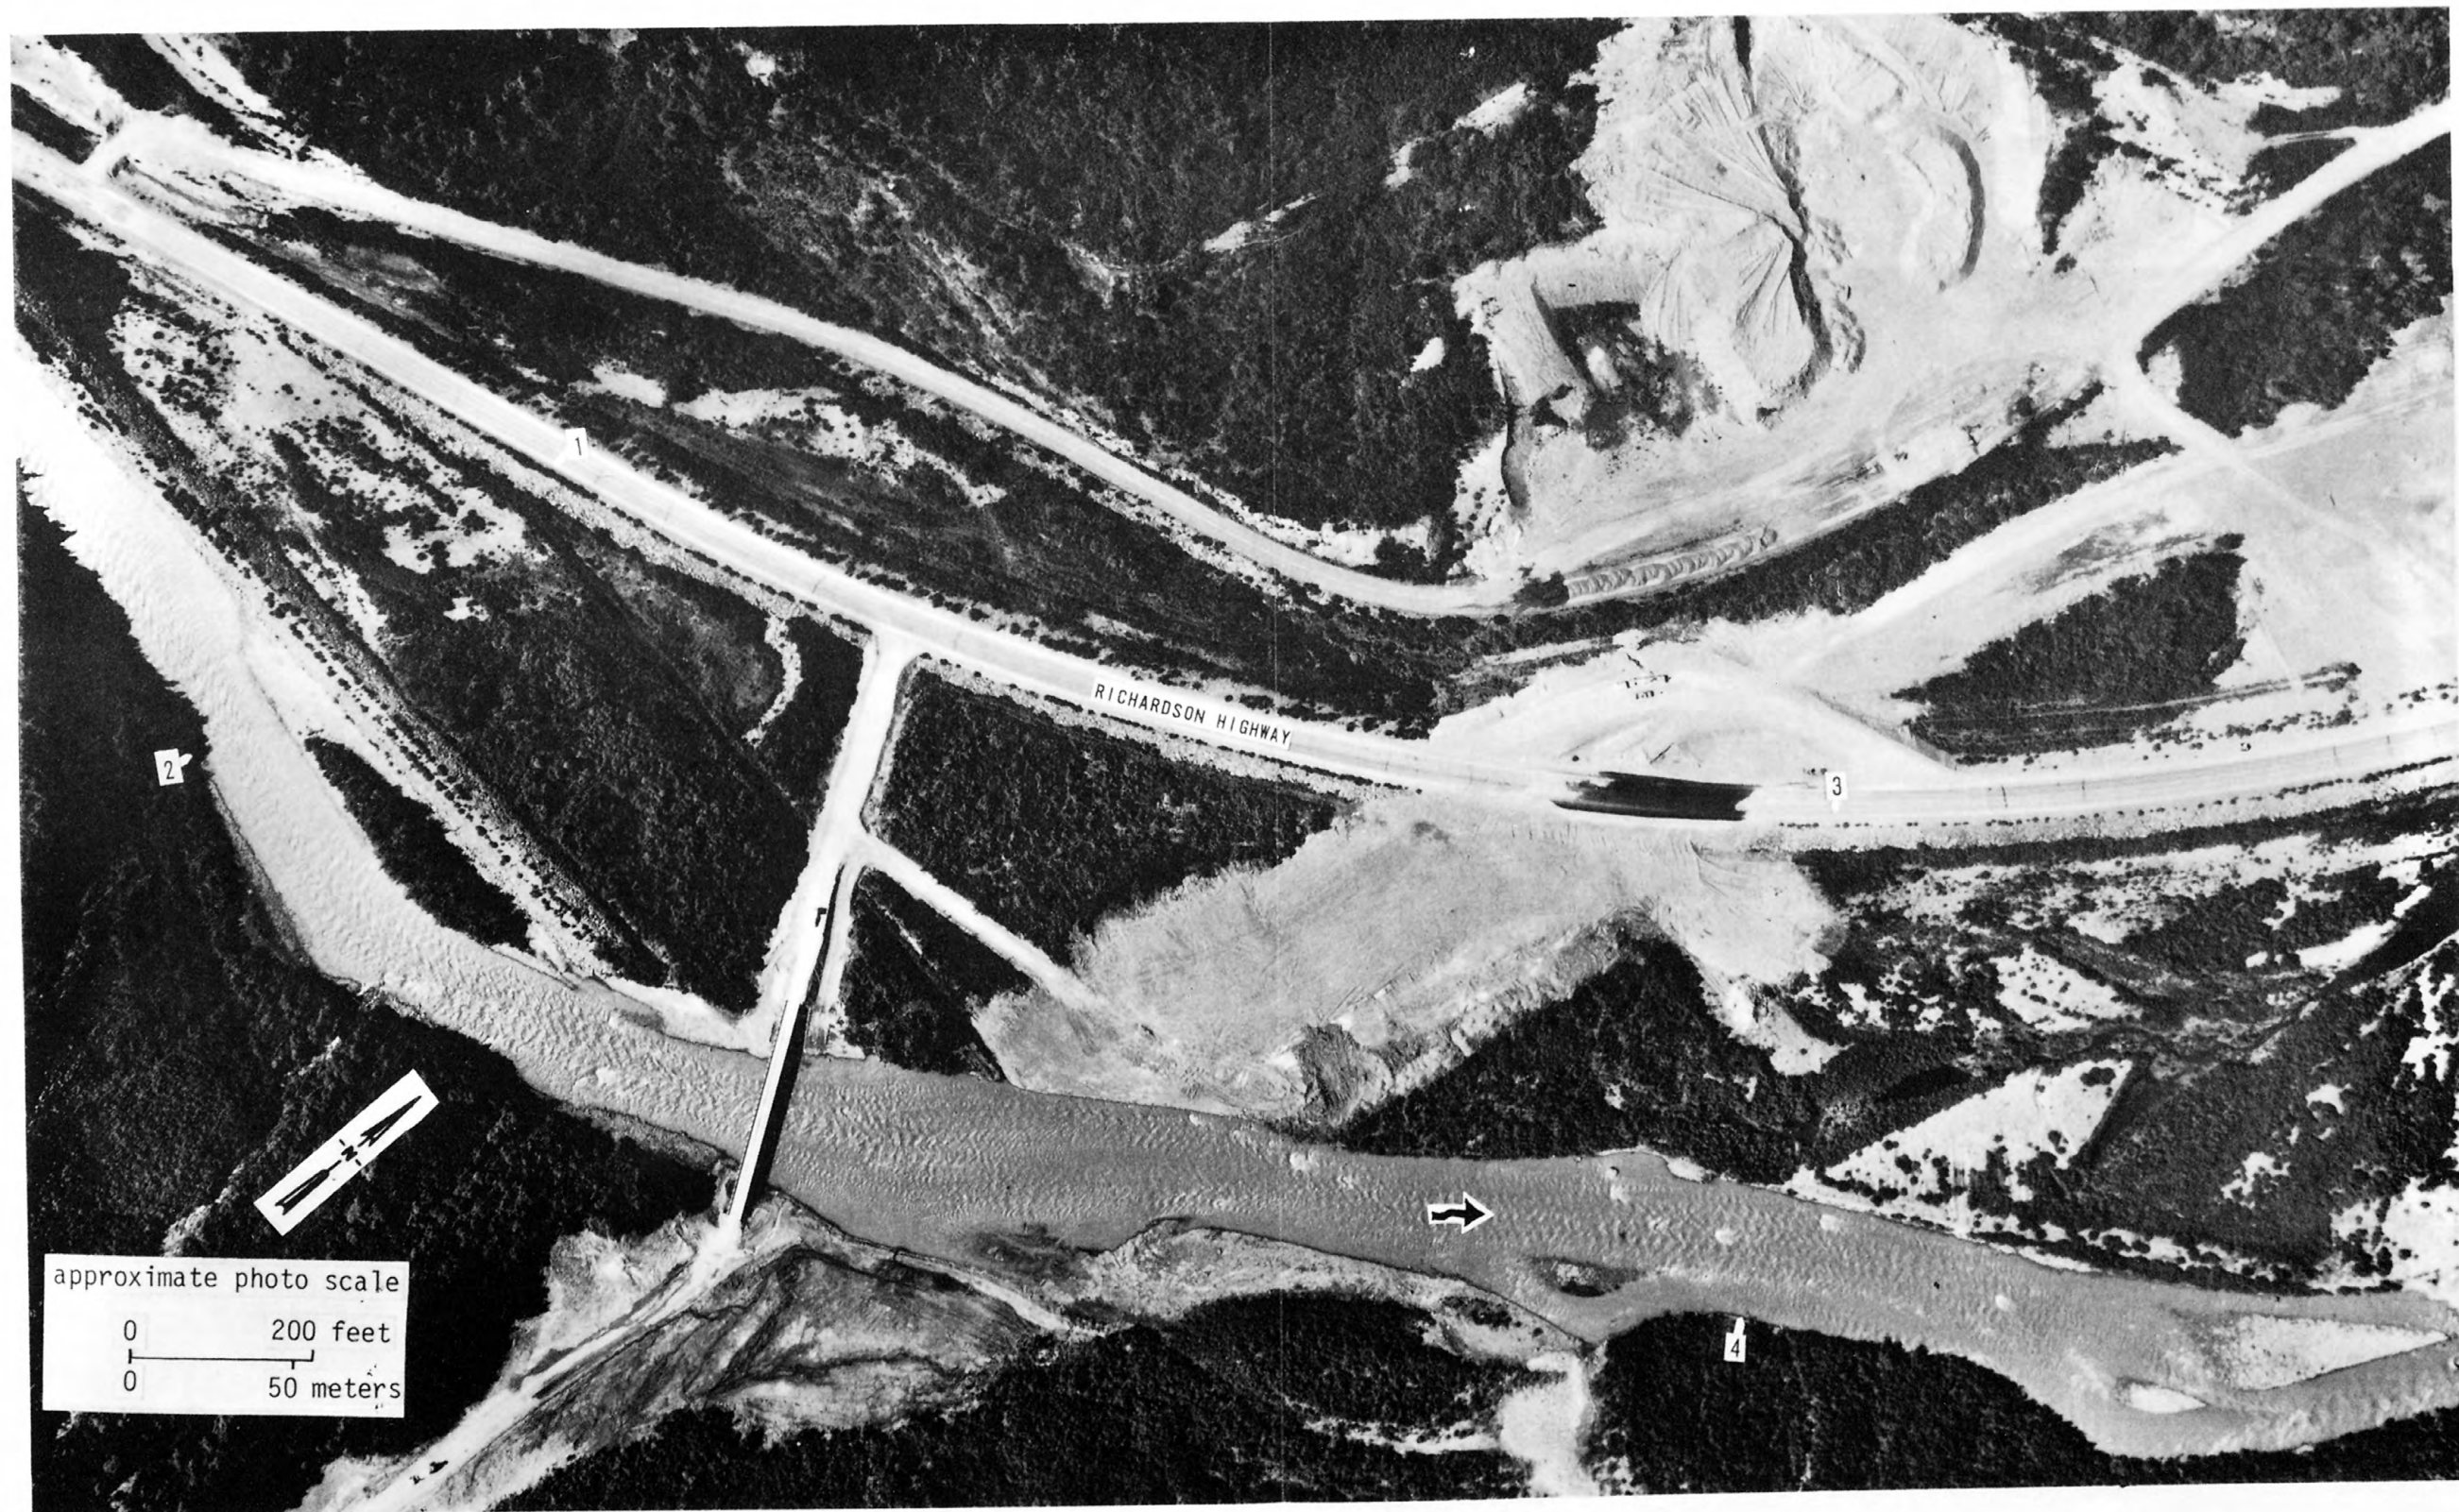
Figure 43.-- Tsina River near Tiekel, July 6, 1976. AIR PHOTO TECH

1976 Surveillance.--Figure 43 shows the Tsina River near Tiekel crossing site on July 6, 1976. The pipe has been buried across the channel.

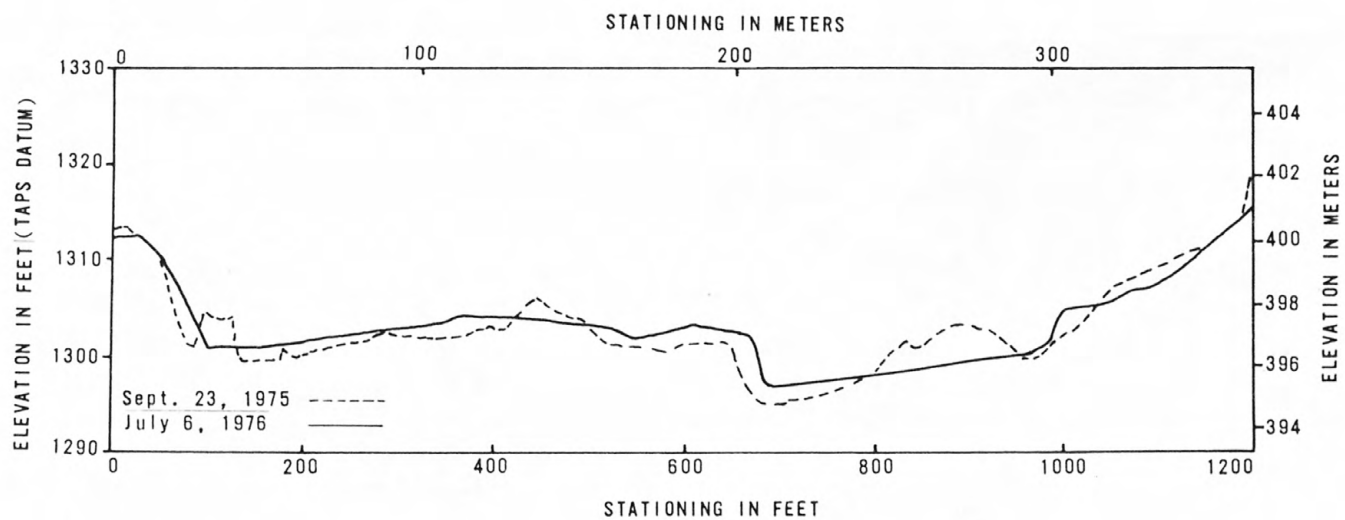
Figure 44.-- Centerline cross section of Tsina River near Tiek1.

The crossing site was resurveyed photogrammetrically in July 1976, and elevations of the streambed below the water surface were obtained in September. No significant changes were found in either the upstream or downstream sections. Figure 44 shows the construction-related change at the centerline section. A September inspection of the site which followed a glacier-dammed lake break-out flood of 10,000 ft³/s (283 m³/s) on August 8, 1976, indicated that the high water had caused little or no change in any of the sections.

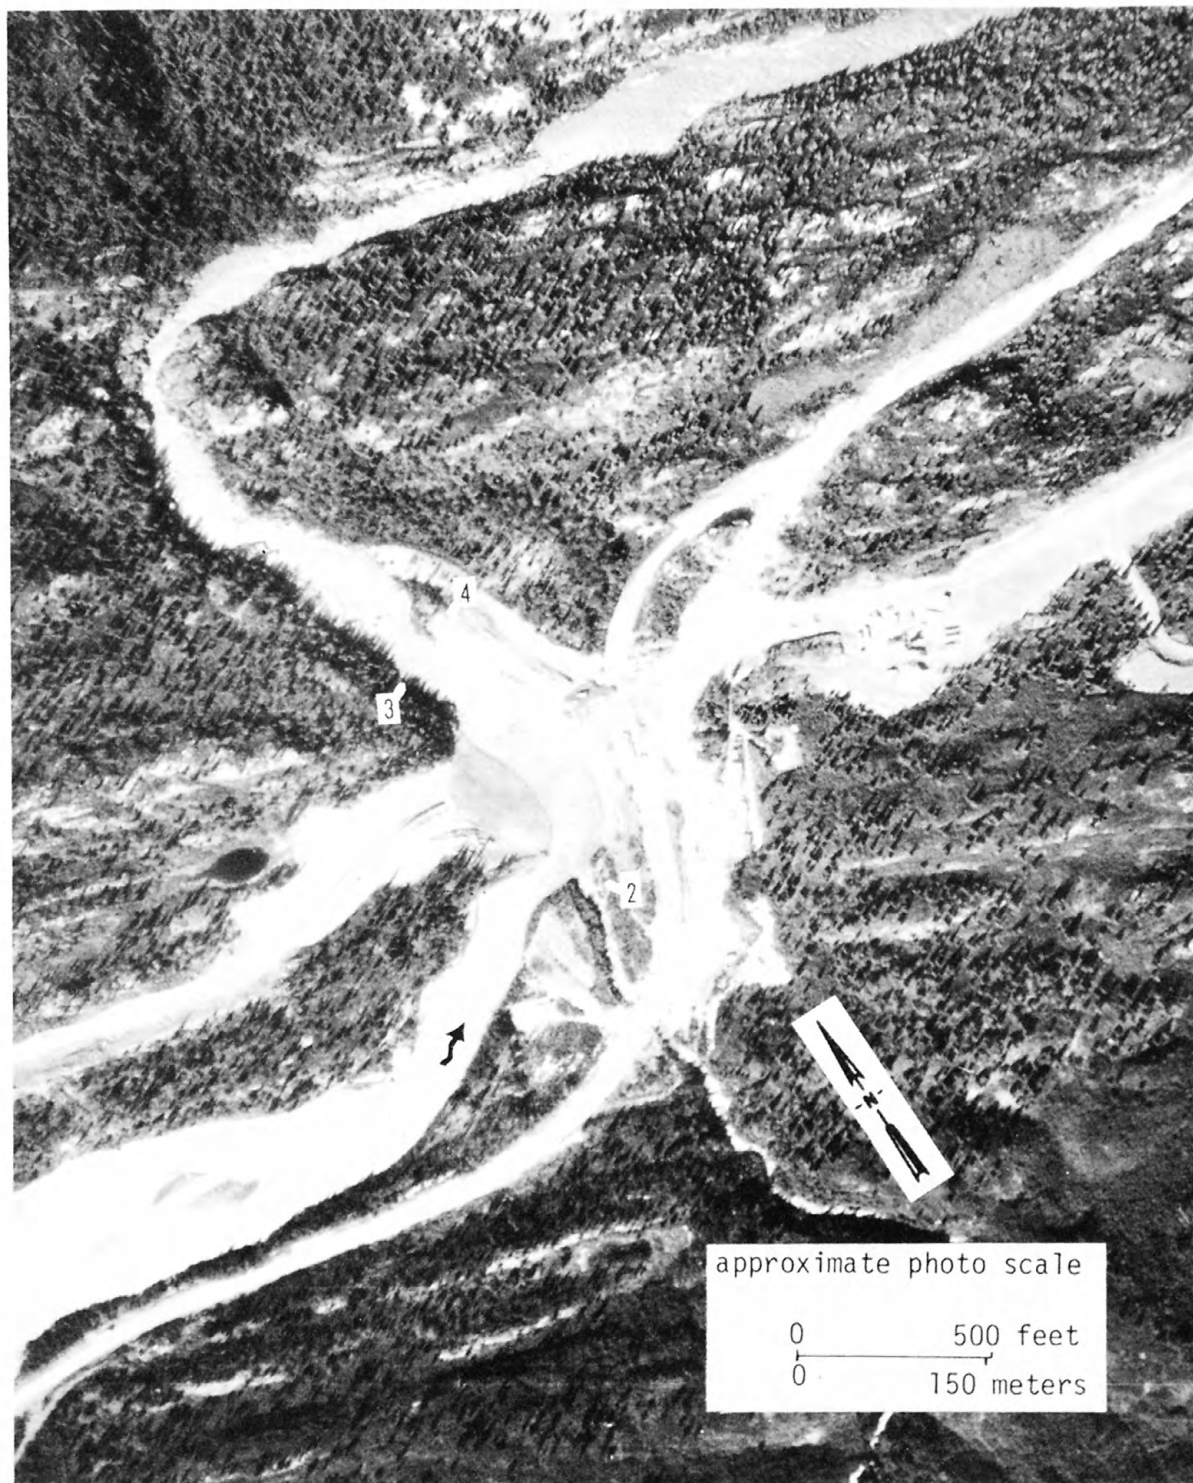
Figure 45.-- Tsina River near Ptarmigan, July 31, 1976. AIR PHOTO TECH

1976 Surveillance.--Figure 45 shows the Tsina River near Ptarmigan crossing site on July 31, 1976. The pipe has been buried under the channel.

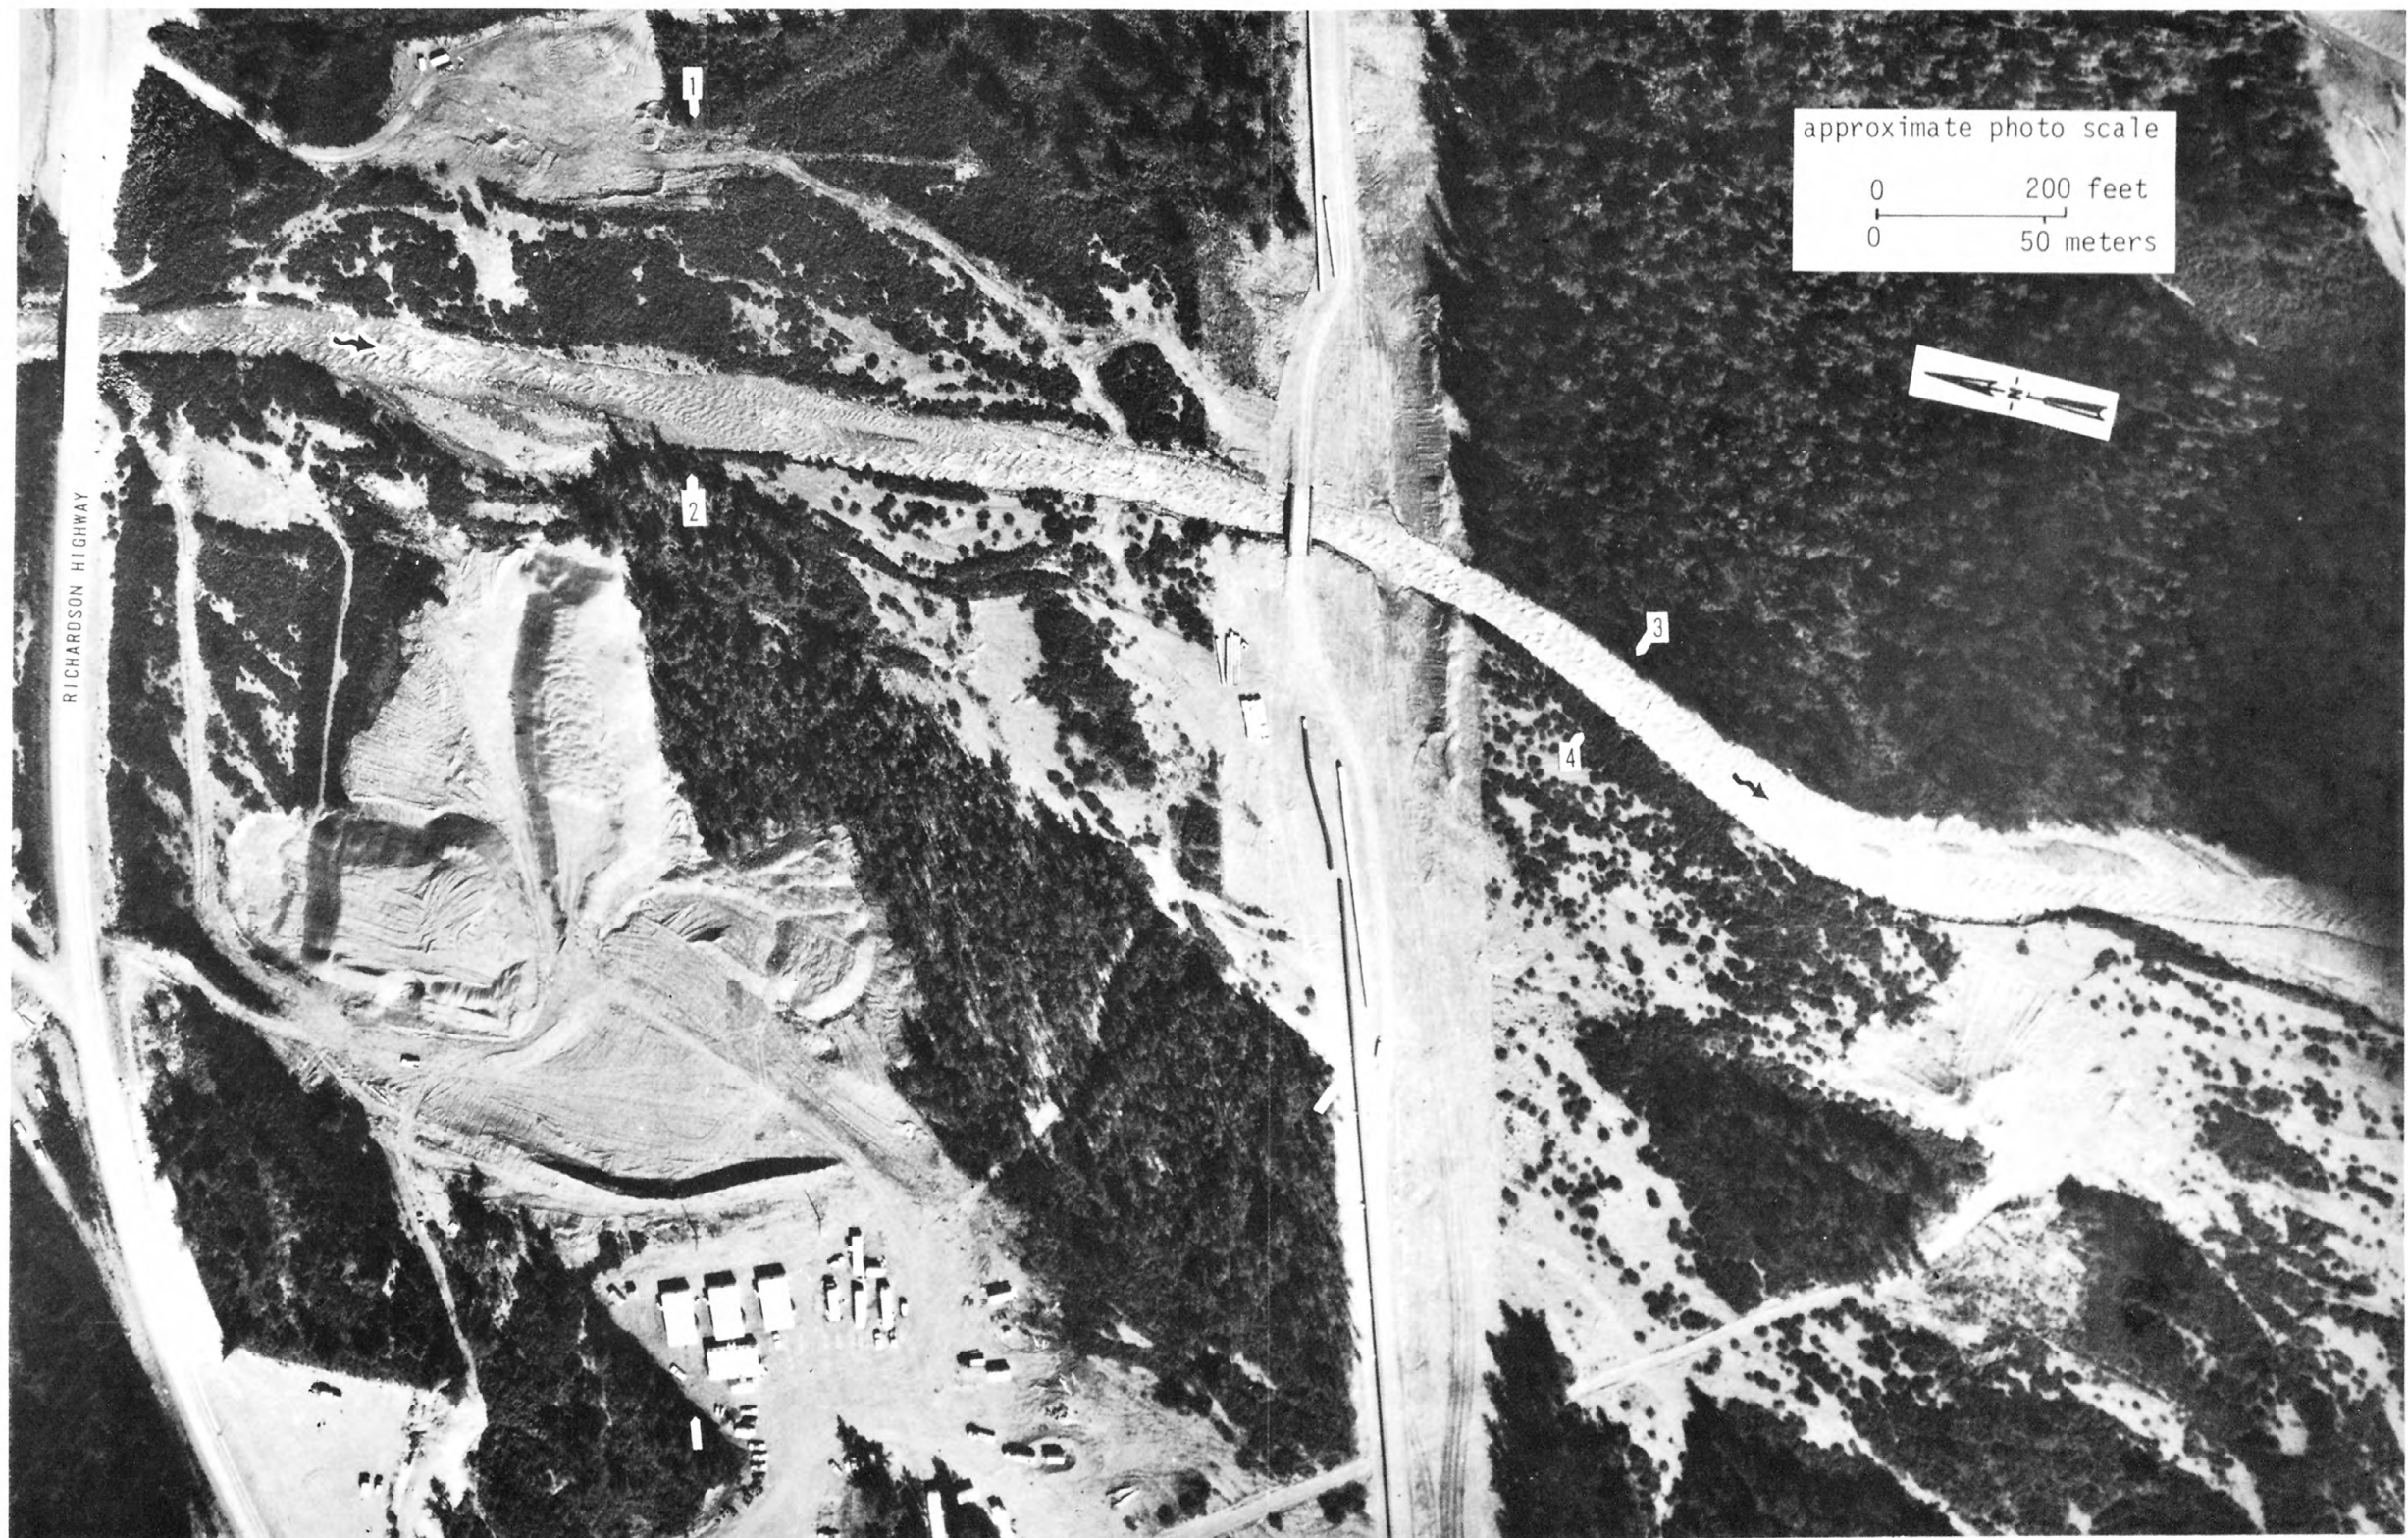
Figure 48.-- Sheep Creek near Valdez, July 6, 1976. AIR PHOTO TECH

1976 Surveillance.--Figure 48 shows the Sheep Creek crossing site on July 6, 1976, during the construction of the buried crossing.

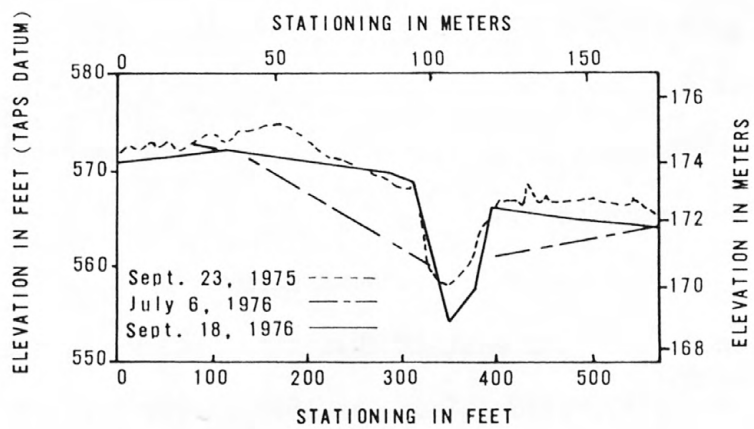
Figure 49.-- Centerline cross section of Sheep Creek near Valdez.

The crossing site was resurveyed photogrammetrically in July 1976 and by an on-the-ground survey in September. There were no significant changes found in either the upstream or the downstream cross sections. Figure 49 shows the construction-related changes at centerline during construction and after construction had been completed.

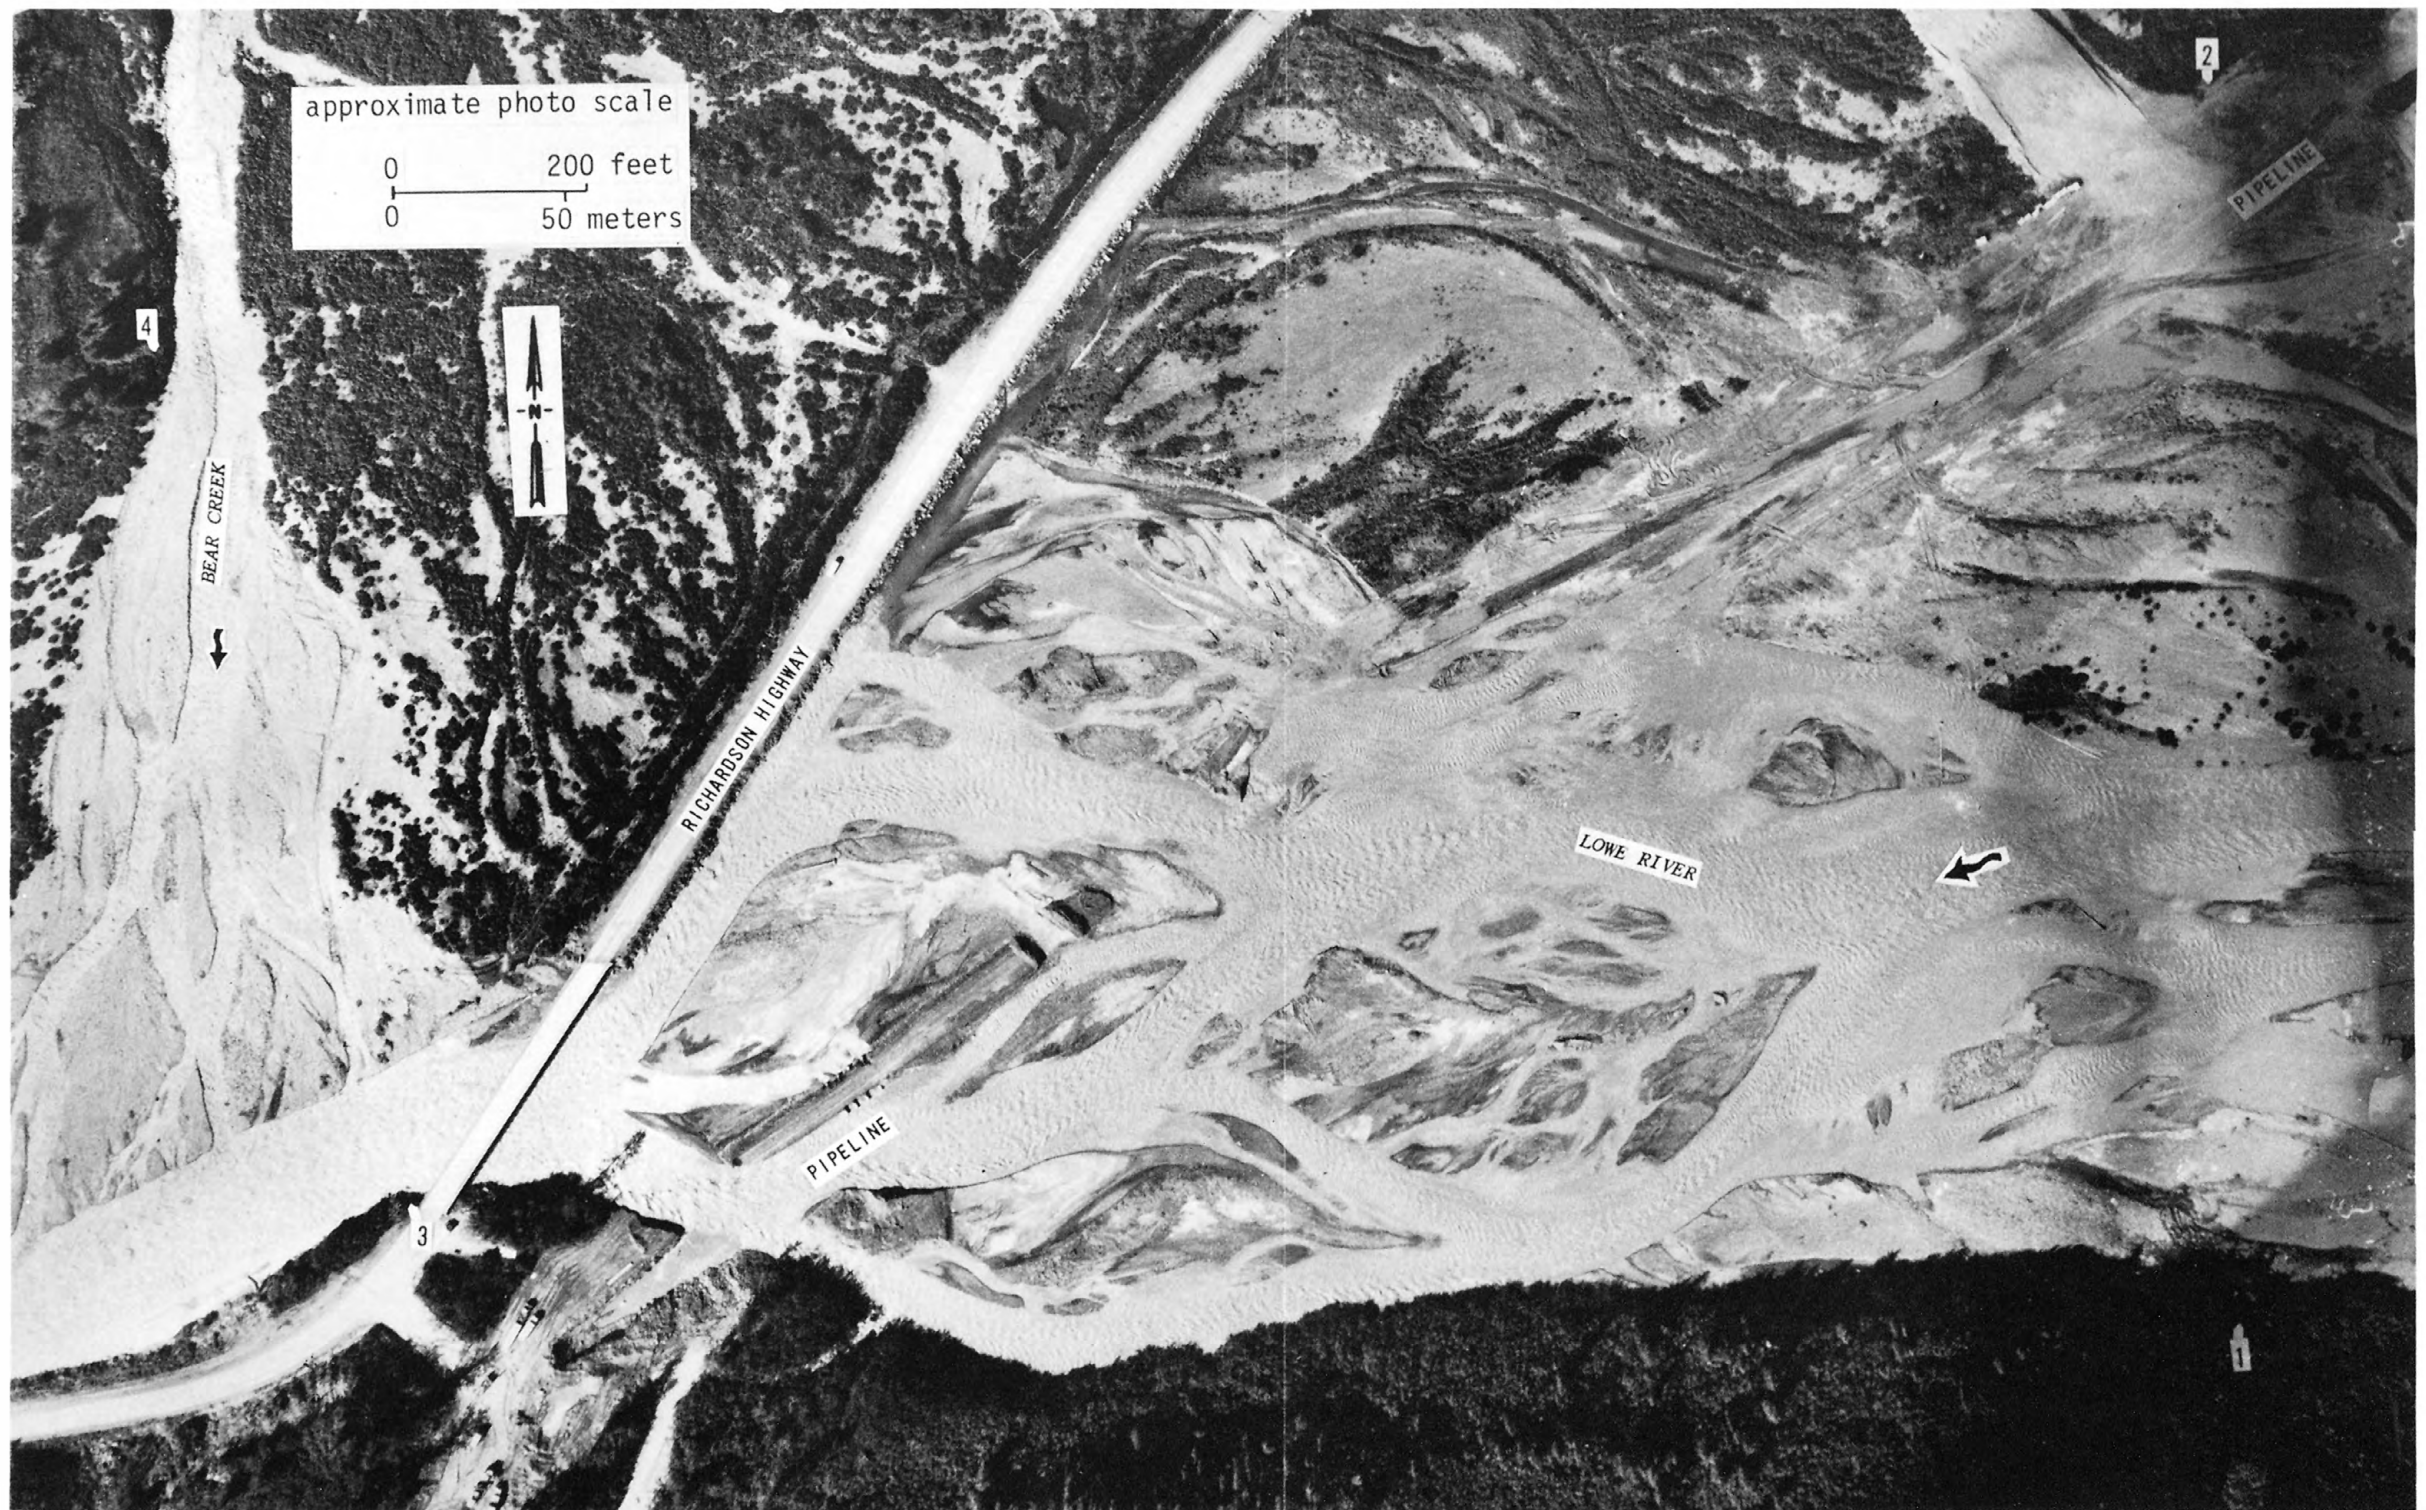
Figure 50.-- Lowe River near Valdez, July 6, 1976. AIR PHOTO TECH

1976 Surveillance.--Figure 50 shows the Lowe River crossing site on July 6, 1976. The pipe has been buried across the flood plain.

The crossing site was resurveyed photogrammetrically in July 1976. There were no significant changes found in any of the cross sections. The centerline left bank excavation remained to be backfilled. As in the past at this site, there has been considerable anabranch migration since the 1975 survey. In September a visual inspection was made of the site and no bank erosion was apparent along the left bank in the vicinity of the centerline. Thalweg depths were not surveyed in 1976.
