**RECONNAISSANCE OF SEDIMENTATION
IN THE RIO PILCOMAYO BASIN, MAY 1975,
ARGENTINA, BOLIVIA, AND PARAGUAY**

U.S. GEOLOGICAL SURVEY
Open-File Report 77-327

By **JOHN R. RITTER**

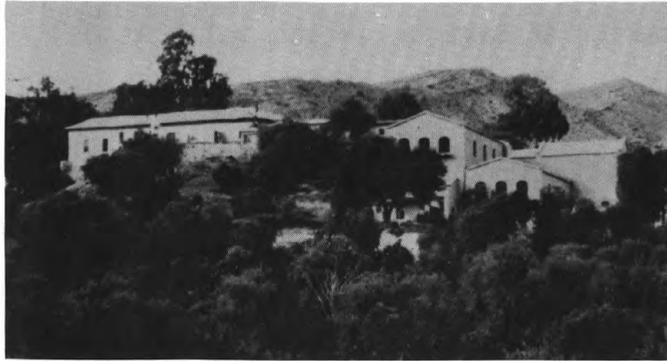
The Río Pilaya between Villa Abecia and Camargo flows through a valley where there is farming on river deposits and where some of the largest wineries in Bolivia are located (fig. 16). The Río Tumusla at Palca Grande (fig. 17), a gaging station site, was muddy, a condition which perhaps was caused by mining upstream. The Río Chico de Camargo, which joins the Río Tumusla near Palca Grande, was clear.

Figure 16.--Winery near Camargo.

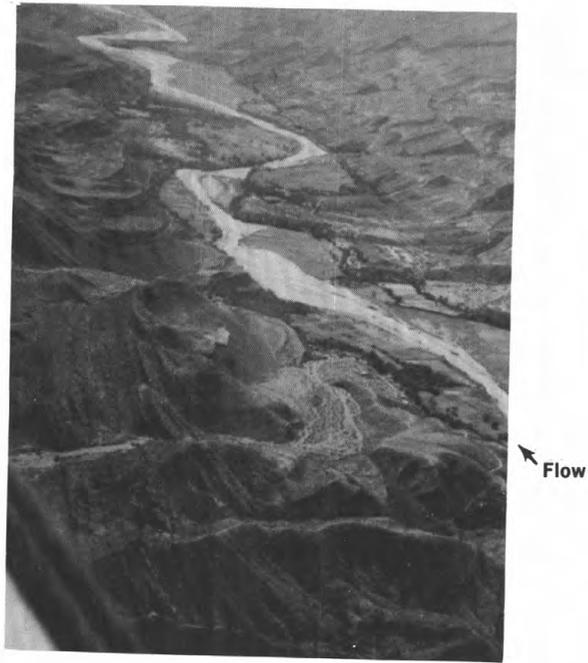
Between Tojo and Villa Abecia, the Río San Juan del Oro flows in a synclinal valley between a series of hogback ridges where the strata are deeply dipping (fig. 18). The river breaks through several water gaps in the ridges along its course (fig. 19). The valley of the Río San Juan del Oro is relatively wide and the several dry channels of tributaries contained deposited sediments. There is little vegetation except along the river itself. This is an arid part of the basin (the average annual rainfall at El Puente is 230 mm) and sediment, particularly coarse sediment, is probably moved only short distances because of the lack of runoff. This is also true in that part of the basin between Iscayachi and El Puente.

Figure 18.—Río San Juan del Oro.

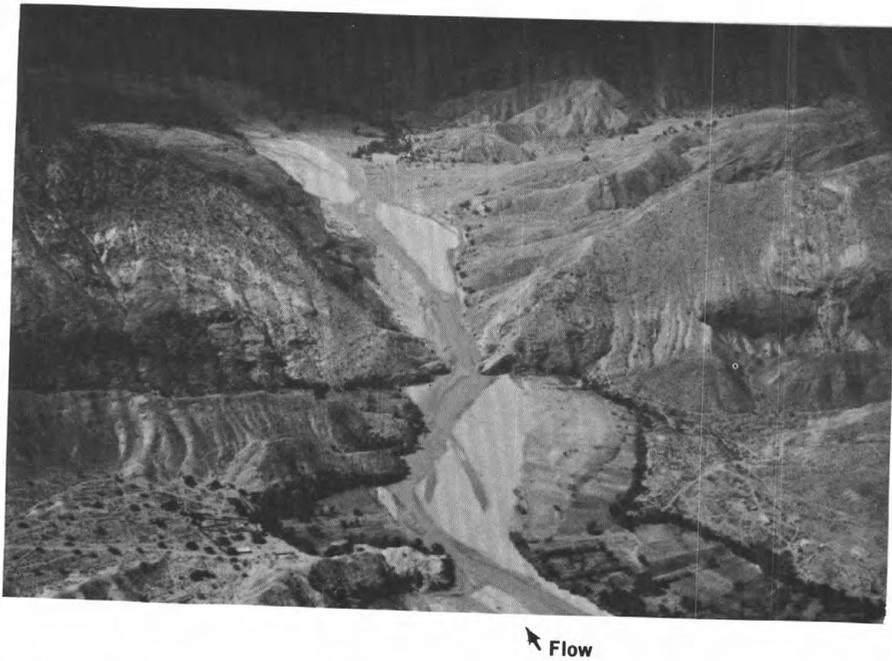
Figure 19.—Watergap on the Río San Juan del Oro.
