UNITED STATES DEPARTMENT OF THE INTERIOR
GEOLOGICAL SURVEY

STUDY RESULTS OF 9 SITES
USED BY OFF-ROAD VEHICLES THAT ILLUSTRATE
LAND MODIFICATIONS

Open-file report

77-601

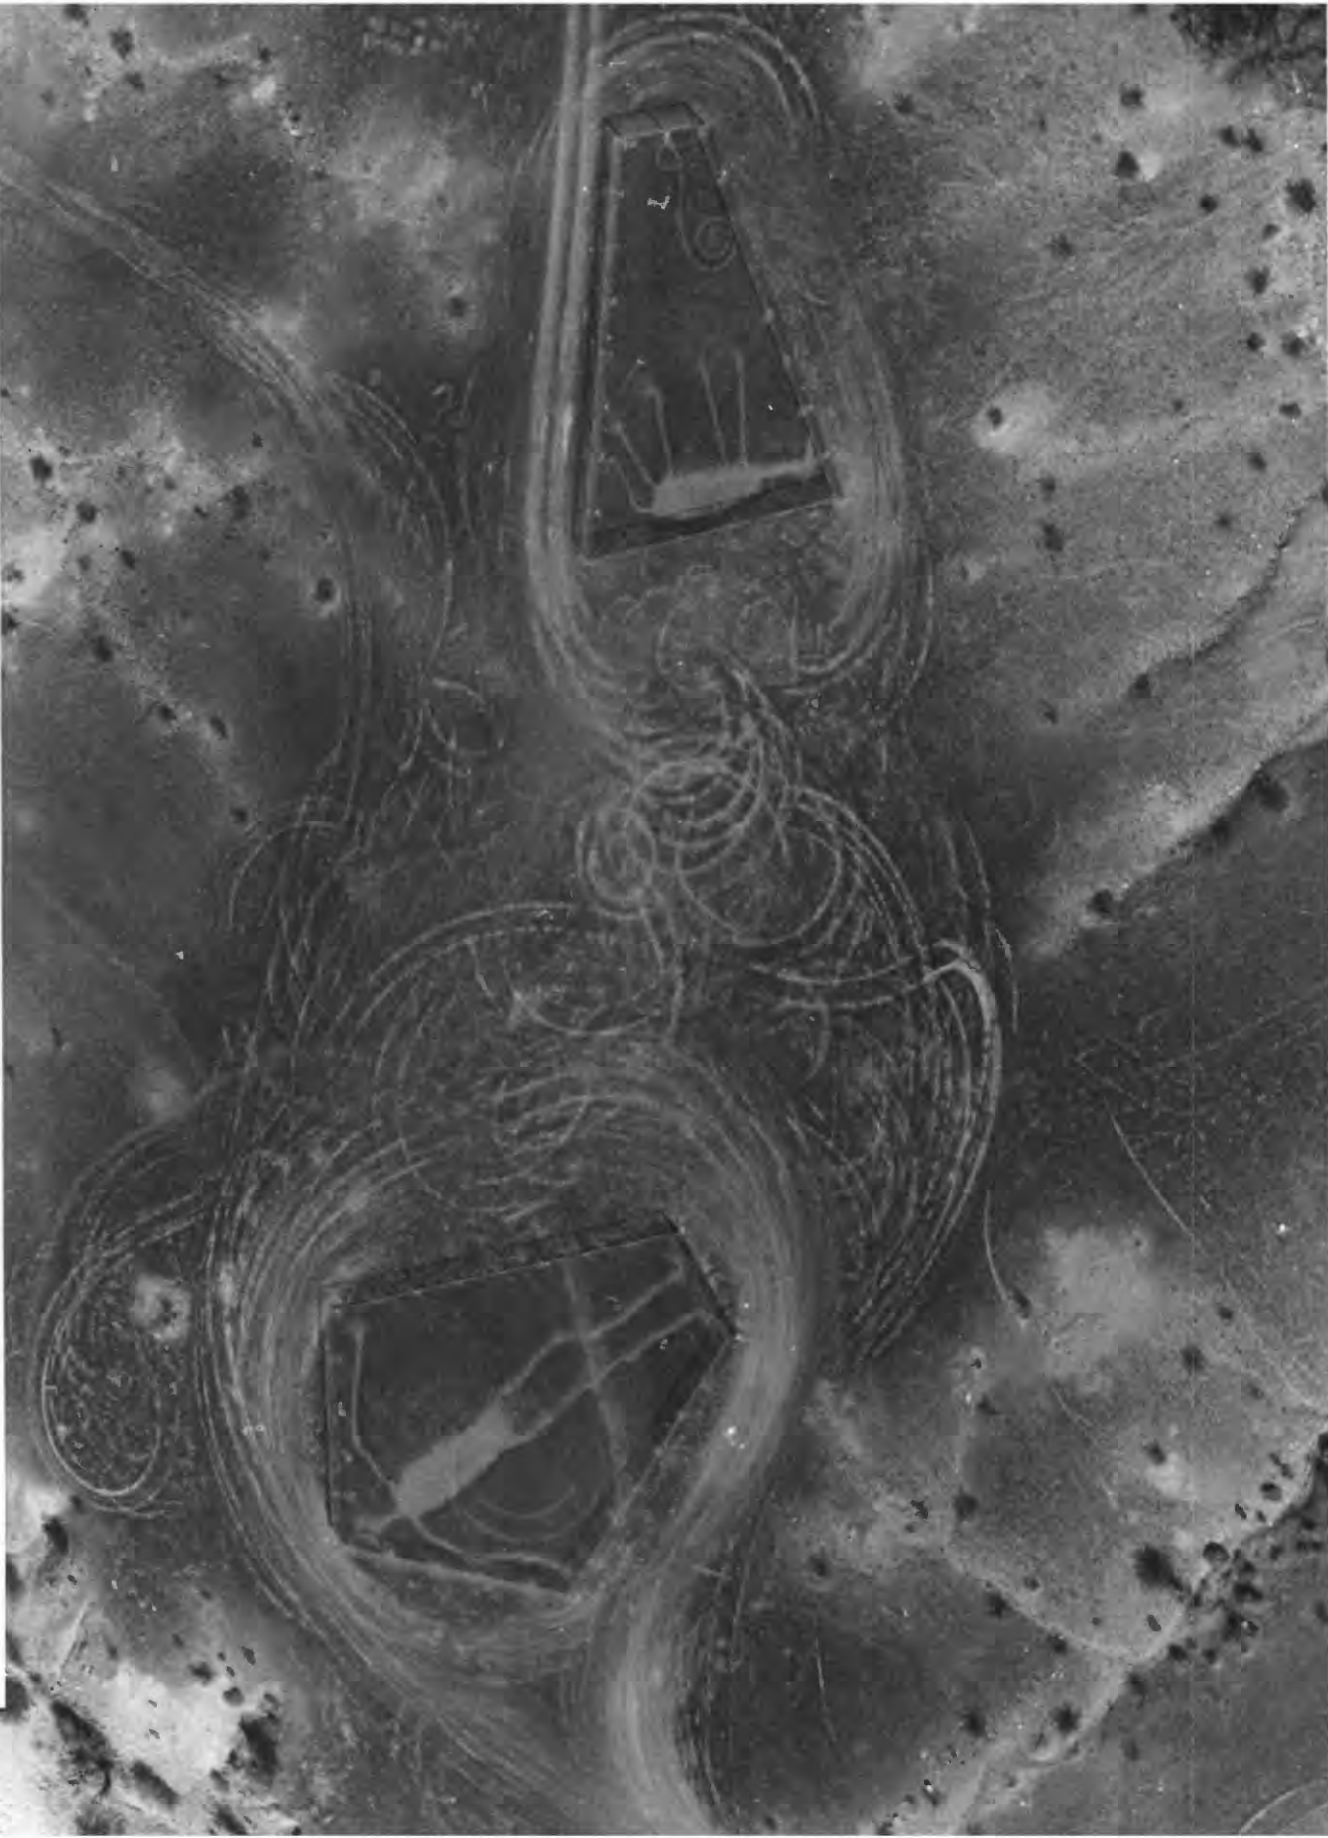
The intaglios near Blythe, California are a valuable archaeological resource that has suffered significant vehicle degradation (Figs. 6,7). The figures were constructed simply by scraping aside a layer of dark pebbles at the surface exposing lighter material beneath. Motorcycles have damaged at least one figure, either before protective fencing was erected, or by gaining access through a gate in the fence. Two efforts were made by 4-wheel vehicles to break down the fence around one of the figures. In the Yuha Desert, protective fencing around an intaglio was cut and the figure destroyed by motorcycles (Los Angeles Times, August 6, 1975).

Fig. 7.--Blythe, California. 1975 photograph of intaglios showing extensive vehicle damage (there are three sets of intaglios in the immediate area; this is not the same set as shown in Fig. 4, but all three sets have suffered similar degradation).
