UNITED STATES
DEPARTMENT OF THE INTERIOR
GEOLOGICAL SURVEY

The Willits, California, Magnitude-4.8 Earthquake
of November 22, 1977

Open-File Report 78-1075

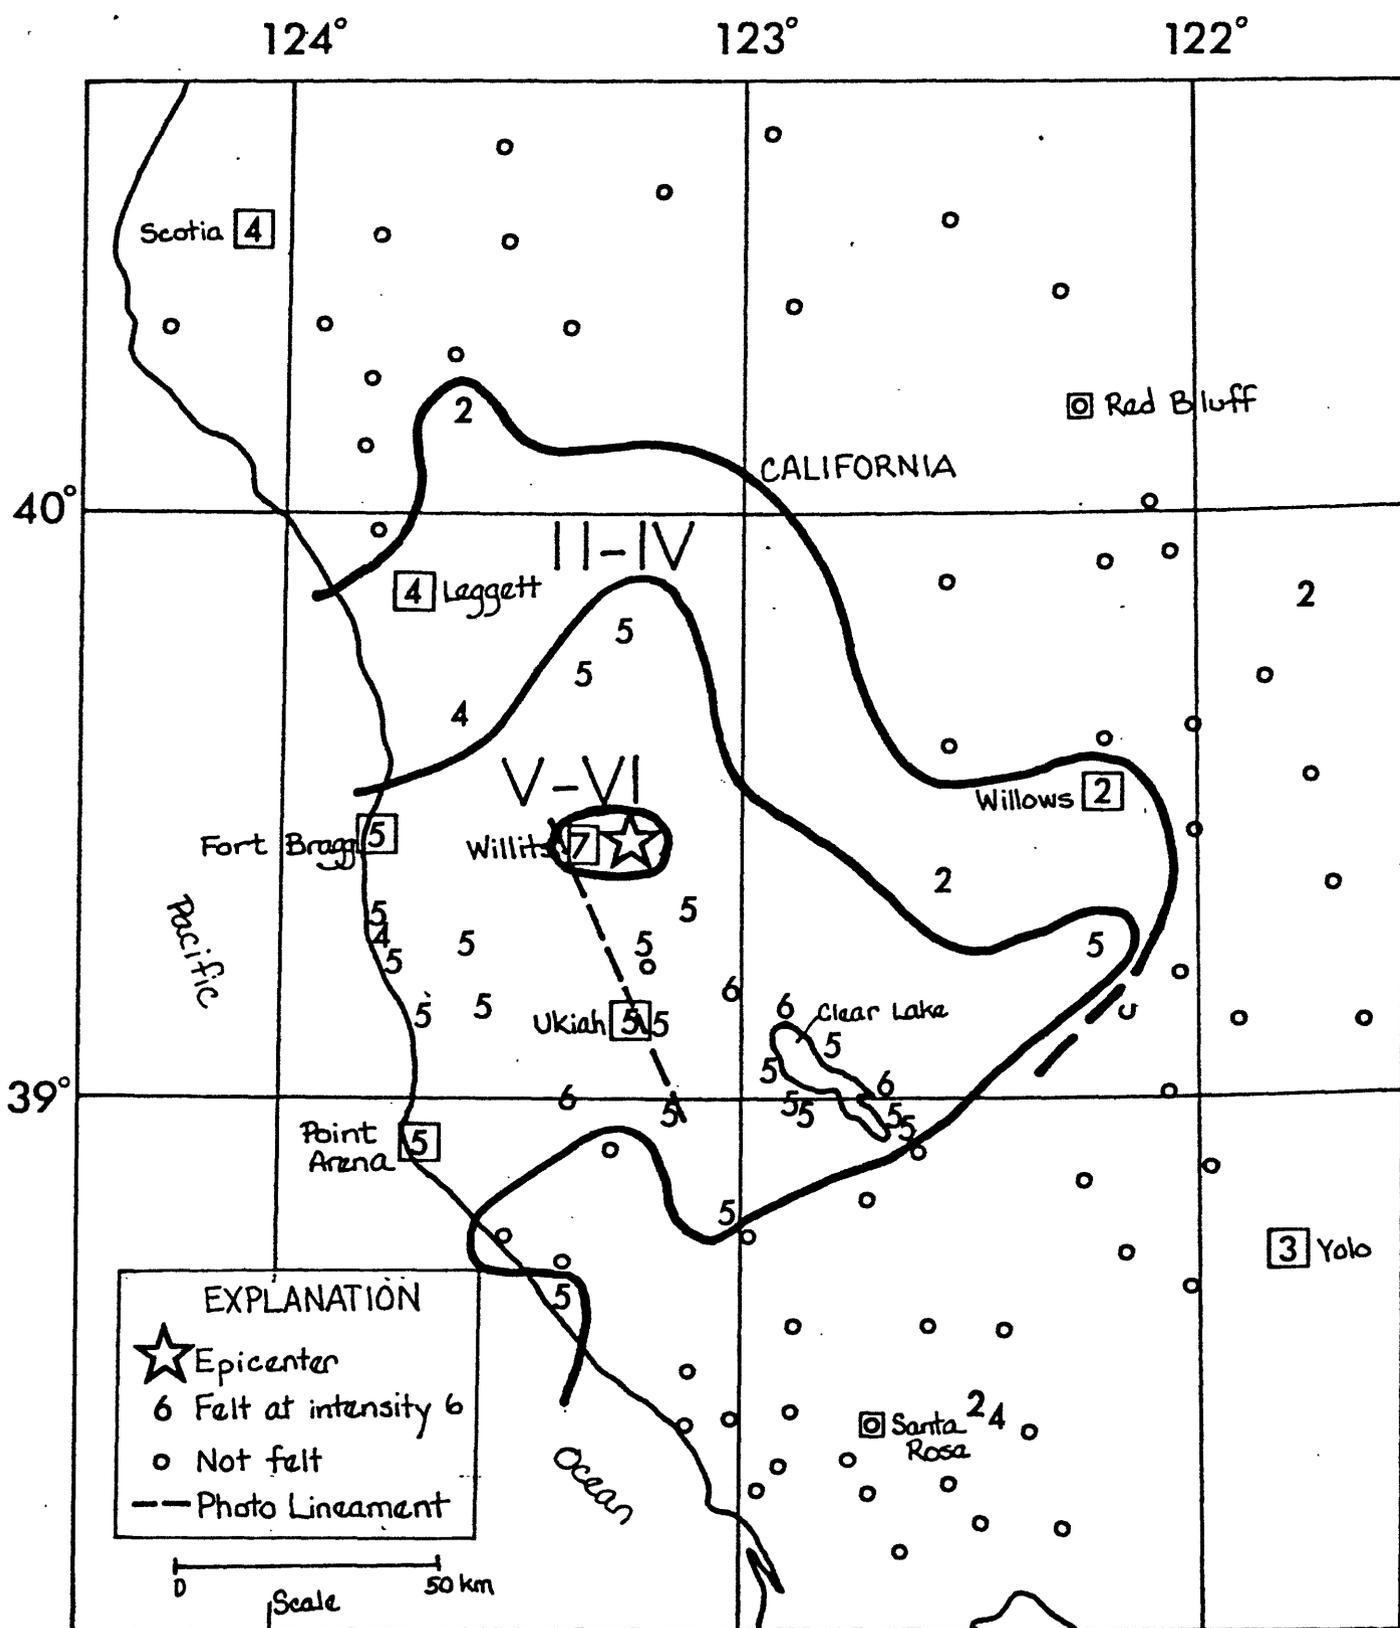
J. M. Coakley had made a preliminary observation of cracked pavements in the course of monitoring aftershocks of the November 22 earthquake. On December 14 a second field investigation was carried out by Pampeyan and P. W. Harsh. They noted sets of en echelon cracks in the pavement and related right-lateral offsets in curbs and sidewalks at five localities. When plotted on a map these five localities define a line about 1 km long, which coincides with a photo lineament plotted through Willits in 1975 (fig. 3). The evidence found by Coakley, Pampeyan, and Harsh indicates that a fault passes through Willits on which tectonic creep is occurring. Most of the creep effects observed predate the earthquake of November 22, but at least a small amount of creep occurred between November 23 and December 14, possibly being triggered by the November 22 shock. The average rate of movement is uncertain, however, because the ages of the offset curbs are uncertain, but it appears to be on the order of 2 mm per year. The area of creep is indicated in figure 3 by a heavy line through Willits.

Figure 3.--Map of the photo lineaments in the Willits, California, area (from E. H. Pampeyan (unpublished data), 1975; Winterhalder, 1977).
