DEPTHS OF CHANNELS IN THE AREA OF THE SAN JUAN BASIN REGIONAL URANIUM STUDY,
NEW MEXICO, COLORADO, ARIZONA, AND UTAH

U. S. Geological Survey Open-File Report 79-1526

February 1979

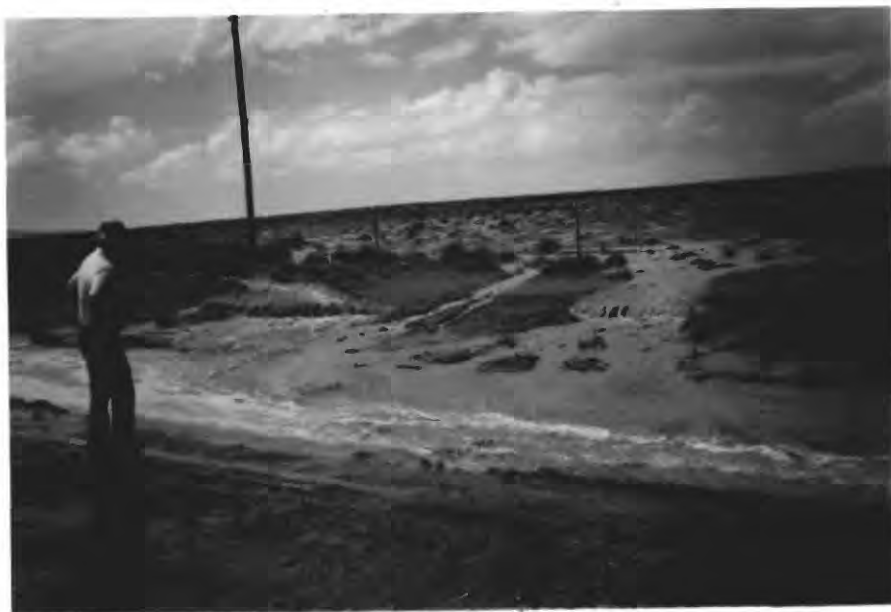
Figure 2. Rapid runoff after a thunderstorm of a few minutes duration that occurred on September 1, 1977, near Tocito Dome. The water has a very high suspended sediment content. Such high velocity flows accelerate or can initiate arroyo cutting, especially in areas of sparse vegetation or where the vegetation has been disturbed by man. Flash runoff resulting from summer storms is typical of the San Juan Basin.
