**DEPARTMENT OF THE INTERIOR
UNITED STATES GEOLOGICAL SURVEY**

**RECONNAISSANCE REPORT ON GROUND FAILURES AND GROUND CRACKS
RESULTING FROM THE COYOTE LAKE, CALIFORNIA,
EARTHQUAKE OF AUGUST 6, 1979**

**Open File Report 80-139
January 1980**

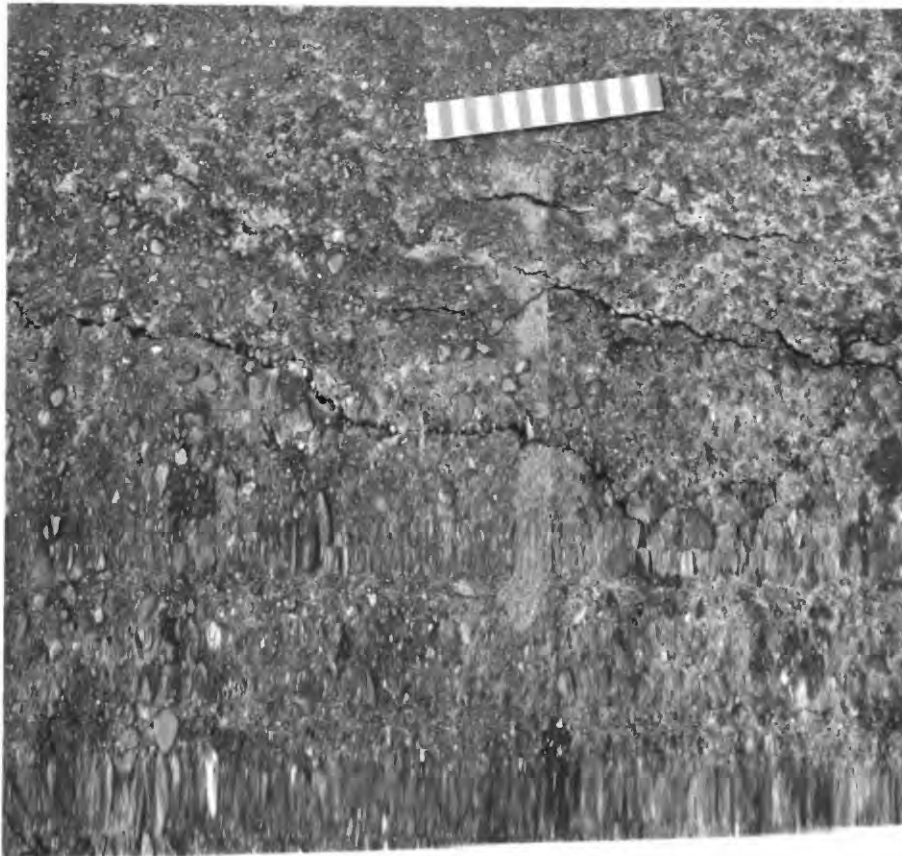
The longer crack, which was 10 m long and 10mm wide, contained several left-stepping en echelon segments with north-south strikes (fig. 1). The orientation of these

The occurrence of these two cracks on and subparallel to the mapped fault trace, their association with a subsidiary crack that subsequently showed right-lateral offset, and the left-stepping en echelon segments in the longer crack indicate that the cracks were surface expressions of the fault.

Figure 1: (Site 3) Crack in pavement on trace of Calaveras fault, a few meters west of Shore Road bridge over Tequisquita Slough. View is northwest. Crack was 10 mm wide. Maximum vertical offset was 25 mm, with the east side down; crack showed no lateral offset. Crack contained several left-stepping, en echelon segments; strike of these segments relative to fault trace was consistent with right-lateral shear. This crack and a shorter crack through the north shoulder of the road had strikes subparallel to the fault. Highway center stripe ended at patch in pavement; the road had been patched before the earthquake, probably because of damage due to fault creep. The two cracks were surface expressions of movement on the fault during the earthquake. Photograph taken 8/6/79.
