UNITED STATES DEPARTMENT OF THE INTERIOR  
GEOLOGICAL SURVEY

Surface faulting near Livermore, California  
associated with the January 1980 earthquakes

Open-File Report 80-523

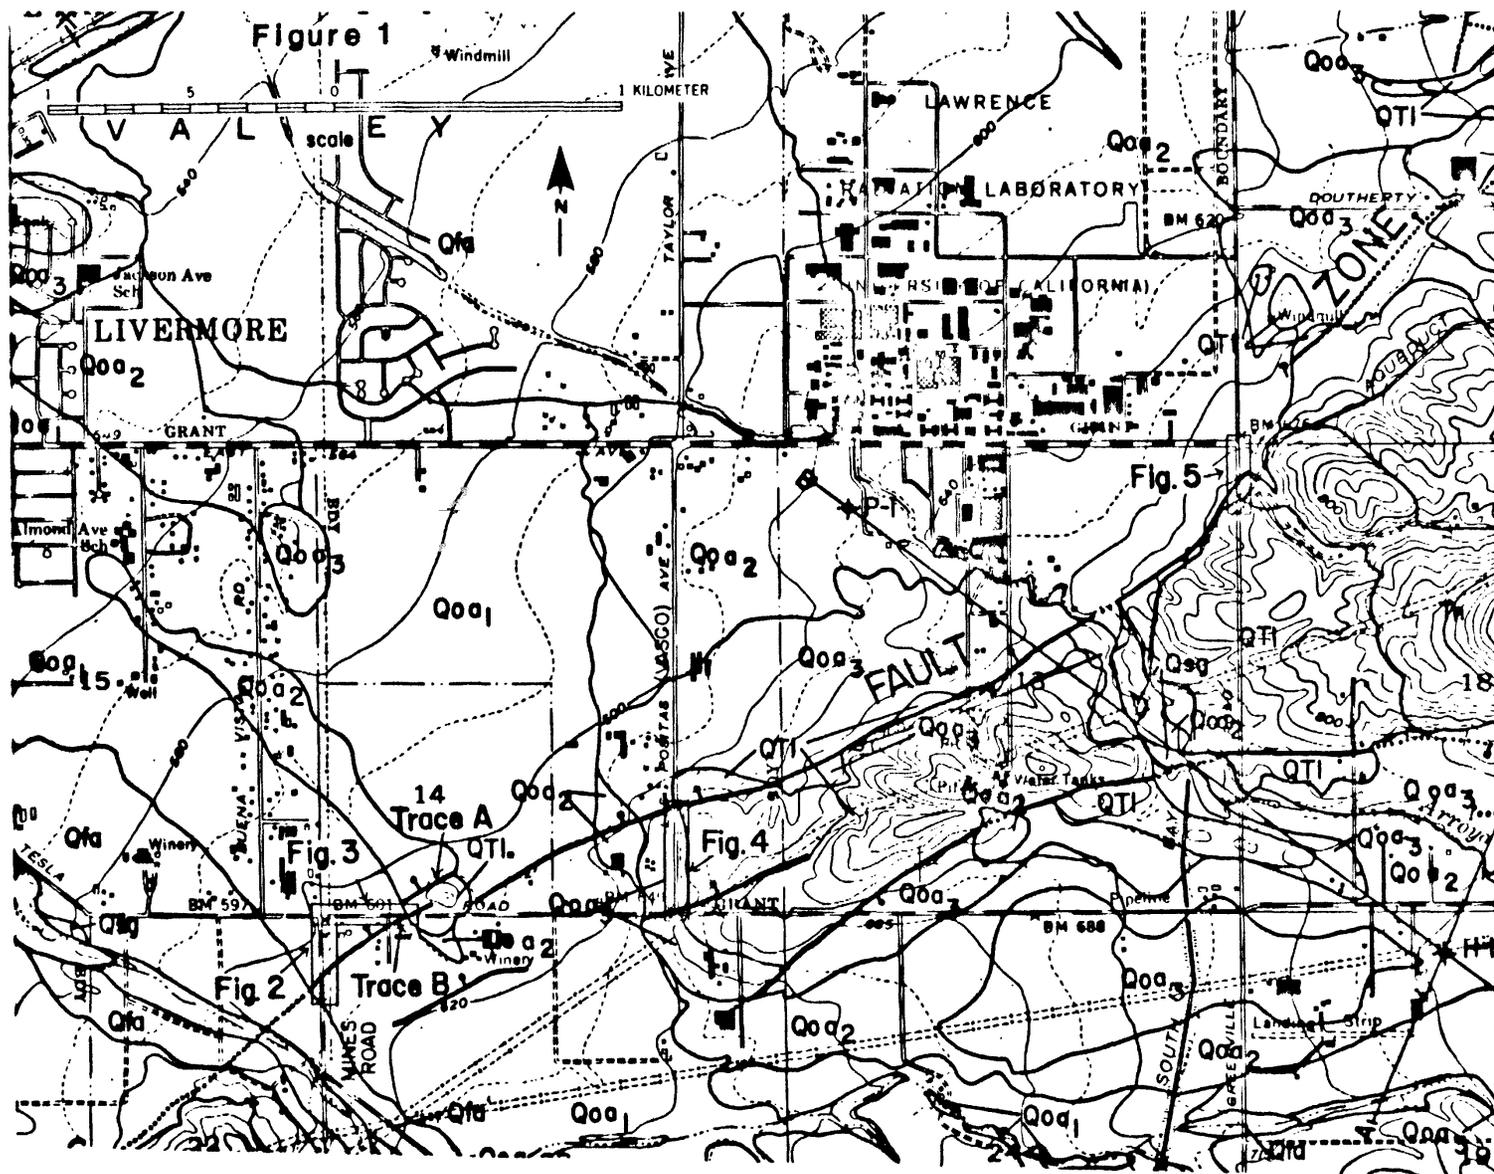
At location 34 along Tesla Road (inspected 7 February) nine fractures comprise three right-stepping en echelon sets of fractures (sketched in figure 3). Fractures 34A, 34B, and 34F-34I coincide with mapped traces or lie on the projections of mapped traces of the Las Positas fault zone (figures 1 and 3). Fracture 34C displays about 1.5 mm left-lateral strike slip displacement. Post-earthquake propagation of fractures C, E, and F apparently occurred; the cracks extended through and beyond spots of blue spray paint which reportedly marked the ends of the cracks at the time the paint was applied. Surfaces of all fractures at location 34 exposed fresh, black asphalt. Commonly, pebbles had been "popped" from their position adjacent to the fracture edge.

At location 36, near where the Las Positas fault zone intersects Greenville Road (figure 1), four fresh fractures without measurable lateral displacement were noted. Three fractures trend perpendicular to Greenville Road and one is diagonal to it. As mapped on 7 February these features are shown relative to the northeast abutment of the Greenville Road bridge where it crosses the South Bay aqueduct (figure 5). No extension or growth of fractures was observed on 29 February. The orientation perpendicular to Greenville Road and the absence of growth or a history of propagation indicate a probably non-tectonic origin for these fractures.

Figure 1. Index map excerpted from Herd (1977) showing locations of figures 2 through 5 in relation to mapped traces of the Las Positas fault zone.
