THE MAY - JULY 1978 EARTHQUAKE
SEQUENCE NEAR THESSALONIKI
GREECE

Richard P. Maley, Charles G. Bufe and
Robert F. Yerkes
U.S. Geological Survey
345 Middlefield Road
Menlo Park, California 94025

OPEN-FILE REPORT 80-937

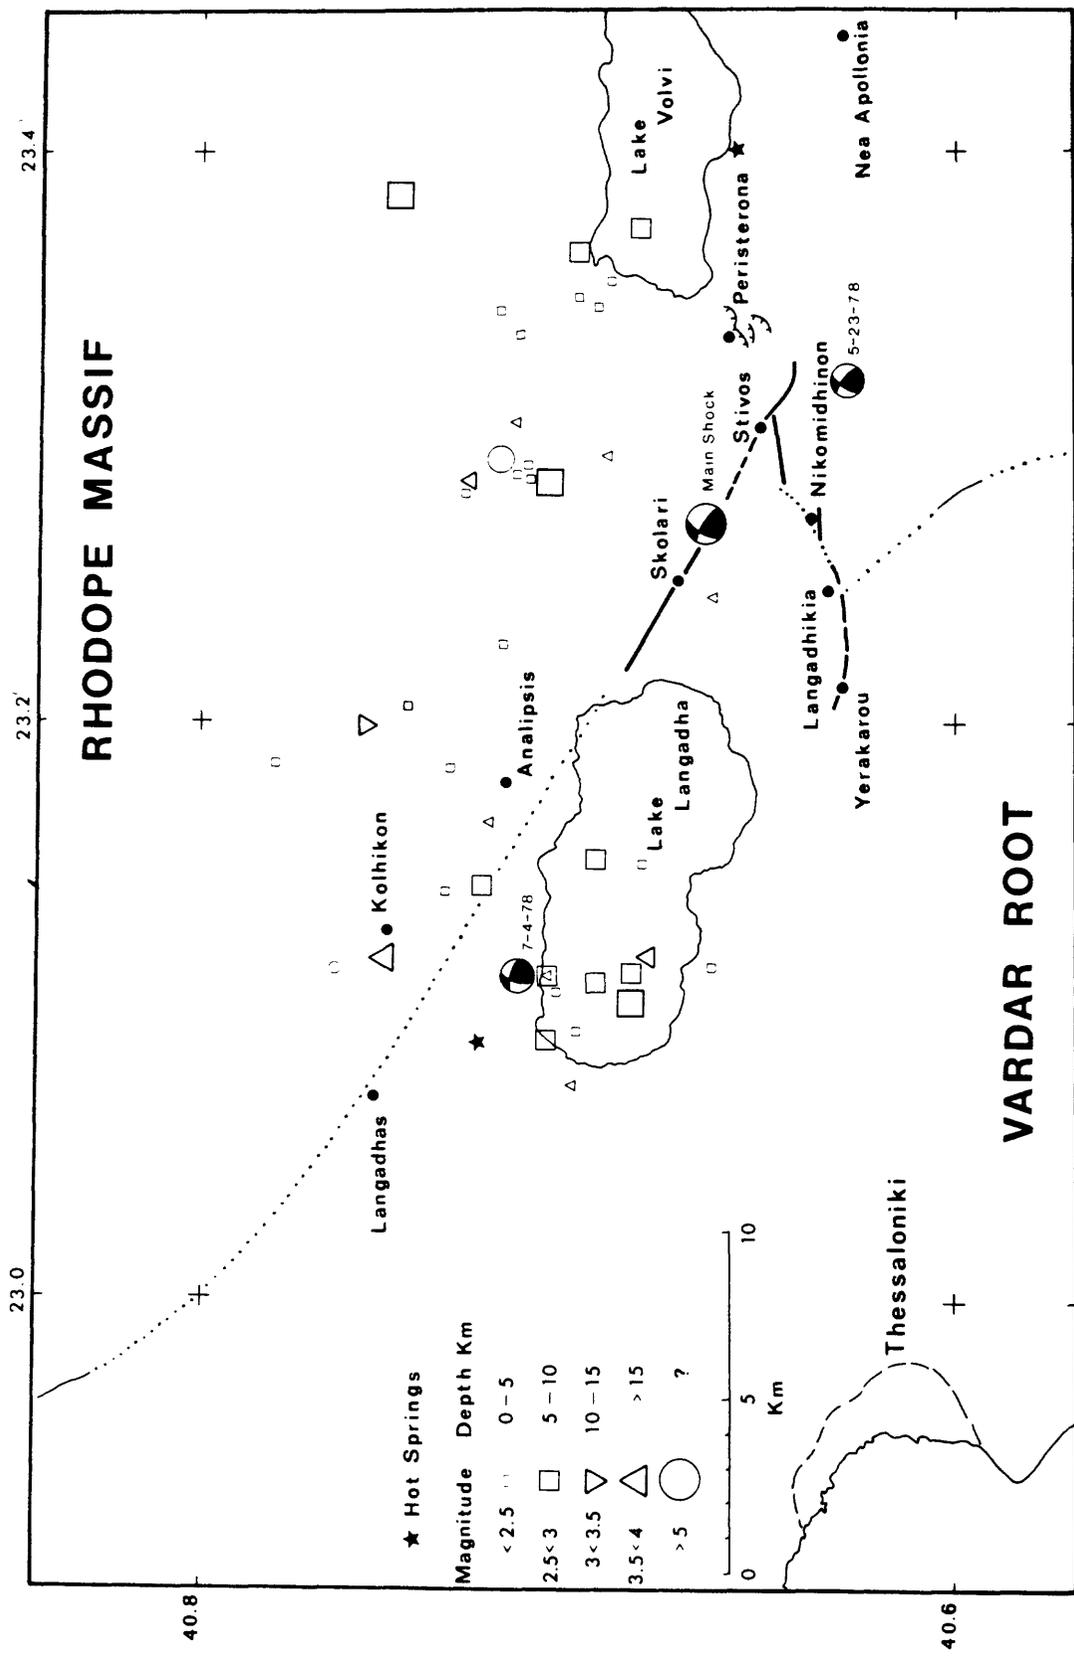
The region of mapped ground rupture occurred in the area between Lakes Langadha and Volvi where the trend of the valley changes from east-west to northwesterly. The surrounding region has experienced moderate to large earthquakes in 1902, 1904, 1905, 1931, 1932, 1952, 1958, 1960, and 1978. On the basis of felt reports, the 1902 and 1978 events were very similar. Ground rupture mapped in the valley between Lakes Langadha and Volvi falls into two patterns, shown in Figure 1.

Preliminary aftershock locations from the local USGS network fall principally into two clusters (Figure 1), one along the north side of Lake Langadha, the other 5 km NW of Lake Volvi. Focal plane solutions for the main shock and the May 23 magnitude 5.8 foreshock obtained from Professors Galanopoulos and Papazachos and for aftershocks located under Lake Langadha using data from a 10-station USGS network of portable seismographs are consistent with left-lateral strike slip along a fault trending WNW and dipping steeply to the north (although this interpretation is not unique). Inferred principal stress orientations are east-west compression and north-south extension, similar to those for the 1963 Skopje, Yugoslavia earthquake.

Figure 1. Map of Langadha-Volvi Lakes area showing 1978 ruptures (heavy lines), faulted boundary between the Rhodope massif and the Vardar root zone, and selected epicenters of the 1978 earthquake sequence. Fault diagrams are lower hemisphere with the compressional quadrants dark.

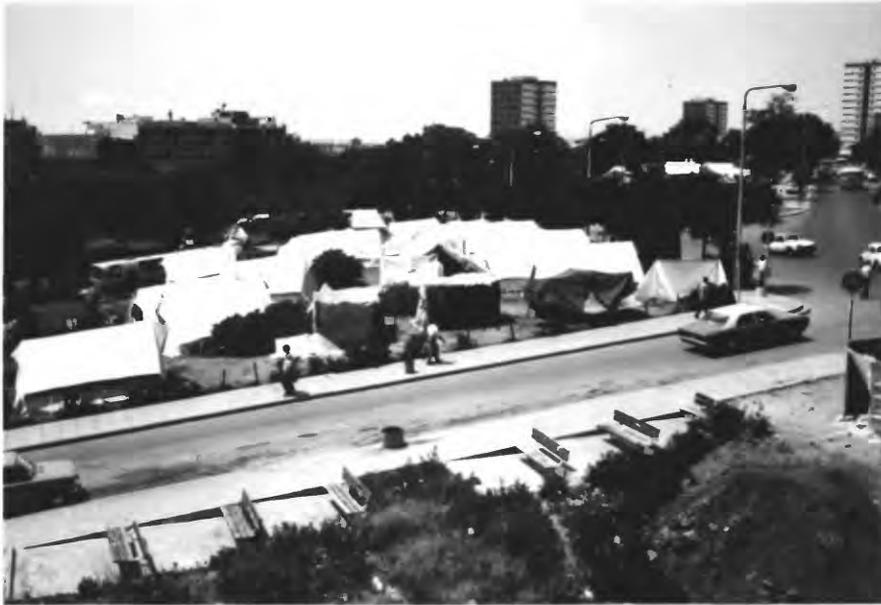
Many residents left Thessaloniki immediately after the mainshock causing severe traffic congestion and numerous serious accidents while a large part of the remaining population began to erect "tent cities" in any available space (Figure 6). In response to this, the Greek army distributed 60,000 large tents to residents who had need for them. Army personnel also prepared sanitary facilities at the sites of large tent concentrations. Because of continuing aftershocks and fearing the occurrence of another and even stronger earthquake, only a limited number of residents had elected to return to their homes by late July, despite the fact that many of them lived in structures that had been inspected and were considered safe for occupancy. This feeling may have been strengthened by the sequence of events that occurred between the May 23 and 24 magnitude 5.8 and 5.1 foreshocks and June 20. Following the May earthquakes, a nervous populace was given the impression from government authorities that the earthquake series was probably over, based on the best of information available. Apparently the public was adequately convinced there would not be further earthquakes and consequently the activity in Thessaloniki returned to normal. After the magnitude 6.5 June 20 earthquake, the populace remained steadfast in their belief that an even stronger earthquake could occur in the future. Since previous seismicity patterns in northern Greece show a series of large earthquakes over several years, 1902 to 1905 and 1931 to 1933; the population in general was yet not ready to return to their residences, at least not within in the first five weeks after the main shock.

Figure 6. Tents erected for temporary housing in a Thessaloniki park.

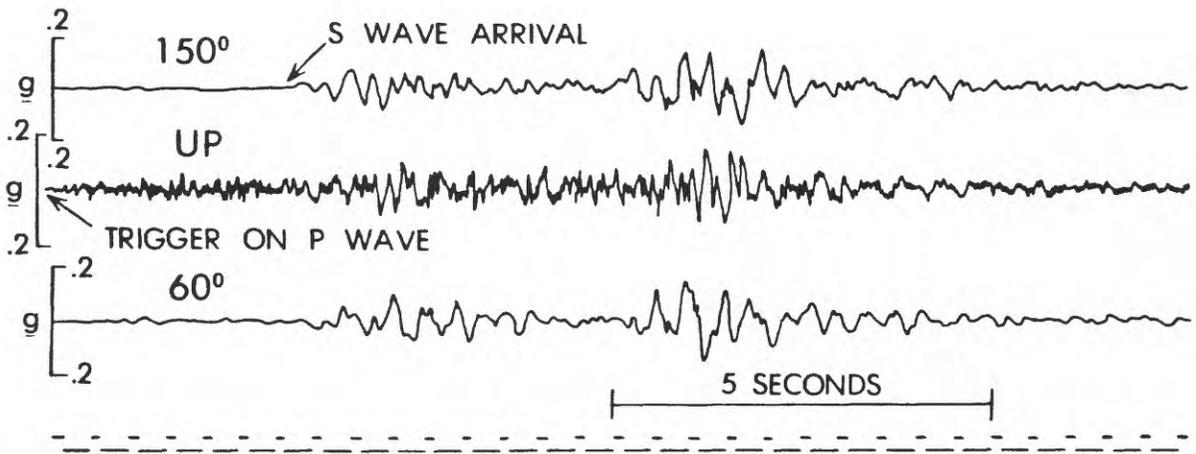
An accelerogram recorded by an instrument operated by the National Observatory of Athens in Thessaloniki suggests the June 20 event was a complex rupture consisting of two or more events (Figure 7). The record is characterized by two distinct sections of higher amplitude motion, one beginning 3.3 seconds after the instrument triggered and other approximately 4.5 seconds later.

Figure 7. Tracing of the Thessaloniki accelerogram.
