AN ANALYSIS OF STRONG-MOTION DATA FROM A SEVERELY DAMAGED STRUCTURE,
THE IMPERIAL COUNTY SERVICES BUILDING, EL CENTRO, CALIFORNIA

Christopher Rojahn and P. N. Mork
U.S. Geological Survey
Menlo Park, California

U.S. Geological Survey
Open-File Report 81-194

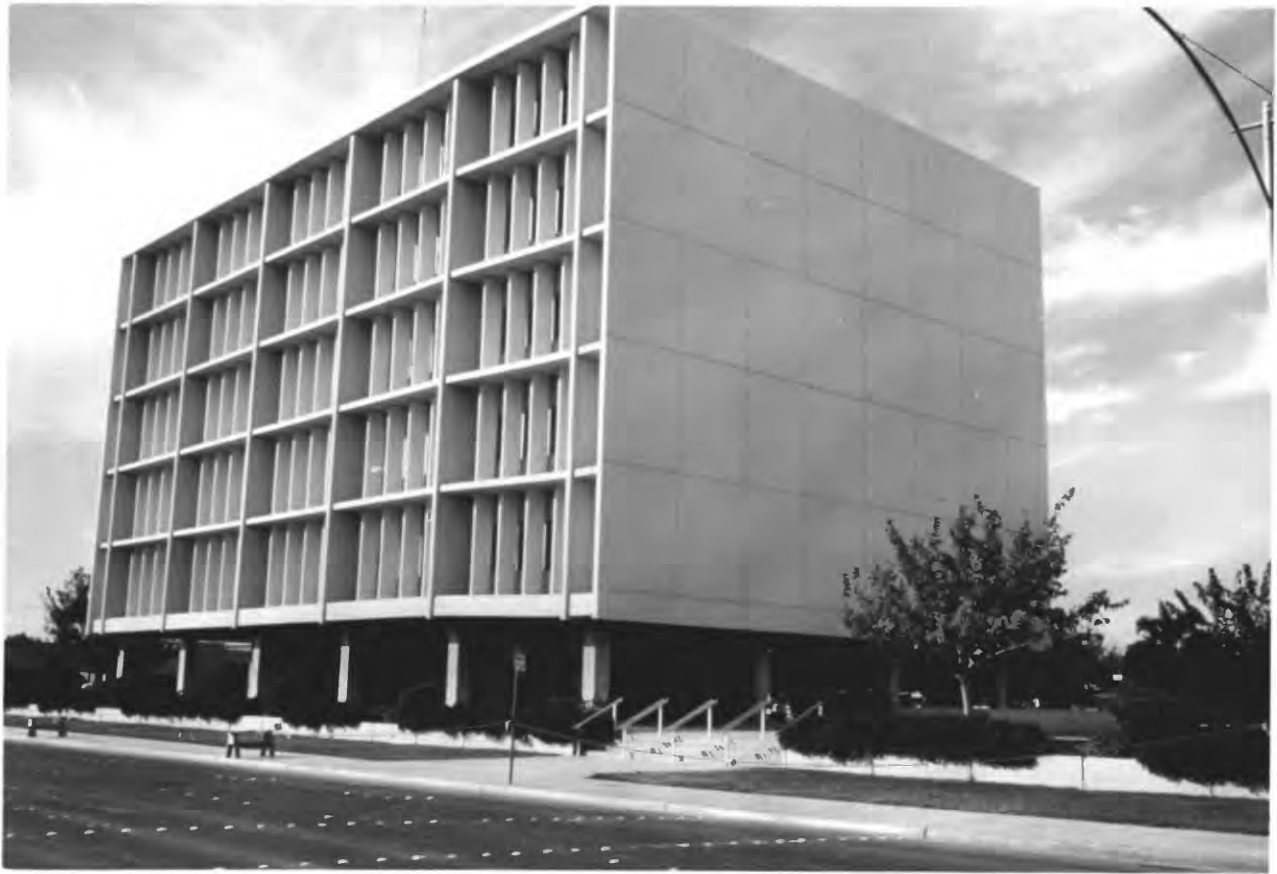
Figure 2.--View northwestward of Imperial County Services Building, El Centro, Calif.

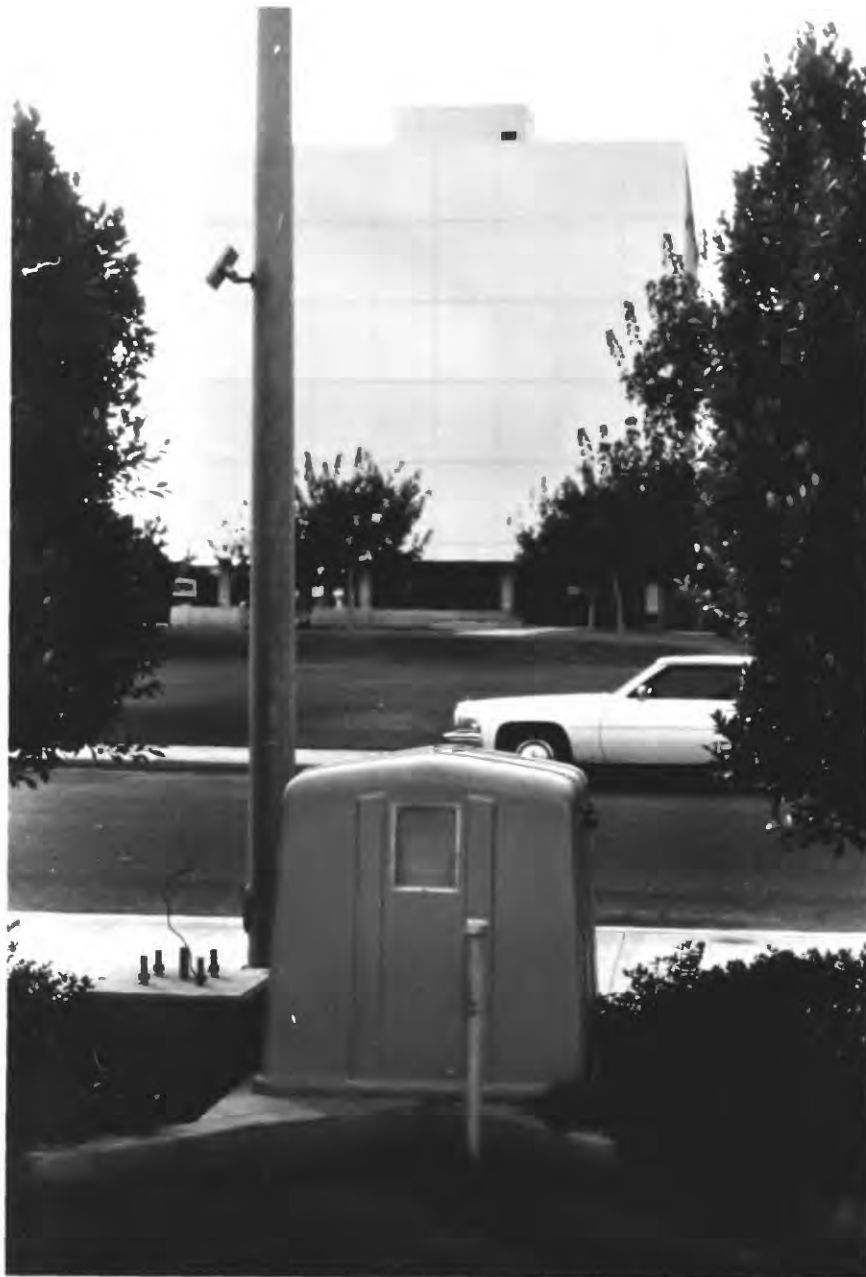
Figure 6.--Fiberglass instrument shelter (foreground) housing SMA-1 accelerograph located east of Imperial County Services Building (background). Note solar cells mounted on pole adjacent to shelter; these cells provide current for accelerograph's battery charger.

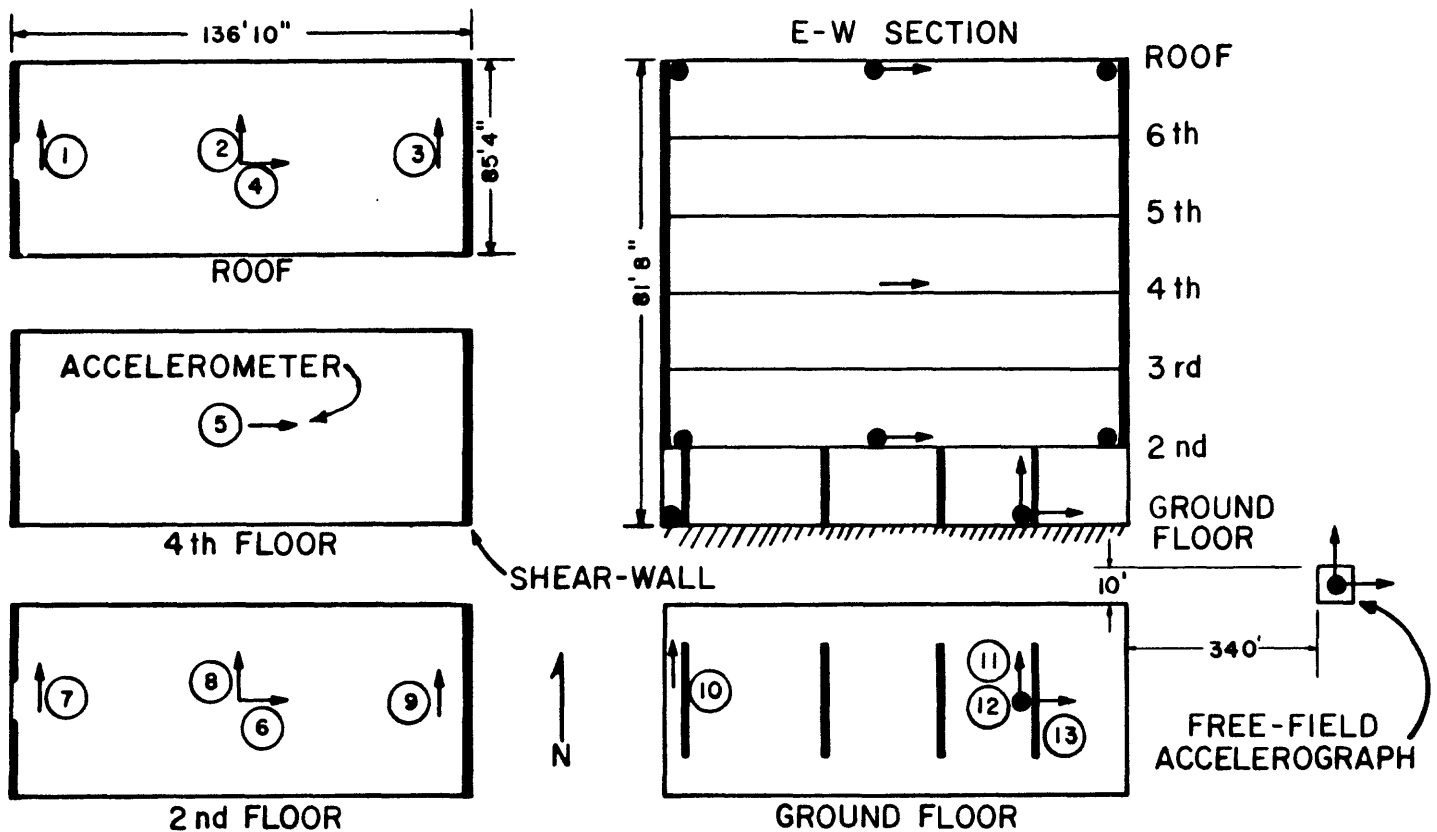
Figure 7.--Locations of FBA accelerometers (arrows with numbers) and SMA-1 accelerograph at Imperial County Services Building and adjacent free-field site (after Rojahn and Ragsdale, 1980b). Arrows denote direction of positive acceleration (on trace).

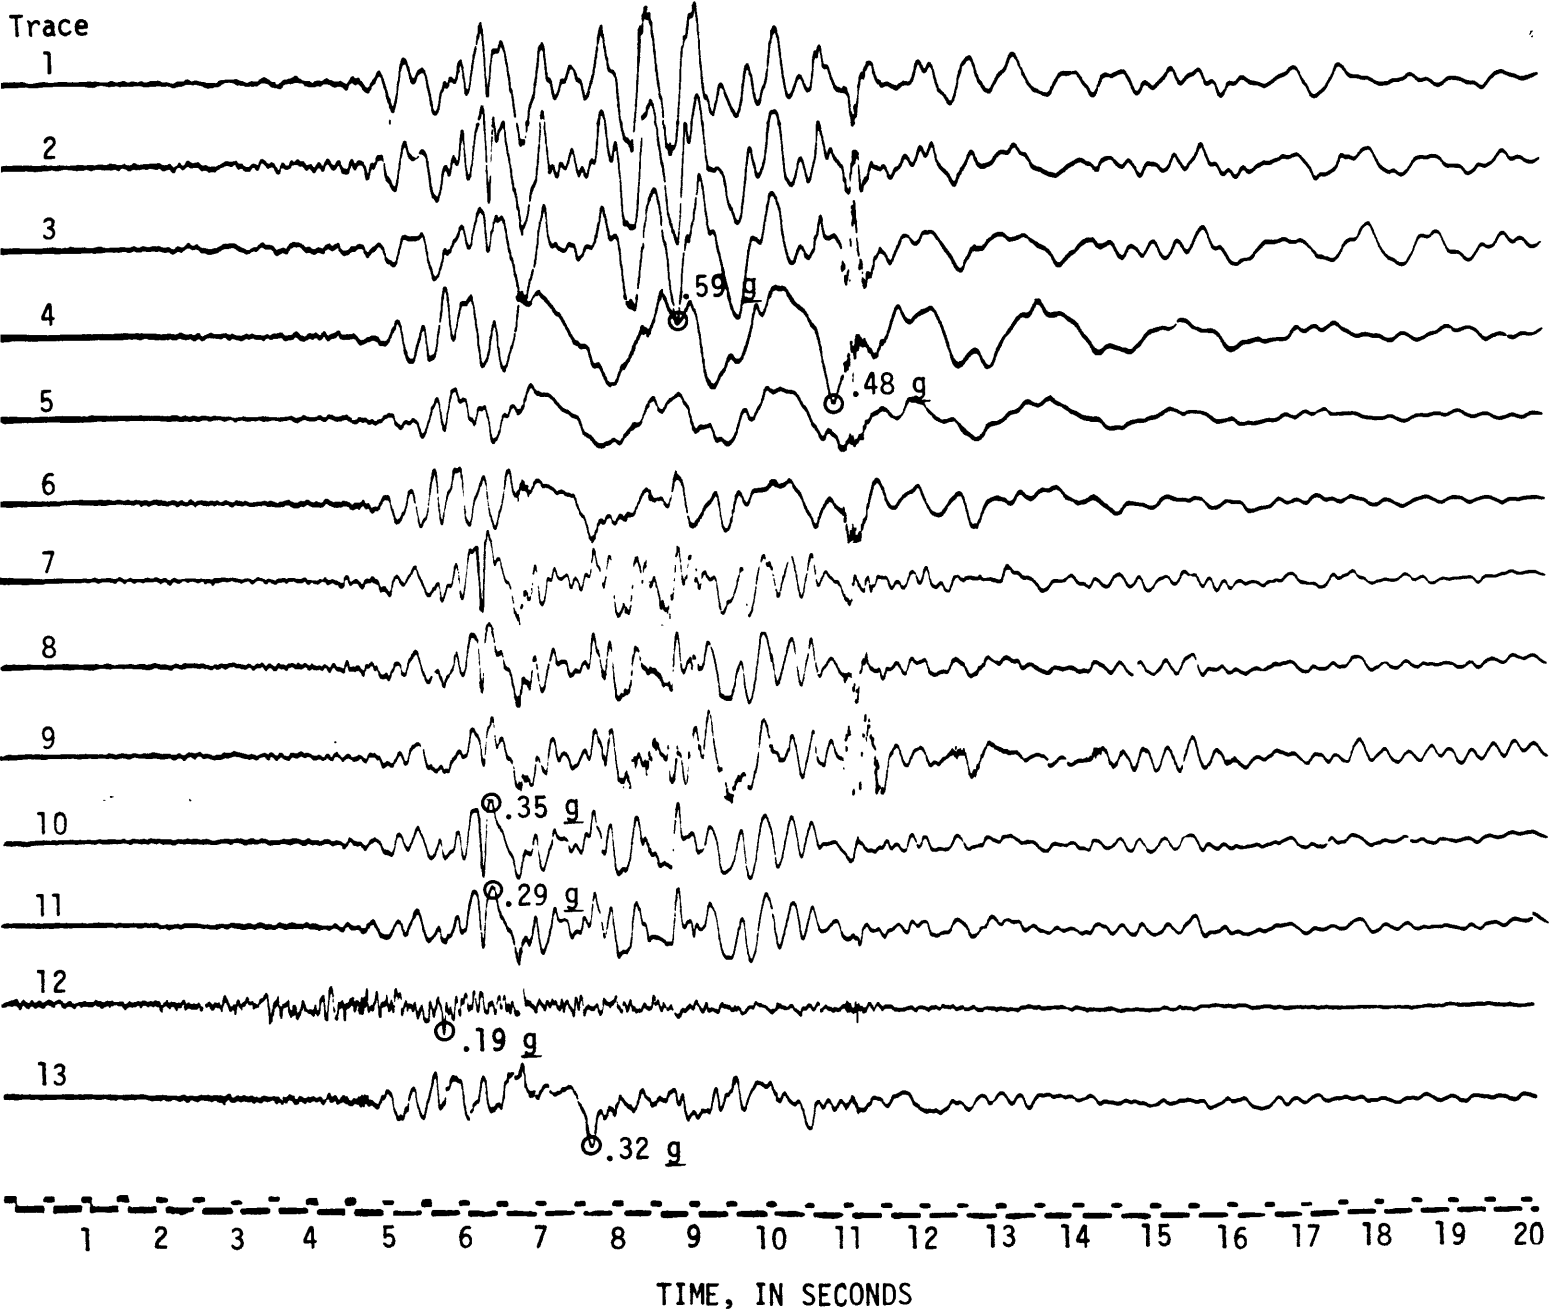
Our analysis of the building accelerogram also includes computing and interpreting the relative-displacement time histories that are obtained by differencing the displacement time histories of various acceleration traces (fig. 8). We refer to this relative-displacement analysis as a preliminary effort to stress that uncertainties are introduced when displacements are obtained by doubly integrating accelerograms. We believe we have minimized the uncertainties by differencing and careful filtering.

Figure 8.--Part of CRA-1 strong-motion accelerogram recorded on October 15 in Imperial County Services Building. Total record length was 90 s (Porter, in press). Trace number at start of record (left of figure) corresponds to accelerometer numbers in figure 7.

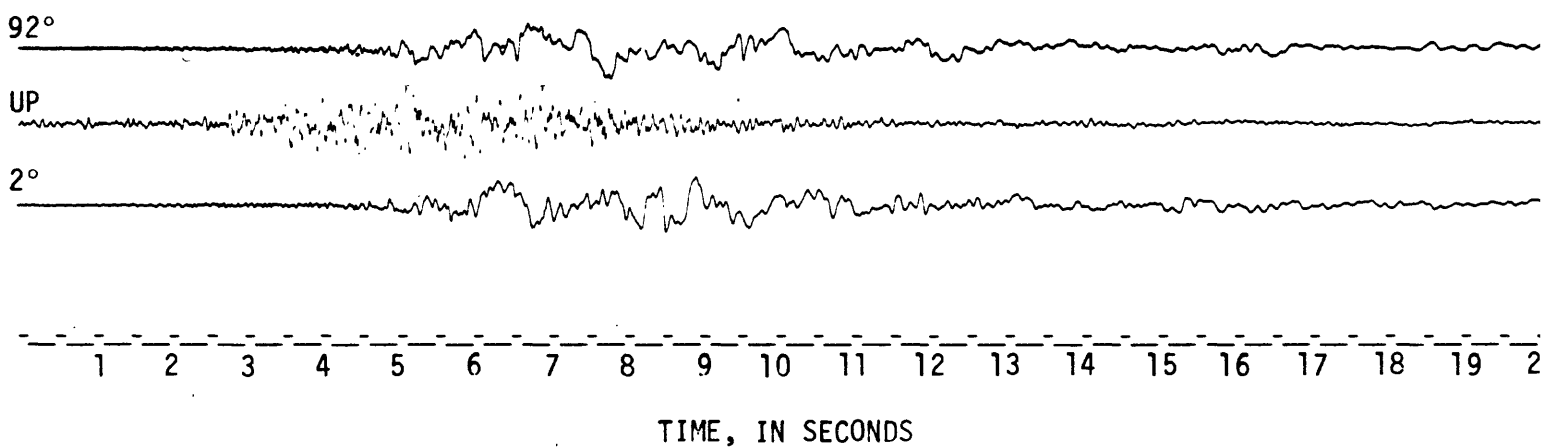
Figure 9.--Part of SMA-1 strong-motion accelerogram recorded on October 15 at free-field site 100 m east of Imperial County Services Building. Direction of positive acceleration given at beginning of trace.

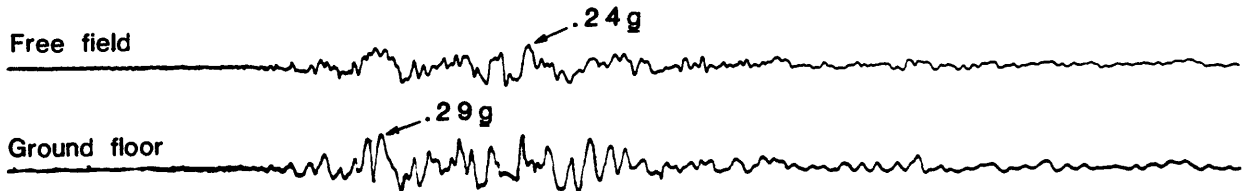
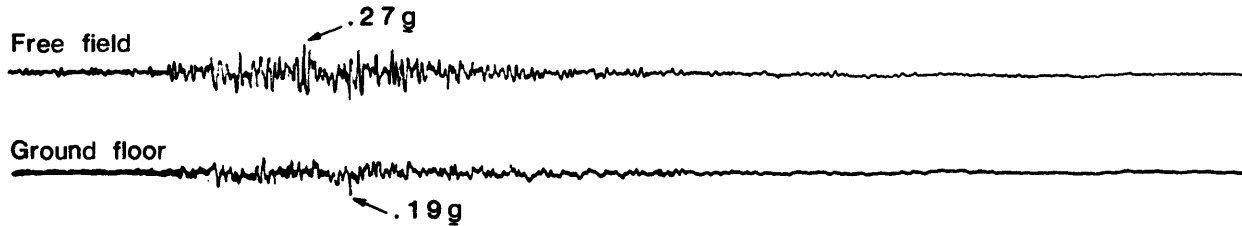
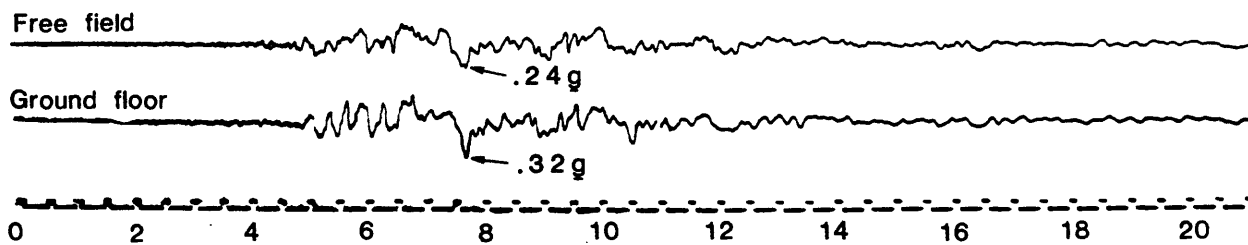
Figure 10.--October 15 acceleration-time histories recorded at Imperial County Services Building and adjacent free-field site.

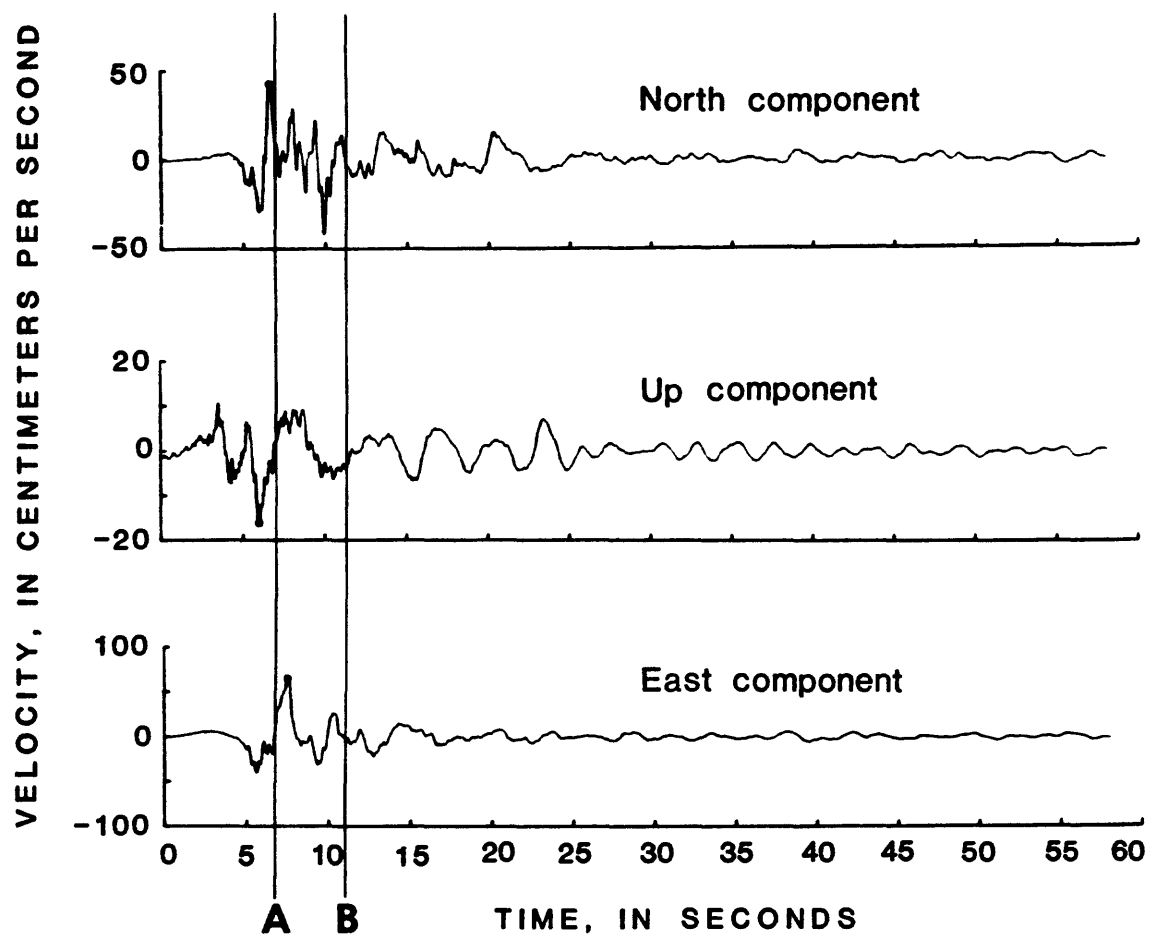
The acceleration and velocity time histories for the three ground-level components recorded near the east end of the building (traces 11-13, fig. 11; fig. 12) indicate that the time of damage initiation (6.8 s) was approximately 2 s after the onset of high-amplitude horizontal motion and that the beginning of column collapse at 11.0 s occurred 4 s later, near the end of these high-amplitude motions, that is, just after the strongest motions had subsided. At the time of damage initiation, for example, ground accelerations in the north-south, vertical, and east-west directions were approximately 0.26, 0.12, and 0.24 g, respectively, whereas at the beginning of column collapse they were approximately 0.07, 0.02, and 0.03 g, respectively. More significant, perhaps, is the evidence that damage initiation occurred during the long-period (greater than 1 s) acceleration pulse in the east-west direction (trace 13, fig. 11) and that it immediately followed the maximum ground velocity of 42.4 cm/s in the north-south direction (fig. 12). It is also noteworthy that (1) the maximum east-west velocity of 64.6 cm/s occurred approximately 1 s after damage initiation and 3 s before column collapse, and (2) peak velocities exceeded 40 cm/s on two occasions (once in the east-west and once in the north-south direction) before damage initiation and on four occasions before column collapse (table 2). These observations, particularly those regarding the number of velocity peaks greater than 40 cm/s and the

Figure 12.--Velocity-time histories for north, up, and east components (accelerometer 11) recorded at ground level (after Porter, in press). Times at which damage initiation occurred and column collapse began are labeled A and B, respectively.

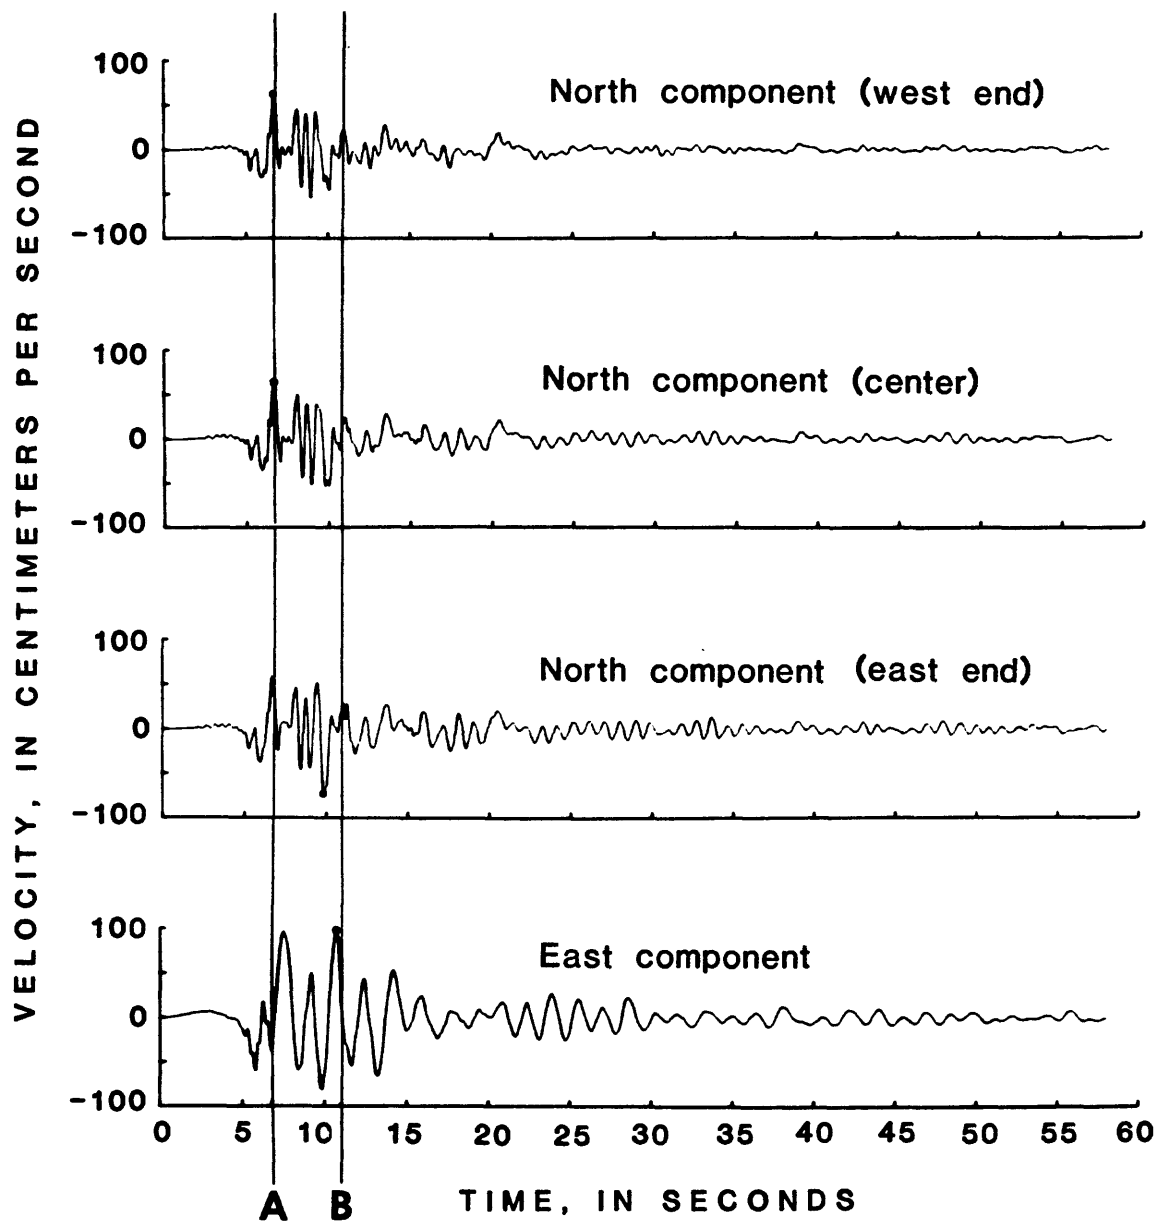
The acceleration and velocity time-histories for the roof-level components (traces 1-4, fig. 11; fig. 13) indicate that the time of damage initiation (6.8 s) was approximately 2 s after the onset of high-amplitude horizontal motions, as was the case at ground level. The plots also indicate that the beginning of column collapse at 11.0 s occurred near the end of high-amplitude response in the north-south direction, whereas in the east-west direction the response level remained high for several seconds after column collapse. In addition, the data indicate that: (1) at damage initiation (6.8 s), peak east-west and north-south accelerations were approximately 0.28 and 0.44 g (avg for traces 1-3), respectively; (2) the maximum east-west acceleration (0.48 g) occurred just before column collapse (11.0 s); (3) the maximum north-south acceleration (0.59 g) occurred midway between damage initiation and column collapse; (4) the building underwent roof-level torsional response approximately 1.3 s before column collapse (at 9.7 s the north-south acceleration at the east end of the building was approximately 0.53 g, whereas at the west end it was 0.26 g); (5) both the east-west and north-south (trace 3, east end) peak velocity responses exceeded 40 cm/s on one occasion before damage initiation and on six occasions before column collapse (table 3); (6) peak north-south (trace 3, east end) velocity response exceeded 60 cm/s on one occasion before column collapse (table 3); and (7) peak east-west velocity response exceeded 80 cm/s on three occasions before column collapse (table 3). These latter observations provide information on the number of cycles of motion (each peak corresponds to half a cycle) above various response thresholds before damage initiation and column collapse; they should therefore aid interpretation of the velocity response envelope spectra (Perez, 1973) obtained from other sites during other earthquakes. In general, the above observations should also help in determining the response levels at which damage can be expected to occur in structures with dynamic properties similar to those of the Imperial County Services Building.

Figure 13.--Velocity-time histories for north and east components recorded at roof level (after Porter, in press). Times at which damage initiation occurred and column collapse began are labeled A and B, respectively.

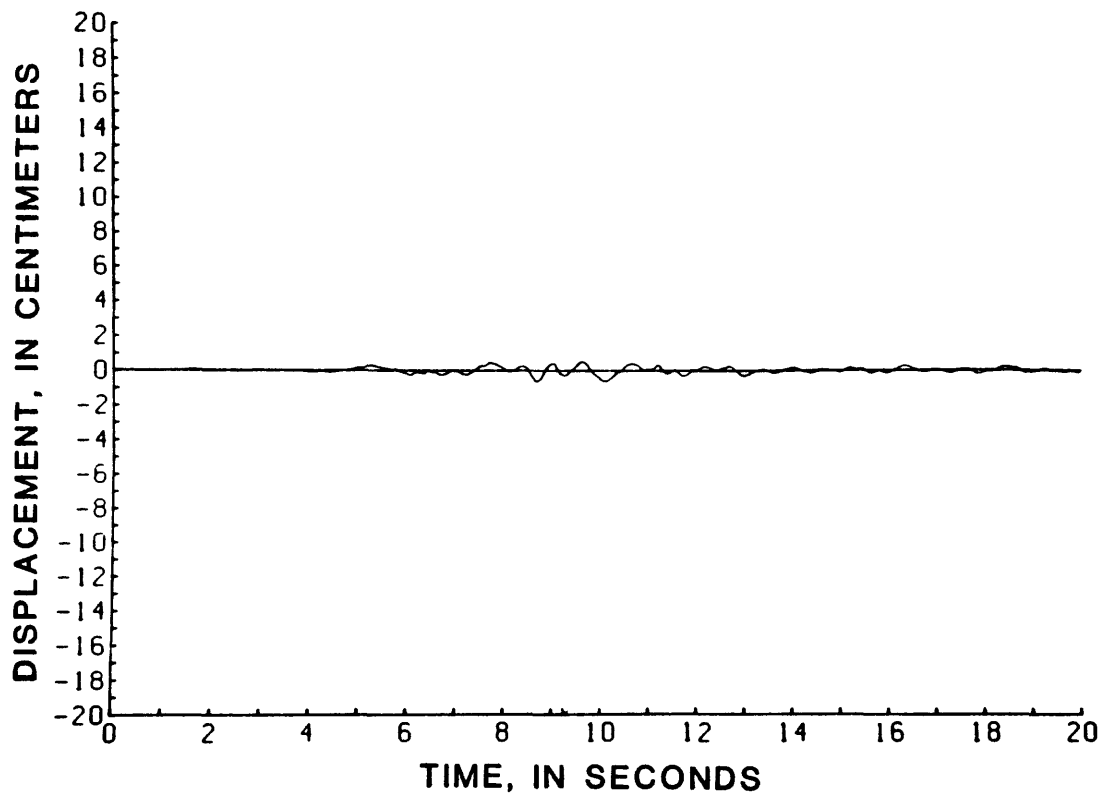
The time history of north-south differential motion at the ground floor (fig. 14), computed by differencing displacement time histories for traces 10 and 11 (fig. 8), indicates that the maximum differential motion between the west and east ends of the building (accelerometers 10, 11, fig. 7) was approximately 0.6 cm. Since accelerometers 10 and 11 are 30 m apart, these

Figure 14.--Time history of north-south relative displacements at ground level, computed by differencing displacement-time histories for acceleration traces 10 and 11 (fig. 8).

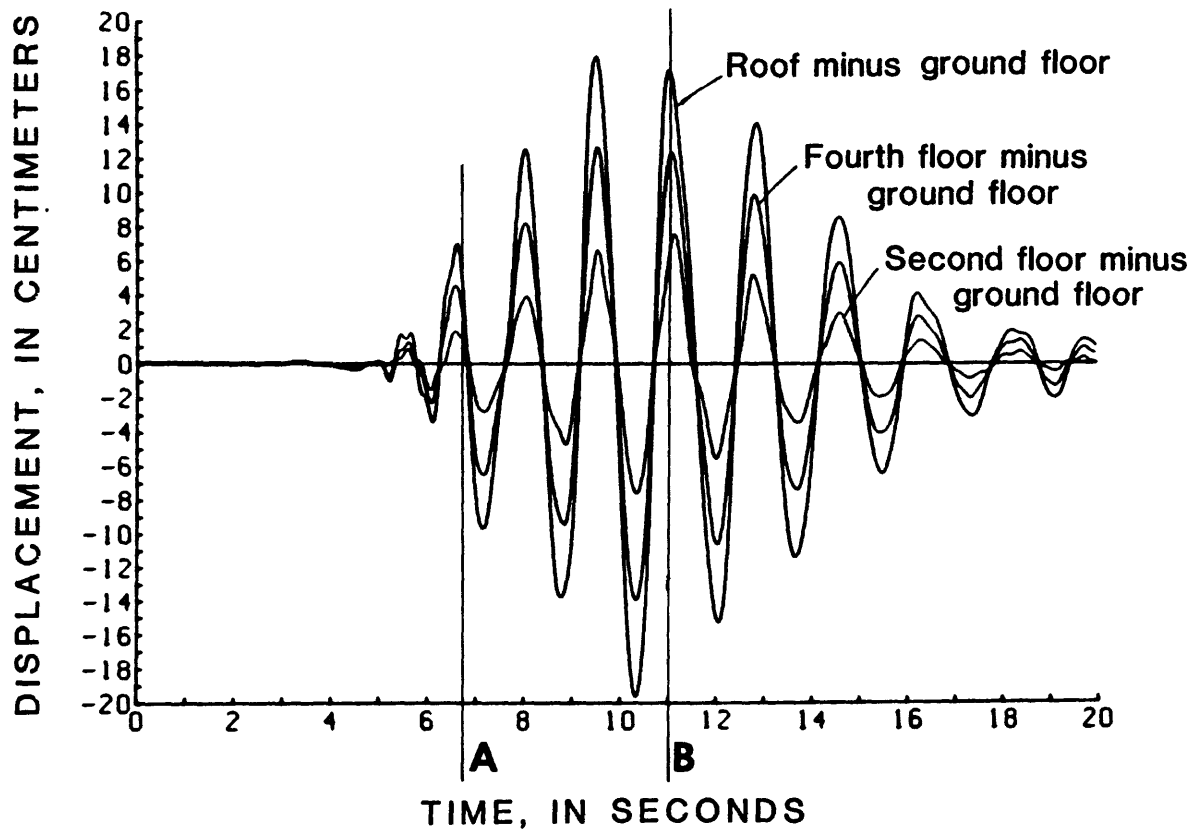
East-west relative-displacement time histories, computed by differencing east-west displacement time histories for the various floor levels, provide insight into the overall extent of building response. Roof minus ground-floor, fourth-floor minus ground-floor, and second-floor minus ground-floor east-west relative-displacement data (fig. 15), computed by differencing displacement time histories for traces 4 and 13, 5 and 13, and 6 and 13 (figs. 7, 8), respectively, suggest that the east-west relative displacements between the second and ground floors (hereafter referred to as the first story) were substantially larger than those between any other adjacent floors (table 5). More specifically, the data suggest that the maximum interstory displacement was approximately 2 cm (average value) in the fourth, fifth, and sixth stories, approximately 3 cm in the second and third stories, and approximately 8 cm in the first story.

collapse apparently began when the east-west relative displacement was approximately 6.2 cm, or 81% percent of the maximum (7.7 cm) that occurred approximately 0.1 s later; and (4) the north-south first-story relative displacement was relatively small (0.4 cm) when column collapse began. Also, the amplitude of north-south relative displacement between the roof and ground floor at the east end (fig. 16) when column collapse began was also small (0.8 cm); in other words, at the time of column collapse, the building was aligned nearly vertical in the north-south direction.

Figure 15.--Time history of east-west relative displacements between roof and ground floor (difference of data from accelerometers 4 and 13), fourth and ground floor (difference of data from accelerometers 5 and 13), and second and ground floor (difference of data from accelerometers 6 and 13). Times at which damage initiation occurred and column collapse began are labeled A and B, respectively.

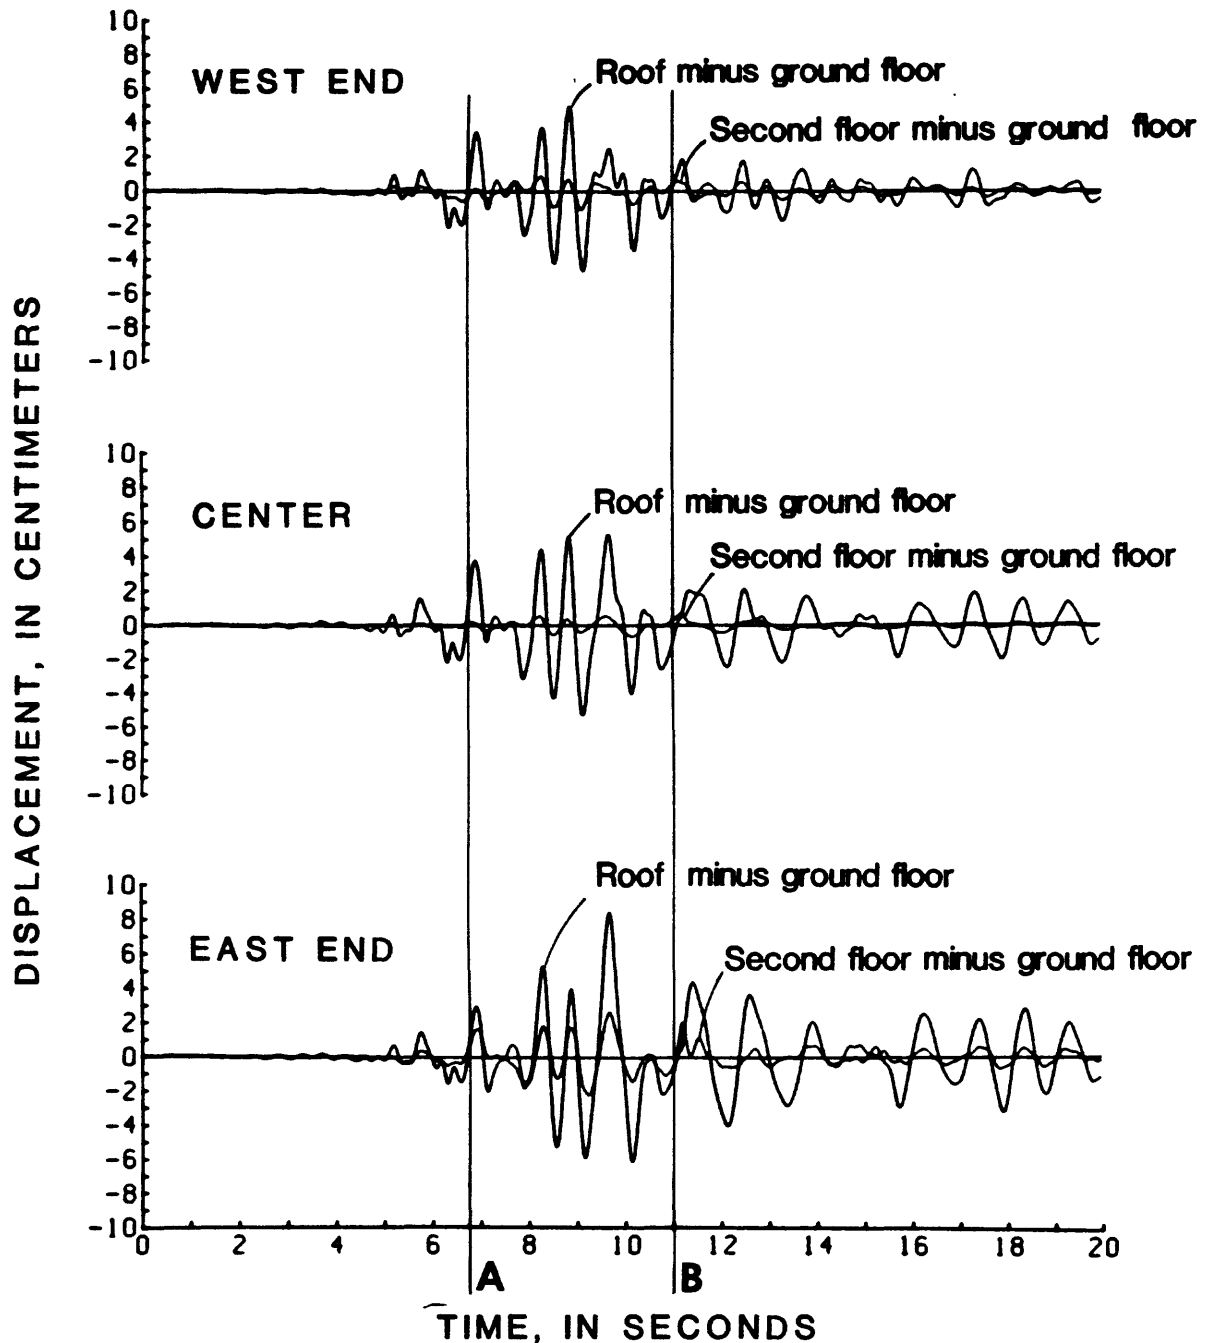
North-south relative-displacement time histories, computed by differencing north-south displacement time histories, for various places (west end, center, and east end) at the roof, second floor, and ground floor (fig. 16, table 6), suggest that interstory motion in the north-south direction was substantially less than in the east-west direction (fig. 15, table 5). Between the roof and ground floor at the east end of the building, for example, the maximum north-south relative displacement was about 9 cm, whereas in the east-west direction it was approximately 20 cm. These data also suggest that the north-south relative displacements between the second and ground floors at the east end of the building (max amplitude, 2.7 cm; fig. 16), where the columns collapsed, were substantially larger than at the center and west end (max amplitudes, 0.7 and 1.1 cm, respectively; fig. 16). These data imply, then, that the row of columns at the east end of the building underwent larger north-south relative displacements between the ground and second floors than did any other north-south row of columns in the first story. These data also imply that that part of the second-floor diaphragm between the east end of the building and the easternmost first-story shear wall (9.4 m to the west) did not remain rigid in its own plane but rather sustained relatively large north-south bending or shear distortions. These diaphragm distortions are clearly evident in figure 17, which shows the time histories of north-south relative displacements between the center and east end (max amplitude, 2 cm) and center and west end (max amplitude, 1 cm) of the second-floor diaphragm.

Figure 16.--Time histories of north-south relative displacements between roof and ground floor and second and ground floor at west end of building (difference of data from accelerometers 1 and 10, and 7 and 10), center (difference of data from accelerometers 2 and 11, and 8 and 11), and east end of building (difference of data from accelerometers 3 and 11, and 9 and 11). Times at which damage initiation occurred and column collapse began are labeled A and B, respectively.

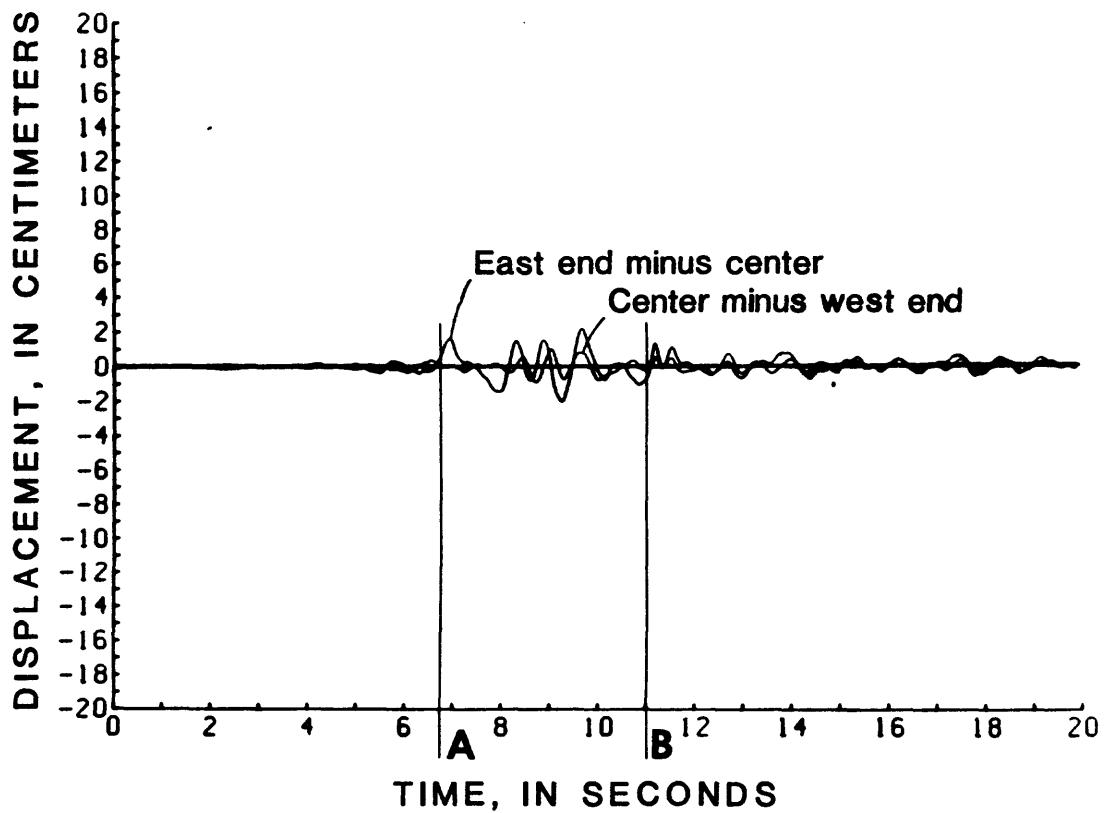
Figure 17.--Time histories of north-south relative displacements between center and east end of second-floor diaphragm (difference of data from accelerometers 8 and 9) and center and west end of second-floor diaphragm (difference of data from accelerometers 7 and 8). Times at which damage initiation occurred and column collapse began are labeled A and B, respectively.
