INVESTIGATIONS OF THE 8 NOVEMBER 1980
EARTHQUAKE IN HUMBOLDT COUNTY, CALIFORNIA

U.S. Geological Survey

Open-File Report 81-397

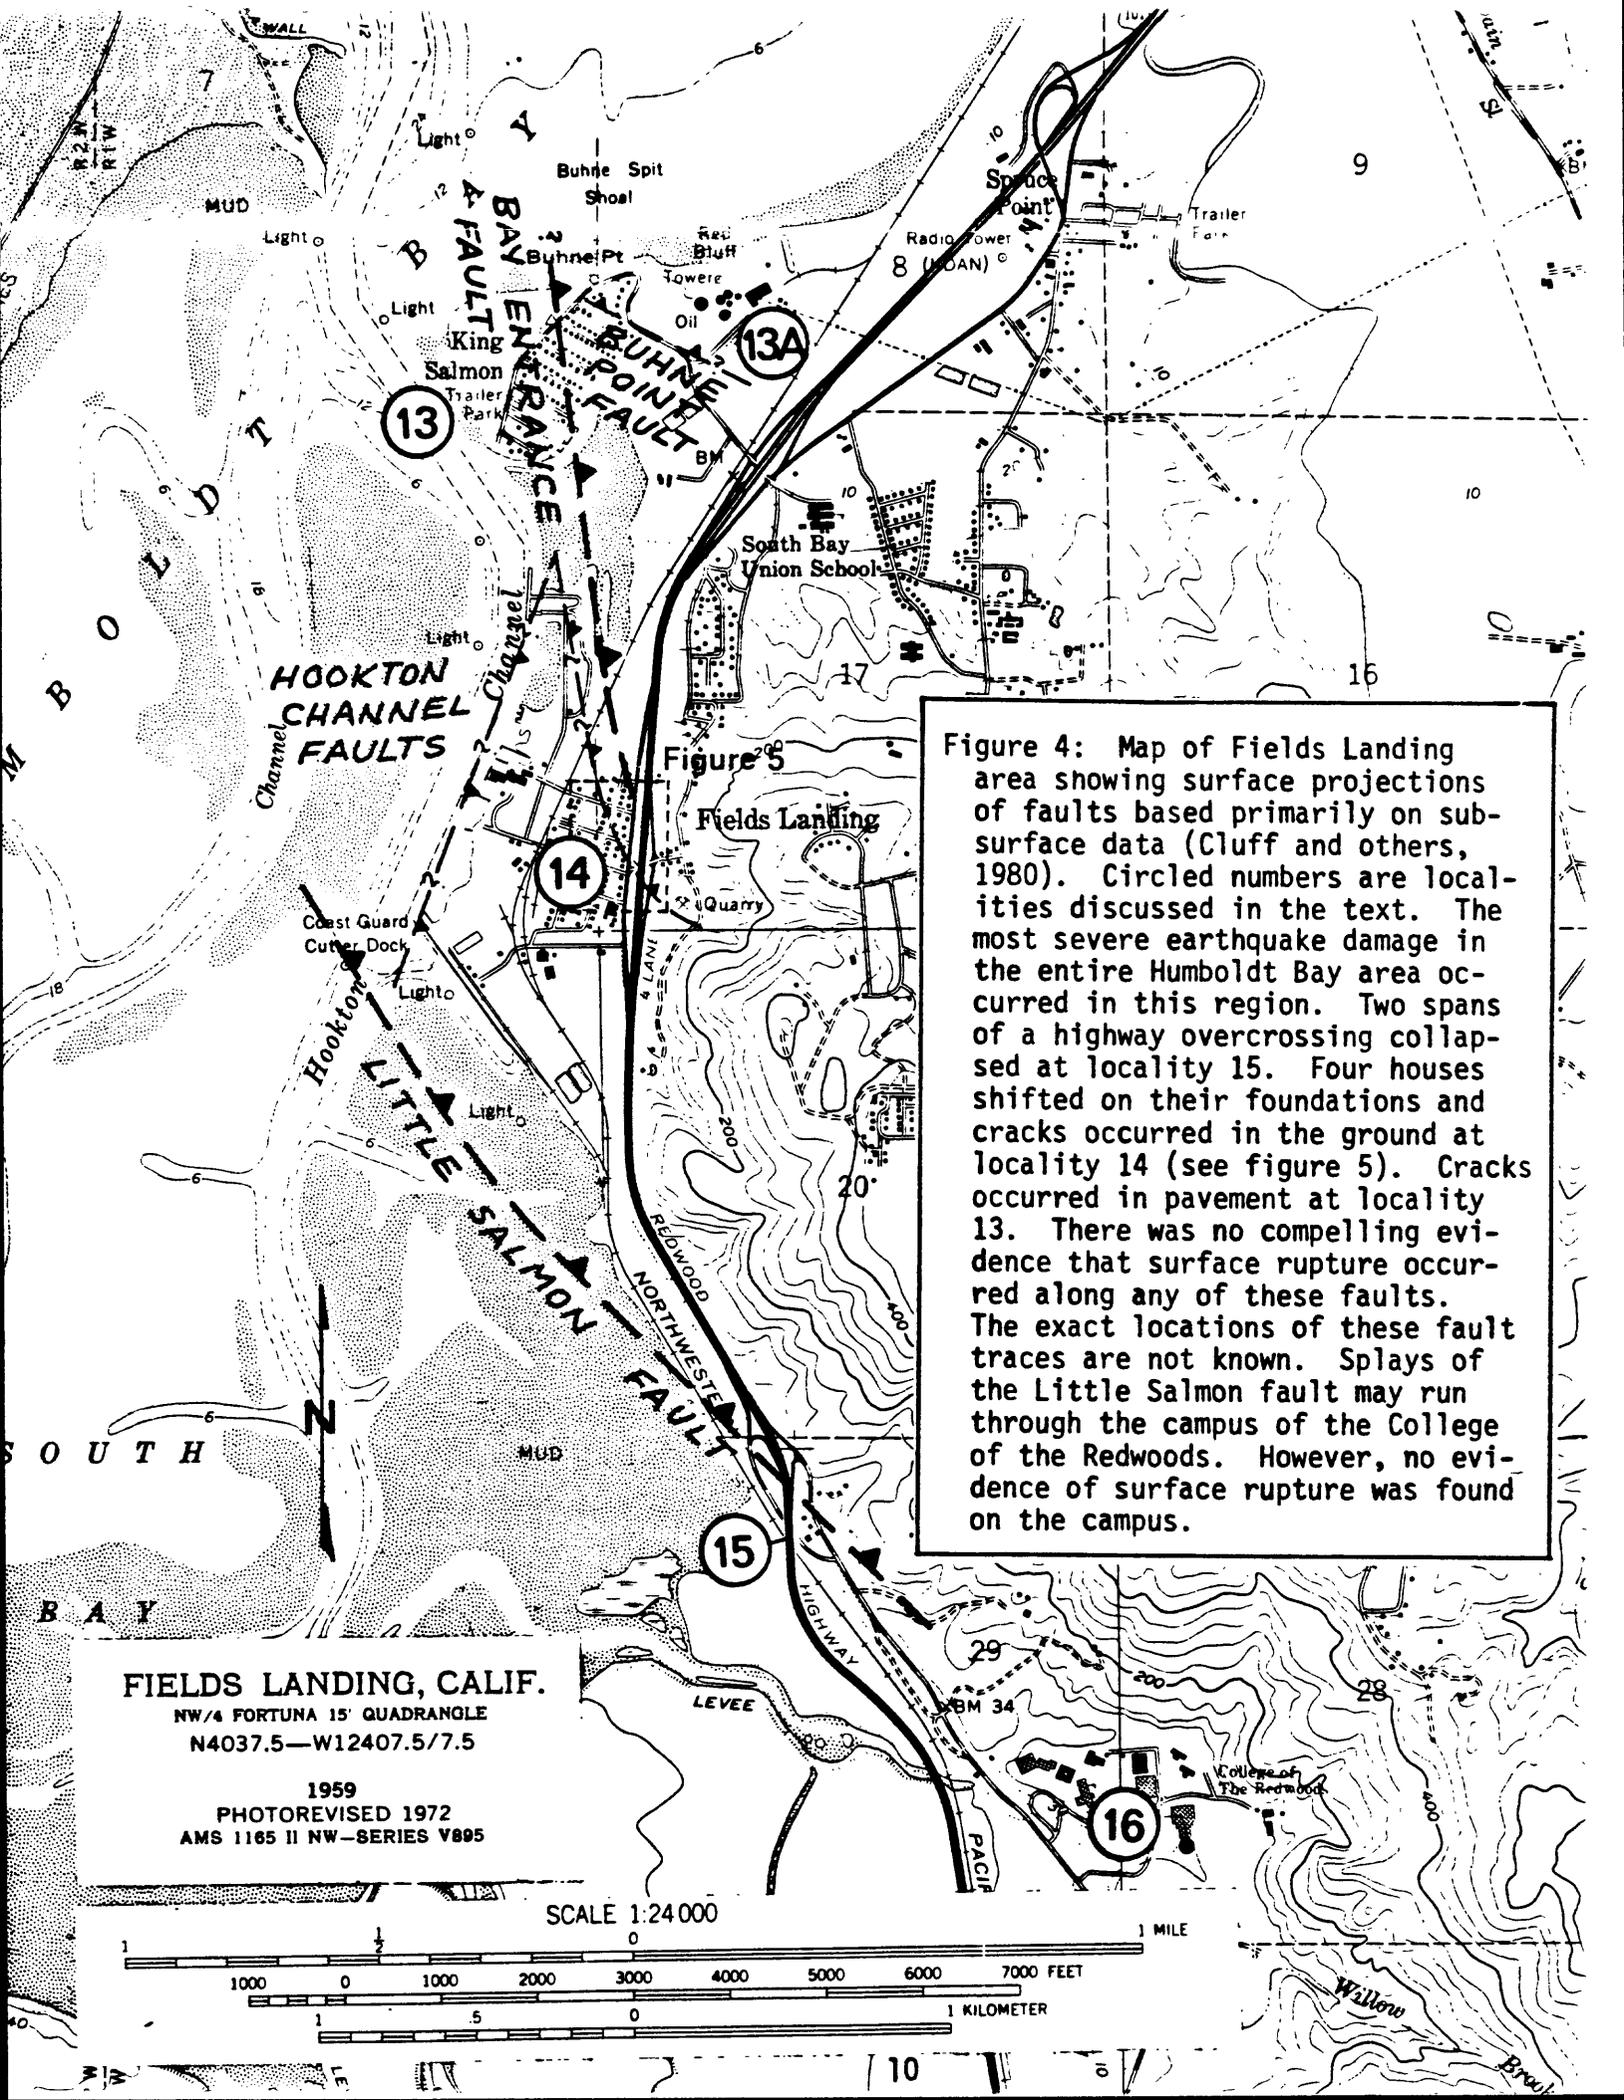
At least four wood-frame houses were shifted northward on their foundations and two of these fell partly to the ground (fig. 5). All were old and, though in good condition, had poor foundations consisting of vertical wooden supports on cement blocks with virtually no lateral bracing. None of these houses sustained severe damage to their superstructures. Nearby houses, some with similar foundations, were not damaged. Mobile homes sitting on cinder block supports did not shift during the earthquake.

At least two brick chimneys fell (fig. 5). The one at the back of the Whaler's Inn was old and had virtually no lateral support. The owner of Bochi's Crab Shack reported the chimney on the roof of his house fell and did slight damage to roof joists. A few other old brick chimneys with weak mortar were cracked.

Figure 4: Map of Fields Landing area showing surface projections of faults based primarily on sub-surface data (Cluff and others, 1980). Circled numbers are localities discussed in the text. The most severe earthquake damage in the entire Humboldt Bay area occurred in this region. Two spans of a highway overcrossing collapsed at locality 15. Four houses shifted on their foundations and cracks occurred in the ground at locality 14 (see figure 5). Cracks occurred in pavement at locality 13. There was no compelling evidence that surface rupture occurred along any of these faults. The exact locations of these fault traces are not known. Splays of the Little Salmon fault may run through the campus of the College of the Redwoods. However, no evidence of surface rupture was found on the campus.

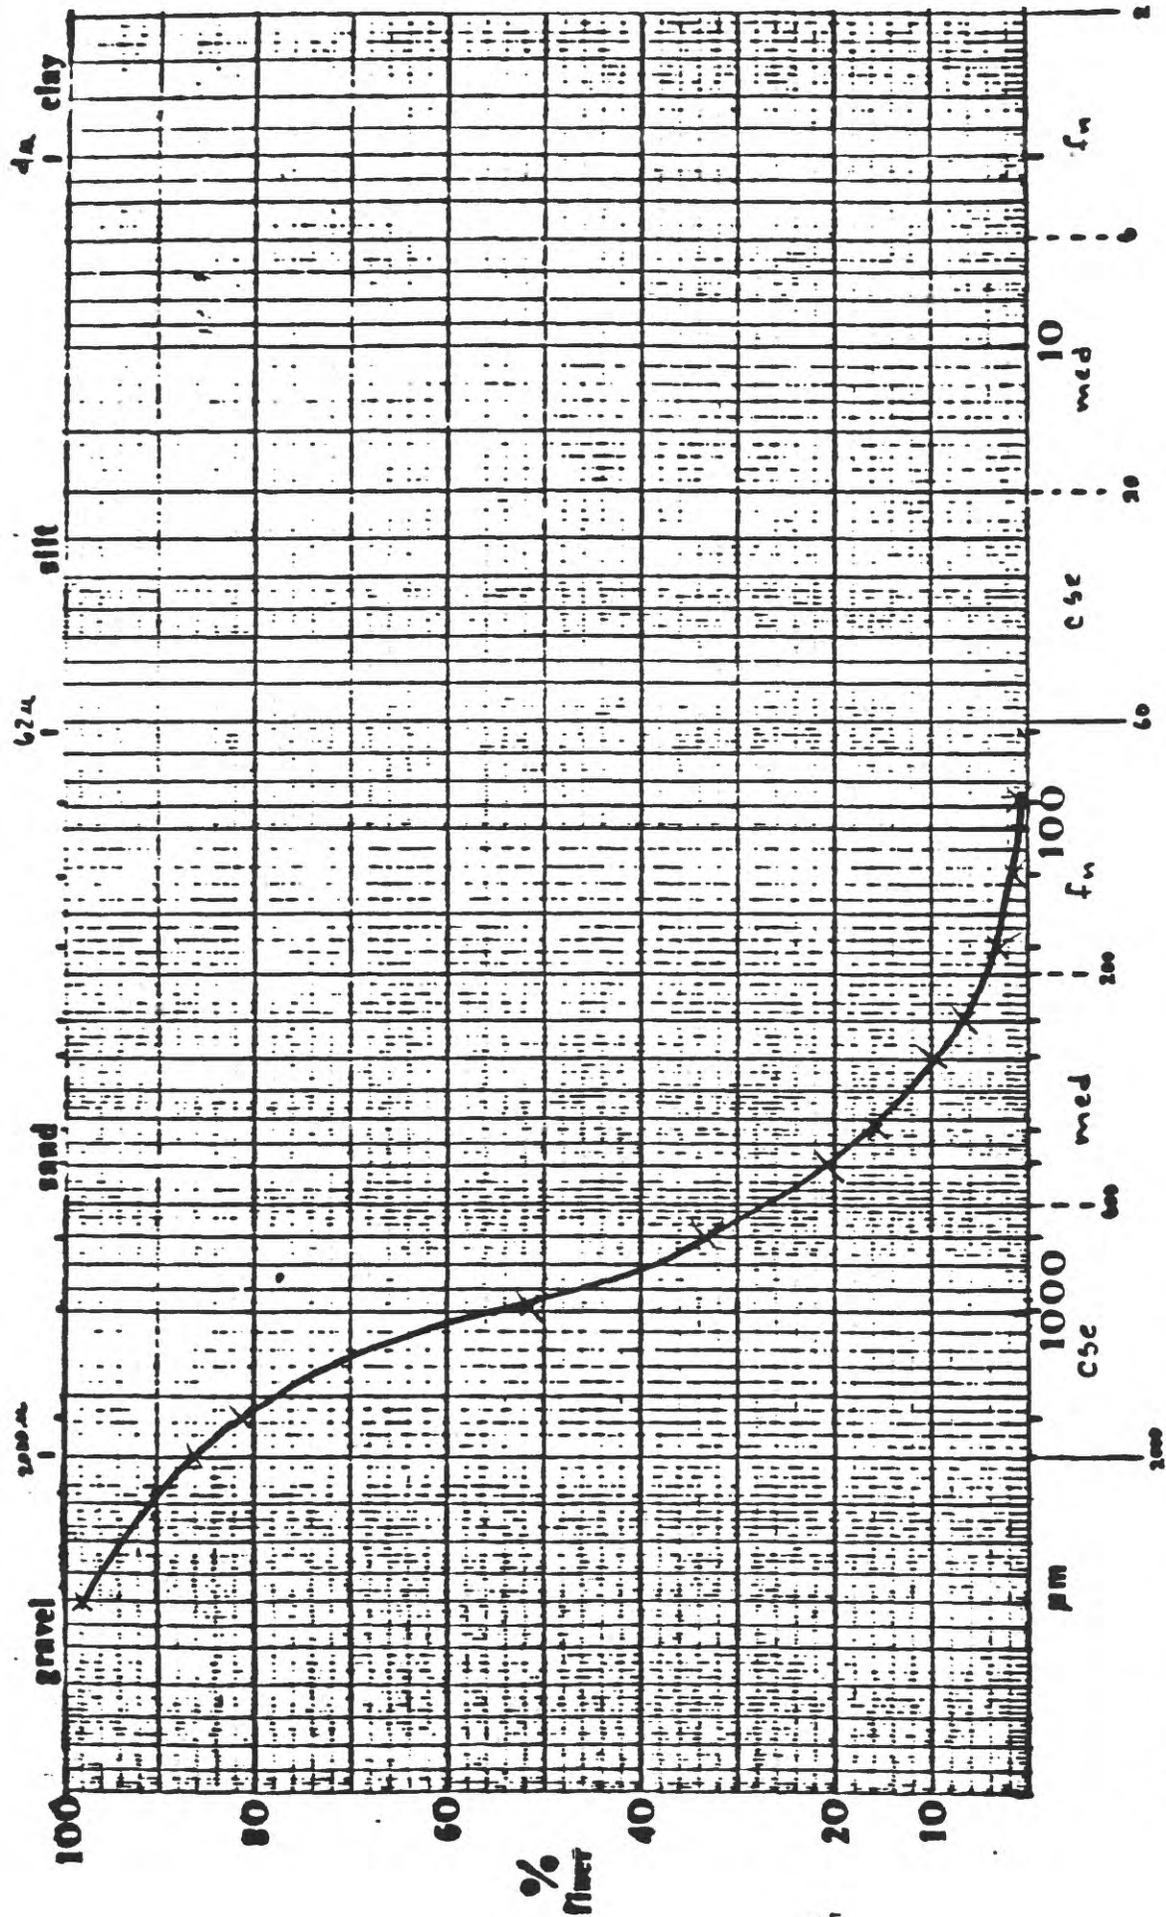
Surficial material in areas of lateral spreads, cracks and sand boils is medium- to coarse-grained, gravelly sand. However, many of the sand boils had aprons composed of fine- to medium grained sand, indicating that liquefaction took place in material finer-grained than that at the surface. Grain-size curves for one sample each of surficial and sand-boil material are given in figures 6A and 6B.

Figure 6A: Grain-size frequency curve for a sample of surface sediment from the southern end of Big Lagoon spit (locality 5).

$D_{60} = 1.16 \text{ mm}$
 $D_{50} = 0.95 \text{ mm}$
 $D_{10} = 0.30 \text{ mm}$
 $C_1 = 74.0 \text{ mm}$
 $\frac{D_{60}}{D_{10}} = 3.9$

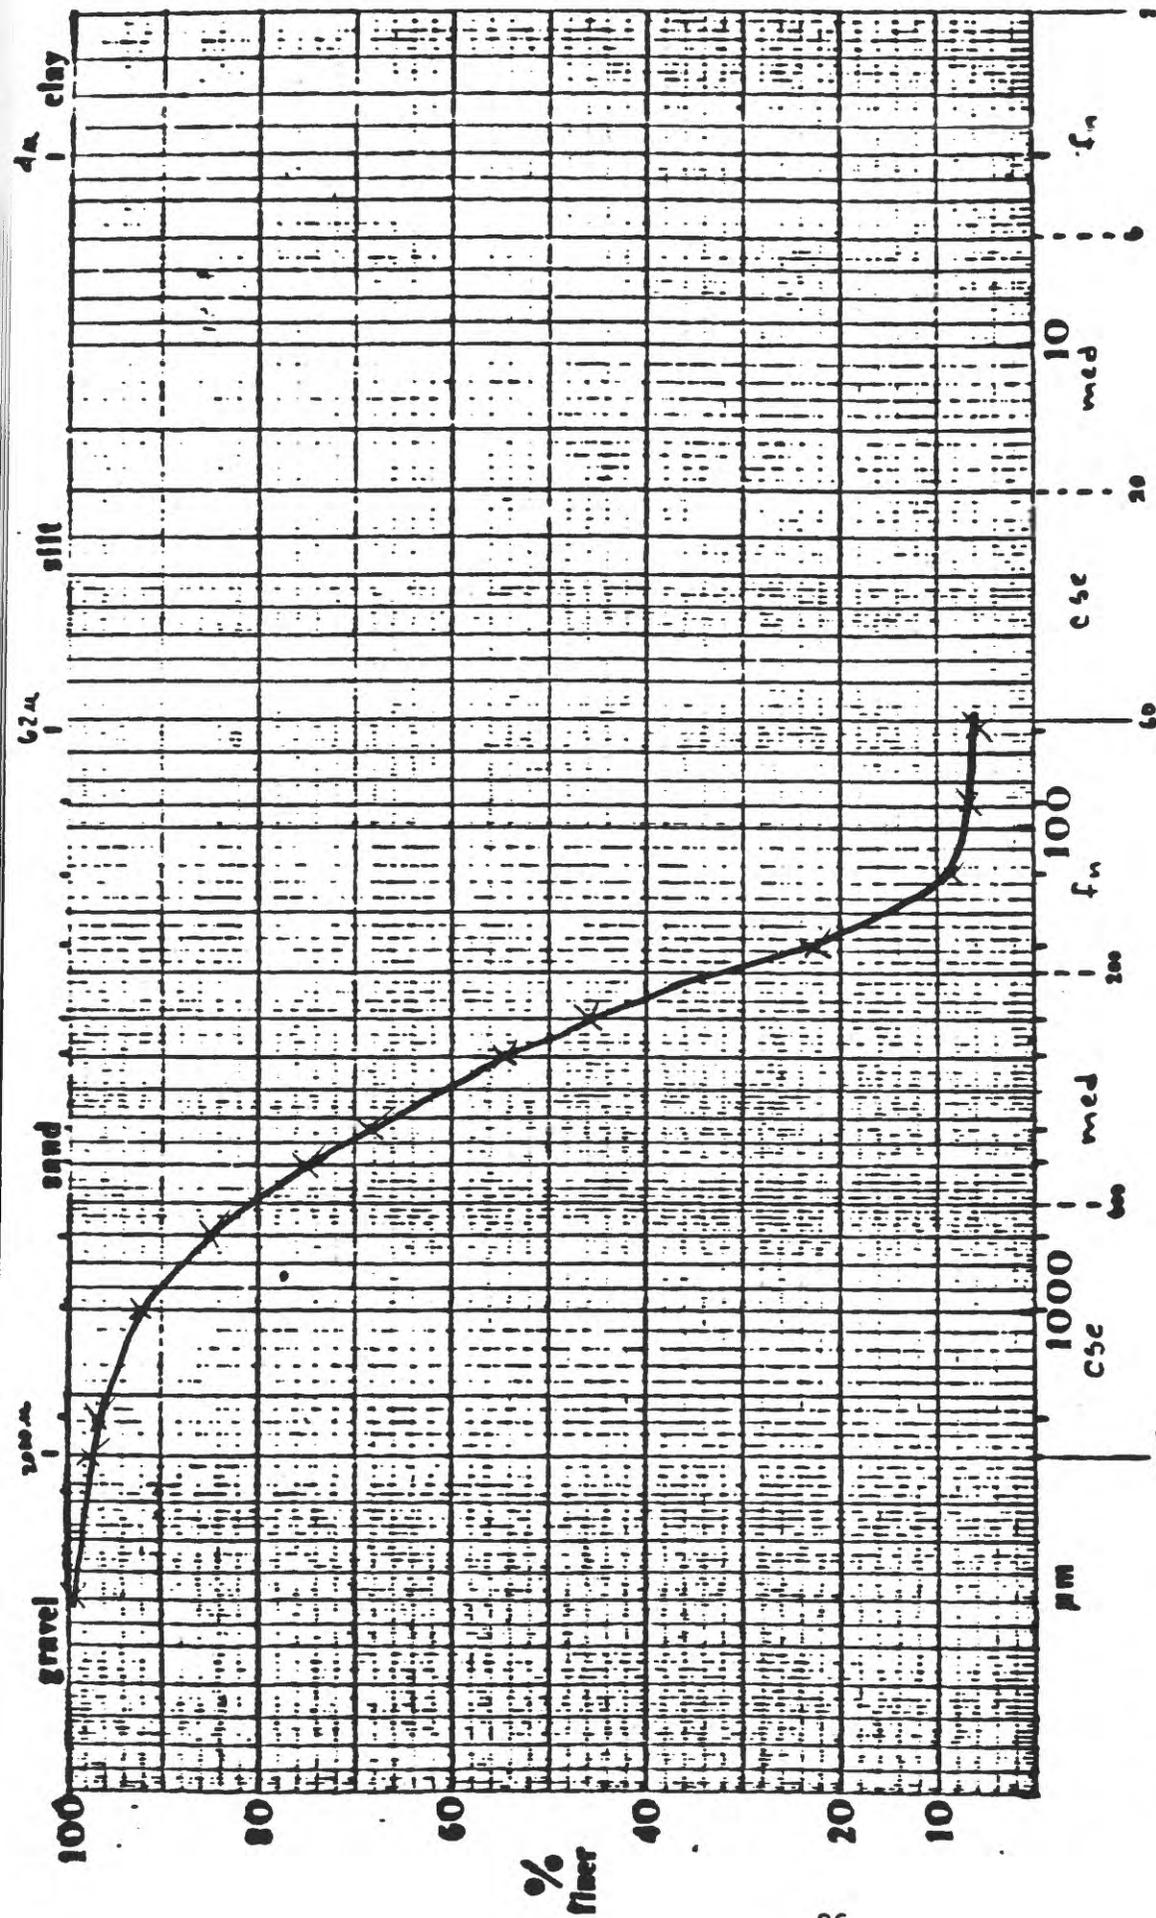
$D_{60} = 0.35 \text{ mm}$
 $D_{50} = 0.28 \text{ mm}$
 $D_{10} = 0.03 \text{ mm}$
 $C_u = 3.6 \text{ mm}$
 $\frac{D_{60}}{D_{10}} = 11.67$

Figure 6B: Grain-size frequency curve for a sample of sediment from a sand boil on the southern end of Big Lagoon spit (locality 5).
