# GEOHYDROLOGIC DESCRIPTIONS OF SELECTED SOLID-WASTE DISPOSAL SITES IN PUERTO RICO

U.S. GEOLOGICAL SURVEY  
Open-file Report 81-490

By Arturo Torres-González and Fernando Gómez-Gómez

Prepared in cooperation with the  
Environmental Quality Board of Puerto Rico

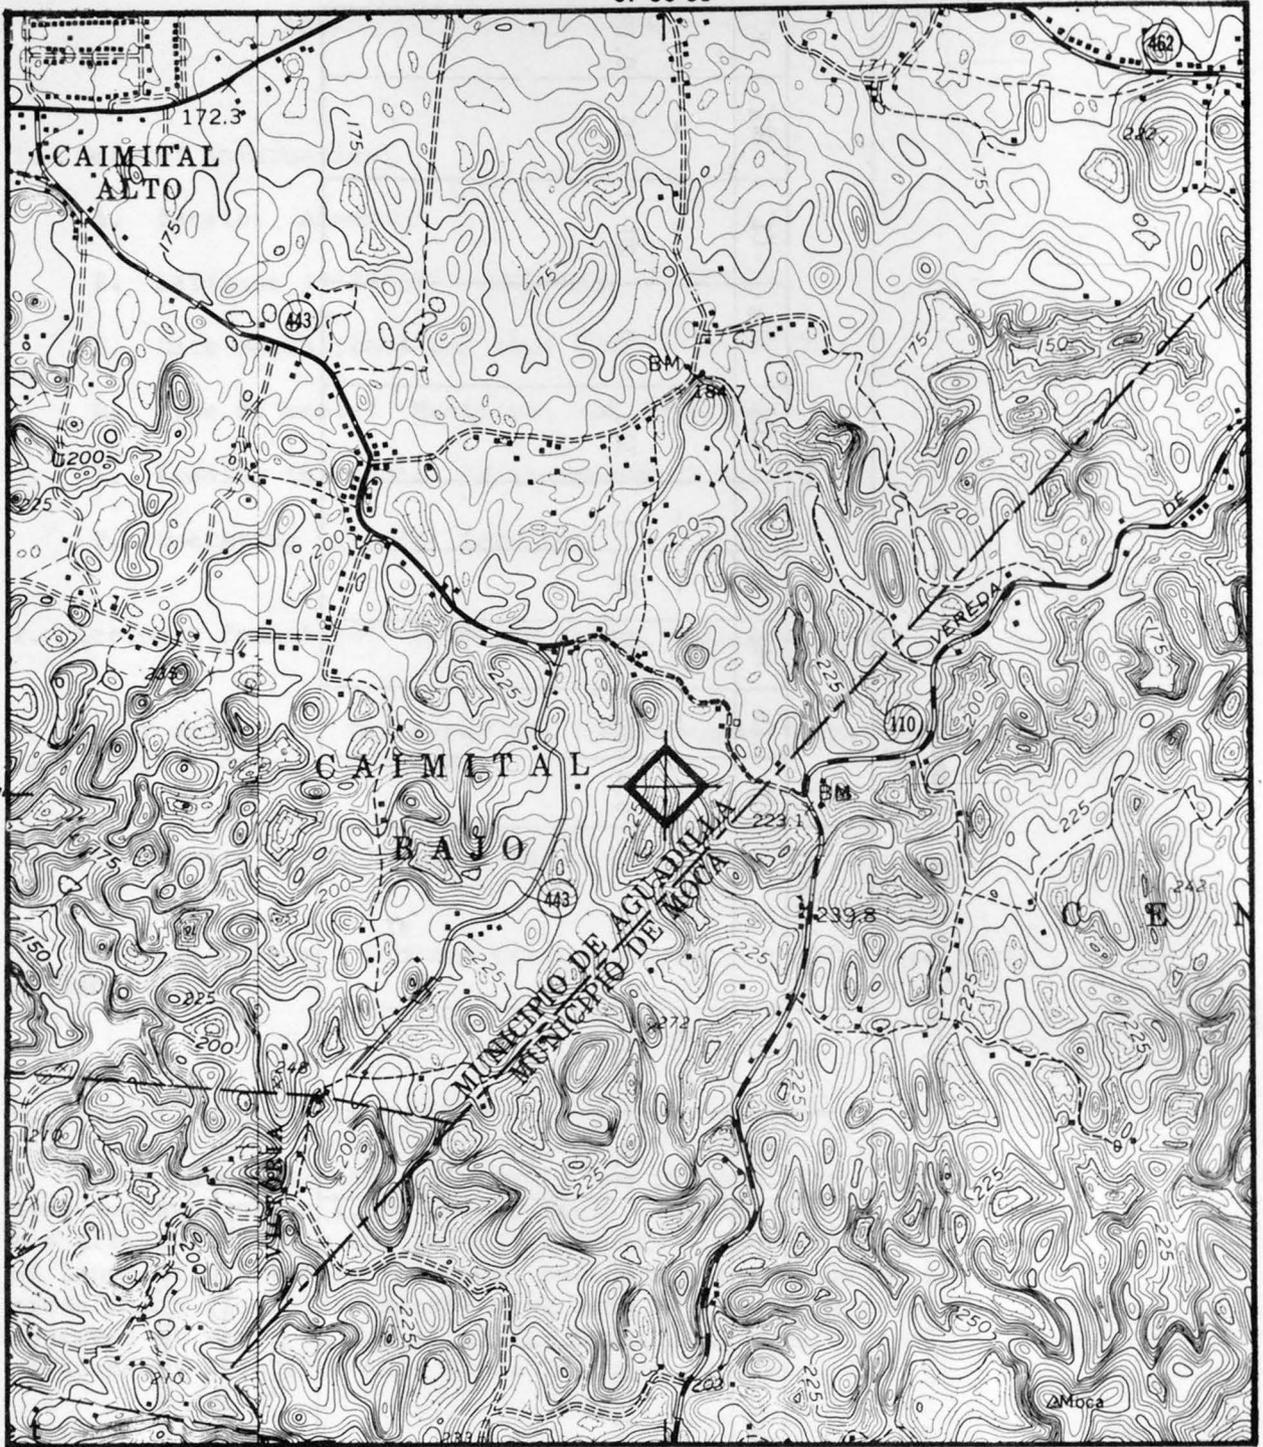
Cover material has a relatively low permeability. Rainfall in area averages about 1,500 mm per year. Runoff from adjacent slopes may affect fill zone but is not critical. Leachate pool at base of landfill. Drainage from pool could be intercepted by adjacent creek which flows into marshy area some 40 meters below fill. Livestock observed at marsh on day of visit, horse seen watering at marsh. Sample obtained at site 2 reveals minor leachate contamination.

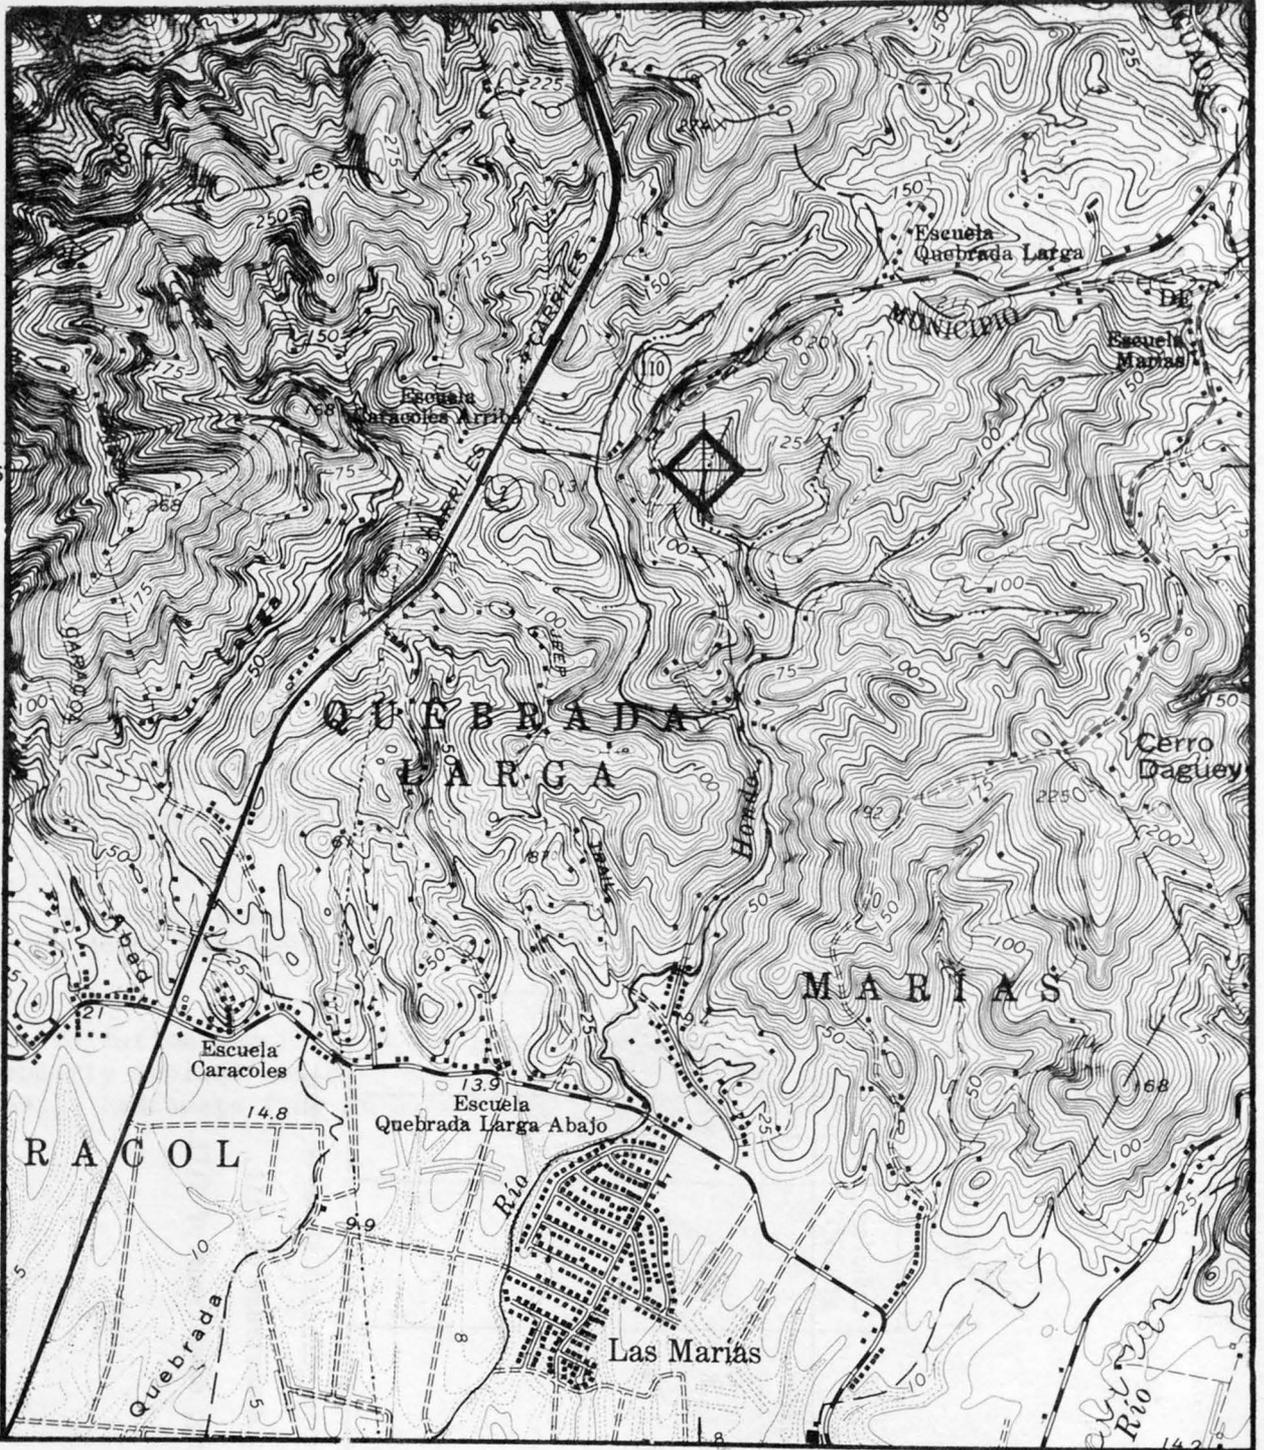
Cover material is relatively permeable and offers insignificant attenuation to leached substances. Rainfall in area averages 2,150 mm per year. Runoff from adjacent slopes not diverted from fill zone. Under such circumstances leachate production could occur and affect unnamed creek whose headwater has been occupied partly by fill zone. When visited creek was dry, but streambed was littered with junk and garbage.

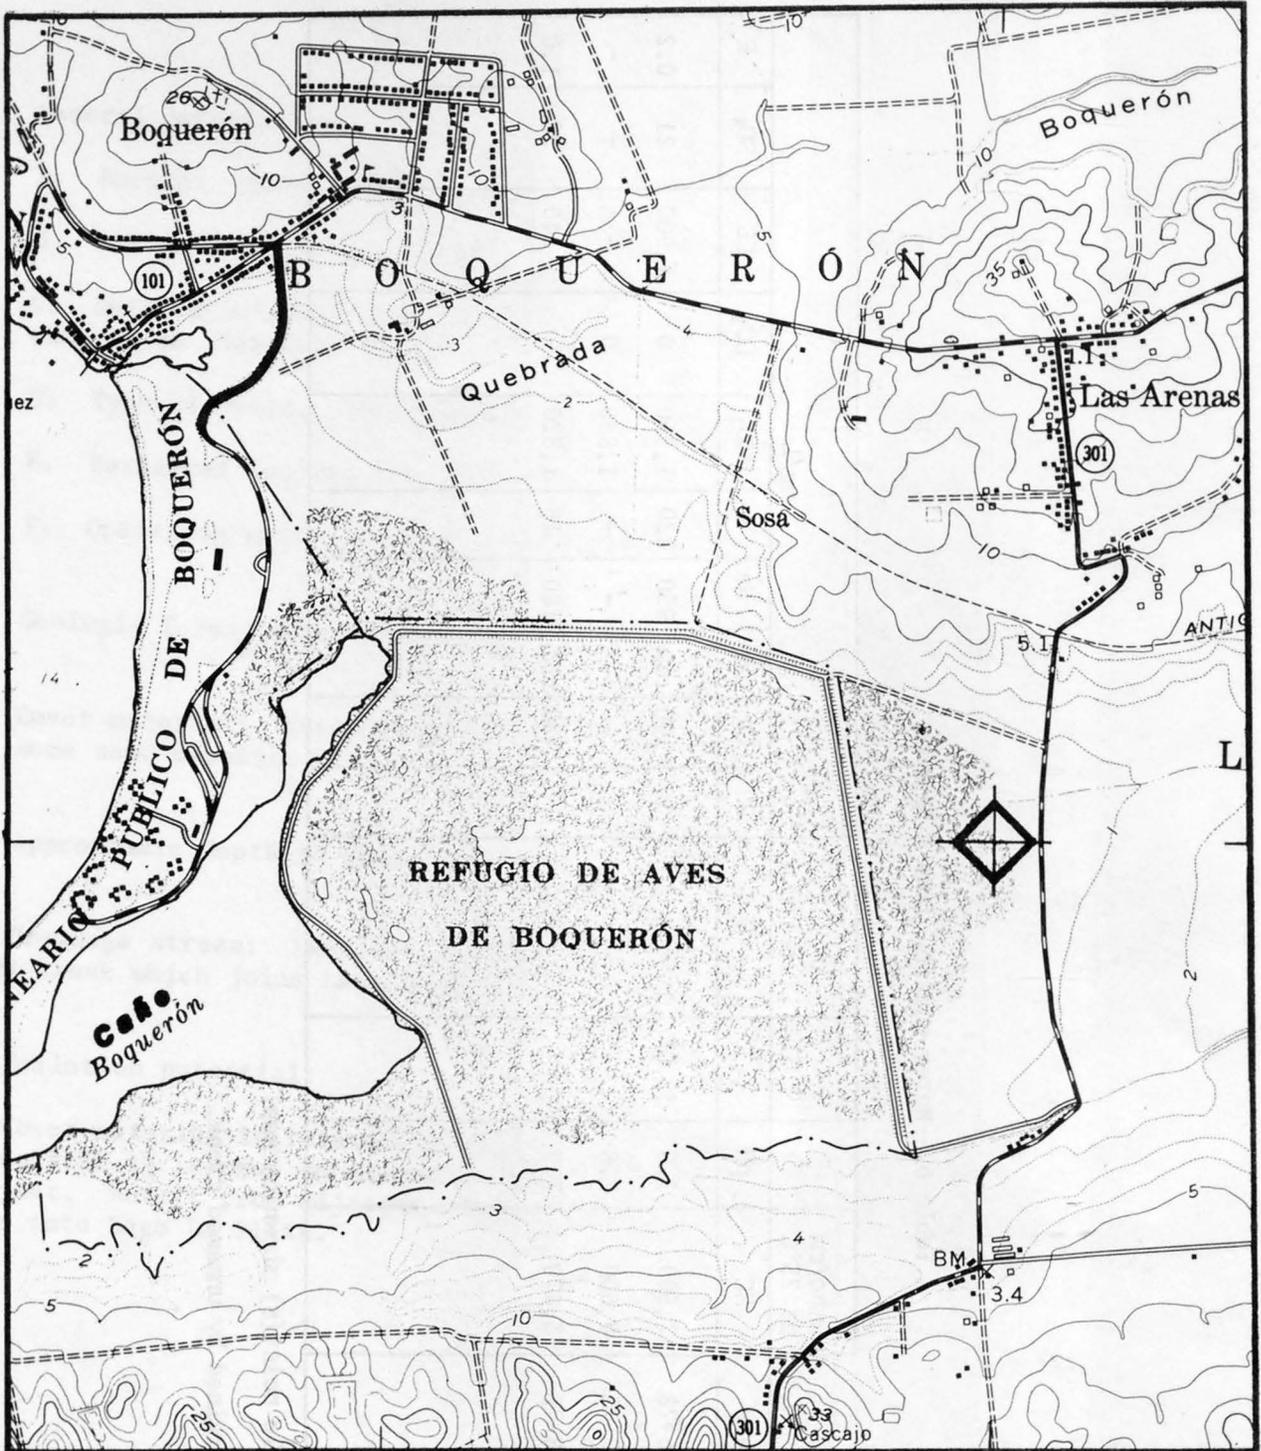
Cover material relatively impermeable if properly utilized (sufficient compaction, appropriate refuse-to-soil ratio and sufficient slope to enhance runoff from filled zone). Rainfall in area averages about 1,900 mm per year. Leachate flow at base of fill and through local ground-water system. Adjacent unnamed creek affected by leachate and refuse. Livestock utilize creek for watering.

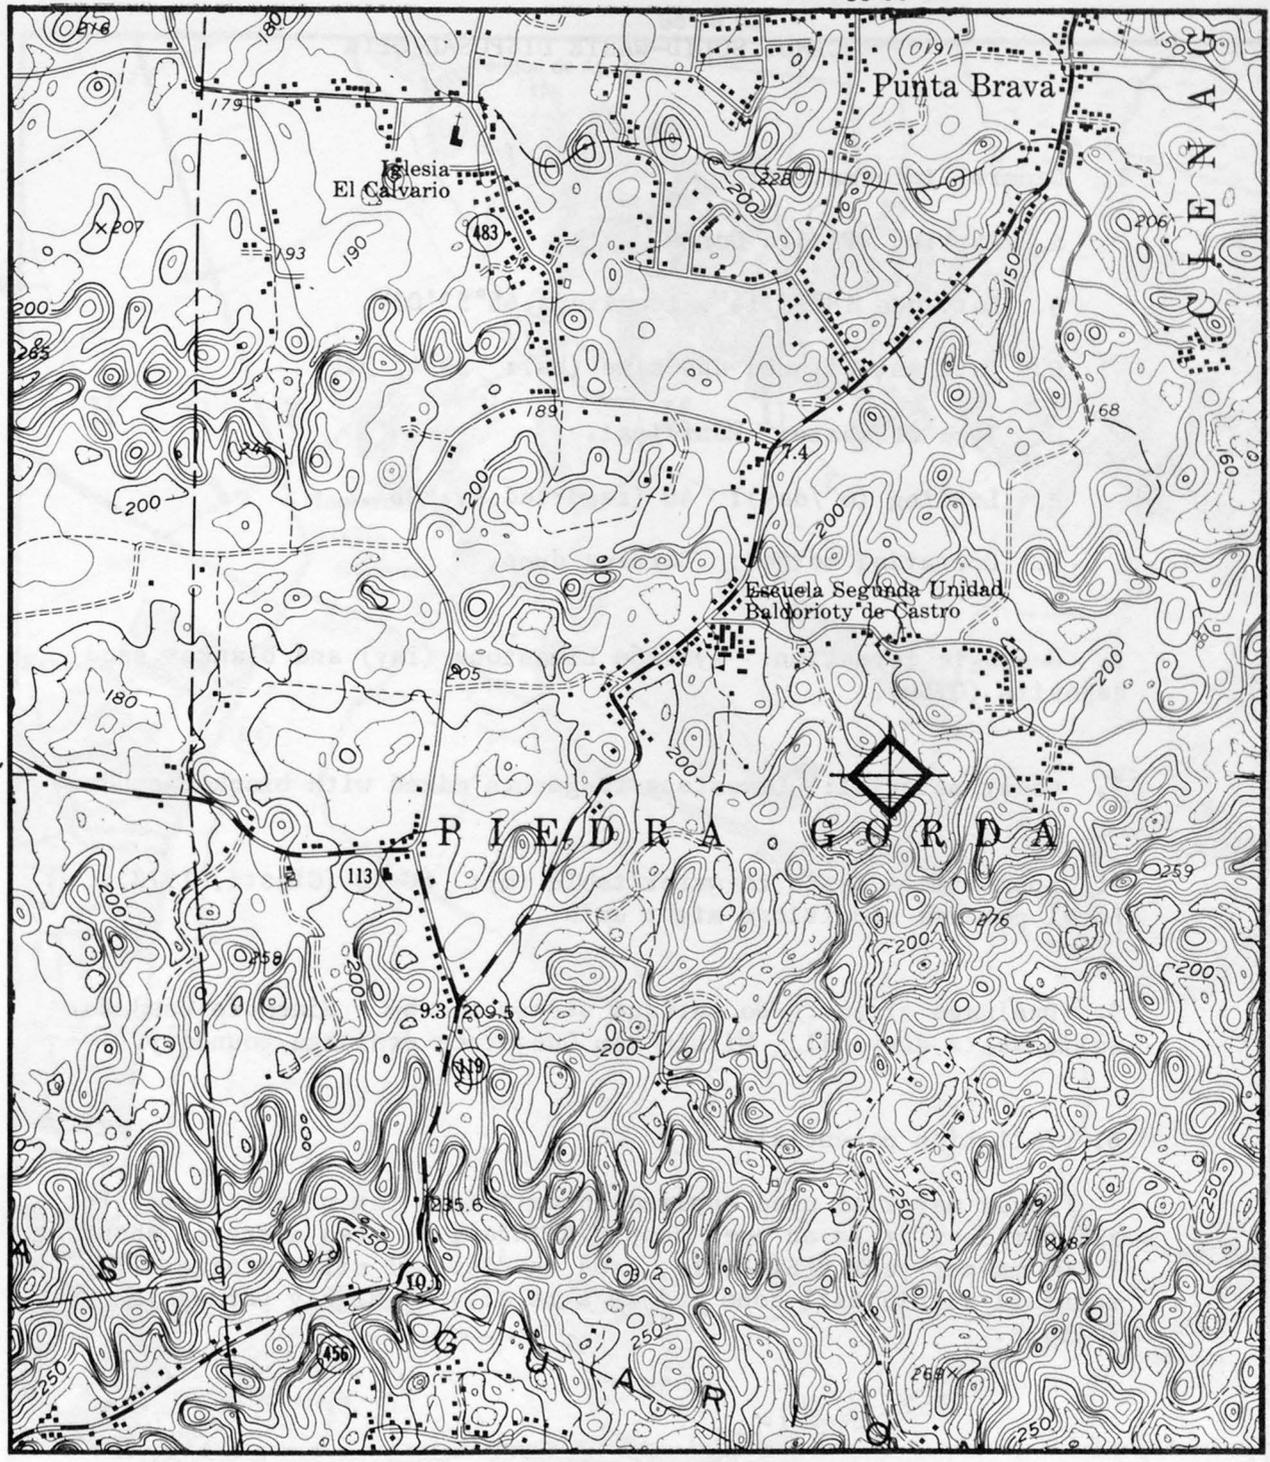
Figure 12.--Camuy solid-waste disposal site at Piedra Gorda.

Cover material used applied in extremely low proportions. For all purposes it is an open dump. Rainfall in area averages about 1,400 mm per year. Sinkhole, used as disposal site, drains all rainfall within fill zone and is a relatively highly permeable feature.

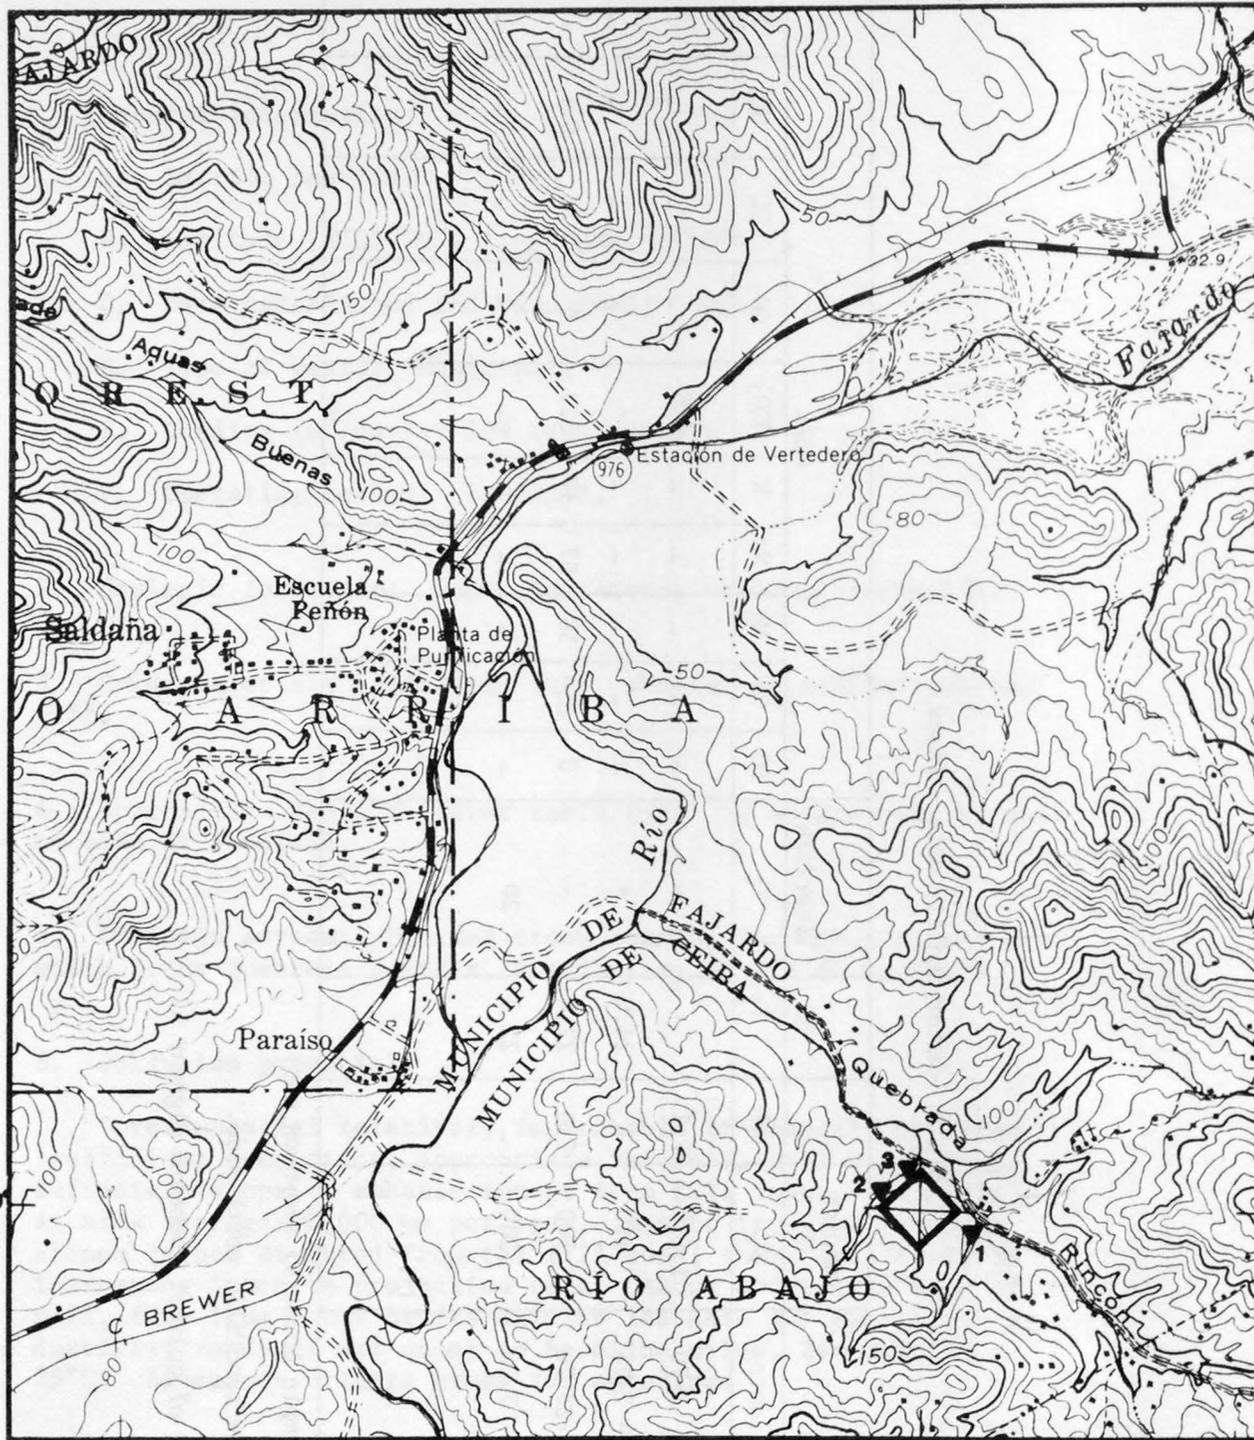
Within a marshy area below fill, indications exist (odor, red stains) of intermittent leachate flow. At time of visit, water quality of adjacent streams appeared not to be affected by leachate.

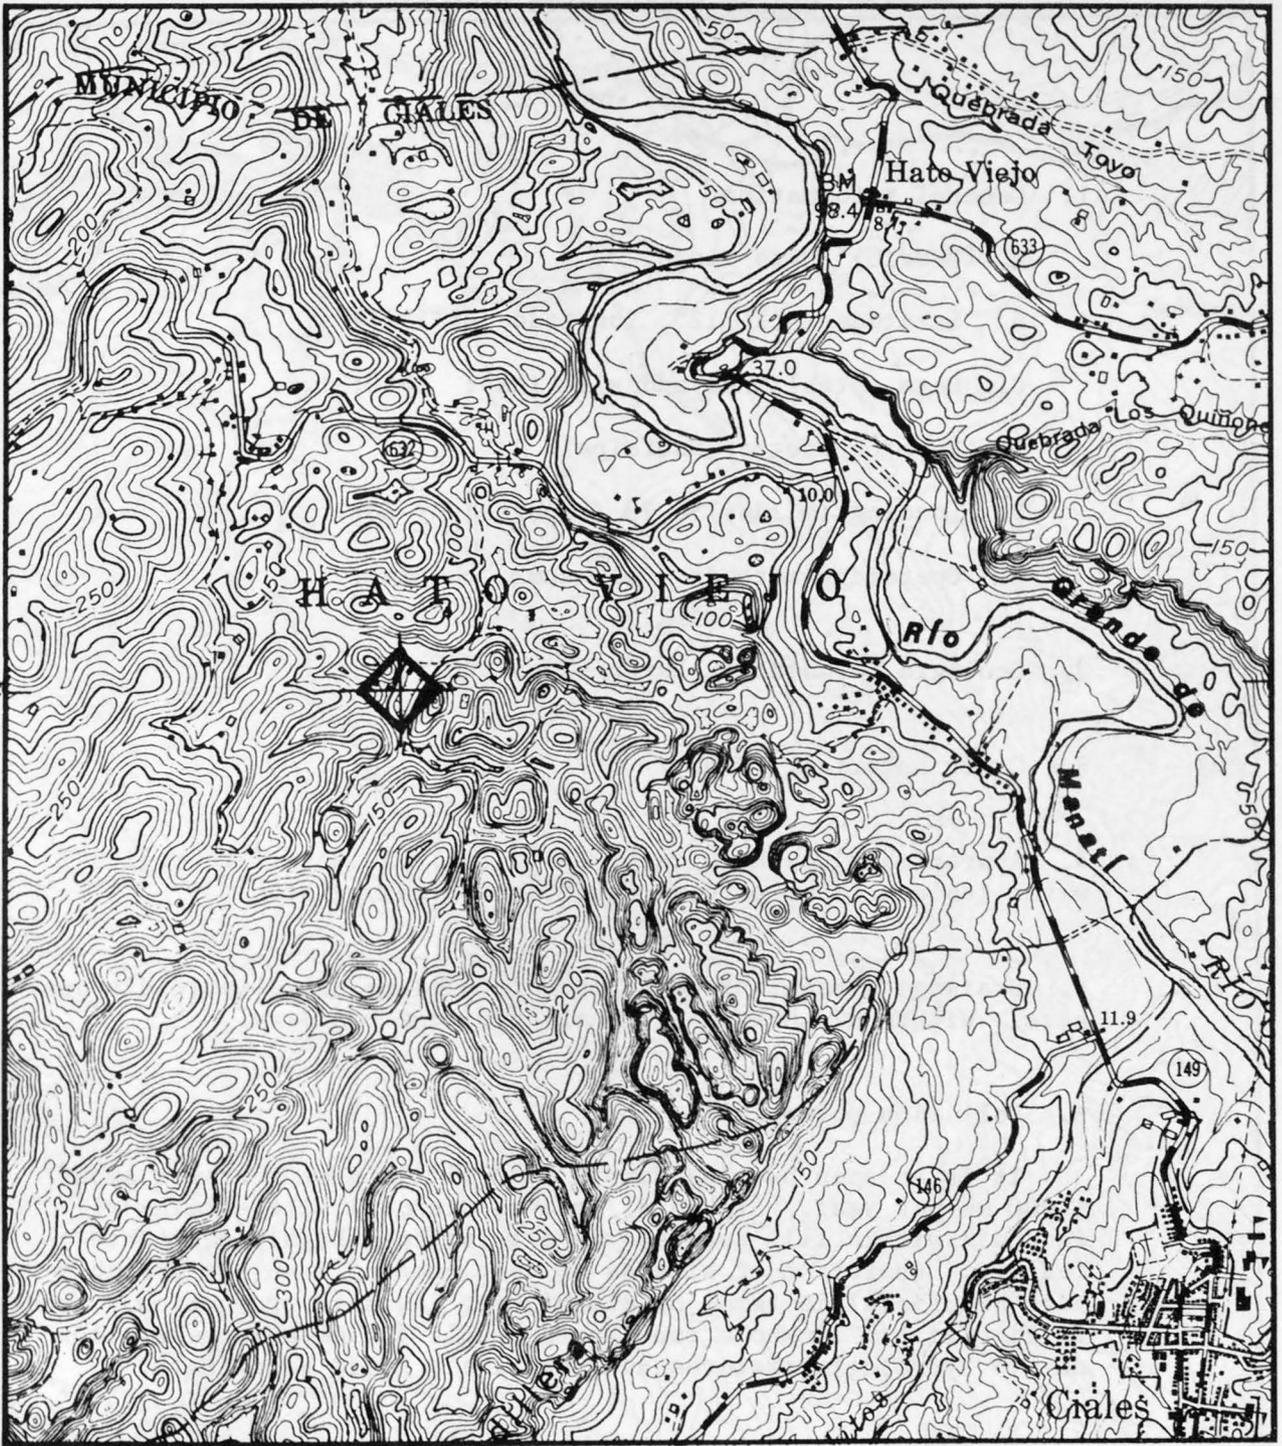
It is an open burning dump. Rainfall in area averages about 1,900 mm per year. Sinkhole, used as disposal site, drains all rainfall within fill zone and is a relatively highly permeable feature. Operation of site as an open burning dump has probably been beneficial in terms of diminishing leachate production. Land-filling within sinkhole zone would result in leachate generation due to hydrologic features and relatively humid subclimate.

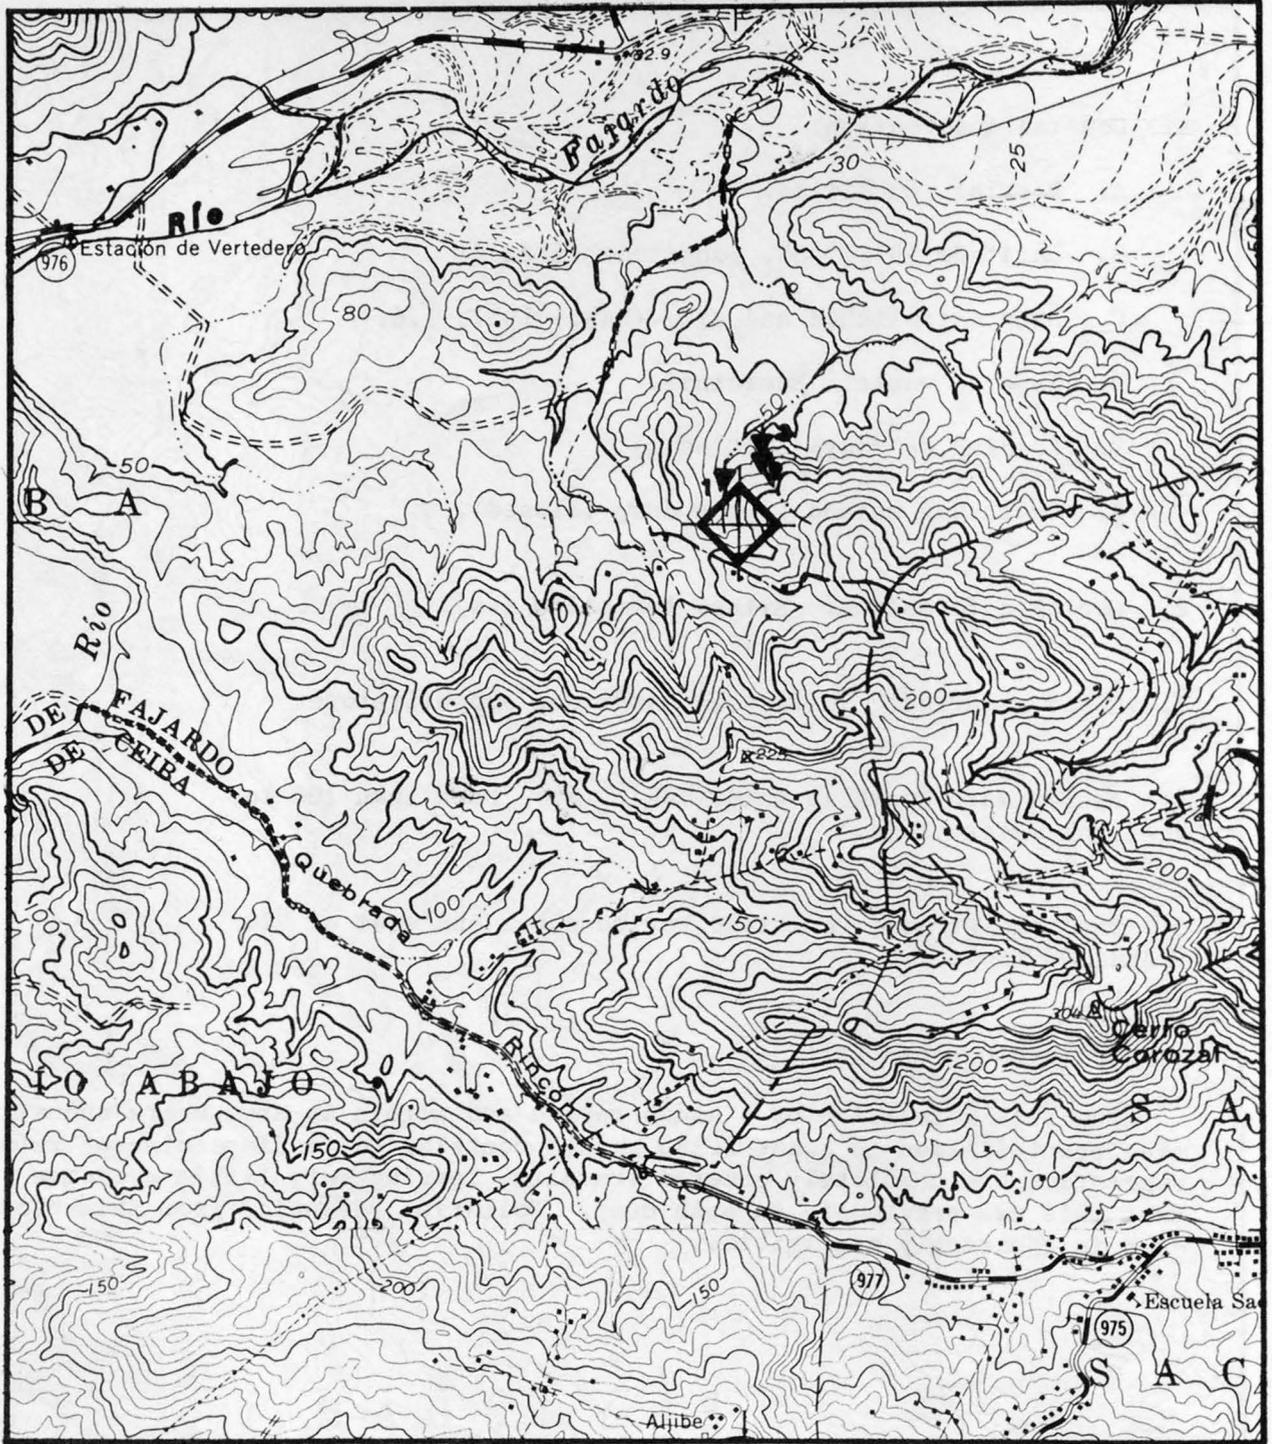
Leachate contamination of creek is minimal. Inspection of site indicates an exceedingly high ratio of soil to refuse being used. At such rate, site cover material may not last for its projected use period (10 years ). This may result in future use of insufficient cover material and deterioration of adjacent stream water quality. Water in stream used for live-stock watering at adjacent farms.

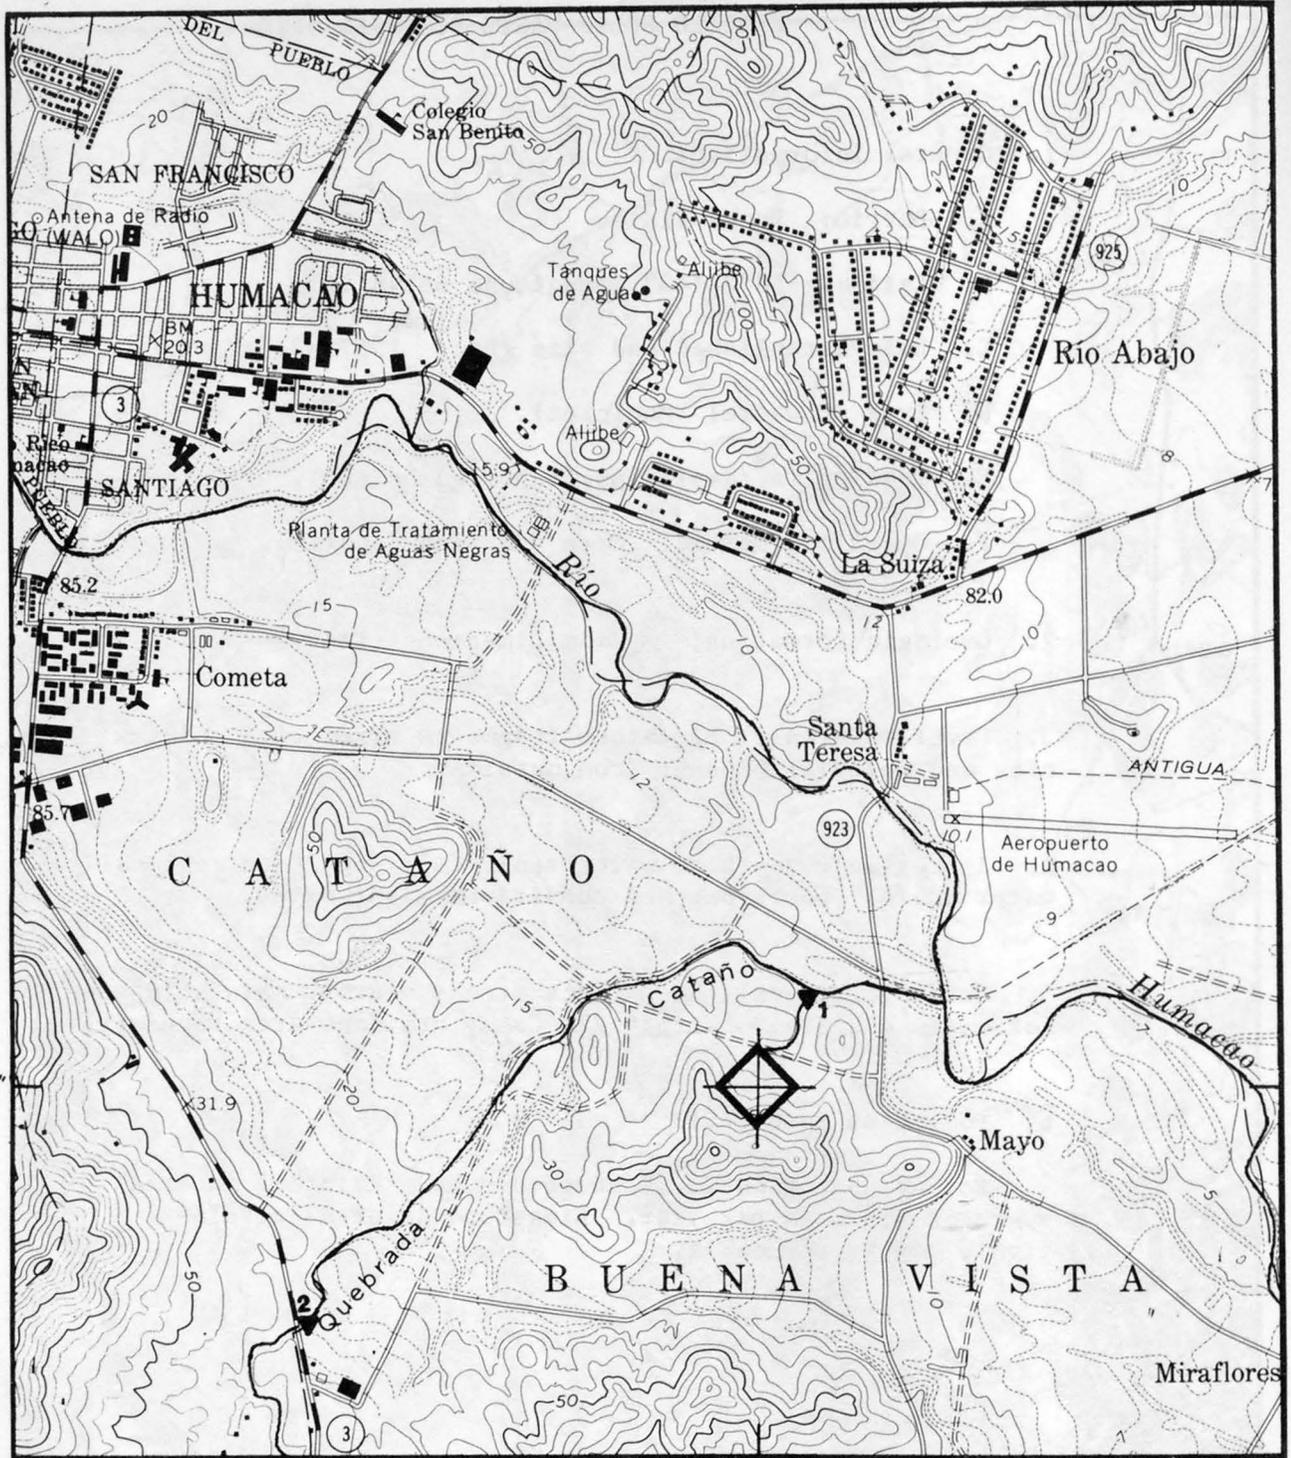
Figure 26.--Humacao solid-waste disposal site at Buena Vista.

For all purposes it is an open dump. Rainfall in area averages 1,520 mm per year. Limestone in area is relatively highly permeable.

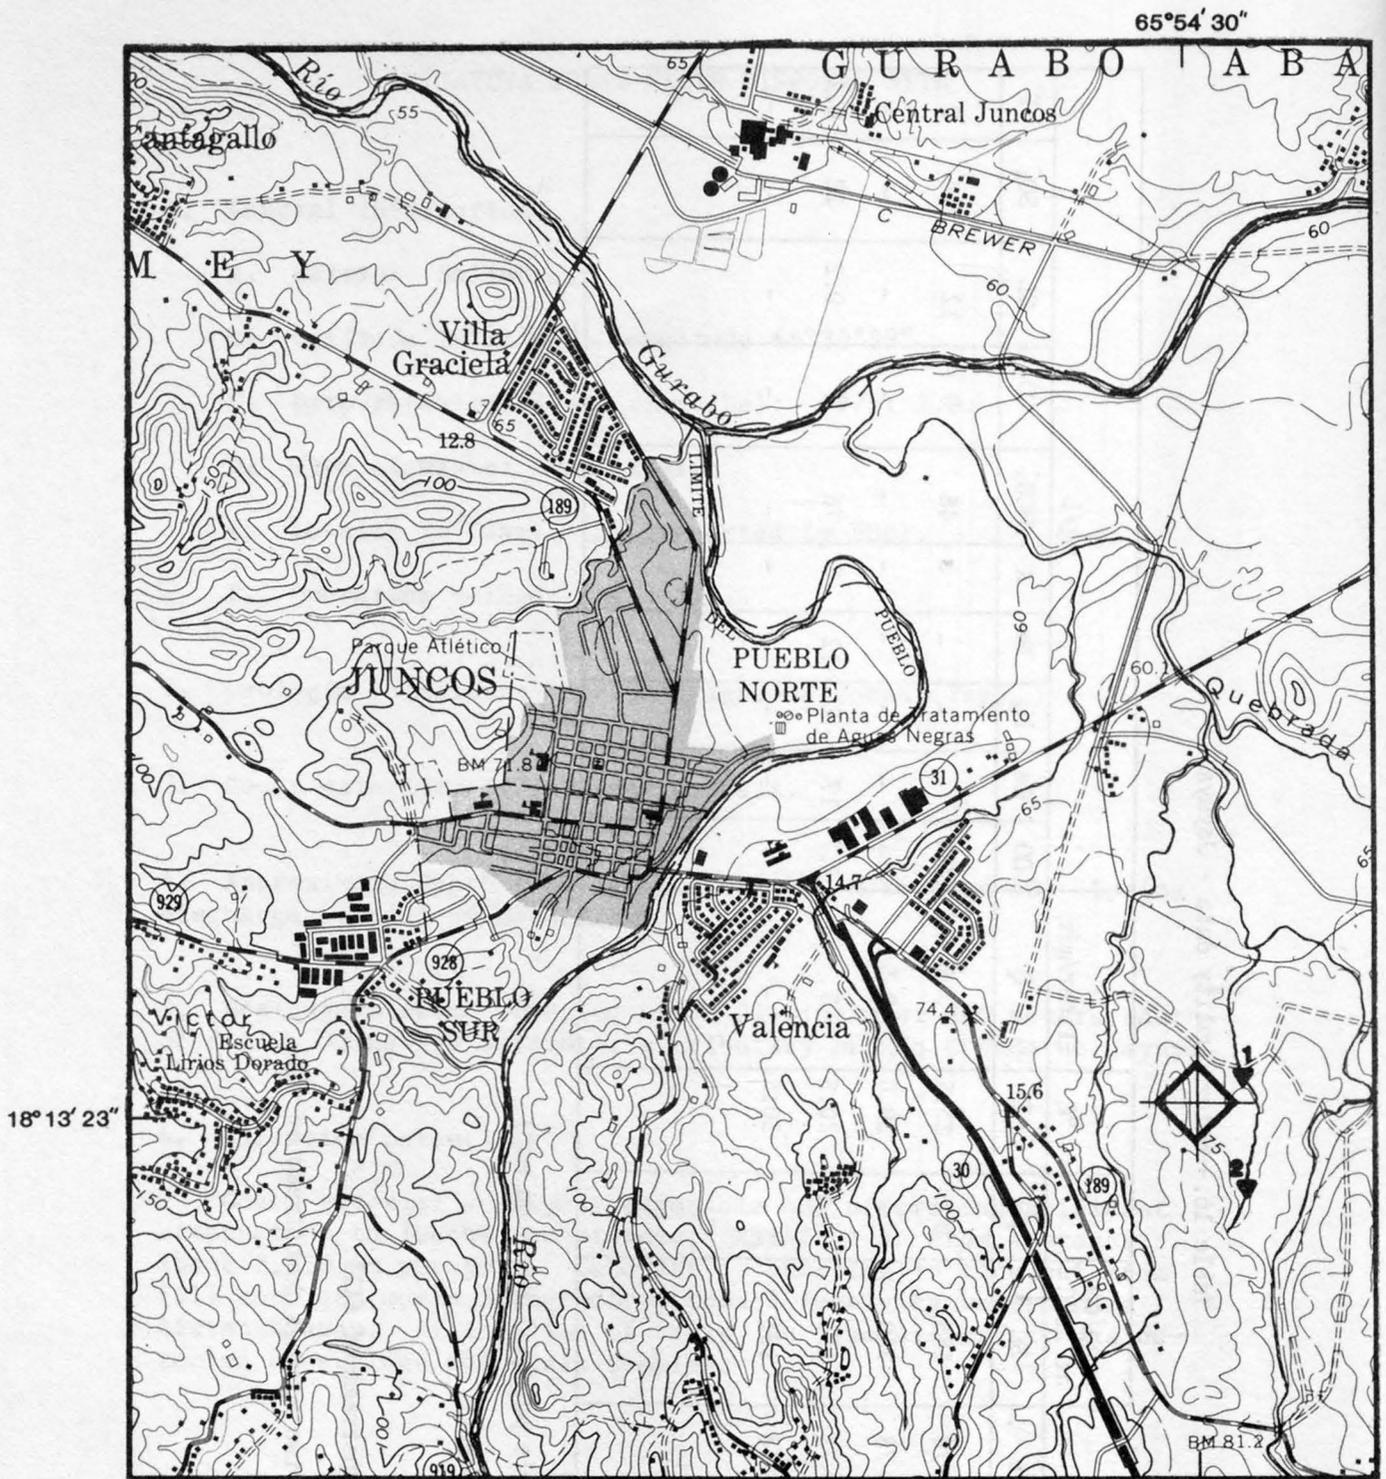
1. At spring above fill.
2. Leachate flow.
3. Unnamed creek upstream of fill.
4. At junction of two springs downstream of fill.

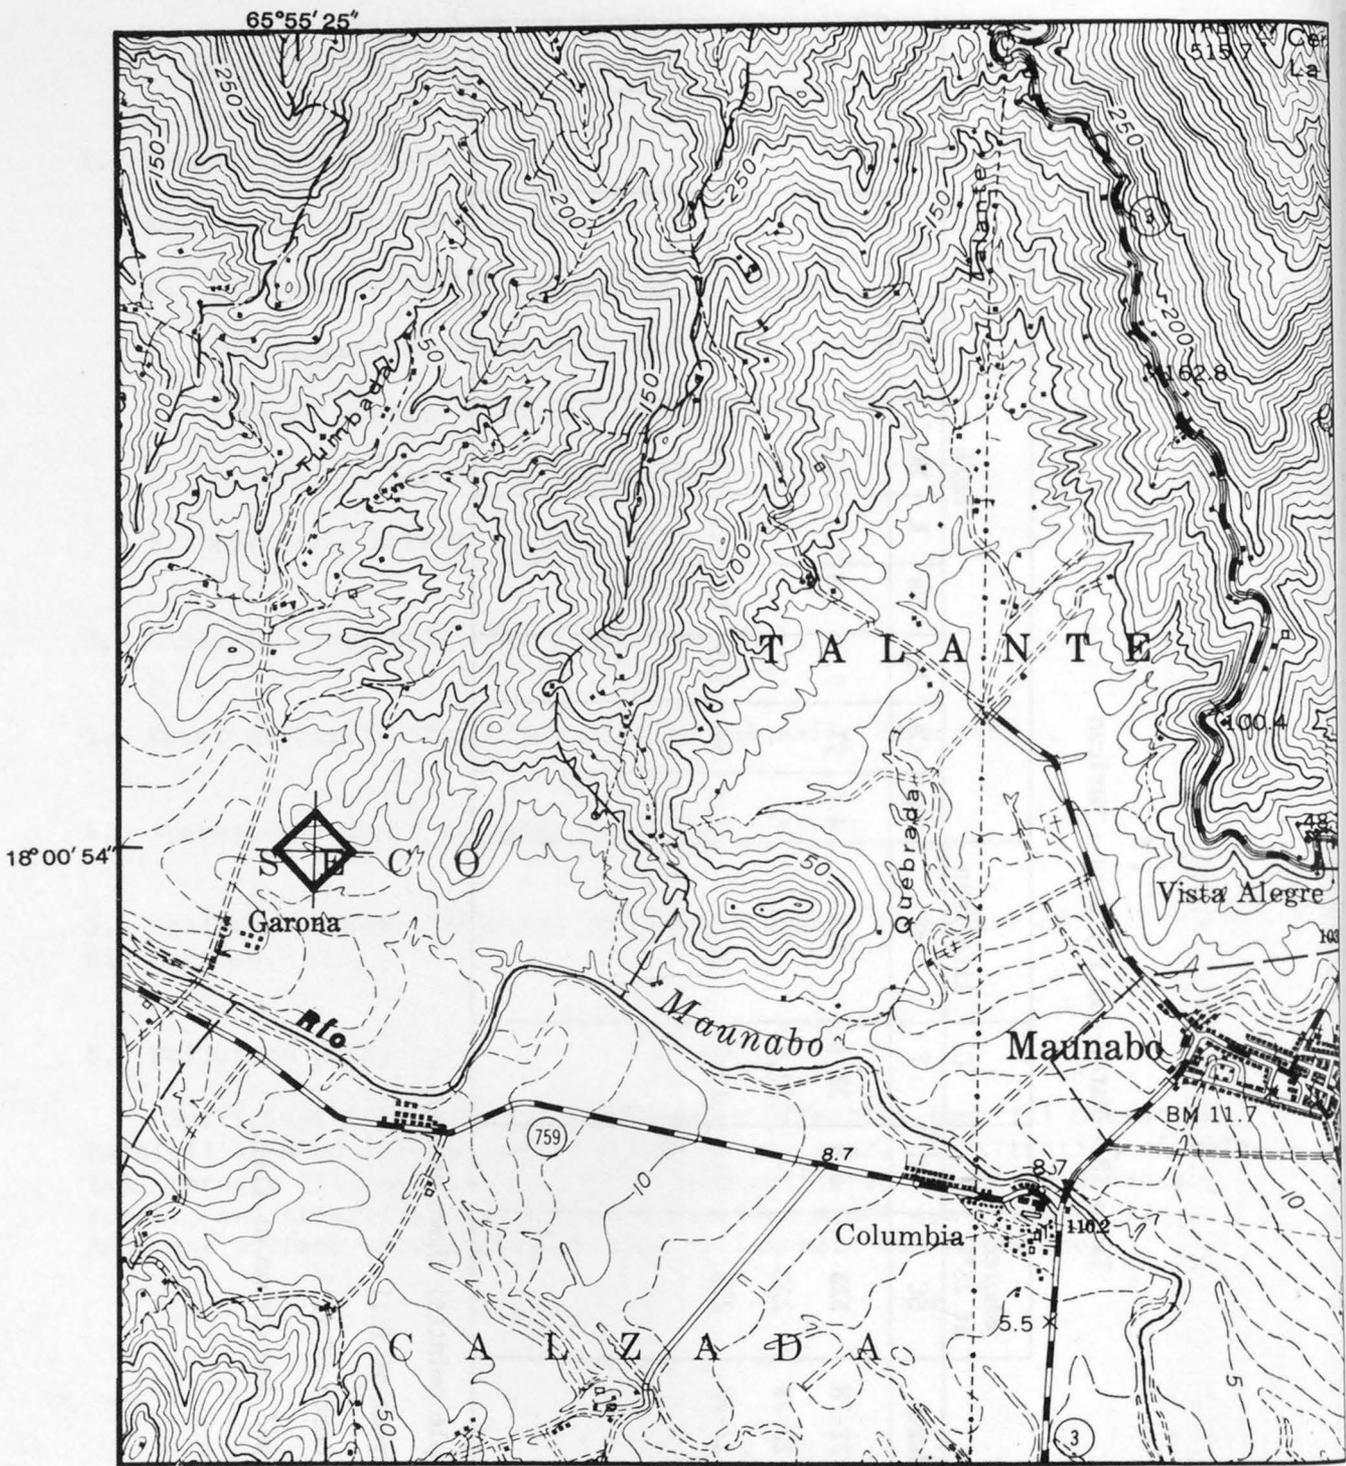
1. At spring upstream of fill.
2. At main creek north of fill.
3. At creek west and downstream of fill.

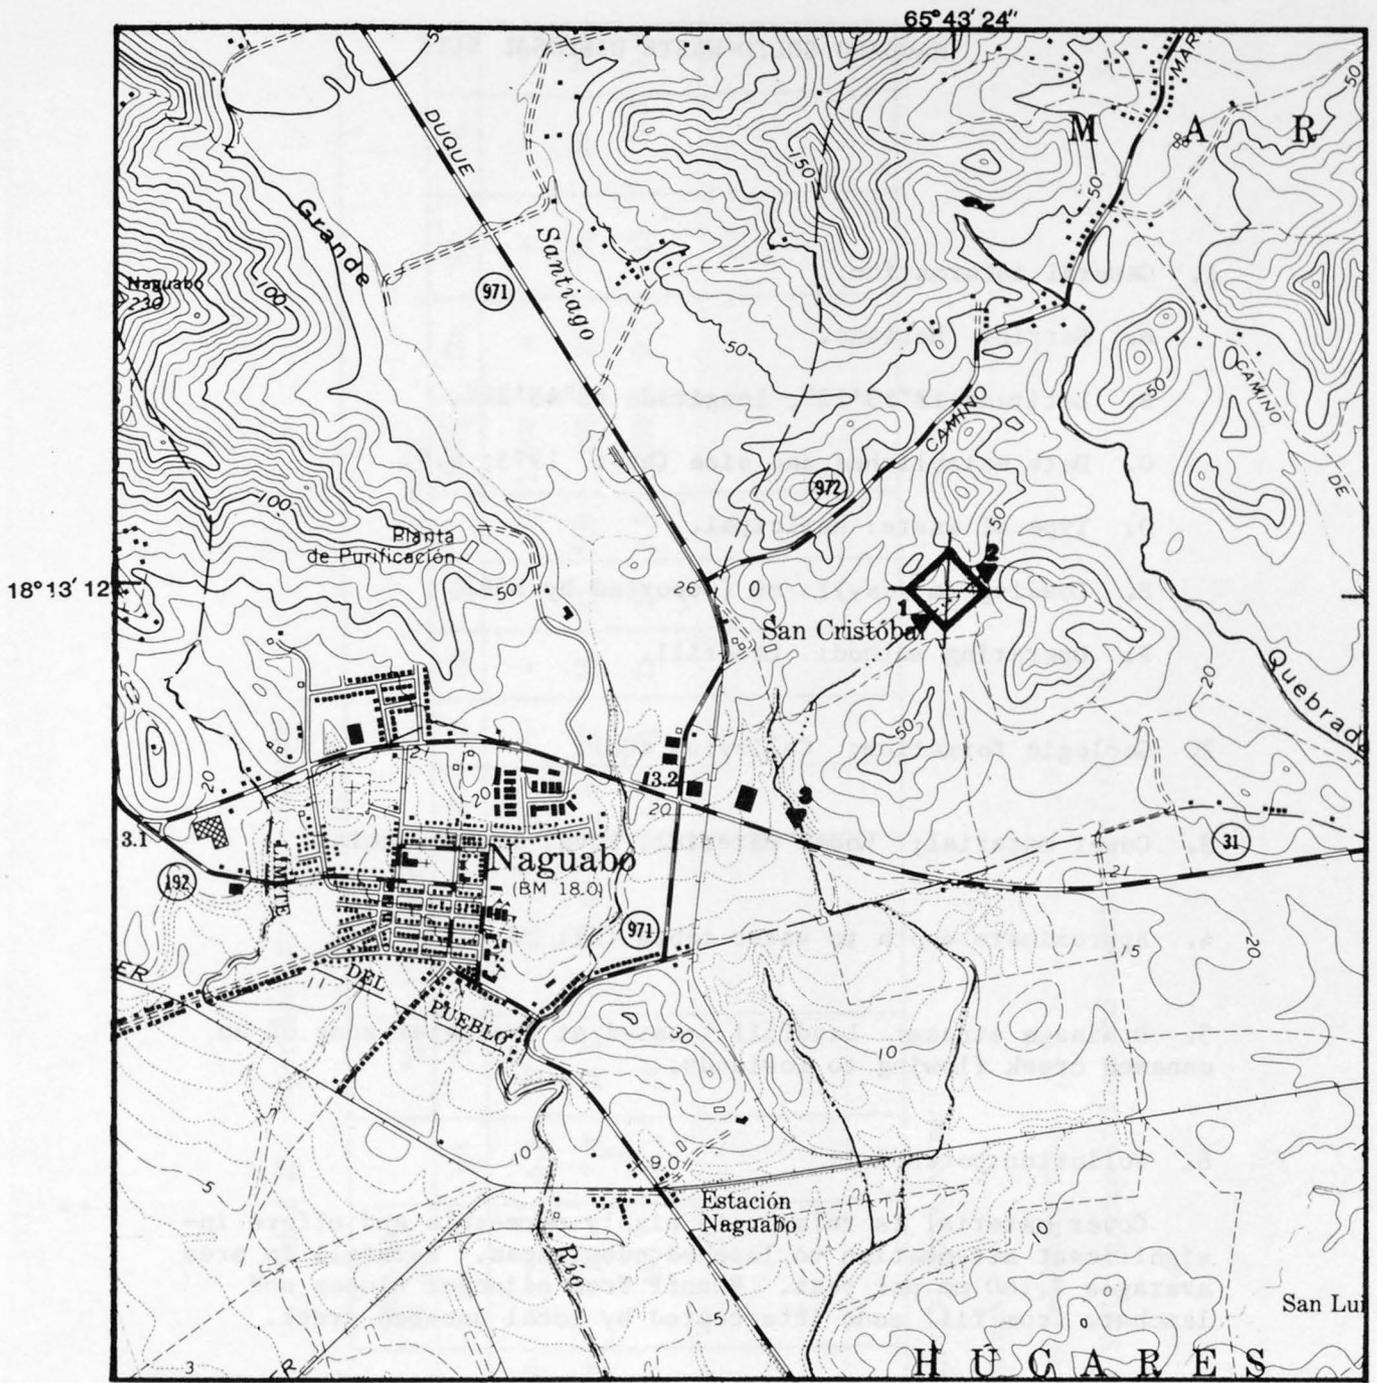
1. Observation well drilled in 1975.
