# GEOHYDROLOGIC DESCRIPTIONS OF SELECTED SOLID-WASTE DISPOSAL SITES IN PUERTO RICO

U.S. GEOLOGICAL SURVEY  
Open-file Report 81-490

By Arturo Torres-González and Fernando Gómez-Gómez

Prepared in cooperation with the  
Environmental Quality Board of Puerto Rico

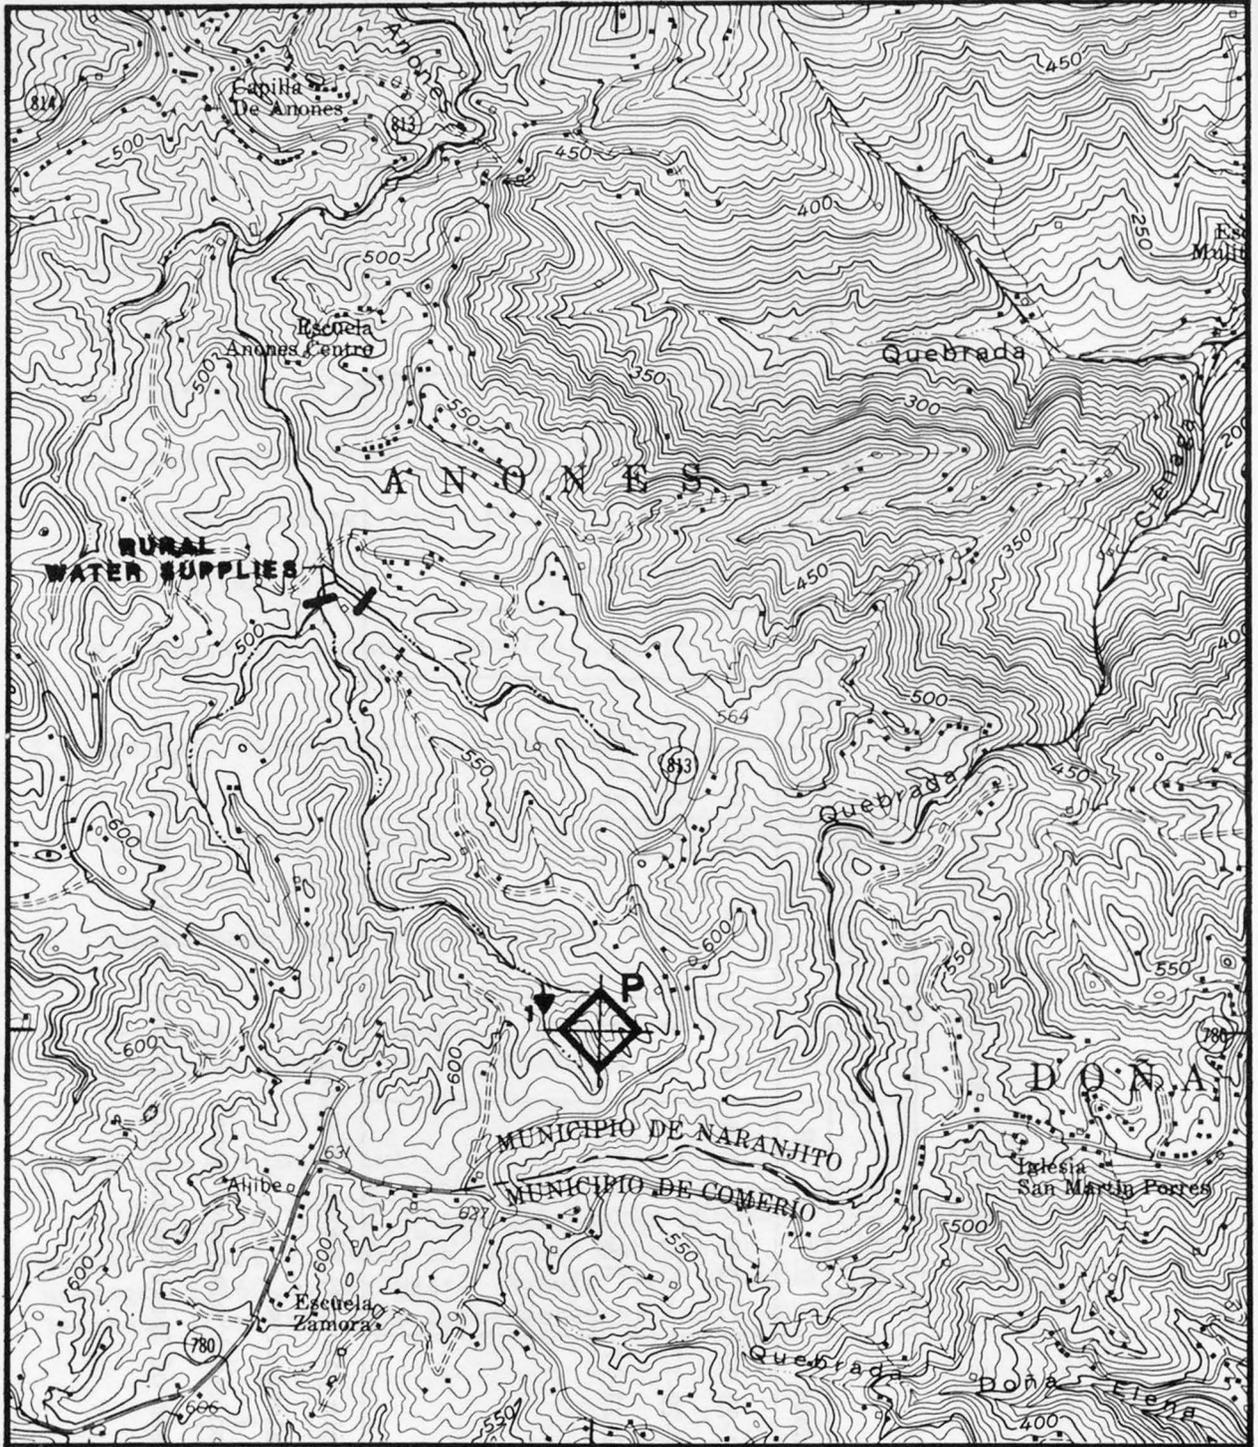
1. Leachate flow along creek.
2. Stagnant pool on creek headwater zone.
3. At creek upstream of Shell Service Station and downstream of fill.

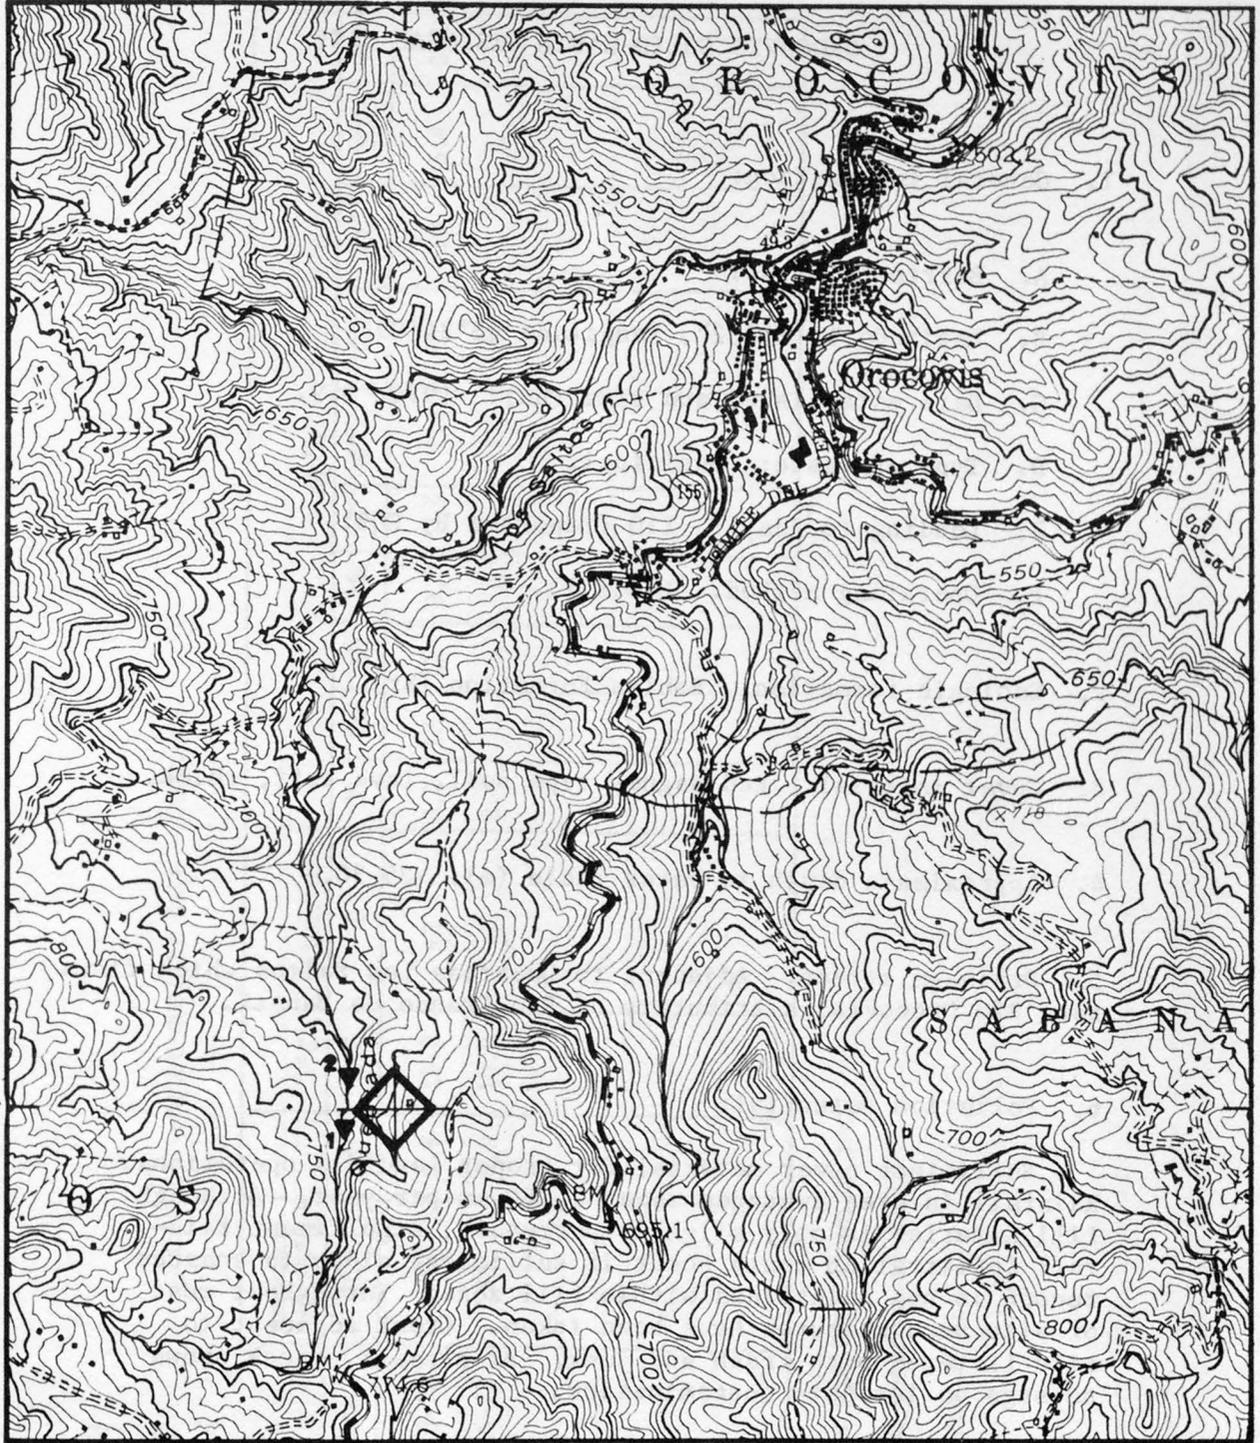
1. At spring below site proposed.

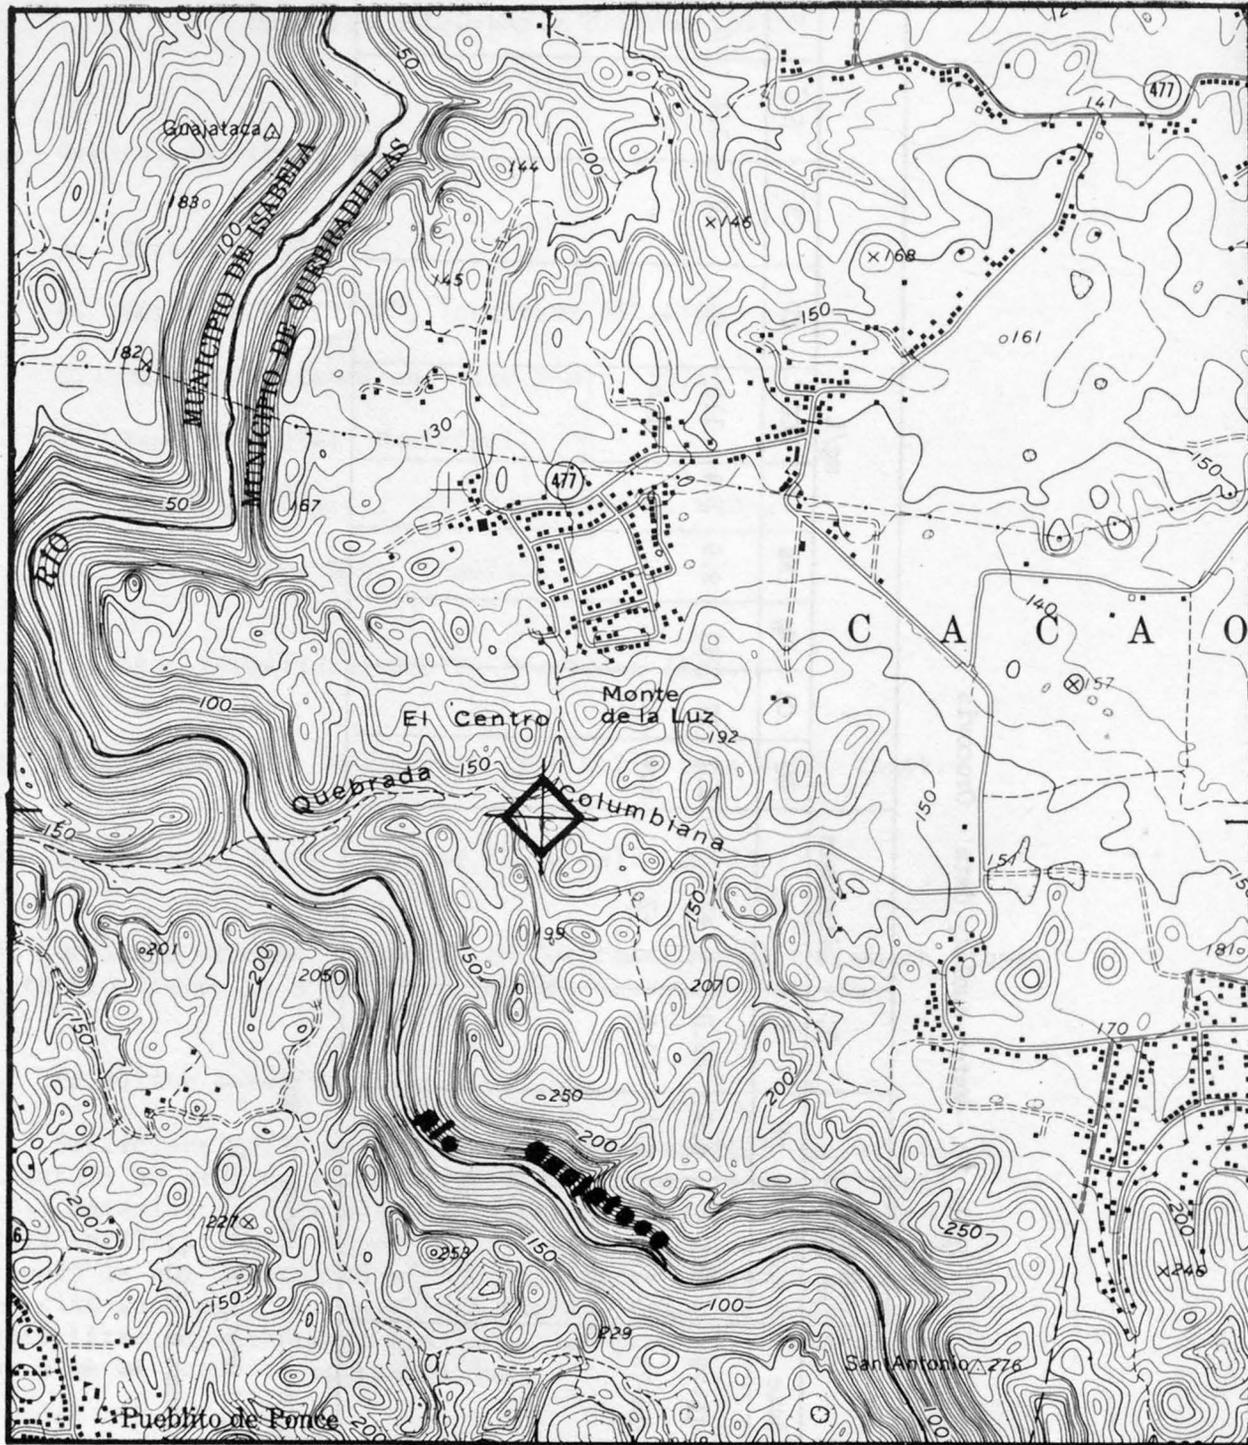
1. At creek west and upstream of fill.
2. At creek downstream of fill.

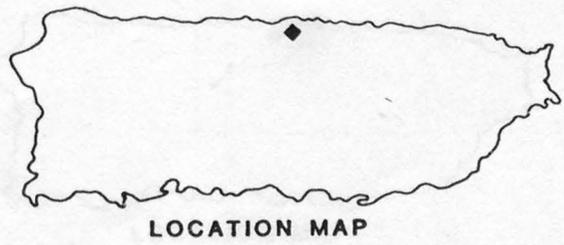
Figure 49.--Vega Baja solid-waste disposal site at Río Abajo, (old landfill).

F. Operating method: Open burning dump.

4. Approximate depth to water table (m): 50 meters to regional water table. Local perched conditions might exist.

It is an open burning dump. Rainfall in area averages about 1,900 mm per year. The geologic formation, Aymamón Limestone, is relatively permeable due to its solution-type porosity and ground-water pollution could be highly possible.

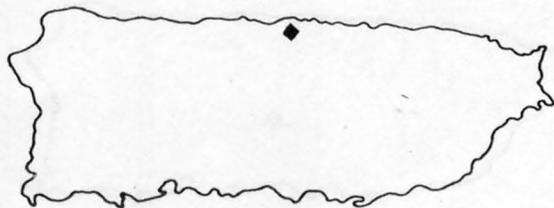
Figure 50.--Vega Baja solid-waste disposal site at Cibuco, (new landfill).

3. Cover material: Loose, coarse material. Fill obtained from surrounding hills. Rock boulders everywhere.

Cover material relatively permeable and offers insignificant attenuation to leached substances. Rainfall in area averages about 1,240 mm per year and this incidence maintains leachate production at a relatively low level. Nevertheless, leachate ponds were observed during the visit. Runoff from fill zone enters headwater zone of the unnamed creek. Anomalous water-quality values at sample site 2 seems to indicate possible effects by leachate pollution.
