INVESTIGATION OF AUGUST 1980
BLOWOUT AND FIRE, LEASE OCS-G 4065
MATAGORDA ISLAND BLOCK 669, GULF OF MEXICO
OFF THE TEXAS COAST

U.S. Geological Survey
Open File Report 81-706

Open File Report 81-706

September 1981

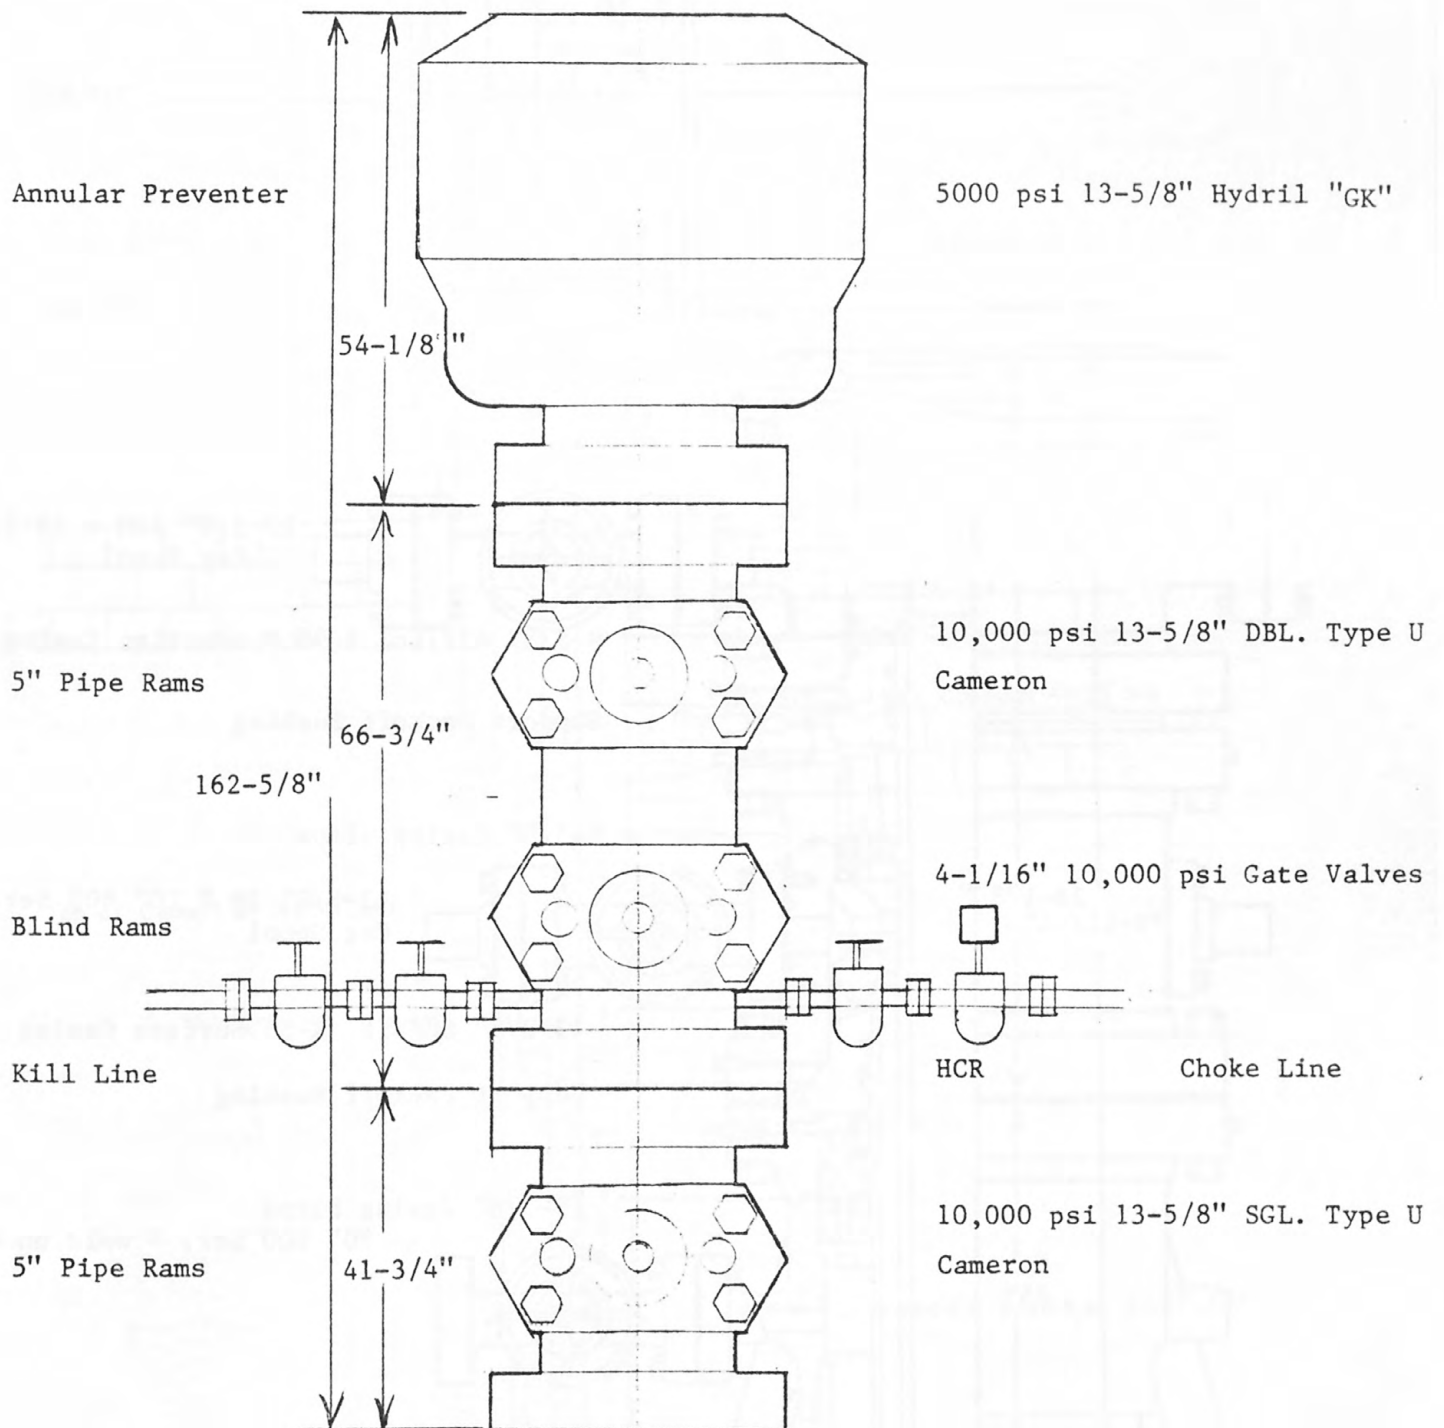
CASING HEAD ASSEMBLY

At about 6:15 a.m., the 13 3/8", 20", and 30" casing strings failed just below the casingheads and blowout-preventer stack. Gas was suddenly released to the atmosphere, and in just a few seconds a fire ignited, an explosion occurred, and flames engulfed the rig (see Photos No. 1 and 2). Of the 11 men aboard the rig at the time of the explosion and fire, 2 were picked up from the water by the MV Mr. David, 6 were picked up from the water by the MV Gulf Fleet 32, and 3 were noted to be missing and presumed dead. Of the eight recovered, two died of asphyxia due to drowning, and six sustained injuries ranging from severe body burns to slight facial and arm burns to broken ribs.

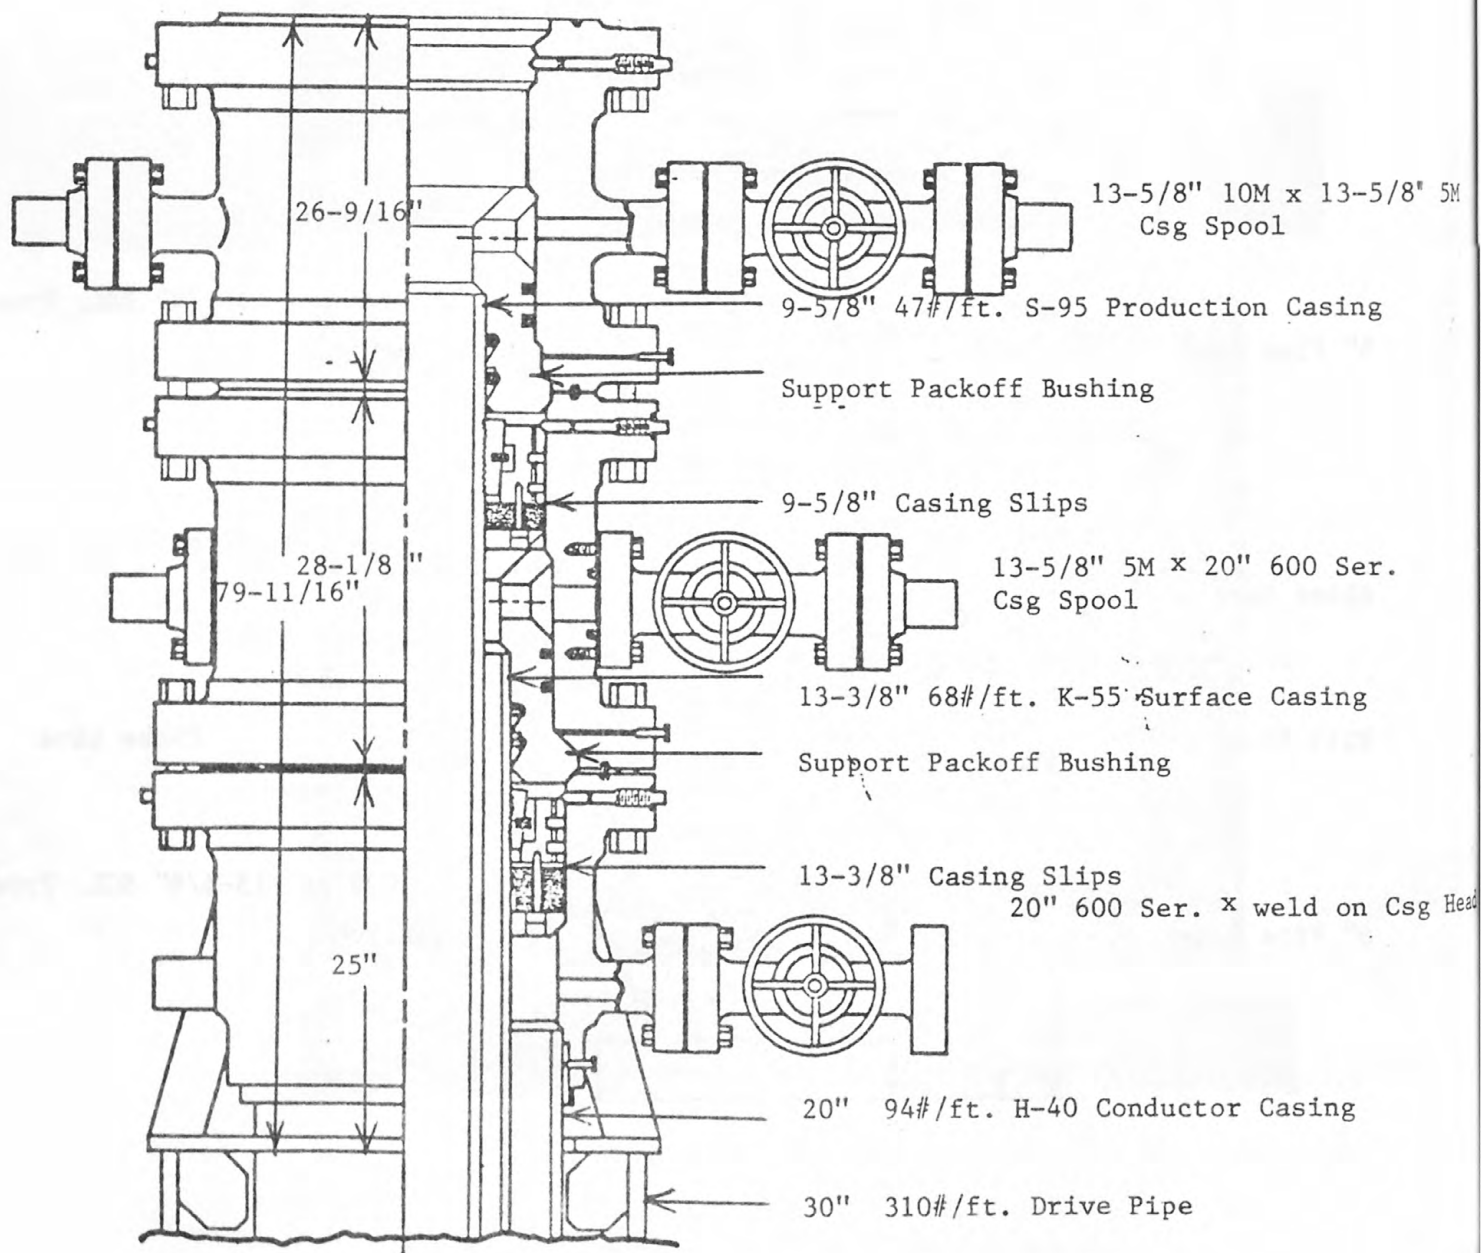
Rupture of 9 5/8" Casing
and
Breakdown of 13 3/8" Casing Shoe
OCS G 4065 Well No. 1
