Investigation of August 1980
Blowout and Fire, Lease OCS-G 2271
Vermilion Block 348, Gulf of Mexico
Off the Louisiana Coast

U. S. Geological Survey
Open File Report 81-712

April 1981

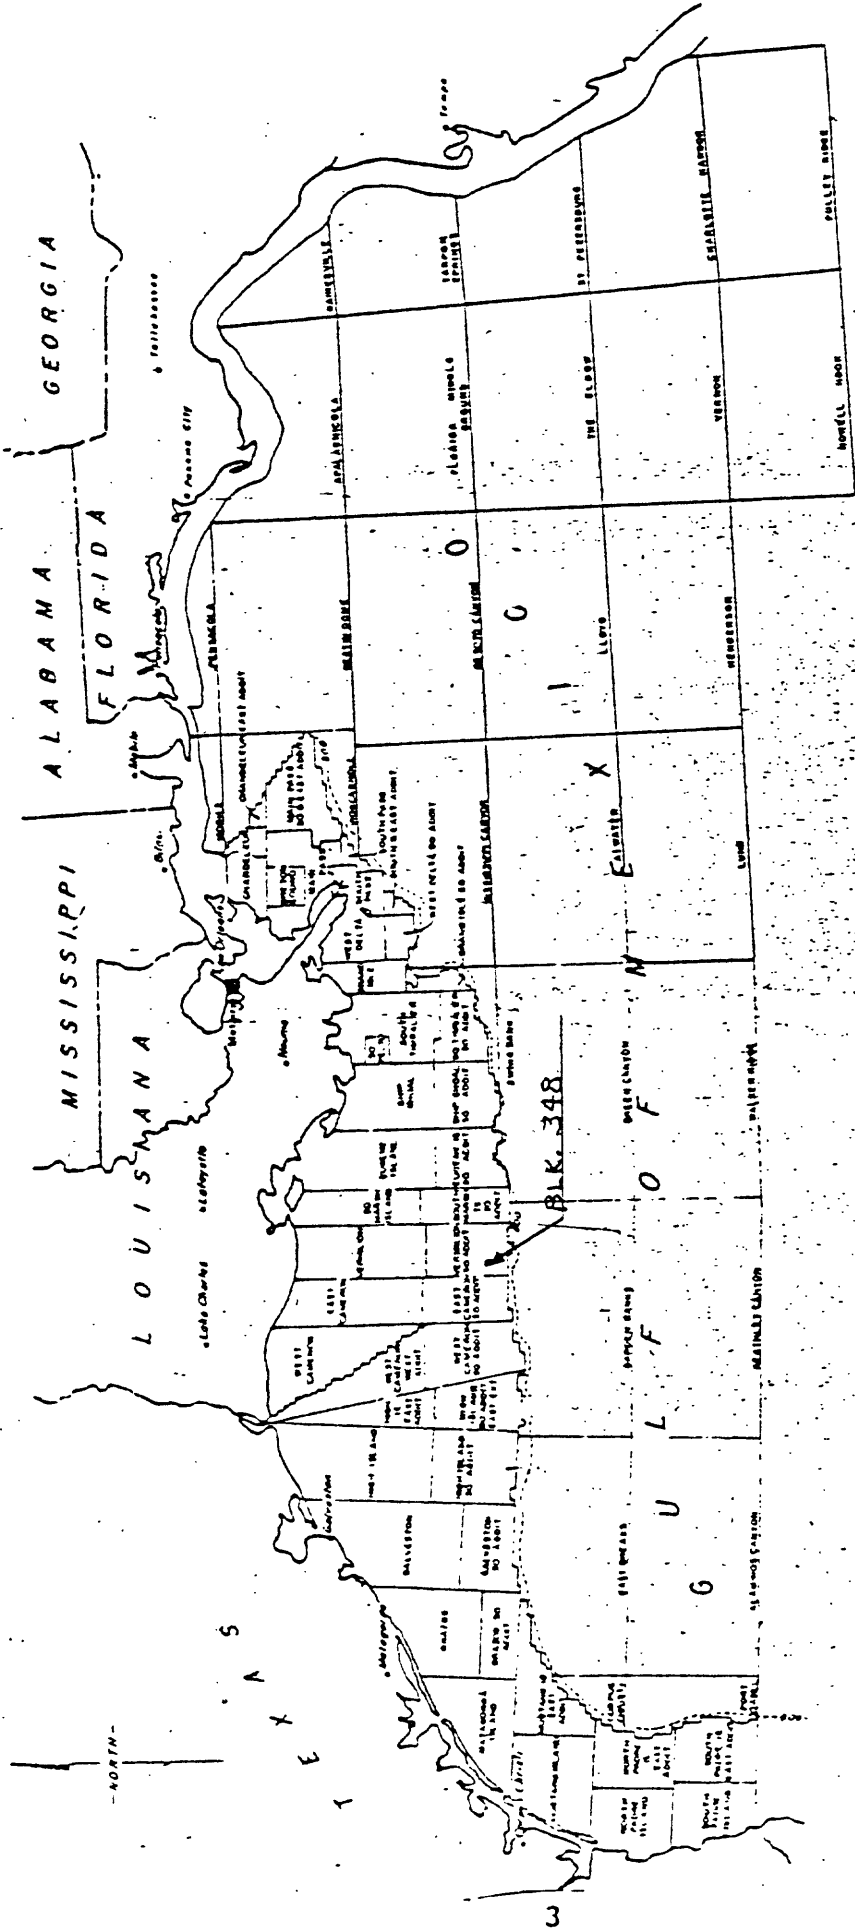
The upper deck of the platform, the drilling rig, SEE Rig 8, and the living quarters were essentially destroyed in the fire (see Attachment 2). All wellheads were damaged and will have to be replaced. Wells on the platform were temporarily abandoned in accordance with OCS Order 3 and were not completed. No pollution resulted, due to the fact that the flow was dry gas.

Date: After Commencement of Spraying by Jet
Barge Jirafa on 8/28/80
Location: Vermilion Block 348, Platform "A"
Photographer: Supplied by Mesa Petroleum Co.
