UNITED STATES DEPARTMENT OF THE INTERIOR  
GEOLOGICAL SURVEY

Distribution of Intensity for the Westmorland, California  
Earthquake of April 26, 1981

Open-File Report 82-485

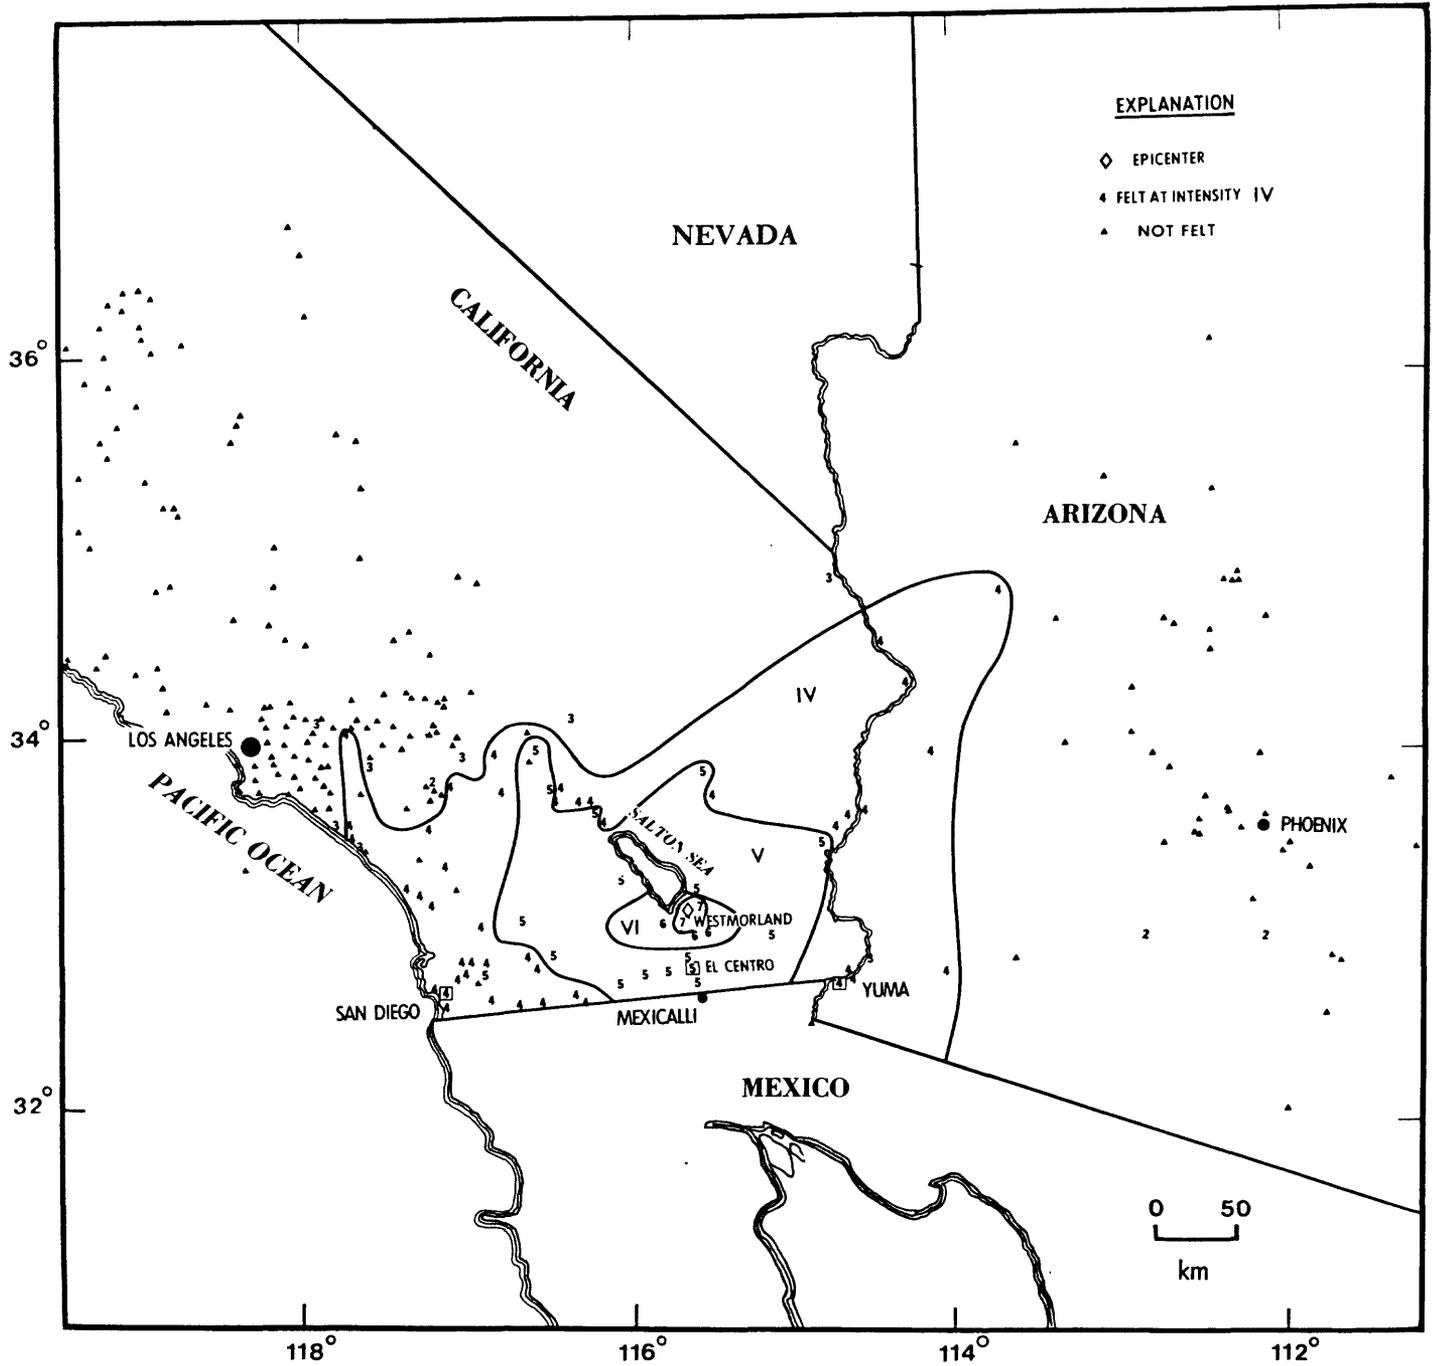
Figure 1.--Preliminary isoseismal map of the Westmorland, California earthquake of April 26, 1981. Intensity evaluations are assigned in accordance with the Modified Mercalli Intensity Scale of 1931 (Wood and Neumann, 1931). Note: Roman numerals are used to delineate isoseismals and, for clarity, arabic numerals are used to indicate intensities assigned at discrete locations.

As shown in Table 2, intensity assignments range from a maximum Modified Mercalli intensity of VII to that of II. "Not Felt" are not listed in Table 2 but are shown on the isoseismal map in figure 1.

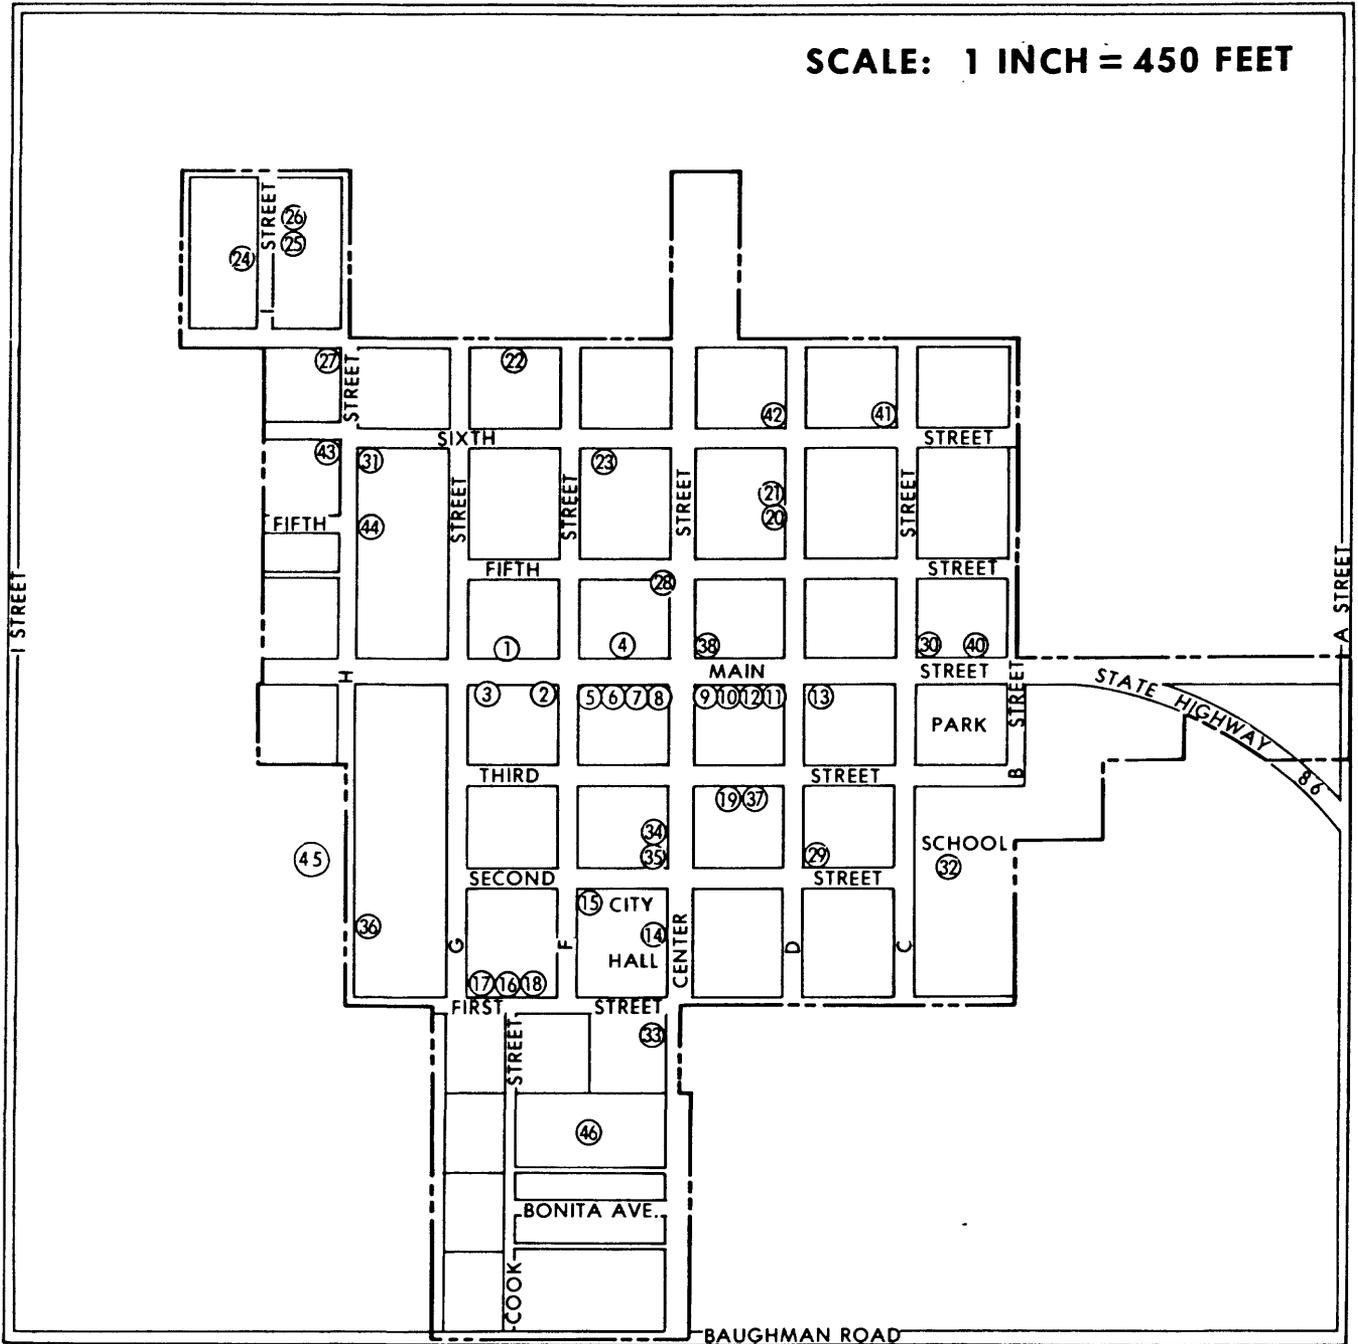
town along Main Street (fig. 2). Six of these buildings were condemned by the Brawley Building Inspector, and the remainder were recommended for repair. The descriptions of damage that follow have been summarized from field notes and from a damage report prepared by the Brawley Building Inspector (written communication, 1981<sup>1</sup>). The numbers of the damage descriptions correspond to the numbered sites of figure 2.

1. The adobe building located at 231, 239, and 241 West Main Street was damaged beyond repair. The adobe wall along the west side of 241 West Main Street fell westward on the roof of the adjoining small building. The east wall of 231 West Main Street collapsed entirely allowing the roof to fall in. The pillars at curbside have deteriorated at their base, and the Brawley Building Inspector recommended that this building be demolished in its entirety.

2. This building has no apparent structural damage. A crack has opened throughout the vertical extent of the front wall where the building adjoins the fire station. The building is constructed of cinder blocks.

3. The Westmorland fire station had a crack open about one-half inch in the brick veneer at the northwest corner of the building.
4. This building had damage to the arcade only. The balance of the building appeared to have escaped major damage.

Figure 2.--Plat of the city of Westmorland, California. Circles indicate damage to a structure at that site and the numbers refer to the corresponding damage description in the text. (Redrawn from a plat of the city provided by the Westmorland City Government.)

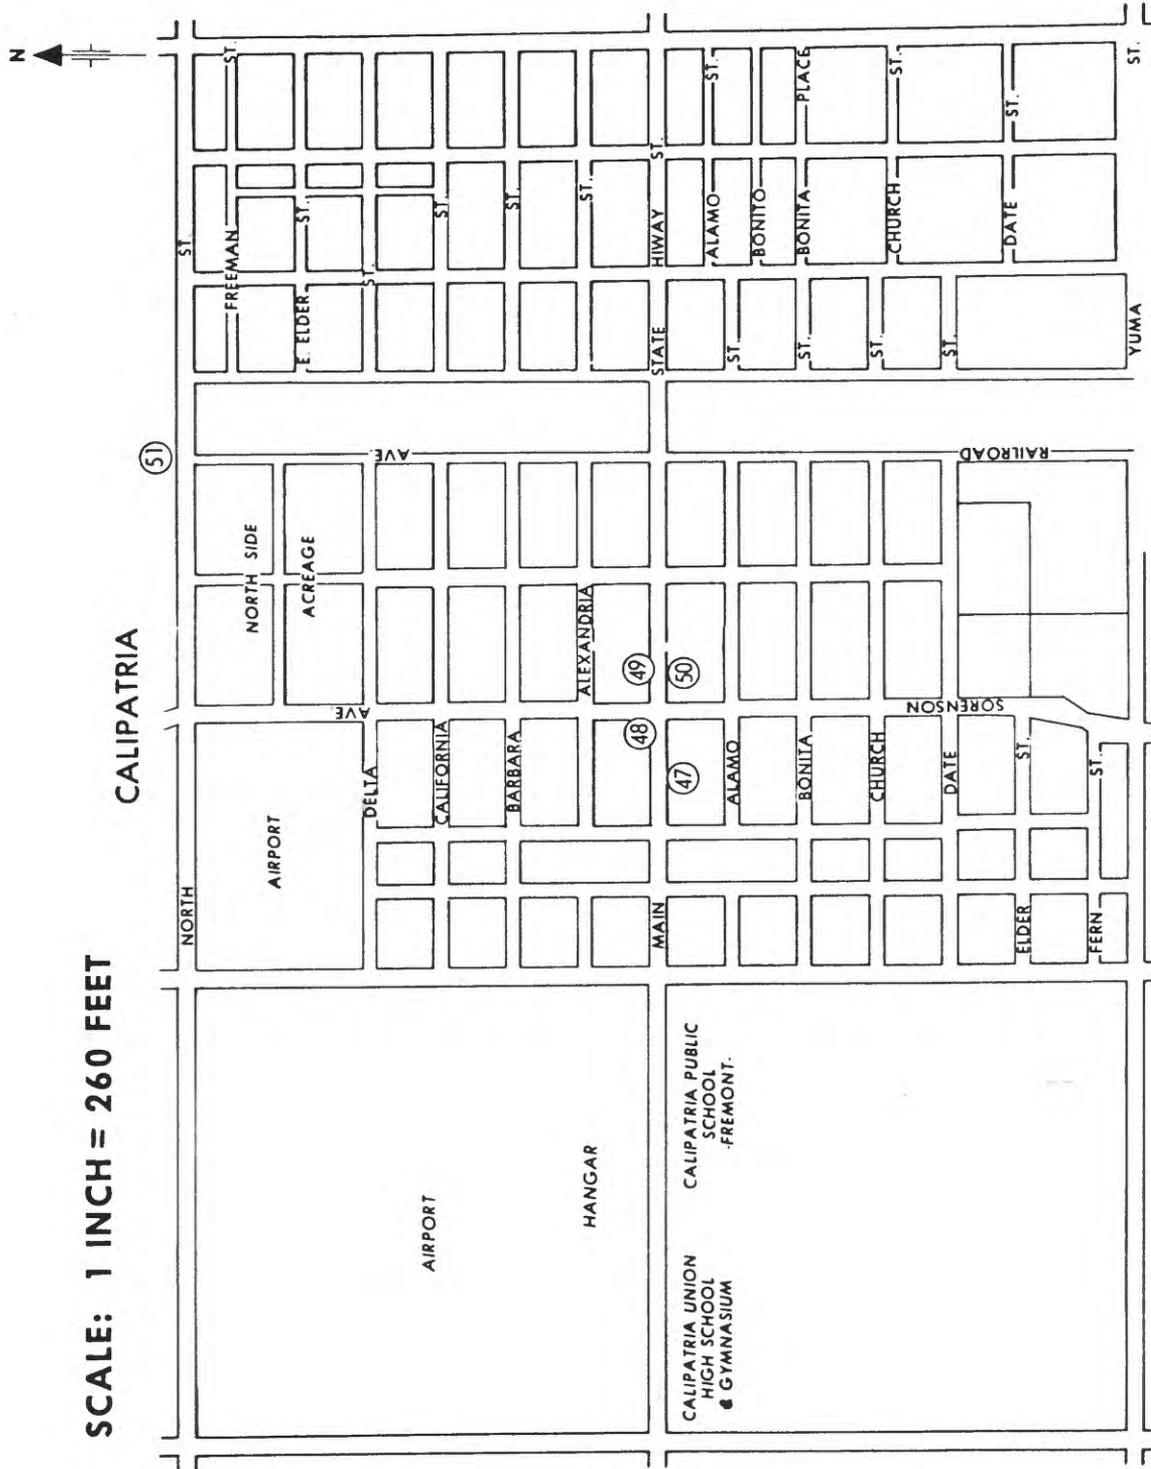
CALIPATRIA

Calipatria, a city of approximately 2,200 people, located 14 km to the northeast of Westmorland sustained damage of Modified Mercalli intensity VII. The following documentation of damage is from field notes only. The numbered accounts correspond to the numbered sites in figure 10.

Figure 10.--Plat of the city of Calipatria, California. Circles indicate damage to a structure at that site and the numbers refer to the corresponding damage description in the text. (Redrawn from a plat of the city, provided by the Calipatria City Government.)
