GEOLOGICAL SURVEY

Intensity survey of the Borah Peak,  
Idaho, earthquake of October 28, 1983

Open-File Report 84-166

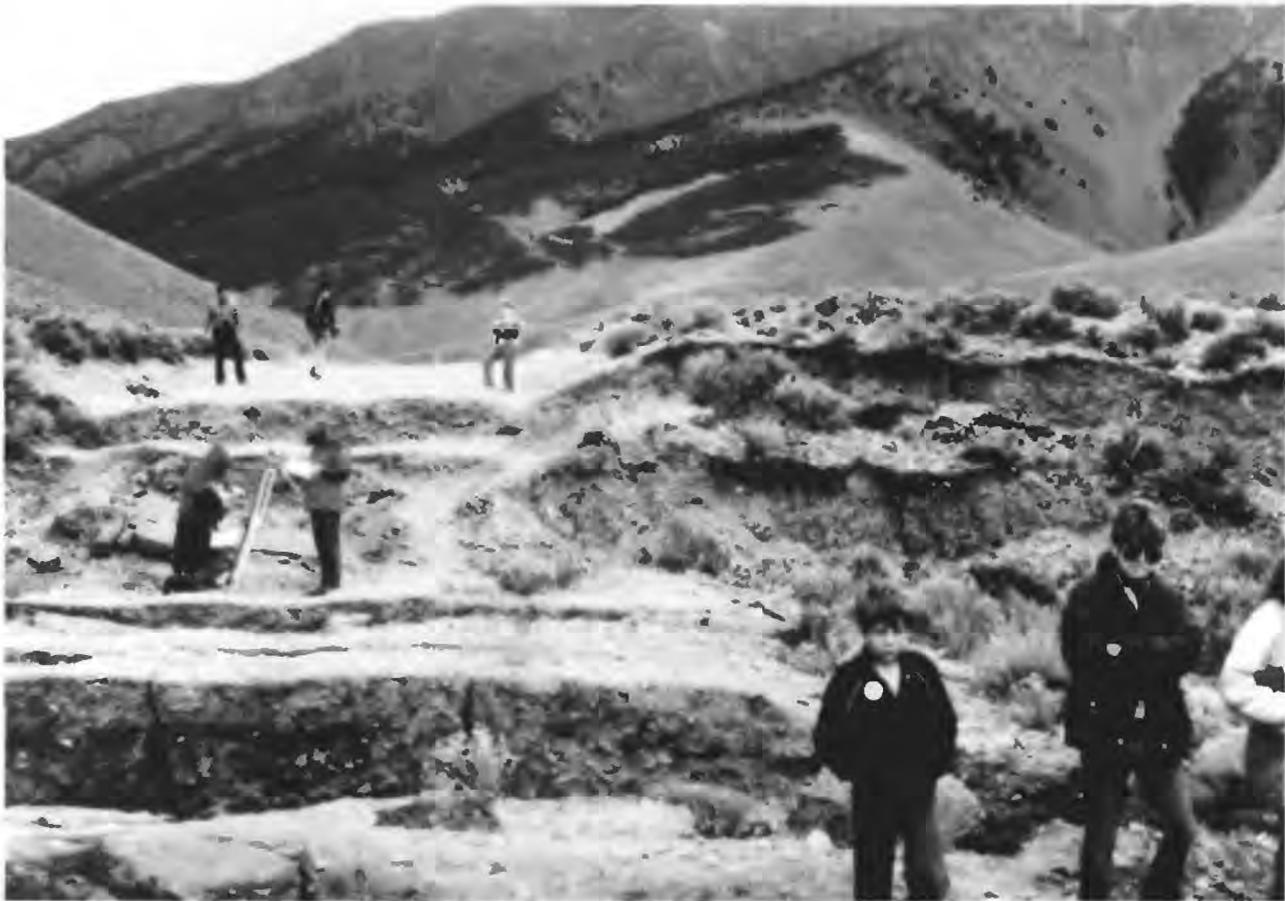
Figure 3.--The upthrown side of the fault scarp. The location is 3 miles east of Dickey, Idaho on Doublesprings Pass Road. The photograph is looking east toward the Lost River Mountain Range.

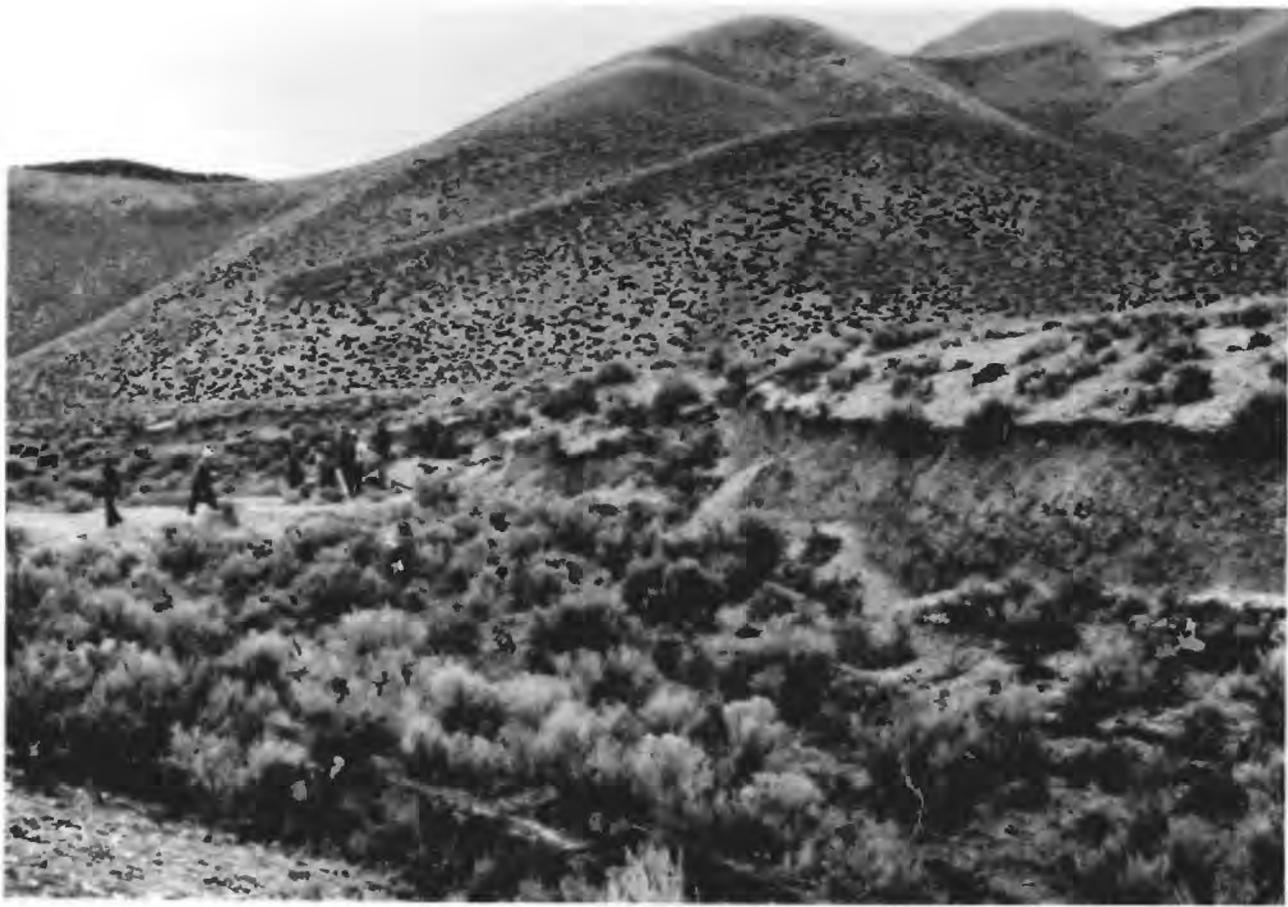
Figure 4.--An oblique view, across the fracture zone, of the upthrown side of the fault scarp on Doublesprings Pass Road. Looking northeast.

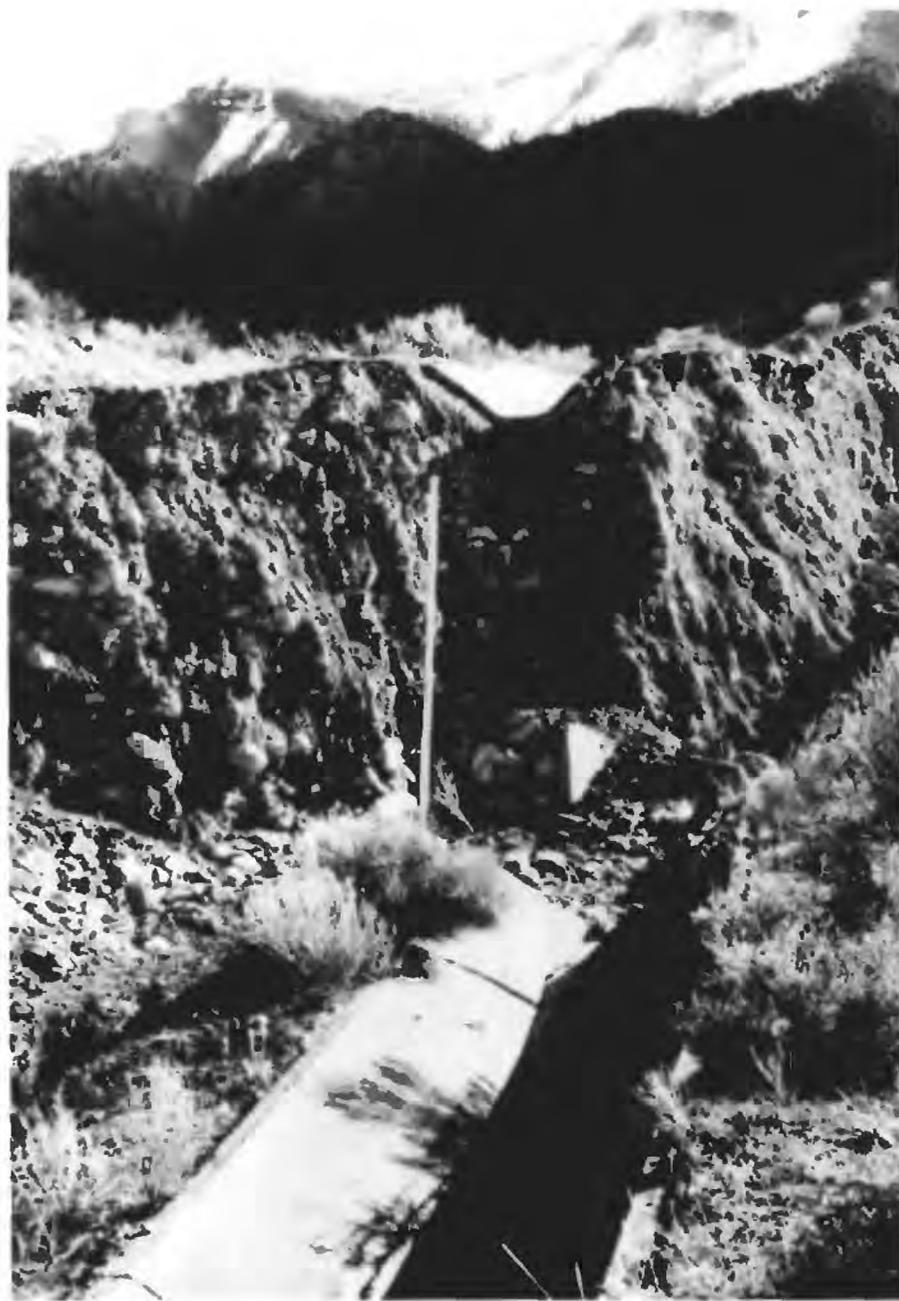
Figure 5.--The fault scarp and fracture zone on Rock Creek. The location is 3 miles east of Dickey, Idaho and a mile south of Doublesprings Pass Road. The wooden pole is 6 1/2 feet high. The northern flank of Mount Borah appears in the upper right corner of the photograph.

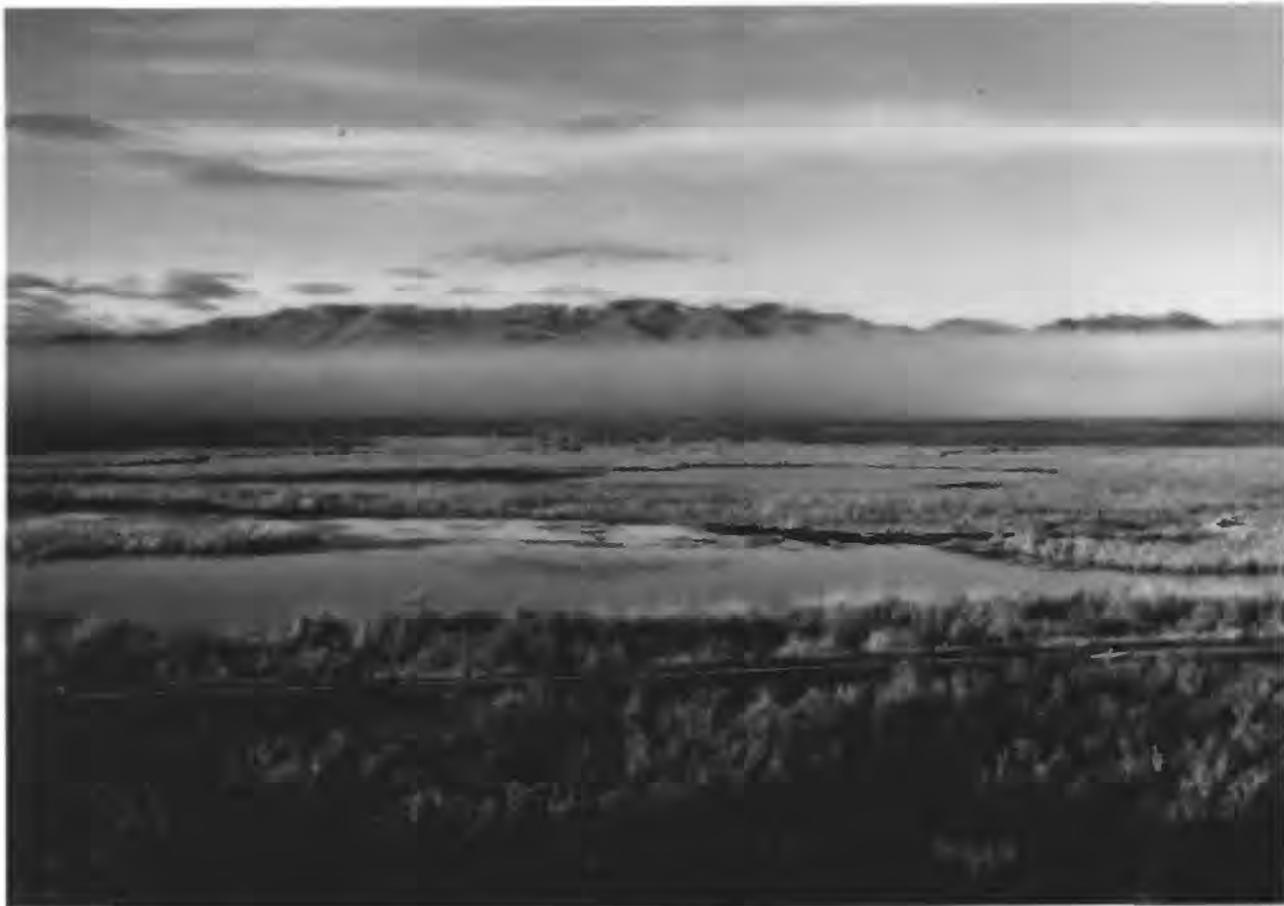
Large ground cracks occurred in an open field at a mile north of the Trail Creek Road intersection on U.S. Alt. 93 (fig. 7 and fig. 8). The ground cracks, which varied in length, width, and depth, trended northeast toward the Lost River Mountain Range. The dry cracks were located 20 yards east of the highway. The Thousand Springs Valley marsh area was adjacent to the west side of the highway (fig. 9).

Figure 9.--The Thousand Springs Valley area borders the west side of U.S. Alt. 93. The ground cracks, as shown in Figures 7 and 8, were located on the east side of the highway. A low fog bank hangs over the valley at the time this picture was taken.

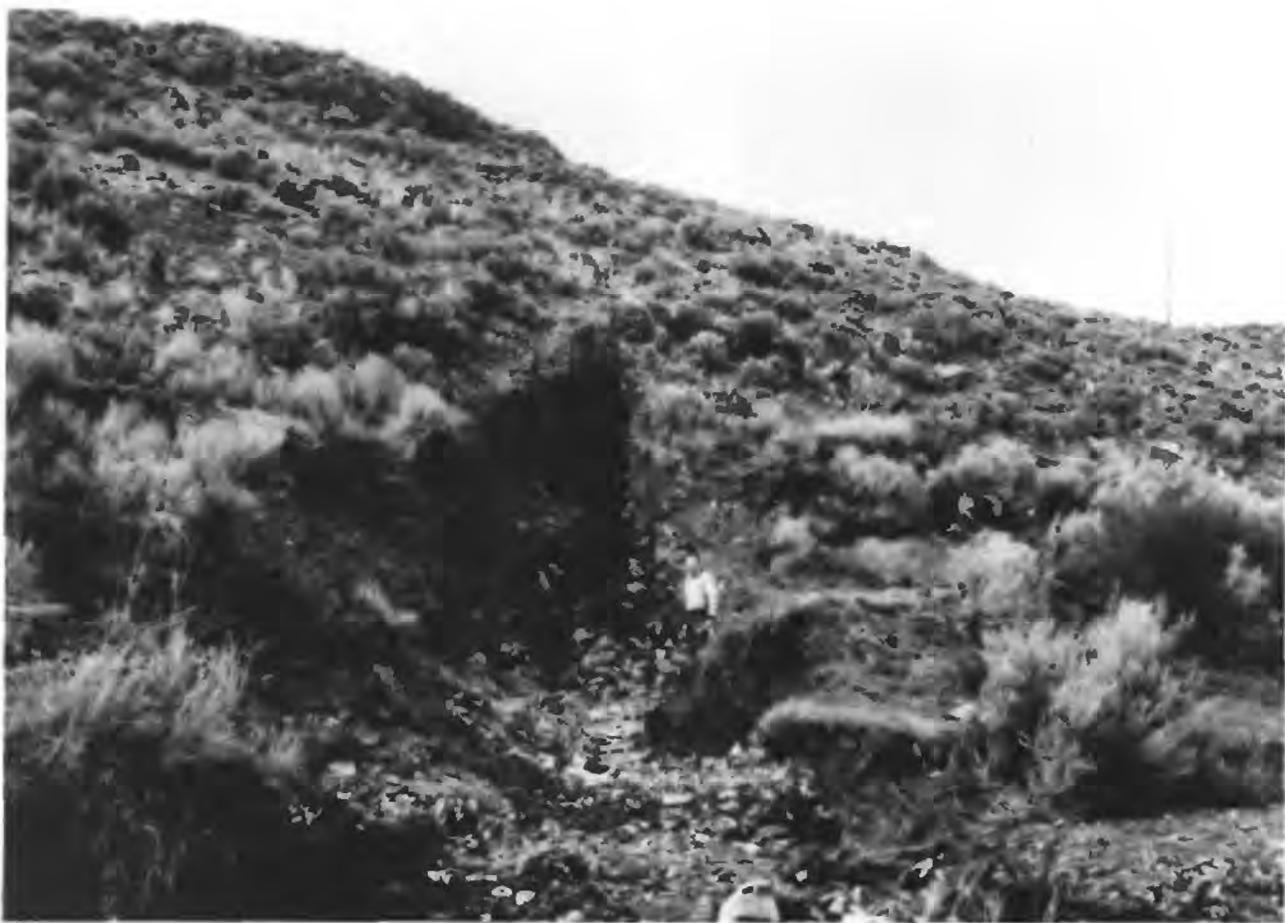
Figure 10.--One of the water spout (earthquake fountain) holes located at the base of Chilly Buttes. The man, which is standing next to the exit of the water spout hole, is 5 1/2 feet tall.

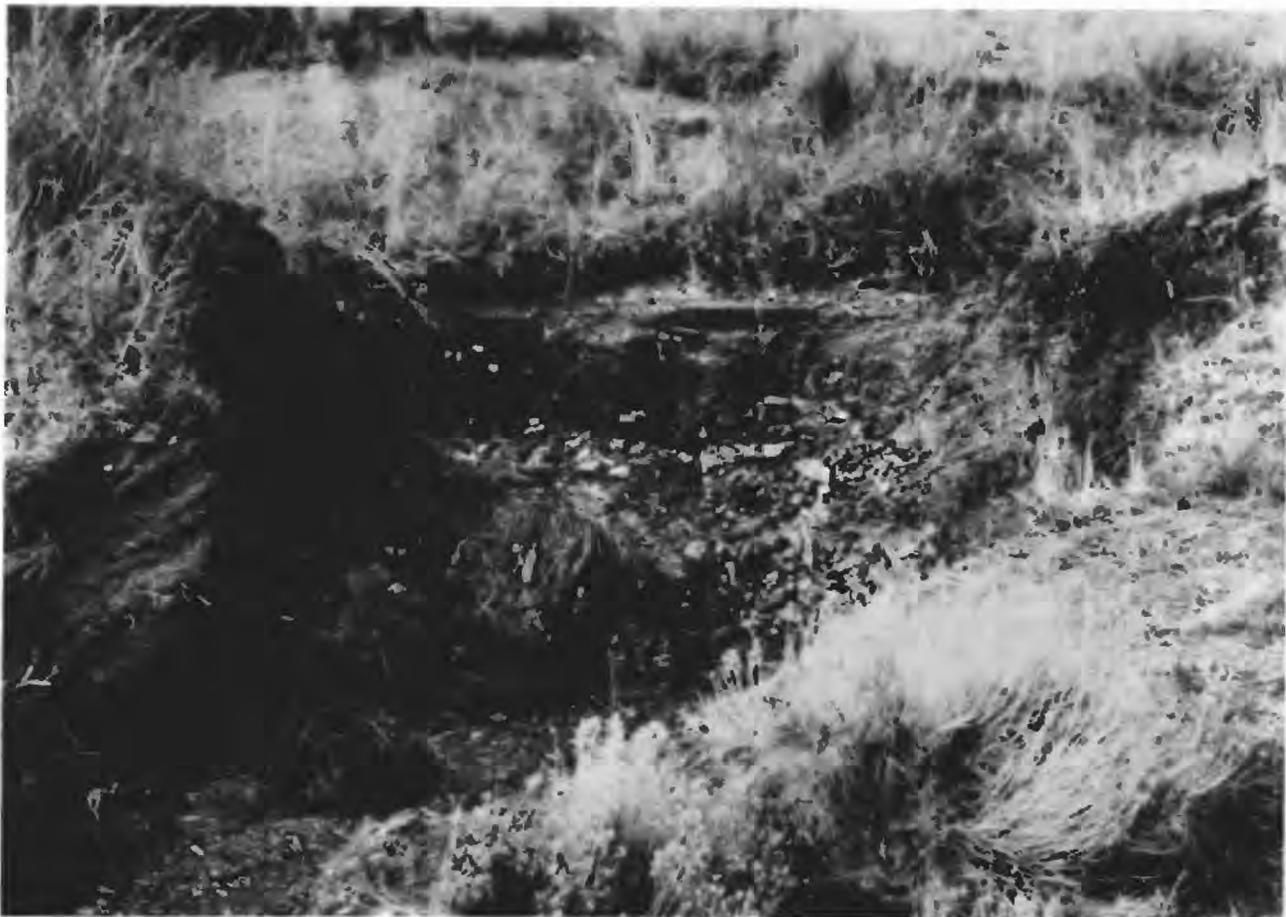
Figure 11.--The overlying vegetation was uprooted by the force of the ejected water at this water spout hole.

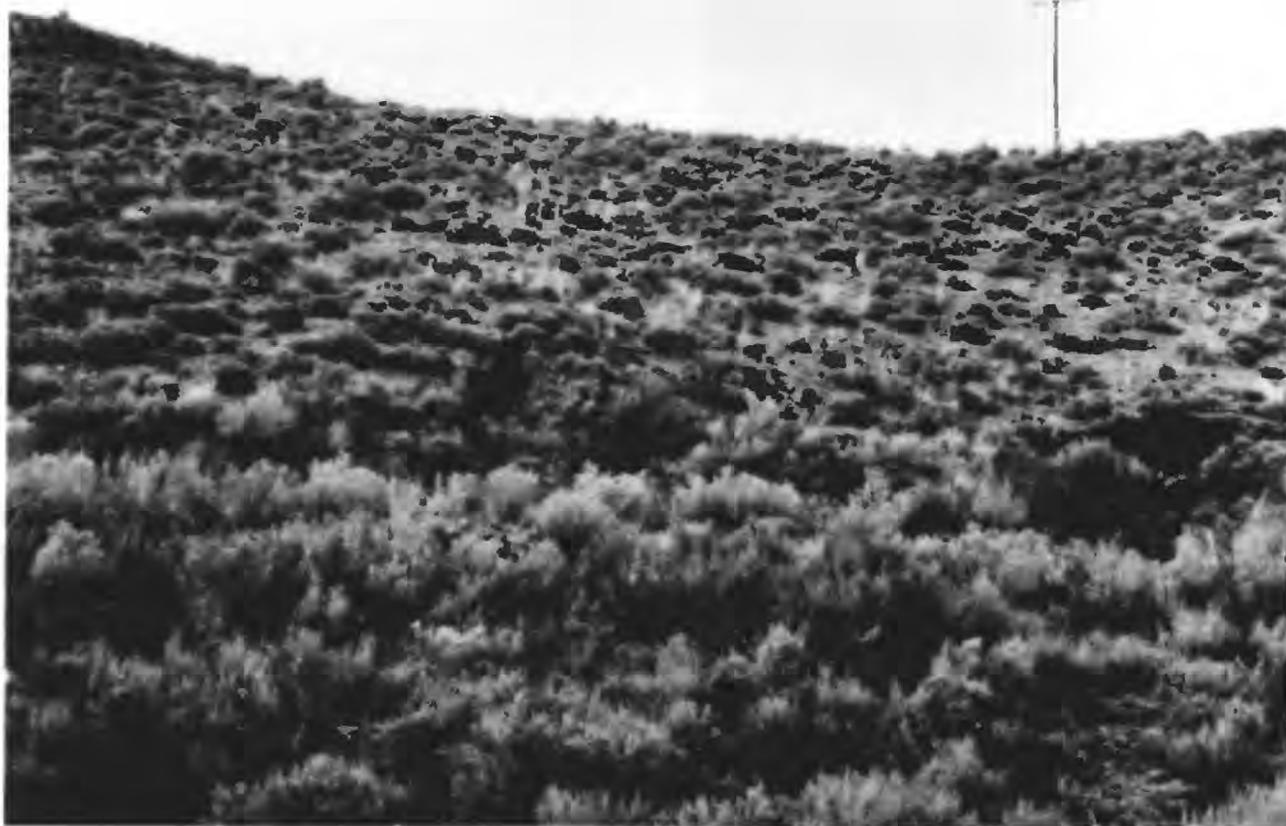
Figure 12.--Two water spout holes located midway up on the east side of Chilly Buttes.

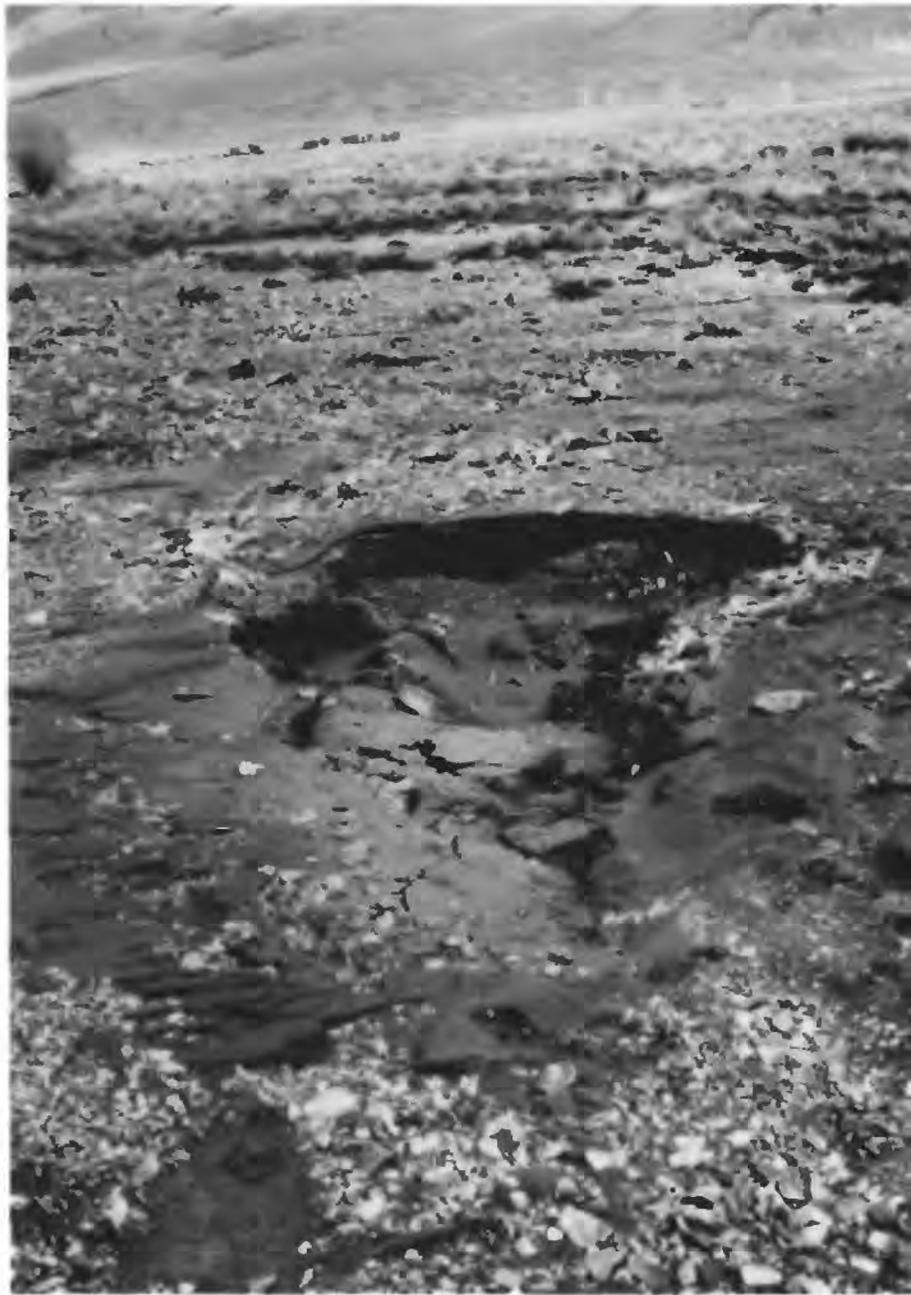
Figure 13.--One of the many collapsed water spout (earthquake fountain) holes in the flat area adjacent to the the base of Chilly Buttes. The hole was estimated to measure 2 feet deep, 17 feet lengthwise, and 10 1/2 feet wide.

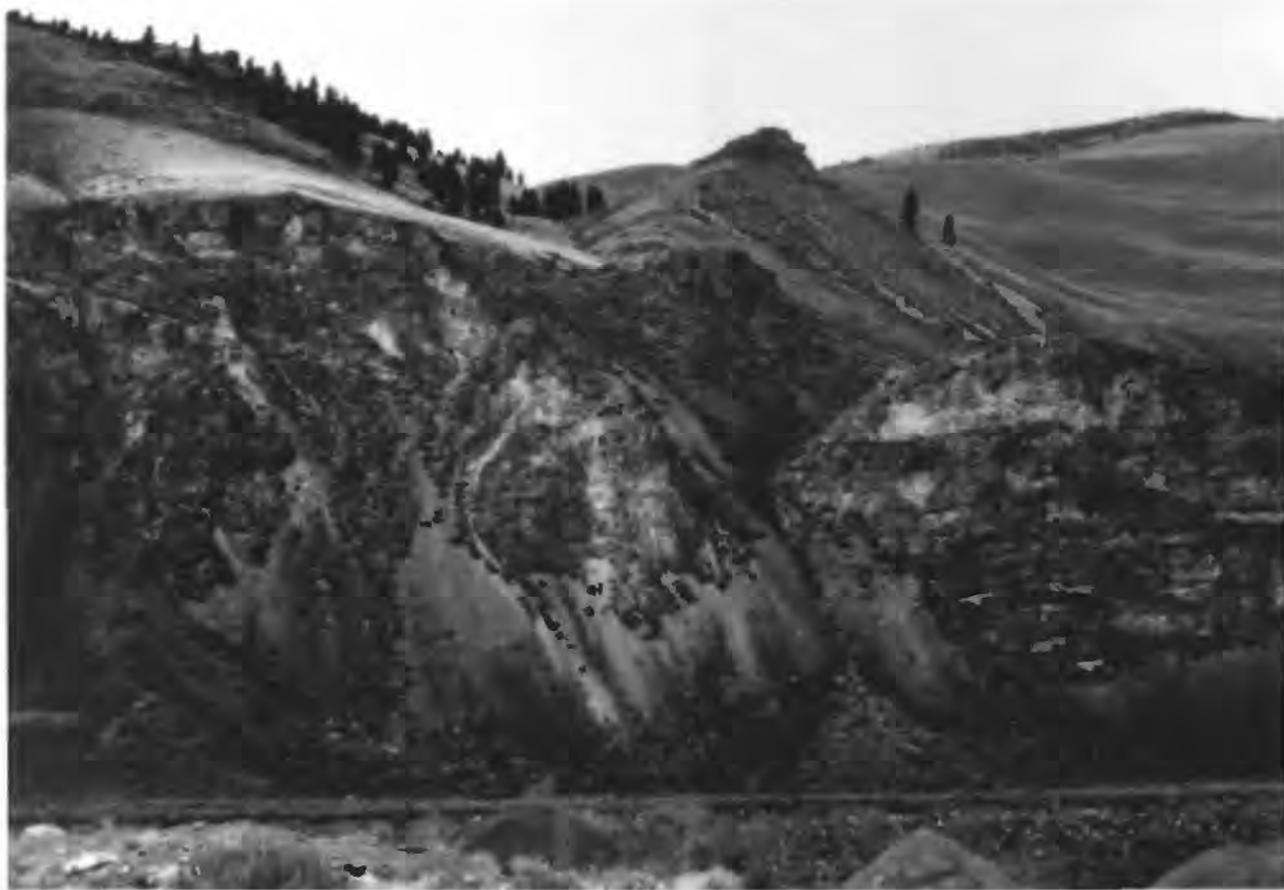
Most of the mountain sides bordering State Highway 75 between Challis and Clayton showed recent landslide scars (fig. 14).

Figure 14.--A photograph taken between Challis and Clayton on State Highway 75. The lighter scars on the hillside are the result of the landslides activated by the recent earthquake. This is a typical picture of the mountain sides in this area.

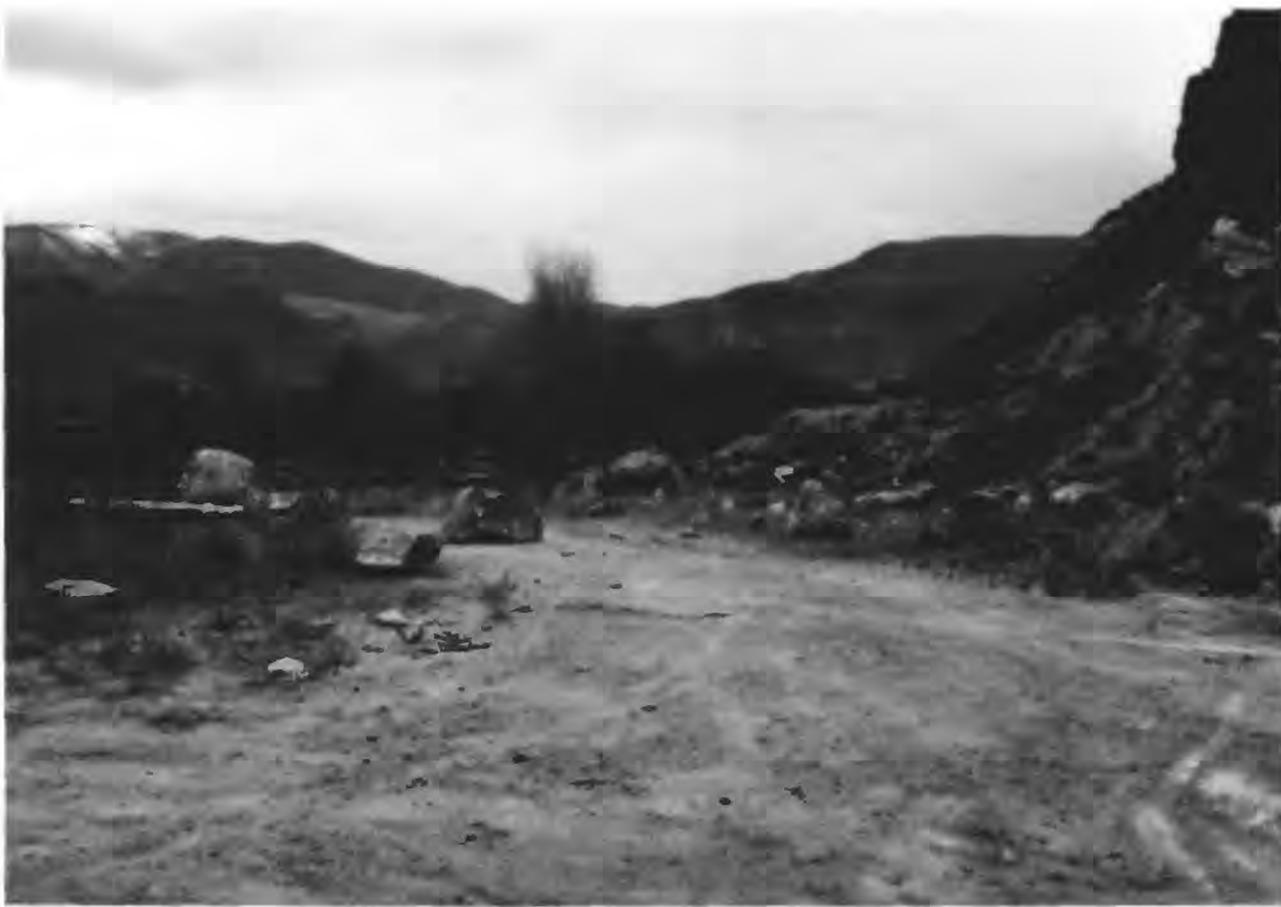
Huge boulders, which rolled down the slopes of the mountains in the northwest section of Challis, were spectacular (fig. 16 and fig. 17). Some of the homes adjacent to the slopes were damaged by the fallen boulders. A huge boulder narrowly missed the residence of Georgia Smith. The house was located one block away from the mountain slope. The boulder rolled between two houses at the base of the slope, down the road, across a wooden bridge, and came to rest in the Smith's front yard. The side of the front porch was slightly damaged on their wood-frame house (fig. 18).

Figure 16.--A view of the large boulders at the base of the mountain slope shown in Figure 17. The slope is located in the northwest section of Challis, Idaho.

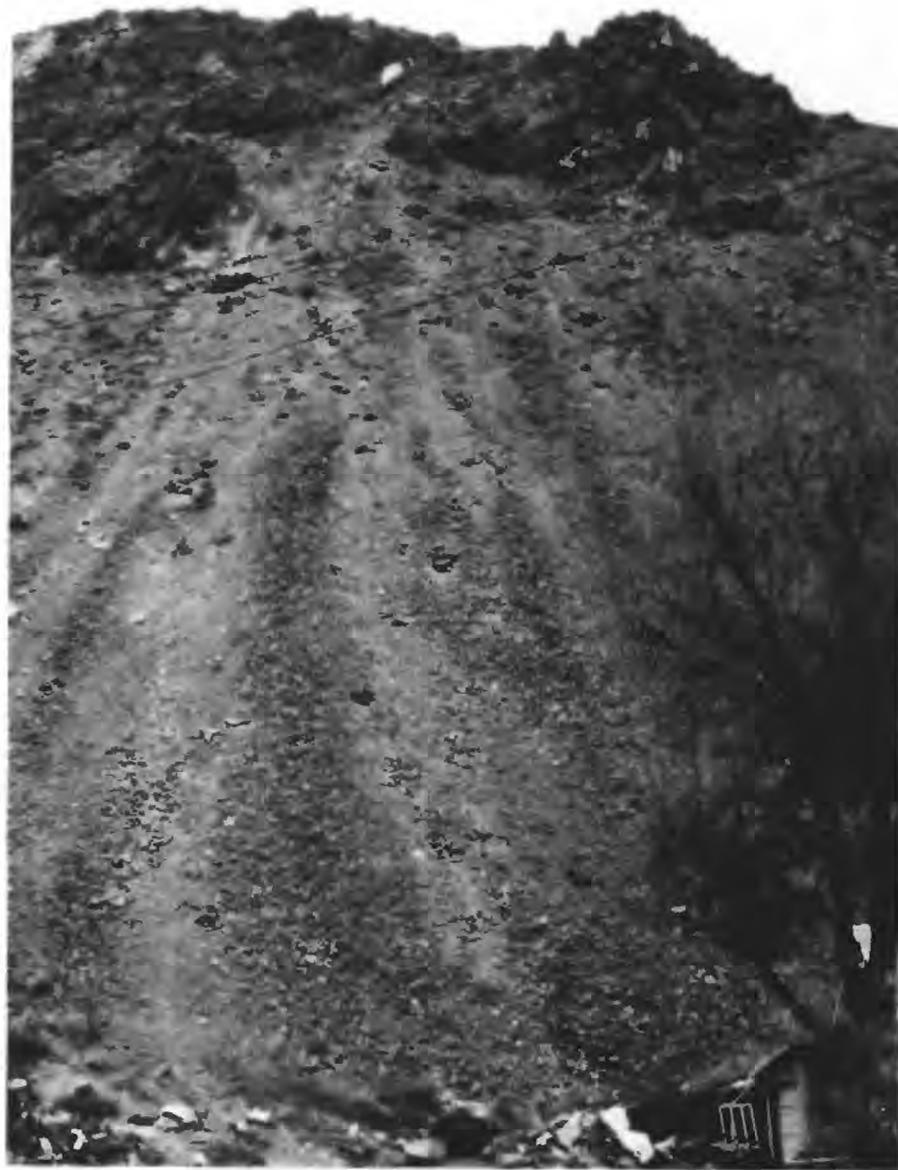
Figure 17.--A view of the mountain slope and the location of the boulders near the top. The size of the fallen boulders can be seen in Figures 16 and 18. Note the building and the fallen boulders at the base of the slope. Challis, Idaho.

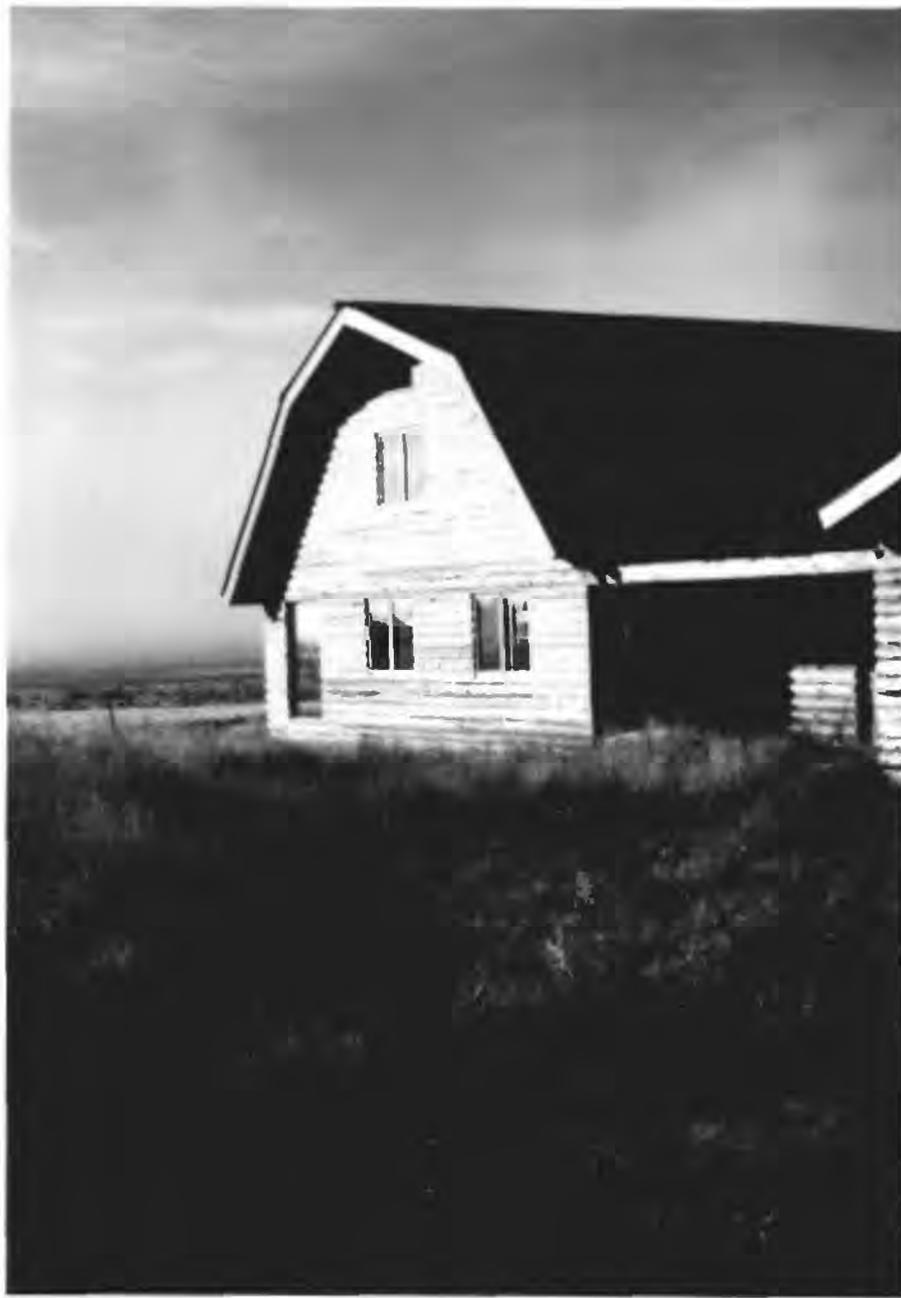
A wood-frame house, set over a concrete basement, was located about 50 yards south of the Fulton residence. The house (under construction) and the reinforced concrete basement were not damaged (fig. 24).

Figure 24.--The frame building was located approximately 50 yards south of the Fulton residence. The building (under construction) or the reinforced concrete basement was not damaged.

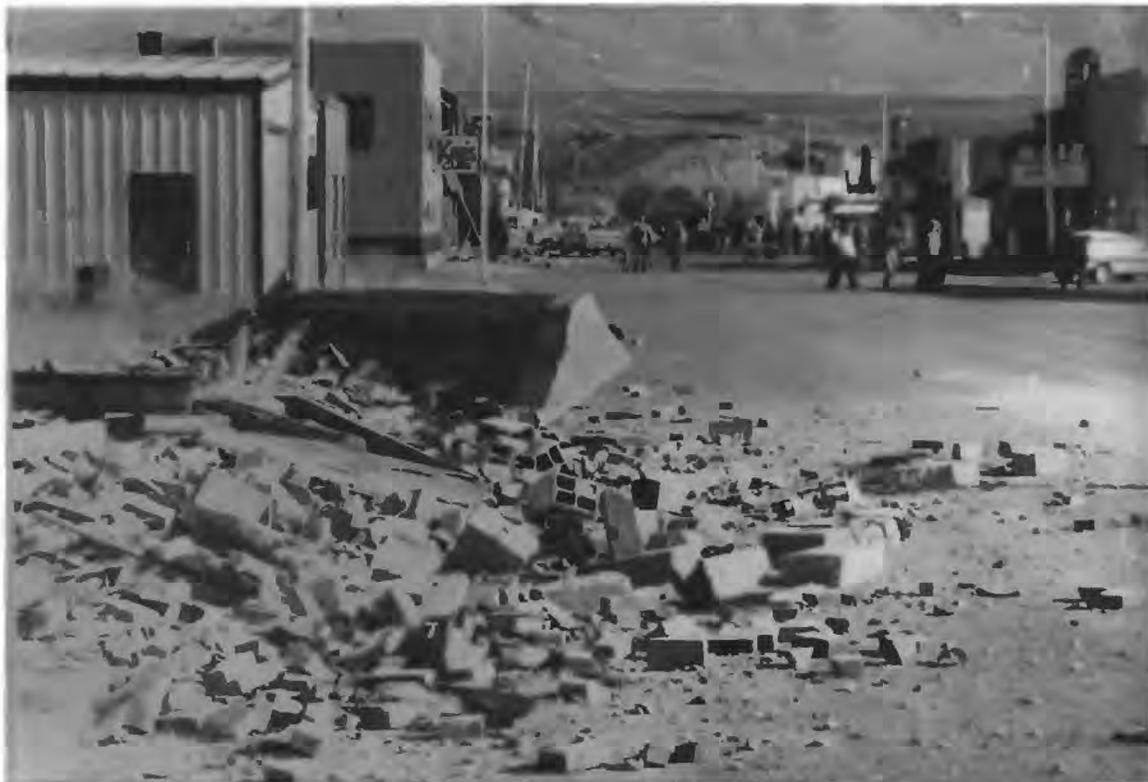
Figure 29.--Main Street in Mackay, Idaho. The business establishments on the north and south sides of Main Street. Looking toward the east. The rubble in the street is from the partially collapsed wall of the Custer Hotel. Photograph by Robert Bower of the Post-Register Newspaper, Idaho Falls, Idaho.

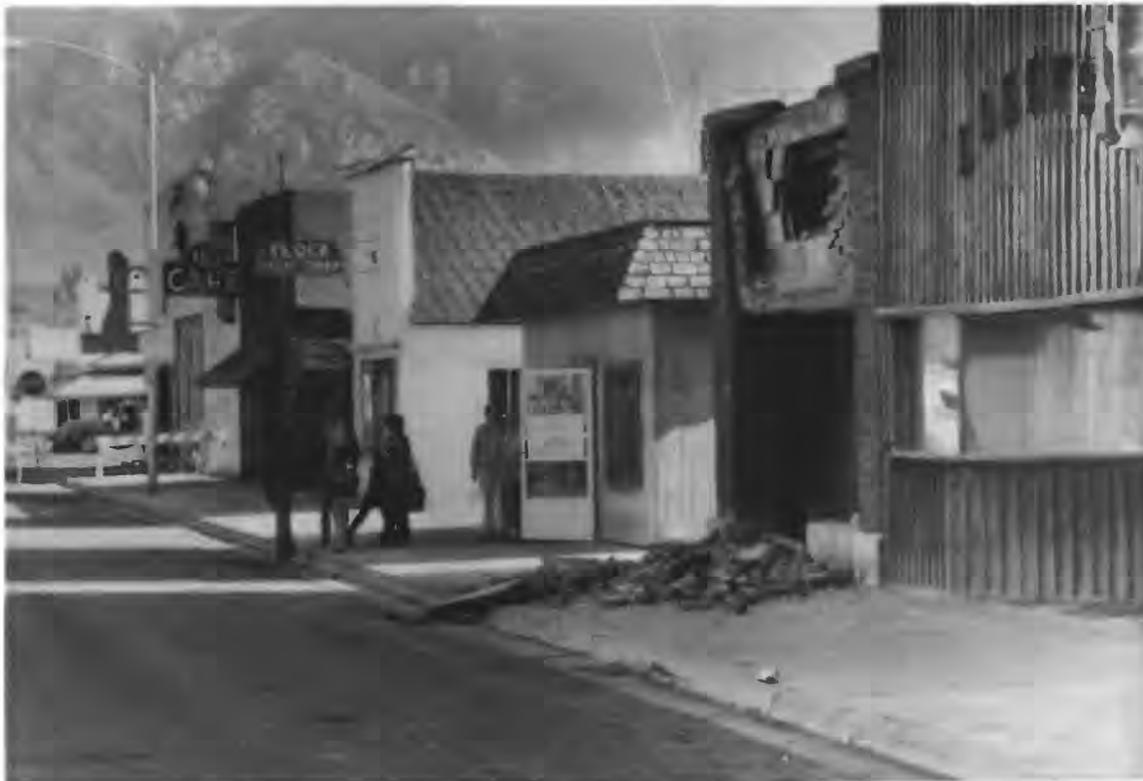
Figure 31.--Looking east along the south side of Main Street in Mackay, Idaho. Bricks, on the sidewalk, fell from the false store front of the unknown establishment. The building with the gaping hole in the masonry store front, above the LLL Cafe sign, is the City Hall (see also Figure 36). Photograph by Robert Bower of the Post-Register Newspaper, Idaho Falls, Idaho.

front windows in the masonry building front. It was a two-level masonry structure (fig. 31 and fig. 36).

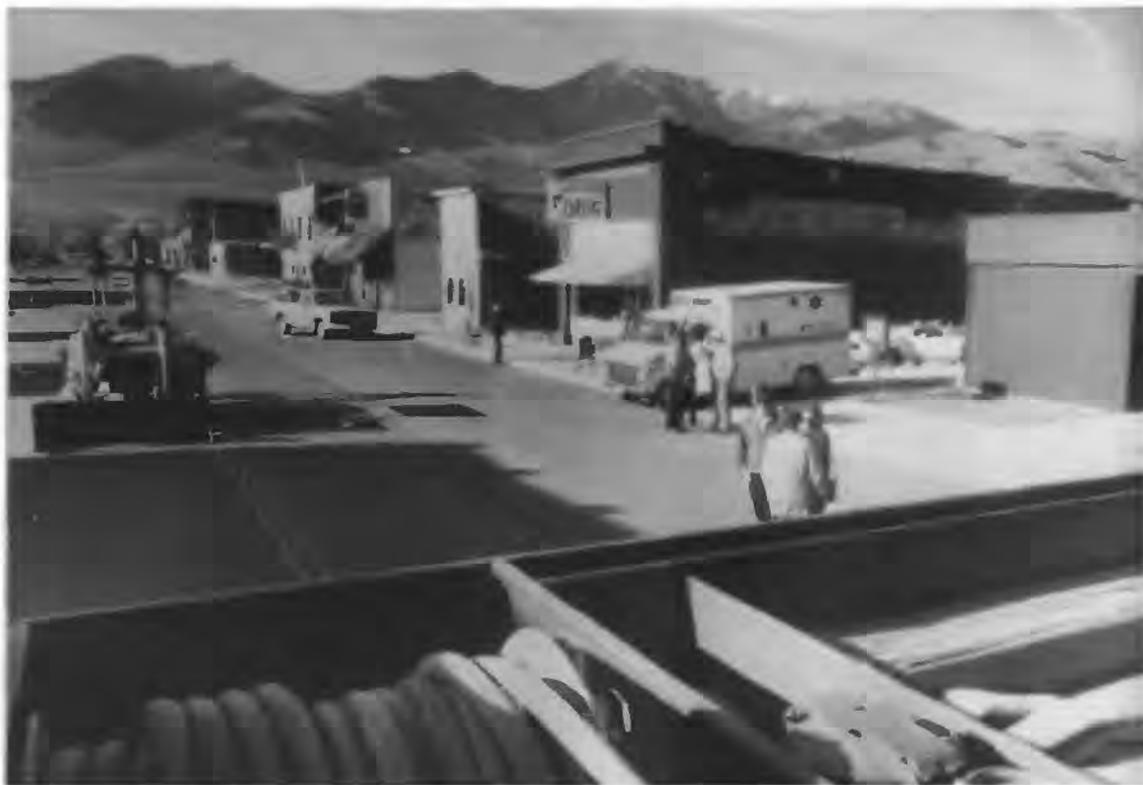
Figure 33.--Looking west along the north side of Main Street in Mackay, Idaho. Mackay Drug is in the foreground and the Custer Hotel, the last multi-story building, is in the background. Photograph by Robert Bower of the Post-Register Newspaper, Idaho Falls, Idaho.

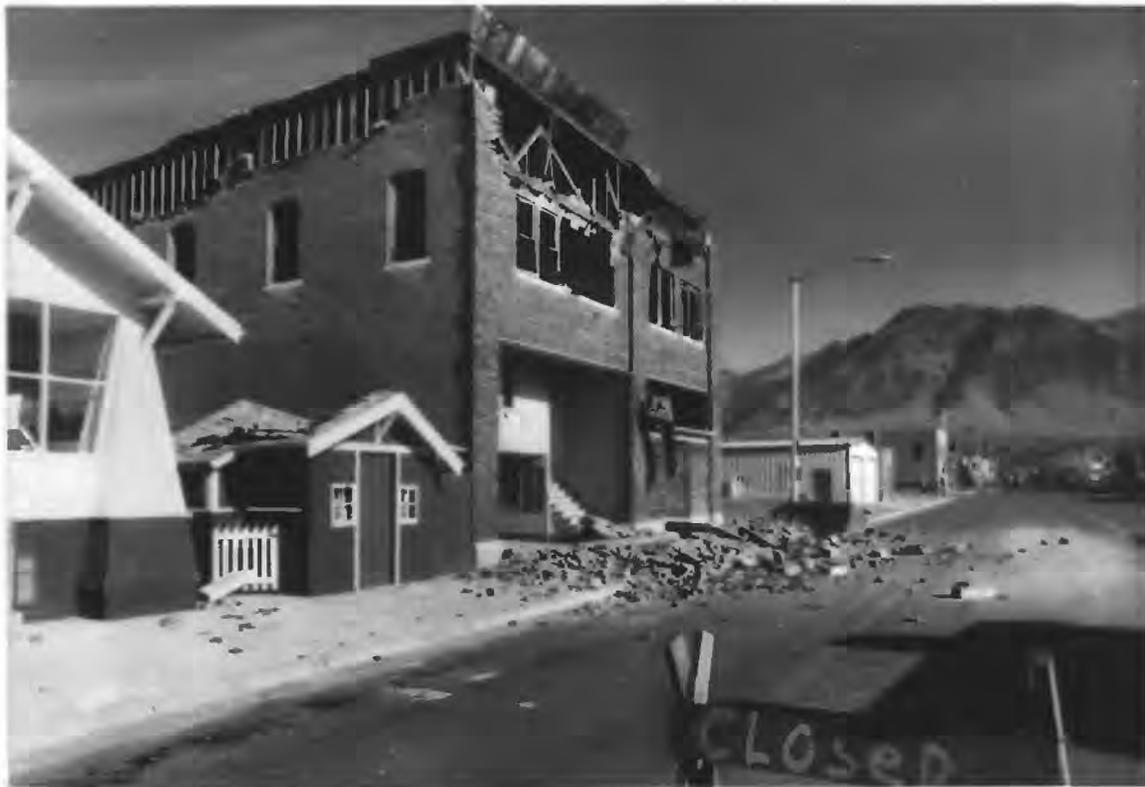
Figure 34.--The Custer Hotel. Looking east on the north side of Main Street in Mackay, Idaho. The Lundberg residence and the utility building is in the foreground. Photograph by Robert Bower of the Post-Register Newspaper, Idaho Falls, Idaho.

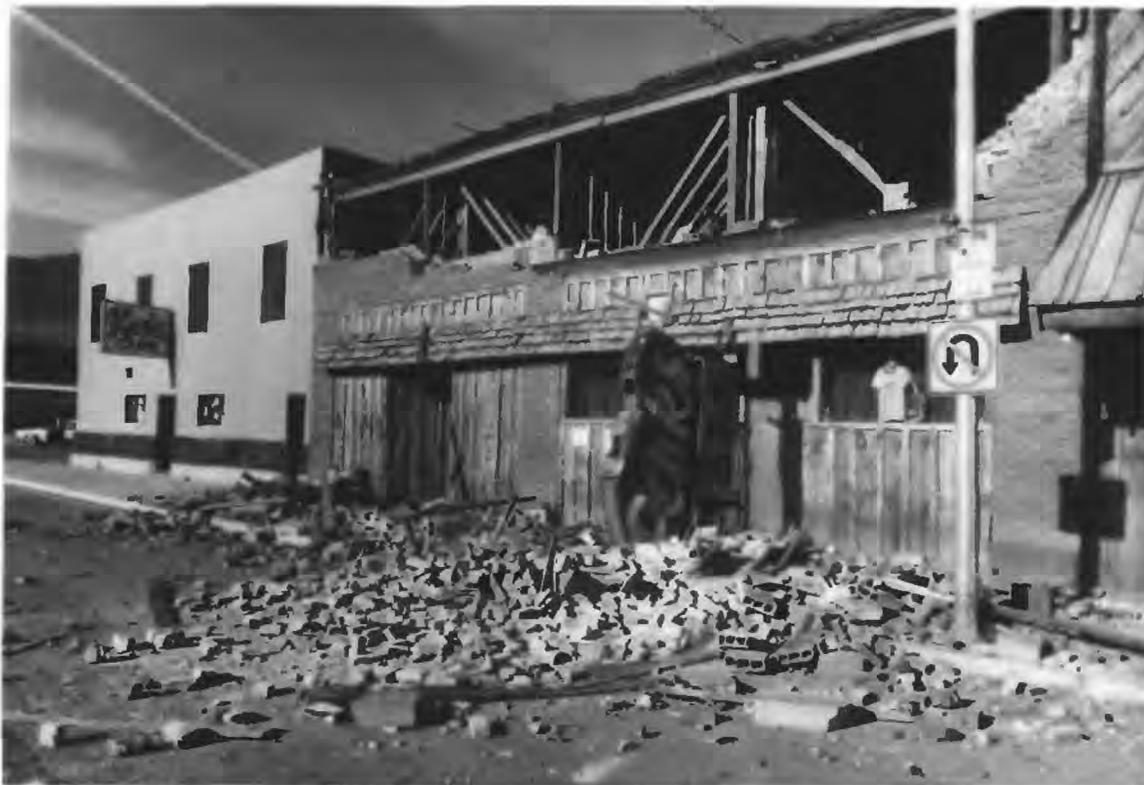
Perks Bar (north side of West Main): This two-story brick building was reported to be seriously damaged. The exterior brick front wall partially collapsed into the street (fig. 35).

Figure 35.--Partial collapse of the south wall of Perks Bar which is located on the north side of Main Street. Mackay, Idaho. The exterior building walls of Ken's Club showed no evidence of damage. Photograph by Robert Bower of the Post-Register Newspaper, Idaho Falls, Idaho.

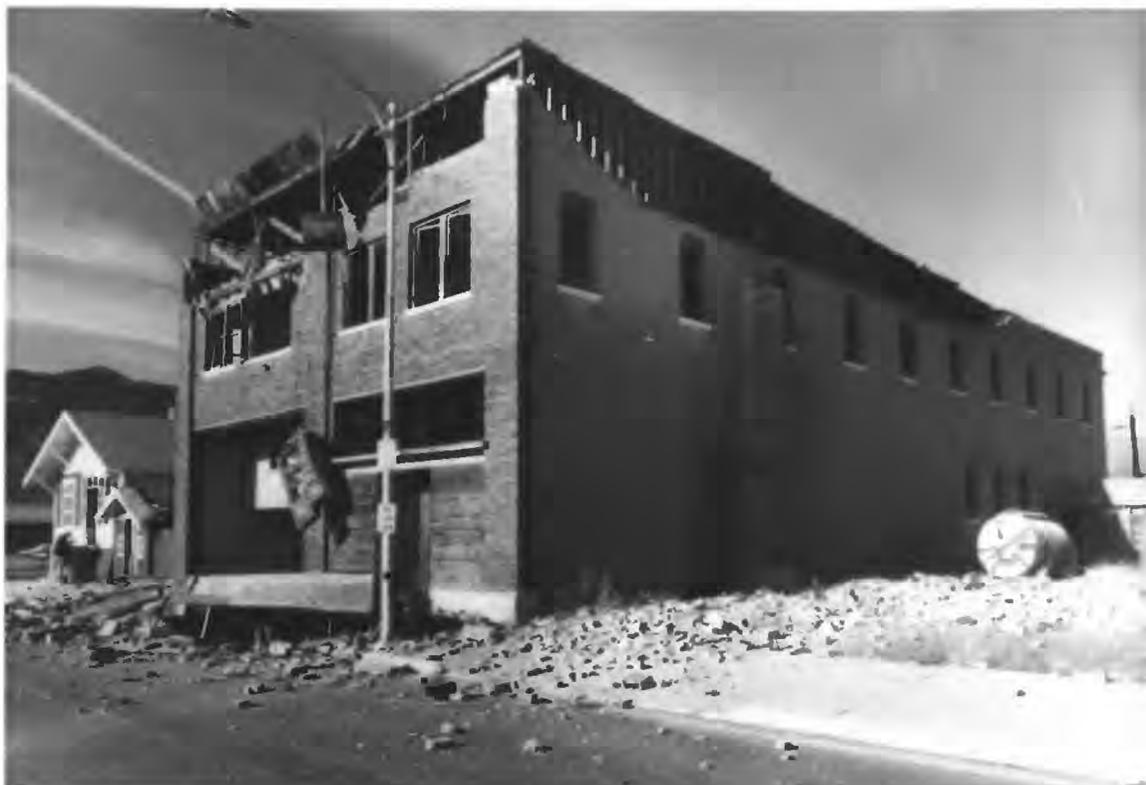
Custer Hotel (north side of West Main): This three-story, brick building with a movie house at street level was built in 1915. The building was severely damaged by the partial collapse of the front and side walls (fig. 37). The chimney, on the east side of the Hotel, partially collapsed due to the collapse of the building wall. At the rear and on top of the Hotel, a 8- to 10-foot brick chimney remained standing (fig. 38). From our ground angle, the chimney appeared to be undamaged. The hotel was reported to have been vacant for the past 20 years.

Figure 37.--The Custer Hotel which is located on the north side of Main Street in Mackay, Idaho. The Lundberg residence is shown at the left of the Hotel. Photograph by Robert Bower of the Post-Register Newspaper, Idaho Falls, Idaho.

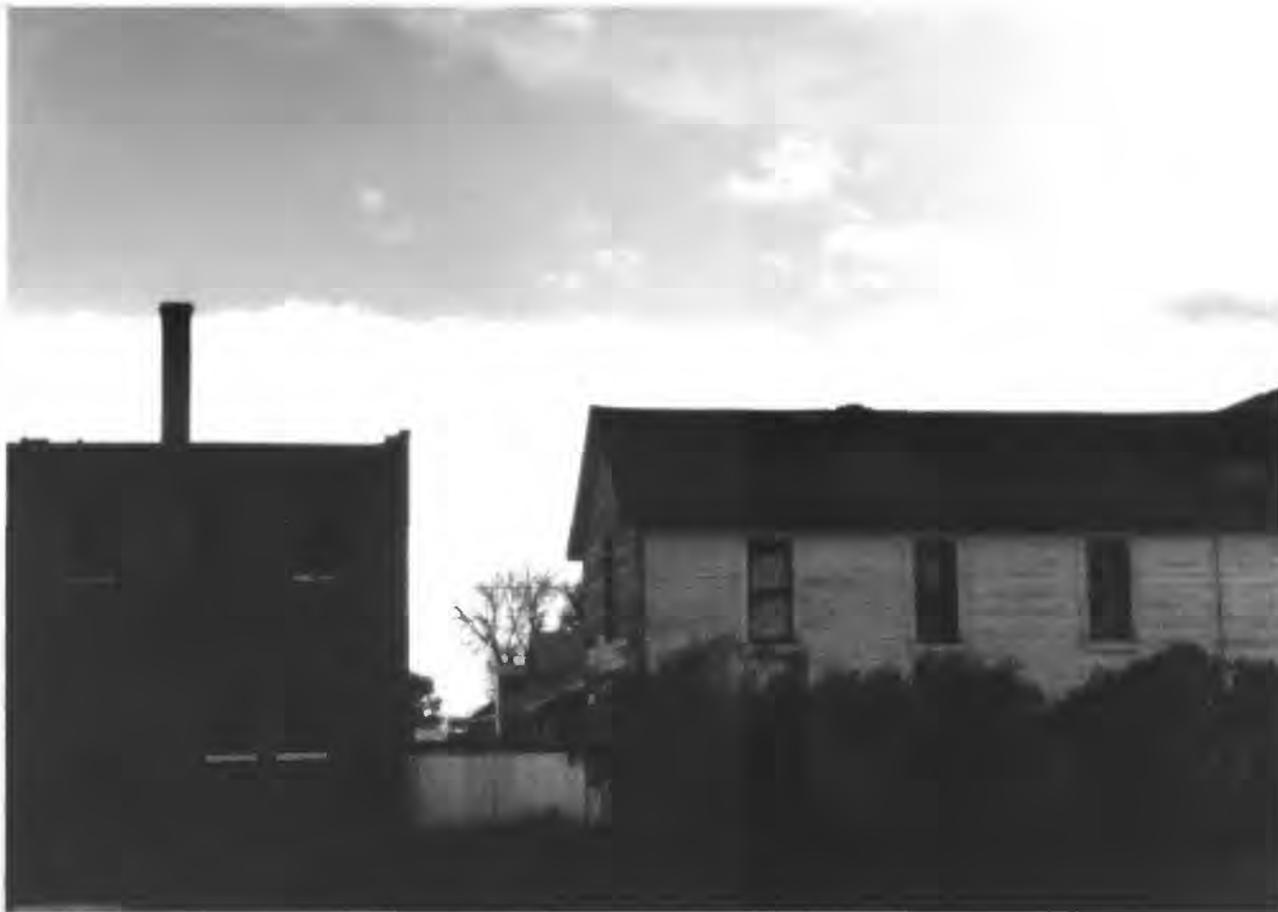
The stubs of two brick chimneys were visible at the roof line (shown in fig. 38) at a two-story, wood-frame house located behind the Lundberg residence.

Figure 38.--The rear of the Custer Hotel. The brick chimney atop the Hotel did not appear to be damaged. The two-story, wood-frame house, located behind the Lundberg residence and to the right of the Hotel, lost two brick chimneys.
