GEOLOGICAL SURVEY

Intensity survey of the Borah Peak,  
Idaho, earthquake of October 28, 1983

Open-File Report 84-166

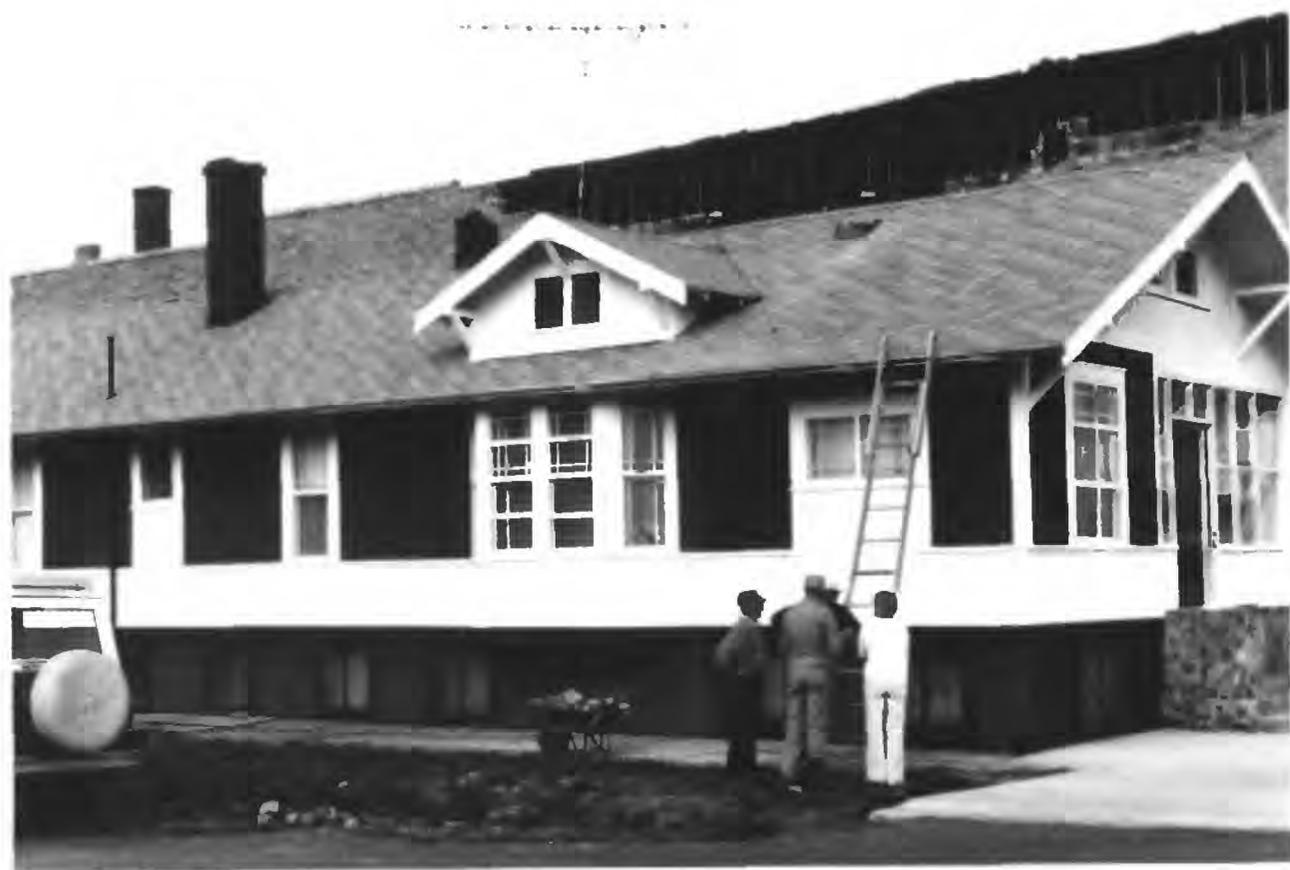
Figure 39.--The Lundberg residence which is located on the north side of Main Street in Mackay, Idaho. The home was not damaged. The front brick chimney, which has been removed, was reported to be twisted 15 degrees counter-clockwise. The other two brick chimneys showed little damage. The partially collapsed west wall of the Custer Hotel is shown above the Lundberg's roof line. The chimney at the rear of the Custer Hotel is the same chimney shown in Figure 38.

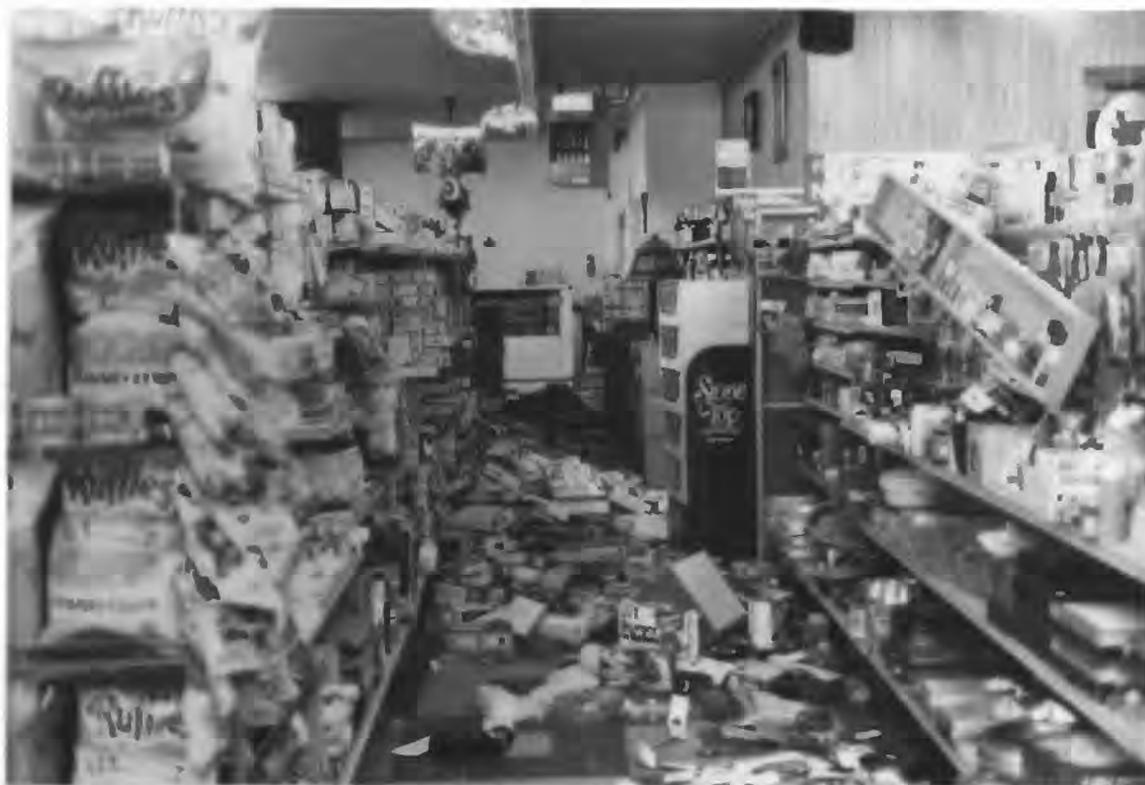
Ivie's IGA Grocery (south side of West Main): The grocery store was in a single story, concrete block structure with a brick front. The metal awning, which was attached to the store front, was shaken down. The store front was extensively cracked; and bricks fell from the store front. Inside the store, very little damage was visible to the interior plaster-board walls. Pictures of the store, following the earthquake, showed that the aisles were filled with merchandise shaken down from the shelves. The store was opened for business, but customers entered at the rear of the store (fig. 40 and fig. 41).

Figure 41.--Inside Ivie's Grocery Store in Mackay, Idaho. A view of the merchandise in the aisle as a result of the earthquake. Photograph by Robert Bower of the Post-Register Newspaper, Idaho Falls, Idaho.

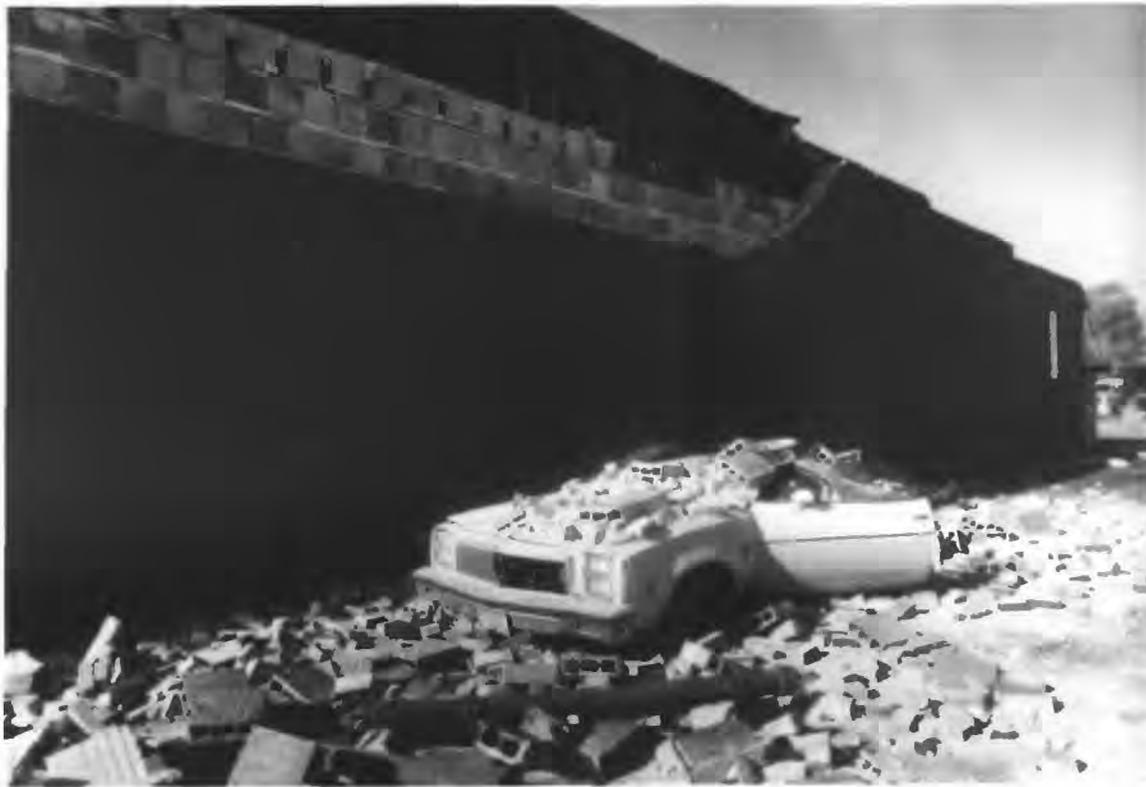
Mackay Drug (north side of West Main): The building was a two-story, brick structure. The building walls partially collapsed. Inside the store, it was reported that the walls were separated at the corners. At the rear of the store, a concrete block chimney was split from top to bottom. On the east side of this building, the collapsed brick wall demolished a car (fig. 42). Note the hollow bricks that were used in the construction of the collapsed wall.

Figure 42.—Partial collapse of the east wall of Mackay Drug which is located on the north side of Main Street. The car was demolished by the falling bricks. Photograph by Robert Bower of the Post-Register Newspaper, Idaho Falls, Idaho.

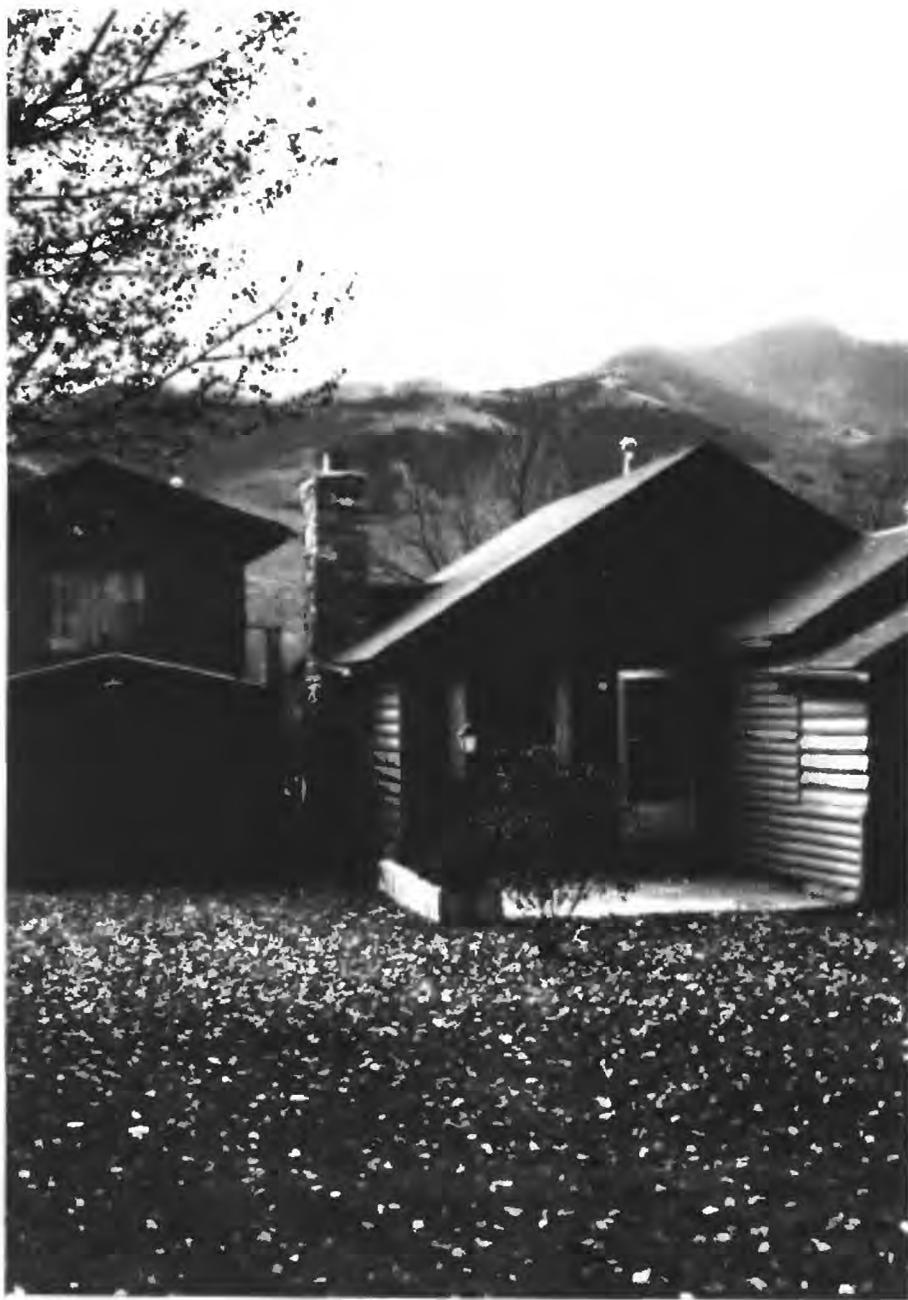
Figure 47.--The Friedl residence at the western end of Main Street in Mackay, Idaho. The home or the chimney was not damaged.

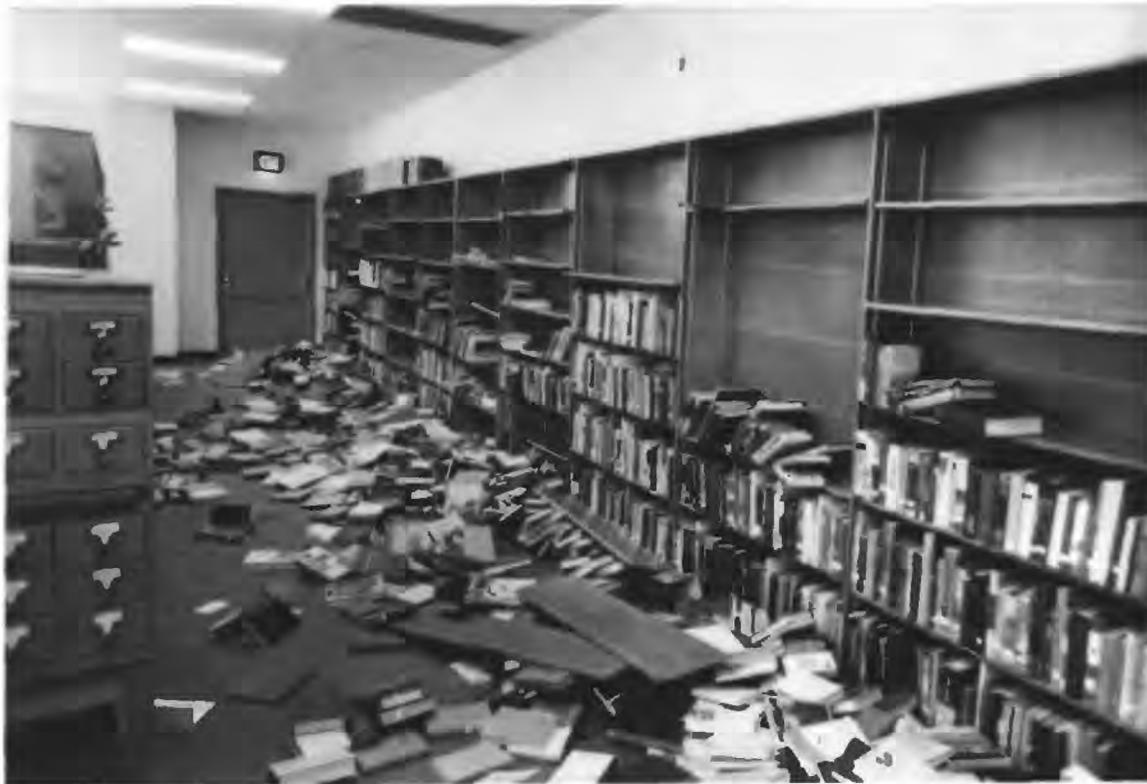
Figure 49.--A view of the fallen shelves and books from the west wall of the Mackay High School library. Photograph by Robert Bower of the Post-Register Newspaper, Idaho Falls, Idaho.
