UNITED STATES DEPARTMENT OF THE INTERIOR
GEOLOGICAL SURVEY

THE MORGAN HILL, CALIFORNIA
EARTHQUAKE OF APRIL 24, 1984
(A PRELIMINARY REPORT)

Open-File Report 84-498 A

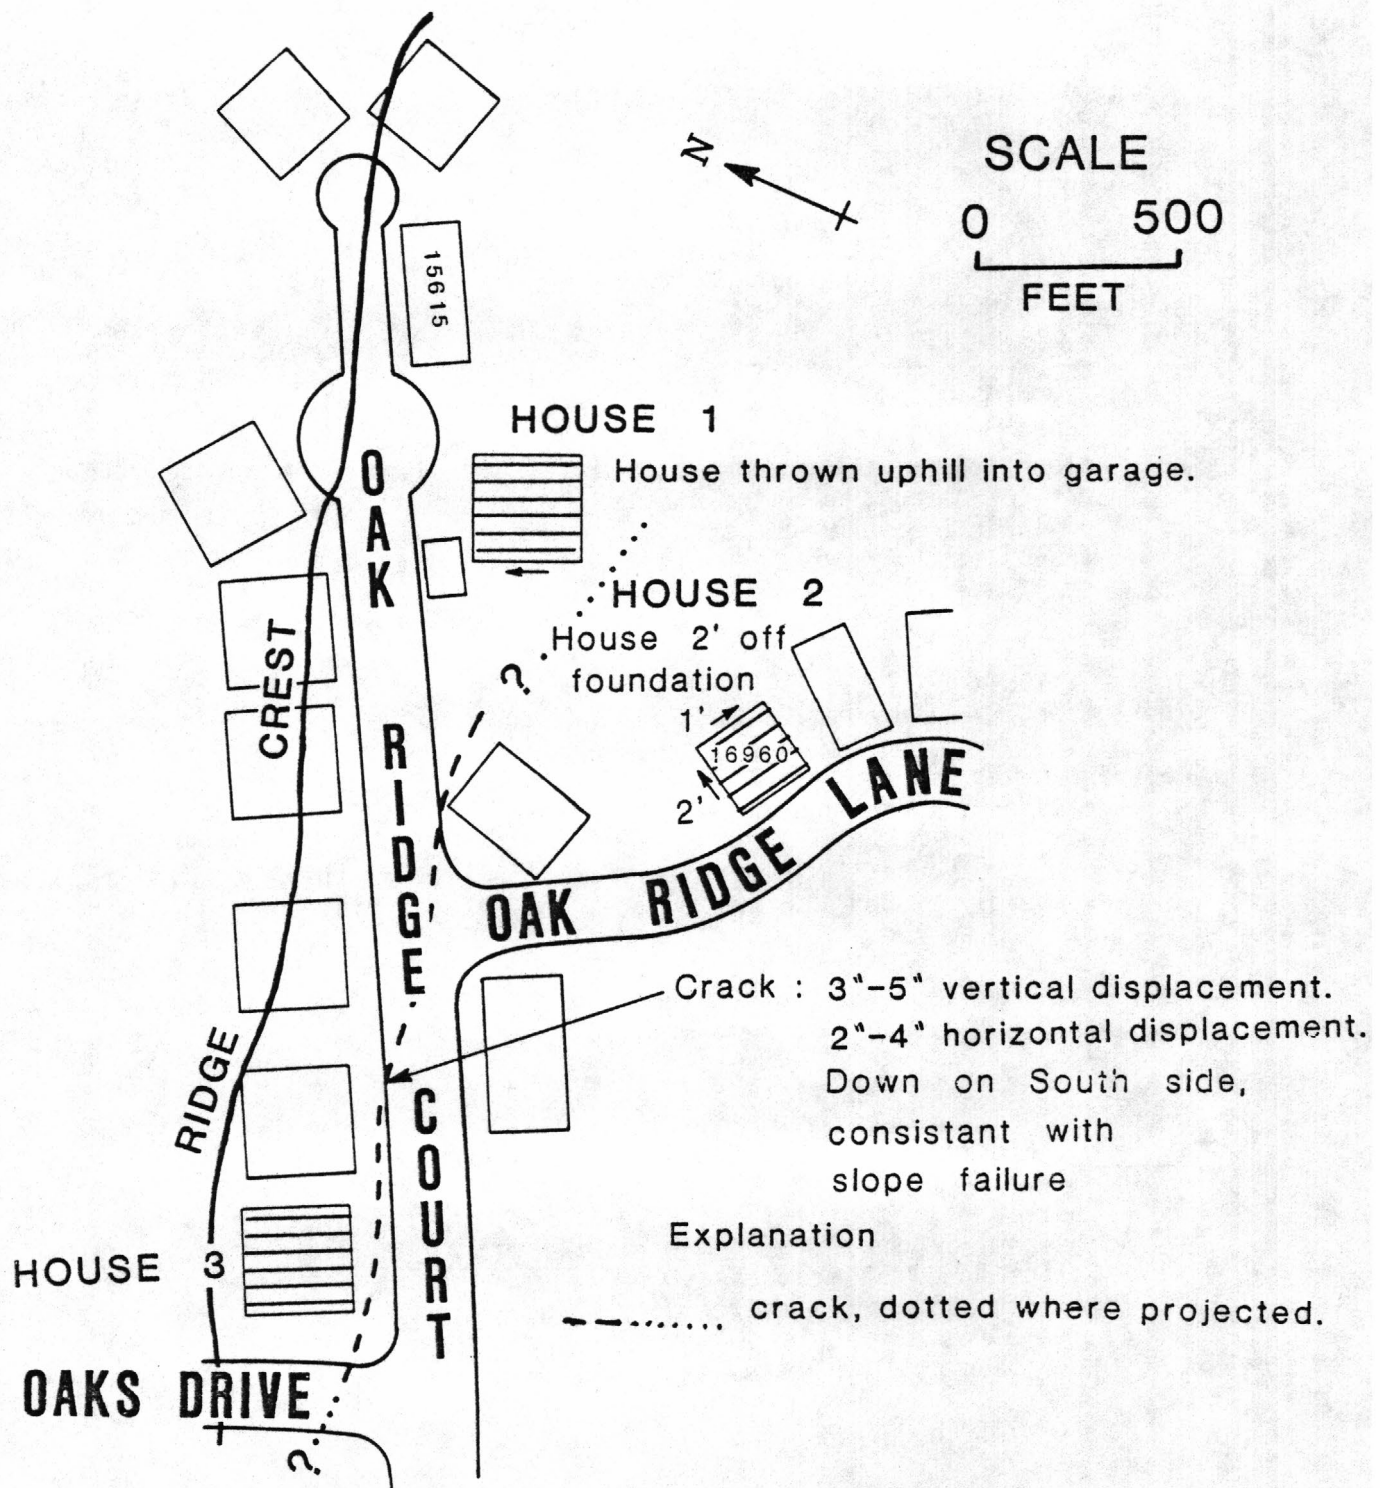
Figure 2. Sketch-map showing crack through part of the Jackson Oaks subdivision and some damage to houses.

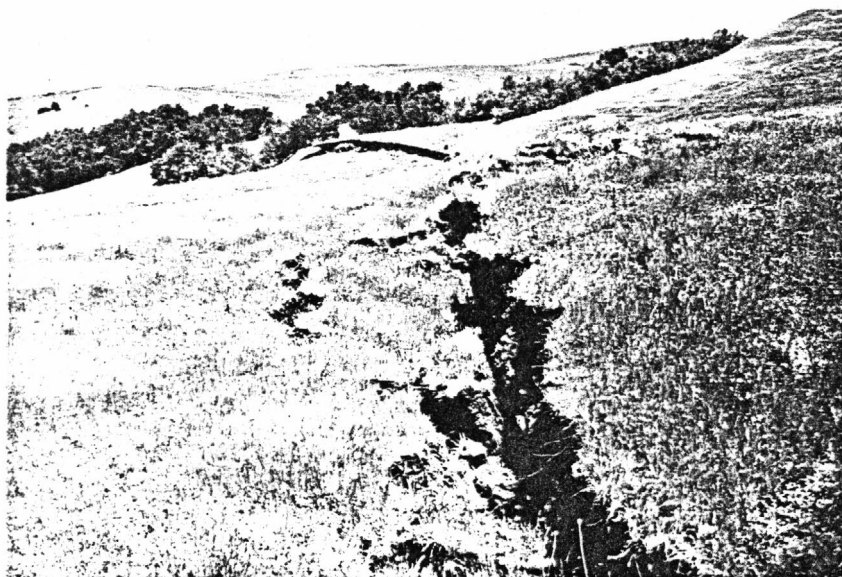
Figure 2. Landslide at La Honda, California probably triggered by the April 24, 1984, Morgan Hill earthquake. a) Scarp along northeastern portion of landslide. View north. b) Graben at head of landslide, measurements across graben show 1.2 m (4 ft) of displacement toward the southwest.

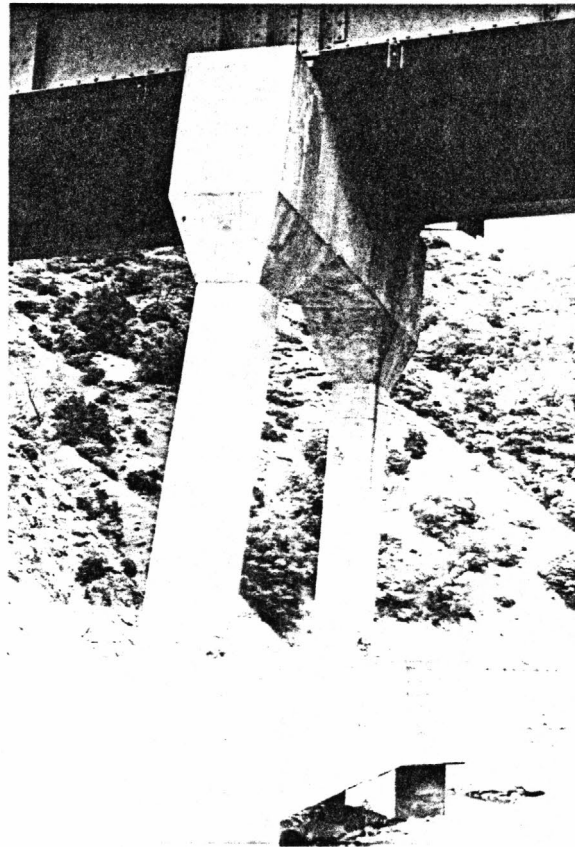
Figure 4. Tilted and fractured bent¹ of Cochrane bridge. The tilting and fracturing of the bent were possibly caused by deep-seated movement of a landslide that pushed or carried the pier supporting the bent toward Anderson Reservoir.

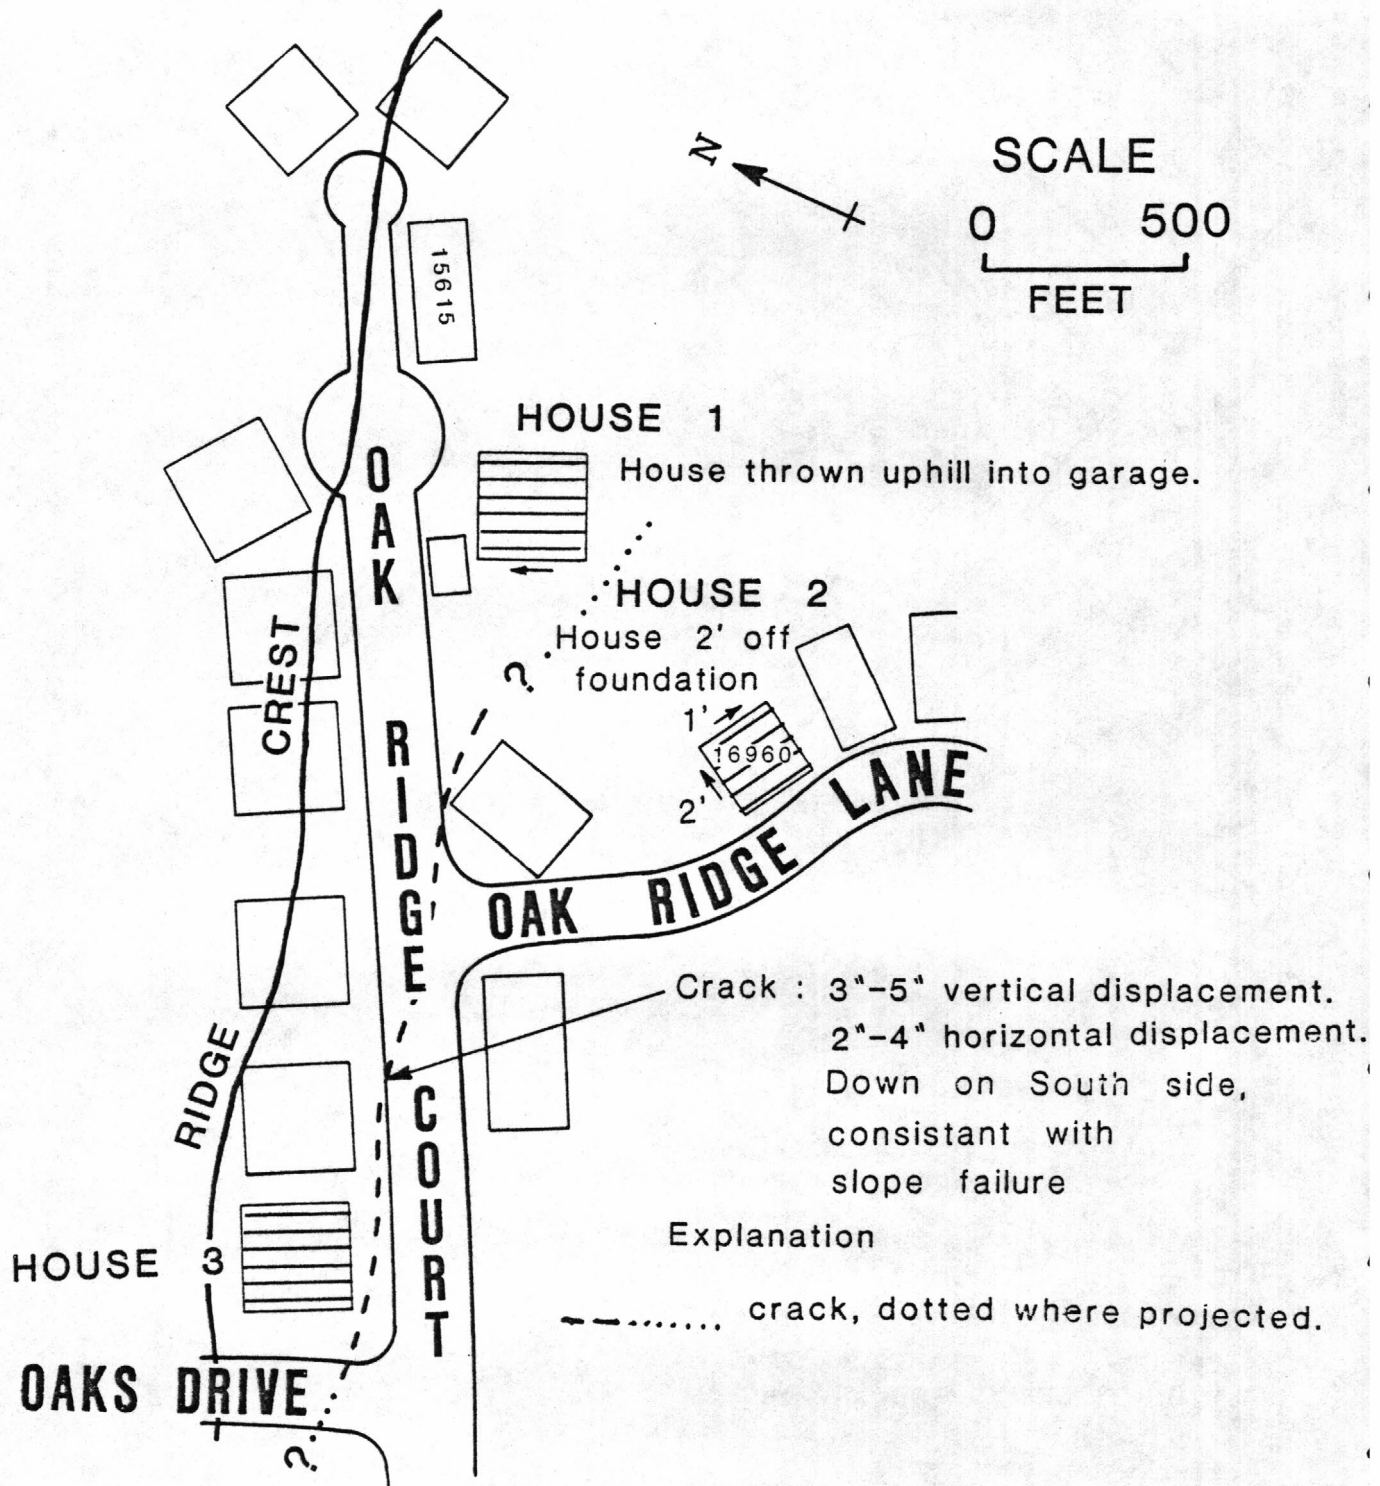
JACKSON OAKS TRACT

- (69). Jackson Oaks Tract--Five houses evacuated and condemned; a prominent crack beginning at the ridge crest was noted (Figure 14). It is associated with land failure, but its geometry was not discernable in the short time I was there. No one knew if the crack was co- or post-seismic but the damage to the homes implied high rates of lateral ground acceleration to the south. Construction in this tract is generally average to poor; no provision for adequate shear protection was evident. Downhill home thrown up and north into its detached garage therefore, the soil was thrust to the south very quickly. This particular house (house #1 on Figure 3)) had inadequate shear protection with few (4?) nails per panel. Panels popped off, leaving 2-3 m (6-10 foot) studs below main-level joists unsupported. House on

Figure 3. Rough sketch map of a portion of the Jackson Oaks housing tract (location (69)). The occasional five digit numbers are house addresses where they were noted. Houses #1, #2, and #3 are referred to in the text.

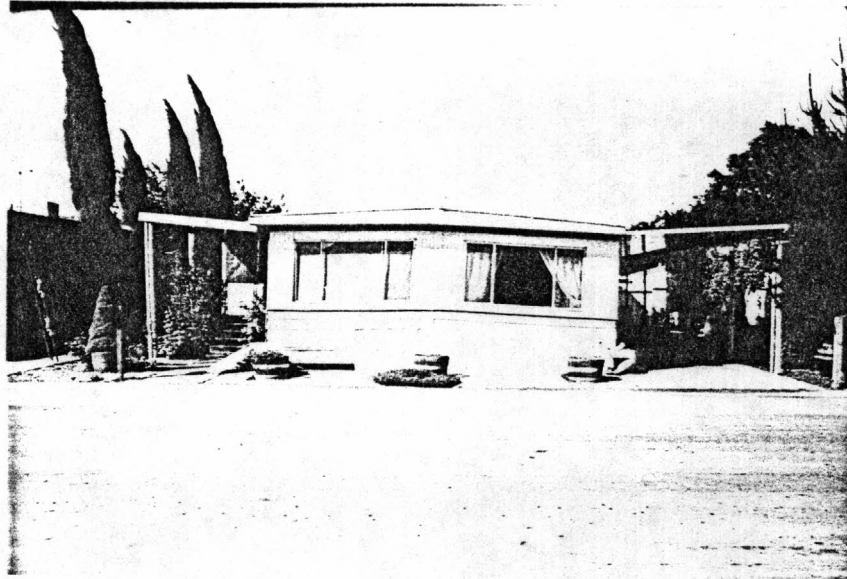
1. Madrone Mobile Estates, 200 Burnett Avenue. Only those homes west of the west side of Greenwood Circle were affected by the earthquake. This may reflect a Qal problem, or perhaps is evidence for artificial fill. Three degrees of damage were noted: 1) Skirt panels popped off but there was no permanent tilting. (Tr. #26 and others.), 2) partial collapse, skirt panels popped and/or rotated. Footings tilted but house did not fall (Figure 5), and 3) total collapse of footings, some jack posts penetrated the floors of some of these homes (figure 6). None of the footings in any of the three cases was attached at the top or bottom. One trailer was destroyed by fire due possibly to disruption of gas or electrical service during the shaking. All of the homes west of Greenwood sustained considerable damage to contents. Those east may also have sustained internal damage, but because of the lack of external damage, no activity was noted and no further investigation was made. The only structure with a conventional foundation is the community center with pool, laundry, game rooms, etc. No damage was noted. No one was available to inquire about a seich in the pool. Of 172 total trailers, approximately 60 are located west of Greenwood, and of those 60 approximately 20, experienced partial or complete collapse. One redwood-potted Juniper toppled. Met Office of Emergency Services inspector assessing damage from here to Gilroy. All trailers tipped or collapsed to the north.

Figure 5. Partially collapsed mobile home at location 1 in Madrone Mobile Home Estates. North is to the right.

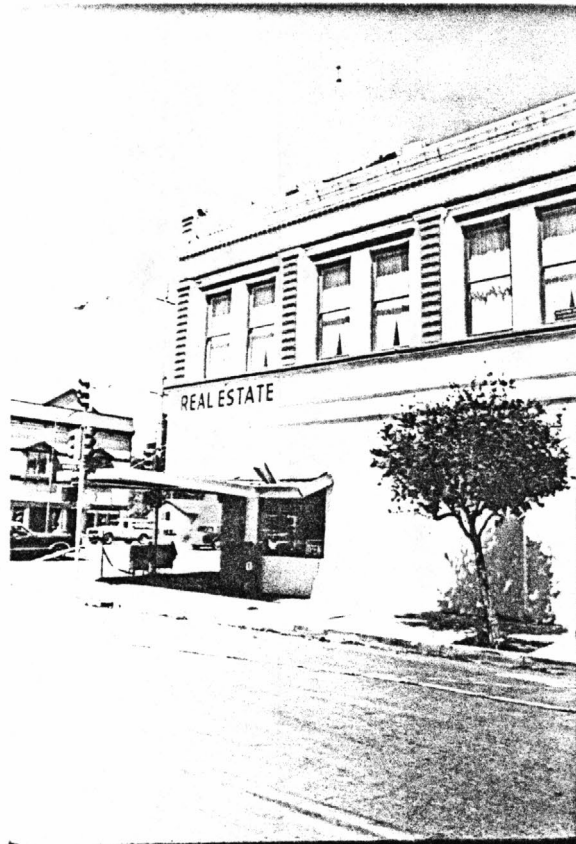
12. 1905 building (Figure 7). South Coast Realty Building, 2nd and Monterey Streets. Building has a skirt or cornice around roof perimeter (Figure 8). The cornice on south side toppled north. The bottoms of the cornice blocks are hollow or partially filled with mortar or concrete. The cornice and perhaps the rest of this building appear unreinforced. (KCBS indicated that gas service was disrupted during the quake). Cinder block or something else fell to the south and hit the awning above front door to South Coast Realty (southwest corner of building). Channel 7 news, 30 April, indicated building is to be torn down. Corner Drugstore at southwest corner 2nd and Monterey Streets. Plate glass window shattered and opening boarded up. Corner Drugstore the only glass damage noted, or that had not yet been repaired in Morgan Hill's downtown.

Figure 7. The 1905 building at location 12. Photo taken from Monterey Road at the corner of 2nd and Monterey.

Figure 8. Closer view of the 1905 building at location 12. Photo taken from Monterey Road at the corner of 2nd and Monterey. Note arrow pointing to the tumbled portion of the roof cornice; cornice fell to the north. Also note partially collapsed awning at the side left corner of the building that was struck by a heavy object, perhaps a block from the cornice.

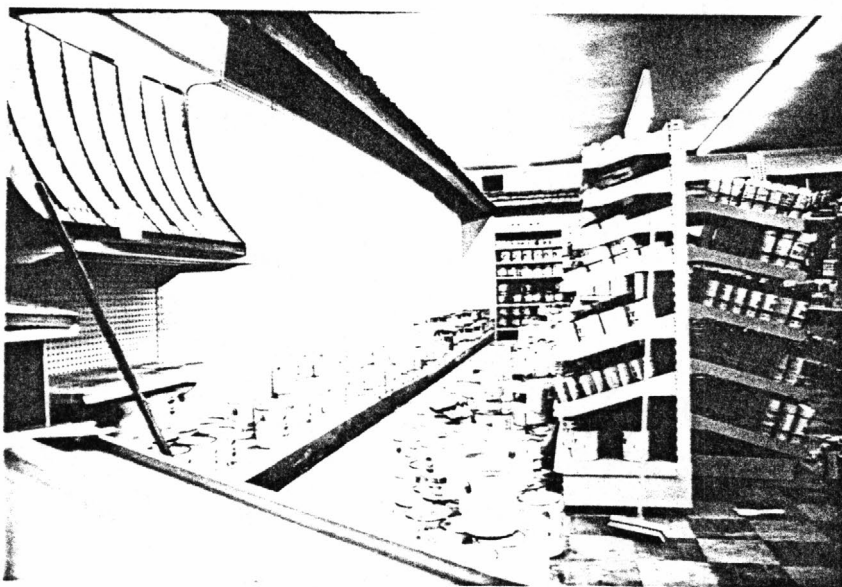
15. Pearson's Hardware and Supply--2nd and Depot. Items outside: roll roofing, fertilizer all toppled to north. Items inside, on north-facing shelves, toppled into the aisles; paint ankle-deep on floors (Figure 9). On south-facing shelves, items stayed in place. Farmers Insurance man saw Dunne Bridge damage; Jackson Oaks damage.

Figure 9. Pearson's Hardware at the corner of 2nd and Depot at location 15. Photograph inside of store shows that paint cans on north-facing shelves were throw into aisles, cans on south-facing shelves remained on the shelves. Paint in this area of the store was ankle deep.

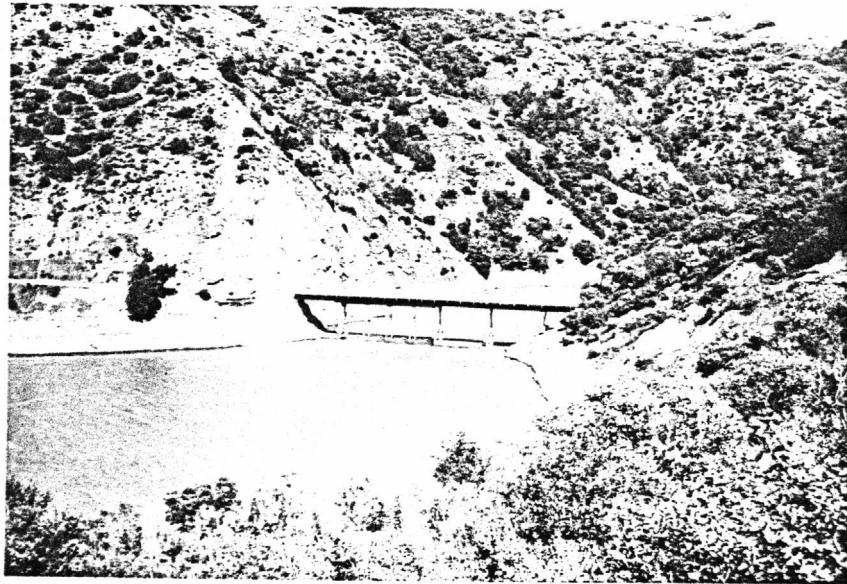
Figure 20. Cochrane Bridge over Anderson Reservoir. Bridge has been shortened by the telescoping of the timbers which support the pavement roadbed. Note the rockfall which covers East Dunne Avenue east of the Cochrane Bridge (near location (69)).

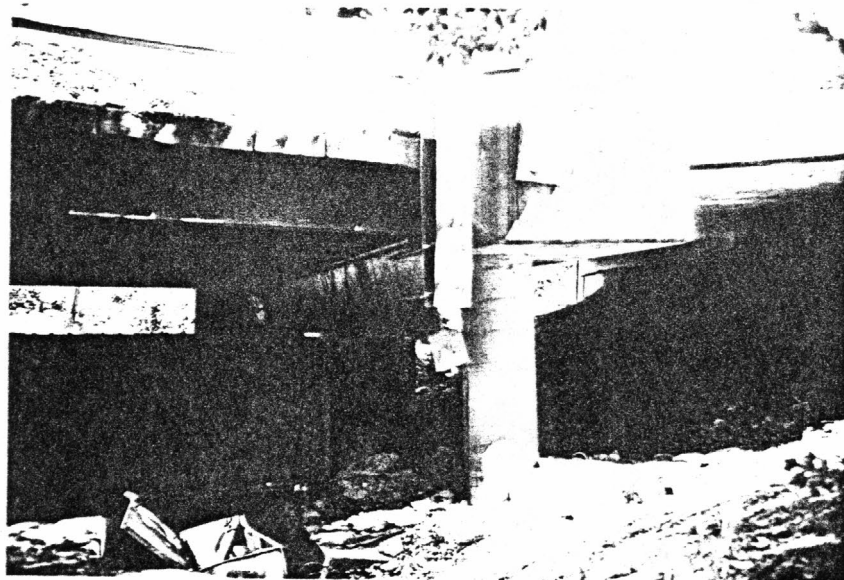
Figure 21. Rotated I-beam beneath Cochrane bridge (near location (69)) and bridge support timbers. Rivets have been torn out at a number of locations.
