# HYDROLOGY, GEOMORPHOLOGY, AND DAM-BREAK MODELING OF THE JULY 15, 1982, LAWN LAKE DAM AND CASCADE LAKE DAM FAILURES, LARIMER COUNTY, COLORADO

U.S. GEOLOGICAL SURVEY

Open-File Report 84-612

By Robert D. Jarrett and John E. Costa

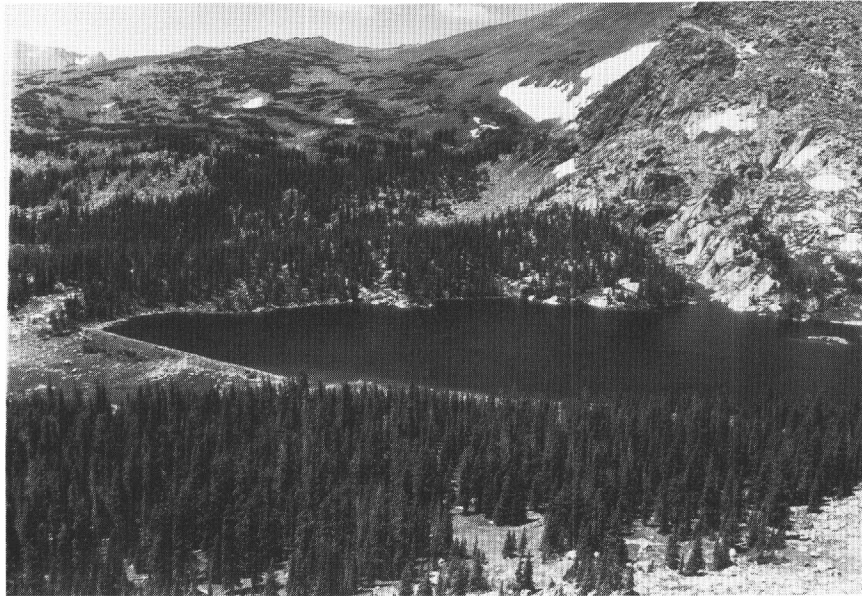
Figure 3.--Lawn Lake dam and Reservoir, prior to failure (July 11, 1958) (aerial). Photo courtesy of the National Park Service.

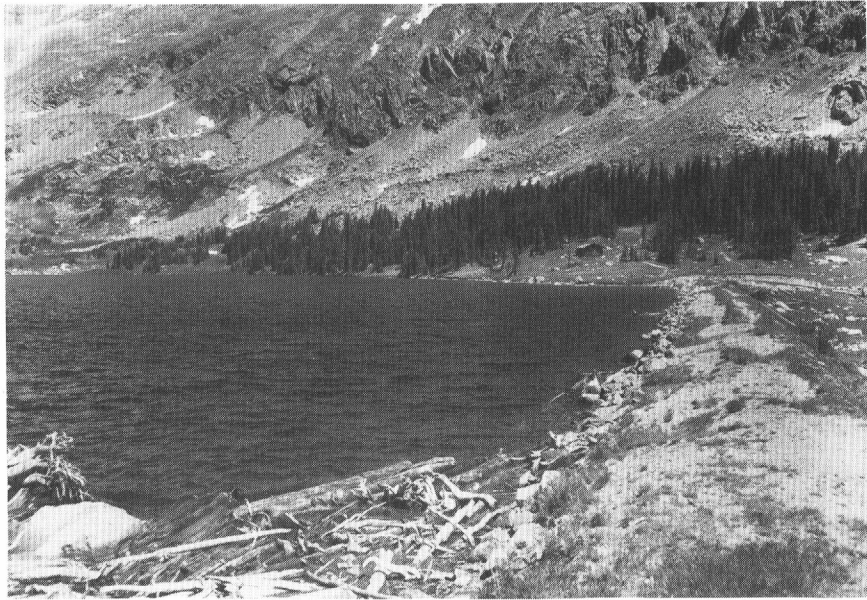
Figure 4A.--The top of Lawn Lake dam, prior to failure, looking north (July 11, 1958). Photo courtesy of the National Park Service.

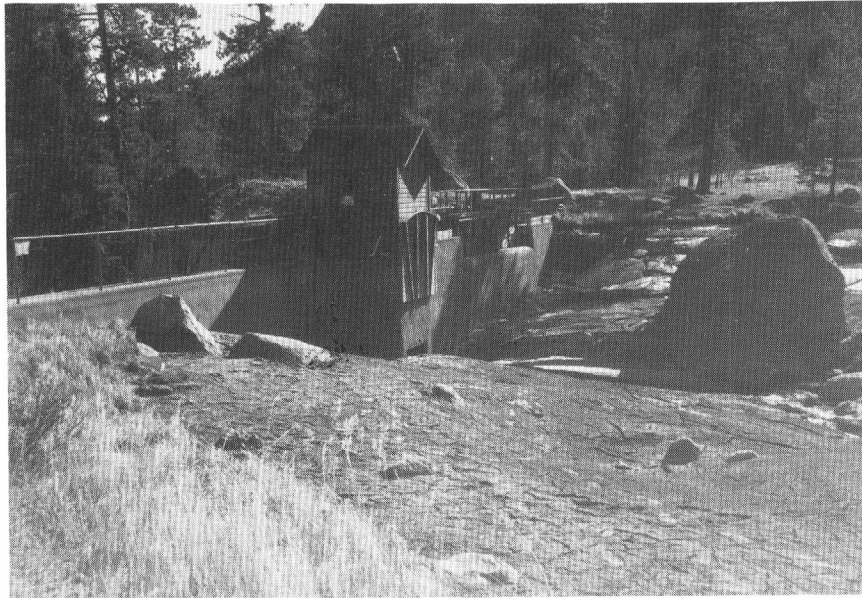
Figure 8.--Empty Cascade Lake prior to failure. View is toward upstream face of dam (date unknown). Photo courtesy of the National Park Service.

As early as 0700 MDT on July 15, 1982, a greater than normal inflow into Cascade Lake was observed. By 0715 MDT, water was flowing over the top of the dam. The dam was overtopped for nearly 30 min, to a maximum depth of 4.2 ft of water, before tipping over and failing at 0742 MDT. Hydrostatic pressure of the water on the dam and erosion of the abutments were the probable causes of the dam failure. The topple failure was recorded photographically by residents of nearby summer cottages (figs. 9A-D). For comparison, figure 9E taken after the flood shows a view similar to that in figure 9D. At the time of failure, inflow into the Cascade Lake dam (Site 1) was approximately 7,210  $\text{ft}^3/\text{s}$  (determined from a slope-area discharge measurement upstream from the lake), and the reservoir capacity due to the additional depth of water (4.2 ft) above the top of the dam was about 25.1 acre-ft. The toppled dam released a peak flow of 16,000  $\text{ft}^3/\text{s}$  (see "dam-Break Modeling") down the Fall River into Aspenglen Campground, about 1/3 mi downstream. Within 5 min after the dam failure, the flood surge had passed the campground.

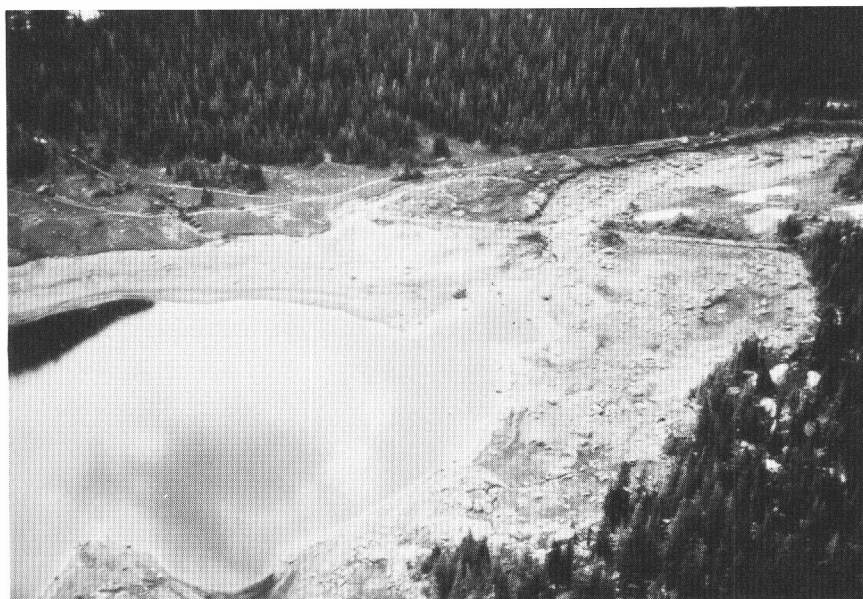
Figure 12.--Lawn Lake about 1 week after the dam failure, showing the amount of water still remaining in the natural depression forming the original lake (aerial).

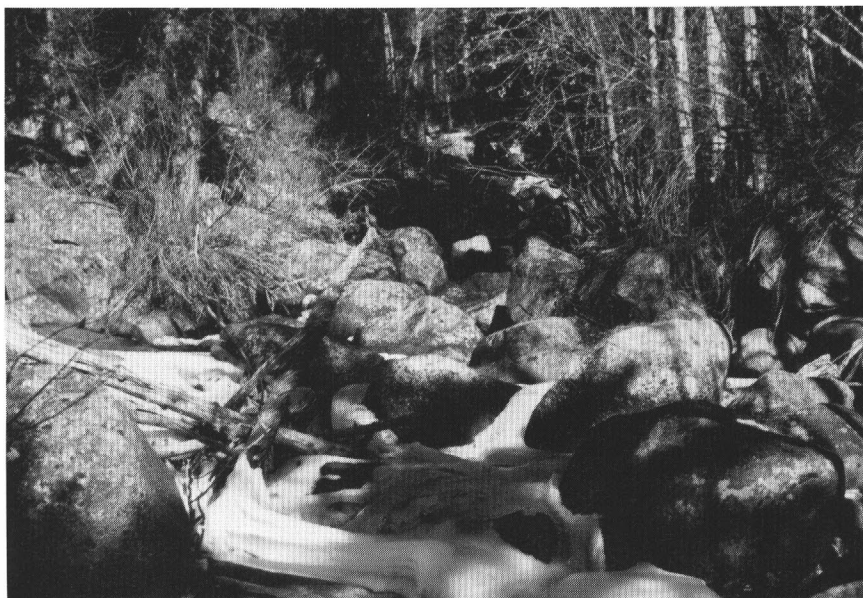
Figure 16A.--The Roaring River, looking upstream from the Endovalley Road in 1978.

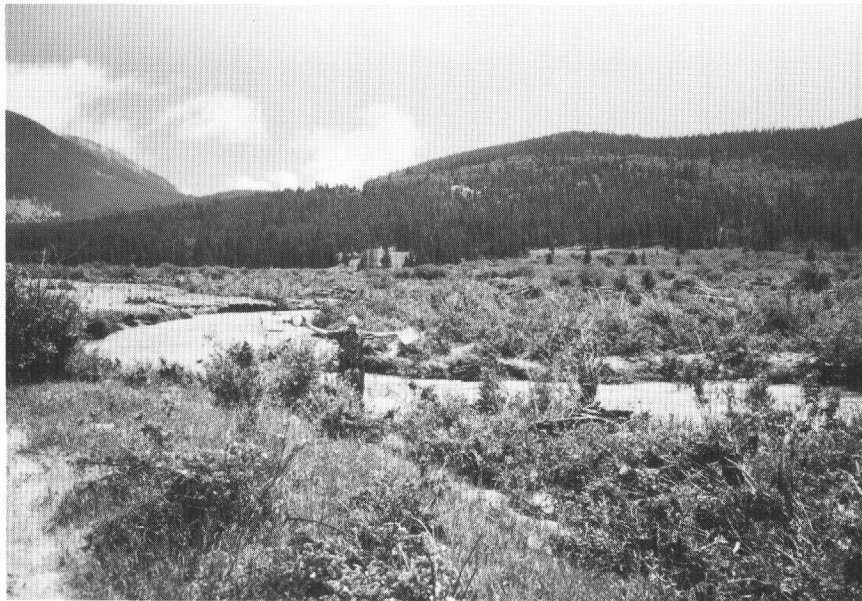
rapidly in Horseshoe Park to 0.7 percent (fig. 2); this decrease in slope dramatically altered the flood-wave characteristics. The combination of the small slope on the prehistoric glacial lakebed, flood-plain widths in excess of 1,000 ft (table 4), and very dense brush (fig. 18) attenuated the flood wave through Horseshoe Park (fig. 11), so that the leading edge was slowed to 2.1 mi/h and was no longer a wall of water (fig. 15). Peak discharge was greatly reduced through Horseshoe Park (fig. 11). The water was very tranquil, as noted by the smooth water surface of the flood near its peak in Horseshoe Park (fig. 19). The flow was subcritical in this segment. Peak discharge decreased from an estimated 18,000 ft<sup>3</sup>/s (see "Dam-Break Modeling") at Lawn Lake dam, to 7,210 ft<sup>3</sup>/s (Site 1) at the downstream end of Horseshoe Park. The majority of this attenuation probably occurred in Horseshoe Park. A large amount of organic debris from the Roaring River was deposited or trapped by the dense brush at the upstream end of Horseshoe Park, and the majority of the sediment load was deposited in a large alluvial fan at the base of Horseshoe Falls (fig. 1). Little debris or sediment was transported by the flood wave in Horseshoe Park.

Figure 18.--Surveyed cross section in Horseshoe Park showing topography of the flat glacial-lake floor. Looking downstream at man standing at cross section at river mile 5.36.

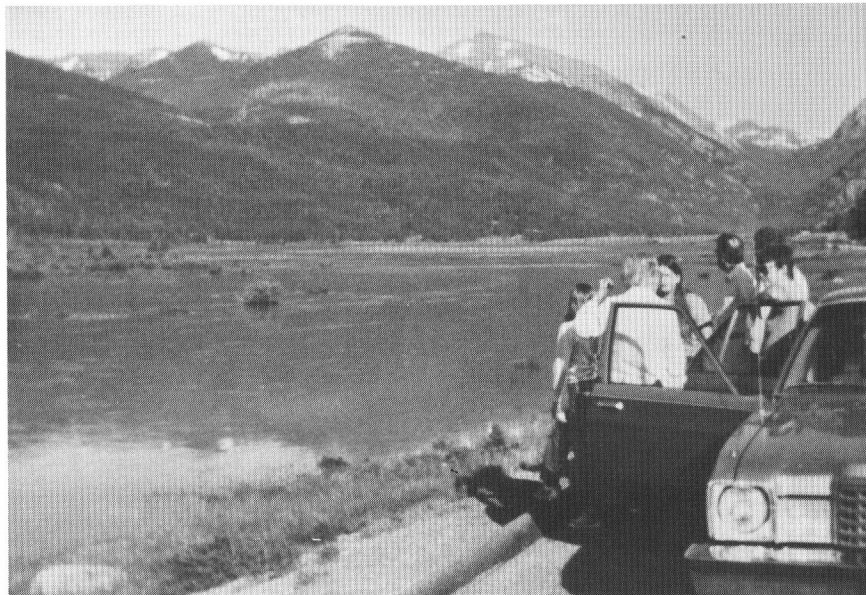
It was fortunate for the numerous people in residences and commercial establishments downstream from Horseshoe Park that the park acted as an efficient flood-retarding basin (fig. 19). By slowing the flood wave, the time available for warning and evacuation was increased. Most other Front Range valleys do not have large mountain meadows (that is, former glacial lakebeds) such as Horseshoe Park; without Horseshoe Park, the flood peak and resulting damages would have been much greater downstream.

Figure 19.--The flood peak in the downstream end of Horseshoe Park. Flow peak is approximately 7,200 cubic feet per second. Photo courtesy of Grace George Davis and Jennifer D. George.

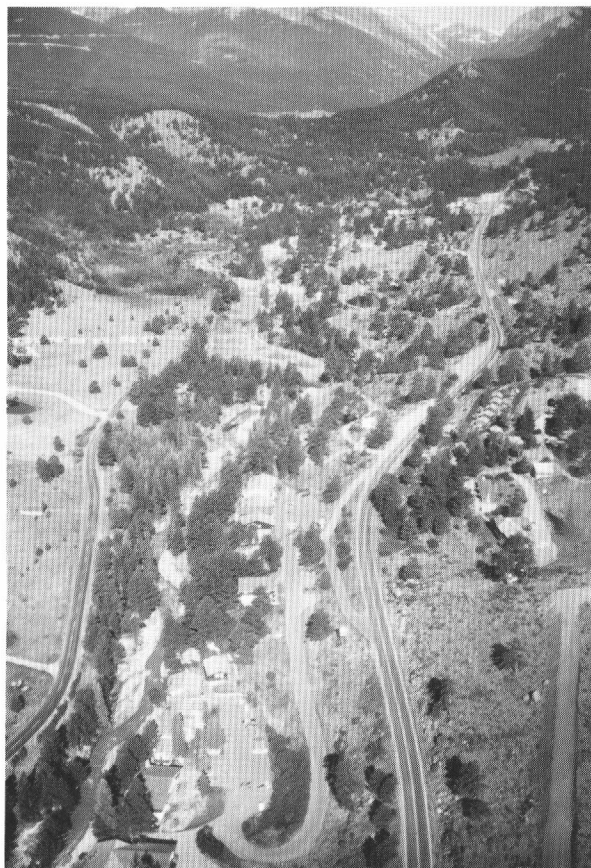
Figure 21.--The Fall River valley downstream from Aspenglen Campground (aerial). View is upvalley from about river mile 8.5.

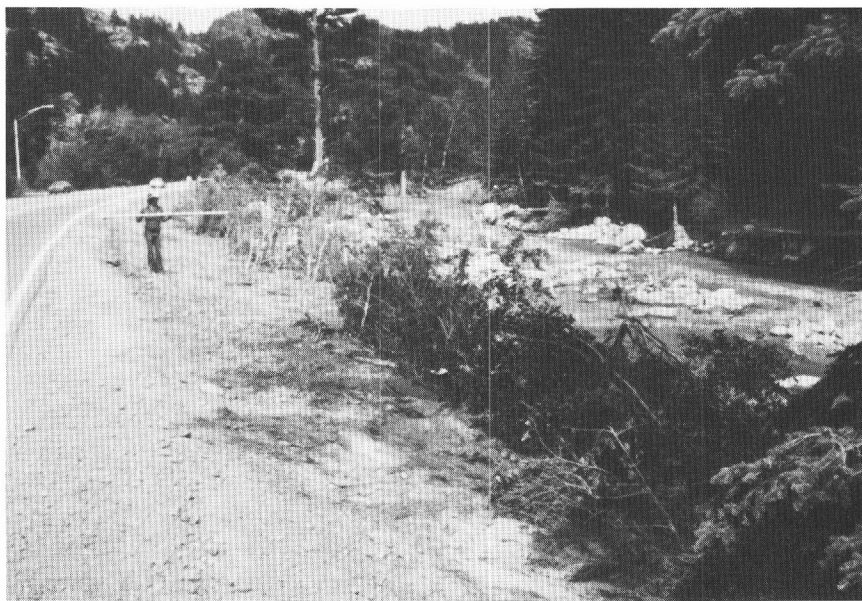
Figure 22.--View downstream at the indirect discharge measurement Site 4 on the Fall River above Estes Park.

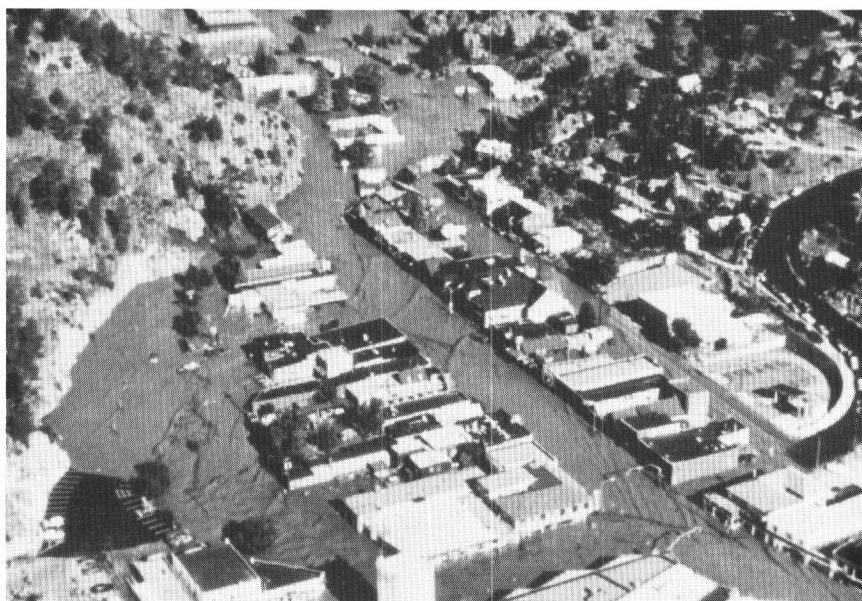
As with the Roaring River, large amounts of debris affected the flow considerably. Bridges and culverts became filled with debris (fig. 49), and energy losses increased, resulting in high-flow resistance. These debris obstructions were noted throughout this channel reach during field work after the flood. Because of these obstructions and the limited channel capacity of the Fall River, the floodwaters went down the main street of Estes Park (figs. 23 and 24).

Figure 23.--The Fall River looking upstream from the western end of Estes Park at river mile 11.9 (aerial). Photo courtesy of Zenas Blevins, U.S. Bureau of Reclamation.

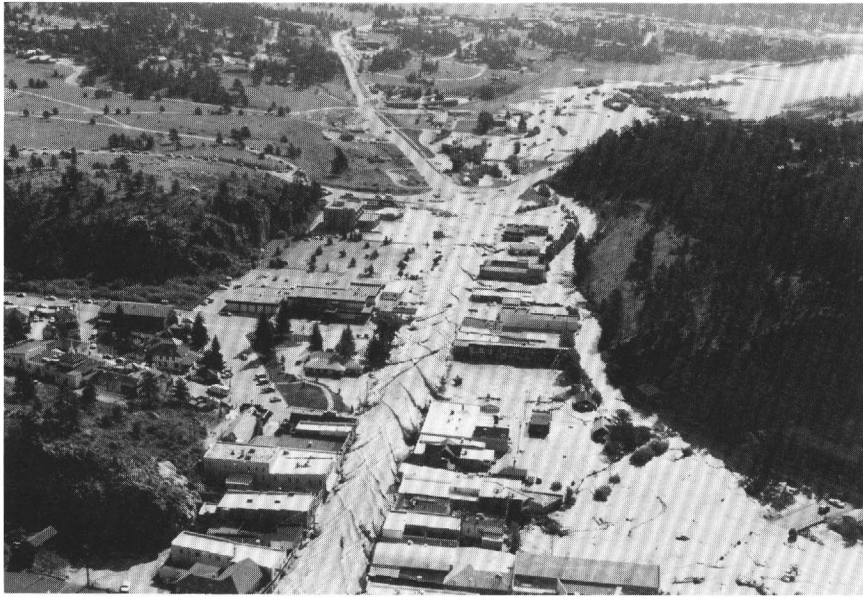
The confluence of the Fall River with the Big Thompson River is in Estes Park (fig. 1). The Big Thompson River streamflow prior to the flood was 385  $\text{ft}^3/\text{s}$ . Note that the water re-entered the main channel before flowing into Lake Estes (upper right, fig. 24). The 06733000 Big Thompson River at Estes Park streamflow-gaging station (Site 6) is shown at the arrival of the flood

Figure 24.--Elkhorn Avenue, Estes Park, looking downstream from river mile 12.0 (aerial). Big Thompson River is along the right side of the photograph; Lake Estes is in the top right-hand corner. Photo courtesy of Zenas Blevins, U.S. Bureau of Reclamation.

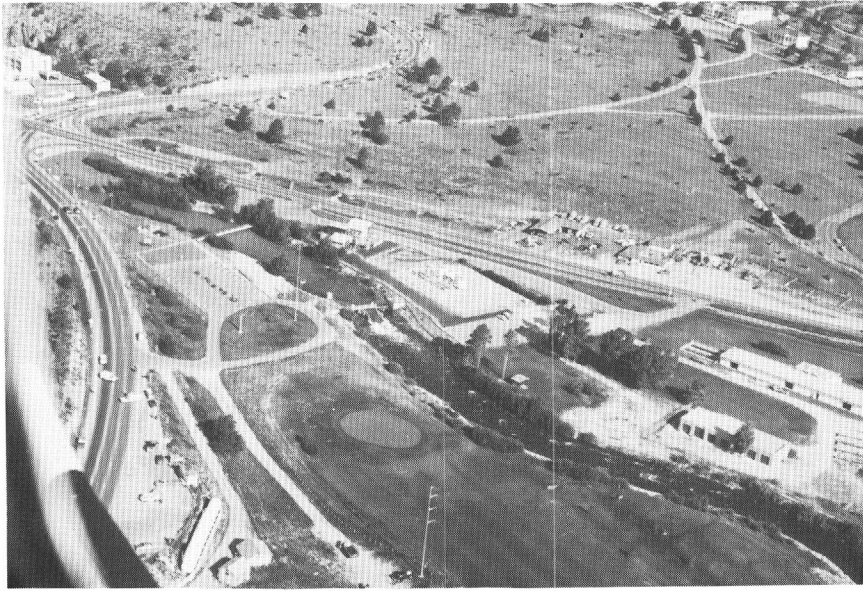
in figure 25A, and at the peak of the flood in figure 25B. Note the approaching muddy water, which supports eyewitness accounts that no wall of water occurred at this location (upper right-hand corner in figure 25A). Patrick McLaughlin, located just upstream from the streamflow-gaging station in Estes Park, described the initial arrival of the floodwaters as a muddy, "jellylike" muck preceding "a surge of water."

Figure 25A.--View upstream at the arrival of the floodwaters at the Big Thompson River at Estes Park gaging station (Site 6) (aerial). Muddy water is arriving under the bridge in the upper left-hand corner. Photo courtesy of Zenas Blevins, U.S. Bureau of Reclamation.

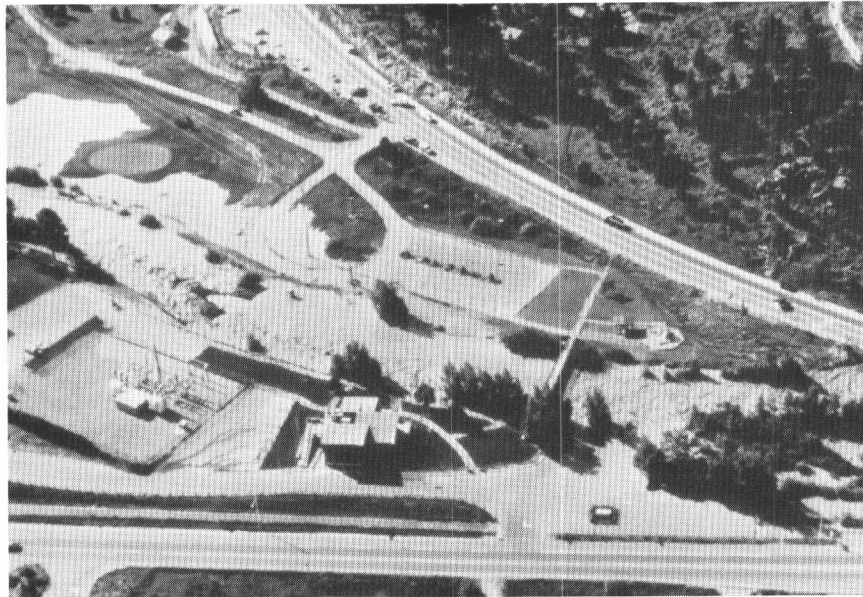
Figure 25B.--View downstream at the Big Thompson River at Estes Park gaging station (Site 6) during the peak flow (aerial). Photograph taken about one-half hour after photograph in figure 25A. Golf green at bottom of figure 25A is in upper left-hand corner of photo. Photo courtesy of Zenas Blevins, U.S. Bureau of Reclamation.

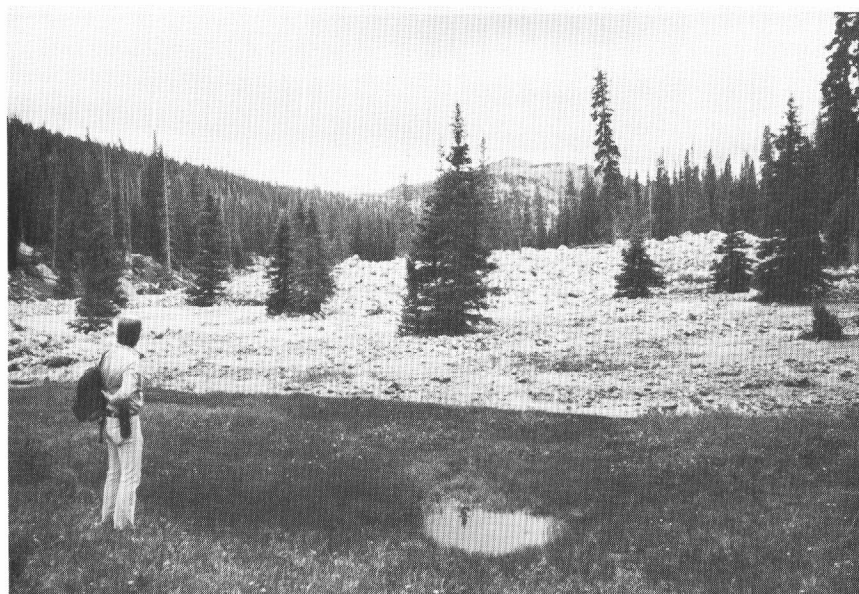
Depositional areas were characterized by more gentle gradients at the breaks in slope below steep reaches. These areas of relatively wide mountain meadows generally had slopes less than 7 to 9 percent. Sediments deposited in the meadow areas were relatively thin, generally no more than 2 to 8 ft thick. Locally, deposits were measured to 10 ft thick (fig. 29). Deposited material in each meadow came from the scoured-valley sides and bottoms of the steep reach upstream. No large boulders or rocks traveled any farther than about 1,000 ft; most probably were moved less than 100 ft. Nearly all the boulders were fresh, with a minimal number of percussion marks, indicating that they did not travel far or very long in the flood.

Figure 29.--View across a mountain meadow at river mile 0.38, showing the accumulation of a thick boulder deposit in a relatively flat reach in the Roaring River valley.

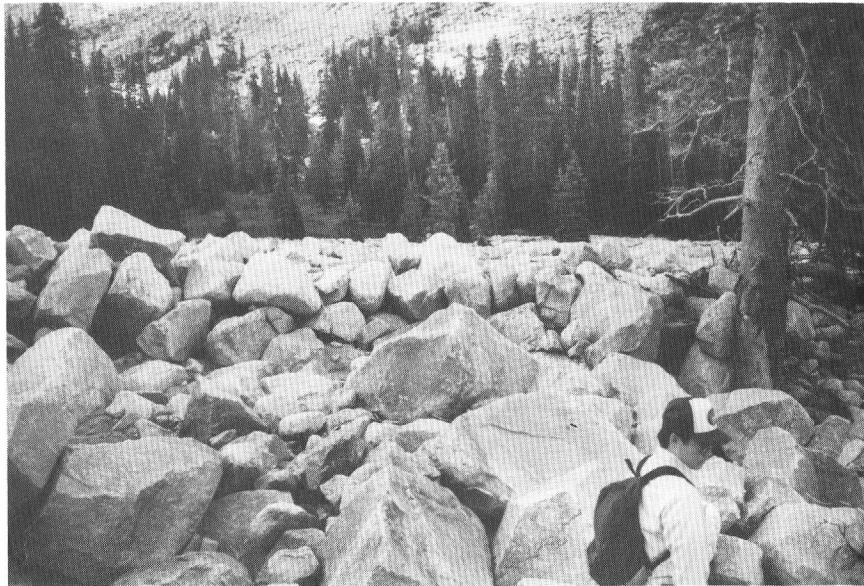
Figure 30.--Imbricated structure in boulders deposited in the meadow shown in figure 29. Flow was left to right. Note the near-vertical imbrication of many of the rocks piled behind the tree.

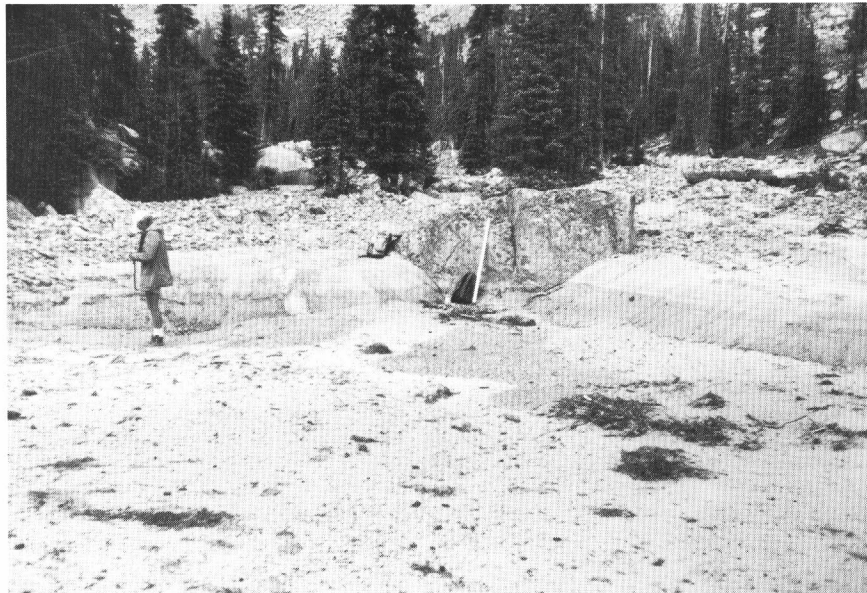
Figure 31.--Unusually thick sand waves deposited in the Roaring River valley on the inside of a sharp valley bend at river mile 0.50.

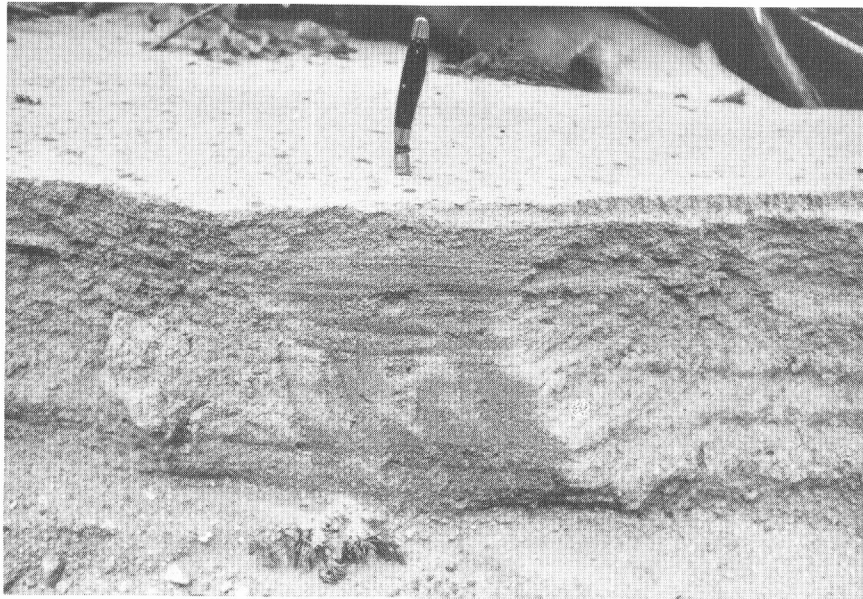
Much less conspicuous, but nevertheless ubiquitous, were sand deposits. Sands were deposited almost continuously, away from the main flood channel, within the edge of the surviving forest and vegetated areas on the valley sides below high-water marks. Some sand deposits were 4 ft thick and had steep wave fronts facing downstream (fig. 31). Sand deposits along the Roaring River are very coarse and massive, or have weak horizontal laminations (fig. 32).

Figure 32.--Horizontal laminations in sand deposits at the edge of flow in the Roaring River valley at river mile 3.41.

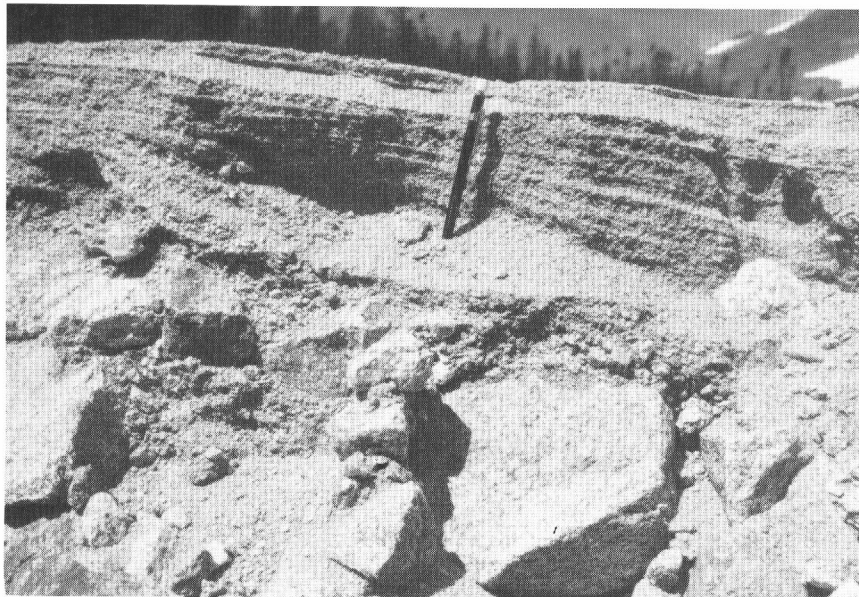
About 400 ft downstream from the Lawn Lake dam, sand splays are extensively developed on the right bank. High-water marks indicated the flood flow was 3.5 ft deep over the top of these splays. Along the edge of the splay next to the deeply eroded channel, backset beds, interpreted to be antidune structures, were preserved (fig. 33). These backset beds were diffuse, curved, and dipping against the flow direction at an angle of  $9^{\circ}$  to  $10^{\circ}$ . These beds were nearly identical with those described from flume experiments by Middleton (1965); they indicated upper-flow regime conditions (and perhaps supercritical flow) in the reach immediately below the dam. When the site was visited 1 year later in July 1983, the antidune structures were no longer preserved, probably because of erosion in the exposed location.

Figure 33.--Gently-inclined backset crossbeds interpreted to be antidune structures in a sand splay 0.25 river mile below Lawn Lake dam. Flow was from right to left; pencil is 5.5 in. long.

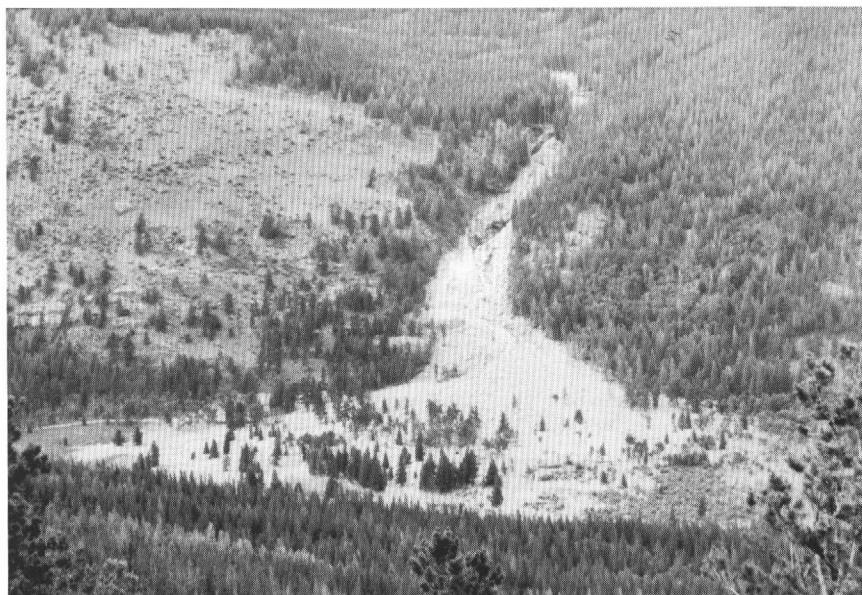
At the mouth of the Roaring River, a large alluvial fan was deposited on the floor of Horseshoe Park at about 0630 MDT on the morning of the flood (fig. 34). Peak flood discharge at that time was estimated to have been 12,000 ft<sup>3</sup>/s (see "dam-Break Modeling"). Sediments for the fan were derived from the large lateral moraine along the Roaring River and Horseshoe Park, just upstream from and including Horseshoe Falls. Boundaries of the alluvial fan were determined from a vertical aerial photograph taken about 4 hours after the flood peak and enlarged to a scale of 1 in. = 96.5 ft. The downstream end of the fan was defined as the location where the Fall River assumed a distinct channel. Upstream from this point, the original stream channel was obliterated and buried by sediments. The area of the alluvial fan is 42.3 acres (0.066 mi<sup>2</sup>) (fig. 35).

Figure 34.--The alluvial fan formed at the mouth of the Roaring River. Note the deep scour into the lateral moraine source materials.

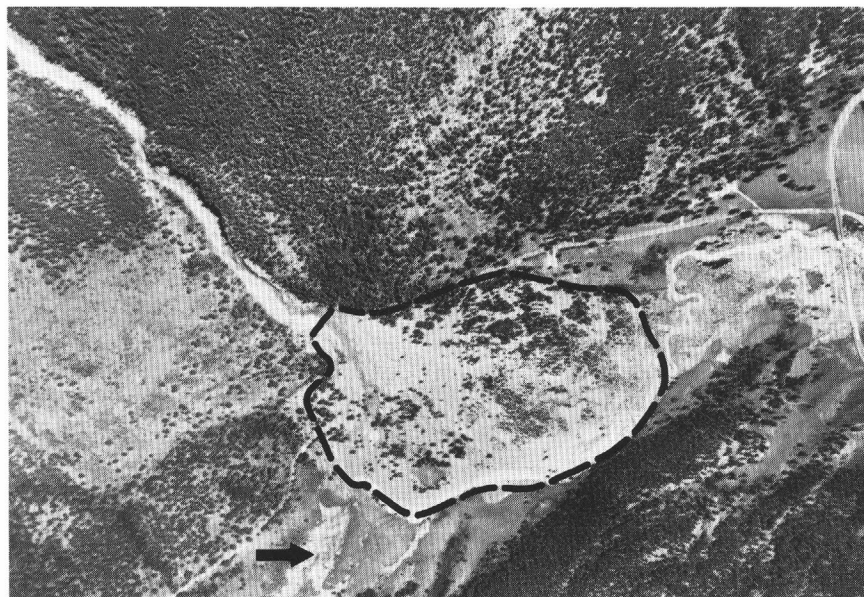
Figure 35.--Roaring River alluvial fan taken about 4 hours after the flood (vertical aerial). Incipient lake formed from the damming of the Fall River shown in figure 39 is indicated by arrow; dashed lines indicate the outline of the alluvial fan.

The large volume of sediment deposited in the Roaring River alluvial fan dammed the Fall River in Horseshoe Park upstream from the fan, forming a small lake (fig. 35). By July 1983, the lake had established an equilibrium between inflow of the Fall River upstream and outflow along a marginal channel that formed at the edge of the alluvial fan (fig. 39). In July 1983, the lake had a surface area of 17.0 acres (0.0265 mi<sup>2</sup>), and appeared to be a permanent hydrologic feature for the foreseeable future.

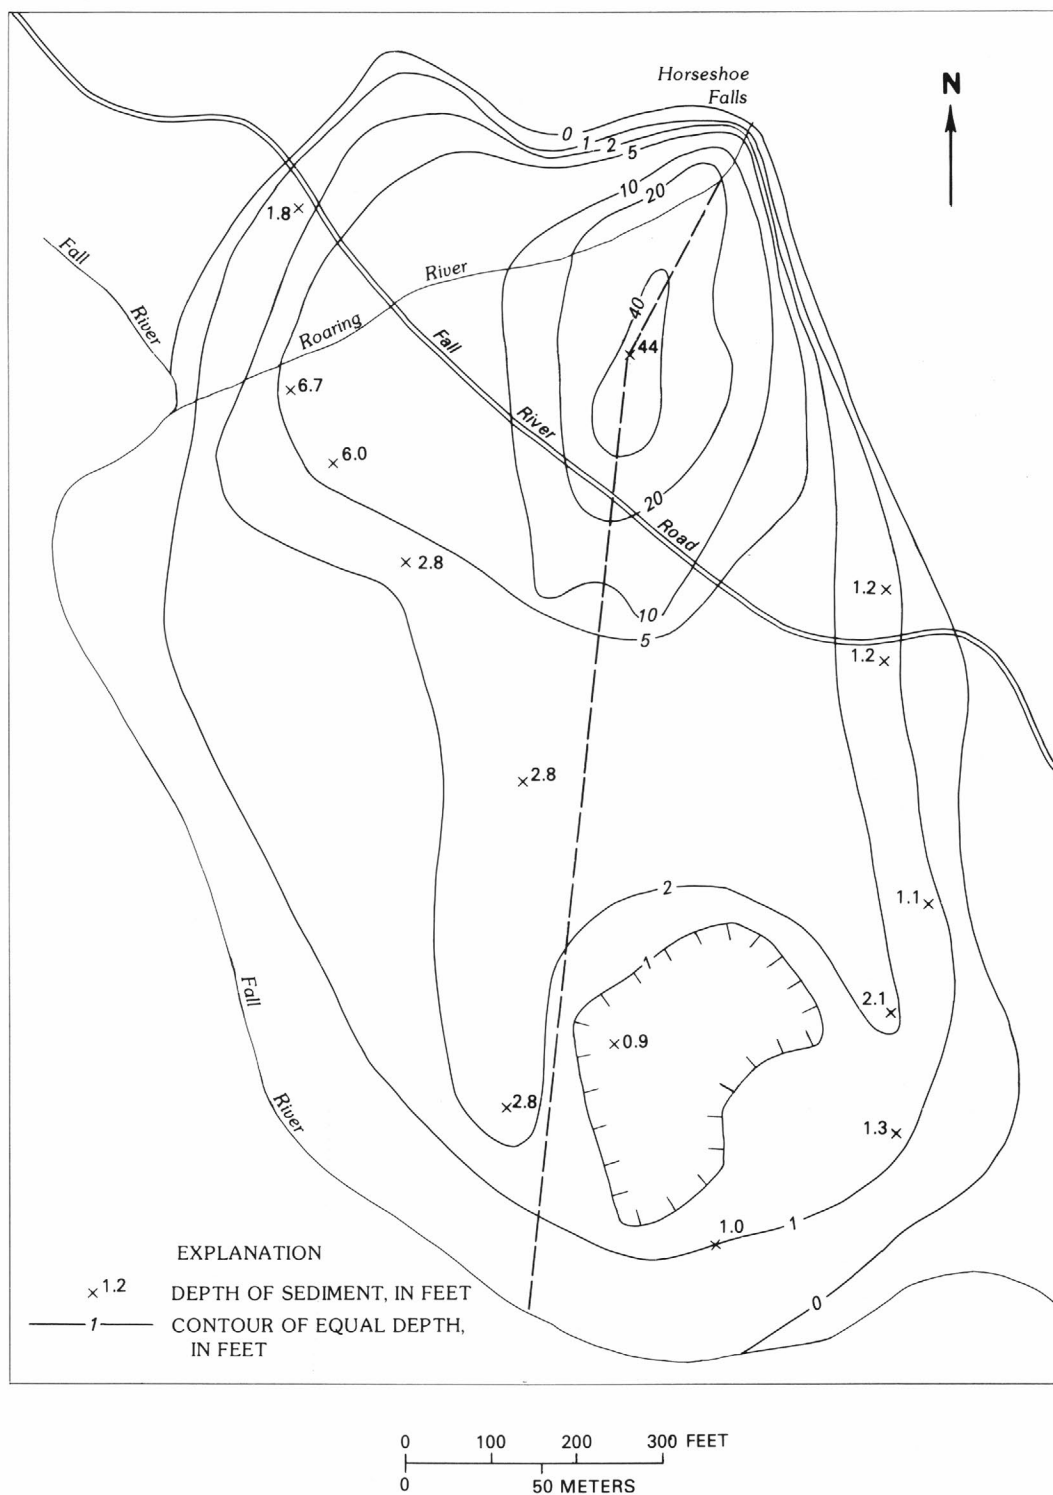
Volume of sediment in the fan was determined by ground measurements of sediment thickness at 14 points on the fan. Thickness was obtained by digging through the sediment to the original ground surface at 11 sites. At two additional sites, the original ground surface could not be reached by digging, so the depths were minimal estimates. The final site was the highest and thickest point on the alluvial fan. Thickness was determined by surveying the height of the deposit above adjacent high-water marks; triangulation of sediment thickness was determined from the slope of the original ground surface beneath the sediments, which produced a maximum thickness of 44 ft in a very small area near the head of the fan. Average thickness of the alluvial fan is only 5.3 ft. A contour map of the sediment thickness of the Roaring River alluvial fan is shown in figure 36.

Volume of sediment in the alluvial fan was calculated two ways; both produced approximately the same volume. First, the area between the contour lines shown in figure 36 was measured and multiplied by the average thickness of the bounding contours. Second, a Thiessen-Polygon method using the 14 data points was used. The calculated sediment volume, assuming 1/3 porosity, is 364,600 yd<sup>3</sup>, which is enough sediment to cover a football field to a height of 205 ft. If a specific gravity of 2.7 is assumed for the granite-gneiss sediments, the unit weight is 168.5 lbs/ft<sup>3</sup>. This produced a sediment weight of 829,000 tons, which is approximately 1½ times the sediment load deposited at the mouth of the Mississippi River in 1 day (Milliman and Meade, 1983).

Figure 36.--Contours of sediments in the Roaring River alluvial fan. Axis of main flow direction is shown by dashed line. Dashed line also is the path along which particle sizes shown in figure 37 were measured.

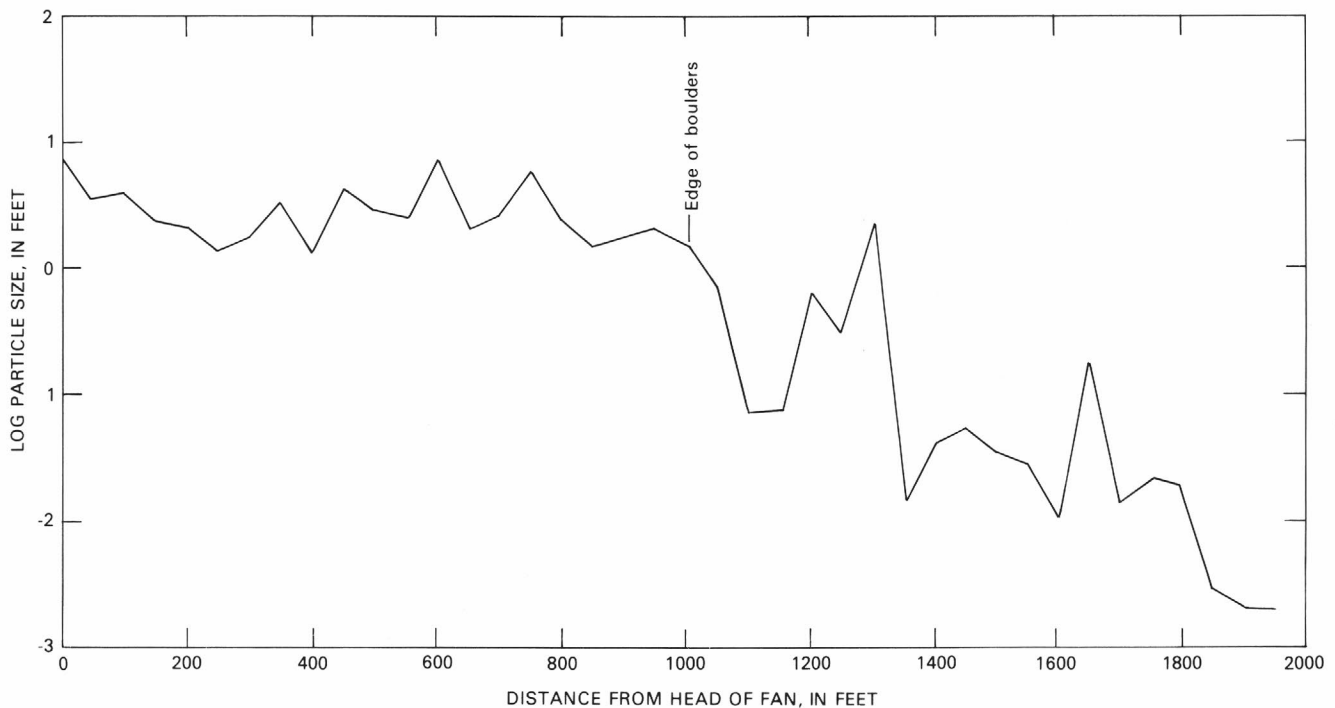
Characteristics of the surface sediments on the Roaring River alluvial fan changed in a downstream direction. The size of the single largest particle in a 3-ft radius, every 50 ft down the major flow axis of the fan is plotted in figure 37. The particle size changed from 7.5 ft at the head of the fan to 1 ft midway down the fan, where the largest concentrations of big boulders ended, to 0.002 ft at the toe of the fan, overlapping the flood plain of the Fall River. Winter winds during 1982-83 subsequently eroded some of the flood-plain sand and silt, which collected against U.S. Highway 34 road embankment (fig. 1) as dunes with heights of 2 to 3 ft.

Figure 37.--Plot of largest particle measured in 3-foot radius every 50 feet down the major flow axis of the dam-break flood on the Roaring River alluvial fan. Path follows dashed line in figure 36.

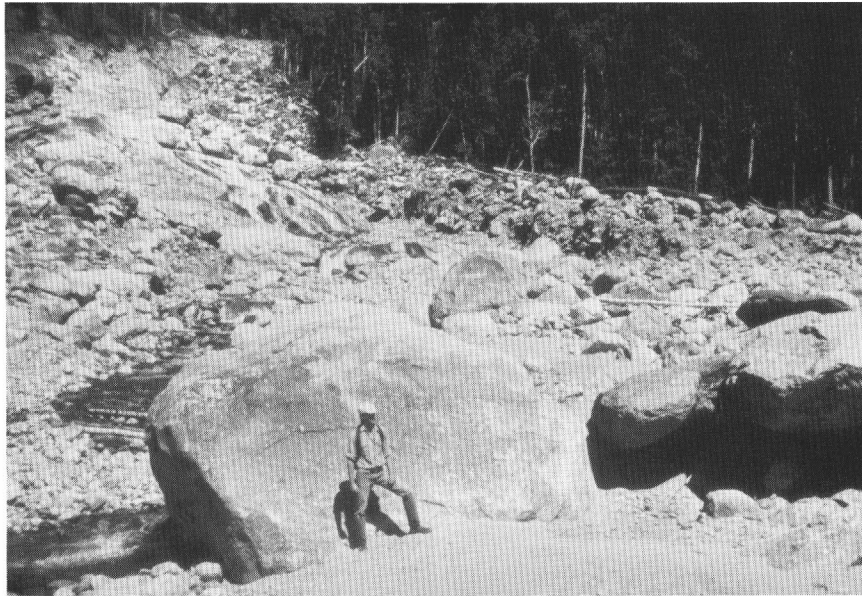
The single largest boulder known to have been transported onto the surface of the Roaring River alluvial fan is 14×17.5×21 ft, and weighs an estimated 452 tons (fig. 38). The force of the boulder-charged flow over Horseshoe Falls battered and destroyed most of the vegetation along the main flow path. Trees still standing after the flood were struck so hard by transported boulders that their tops were snapped off.

Figure 38.--The single largest boulder thought to have been moved by the flood onto the Roaring River alluvial fan. Dimensions of the boulder are 14×17.5×21 ft.

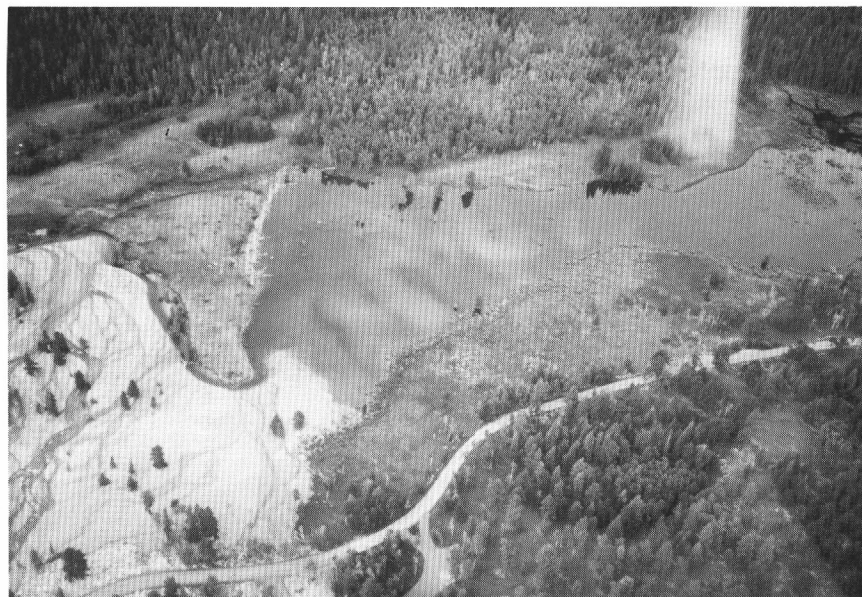
Figure 39.--The 17-acre lake formed in Horseshoe Park by the damming of the Fall River, taken in August 1983 (aerial). Downstream is to the left.

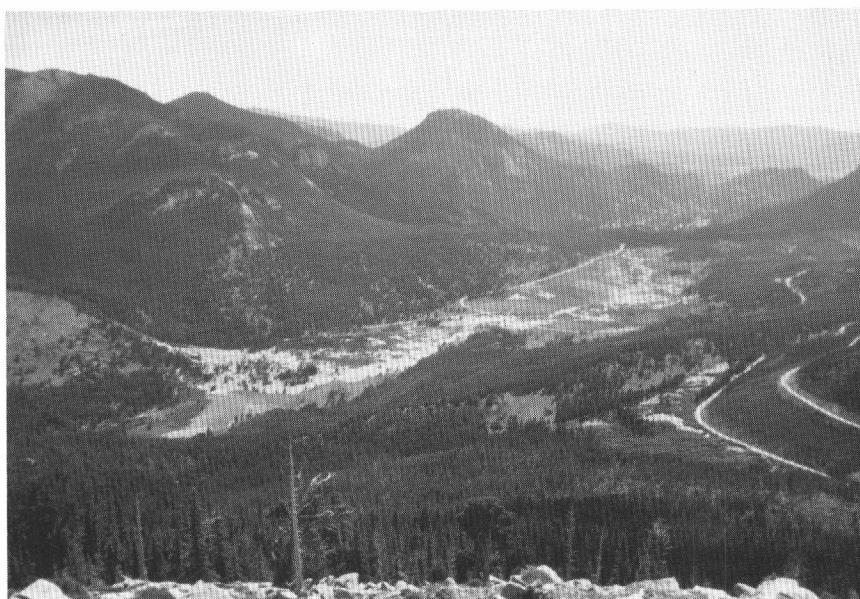
Figure 40.--Horseshoe Park and the Fall River valley, looking down-valley. Roaring River alluvial fan is in left-center of photo.

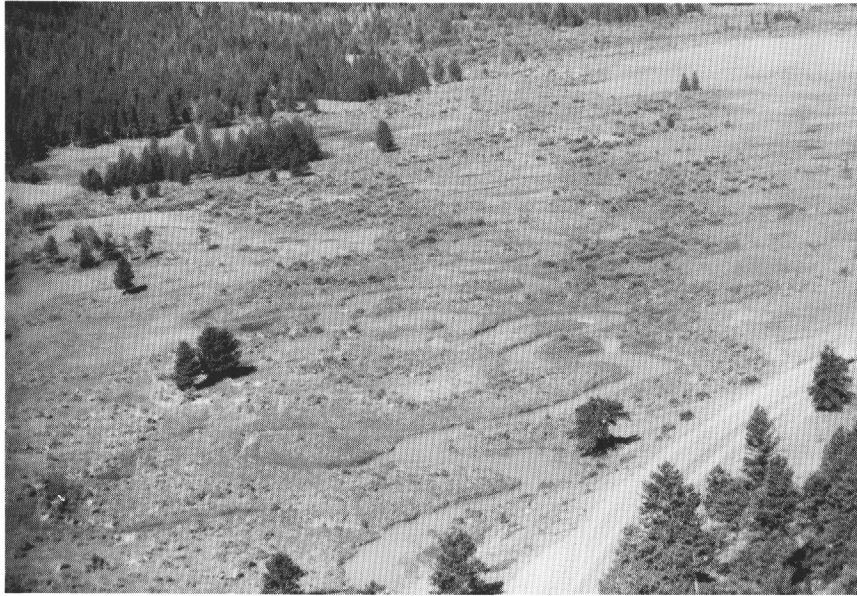
In Horseshoe Park maximum flood depth was about 10 ft, and maximum width was 1,300 ft measured on the aerial photograph. Water was out of the banks of the Fall River in Horseshoe Park for less than 4 hours, except for local ponded water. The photograph in figure 41 was taken about a week after the flood; it clearly shows that no immediate visible modification occurred to the meandering channel pattern of the Fall River.

Figure 41.--Horseshoe Park taken 1 week after the flood, looking upstream from river mile 6.5 (aerial). The tight meanders of the Fall River were unaffected by the floodwaters.

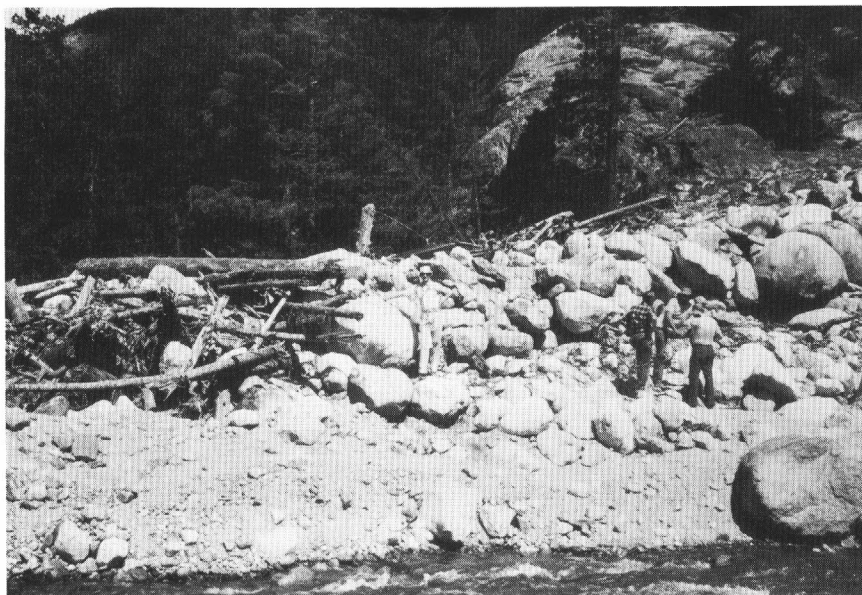
Two types of sedimentary features were especially well developed during this flood--boulder berms and step-pool long profiles. On the west side of Roaring River alluvial fan, and below Cascade Lake dam above the Aspenglen Campground, boulder berms similar to those described from other catastrophic floods in steep mountain channels (Scott and Gravlee, 1968, p. M13-M14) were well-developed (fig. 43A). These boulder berms are boulder levees deposited by floodwaters in the two locations where sufficient sediment was entrained in the flow to temporarily produce a debris torrent. These conditions existed for only two short reaches where (1) the Roaring River eroded through the high lateral moraine at Horseshoe Falls, and (2) the Fall River deeply eroded Pleistocene terminal moraine sediments below Cascade Lake dam.

Figure 43A--A well-developed boulder berm along the right bank of the Roaring River on the large alluvial fan at river mile 4.73, showing the concentration of organic material in the front of the berm. View is upslope on the surface of Roaring River alluvial fan.

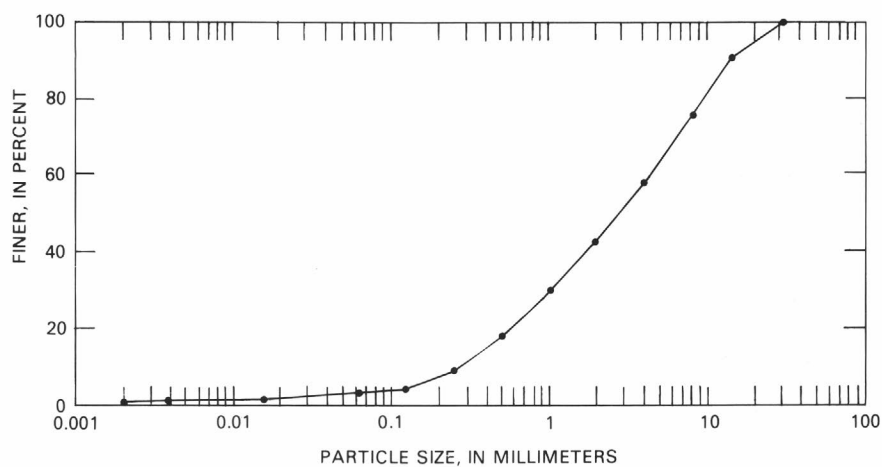
Particle-size analysis of a sample of matrix material from the right boulder berm or debris-torrent levee at the Roaring River alluvial fan is shown in figure 43B. The median particle size is 0.118 in., and the matrix contains only 0.5 percent clay. The berm ends with a steep front that includes numerous large shattered tree trunks and other organic material as well

Figure 43B.--Particle-size analysis of matrix from Roaring River alluvial fan boulder berm.

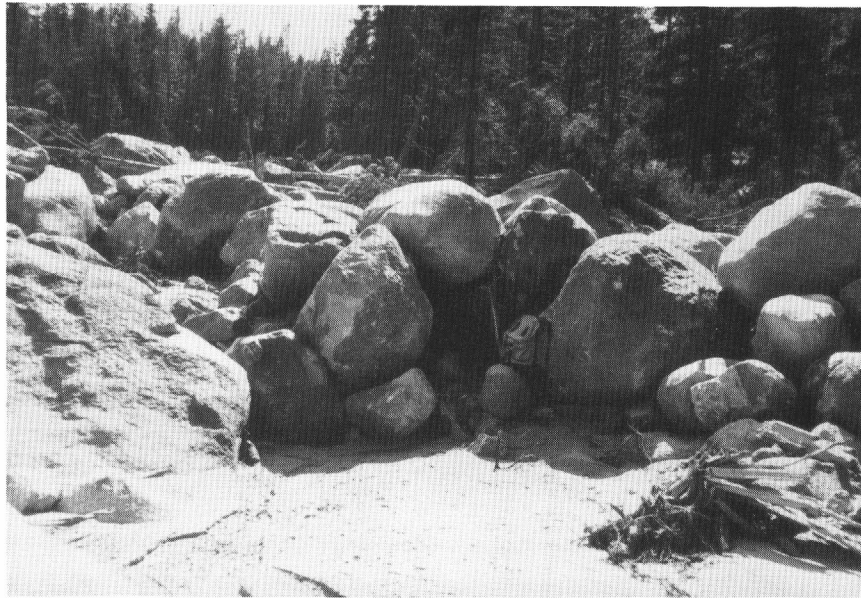
Four well-developed steps ranging in height from 4 to 9 ft were formed within a distance of 110 ft in the Fall River just upstream from Aspenglen Campground. One step-pool bedform in boulder deposits in the Fall River is shown in figure 44. Average sizes of the 10 largest boulders exposed in the front of each of the steps were 3.4 ft, 3.5 ft, 4.0 ft, and 4.4 ft. The steps formed downstream from Cascade Lake dam probably were analogous to the step-pool forms so common in coarse-boulder steep channels, and support the belief that they originate as bedforms under catastrophic flood conditions, probably collecting under hydraulic jumps formed near the peak of the flood.

Figure 44.--The front of one step-pool bedform in boulder deposits in the Fall River upstream from Aspenglen Campground at river mile 7.01.

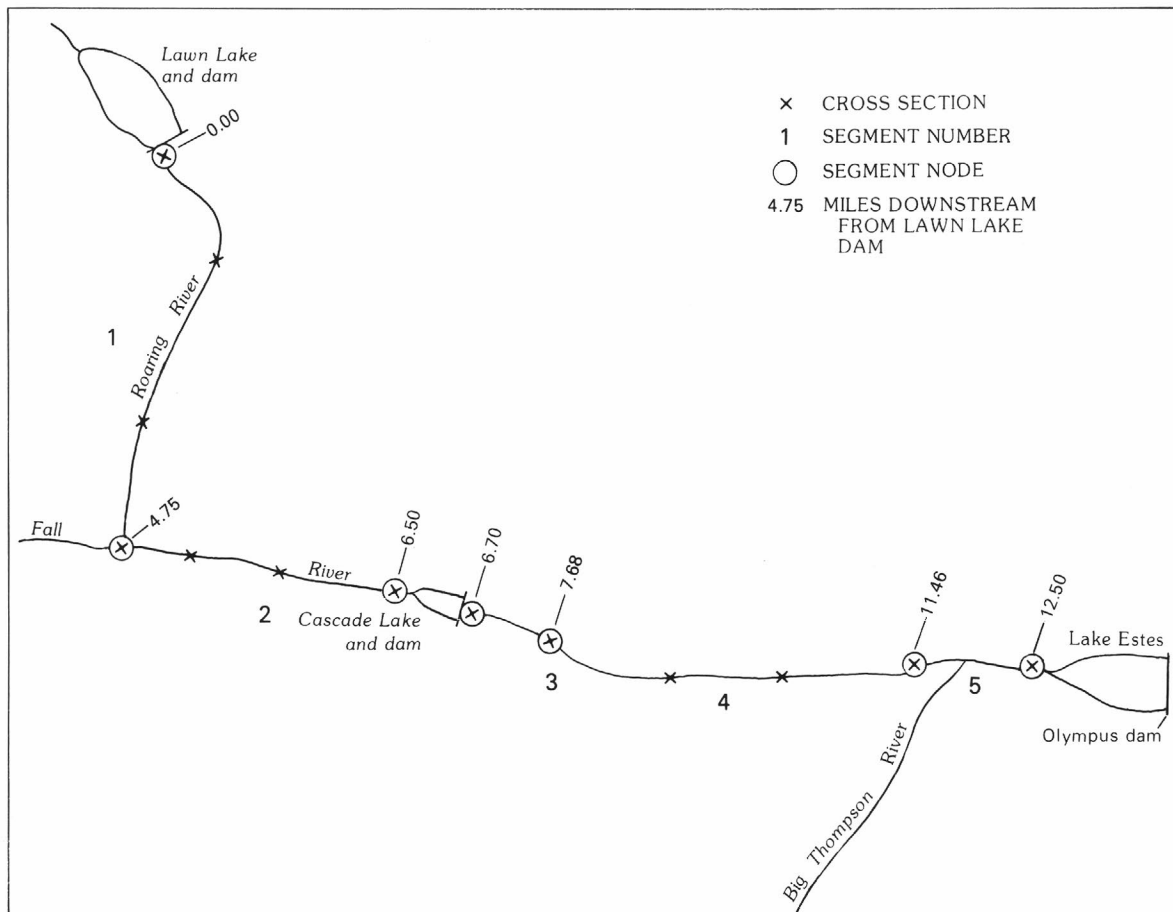
The model requires initial and boundary conditions, as well as a physical description of the lakes, dams, and stream-channel reach. The model layout shown in figure 45 indicates the location of the segment numbers, cross sections, and computational nodes. Computational nodes, or nodes, refer to the location where discharge and water-surface elevations are computed inside the model. These data can be either measured or estimated. For this study, most of the data were available, particularly for calibrating the model with observed data to evaluate its capabilities on high-gradient streams.

Figure 45.--Dam-break model layout for the lakes-stream system.
