# HYDROLOGY, GEOMORPHOLOGY, AND DAM-BREAK MODELING OF THE JULY 15, 1982, LAWN LAKE DAM AND CASCADE LAKE DAM FAILURES, LARIMER COUNTY, COLORADO

U.S. GEOLOGICAL SURVEY

Open-File Report 84-612

By Robert D. Jarrett and John E. Costa

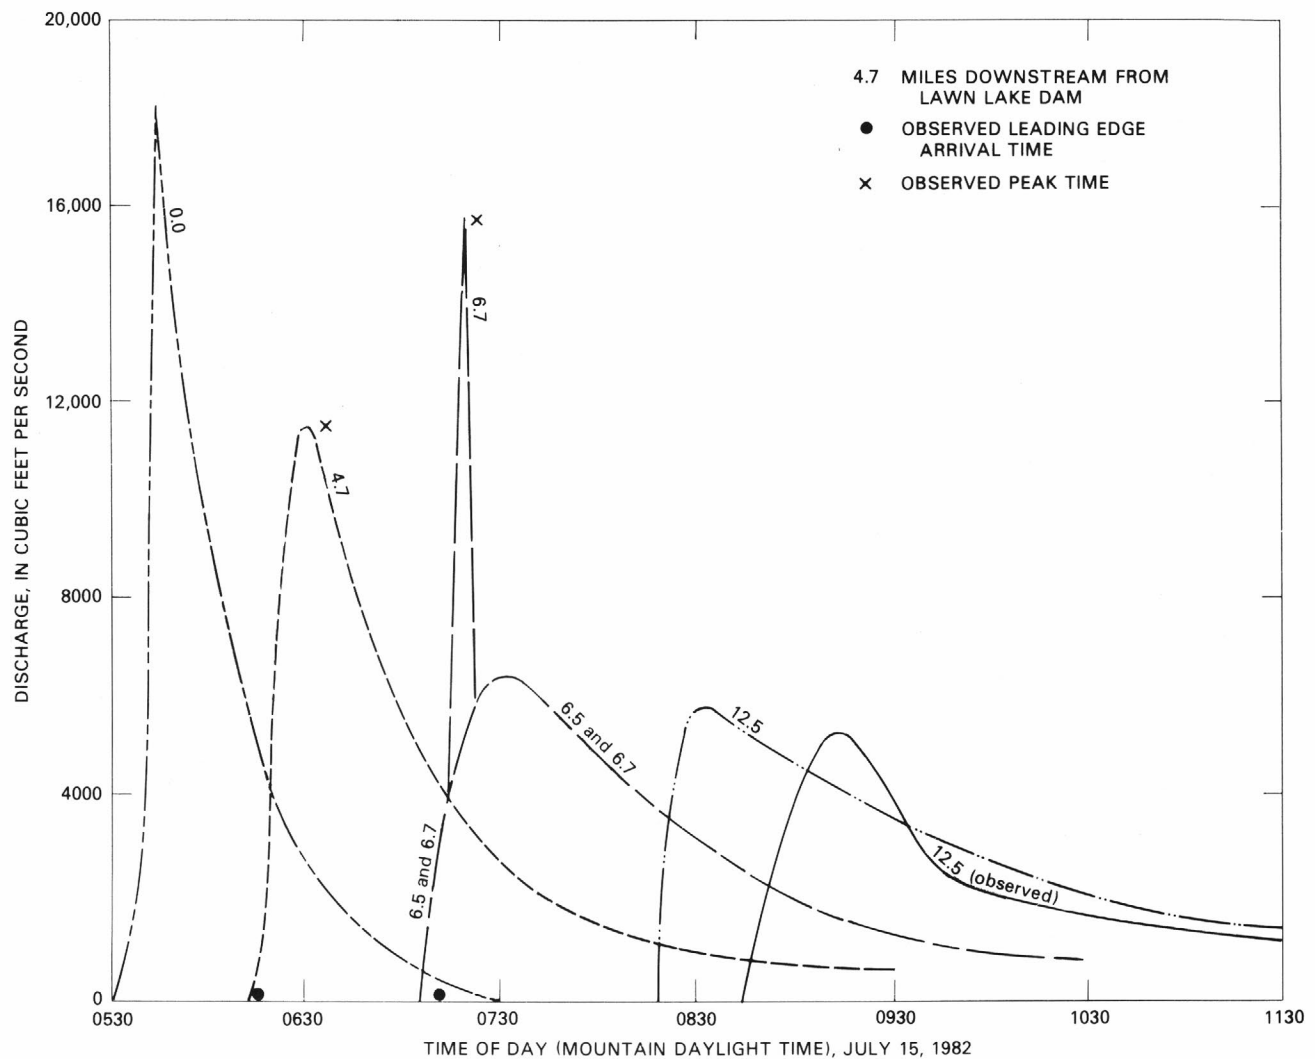
Figure 46.--Selected modeled and observed hydrographs.

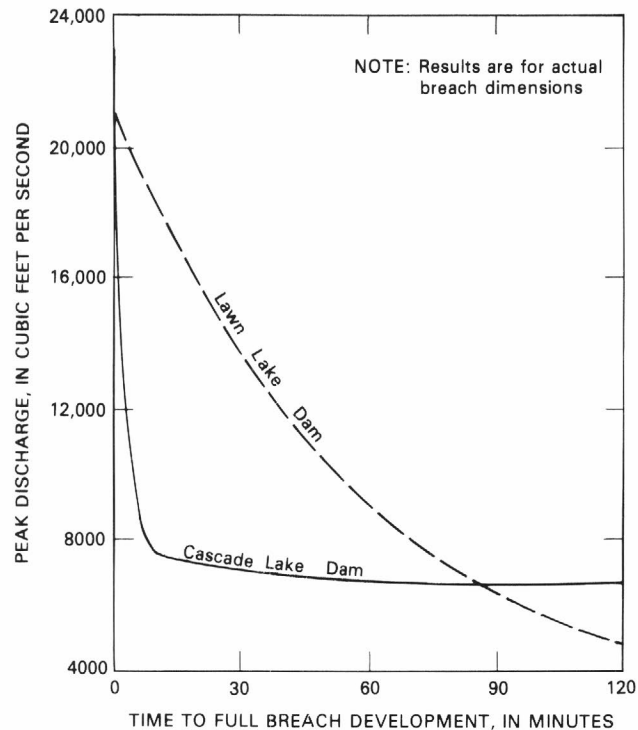
Accuracy of the modeled peak discharges was lowest immediately downstream from Lawn Lake and Cascade Lake dams, primarily because of the uncertain aspects of length of time of full breach development, as well as dimensions of the breach at the time of the peak. For the actual breach dimensions, the model was able to evaluate the variation of time of full breach development on the magnitude of outflow discharges from the dams. Outflow discharge for various times to full breach development for both dams is shown in figure 47. This analysis indicates less change of discharge with time occurred for the failure of Lawn Lake dam, and available information indicated a full breach-development time of 10 min, with a probable range of 5 to 20 min. Hence,

Figure 47.--Outflow discharge for various times of breach development for Lawn Lake dam and Cascade Lake dam.

discharge from Lawn Lake dam probably ranged from 20,000  $\text{ft}^3/\text{s}$  to 16,000  $\text{ft}^3/\text{s}$  in that time frame. However, for Cascade Lake dam, the rate of change in peak discharge was much greater in the probable time of full breach development of 30 s to 5 min (1 min was assumed). The range of peak discharge from Cascade Lake dam could have been 23,000  $\text{ft}^3/\text{s}$  to 9,000  $\text{ft}^3/\text{s}$  in that time frame. As the modeling demonstrated, because of the smaller capacity of Cascade Lake, greater attenuation occurred downstream.

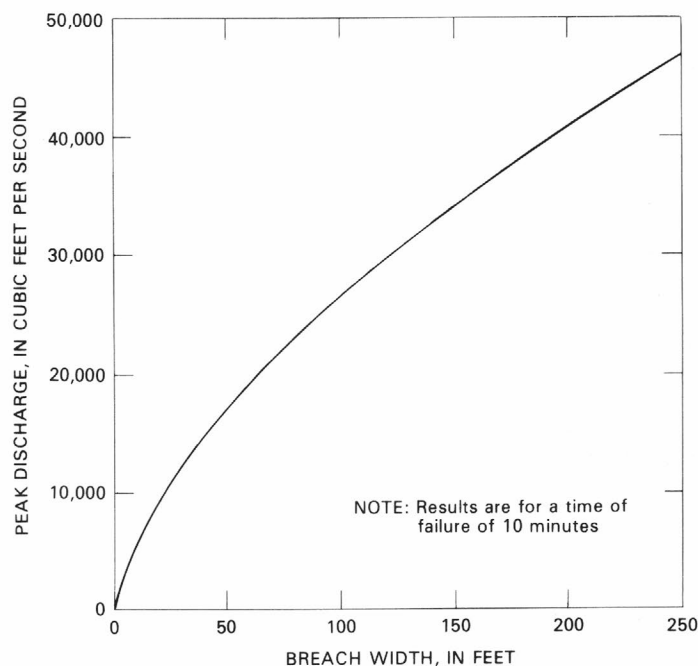
The model also was used to evaluate a worst-case scenario for the failure of Lawn Lake dam that would reflect a very abrupt and almost complete breach of the dam embankment in a short span of time. Outflow peak discharges could have been as high as 56,000 ft<sup>3</sup>/s for a time of full breach development of 10 min (or a greater peak discharge for a shorter breach time), and a breach width of 550 ft, for these extreme conditions.

Figure 48.--Outflow discharge for hypothetical breach width for Lawn Lake dam, assuming 10-minute time of failure.

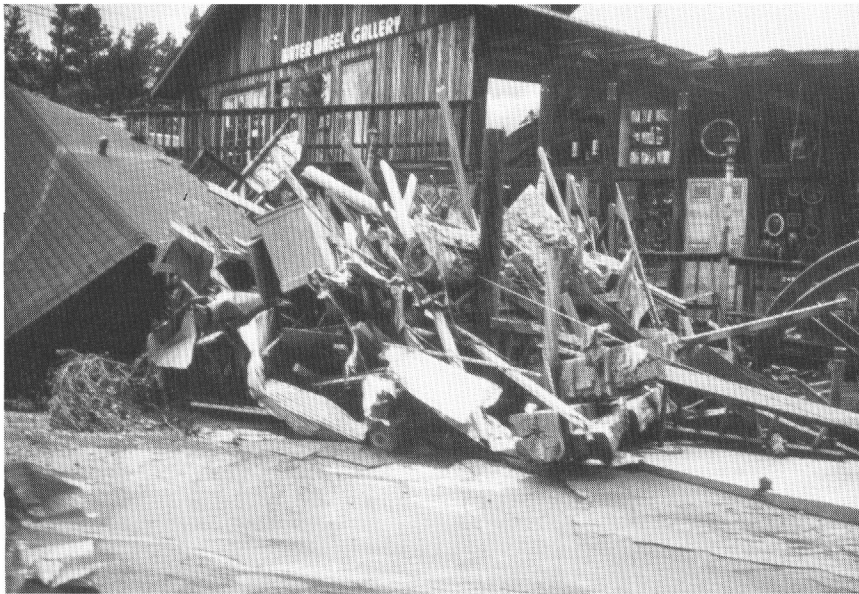
Selected photographs of damages and debris are shown in figures 50, 51, 52, and 53. The Ponderosa Lodge at river mile 9.9 on the Fall River, which was reconstructed above the 500-yr flood level, was totally destroyed (fig. 51A); however, the lodge was rebuilt in the same location as shown in figure 51B. Farther downstream, damages were prevented when the floodwaters were contained in Lake Estes (fig. 54).

Figure 52.--Debris jam on the upstream side of Elkhorn Avenue at river mile 11.8 along the Fall River in Estes Park.

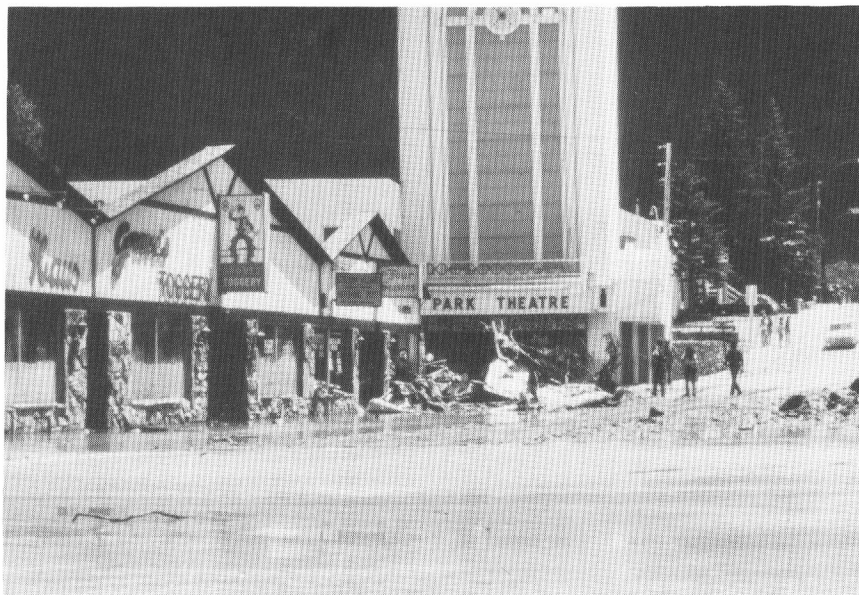
Figure 53.--High-water lines on buildings along the Fall River at Estes Park.

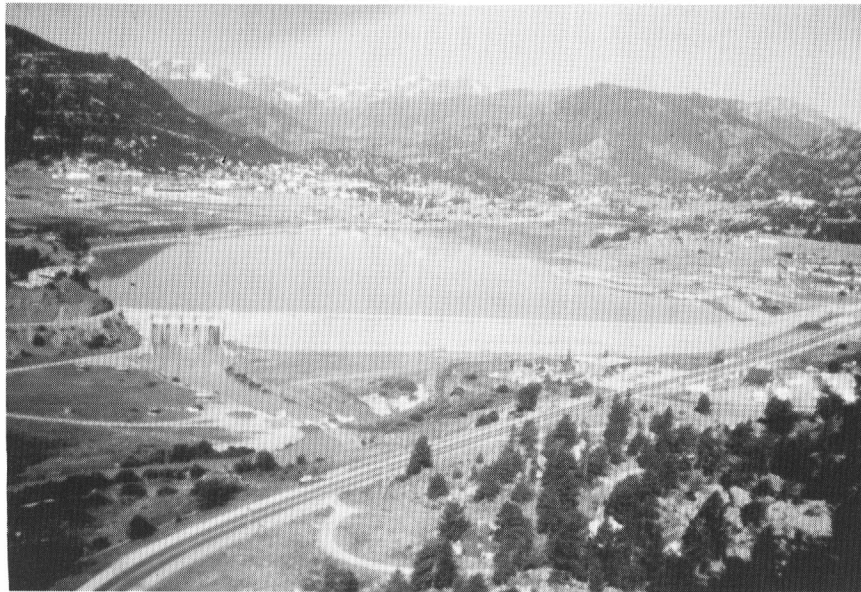
Figure 54.--View upstream from Olympus dam and Lake Estes, containing the floodwaters (aerial).

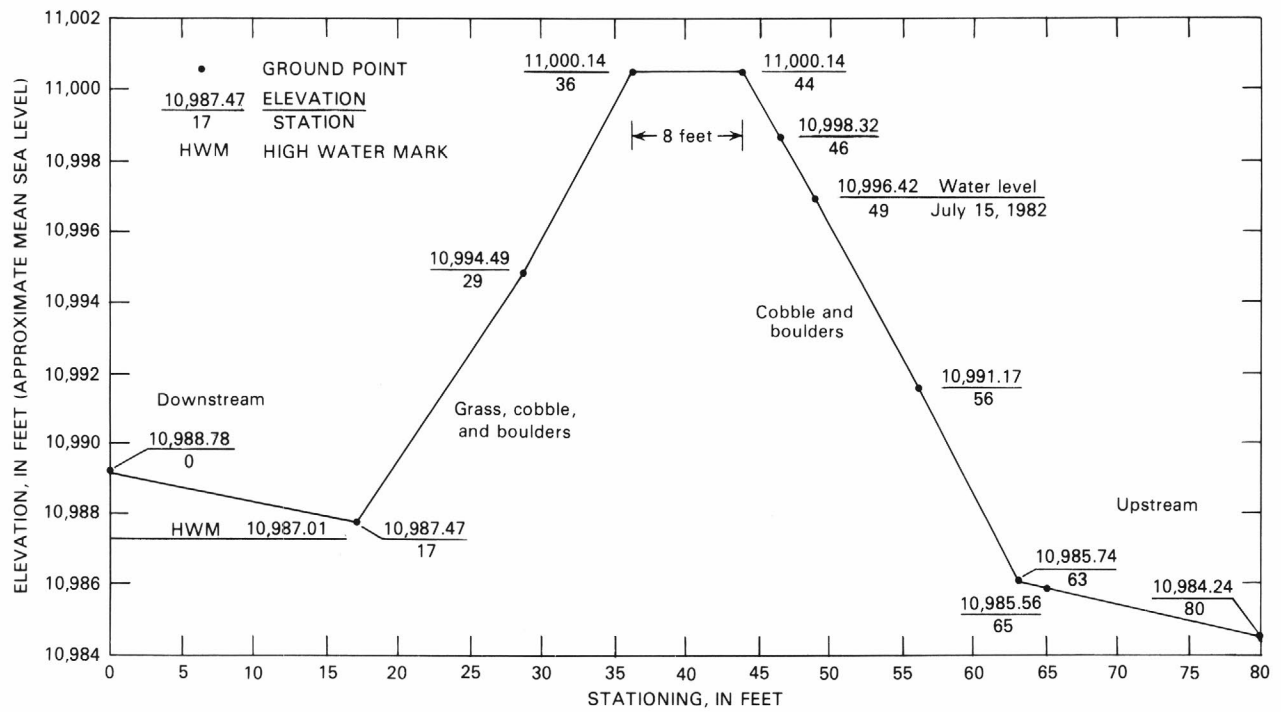
Figure 56.--Lawn Lake dam cross section of breach (right side) on the Roaring River at river mile 0.0.

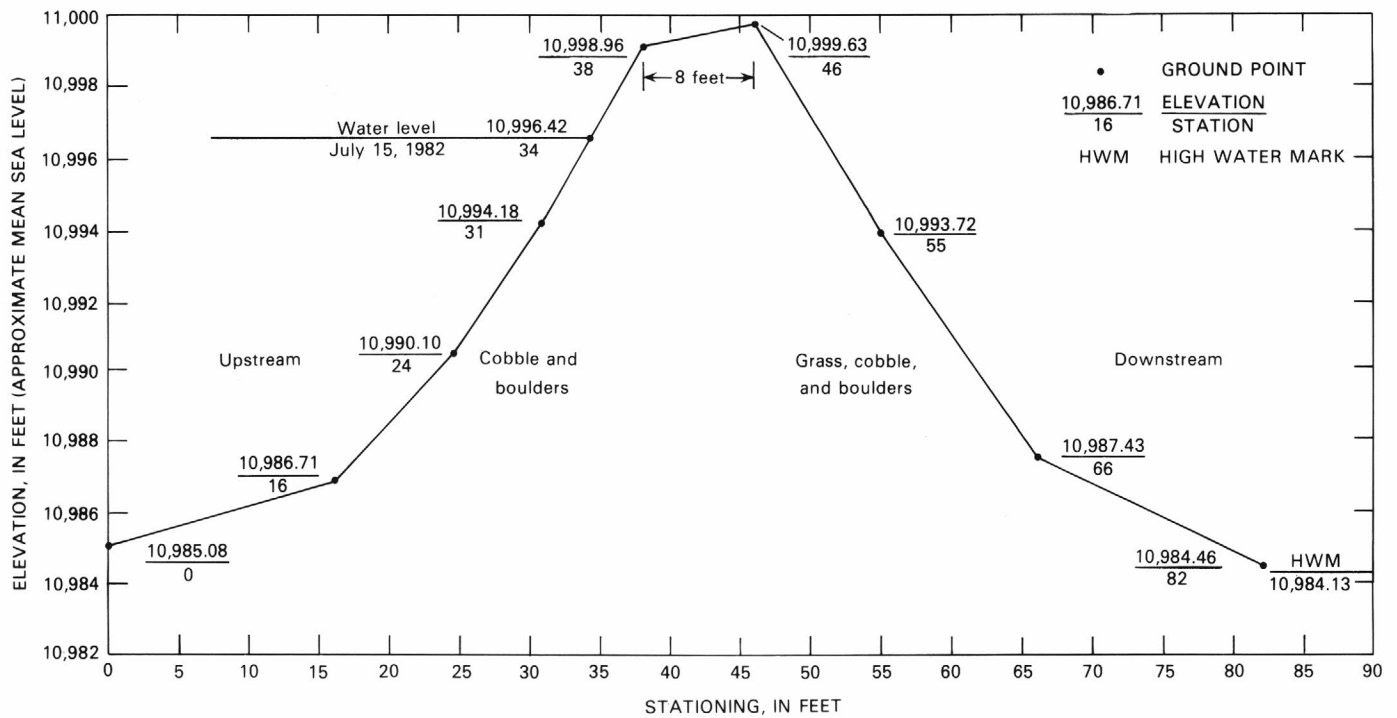
Figure 57.--Lawn Lake dam cross section of breach (left side)  
on the Roaring River at river mile 0.0.

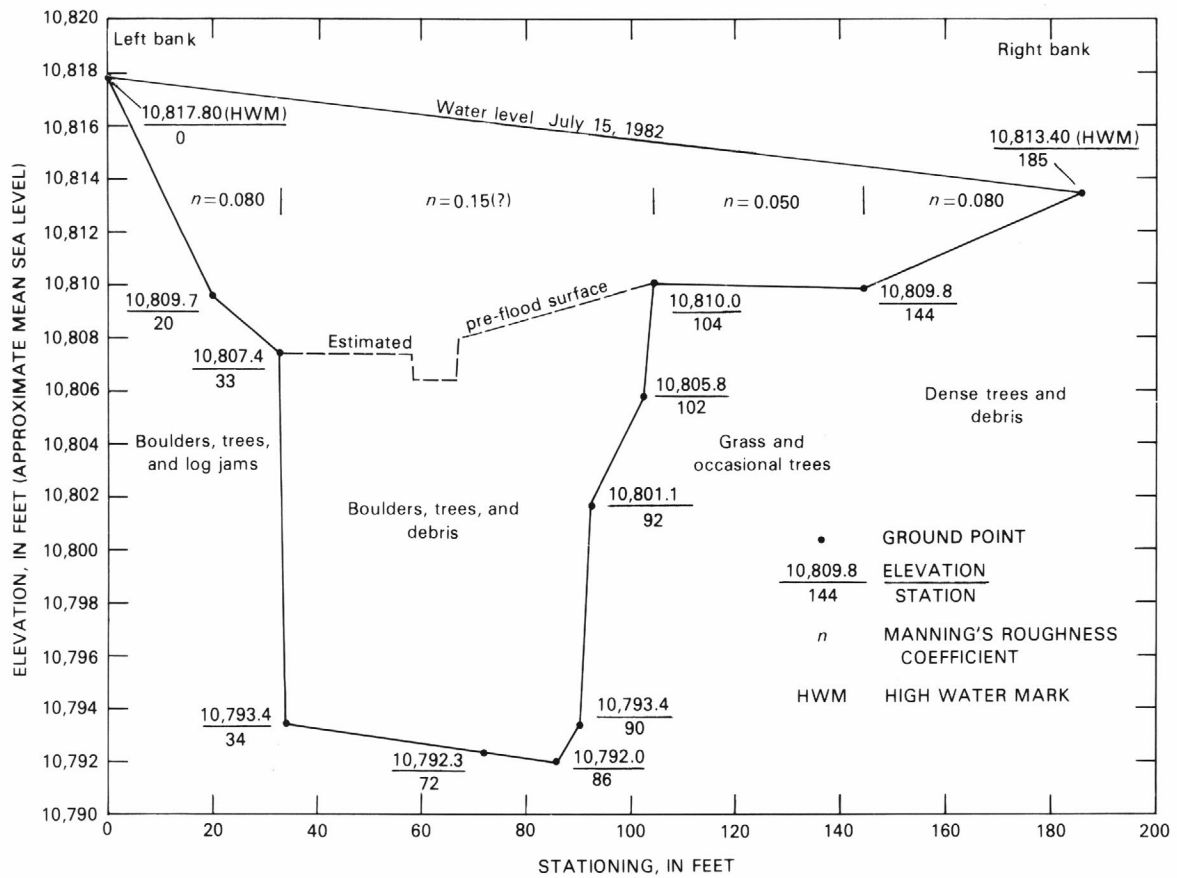
Figure 58.--Roaring River cross section at river mile 0.55.

Scoured reaches are steep, and the newly eroded channel is narrow and deep (fig. 28); also see the Roaring River valley cross section at river mile 0.55 (fig. 58) in the Supplemental Cross-Section Data section at the end of the report. In many places, scour removed all overlying glacial material and exposed fresh bedrock in the channel bottom (fig. 27). The flood eroded laterally into glacial sediments, and left steep, overhanging banks, with numerous large boulders half-exposed and ready to fall into the channel below (fig. 26). Thousands of trees in the valley floor were uprooted as their footings were eroded. Little evidence was found of remaining rooted trees having been snapped off or shattered; most trees probably were lost from toppling or undermining and caving of eroding banks during the flood wave. Once incorporated into the floodflow, trees were extensively battered and scarred (fig. 17).

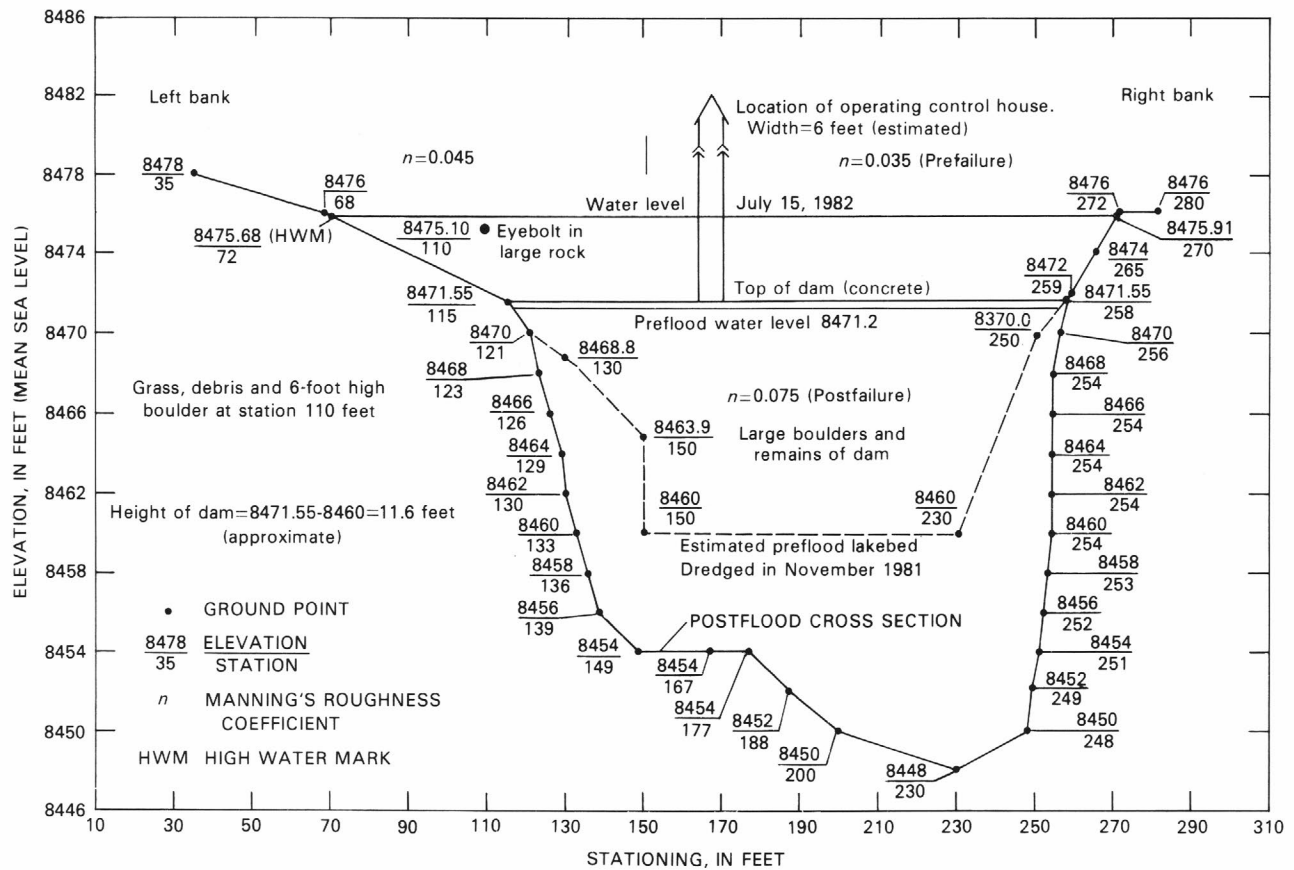
Figure 64.--Cascade Lake dam cross sections on the Fall River at river mile 6.67 (site 2).
