Stability of Slopes Below the Sherwood Uranium Mine, Spokane Indian
Reservation, Northeastern Washington

Alan F. Chleborad and Robert L. Schuster

Open File Report 84-627

1984

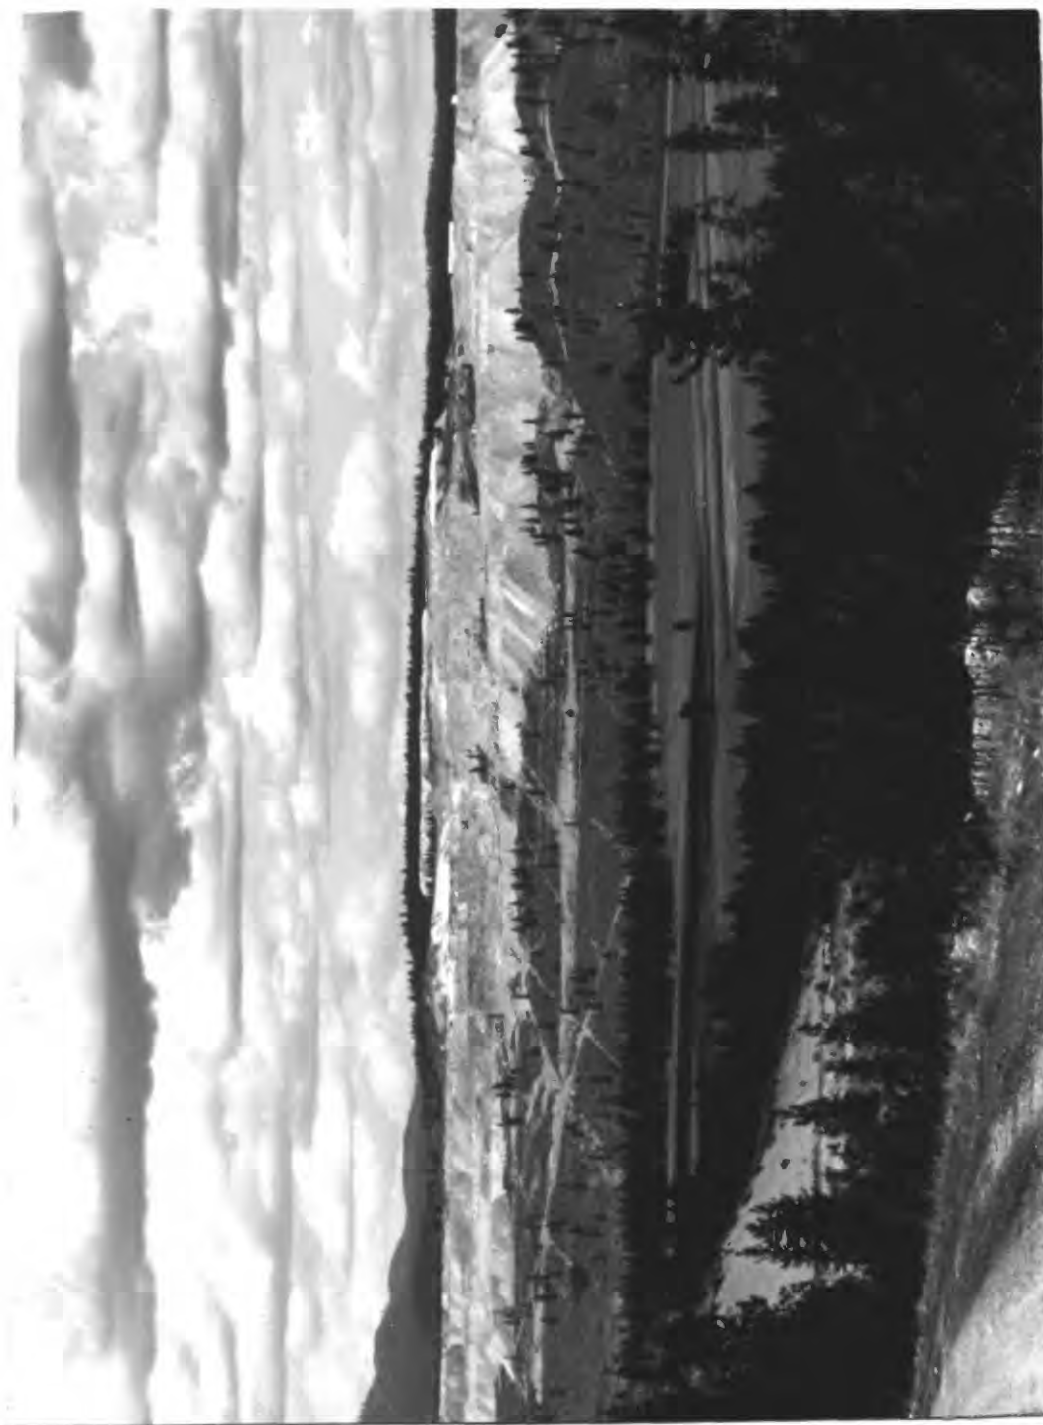
Figure 2.--Sherwood Uranium Mine on the ridge in the background overlooks the Spokane River Arm of Franklin D. Roosevelt Lake (hidden from view behind the large terrace that forms the open field in the lower middle of the photograph).

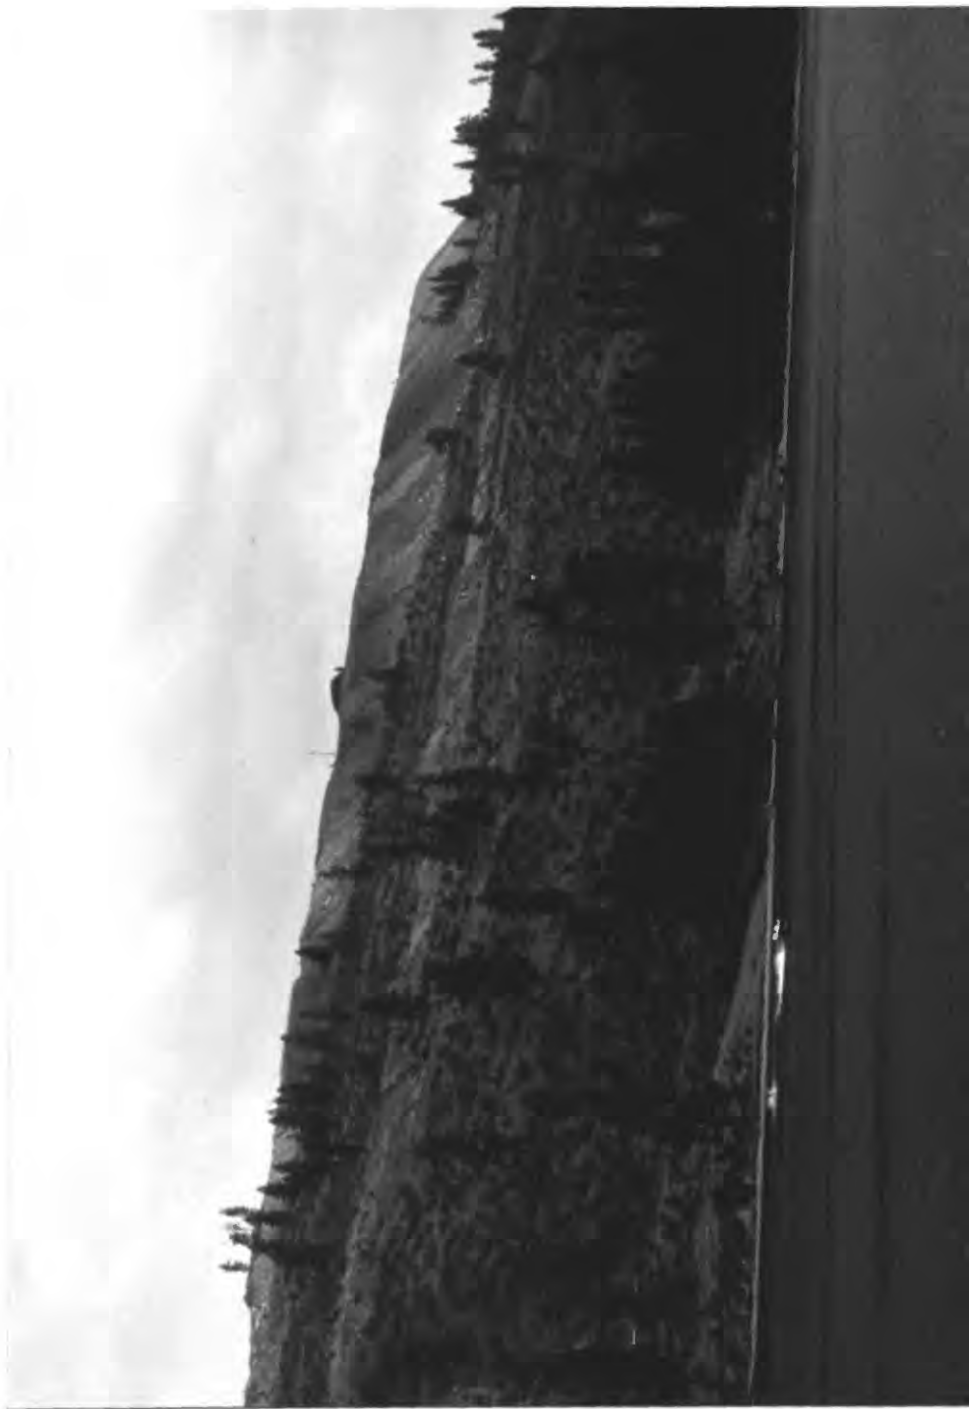
Figure 3.--Photograph showing part of the Spokane River Arm (foreground) and the steep natural slope below the Sherwood Uranium Mine. Boating, fishing, water skiing (left side of view), and other recreational uses of the lake are common.

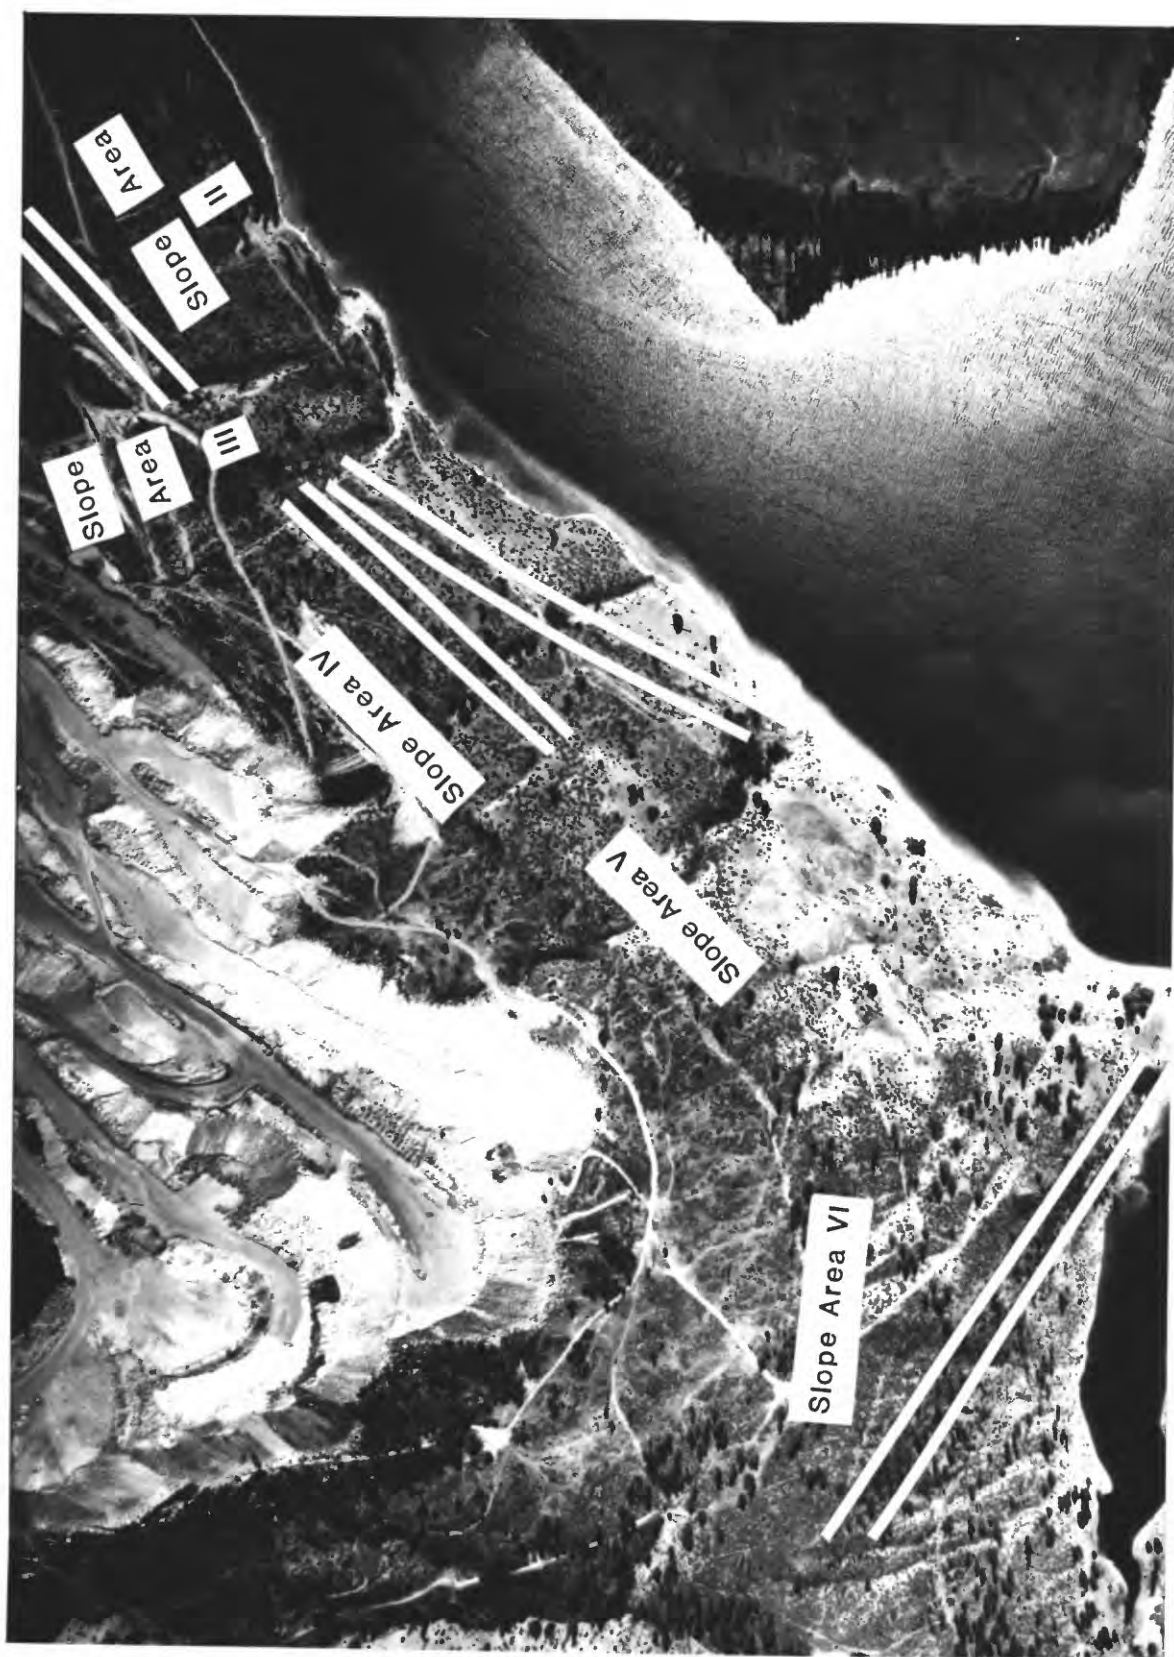
Figure 8.--Air photo showing the locations of linear zones of vegetation (between parallel white lines) that indicate lithologic change in surficial deposits (scale 1:9,000).

Sands and gravels, which are the preponderant slope materials, are free-draining. However, small springs were noted at clay-exposure localities no. 1 in slope area VI and no. 8 in slope area IV where the uppermost claybeds at those localities blocked the downward flow of ground water, diverting it to the surface. Other areas of the slopes where slope materials were damp, but not saturated, reflect similar litho-stratigraphic relationships with less ground-water concentration. The springs and damp zones are located along the lines of vegetation shown in figure 8.

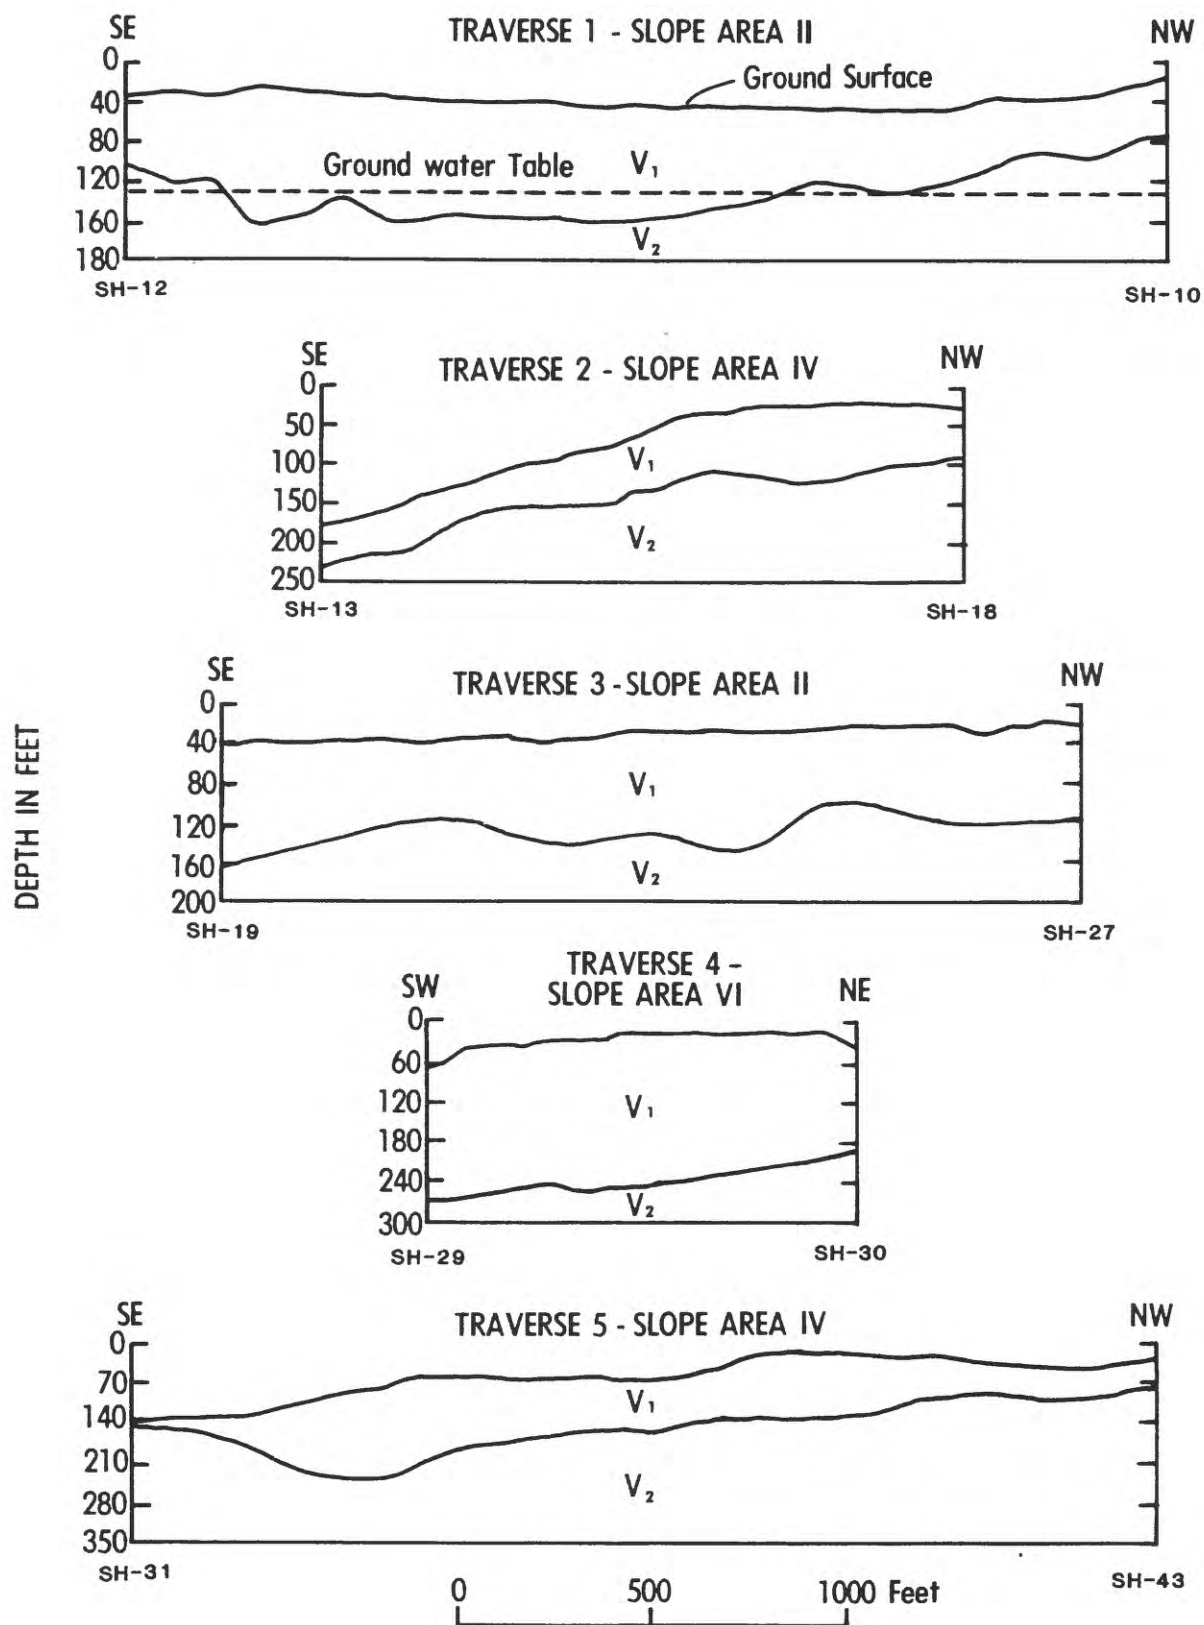
Figure 12.--Subsurface profiles for slopes below the Sherwood Mine showing ground surface, velocity layers V_1 (surficial material overlying bedrock), V_2 (bedrock), and ground-water table where present. Shot hole numbers (SH) indicate traverse locations as shown in figures 10 and 10a.

Irregularities, not shown in the longitudinal bedrock profiles, probably exist as they do in the cross-slope refraction survey profiles of figure 12. It is assumed, however, that the irregularities are not as pronounced as those in the cross-slope directions, which cross downslope drainage and erosion channels on the old bedrock surface. Consequently, the bedrock profiles shown in figure 14 are considered reasonably accurate.

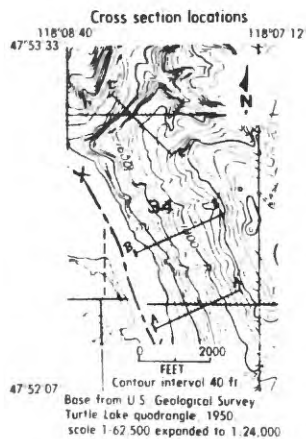
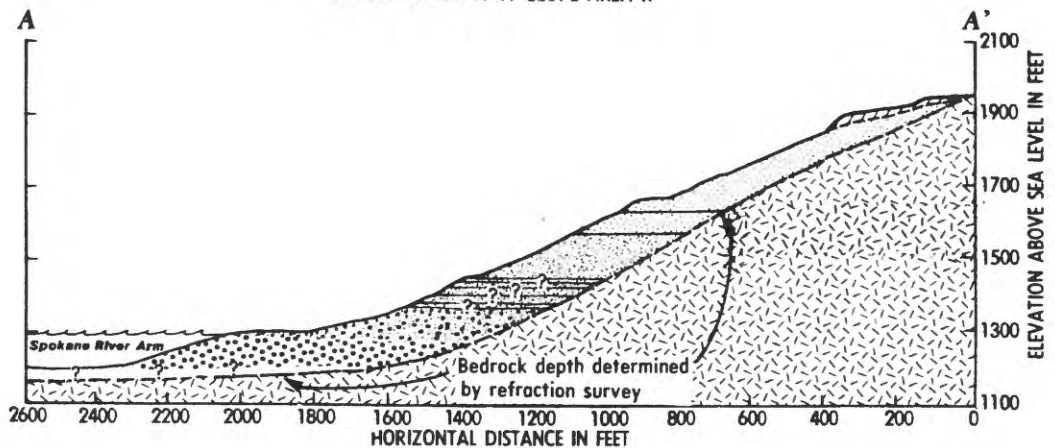
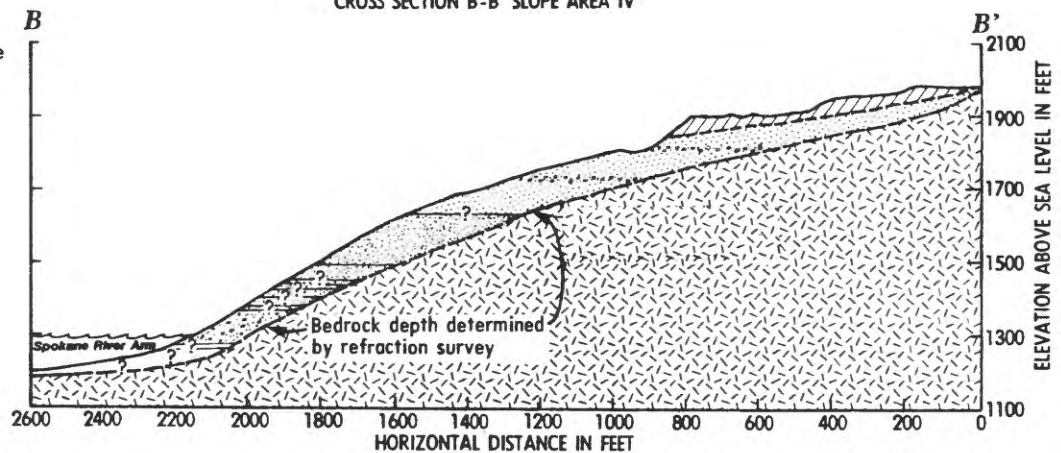
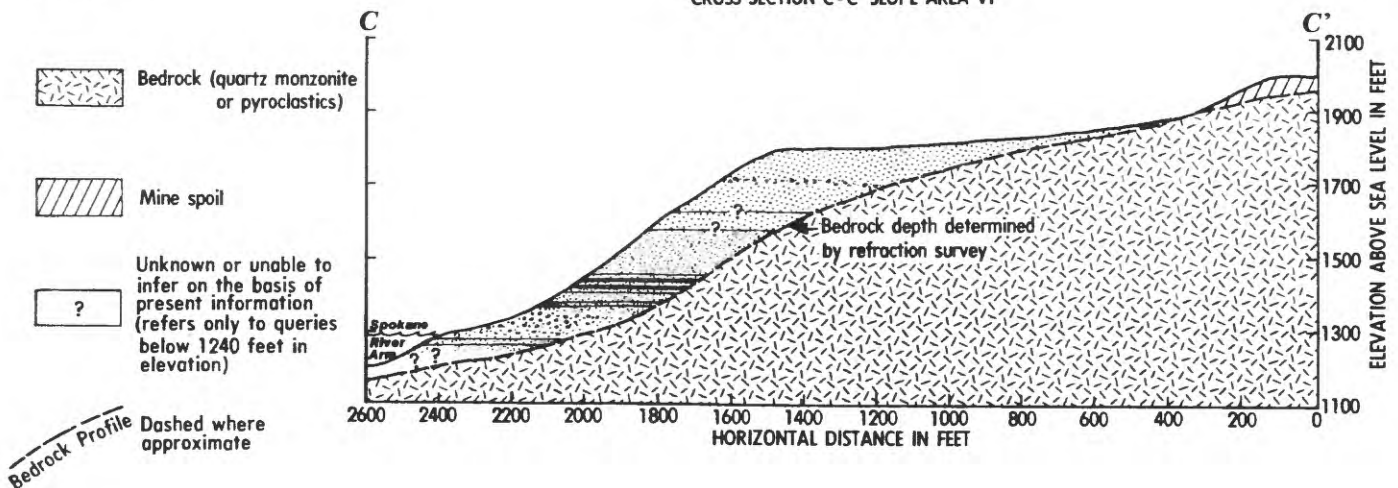
Figure 14.--Cross sections of selected slope areas below the Sherwood Mine. For locations relative to the surface geology of the area, see plate 1.

likelihood that such a failure on the slopes below the Sherwood mine would result in blockage of the Spokane river or in contamination of lake water by mine spoil appears remote, however, for two reasons. First, the upper slope areas adjacent to the spoil have slope angles which are generally well below the estimated internal angle of friction (see fig. 14), and second, the probable form of failure precludes the involvement of a large volume of material.

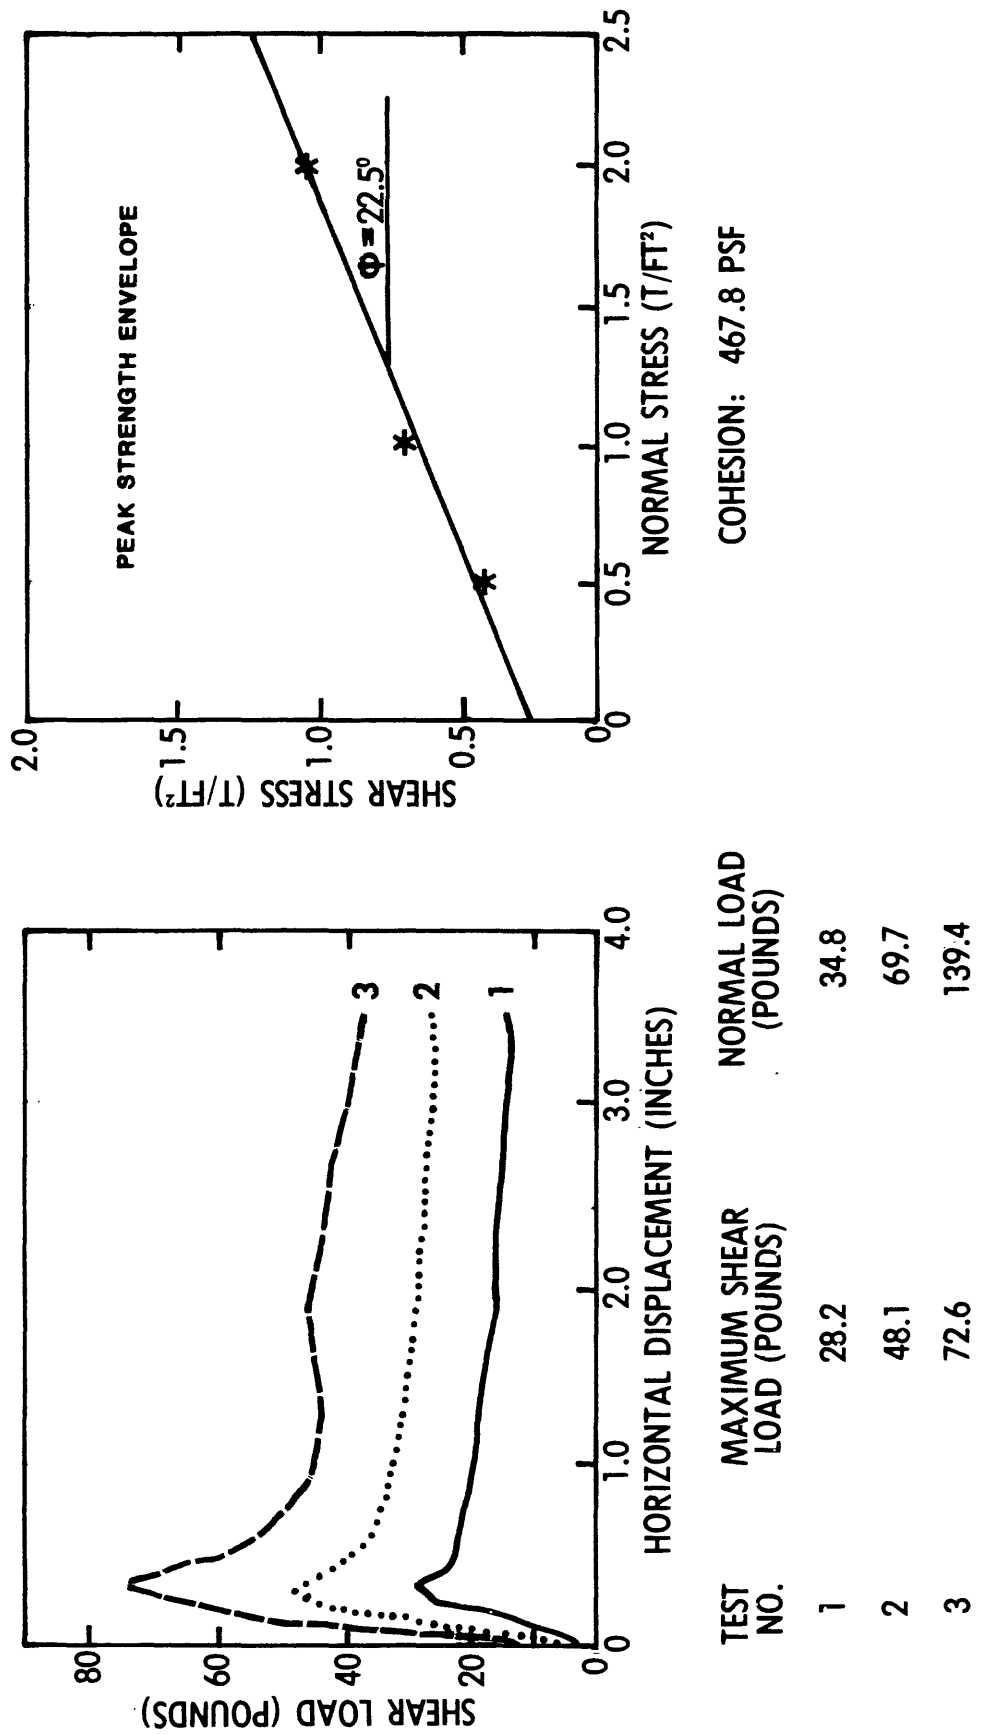
Figure 17.--Typical direct-shear test plots for varved clay (dark lamina, sample no. C-17) showing shear load-displacement curves and Mohr envelope relating shear stress and normal stress.

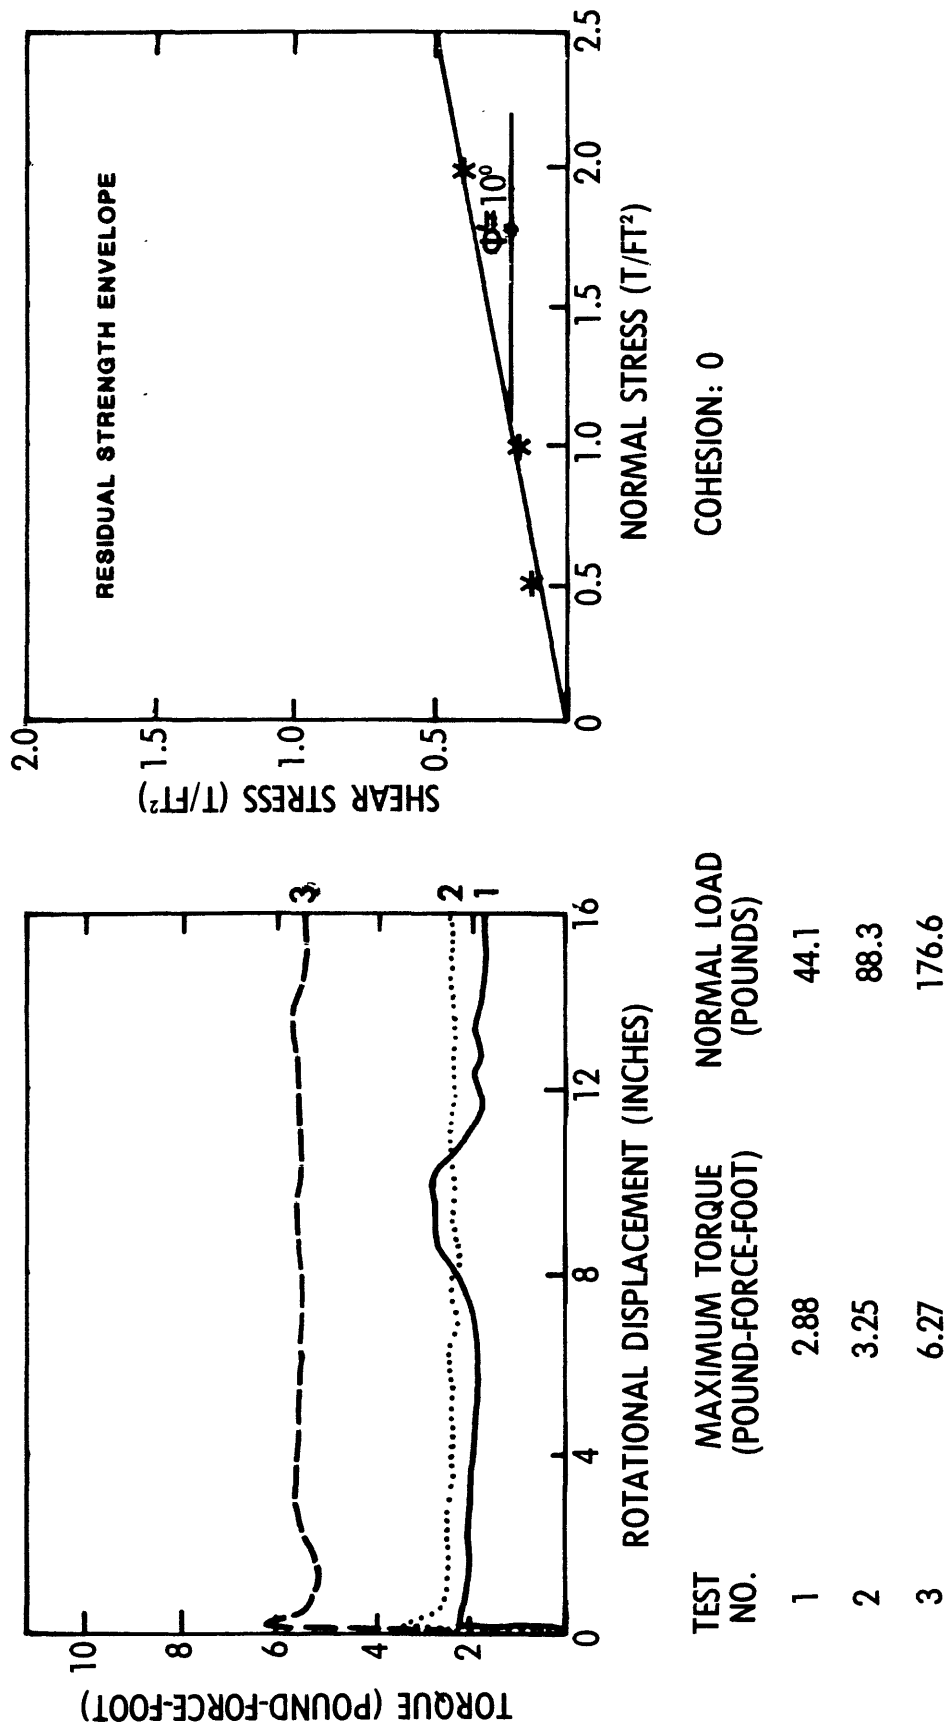
Figure 18.--Typical ring-shear test plots for remolded varved clay (dark lamina, sample no. C-17) showing torque-displacement curves and Mohr envelope relating shear stress and normal stress.

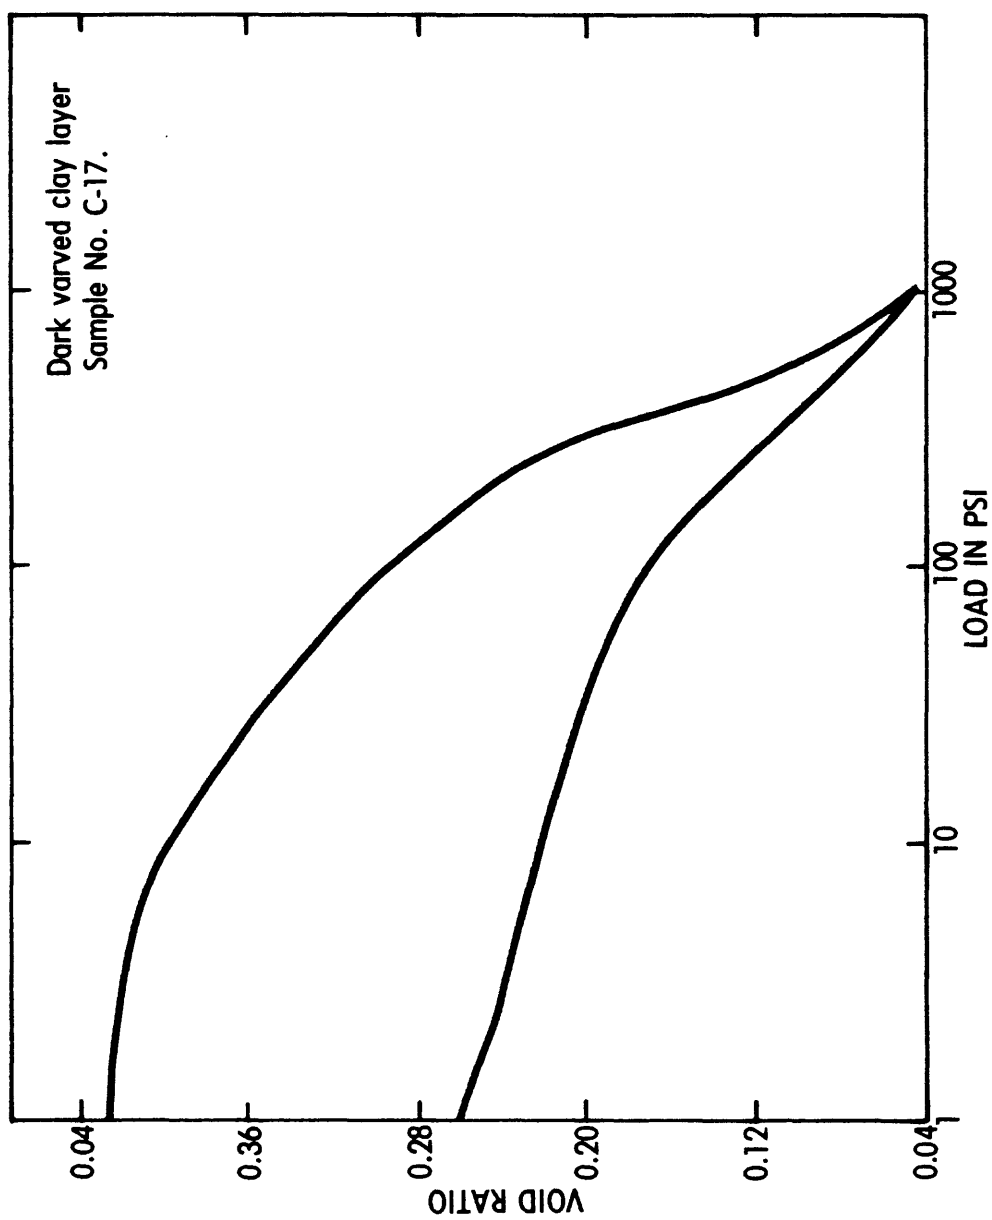
Maximum past consolidation stress interpreted by the Casagrande method for varved clay samples (fig. 19) is 5.8 tons/ft². The past consolidation stress may be accounted for by the previous overburden of valley-fill material, since removed by erosion.

Figure 19.--Consolidation test results for sample no. C-17 from slope area VI,
locality no. 1.
