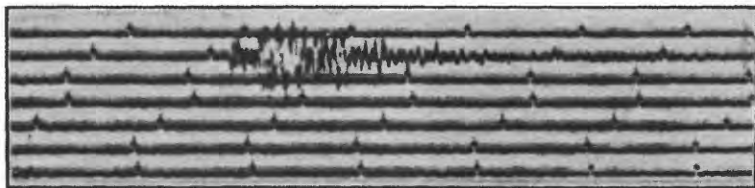
FIGURE 10.—Seismograph record of the Helena earthquake of November 28, obtained at the Montana State College, Bozeman.

with the adopted epicenter northeast of Helena. The interval for the November 29 shock is 2 seconds less, indicating an epicentral distance 15 kilometers shorter. This cannot be reconciled with the strong-motion data at Helena and should apparently be charged to questionable instrumental performance. The accelerograph data in this instance must be given the preference because of more precise time control. One millimeter corresponds to 4.0 seconds on the teleseismic record at Bozeman, but only 0.1 second on the Helena accelerograph.
