U.S. GEOLOGICAL SURVEY

**Preliminary Report**

**Investigations of the Central Chile**

**Earthquake of March 3, 1985**

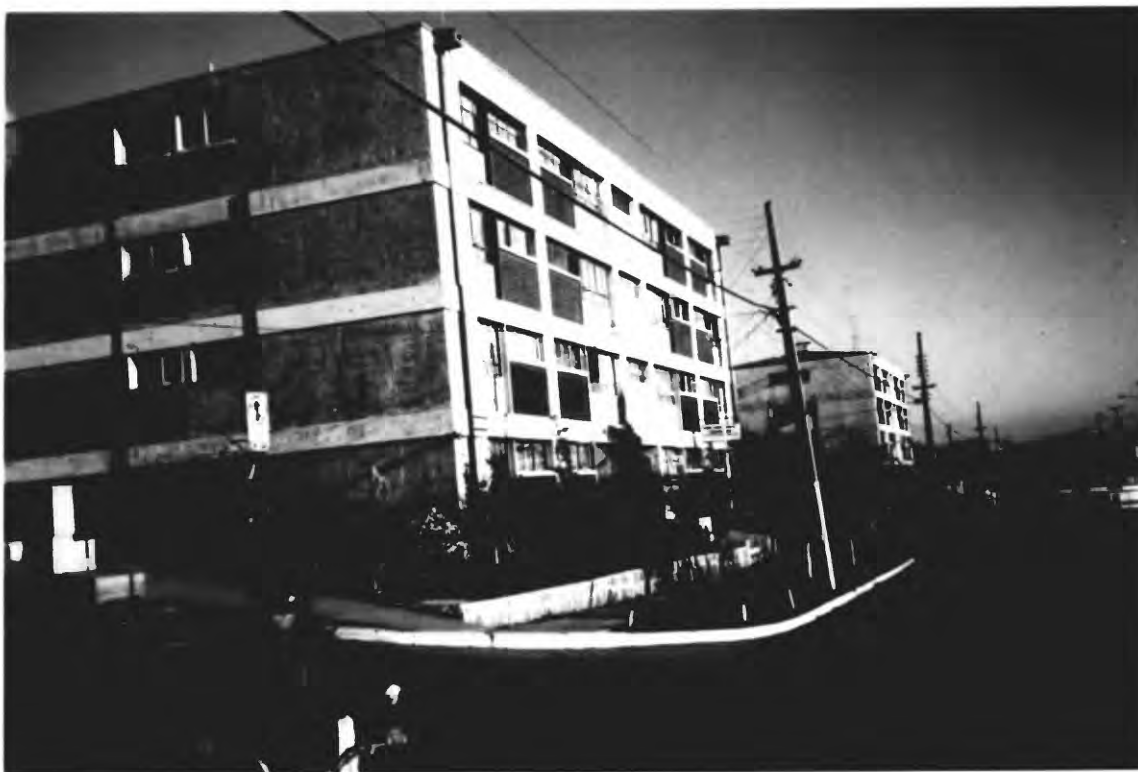
The apartment buildings in figure 12 located only two blocks from Claudio Vicuña Hospital suffered no damage.

Figure 12.--These apartment buildings near Claudio Vicuña Hospital were not damaged.

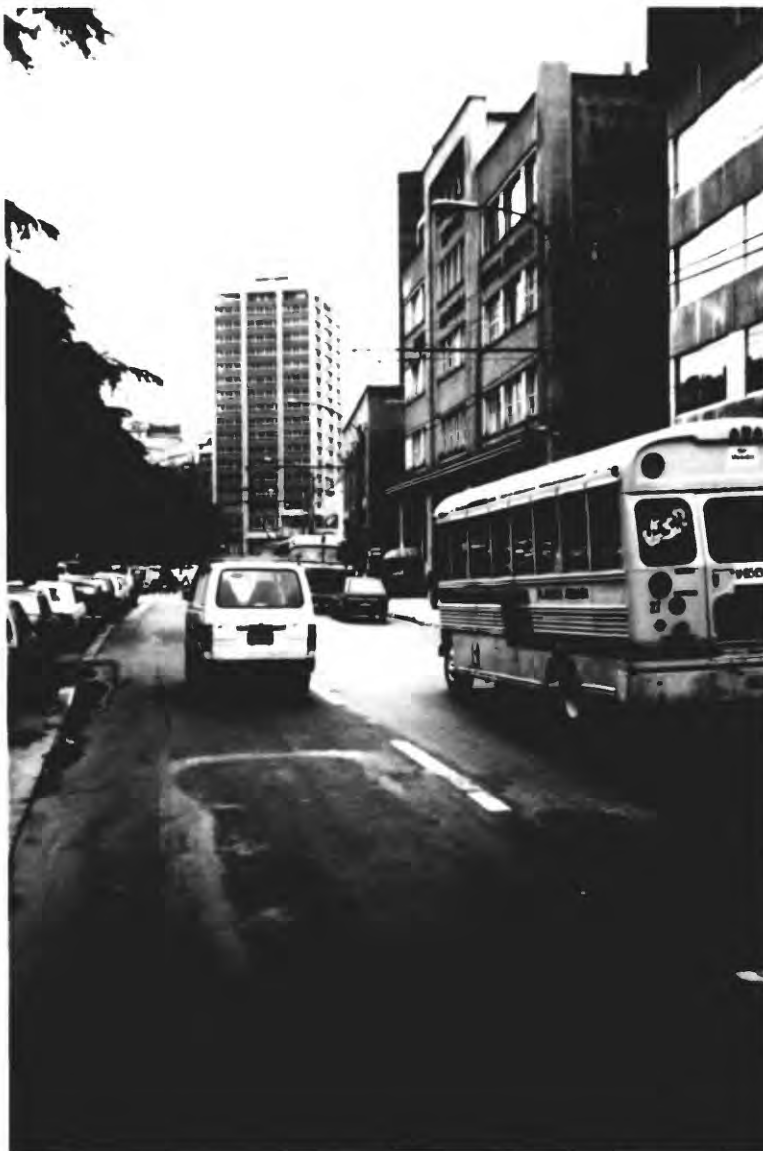
Near this hospital, other structures, particularly modern symmetrical structures with center shear wall core and columns in the exterior perimeter (fig. 16) performed well. This type of construction has been applied also in Viña del Mar and Santiago. No damage has been reported on these types of structures in those towns either.

Figure 16.--A modern symmetrical reinforced concrete structure near the Sermana Hospital. The building had a reinforced concrete core shear wall and columns around the perimeter. No damage was reported in this structure or other similar structures in Viña del Mar and Santiago.

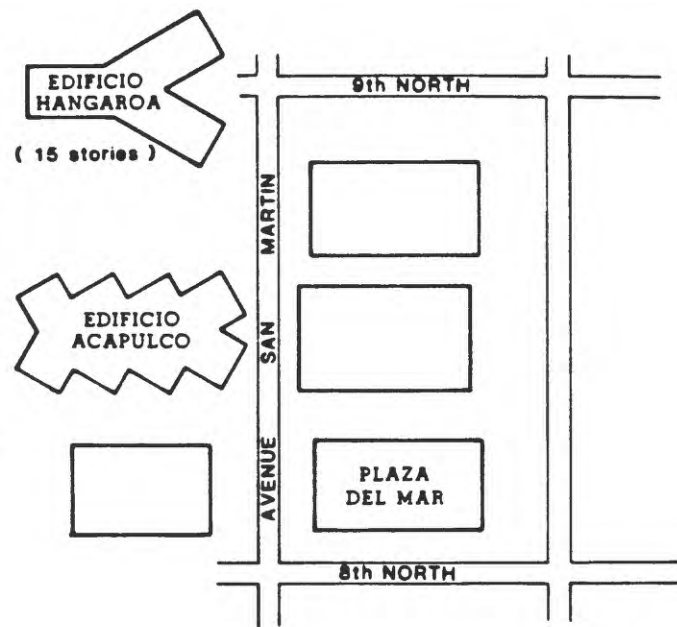
Figure 18.--Locations of low-rise damaged and undamaged buildings on the coast of Viña del Mar. See text for discussion.

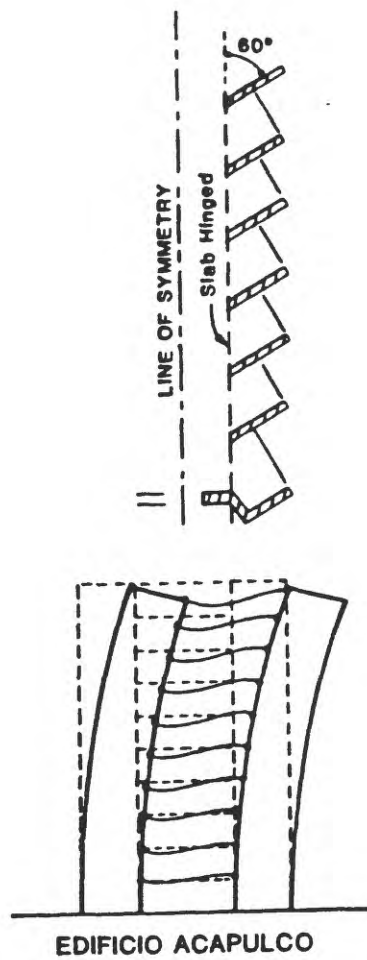
Figure 21.—Qualitative behavior of Edificio Acapulco.

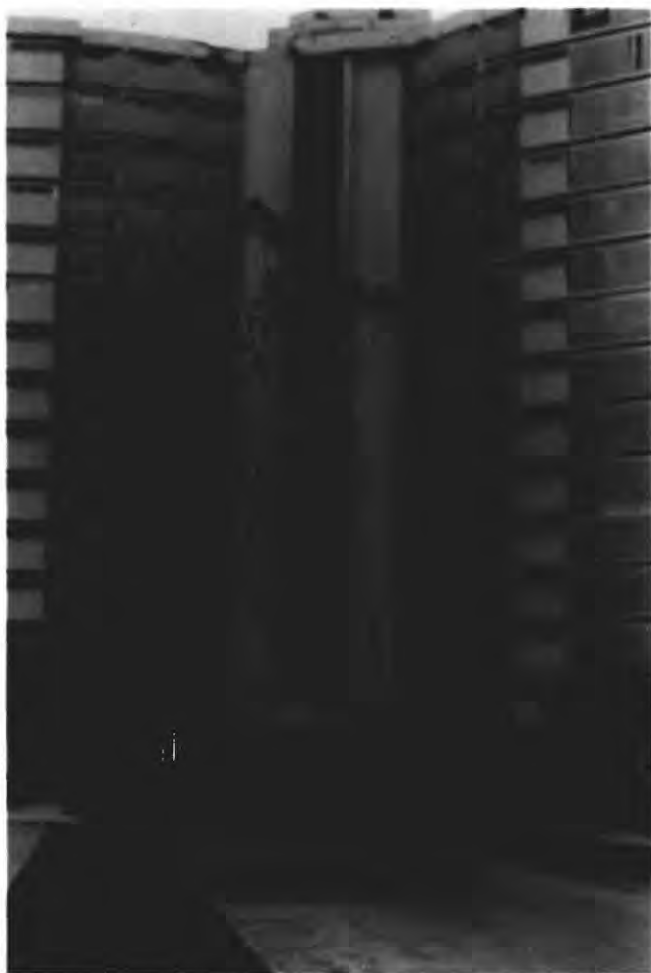
Figure 22.--Edificio H'Angoroa - 15 stories next to Edificio Acapulco. All fifteen floors had cracks in the diaphragms and the shear walls.

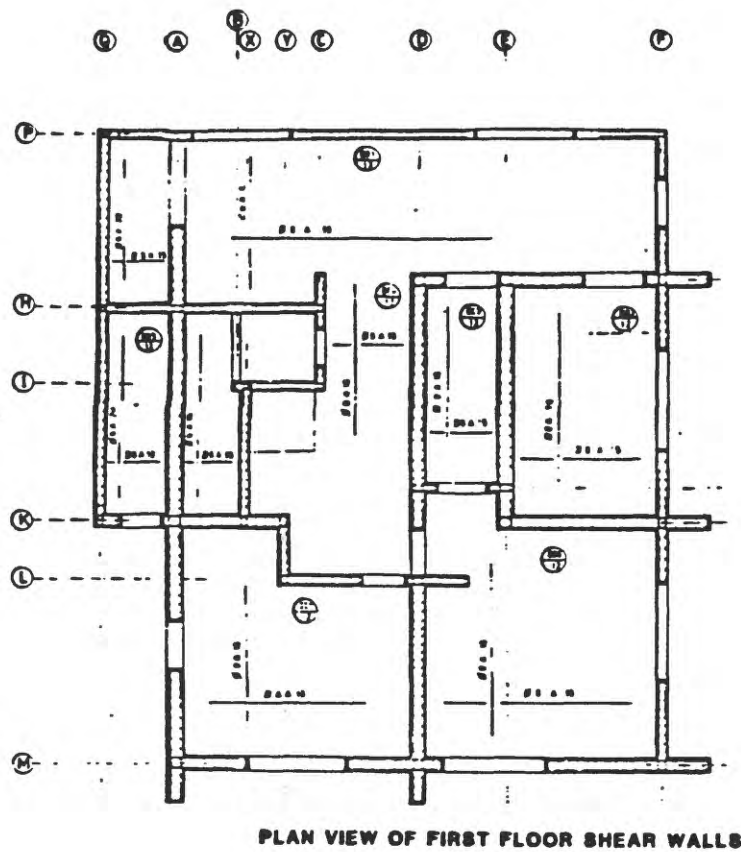
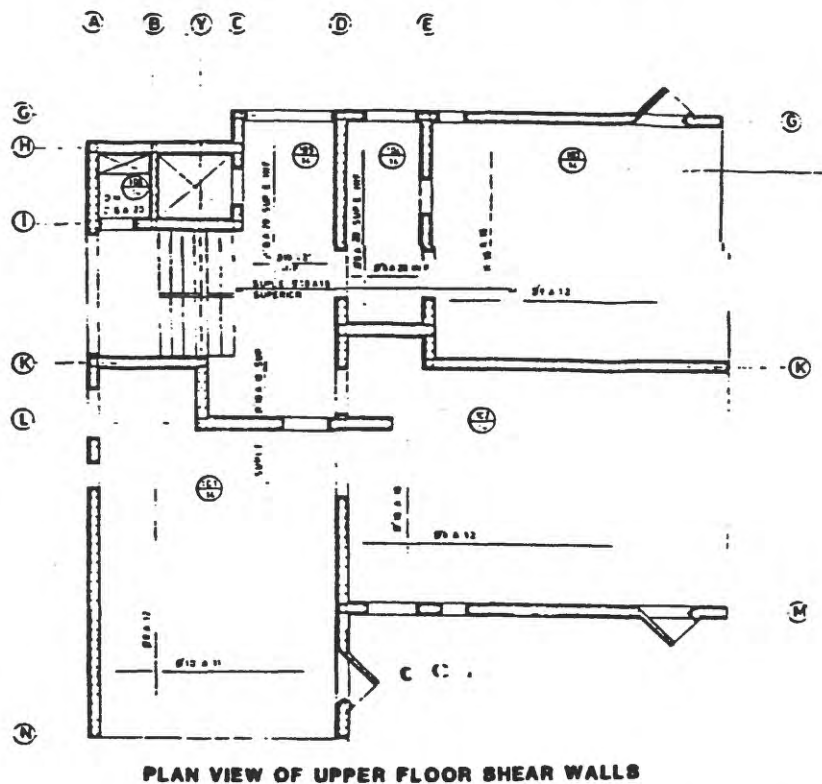
The third structure, Edificio El Faro, on top of the sand dunes of Reneca was a shear wall structure constructed on a continuous wall footing foundation. The foundation was not embedded effectively. The footing thickness was consistently 0.50 meters and the footing wall thickness varied between 0.20-0.30 m (only in one location the wall of the footing was 0.85 m thick, while generally the footing wall height is 2.5 m). The footings extended throughout the whole plan of the structure, leaving very small uncovered areas; therefore, for all practical purposes, the footing acted as a mat of 0.50 m thickness and with openings. The highly unsymmetrical layout of the shear walls is exhibited in figure 24. The total floor area accommodating three units of apartments per floor was 140 m<sup>2</sup>. The total weight of the structure was estimated to be 800-900 kips. At the entrance floor level there was approximately 11.5 m<sup>2</sup> of shear wall in each direction. In the upper floors the shear wall area was approximately 5.50 m<sup>2</sup> in each direction. If

Figure 24.—Plan view of the shear walls of Edificio El Faro - on the hilltop of sand dunes of Reneca.

only direct shear forces are considered, the available shear walls appear to be sufficient even when minimum concrete shear resistance is considered. However, preliminary evaluations point out that the structure may have been subjected to rocking and uplift, particularly since its foundation had little or no effective embedment. Also, it may have been subjected to torsional effects. Considering the fundamental period of the structure incorporating soil structure interaction as compared with that of sand, it is totally conceivable that the structure was also in resonance. During the earthquake, the walls in the first floor of such a structure were completely crushed and the structure tilted off its vertical axis by 12-15° (fig. 25). As a consequence, the structure was dynamited to level it off on the ground. Further detailed analysis into the failure aspects of the structure is being performed by the author.

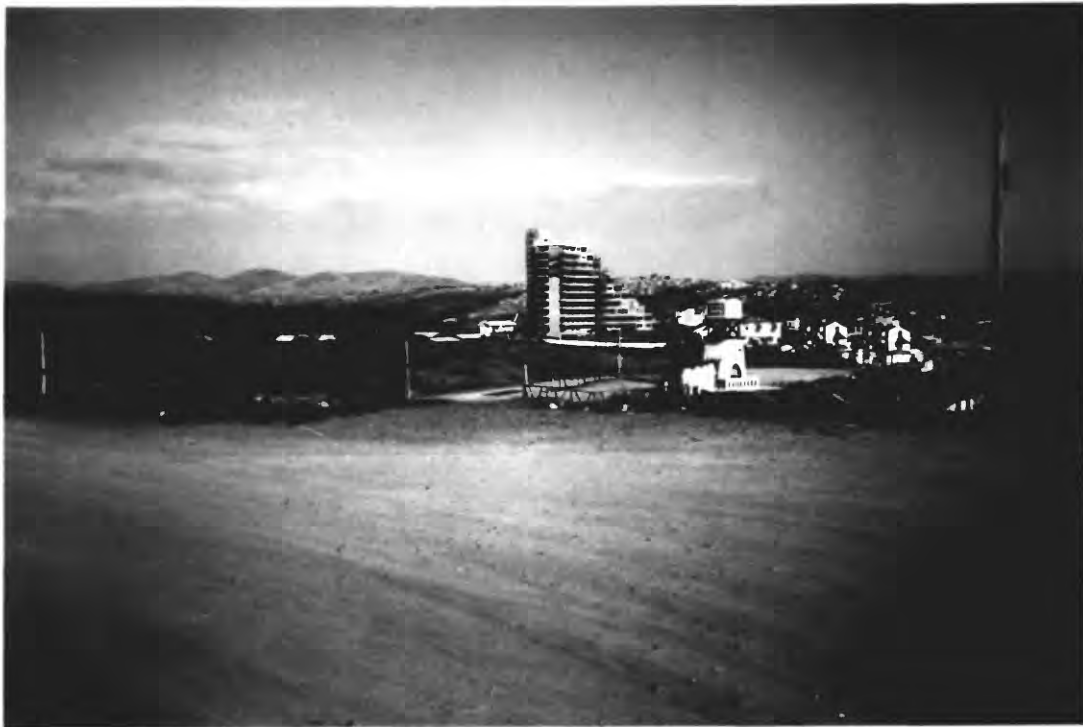
In close proximity to Edificio El Faro (approximately 150 yards), and on the steep hilltop, a new reinforced concrete structure still under construction was not damaged (fig. 26). Also, another new reinforced concrete framed structure still under construction on rock right on the coast and down from the sand dune hill where Edificio El Faro once stood, was not damaged at all (fig. 27).

Figure 26.--On the same hill as Edificio El Faro, this new structure under construction suffered no damage.

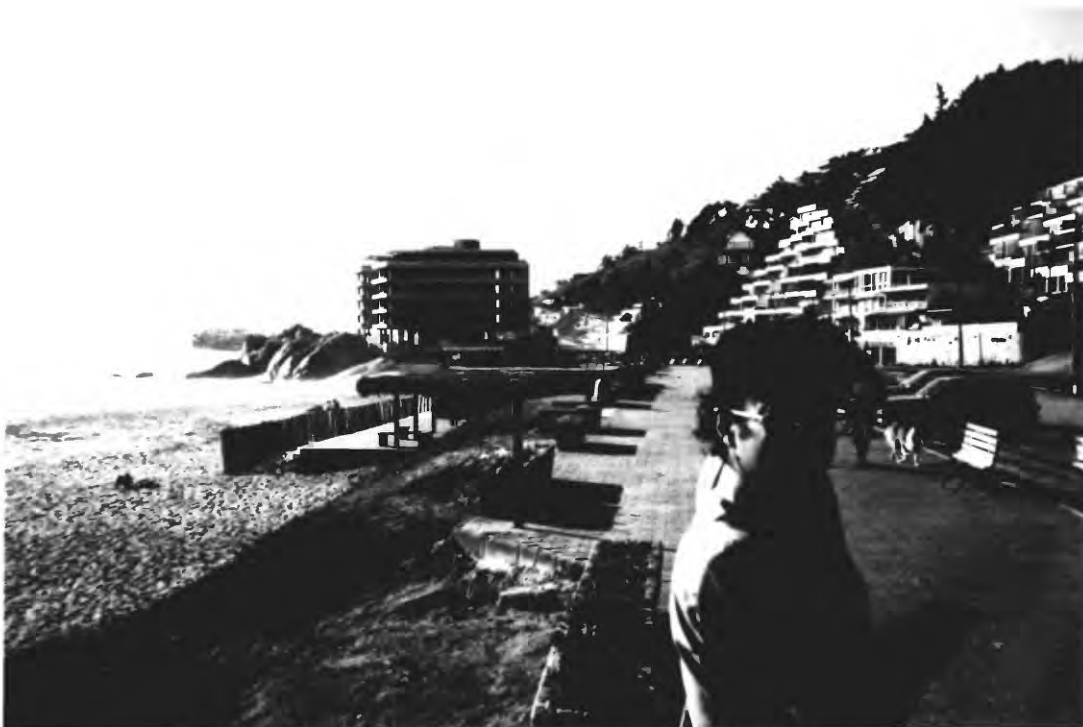
Figure 27.--Down from the hilltop where Edificio El Faro was located, this new structure under construction on the rocky part of the beach suffered no damage. Note, to the right, modern condominium structures built on the slope.

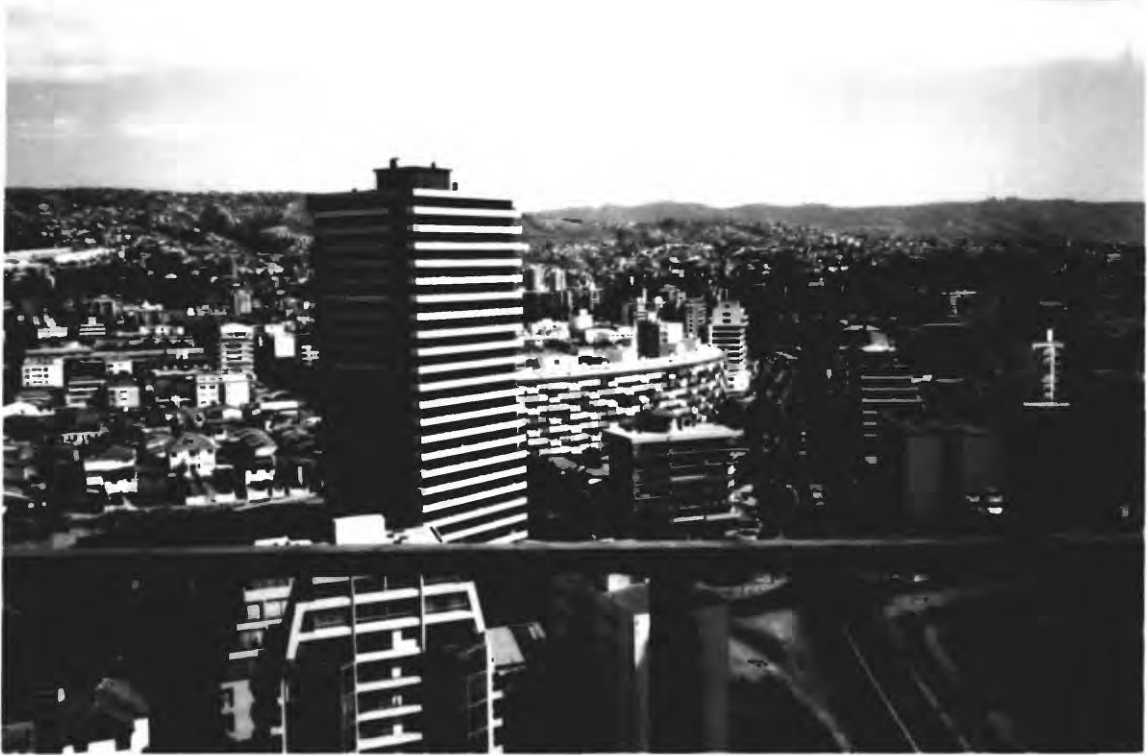
Only two blocks away from the structures in figure 18, the 23 story symmetrical structure (fig. 30) with central core shear wall performed well without distress.

Figure 30.--Another symmetrical structure with central concrete shear wall core on Avenue San Martin performed well.

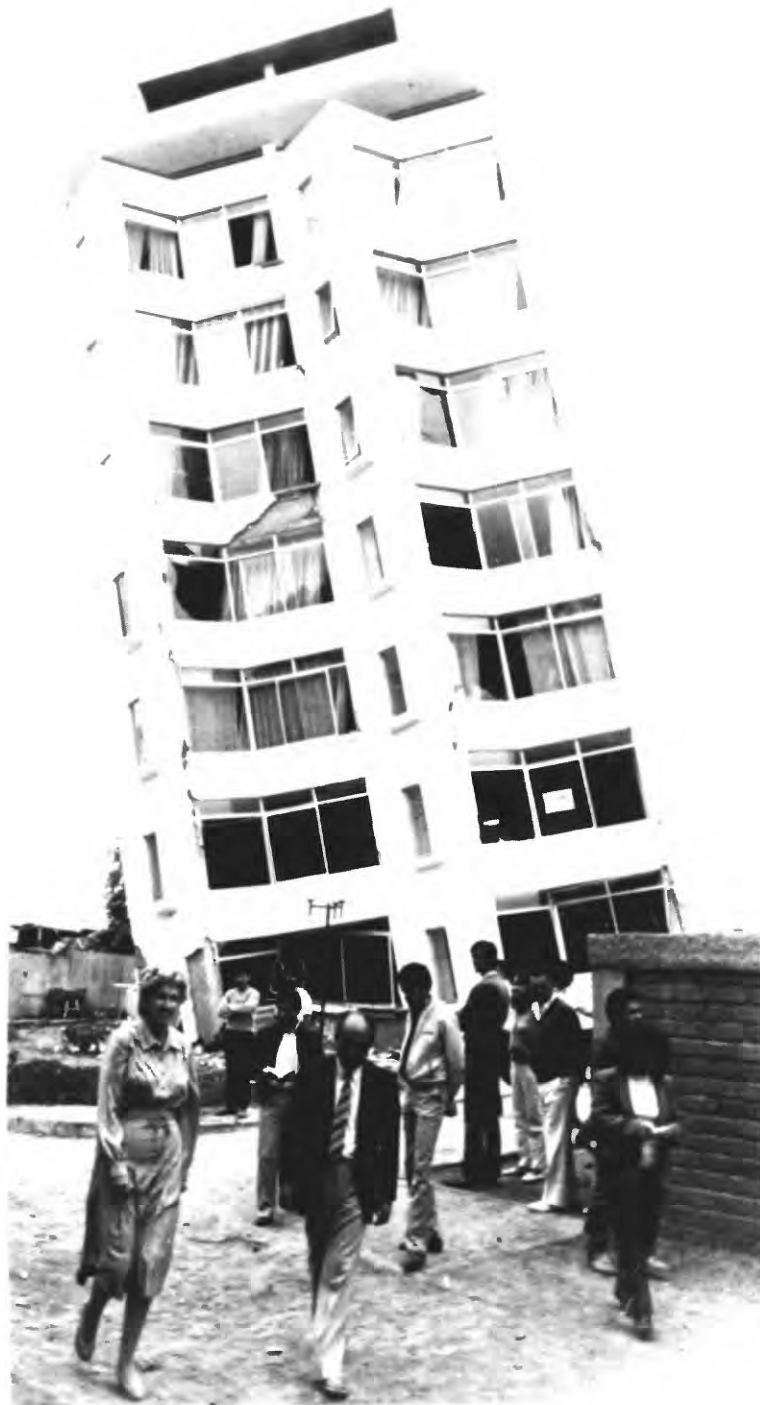
Figure 25.--Tilted view of Edificio El Faro before it was dynamited. The first story shear wall had been completely crushed.

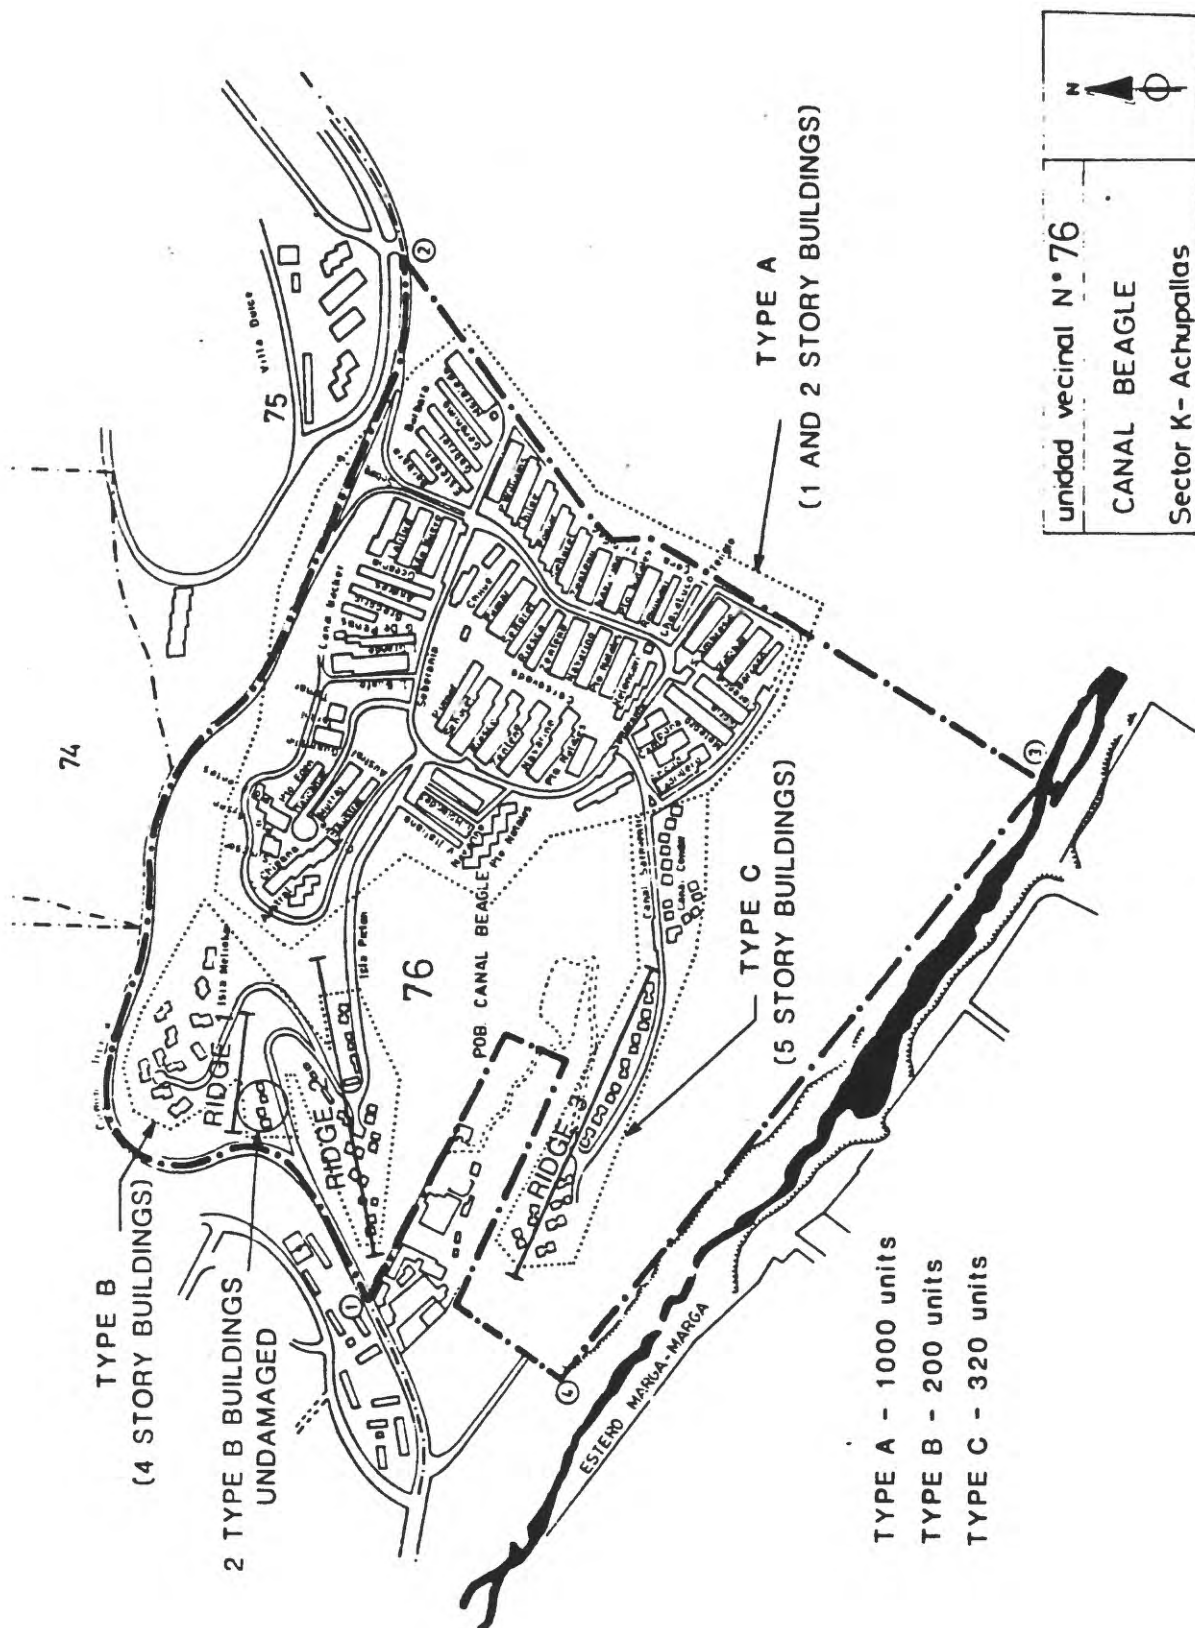
The general topography of the subdivision can be best described to consist of three steep sloped ridges (marked on fig. 31) emerging from a less steep hilltop on which Type A structures have been constructed. Most Type B and all of Type C structures are on the steep sloped ridges.

Figure 31.--General layout of Canal Beagle Subdivision. Note locations of Type A, B, and C structures. Also, qualitatively, major axis of the three ridges are given.

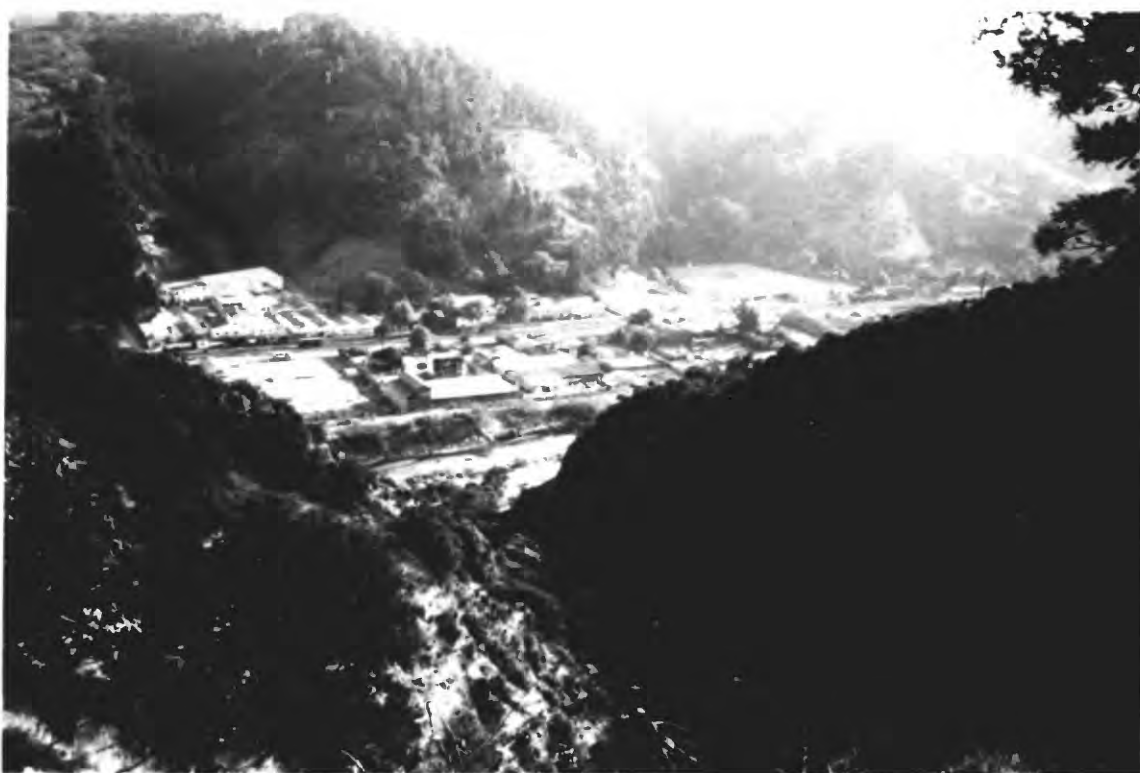
5. Type A structures founded on relatively easier slopes of the hill from which the described ridges emerge performed well except for two. The two damaged Type A structures (one seen in fig. 37) are on a street which is next to a steep canyon. The street had cracked extensively (fig. 38) and the canyon next to the street is seen in figure 39. Pertinent information on these structures as well as the general distribution of damage is summarized in Table 1.

Figure 39.--Canyon next to the street with the two damaged Type A structures.

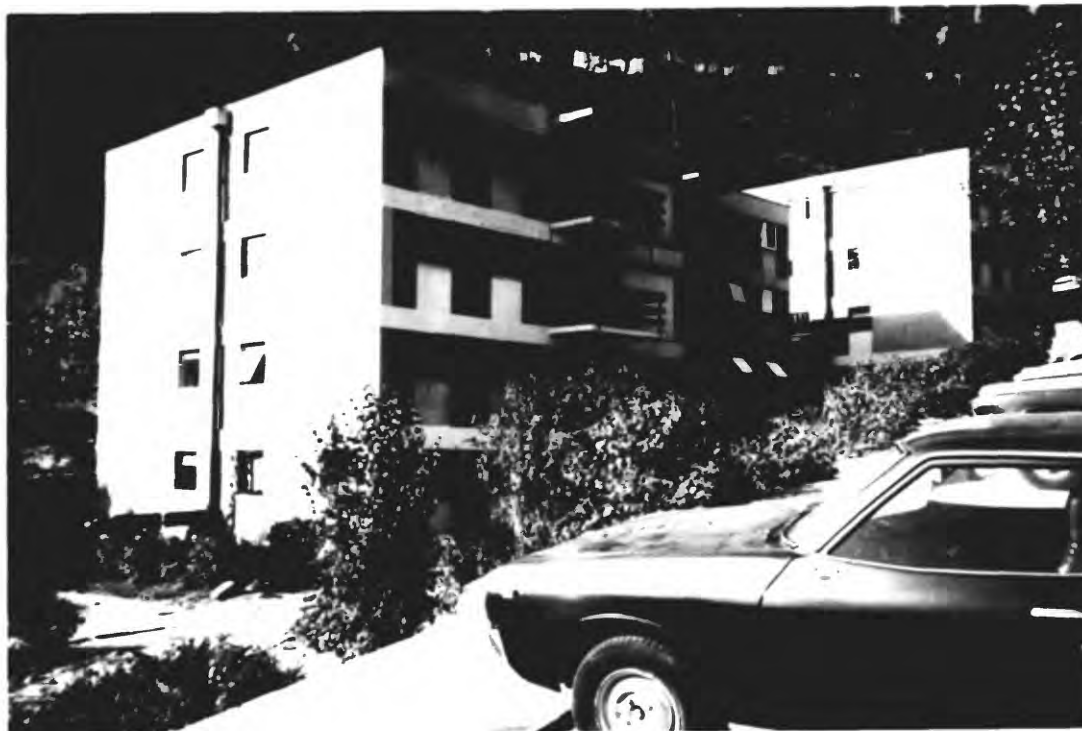
- Fig 1. Two Type B structures (fig. 34) at entrance to the Canal Beagle Subdivision were not damaged at all. These two structures were constructed on relatively flat land at the foot of one of the ridges.

Figure 34.--These two Type B structures at entrance to the Canal Beagle subdivision were not damaged at all. These two structures were constructed on relatively flat land at the foot of one of the ridges.

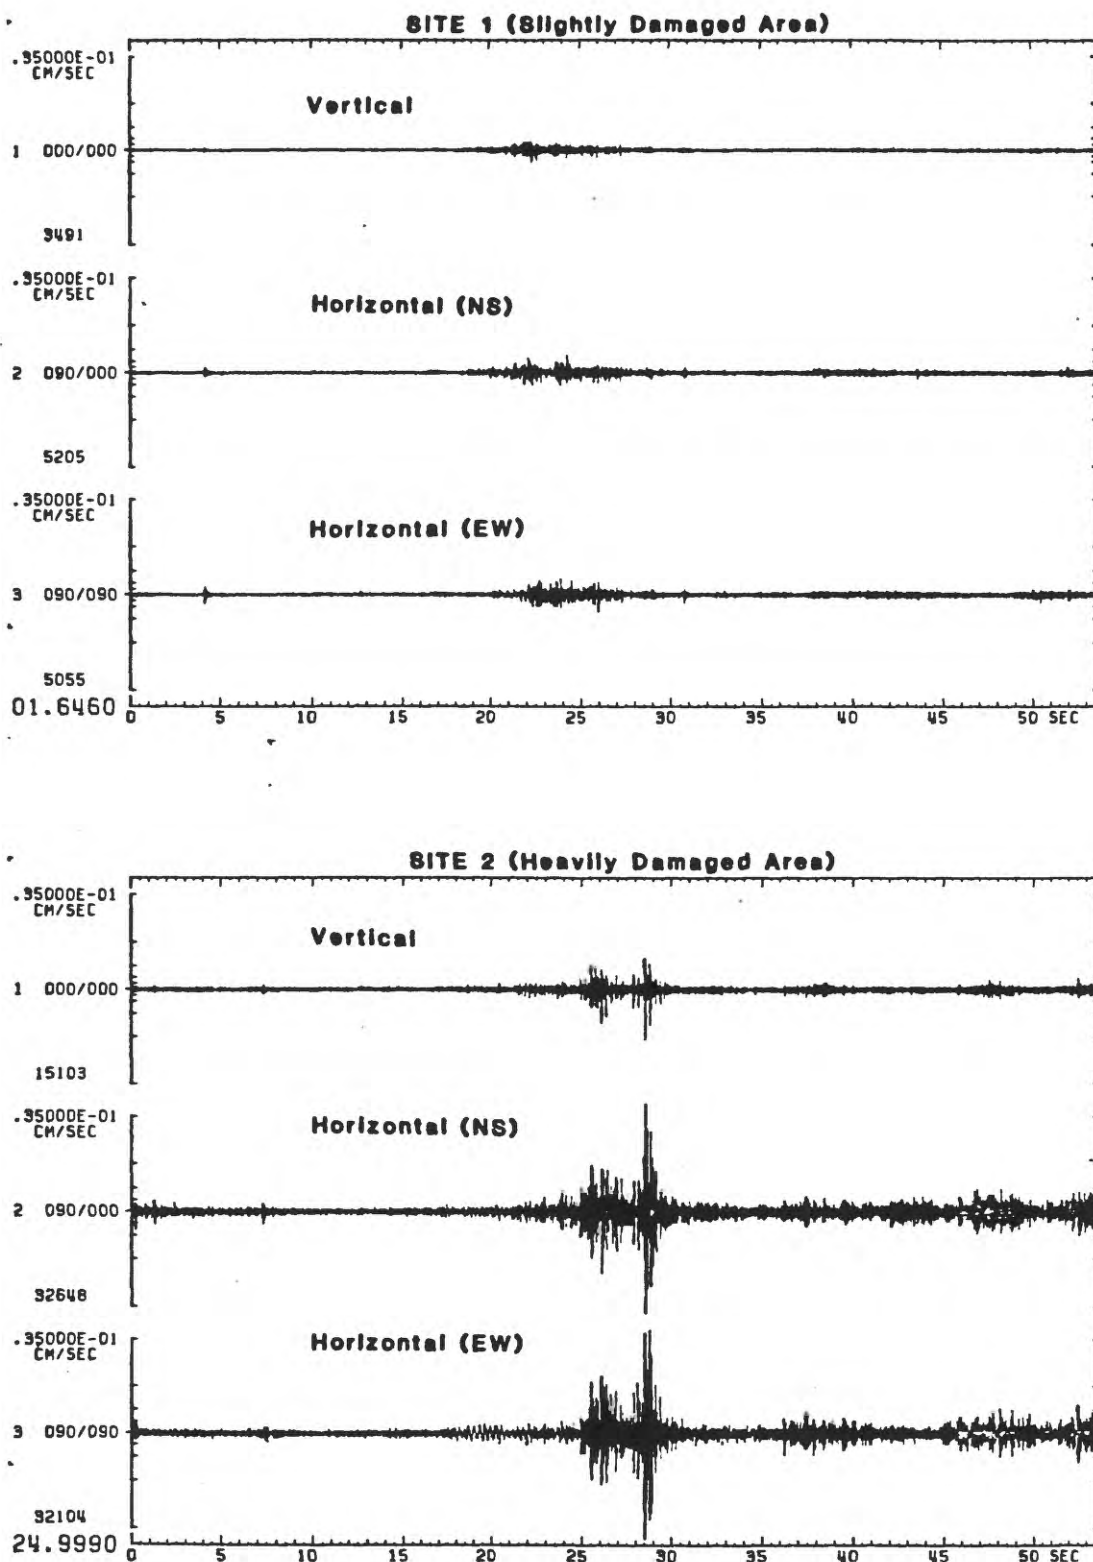
The possibility of amplification due to topography has been preliminarily investigated by the writer. One set of velocity transducers (with two horizontal and one vertical component) were placed at nearby free field grounds of each of two Type B structures on sloping terrain. One of these structures was damaged only slightly (designated as Site 1), and the other was heavily damaged (designated as Site 2). Figure 40 illustrates a portion of the velocity response obtained with General Earthquake Observation System (GEOS) detailed description of which is provided elsewhere (Borcherdt and others, 1985). As exhibited in figure 40, there is substantial amplification of velocity response in each of the components at Site 2 as compared with Site 1. However, this evidence is very preliminary, and further detailed measurements need to be obtained at the Canal Beagle Subdivision.

Figure 40.—Comparison of three components of velocity responses of noise at two sites at Canal Beagle (Site 1 was slightly damaged, whereas Site 2 was heavily damaged). Although this is a very limited and preliminary result, it indicates qualitatively that there is amplification at Canal Beagle topography.

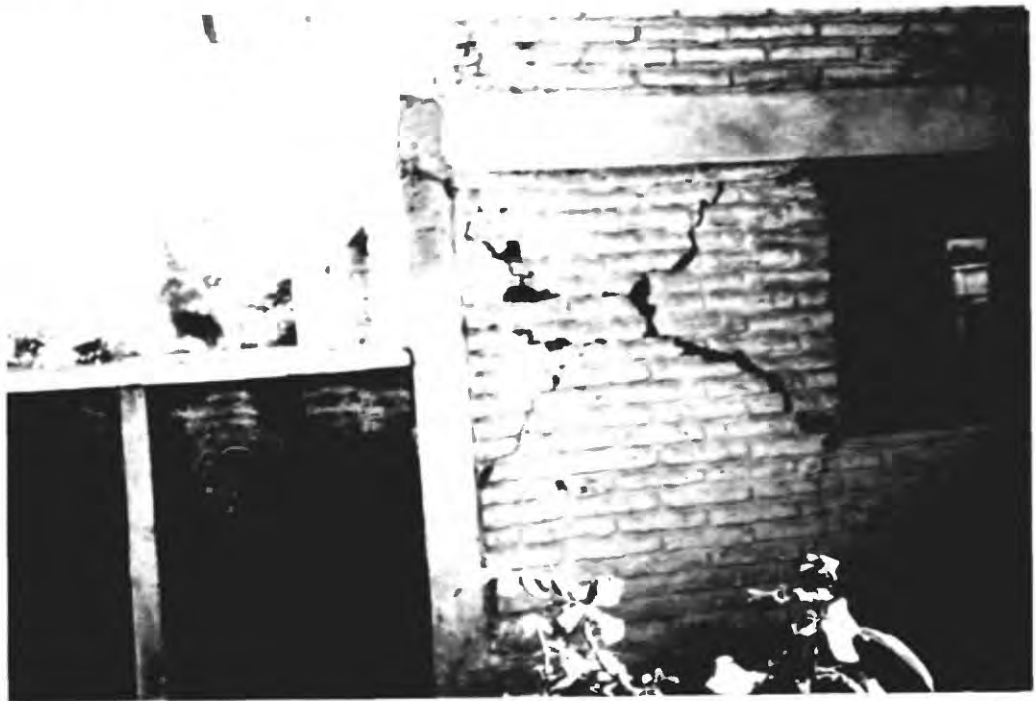
In figure 50, a general view of these buildings is provided. Figures 51a through 51d depict the type of damage that was repetitious in these structures. Typically, distress occurred at beam to column connections at the corners of the buildings as well as diagonal cracks in the infill brick walls. The ground floor mat appeared not to have suffered any distress. The damage sustained by these structures can generally be attributed to insufficient lateral resistance of the ground floor and specifically may be attributed to: 1) design deficiencies such as large openings, insufficient shear reinforcement for columns and the embedment length of rebars, and 2) construction deficiencies such as poor quality of concrete (large gravels, low strength concrete), poor quality mortar, and possibly low quality bricks used in the masonry.

Figure 51.--Typical damages sustained by the infill walls and concrete frame elements as well as corner beam to column connections (a,b,c,d).

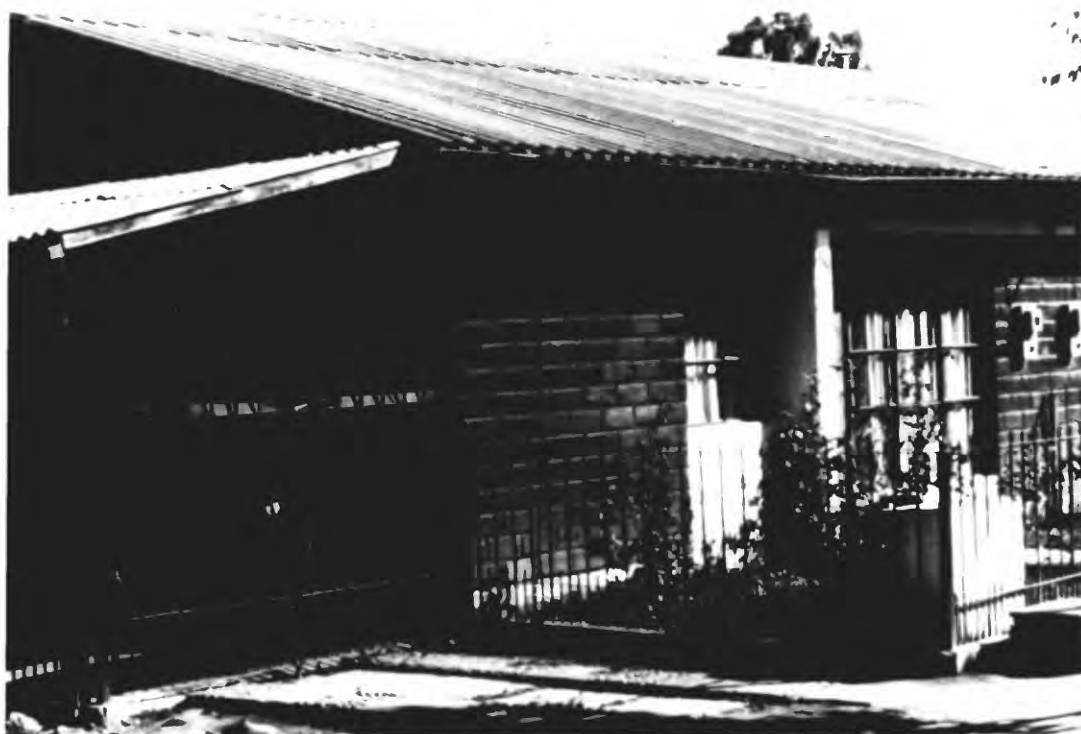
An interesting aspect of this particular site was that across the street in the next block were numerous single story (social housing) buildings (fig. 52), none of which were damaged. These homes were constructed well and each had an effective tie-beam on the load bearing masonry walls, which were strengthened by four reinforced concrete columns that were not in the corners of the buildings.

Figure 52.--Single story social housing structures in Melipilla. These structures were not damaged. They are in the next block from the three story reinforced framed structures that were damaged.

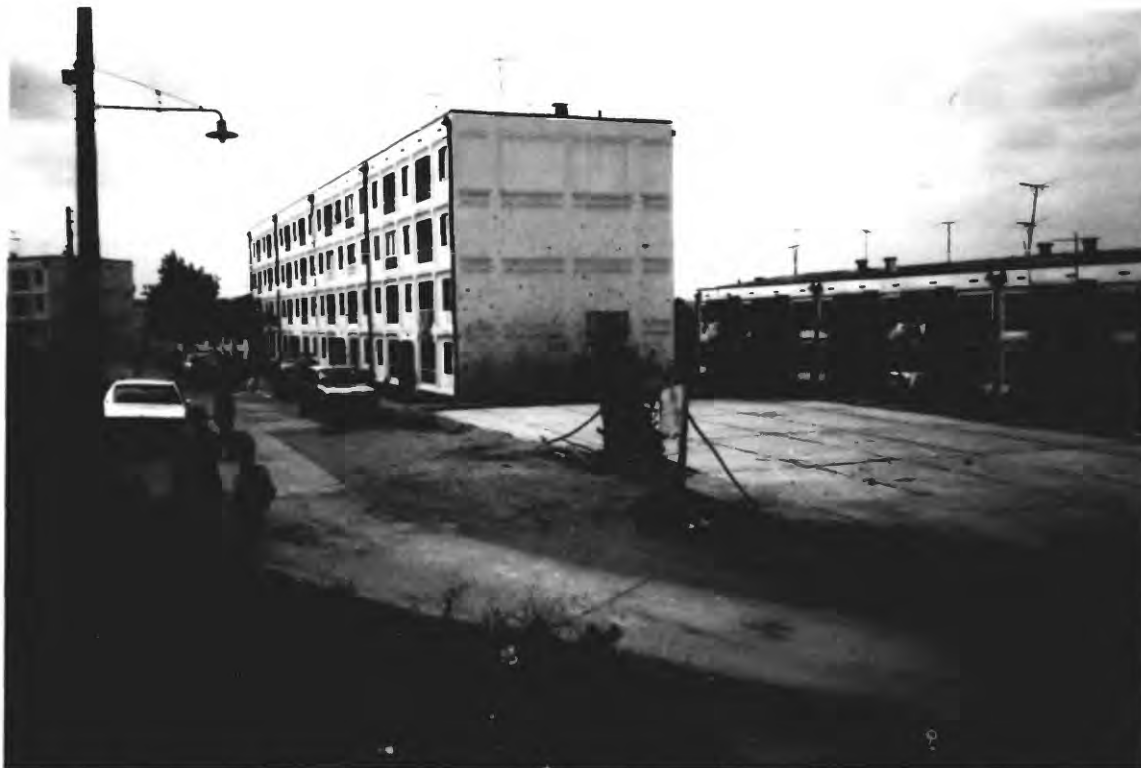
Figure 53.--General view of precast structures built with prefabricated panels. Approximately 150 of these structures were built in Viña del Mar and Valparaiso. Only two suffered minor damage.
