UNITED STATES DEPARTMENT OF THE INTERIOR

GEOLOGICAL SURVEY

SOME SLOPE MOVEMENT PROBLEMS IN WINDSOR COUNTY,

VERMONT, 1984

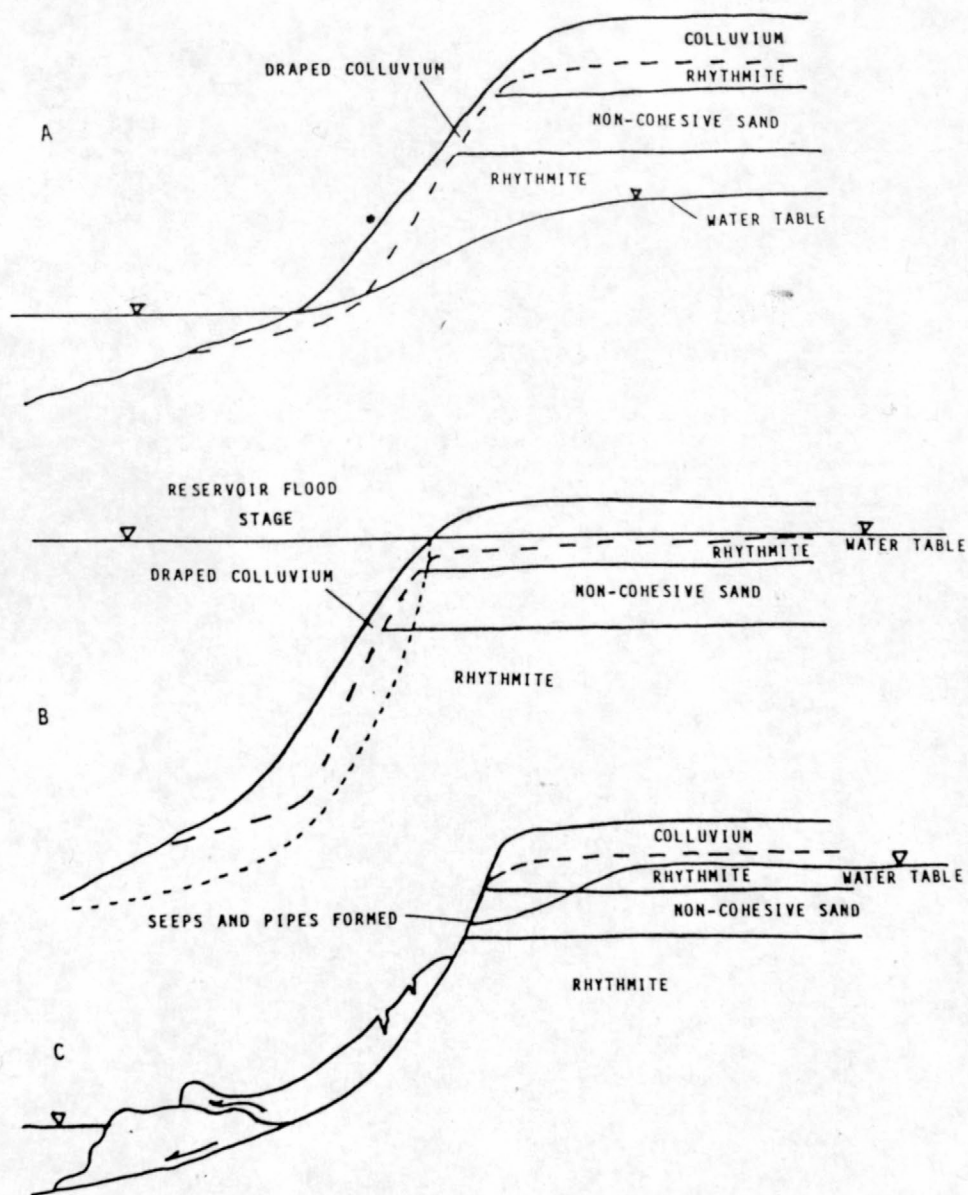
Figure 4. Schematic cross sections of a typical flood reservoir slope configuration in which earth flow and piping failures have developed. A - pre-flooding configuration; B - flood stage; C - post-slide and piping configuration.

Of the many landslides that occurred on the southwest valley wall of the North Hartland reservoir, one in particular, just west of the boat ramp parking lot had piping associated with the failure (Fig. 6). The site, a terrace, consisted of a rhythmite sequence, covered by a layer of colluvium. Near the top of the terrace, the rhythmite sequence was interrupted by a 4 foot (1.2 m) thick medium sand layer. The non-cohesive sand layer, having had a higher hydraulic conductivity than the surrounding rhythmites, acted as a confined aquifer as shown in Fig. 4.

The slope failed as an earth flow, which was partially fed by water from the confined sand layer as well as from the saturated colluvium (Fig. 4). The material involved in the failure included the colluvial cover along the slope face as well as some of the rhythmite sequence. It moved as a rapid fluid earth flow across a stream channel and was stopped by the parking lot embankment (see foreground of Fig. 9). The failure removed

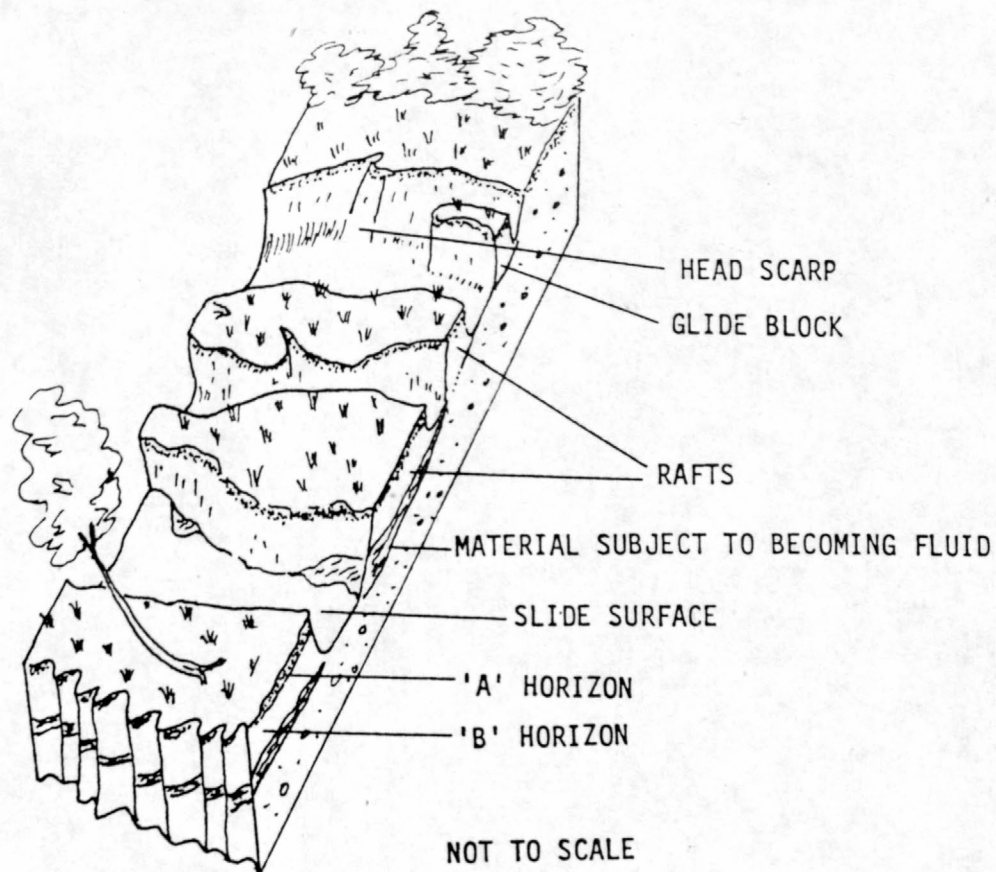
In the upper part of the slide mass near the head scarp, the basal zone of liquified material pinched out and was replaced by a planar failure surface (Fig. 8). In the headscarp area of these earth flows some small minor rotational slumps were seen that were separate from the main failure mass.

Figure 8. A block diagram showing rafts of intact material sliding on a fluidized substrate which pinches out headward. The failure surface above the pinchout point becomes a planar frictional surface. This friction creates a pulling apart of the slide material on tension cracks, developing some separated glide blocks.

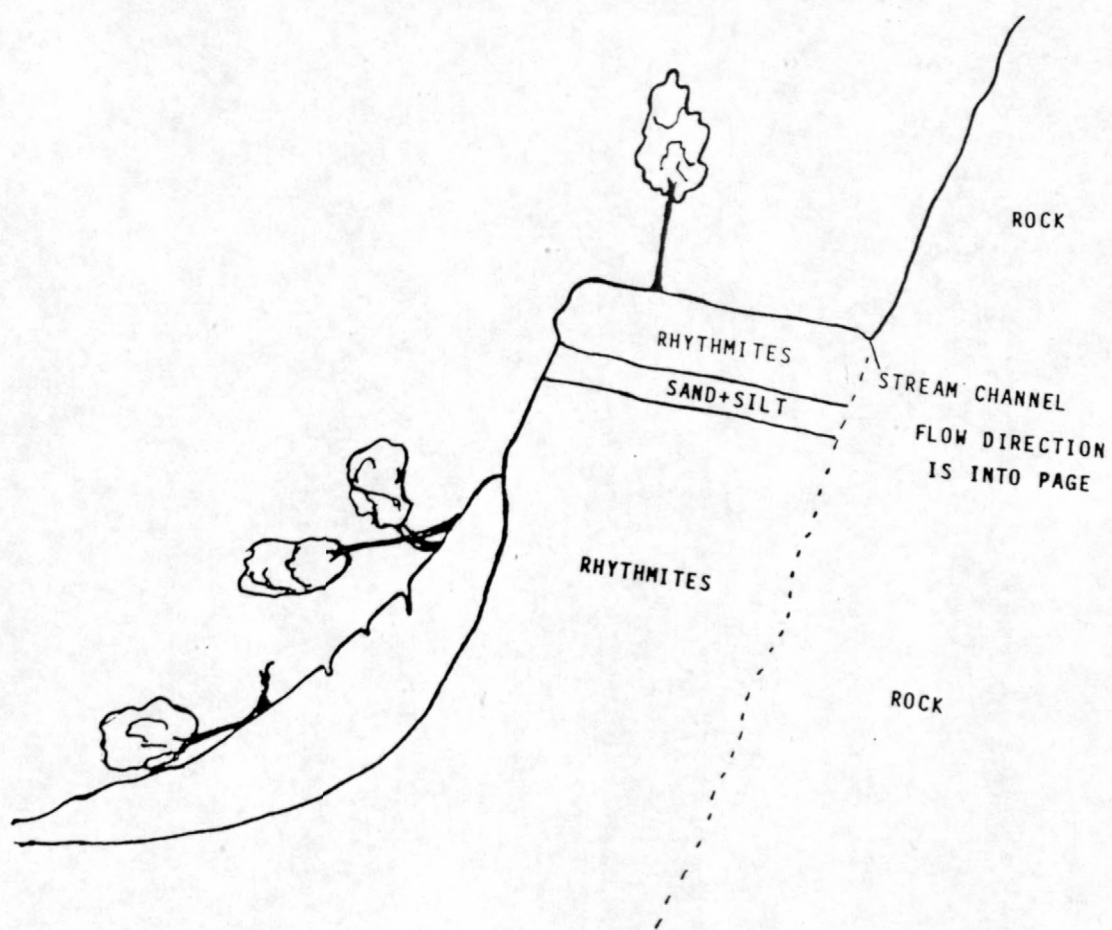
parallel to the bedrock hill. Water from these springs also soaks into the terrace sediments and re-emerges as springs on the terrace front (Fig. 11). In a trench excavated in the scarp face to obtain a clean exposure of the rhythmic sequence, water flowed from the silty sand layers.

Figure 11. Schematic section of the terrace configuration at Vermont Route 11 slide site showing strata and water flow direction.

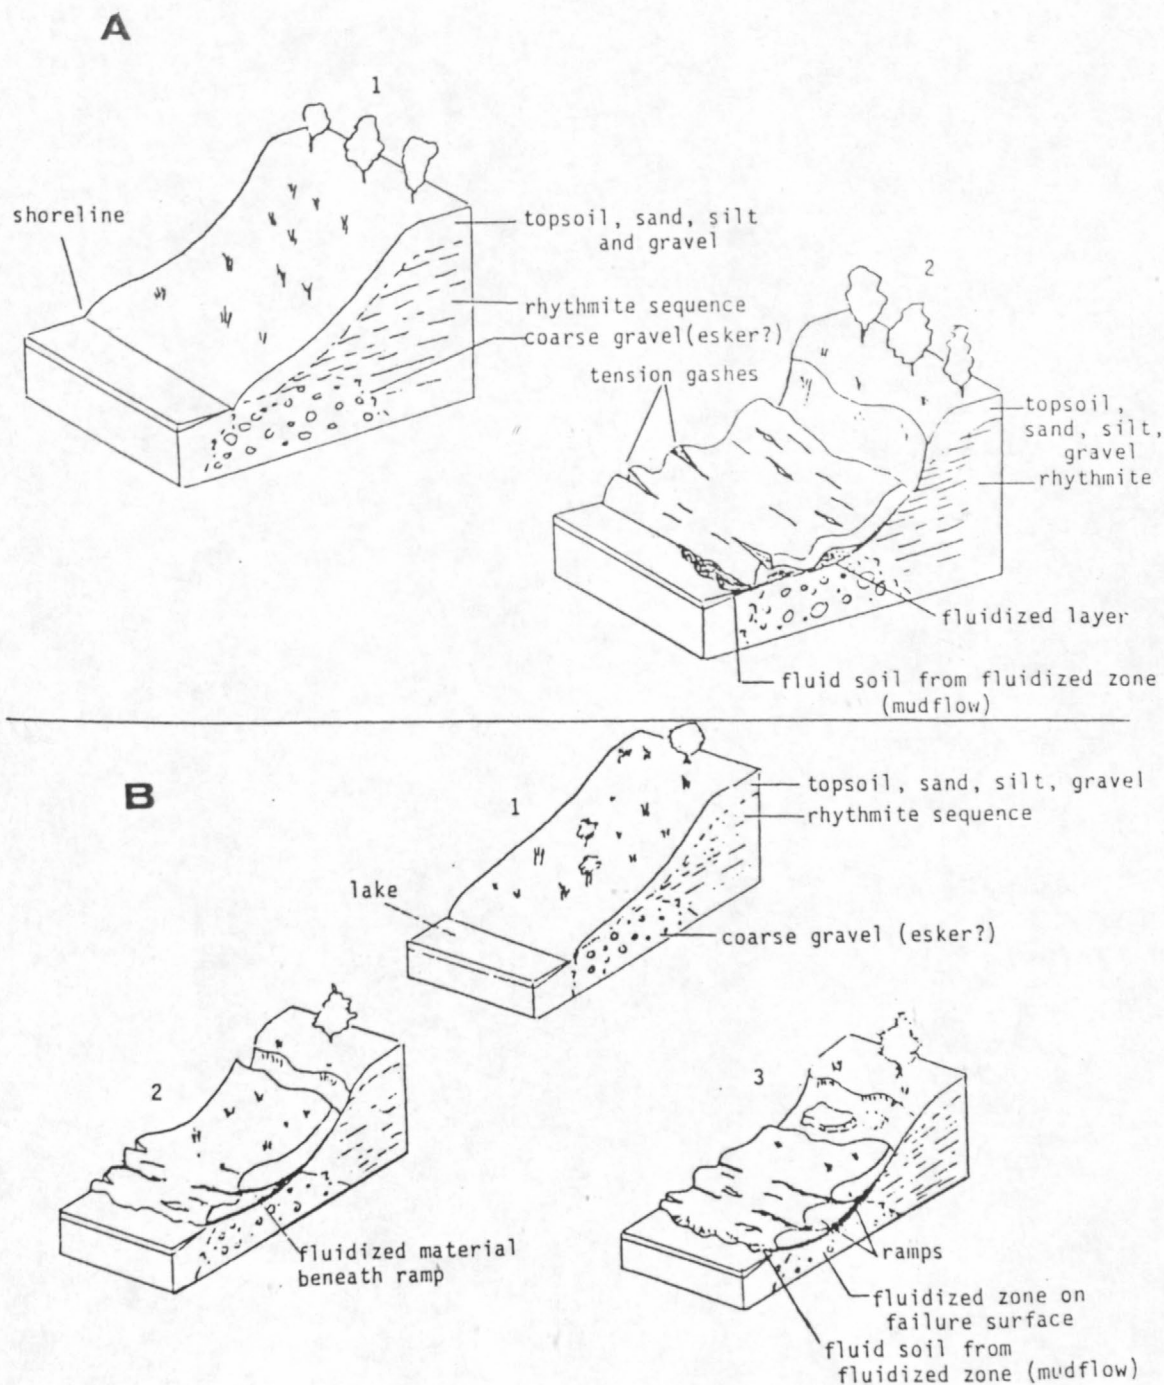
Toes on failures at the North Springfield site were somewhat different from what was observed at the North Hartland site. At North Springfield, multiple ridges or hummocks of slide material were aligned parallel to the toe, whereas many of the toe areas at North Hartland had relatively smooth surfaces with en echelon tension gashes normal to the slide axis. At the site which was stabilized by the Corps of Engineers closest to the dam, on the east valley wall (B in Fig. 13), the hummocky toe consisted of a rigid layer which buckled upon sliding; small crevasses formed by the buckling became filled with fine grained fluidized material from beneath the flow (Fig. 14A). This buckled layer had the appearance similar to a rug which has been slid against a wall and folded.

In some of the toes the buckling appeared to go a step further probably due to a greater velocity or a greater fluidity in the sliding material. As the distal part of the toe stopped moving, slide material in the main track behind the toe would still be travelling on a fluidized substrate. The still moving mass then probably formed an overthrust sheet, and ramped up onto the first sheet. This process apparently repeated itself several times (Fig.14B). At the leading edge of a thrust sheet, a linear trough occurred that was filled with material from the fluidized fine grained substrate.

Figure 14. Section sketches depicting the processes for the formation of multiple ridges or hummocks at the east abutment of the North Springfield dam. (A) The hummocks developed in the intact layer are shown with the fine grained fluidized material from beneath penetrating the cracks in the upper layer. (B) Mode of overthrusting and ramping in the toe area of slope movements. These sketches are not to scale.

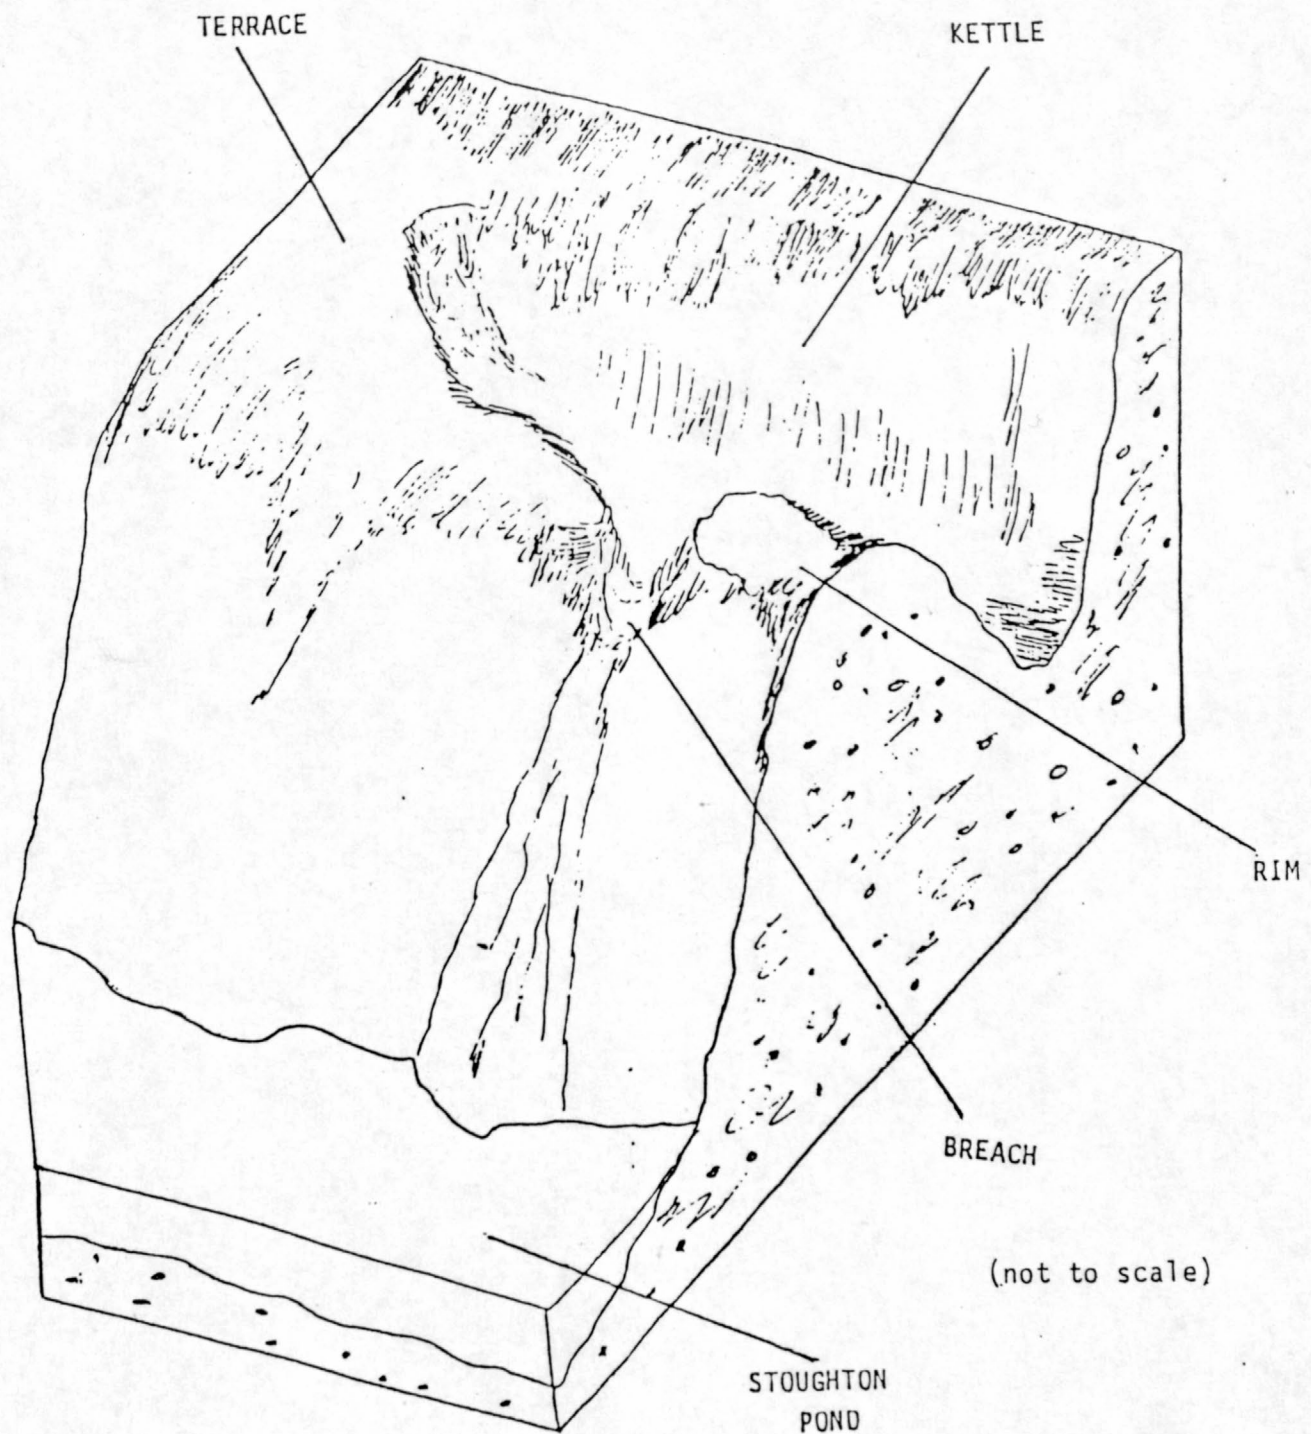
depression (kettle) (Fig. 18) that strikes N. 30 E. The floor of the kettle is about 15 feet (4.57 m) above the normal pond level. The crest of the west rim of this depression, which is also the east rim of the reservoir, is approximately 20 feet (6.09 m) above the depression floor. Rim width averages about 15 feet (4.57 m). The rim has been breached several hundred feet (tens of meters) north of the east abutment of the dam (Fig. 18). The breach extends 5 to 6 feet (1.52 to 1.83 m) below the top of the rim.

Figure 18. A block-section sketch of a portion of the east shore of Stoughton Pond to show the reservoir terrace kettle rim relationship. This sketch is not to scale.
