**Preliminary Evaluation of Structures:
Whittier Narrows Earthquake of October 1, 1987**

OPEN-FILE REPORT 87-621

October 1987

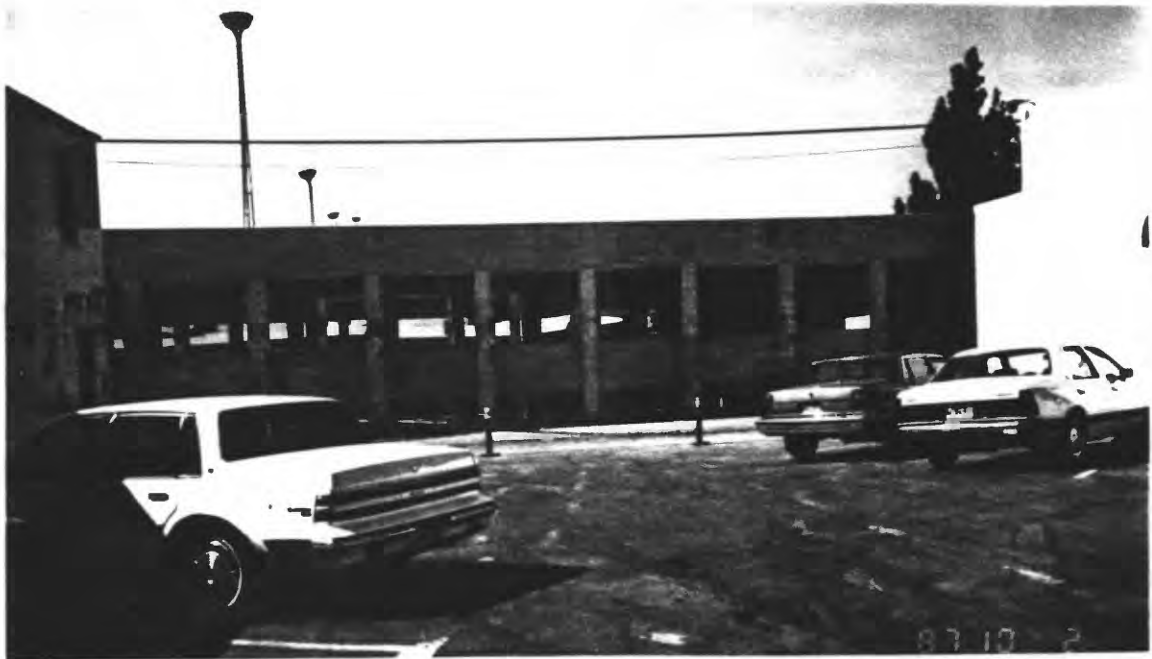
is seen in Figure 11. The partially collapsed section of the garage is seen in Figure 12. A cursory inspection of the damaged building brought forth the following characteristics:

Figure 11. A general view of the May Company Parking Garage in downtown Whittier.
