U.S. Department of the Interior
Geological Survey

**Vibration Investigation of the Museum Building at
White Sands National Monument, New Mexico**

Open-File Report
88-544

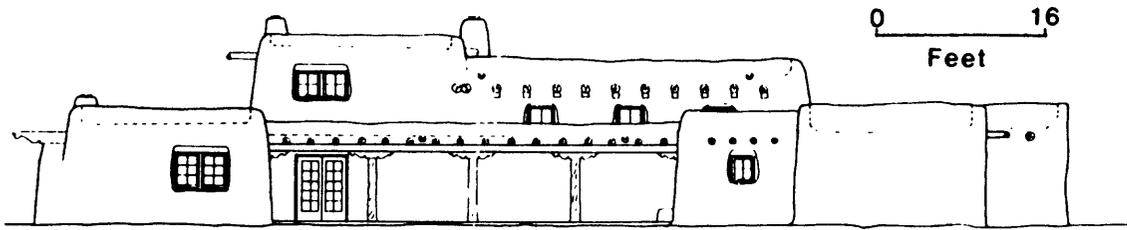
A

Fig. 2. (A) White Sands National Monument Museum and Administration Building, front view (Southeast elevation). (B) plan view showing wall and roof identifiers and locations of long-term instruments.
