DEPARTMENT OF THE INTERIOR
UNITED STATES GEOLOGICAL SURVEY

HIGHWAY DAMAGE RELATED TO FAULTS NEAR PIERRE, SOUTH DAKOTA

Open-File Report 88-674

Highway Damage Related to Faults Near Pierre, South Dakota

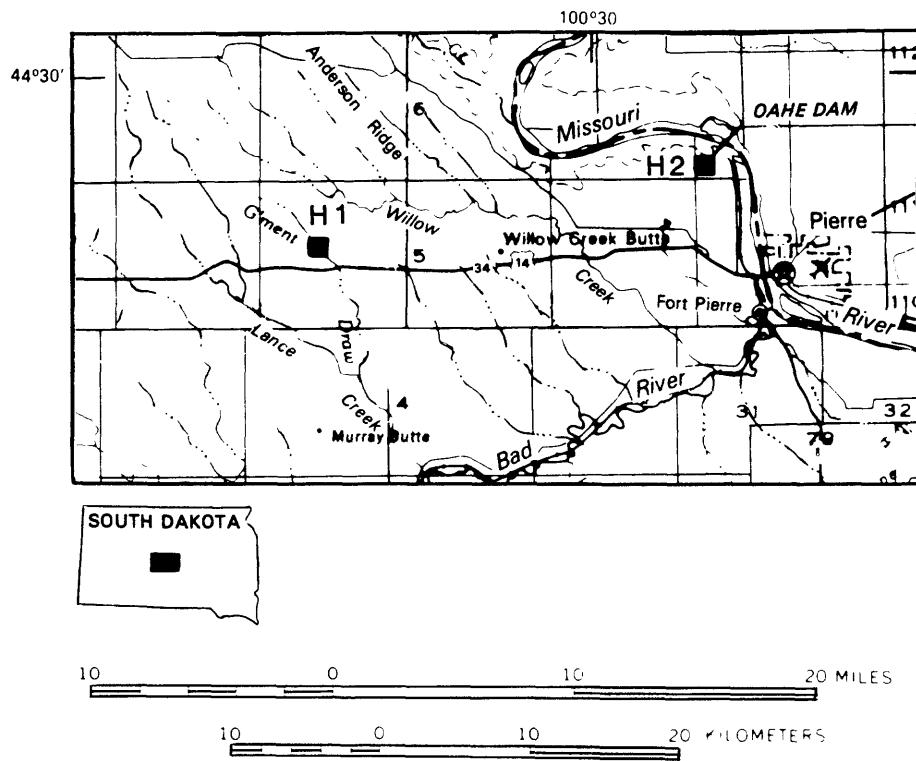
FIGURE 1. Map showing two locations of highway damage (H1 and H2) related to faults within the Stanley County, South Dakota, study area.

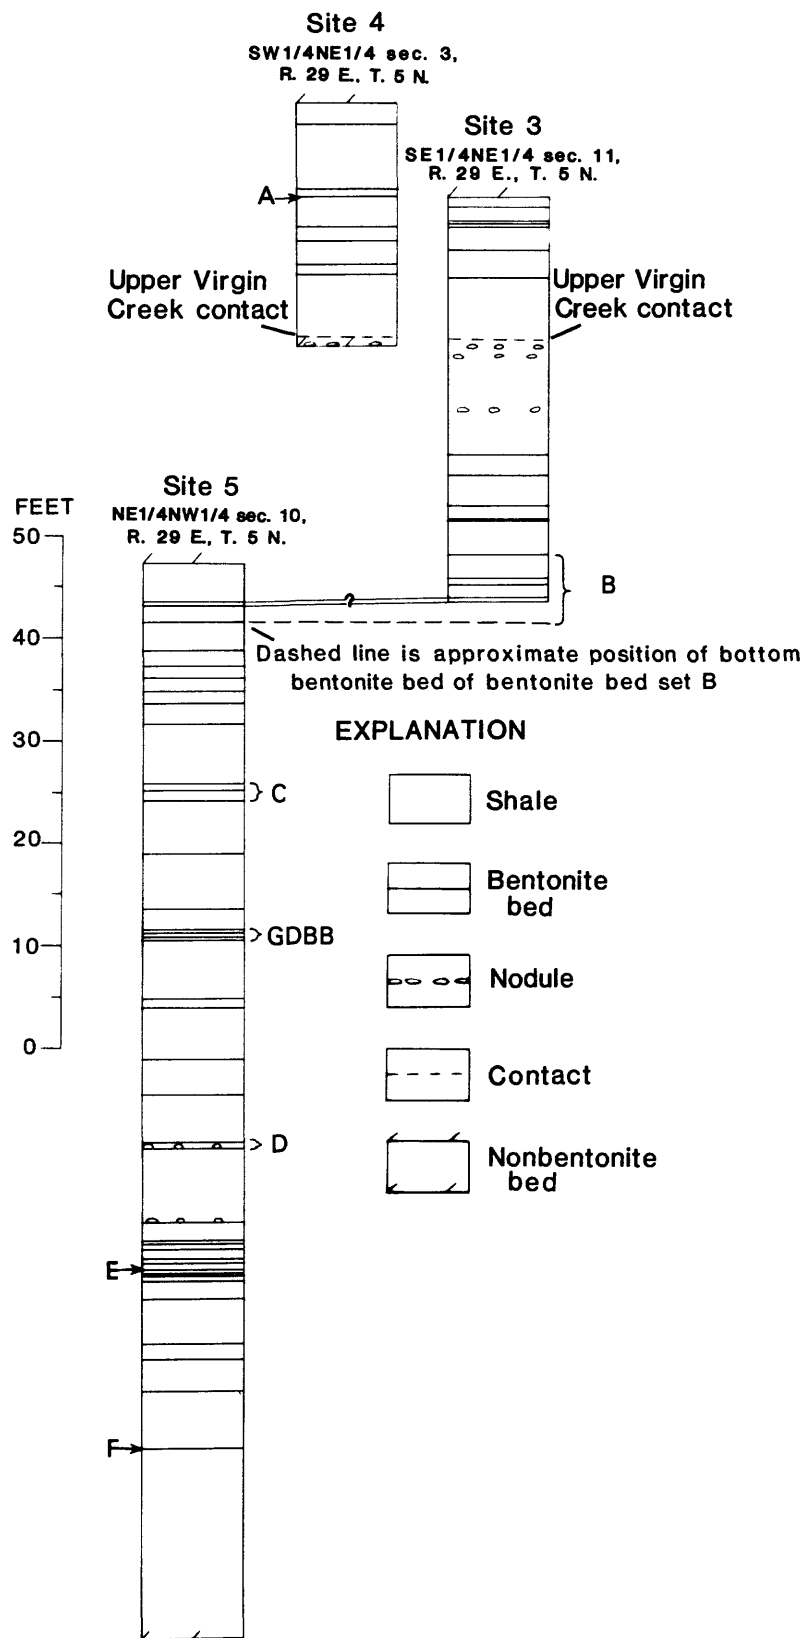
FIGURE 2. Selected measured sections of the Virgin Creek Member of the Pierre Shale. The important bentonite marker horizons within the study area are labeled F, E, D, GDBB, C, and B. (Modified from Collins, 1987.)

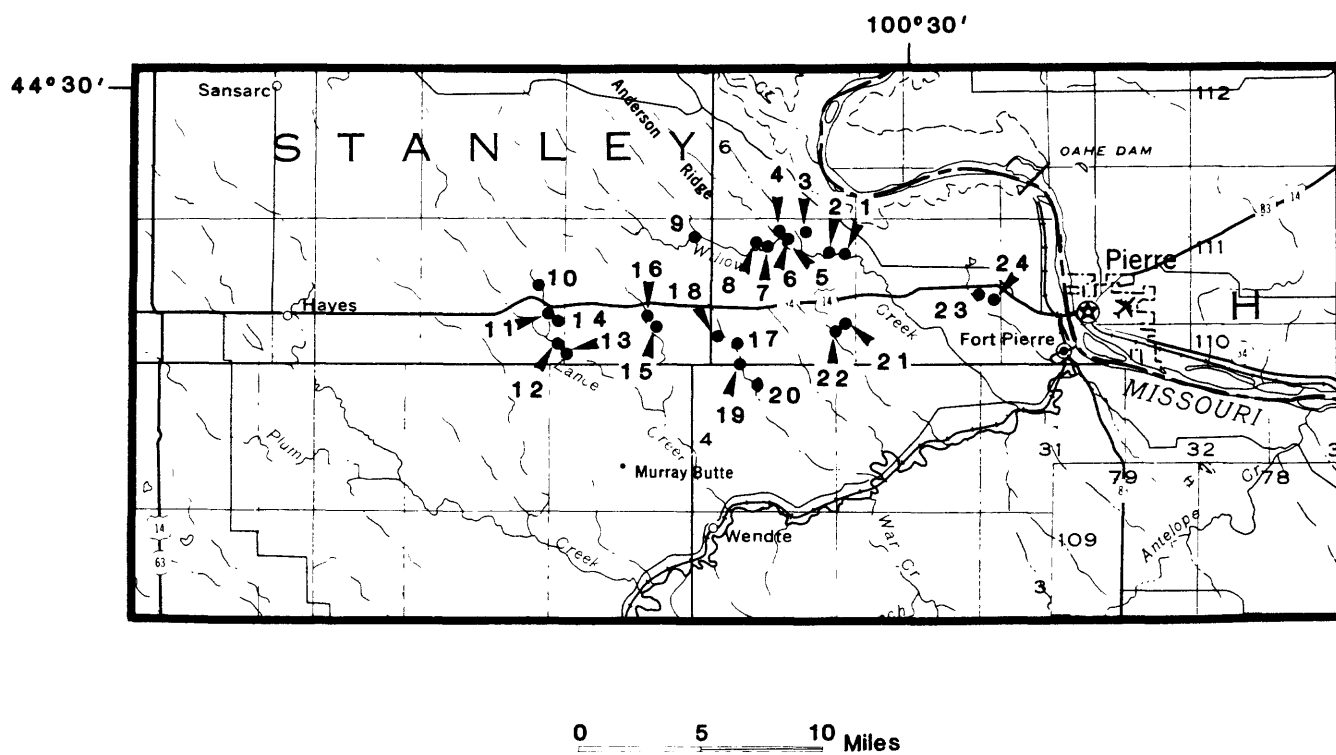
FIGURE 3. Location map showing selected fault sites described in table 1.

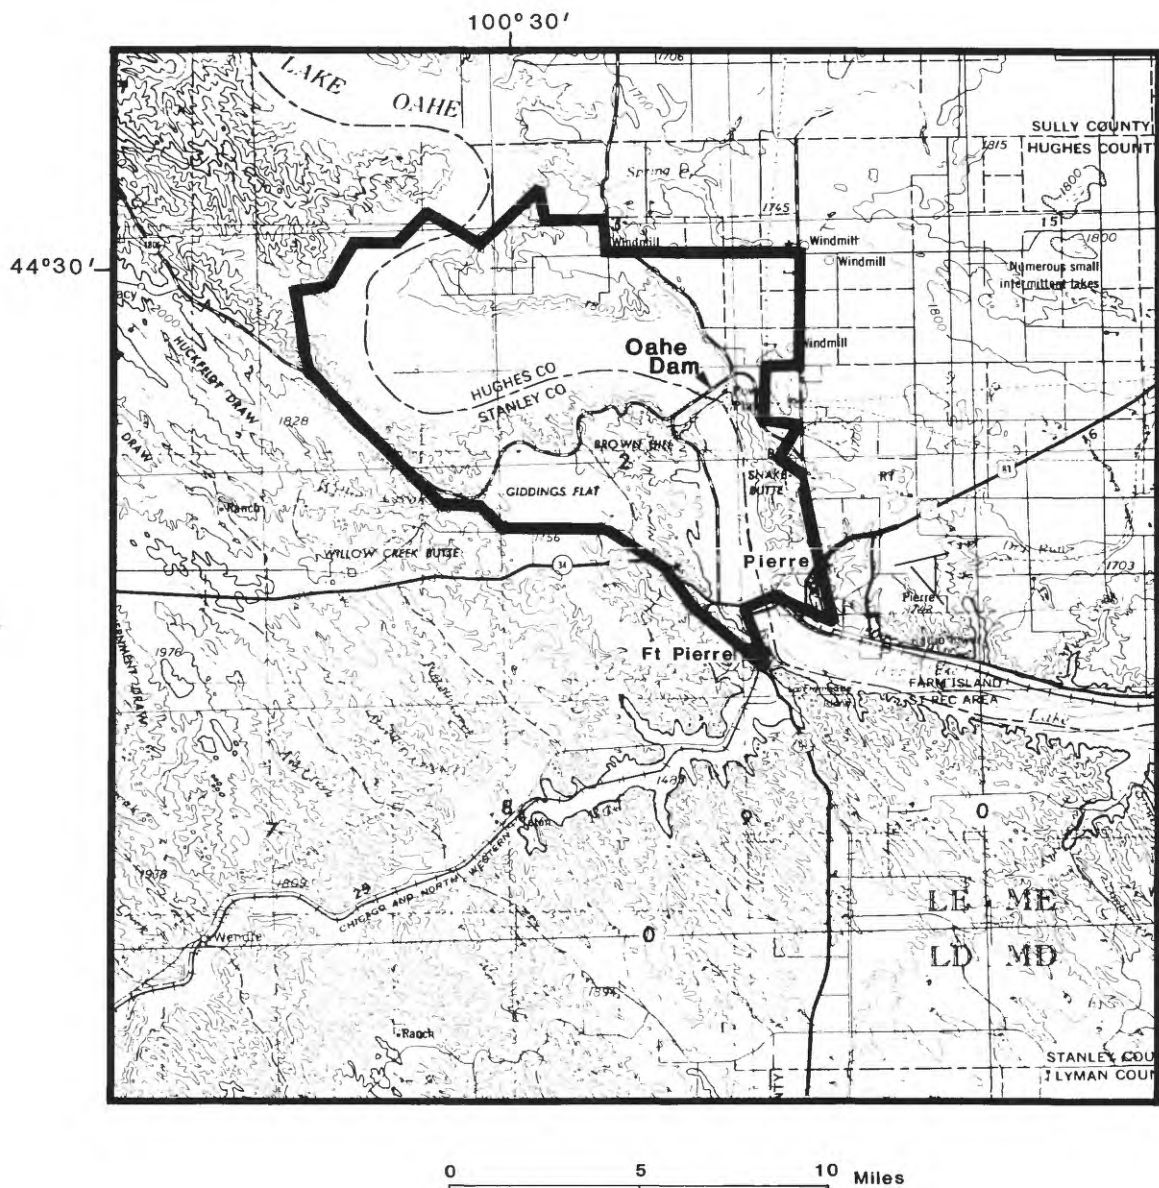
To investigate the possibility of recent or current deformation in the study area as a cause or contributing factor of highway fault movement, leveling data obtained from NOAA (National Oceanic and Atmospheric Administration) was examined for significant elevation changes. First-order level lines located in the eastern part of the study area (fig. 18) were measured for June 21 to September 27, 1949 (time A), and for June 18 to August 8, 1951 (time B). Comparison of these data (table 3) shows that elevation differences between the 2 years (time A minus time B) ranged from a positive 118.62 mm (4.67 in.) to a negative 36.37 mm (1.43 in.). The positive value represents a relative drop in elevation, whereas the negative value indicates a relative increase in elevation. The smallest (less than 5 mm (0.2 in.) in elevation) differences and some of the positive changes in elevation (that is, relative drops in elevation) occur at probably more stable bench marks that are placed on large structures such as buildings and bridges having foundations in alluvial sands and gravels. On the other hand, most of the negative elevation changes (that is, relative increase in elevation) were determined from possibly less stable concrete-post bench marks set in shale or soil deposits on higher ground in the rural areas. An examination of the weather records for the months of June through August for both 1949 and 1951 showed that 1951 was nearly three times wetter during June and August than during the same period of time for 1949 (table 4). Therefore, higher moisture values recorded in 1951 may have caused the swelling clays in the shale and soils to expand resulting in higher bench-mark elevations than observed in 1949. As a result of these findings, current uplift within this study area cannot be verified or denied from present level-line information.

FIGURE 18. Location map showing traverse of level line. Leveling data (table 3) for this traverse was gathered from June 21 to September 27, 1949, and from June 18 to August 8, 1951.
